SOUTHWEST BROOKLYN MARINE TERMINAL STATION BULKHEAD INVESTIGATION

ANNUAL BULKHEAD INSPECTION

PROJECT NO. A077181
DOCUMENT NO.
VERSION 1
DATE OF ISSUE 11/25/2015
PREPARED DDJS
CHECKED JOAC
APPROVED JOAC

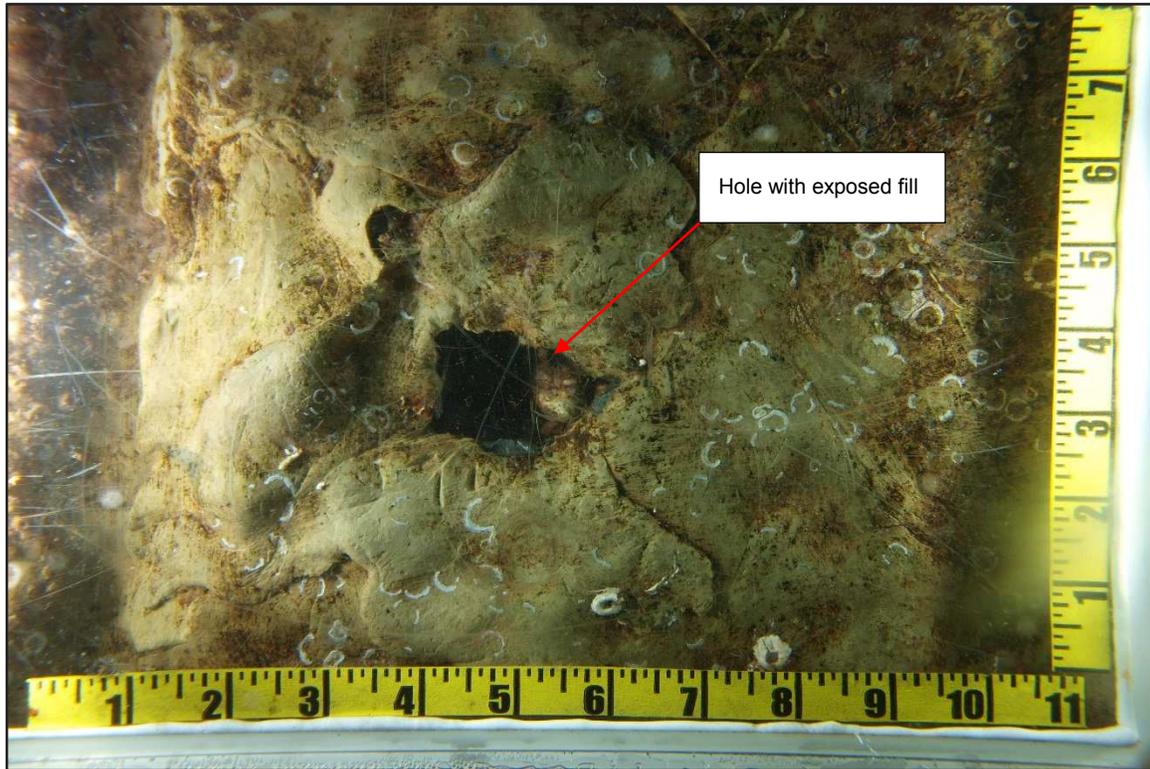
Overall, the West Bulkhead is in Poor condition due to an isolated hole within the intermediate cell adjacent to Cell F-1, a loose bracket at the cell-to-bulkhead intersection, moderate corrosion and coating failure located within the splash and tidal zone of the steel sheet piles and cellular cofferdams. Below mean low water, the steel sheet pile bulkhead was typically sound with isolated areas of failed coating and surface corrosion, and isolated coating loss and splash zone failures with surface corrosion on the steel sheet pile cellular cofferdams (Photograph 23 through Photograph 26). The steel sheet pile cellular cofferdams located at the western extent of the bulkhead have been repaired with an epoxy coating along the entire exposed face of the sheets. No access hatches for the cofferdams were exposed, so the sand levels could not be verified. Additionally, the missing steel pile cap section located at the western edge of the Z-shape steel sheet pile bulkhead noted during the previous inspection is still missing (Photograph 27).

Photograph 23: West Bulkhead – Hole through splash zone epoxy repair and steel sheet pile cell with exposed fill at intermediate cell adjacent to Cell F-1

- › Install and coat a steel patch plate (6 inches by 6 inches) over the 1 inch diameter hole observed at the intermediate cell adjacent to Cell F-1.
- › Repair the loose transition anchor bracket connection between the West Bulkhead and intermediate cell adjacent to Cell F-1. This repair will require the bearing plate to be realigned, and the nut to be tightened.

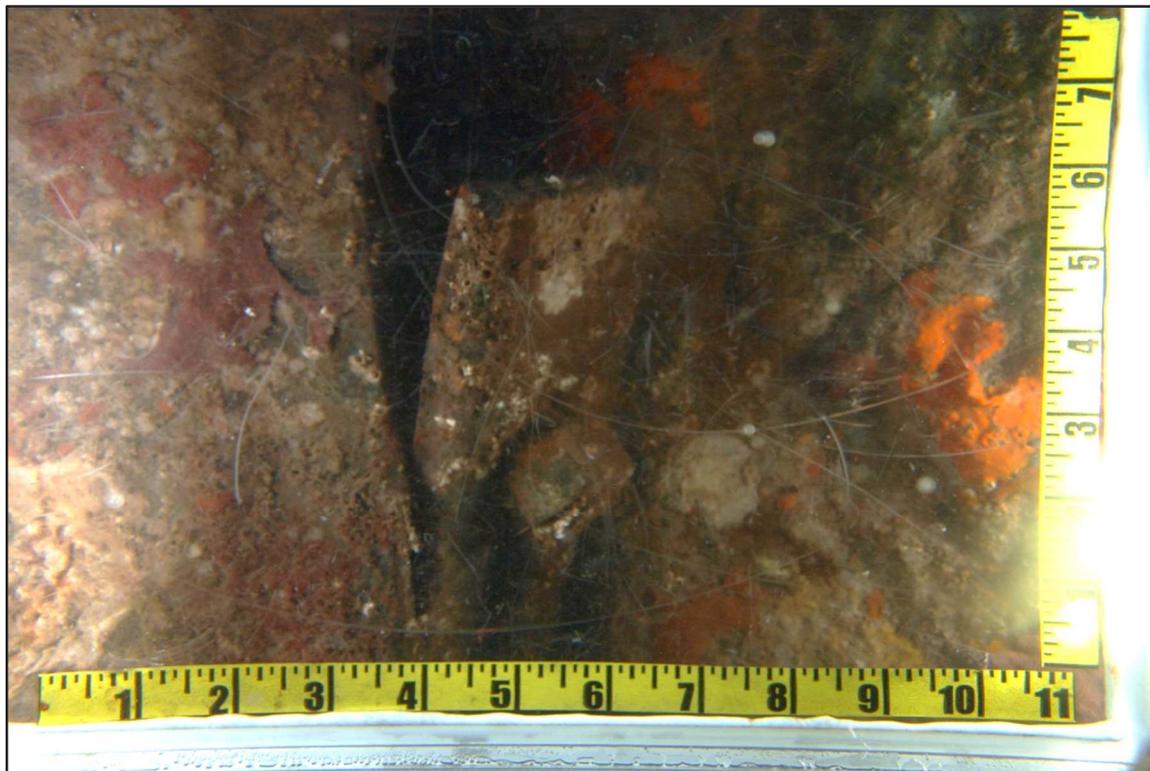
Photograph 24: West Bulkhead – Loose bracket at interface between steel sheet pile bulkhead and steel sheet pile cell

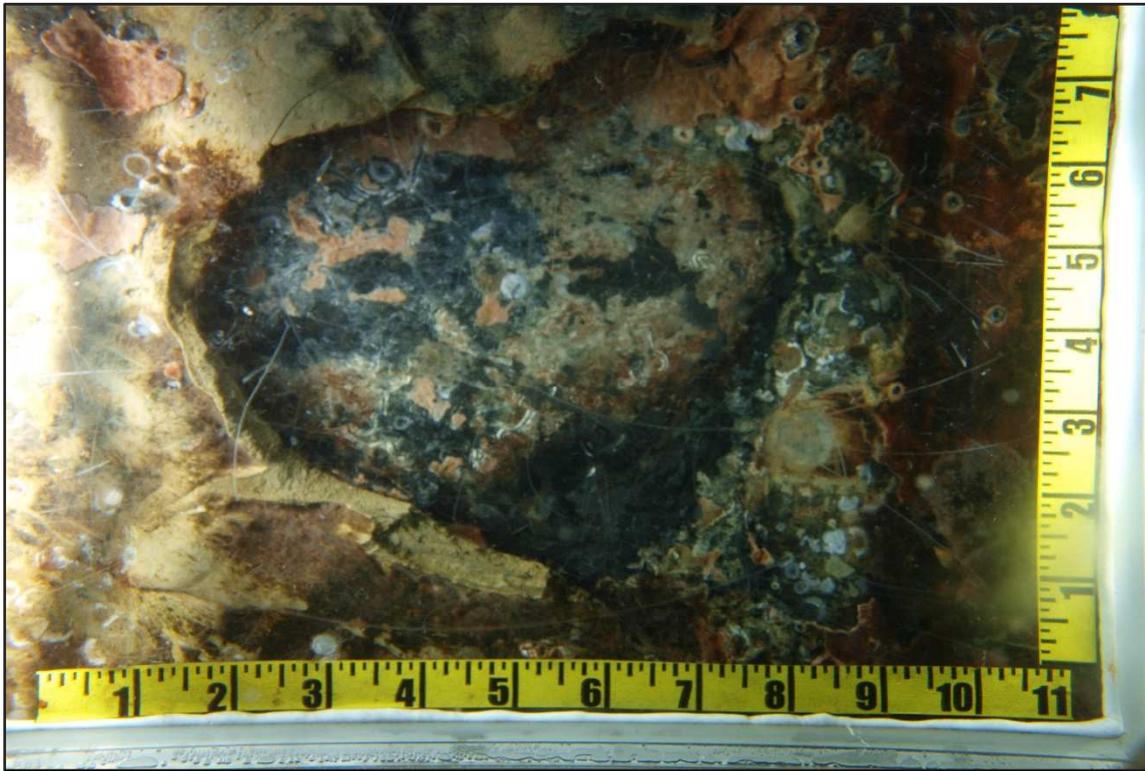
Photograph 25: West Bulkhead – Typical splash zone epoxy repair failure with moderate corrosion of exposed steel sheet pile

- › Clean and recoat the steel sheet pile cells from MLW to the top of the element at each cell. Additionally, the splash zone repairs located below MLW should be cleaned and patched, as required. Where failures have occurred, the steel should be assessed by a qualified professional to determine if structural repairs are required.

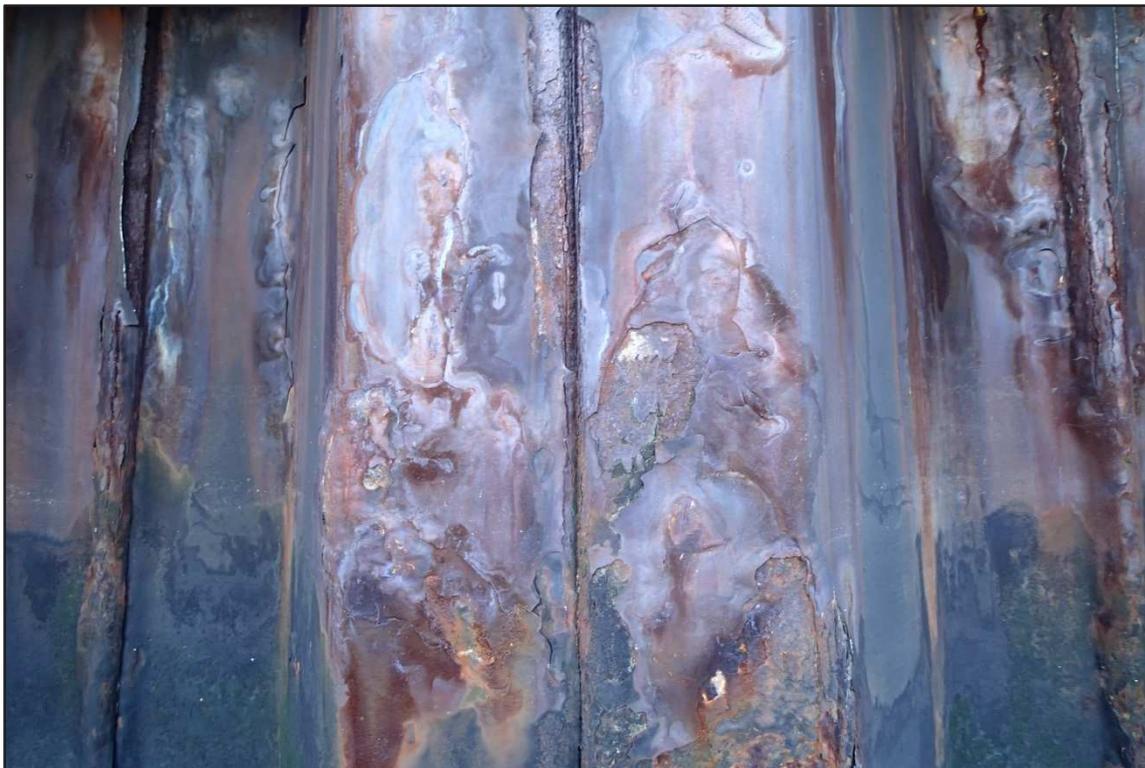
Photograph 26: West Bulkhead – Typical coating failure with moderate corrosion of steel sheet pile in splash/tidal zone

- › Clean and recoat all steel sheet piles from Mean Low Water (MLW) to top of pile at each of the three bulkheads. It is our understanding that the entire length of the North Bulkhead is scheduled to be encased in concrete pursuant to the U.S. Army Corps of Engineer's permit issued for the construction of the MTS (NAN-2008-0927). That would adequately address this recommendation for that section of bulkhead.

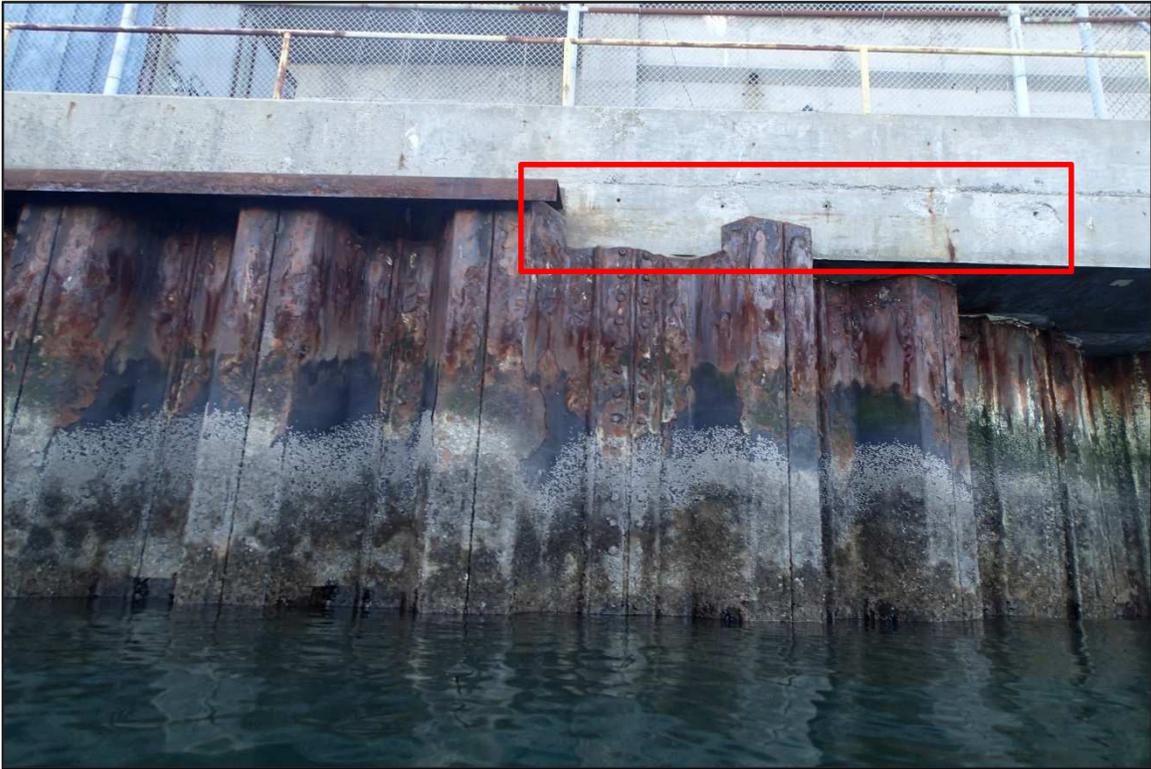
Photograph 27: West Bulkhead - Missing steel pile cap (Looking south)

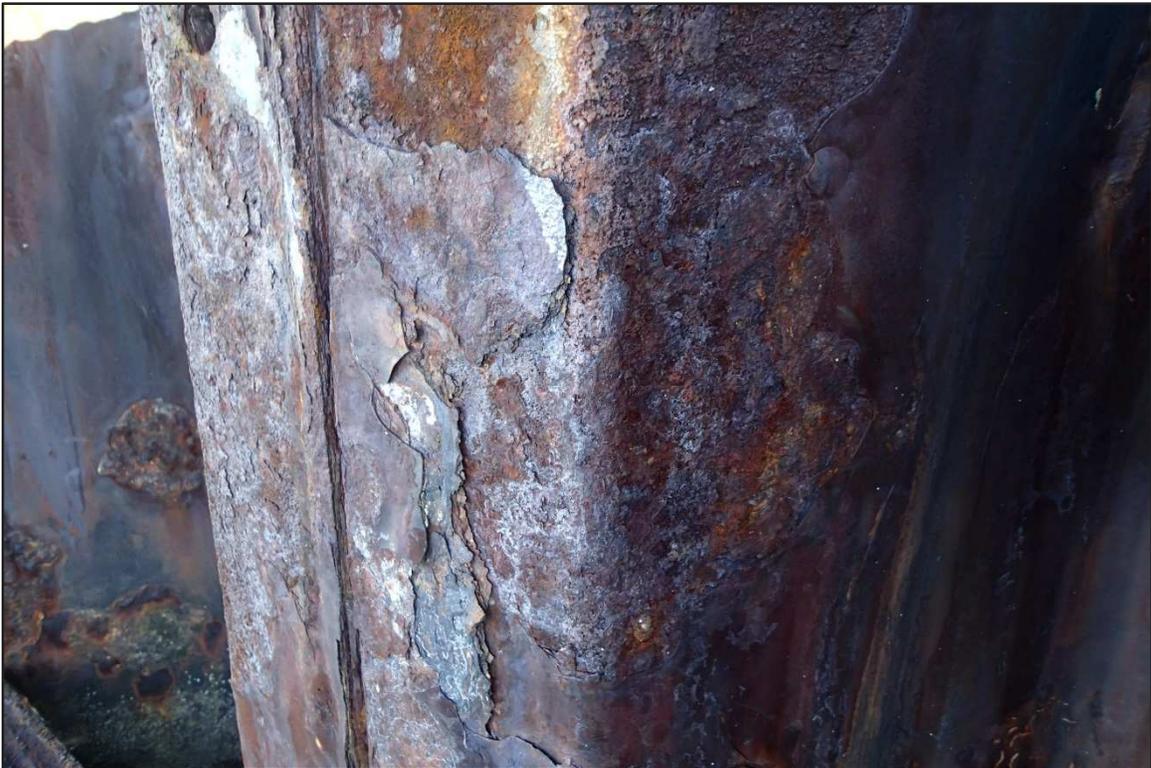
The North Bulkhead is in Fair condition due to moderate to advanced corrosion and coating failure located within the splash and tidal zone of the steel sheet piles and steel cellular cofferdams, and steel anchor tie-backs (Photograph 28 and Photograph 29). Below mean low water, the steel sheet pile bulkhead was typically sound with isolated areas of failed coating and surface corrosion (Photograph 30), and isolated coating loss and splash zone failures with surface corrosion on the steel sheet pile cellular cofferdams. The steel sheet pile cellular cofferdams located at the western extent of

Photograph 28: North Bulkhead - Typical coating failure with moderate corrosion of steel sheet pile in splash/tidal zone

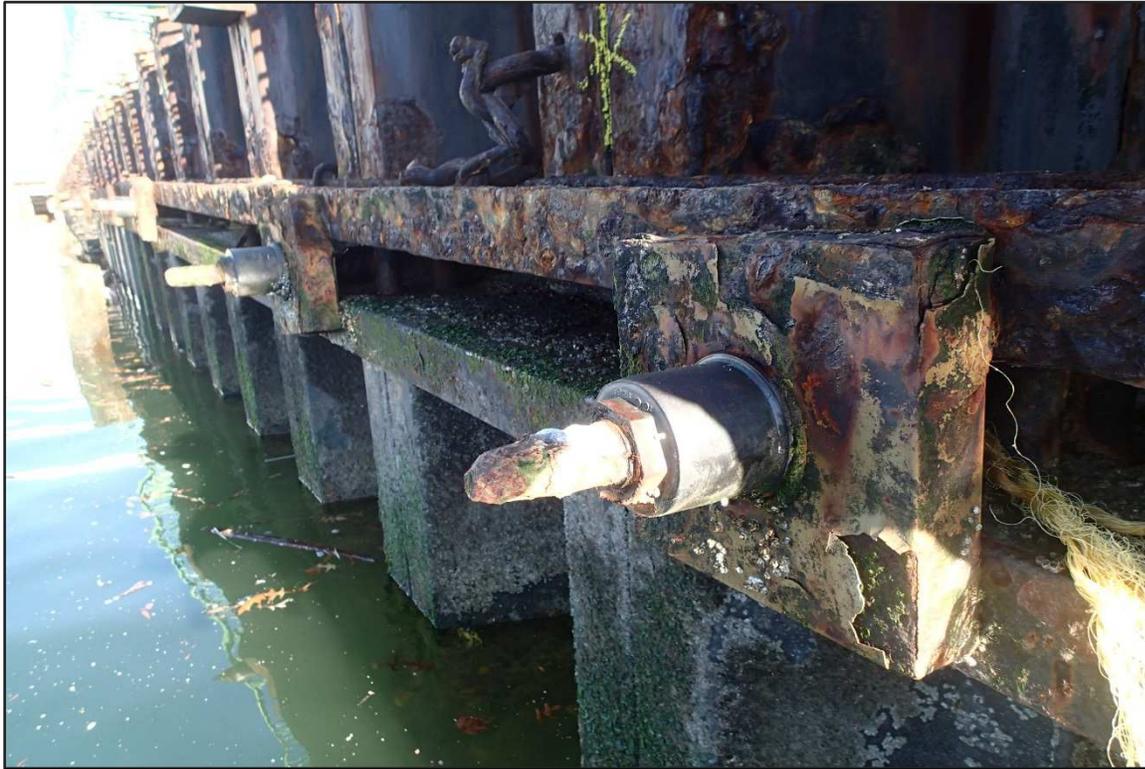
Photograph 29: North Bulkhead – Typical coating failure with moderate corrosion of steel channel wale, anchor rod, and hardware in splash/tidal zone

- › Clean and recoat the double channel tie-back wale along the North and East Bulkheads. It is our understanding that the entire length of the North Bulkhead is scheduled to be encased in concrete pursuant to the U.S. Army Corps of Engineer's permit issued for the construction of the MTS (NAN-2008-0927). That would adequately address this recommendation for that section of bulkhead.

- › Clean and recoat the exposed portions of the steel anchor tie-backs and associated hardware along the North and East Bulkheads. It is our understanding that the entire length of the North Bulkhead is scheduled to be encased in concrete pursuant to the U.S. Army Corps of Engineer's permit issued for the construction of the MTS (NAN-2008-0927). That would adequately address this recommendation for that section of bulkhead.

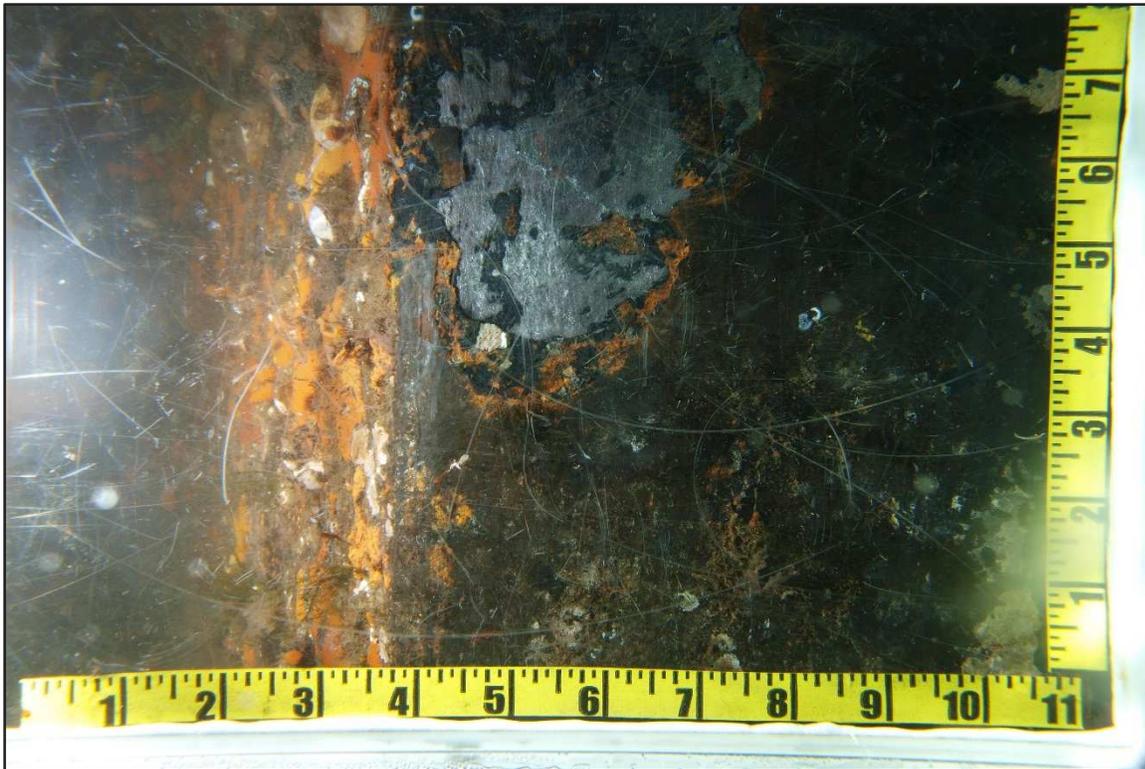
Photograph 30: North Bulkhead - Typical coating failure with moderate corrosion of steel sheet pile underwater

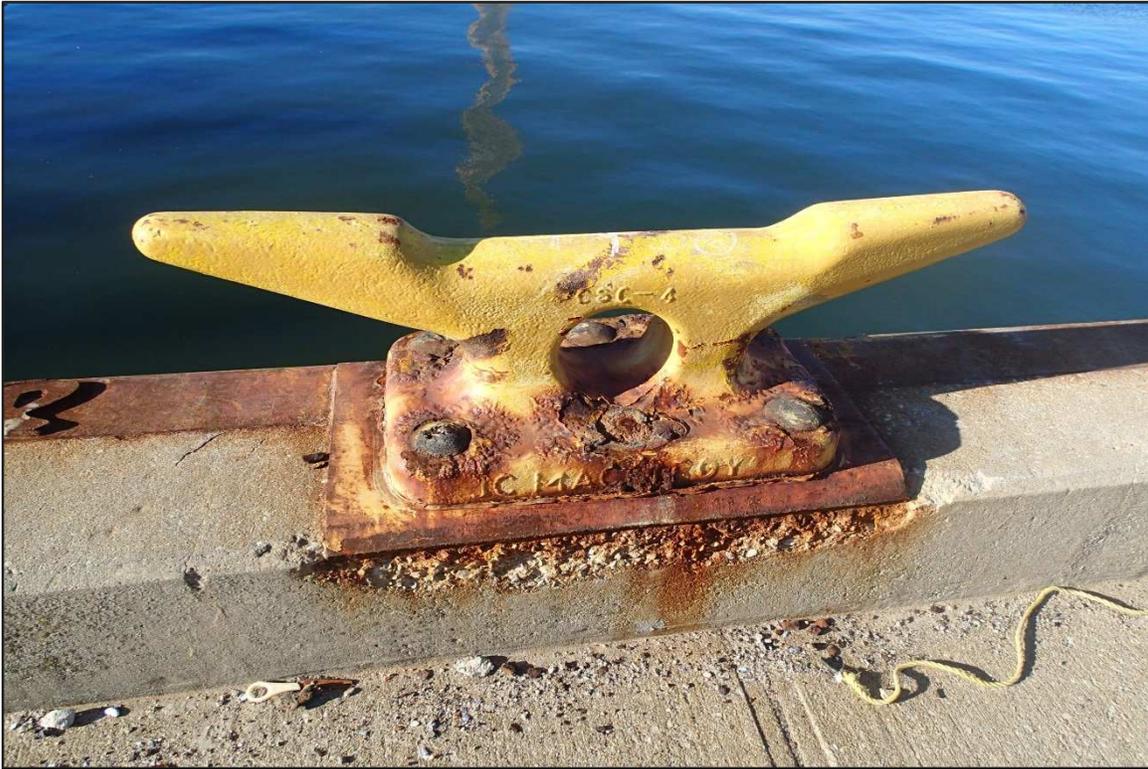
Photograph 31: North Bulkhead - Typical light to moderate corrosion of mooring hardware cleat

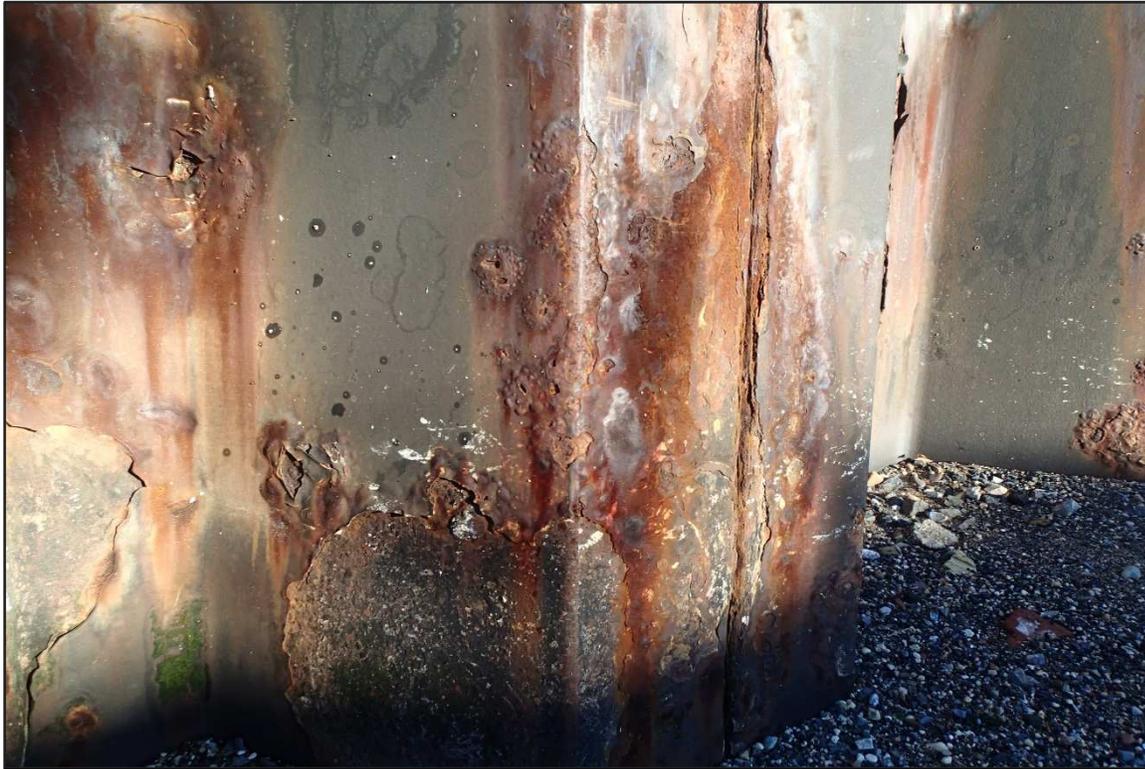
Overall, the East Bulkhead is in Fair condition due to moderate corrosion and coating failure located within the splash and tidal zone of the steel sheet piles and of the steel anchor tie-backs (Photograph 33 and Photograph 34), and isolated spalling of the concrete curb (Photograph 35). Below mean low water, the steel sheet pile bulkhead is typically sound with isolated areas of failed coating and surface corrosion. The external double channel wale has 100 percent coating loss with moderate corrosion (Photograph 36). No access hatches for the cellular cofferdams inshore of the existing bulkhead were exposed, so the sand levels could not be observed or measured. The areas where the access hatches would presumably be located appear to have been paved over and are currently staging construction material for the ongoing construction effort

Photograph 33: East Bulkhead - Typical coating failure and moderate corrosion in the splash/tidal zone

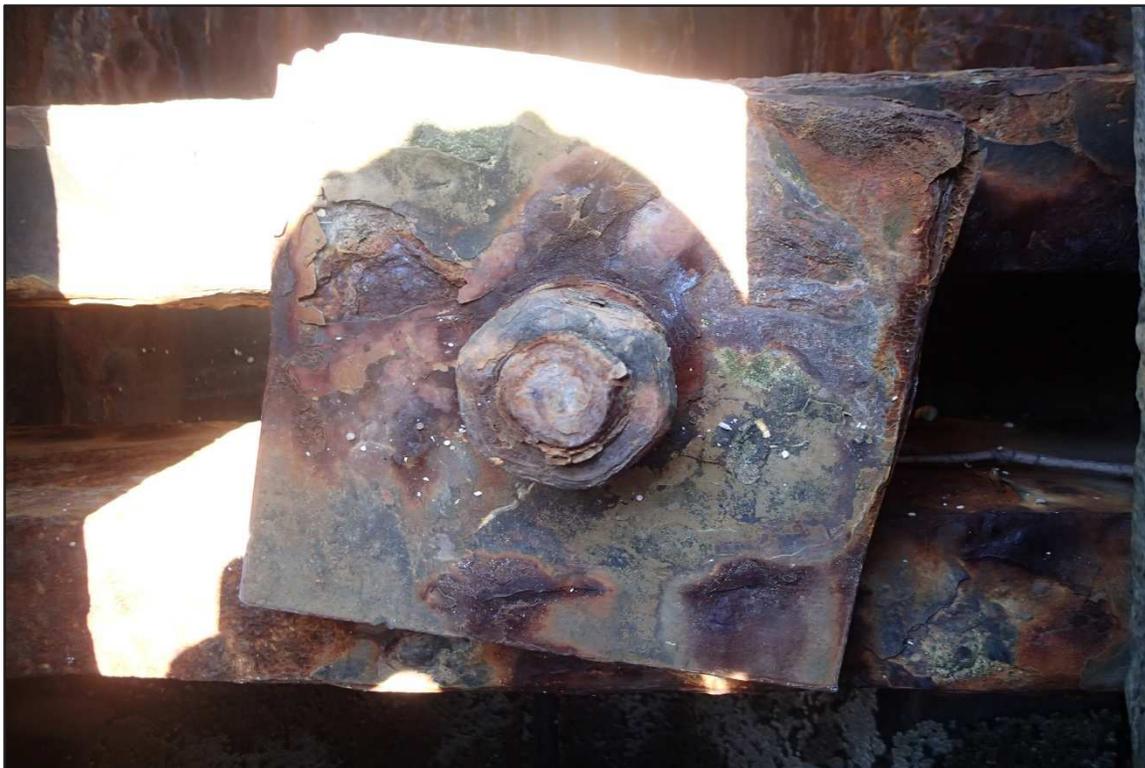
Photograph 34: East Bulkhead - Typical coating failure with moderate corrosion of steel channel wale, anchor rod, and hardware in splash/tidal zone

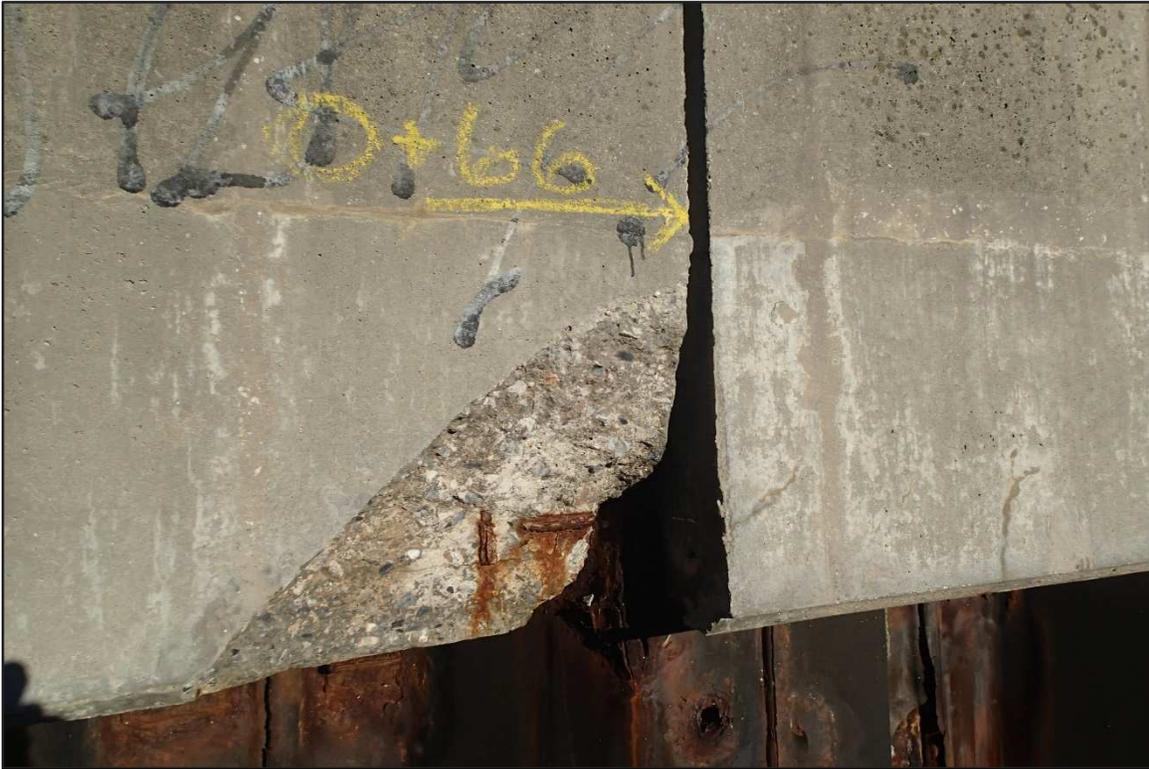
Photograph 35: East Bulkhead – Open spalling with exposed reinforcement at Sta. 0+66

Clean and recoat the steel sheet piles from Mean Low Water (MLW) to the top of the element.
	Clean and recoat the double channel tie-back wale. It is our understanding that the entire length of the North Bulkhead is scheduled to be encased in concrete pursuant to the U.S. Army Corps of Engineer's permit issued for the construction of the MTS (NAN-2008-0927). That would adequately address this recommendation for that section of bulkhead.
	Clean and recoat the exposed portions of the steel anchor tie-backs and associated hardware. It is our understanding that the entire length of the North Bulkhead is scheduled to be encased in concrete pursuant to the U.S. Army Corps of Engineer's permit issued for the construction of the MTS (NAN-2008-0927). That would adequately address this recommendation for that section of bulkhead.
East Bulkhead	Clean and patch the observed open spalling located at Station 0+66.

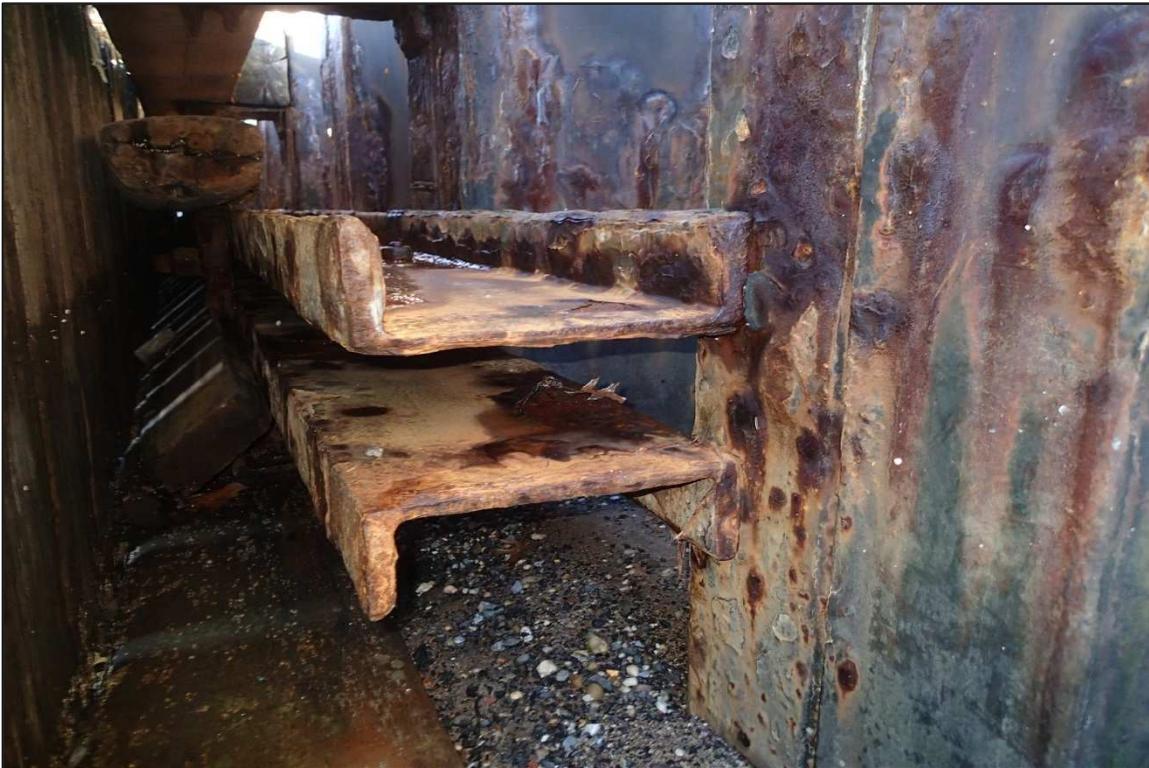
Photograph 36: East Bulkhead - Typical coating failure with moderate corrosion of steel channel wale inshore of timber fender system in splash/tidal zone

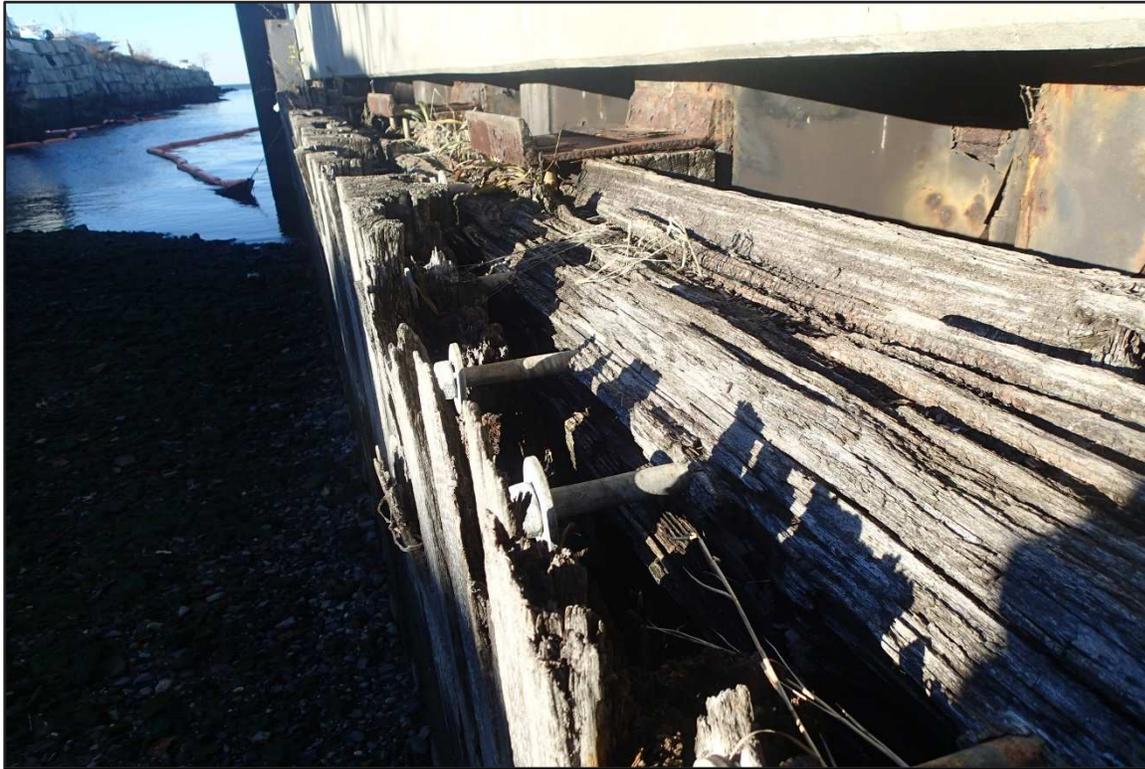
Inspection of the fender system was outside the scope of work for this investigation, but as stated above, the fender system along the North Bulkhead has been removed. It should also be noted that the East Bulkhead fender system is clearly in Serious condition. Severe deterioration due to rot and weathering was observed at the upper wale and at the top foot of the timber planks (Photograph 37 and Photograph 38).

Photograph 37: East Bulkhead - Failed timber panel upper connections due to rot

- › Remove the timber fender system located along the East Bulkhead to reduce the dead load on the steel sheet piles and provide access to the steel sheet pile bulkhead should cleaning and recoating repairs be necessary. It is our understanding that the existing fender system is scheduled to be replaced pursuant to the U.S. Army Corps of Engineer's permit issued for the construction of the MTS (NAN-2008-0927). That would adequately address this recommendation.
- › Clean and patch the observed open spalling located at Station 0+66 at the East Bulkhead. If this segment of bulkhead is schedule to be removed as a part of the ongoing construction efforts, this recommendation is not required.

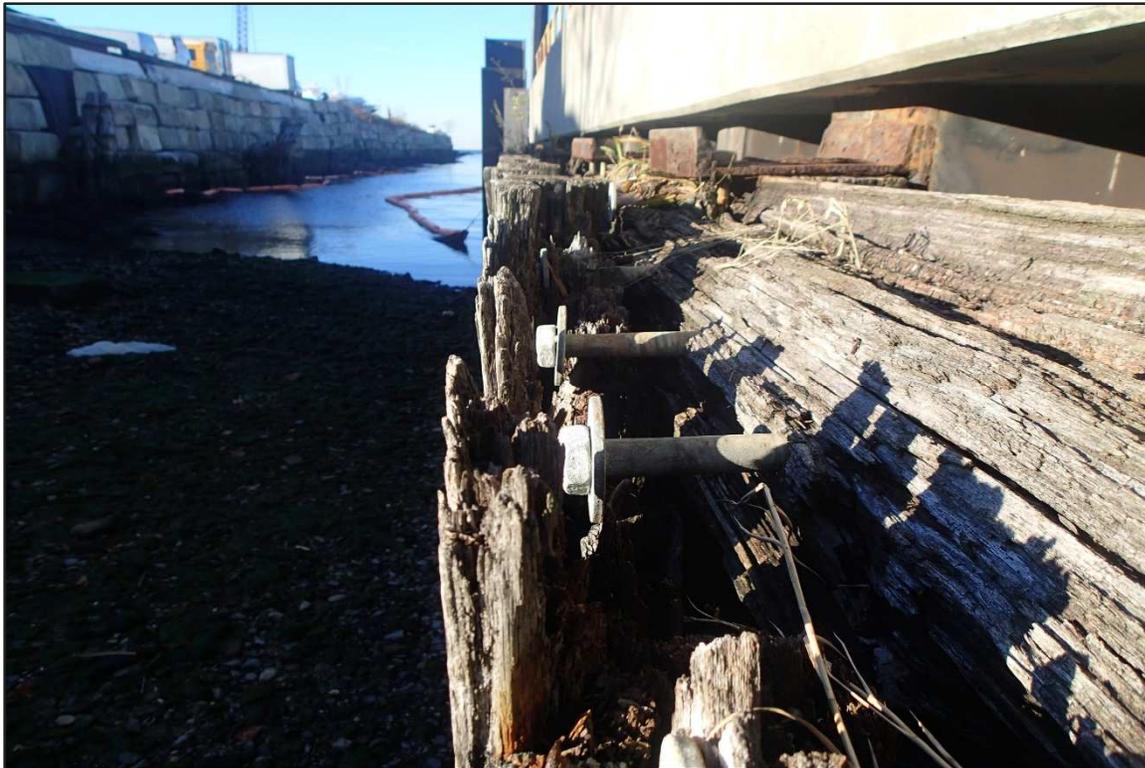
Photograph 38: East Bulkhead - Heavy rot of the upper timber horizontal wale and panels
