New York City Department of Sanitation
Marine Export of Solid Waste

COFFERDAM INPECTION REPORT

**SOUTHWEST BROOKLYN MARINE
TRANSFER STATION**

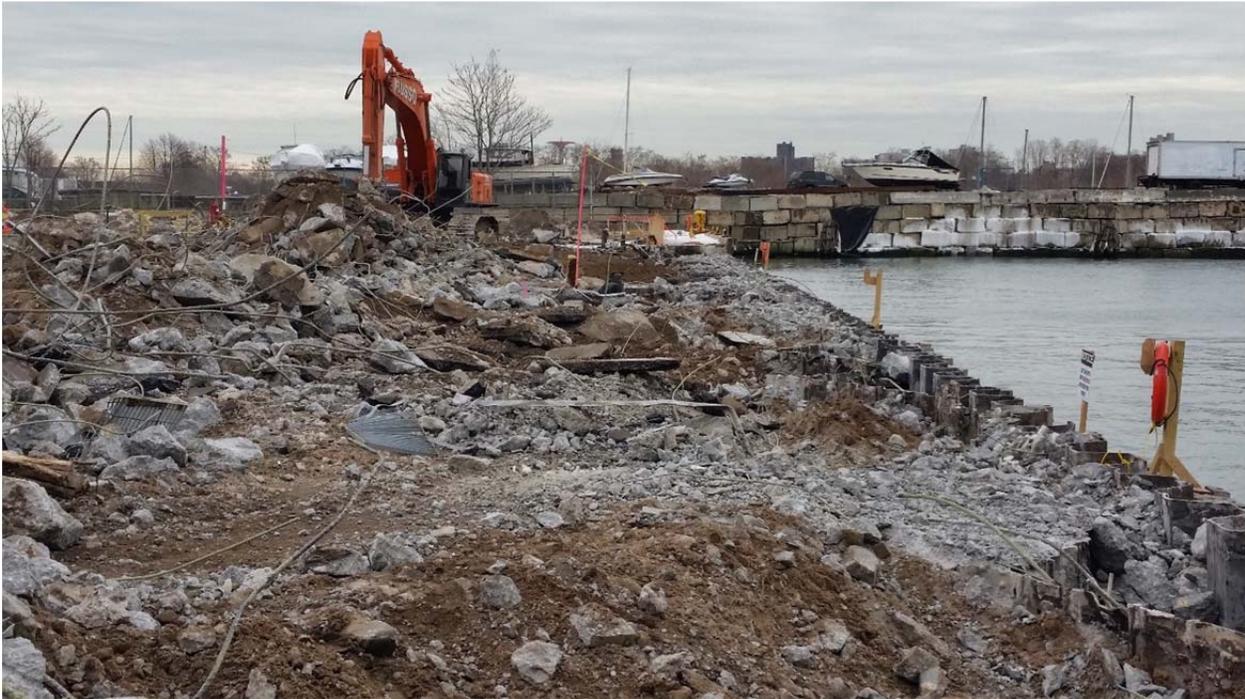
The Contractor performed the demolition of the slab along the North bulkhead and exposed the cofferdams. The cofferdams are at approximately the same elevation as the existing bulkhead as shown on the attached photographs. A visual inspection was performed and there is no apparent loss of fill in the cofferdams.

Figure 2: Photograph of Exposed Cofferdam

The cofferdams appear to be in good condition with no apparent loss of fill. Therefore, no remedial action is required or recommended at this time. During construction, inspection ports will be installed in the pier deck at the location of each cofferdam and as close to the bulkhead as possible. From these ports a stick measure can be taken of the cofferdam fill level every five years as required by Special Condition 24(ii) of the Permit.

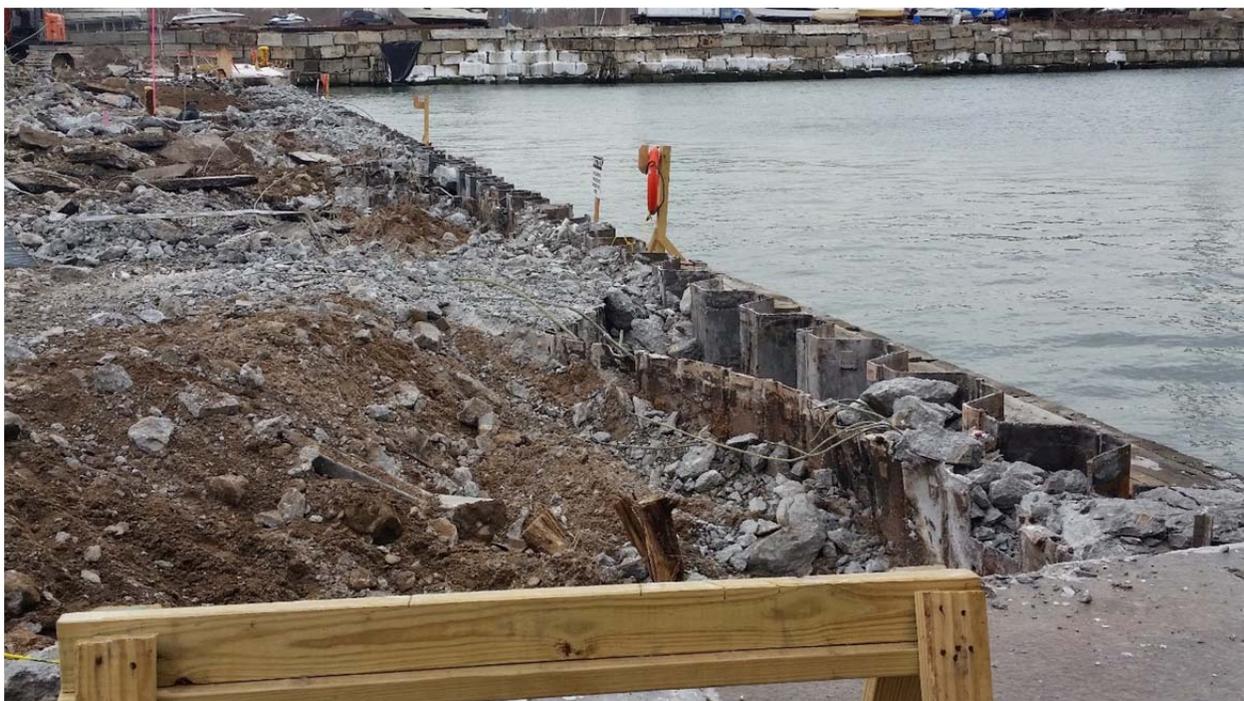
Figure 3: Photograph of Exposed Cofferdam

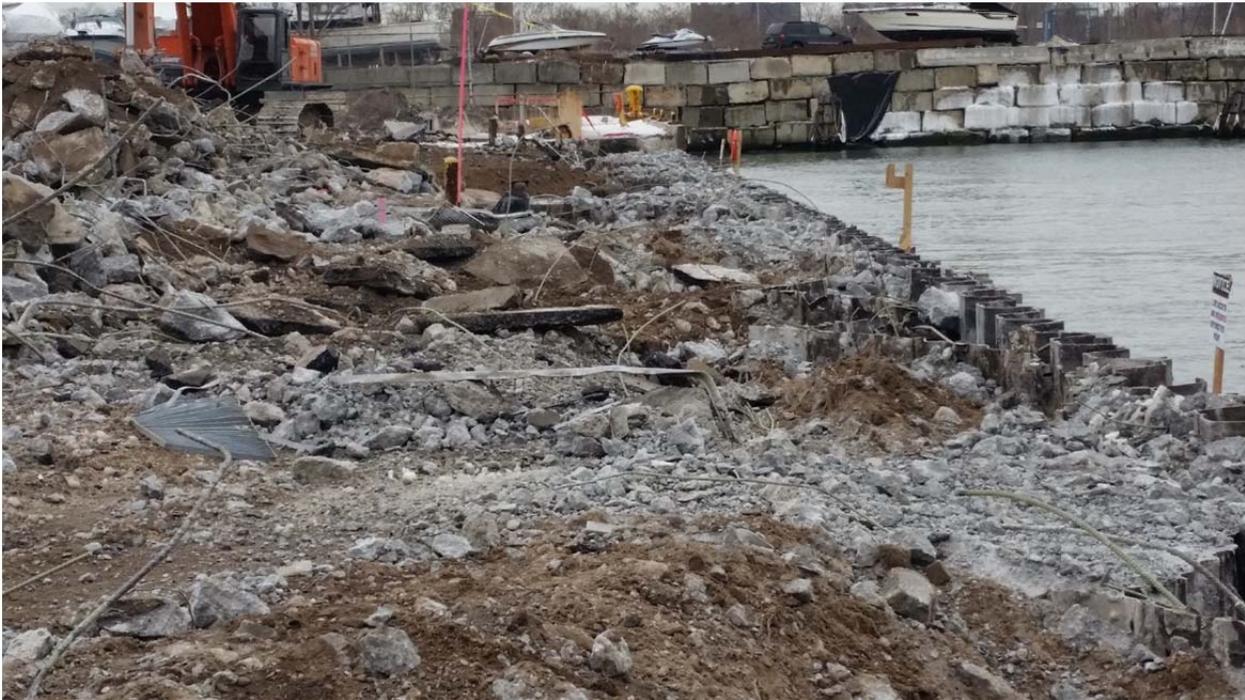
Figure 4: Photograph of Exposed Cofferdam
