62 GREENE STREET

ADDRESS: 62 GREENE ST., NEW YORK, NY 10012
MANHATTAN COMMUNITY BOARD: 2
BLOCK: 485
LOT: 3
ZONING: M1-5A

SoHo-Cast Iron
Historic District
Manhattan
Designated: August 14, 1973

**62 GREENE STREET
EXISTING CONDITIONS**

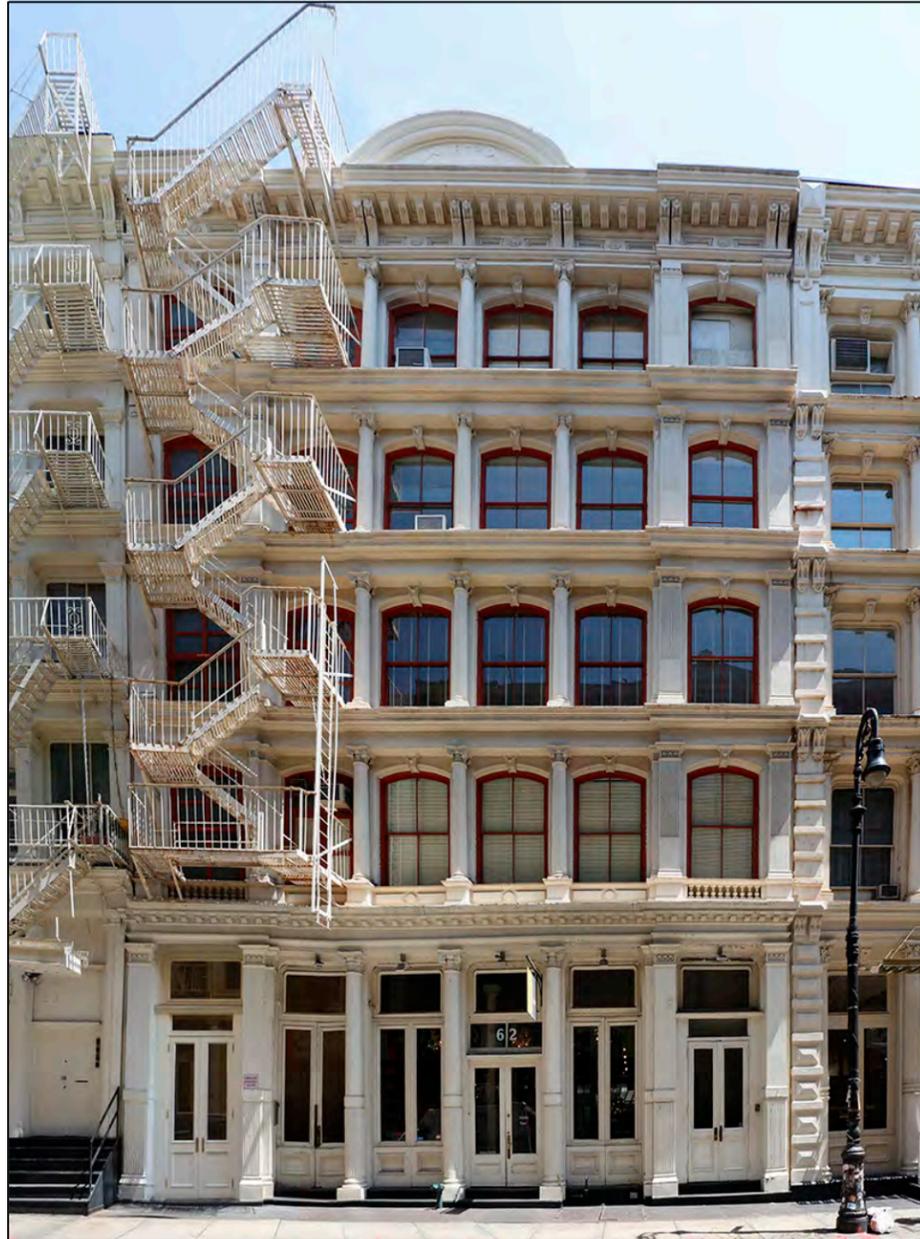
Present Condition, Street Façade (West)

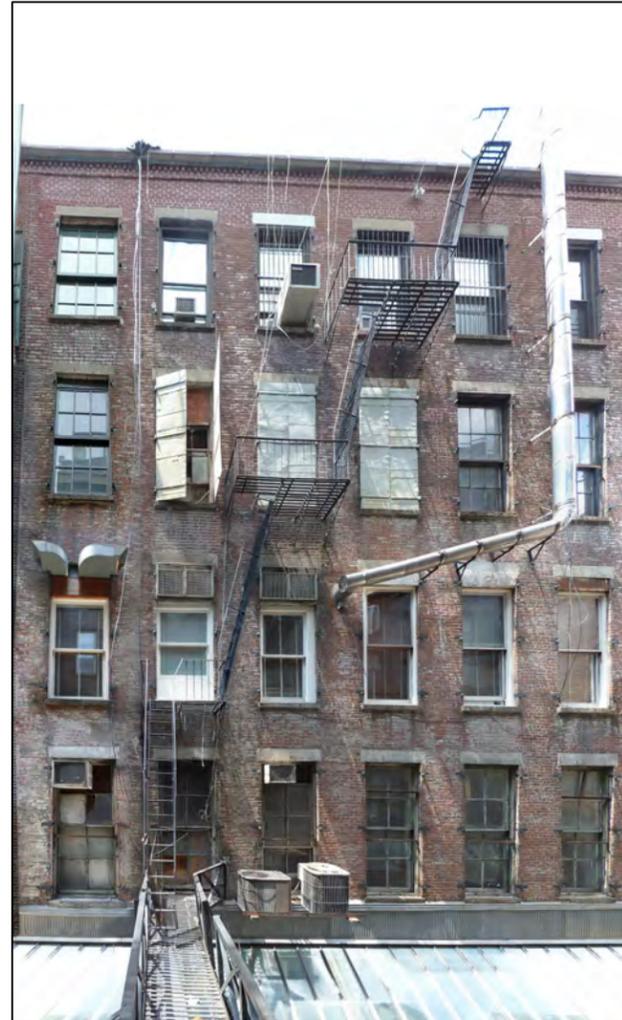
Present Condition, Rear non-visible Elevation (East)

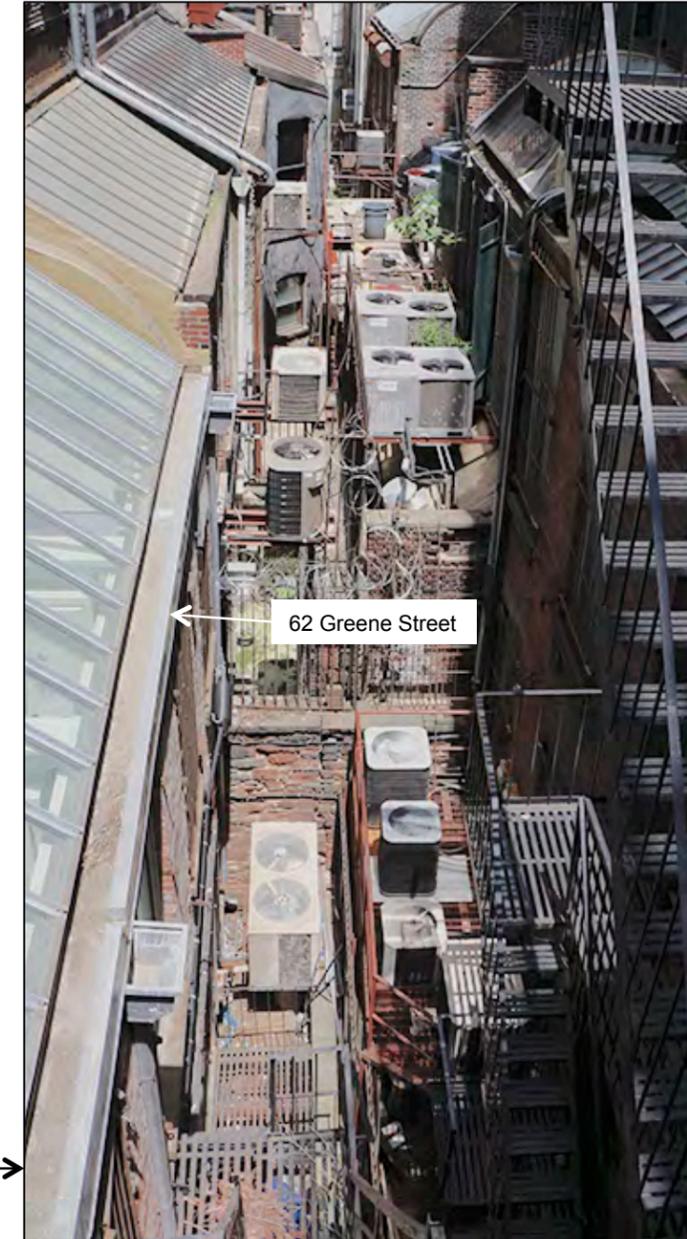
Present Condition of Rear Yard below setback skylight

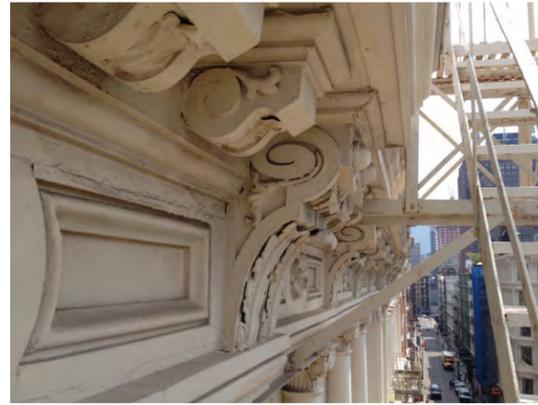
PHOTO 3: Cornice frieze and dentils. Sheet metal is in good condition.

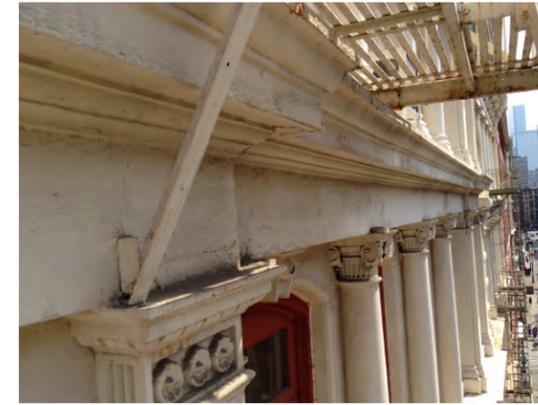
PHOTO 8: Fifth floor water table. Cast iron is in good condition.

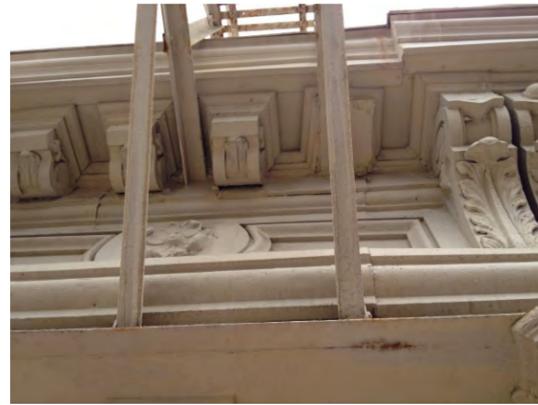
PHOTO 5: Lintel plate supporting the fire escape brackets needs to be repaired.

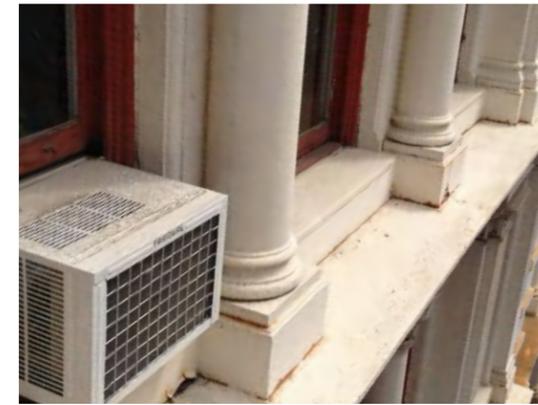
PHOTO 10: Third floor water table and columns. Cast iron is in good condition, repainting is required.

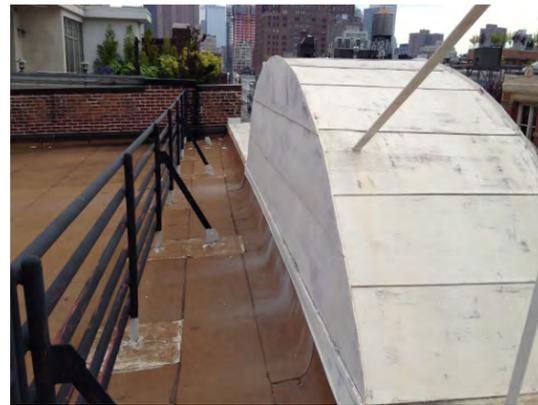
PHOTO 7: Pediment roof is in good condition, sheet metal needs repainting.

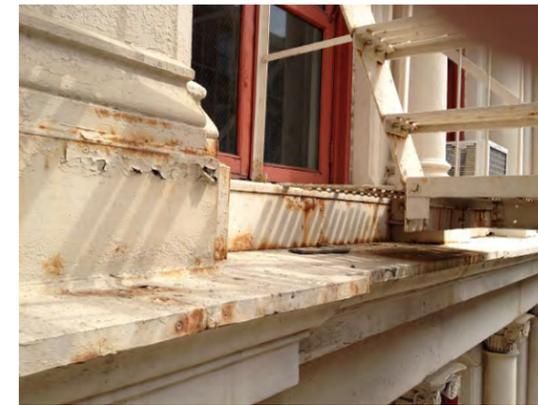
PHOTO 12: Ledges at fire escape require detailed review of all plates and fire escape components.

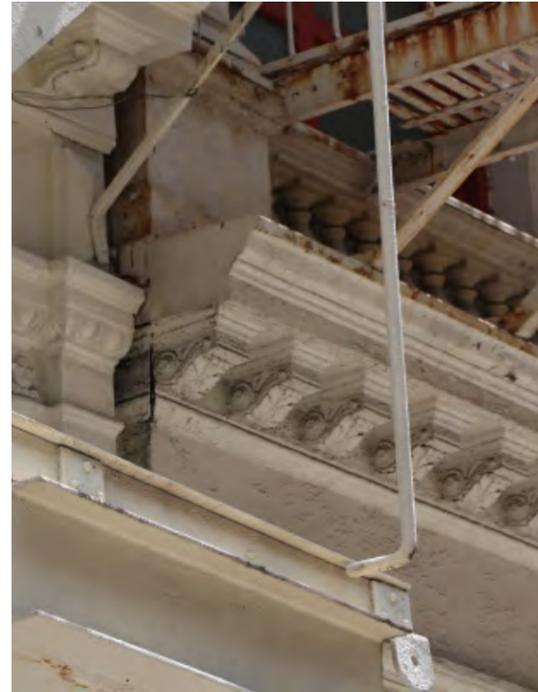
PHOTO 14: Second floor, north end. Signs of corrosion at cast iron and fire escape components.

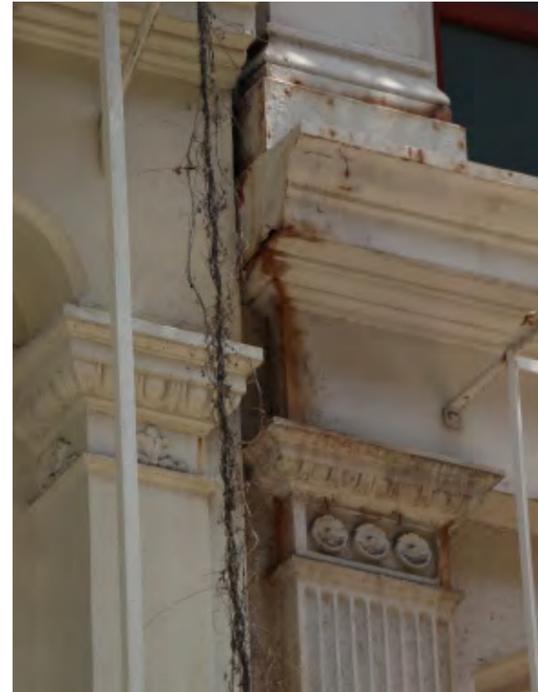
PHOTO 15: Third floor, north end. Signs of corrosion at mitered cast iron joints.

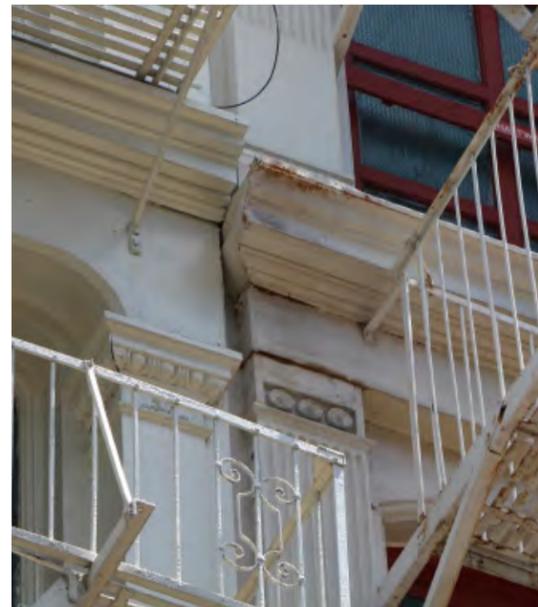
PHOTO 16: Fifth floor, north end. Signs of corrosion at cast iron joints, pilaster capital missing.

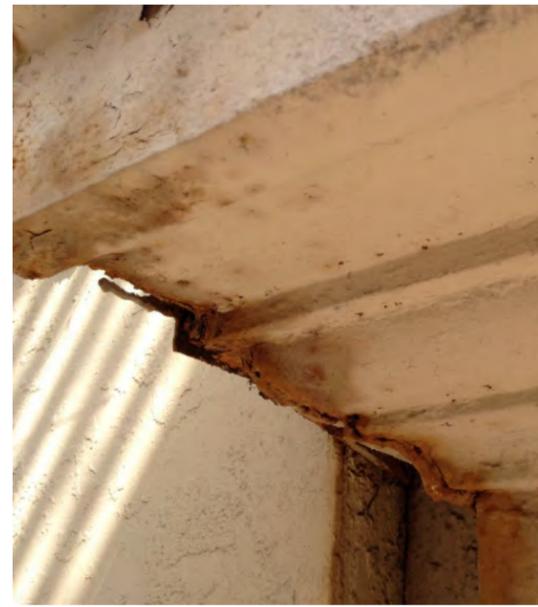
PHOTO 17: Close-up view of corroded, mitered joint.

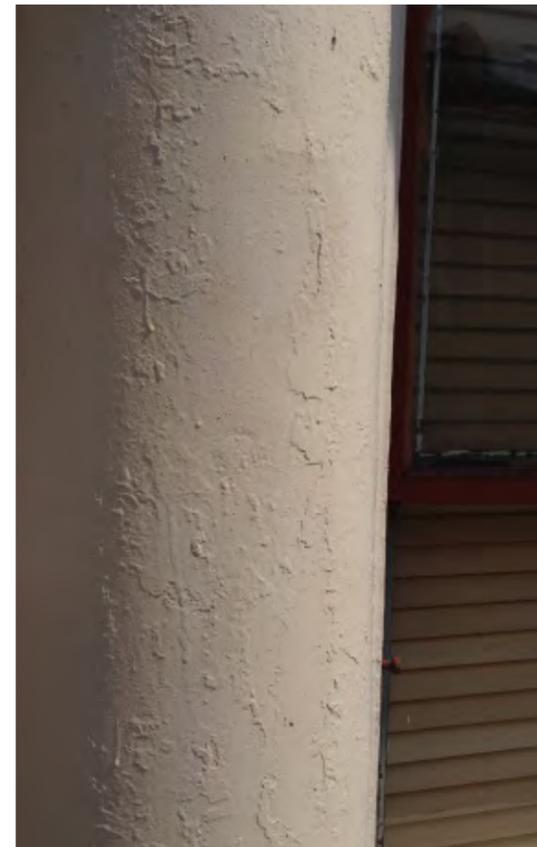
PHOTO 18: Column shaft. Minimal paint preparation performed, topcoat applied over textured surface (previous coatings not removed).

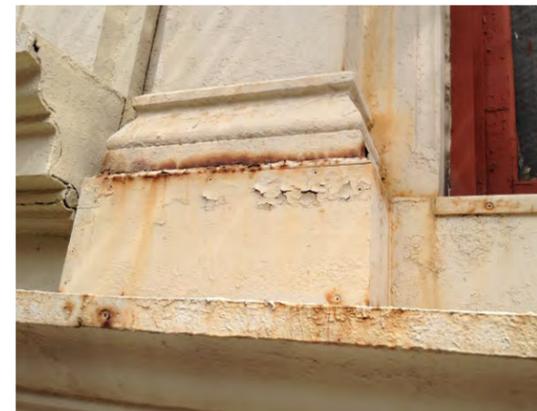
PHOTO 20: Pilaster shaft and water table ledge. Paint is in poor condition, cast iron corrosion has developed.

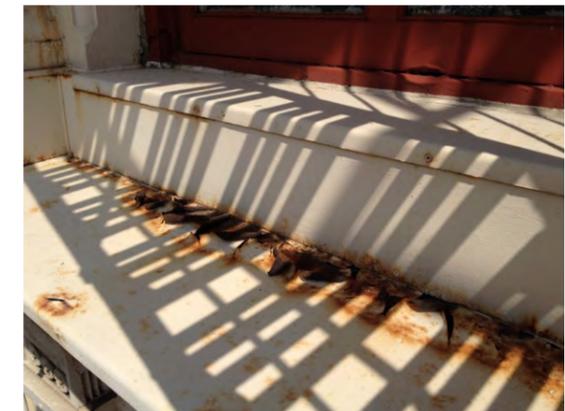
PHOTO 21: Water table ledge. Paint is peeling, cast iron is corroding at areas where paint has failed.

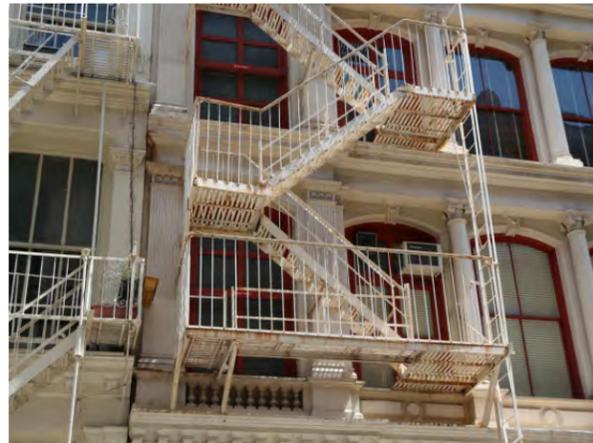
PHOTO 22: General view of fire escape, floors 2-3. In fair condition. Requires review of fasteners, repairs to connections, & repainting.

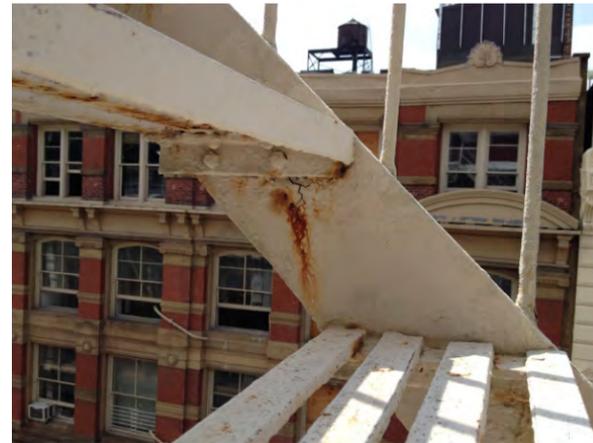
PHOTO 23: View of stair tread. Corrossion observed at connections and stringers.

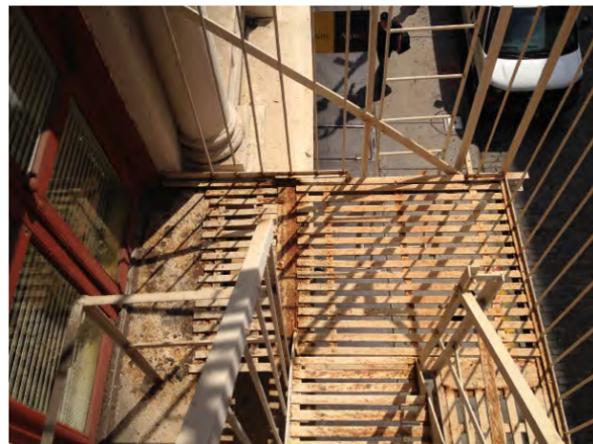
PHOTO 24: View of fire escape landing. Rust and corrossion observed.

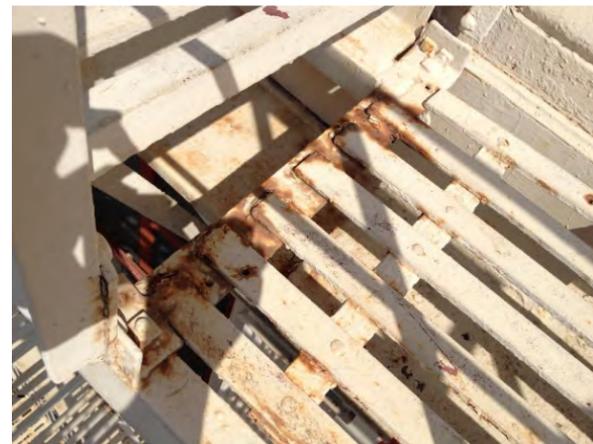
PHOTO 25: Close-up view of corrossion at landings, where horizontal slats meet support brackets.

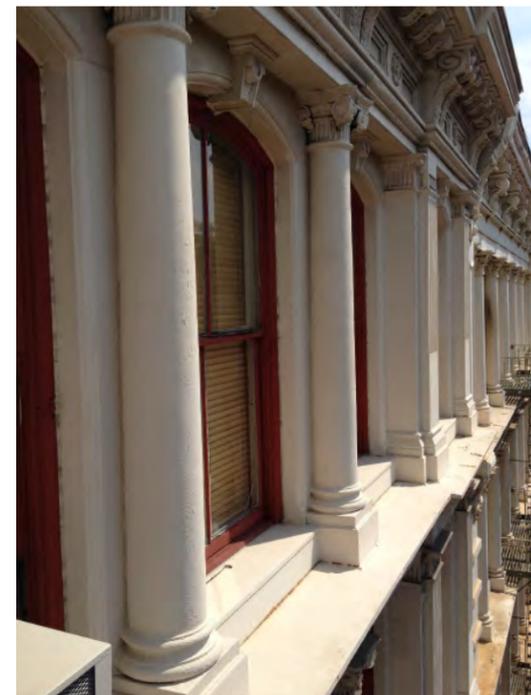
PHOTO 26: 5th floor windows, bays 3-5. Original double-hung wood windows w/single pane glazing and glazing putty are in very poor condition.

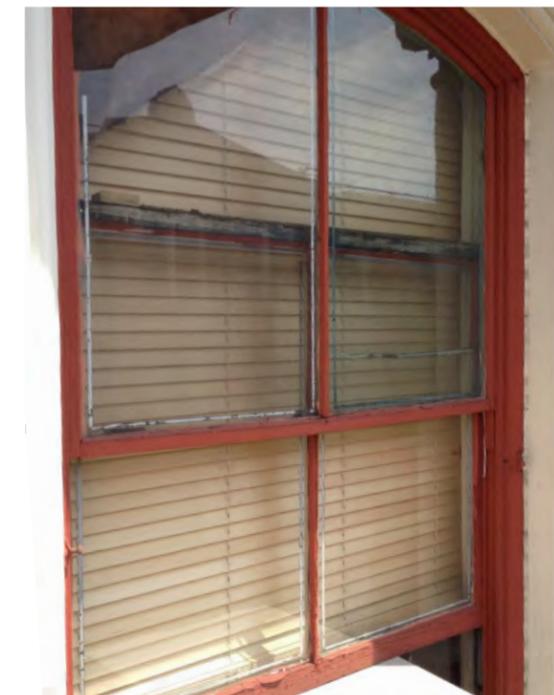
PHOTO 27: Close-up view of 5th floor, deteriorated window.

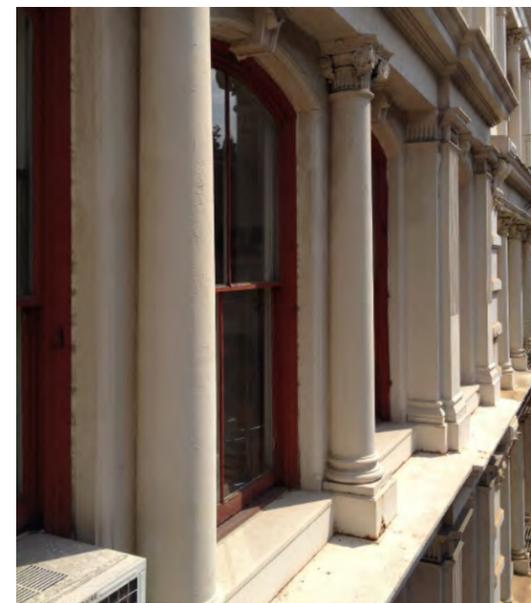
PHOTO 28: 4th floor windows, bays 3-5. Original double-hung wood windows w/single pane glazing and glazing putty. In very poor condition.

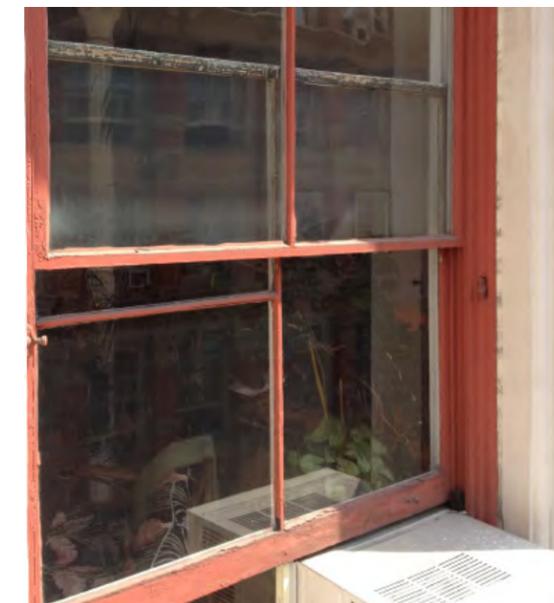
PHOTO 29: Close-up view of 4th floor, deteriorated window.

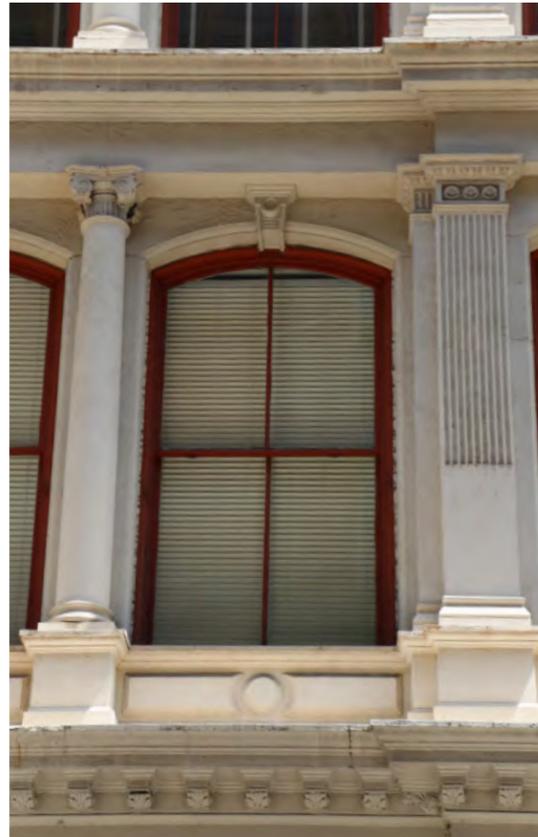
PHOTO 30: 2nd floor. Double-hung sashes were previously replaced in kind and are in good condition.

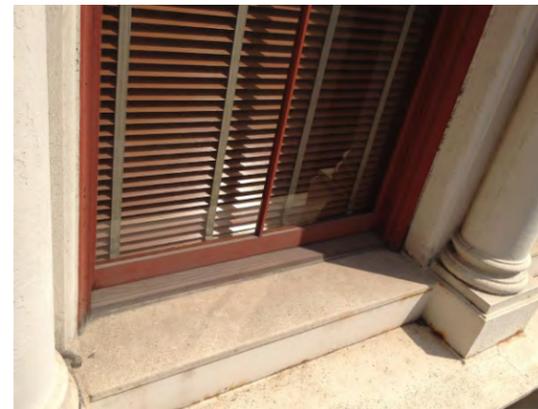
PHOTO 33: 2nd floor. View of lower sash and windowsill. Servicing of sill and bottom rail is recommended.

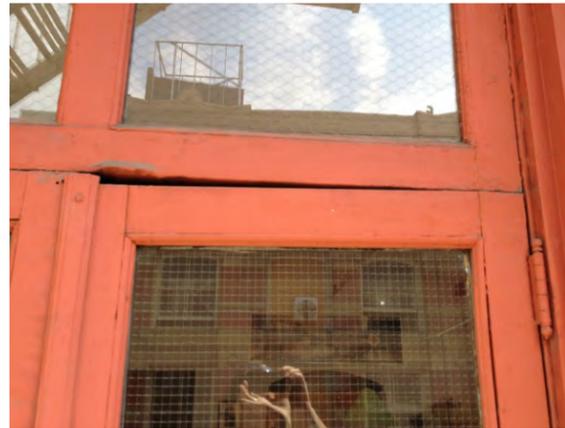
PHOTO 34: Sheet metal double door at fire escape, typical condition. Components are dented, sagging, and in very poor condition.

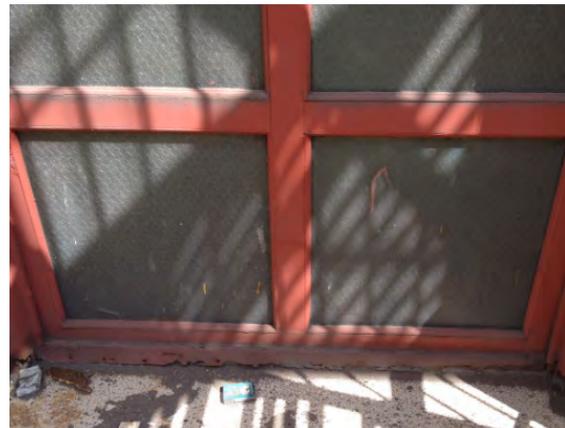
PHOTO 36: Sheet metal window at shaftway. In very poor condition. Sealant has failed, sheet metal is corroded.

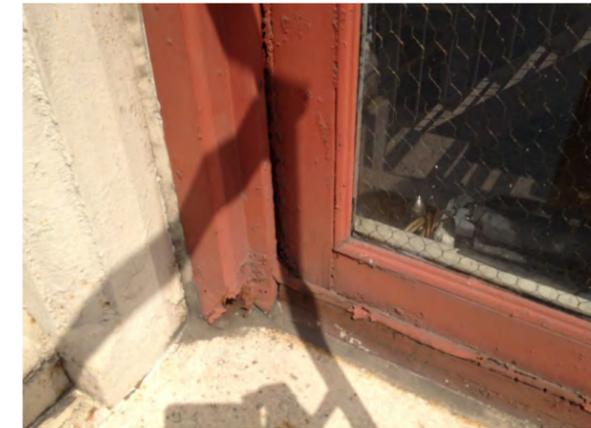
PHOTO 35: Sheet metal double doors, corner conditions (threshold). Components are corroded, open, and not properly sealed.

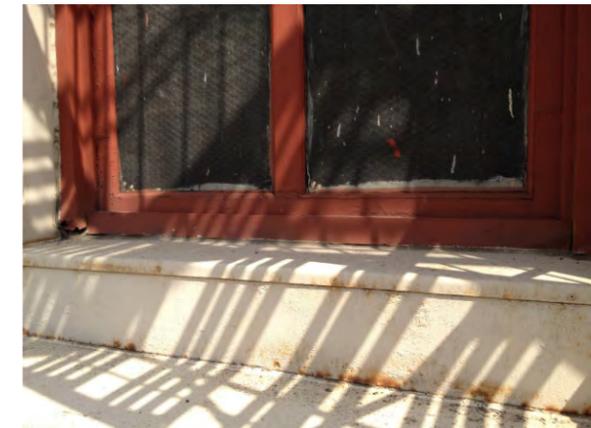
PHOTO 37: Sheet metal window at shaftway. Sill conditions. View of open joints, failed sealant, & corroded metal.

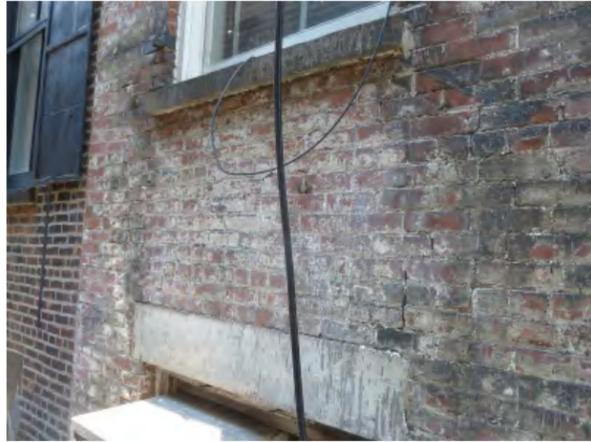
PHOTO 39: Typical masonry conditions. Face brick is covered with remnant of old paint.

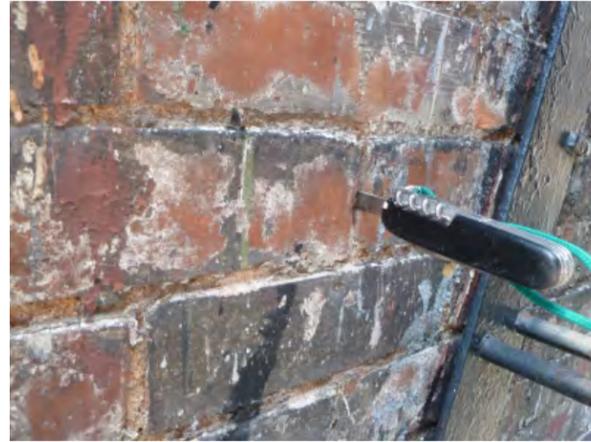
PHOTO 40: Mortar joints are weathered, soft, and washed-out.

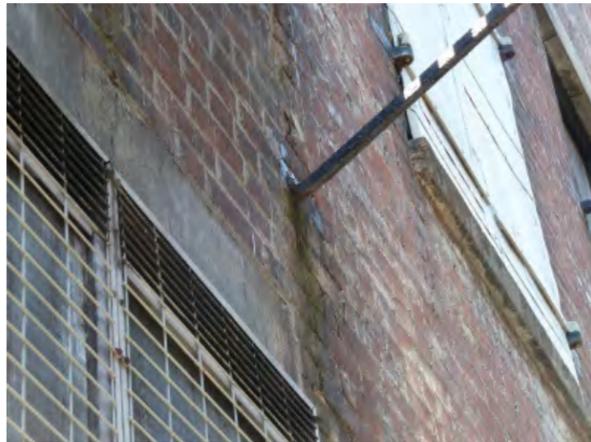
PHOTO 41: Poor facebrick conditions. Staining has developed below masonry penetration.

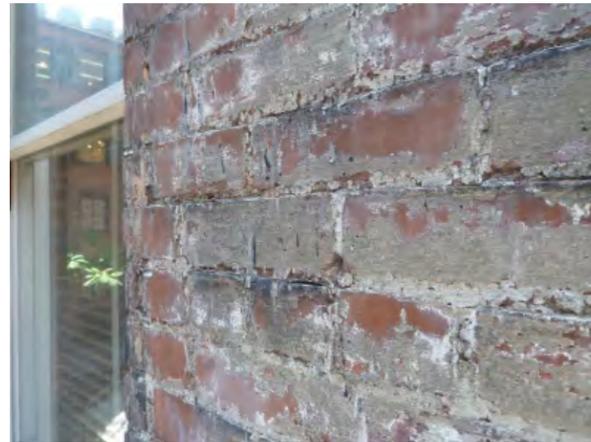
PHOTO 42: Mortar joints are weathered, soft, and washed-out.

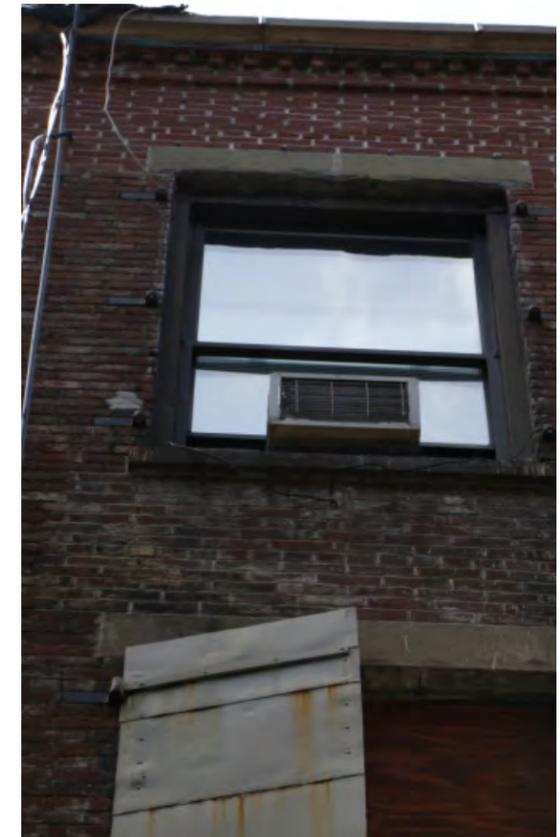
PHOTO 44: New aluminum replacement window, in fair condition. Window mounted AC unit does not appear properly supported.

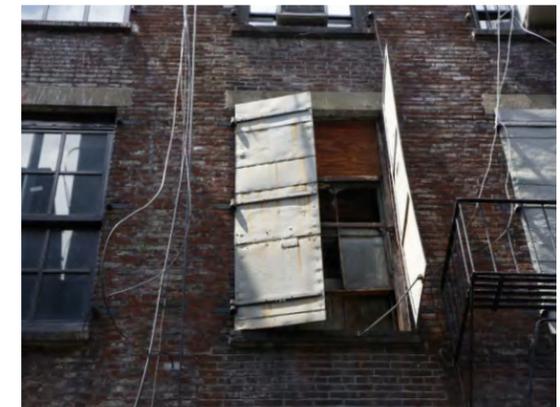
PHOTO 46: Window behind the shutters is deteriorated beyond repair.

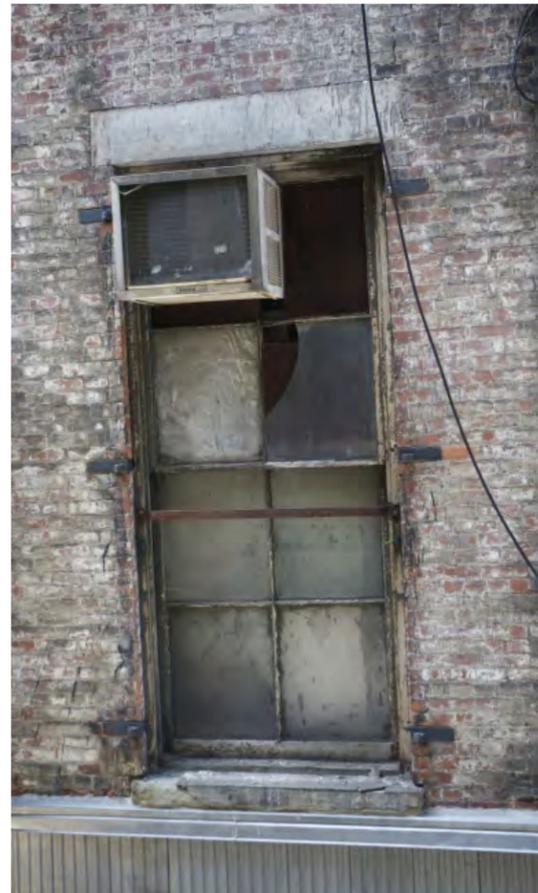
PHOTO 50: 2nd floor, southernmost window. Non-compliant sash mounted AC unit. In deteriorated condition.

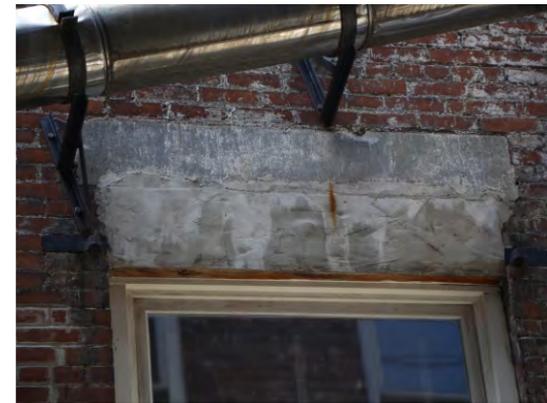
PHOTO 54: 3rd floor. Stone lintel has a cement patch over wood substrate. Modified opening requires repairs.

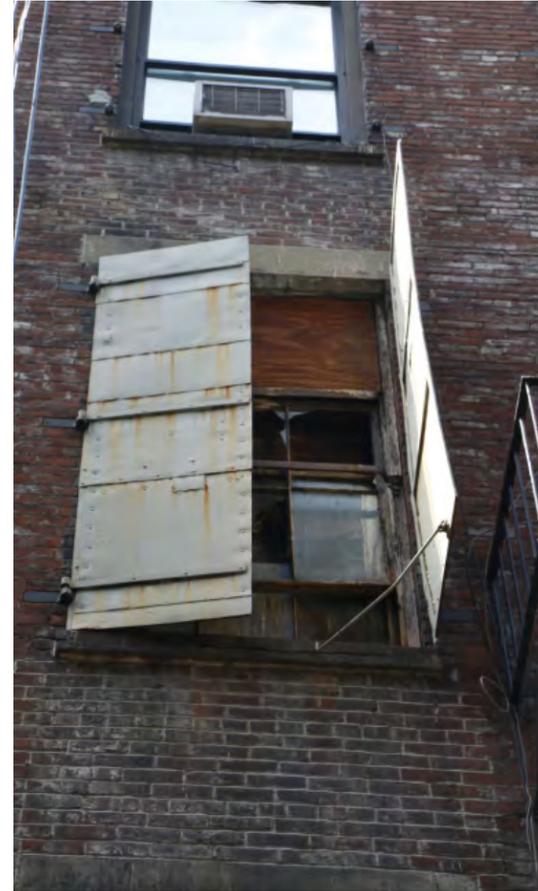
PHOTO 59: Original shutters are in very poor condition.

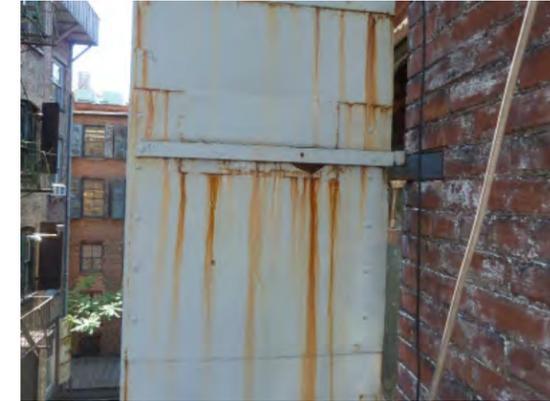
PHOTO 60: Sheet metal shutter with rust stains.

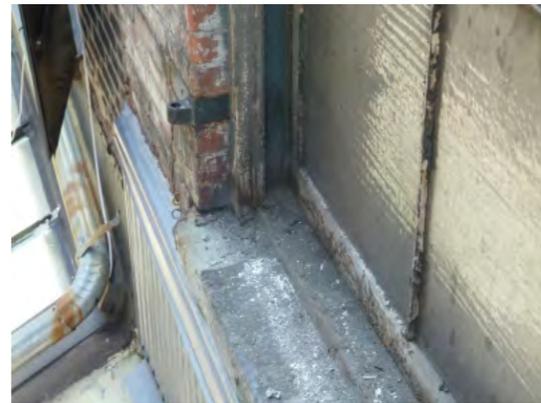
PHOTO 57: Original stone window sill, cracked and delaminated at corner.

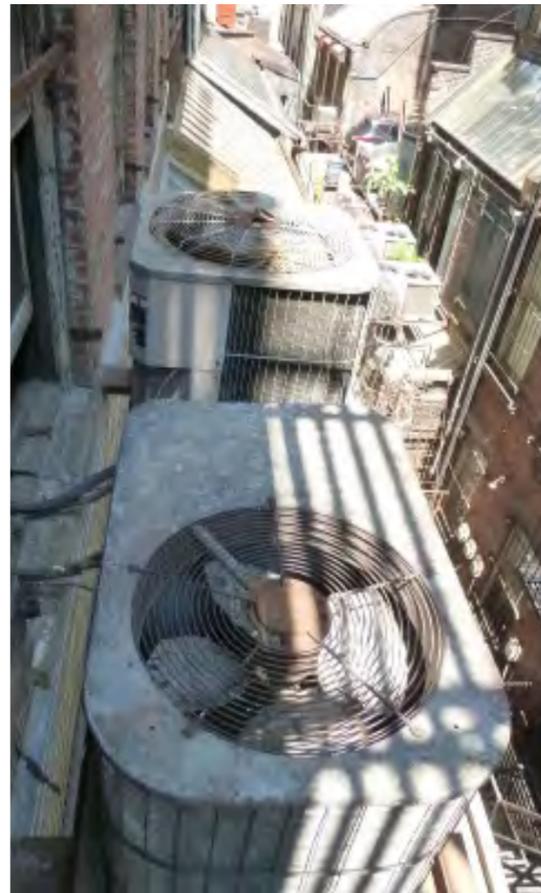
PHOTO 58: Abandoned wall mounted HVAC condenser units. Removal is recommended.

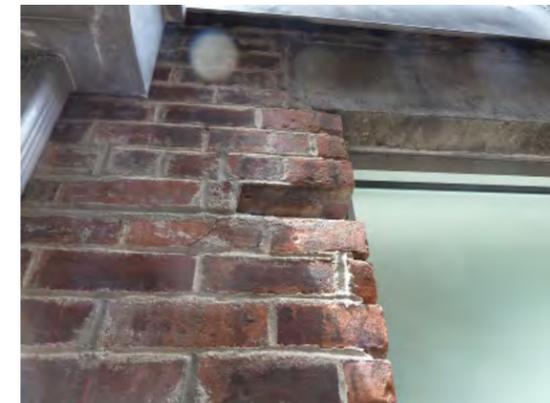
PHOTO 63: Spalled and missing brickwork at window opening.

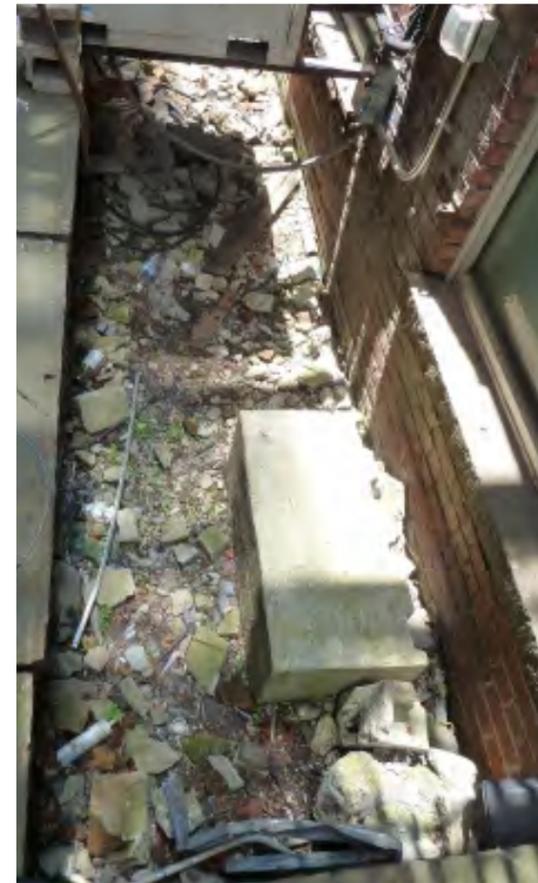
PHOTO 71: Rear yard is filled with debris.

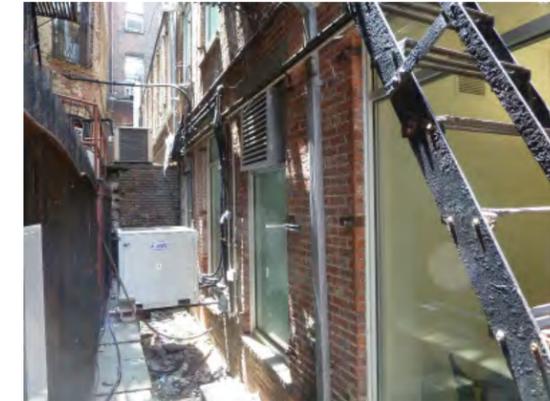
PHOTO 72: Cellar level set-back wall is in fair condition, with exception of the window/door openings. Brickwork has been repointed.

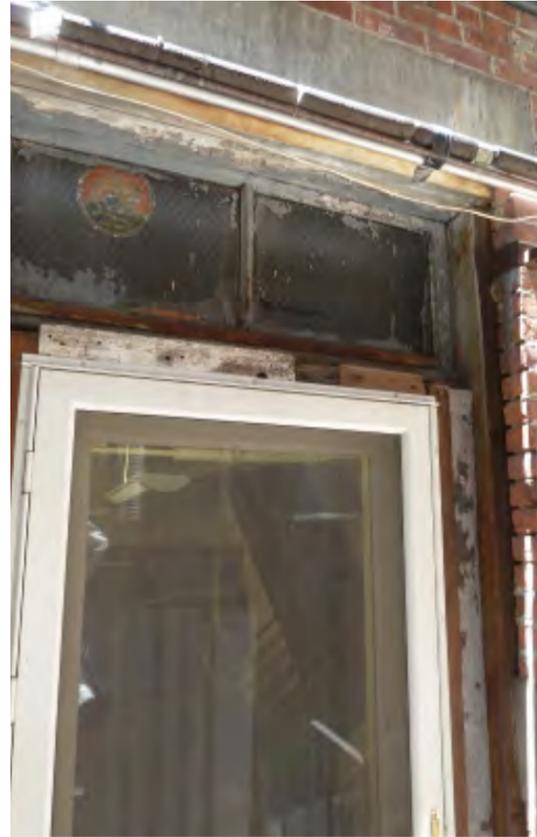
PHOTO 73: Modified window opening. Door framing is exposed, joints are open, assembly lacks flashing.

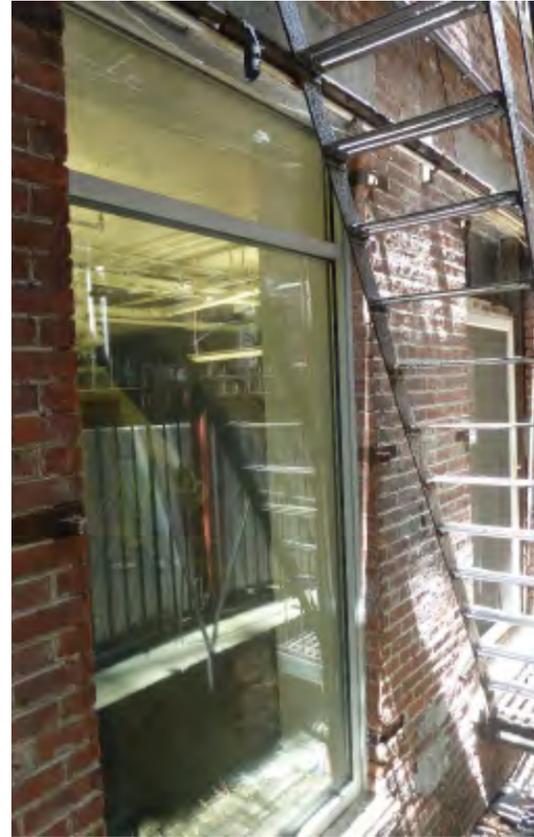
PHOTO 74: Non-operable window at basement level. Mortar joints are in poor condition at masonry openings.

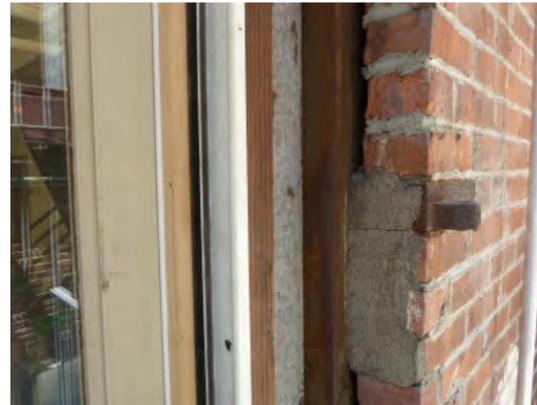
PHOTO 75: Cement patch at masonry opening. Wood framing for door is exposed. Opening is not flashed and has open joints.

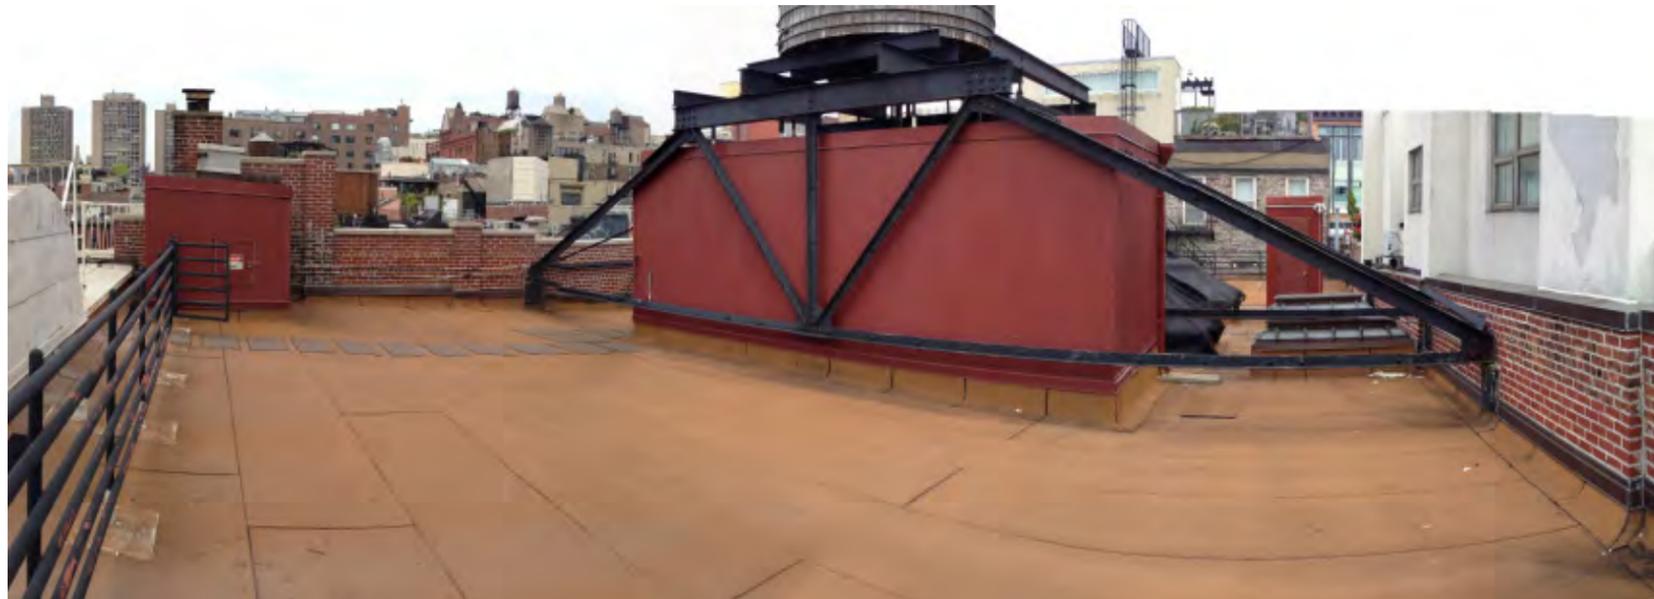
PHOTO 78: Roof level elements are in good condition, with isolated areas that require repair.
