121 Chambers Street AKA 103 Reade Street - Manhattan
Tribeca South Historic District

**EXISTING CONDITION REPORT & BUILDING
RESTORATION PROGRAM**

**Prepared by Joseph Pell Lombardi, Architect
February 9, 2017**

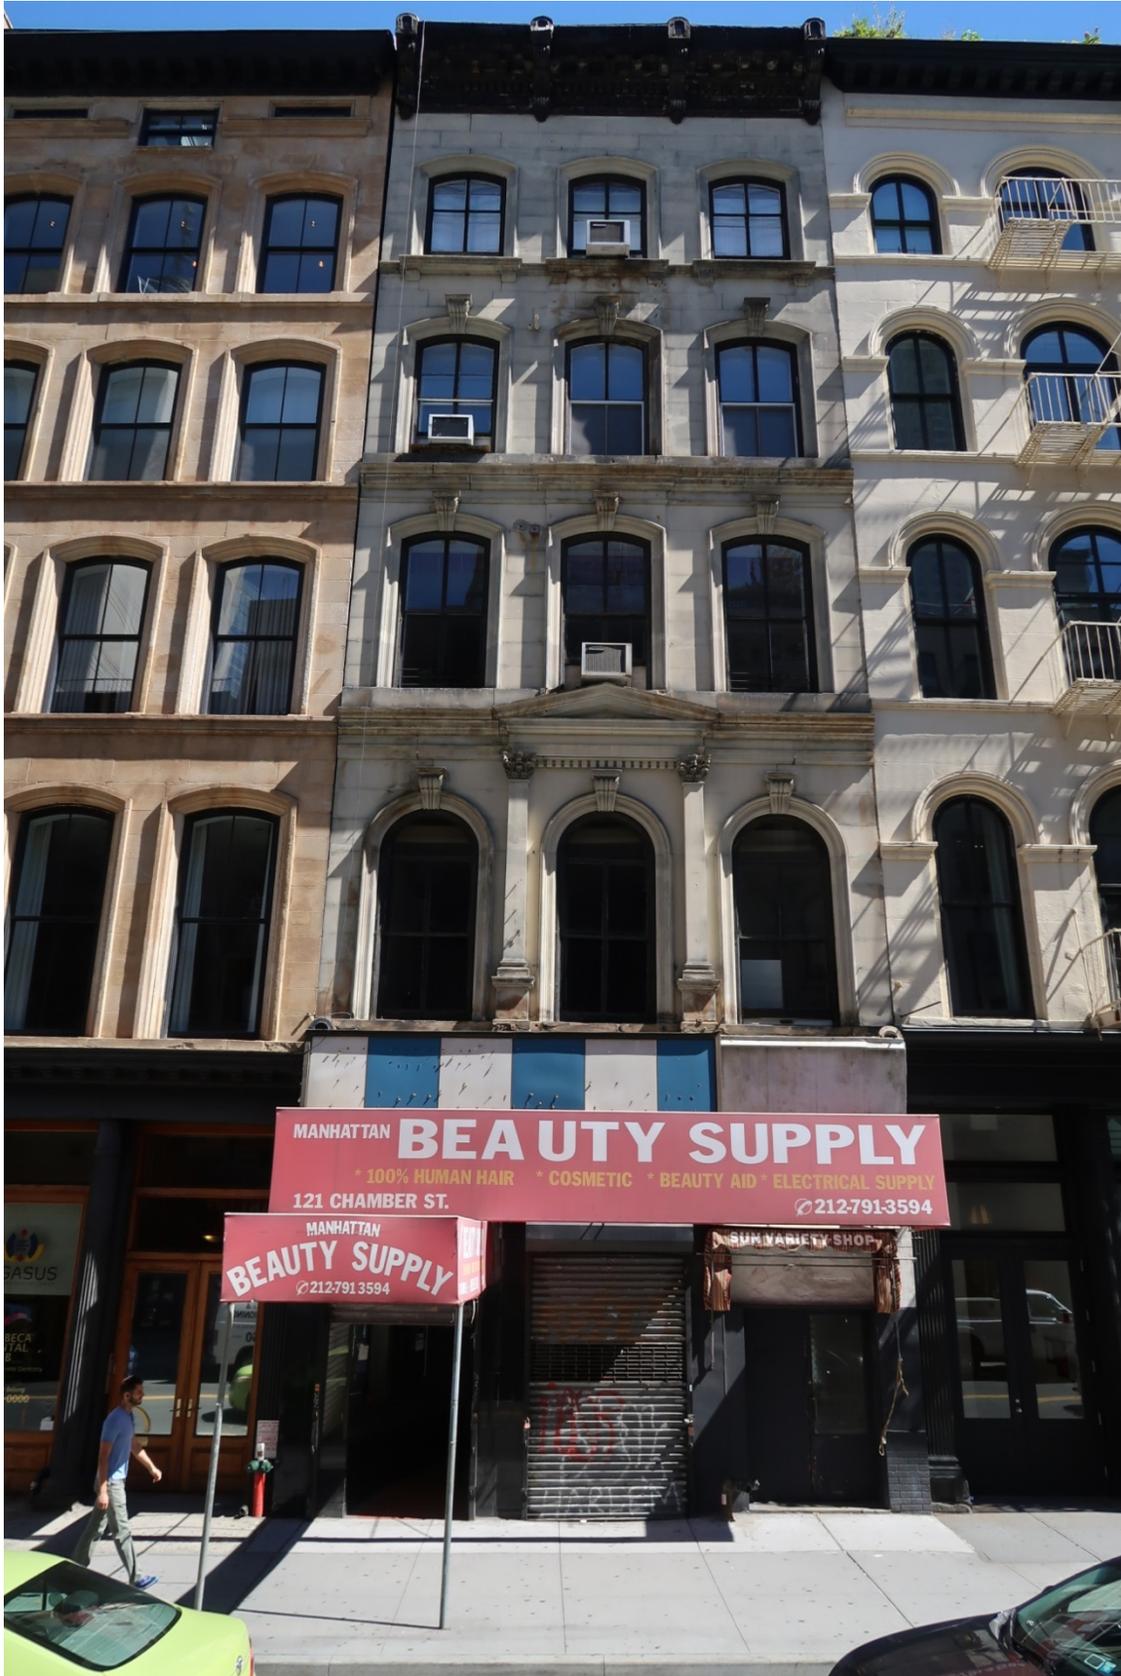
Fig. 1- Chambers Street Façade, 2016

- a) Existing Condition – Masonry: The entire masonry façade is covered with an evenly distributed thin coat of adhesive material from the top of the existing storefront cornice to the bottom of the building’s cornice. Behind the cement, the building is faced with sandstone above the first story. All of the masonry window frames, sills, water tables, keystones and columns are in excellent condition. There are three areas where the masonry layer has been punctured by ventilation pipes. The cement layer is weathering, staining from pollution, and dirt accumulation is evident; There are several areas where the original sandstone façade surface can be seen beneath the cement. At the second floor aedicule bases, there is cracking at the bottom of the engaged columns.

- i) Restoration Work – Masonry: Clean all masonry surfaces with Rotec Vortex cleaning process system to remove top layers of dirt. The Vortex process uses pressures from 10 to 55 psi mixed with water that can be precisely regulated within the range of 1 to 15 gallons per hour mixed with extremely fine micro abrasive powders, selected exactly to suit the low-pressure technique and remove dirt and paint surfaces without damaging the original masonry surface beneath. Sample cleaning areas will be performed prior as approved by architect, owner & LPC.

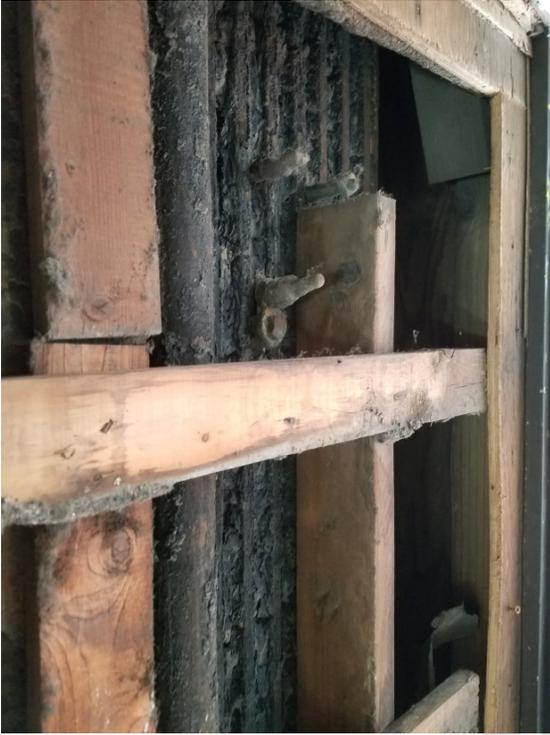
Fig. 4- Reade St cast-iron column- exposed

- a) Existing Condition – Cast Iron Elements: The first floor retains the original cast-iron storefront, which is listed on page 32 in Daniel D. Badger’s Catalogue of *Architectural Iron Works of New York*, published in 1865. The early twentieth century metal and non-historic stone storefront layers partially cover existing nineteenth century features, including: the painted cast-iron fluted pilasters and columns on bases, arched surrounds with bracketed keystone, transom bars with egg-and-dart decorative moldings and cornice with bracket and modillions. The overall condition of the cast-iron features is currently unknown because it is partially covered.

- ii) Investigate historic finish treatment of cast-iron columns. Preliminary findings show that all storefront columns were most likely a ceramic quality material that was used to create the look of sandstone to match the sandstone façade above.

- iii) Remove all existing column paint layers using chemical paint remover such as Peel-Away ST-1 or an approved equivalent. Excess paint can be removed by hand-scraping or using the gentlest methods possible. No mechanical removal of paint is allowed.

- iv) Prime and paint all columns and column elements with a color that matches the sandstone façade above using zinc-rich primers and exterior grade metal paint. The closest present day color is Pratt & Lambert 426D “Expedition.”

- v) Corinthian column foliate capitals have deteriorated. Any column elements that have deteriorated beyond repair, or are missing altogether, shall be replaced with cast iron components of the appropriate style, scale, and appearance and painted to match the original column.

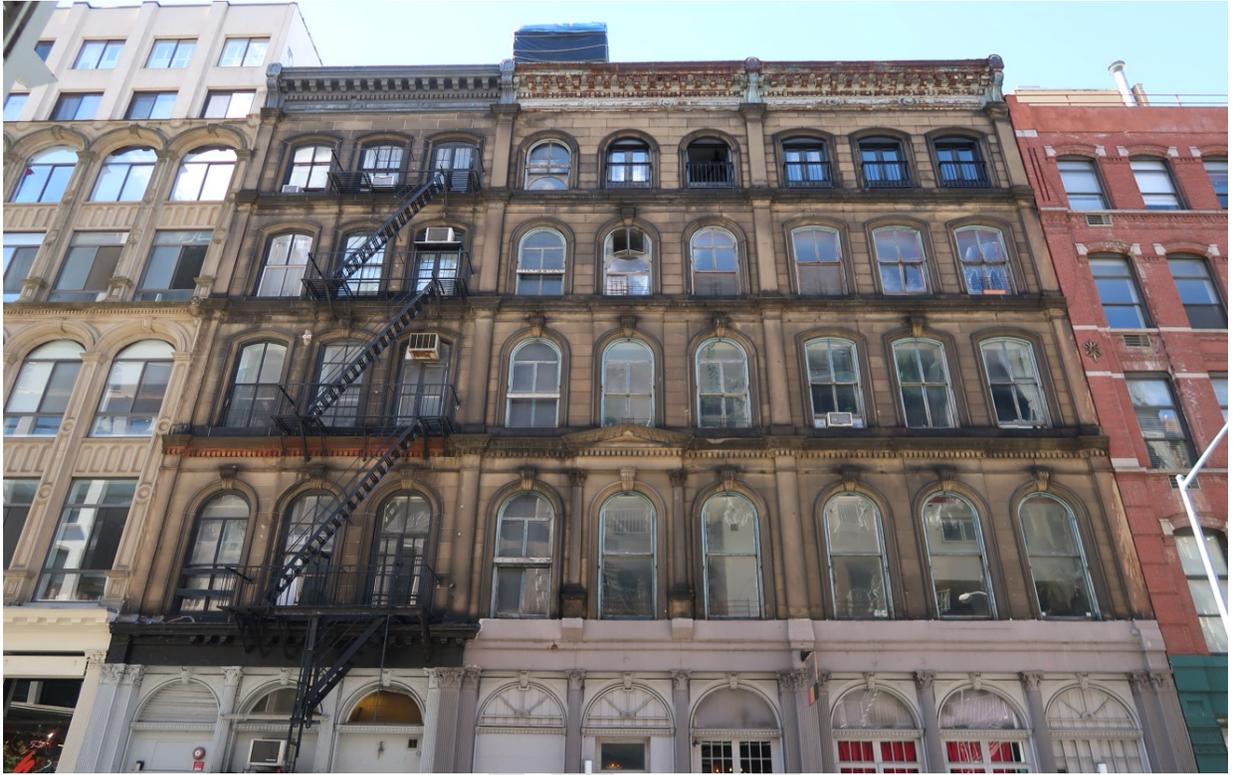
Fig. 7- Reade Street Façade, 2016

- a) Existing Condition – Masonry: The building’s Reade Street façade, also of sandstone, is one section of a tripartite composition, matching the western three bays of the adjoining double façade at 105-107 Reade Street. No work is proposed under this application for 105-107 Reade Street. The sandstone façade is stained from pollution and dirt accumulation. There is a non-decorative fire escape attached to the stone at several locations on the second through fifth floors. There are four dentils that are either cracked or missing where the fire escape is attached at the third floor. Several sandstone window sills are cracked above the second story.

- b) Restoration Work – Masonry: Clean all masonry surfaces with the gentlest method possible, such as low pressure water and detergents, using natural bristle brushes. Water pressure must be below 500 psi.

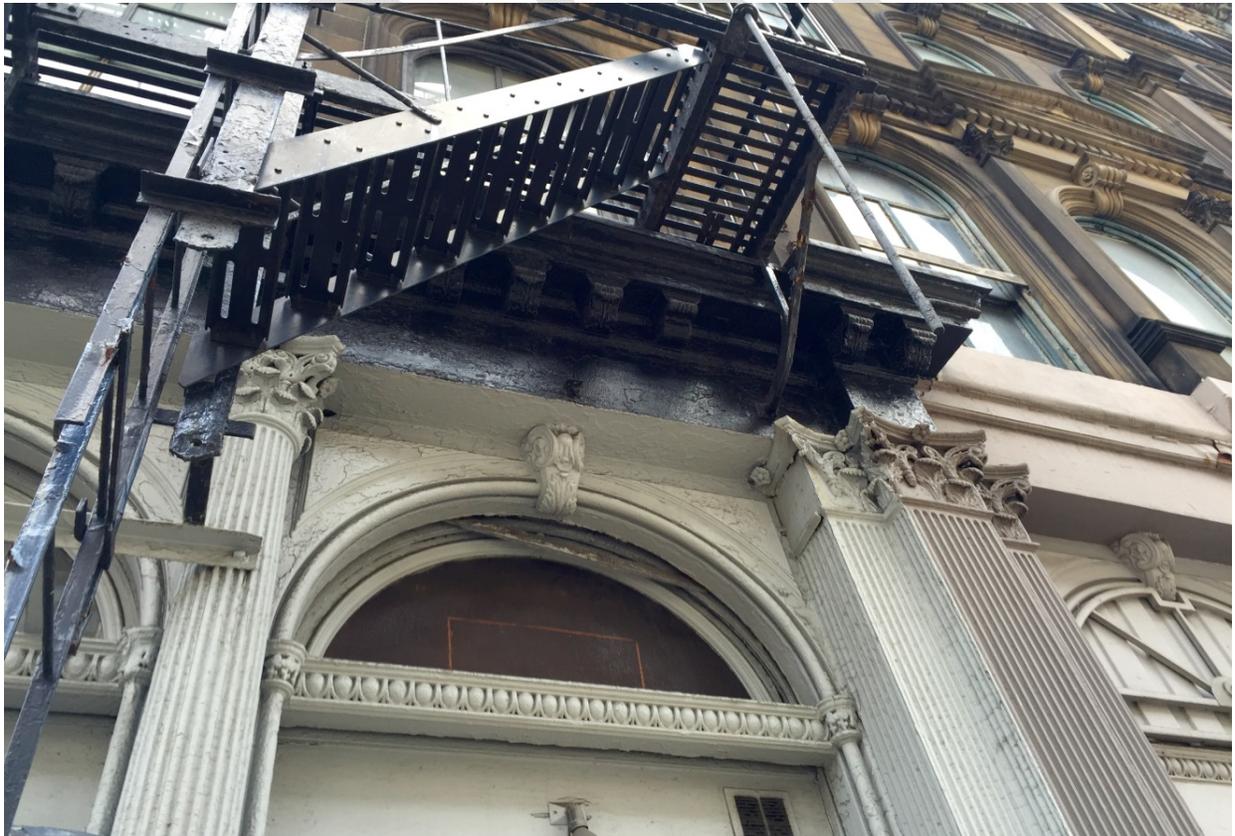
Fig. 8- Reade Street façade cast-iron storefront details and fire escape, 2016

- e) Existing Condition – Fire Escape: The non-decorative fire escape and drop-down stair on the façade is presumably a twentieth century addition. The design of the fire escape can be attributed to the specifications for exterior fire escapes as outlined in the New York Labor Law 273 of 1913.

- f) Restoration Work – Fire Escape: Fire escape removal will not leave gaps, holes, or unsightly conditions on the marble facade. All fire escape stone connection points will be repaired with Jahn patches no more than three inches square. Remove all existing deteriorated metal anchors embedded in the façade at locations as indicated on the drawings and as directed by the architect. Cut damaged sandstone back, remove metal corroded areas and replace with in kind color-match Jahn Patch. Submit samples patch for architect, owner and LPC to approve.

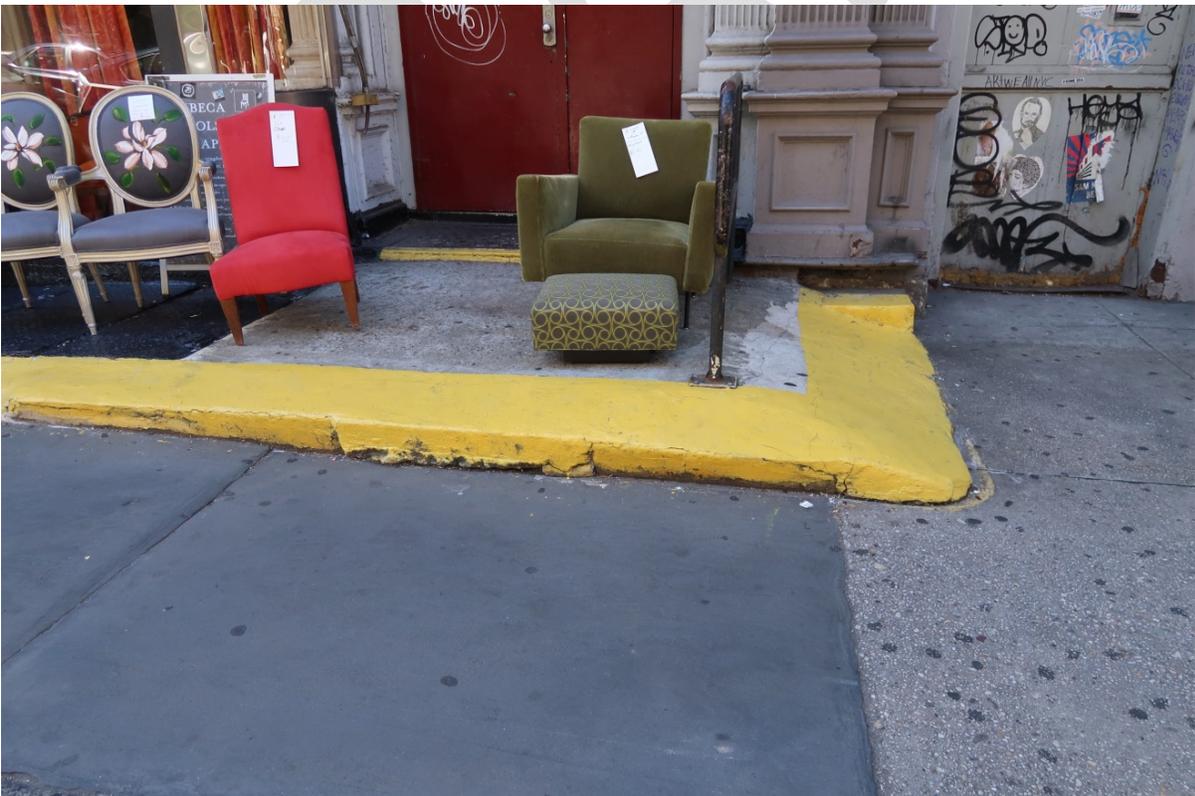
Fig. 10- Reade Street sidewalk, west corner, 2016

- g) Existing Condition – Sidewalk: The twenty-five foot wide by fifteen foot deep sidewalk is a mixture of bluestone pavers, concrete curbs, diamond plate, waterproofing membrane, concrete sidewalk flags and cast-iron vault lights. The diamond plate and concrete curb cover a portion of the sidewalk vault.
 - i) The cast-iron sidewalk vault lights exist only at the westernmost bay step tread. The lights are hexagon shaped. A majority of the glass vault lights are cracked, missing or replaced with glass. The cast-iron frames are all intact in this area.
 - ii) The step at the eastern building entrance is a combination of several layers of waterproofing and diamond plate, painted over black many times.

- iii) For the entire length of the facade and approximately five feet from the face of the building (heading North), the sidewalk vault ramps up to the westernmost storefront entry bay. The ramp is constructed with a combination of (mostly) painted diamond plate and concrete. A non-decorative and non-historic railing is attached to the concrete on the west side of the sidewalk vault.

- h) Restoration Work – Sidewalk: To provide ADA access for the commercial and residential building entry points at the east and west storefront bays, the entire sidewalk will be altered. The sidewalk work includes the area from the face of the building to the street curb. The structural supports under the sidewalk vault will be removed and rebuilt from the cellar level up.

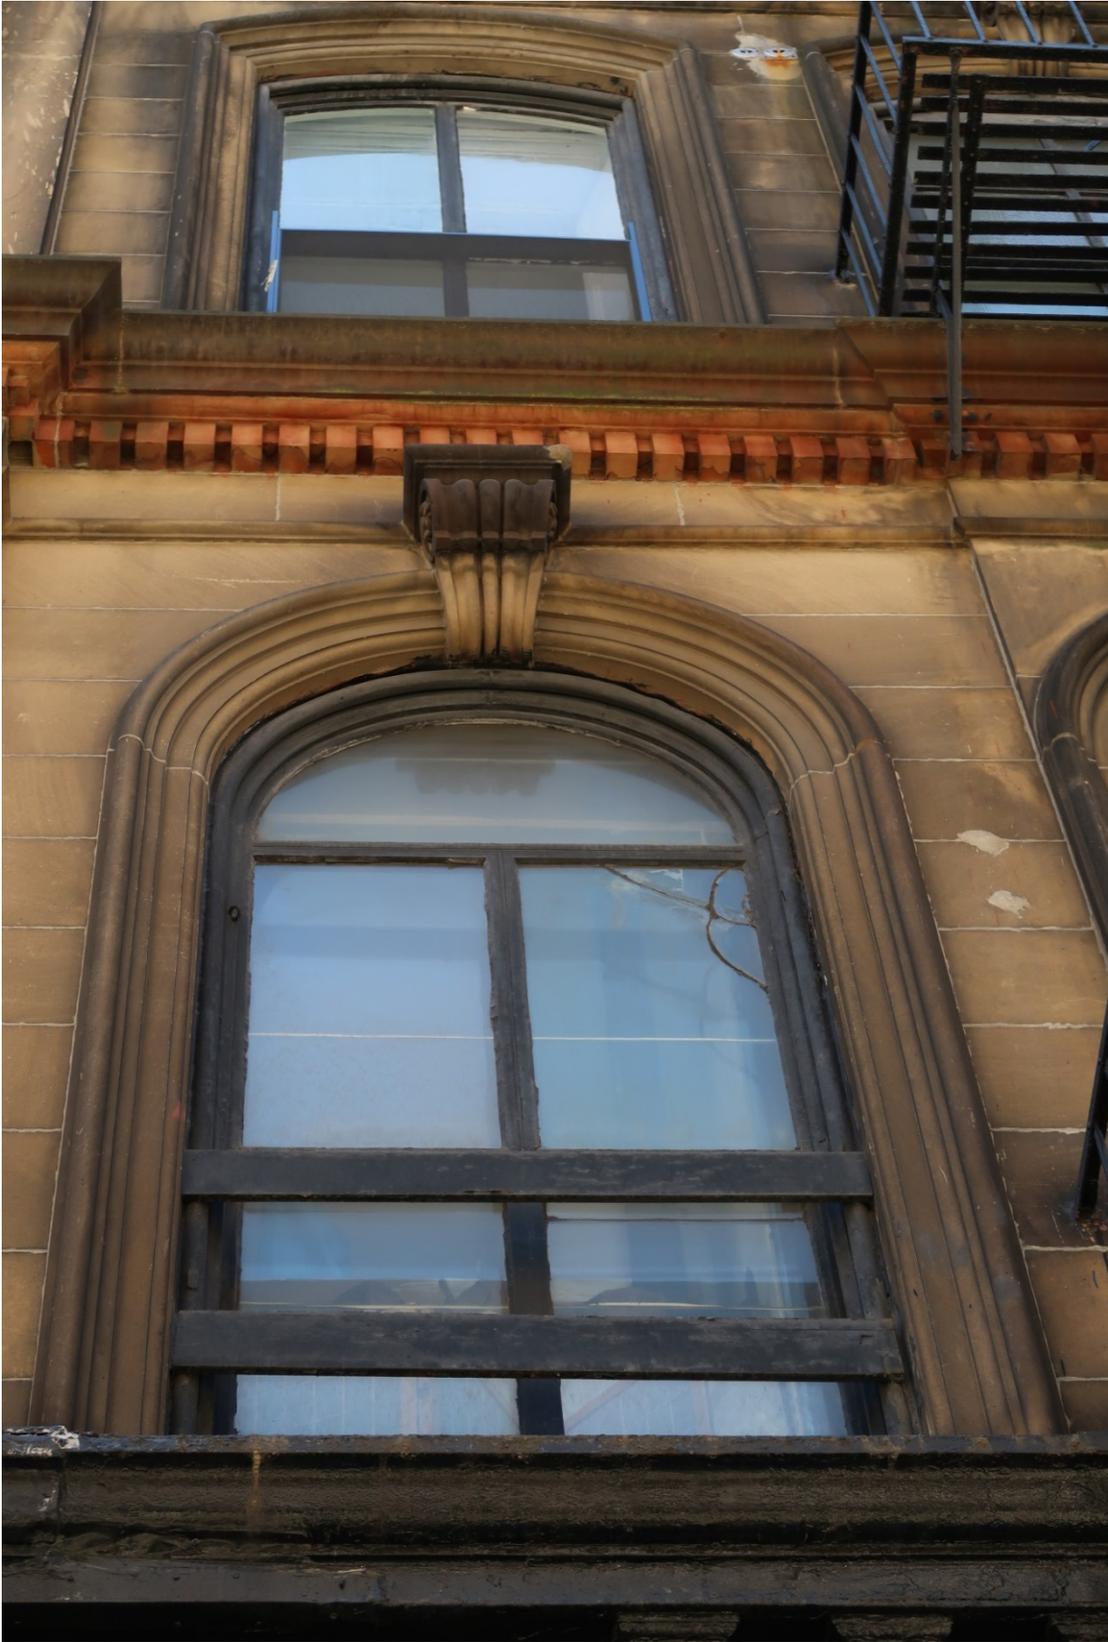
Fig. 11- Reade Street window and close-up of sandstone façade, 2016

- c) Existing Condition – Windows: There are total of twelve windows on the Reade Street façade. The eastern window sashes at the third, fourth and fifth floors are original nineteenth century windows. The remaining windows are a mixture of early twentieth century modified sashes and fire-escape doors with transoms. All the existing historic window trims exist and match throughout. Most window sashes and moldings are extremely weathered with areas of wood rot on each window.

- d) Restoration Work – Windows: All of the twelve existing windows and window frames from the second through fifth floors will be removed and replaced with painted wood

two-over-two double-hung windows of varying heights. The new second floor windows will be replaced without a transom. Instead the second floor windows will have a semi-circular shaped upper sash profile to match the masonry opening. All new window profiles will match existing historic profiles from the nine existing nineteenth century painted wood one-over-one double-hung windows and window moldings.

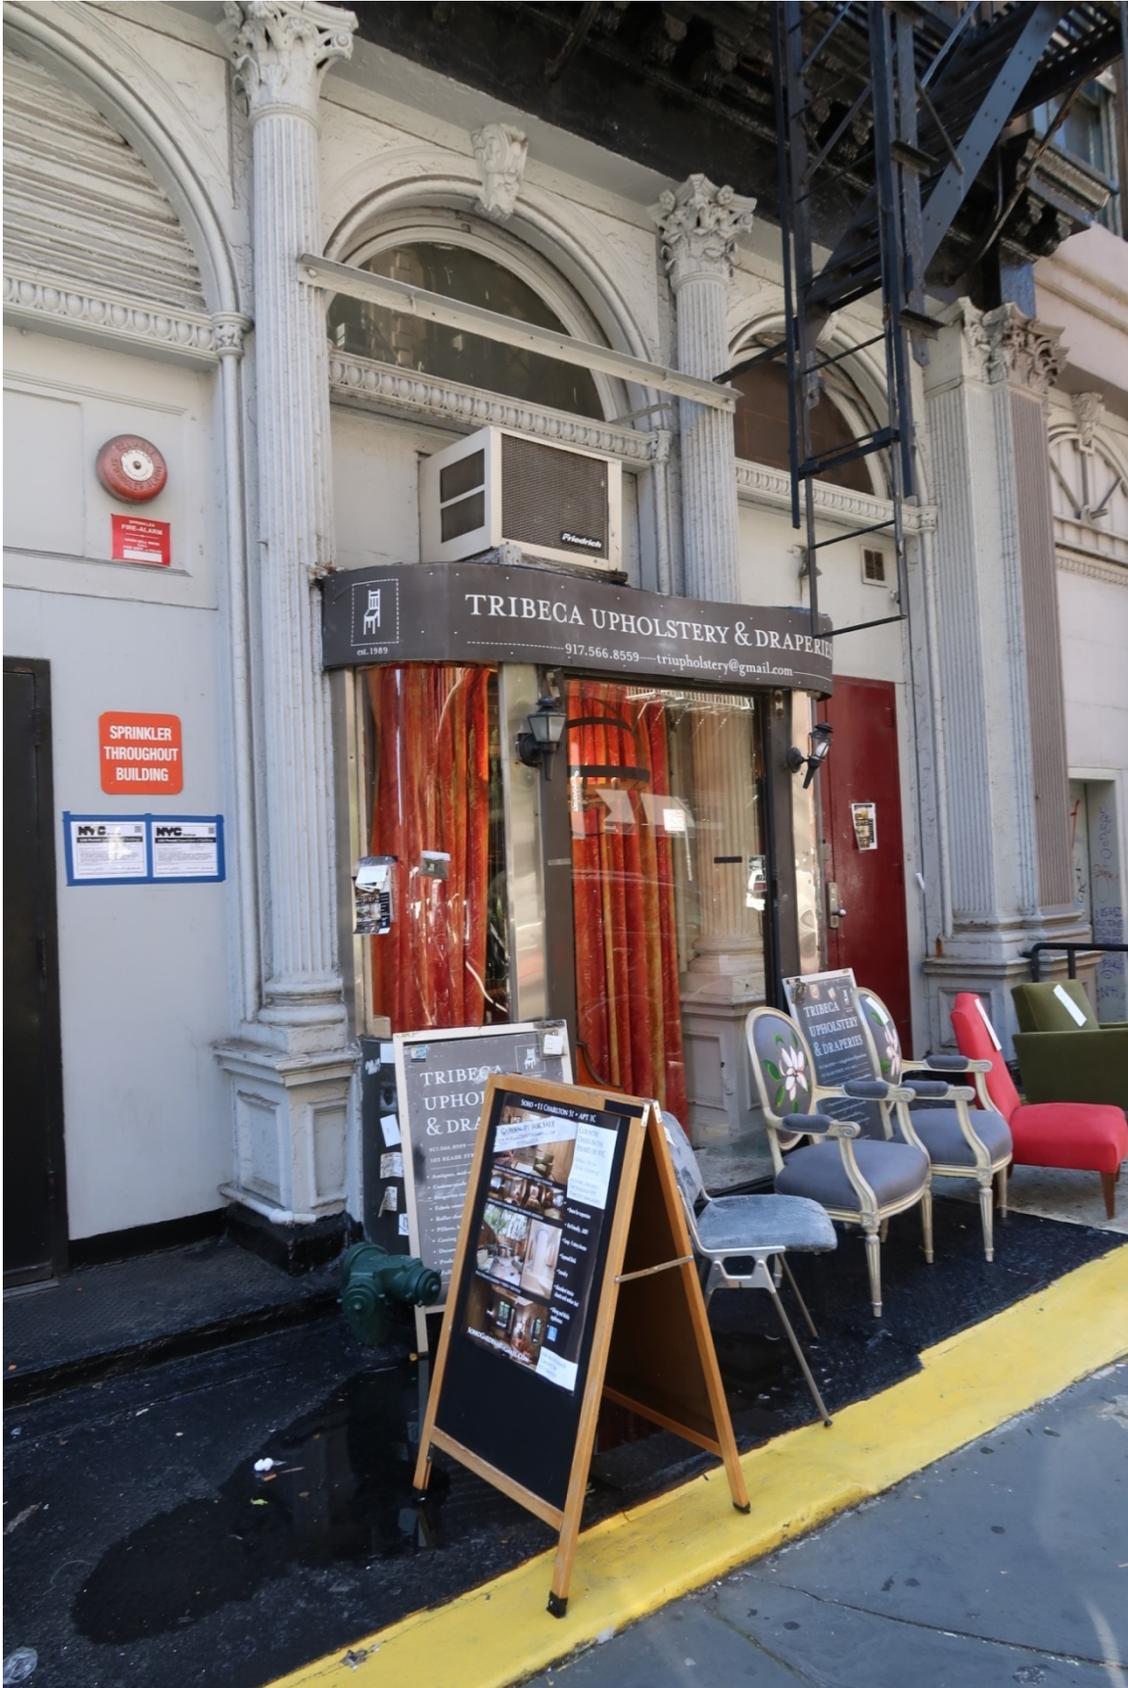
Fig. 18- Reade Street storefront and show window, 2016\

- c) Existing Condition – Show window: The wood has deteriorated due to rotting and molding. Parts of the show window are covered by twentieth century additions.

- d) Restoration Work – Show window: Remove all twentieth century additions covering the original show window. All existing work will be repaired and consolidated. New elements will be added based on historic photos and investigation.

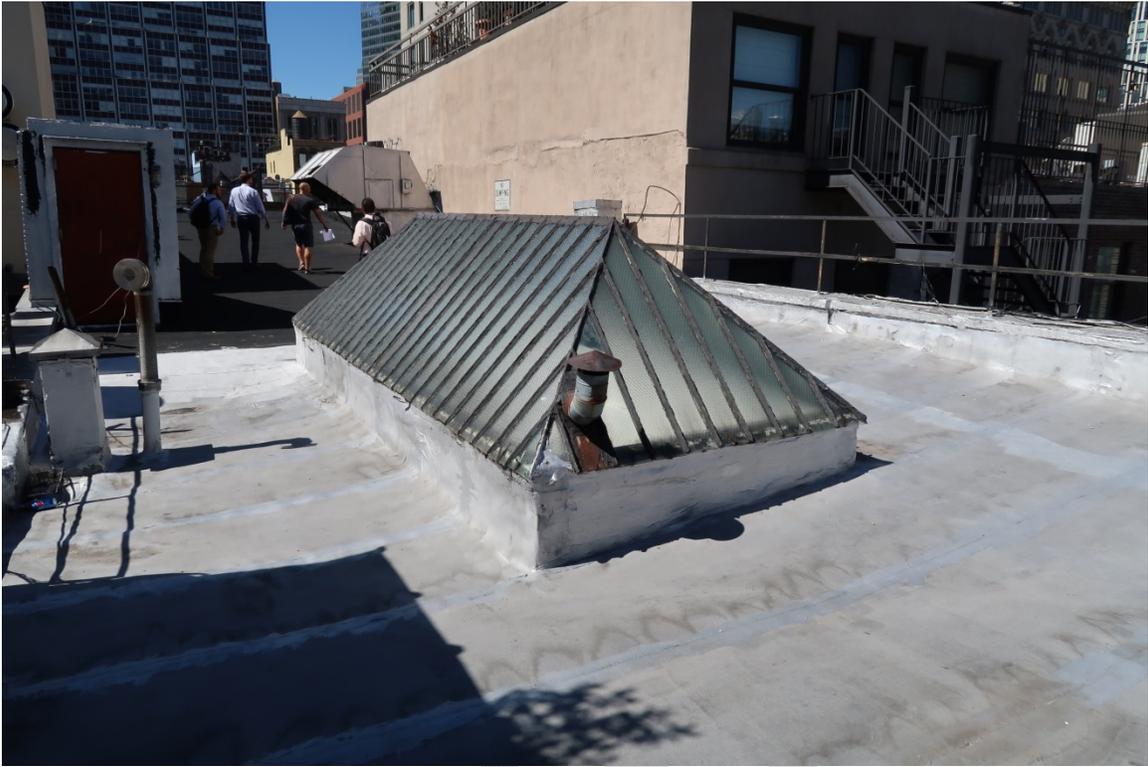
Fig. 19- Existing roof skylight, 2016

- a) Existing Condition – Roof: The existing roof is a hot roll roof that pitches to the center with a large skylight in the middle. The entire roof and skylights will be removed and the new sixth floor slab will be approximately four feet below the existing roof level.

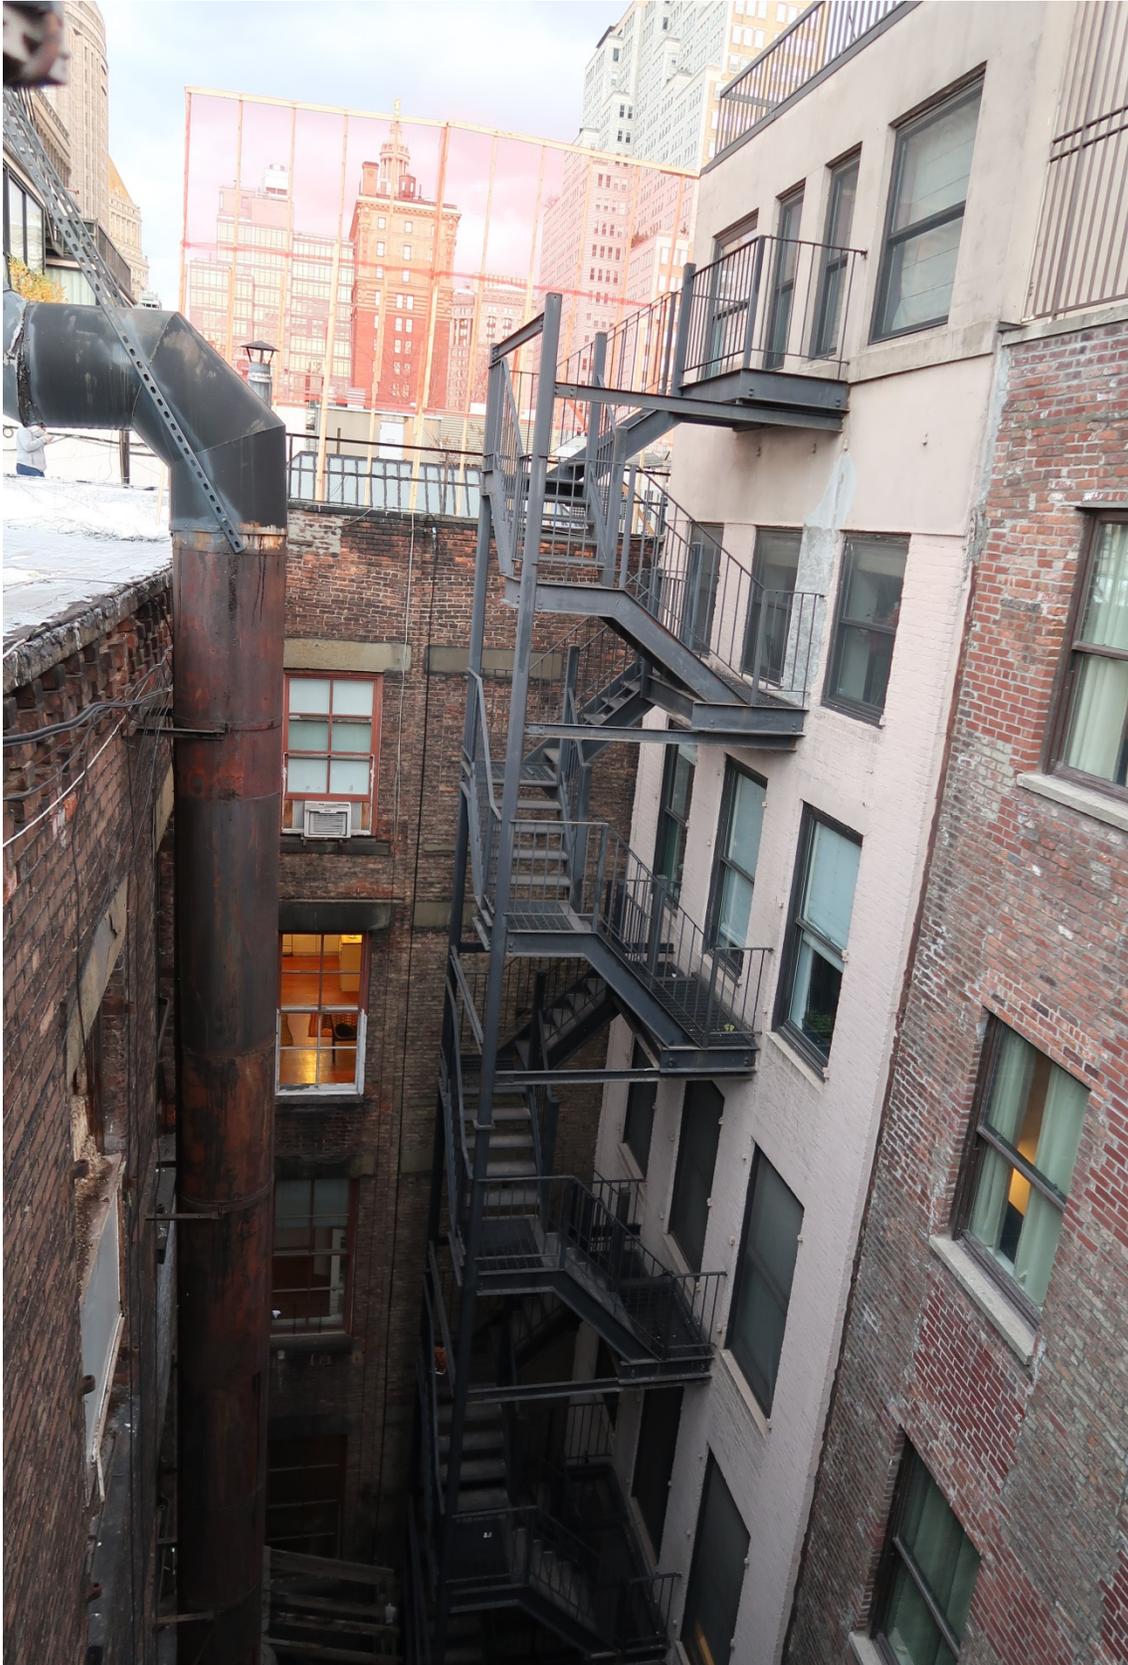
Fig. 21- View of windows at the “West court” between Chambers and Reade Streets, 2016

- iv) Remove all conduits, mechanical equipment connections, wires, etc. from brick surfaces.
- a) Existing Condition – Windows: (8) Eight two-over-two fireproof metal windows exist on the east and west sides of the building facing the inner courts (four on each side). The remaining eight nineteenth century masonry window openings on the east and west facades are filled in with twentieth century brick

- b) Restoration Work – Windows: The existing metal two-over-two windows at the North side of the west court will remain from the second through fifth floors. Existing windows will be washed and remain in place.

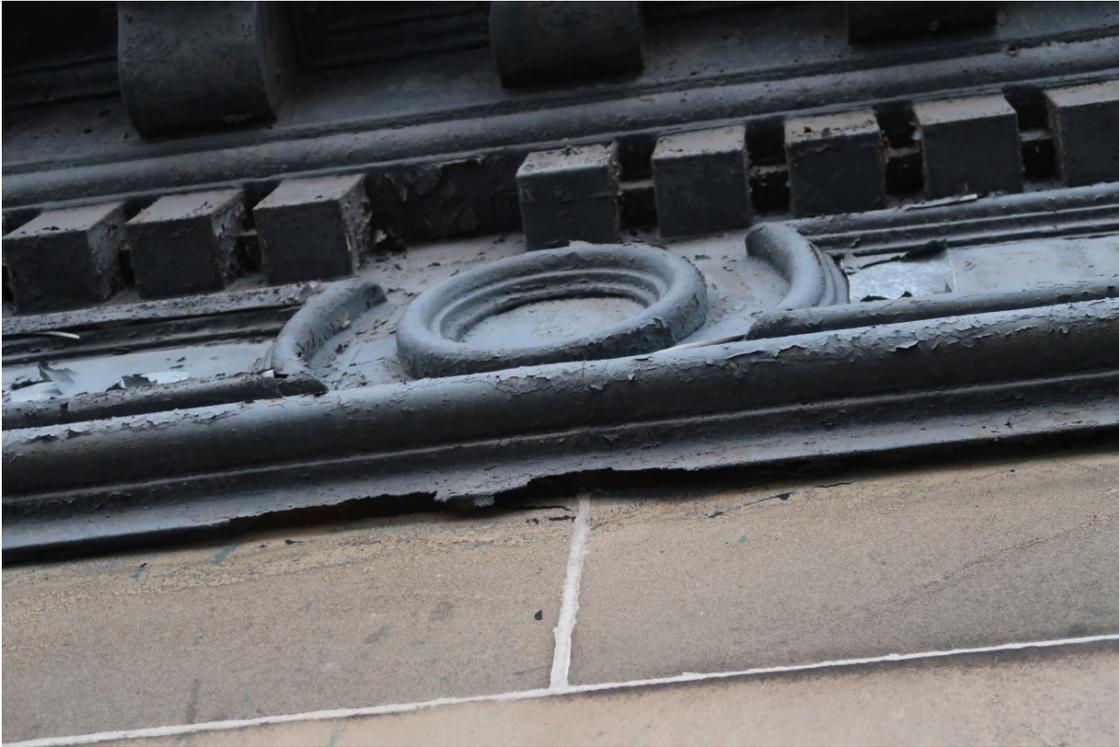
Fig. 22- Reade Street cornice and sandstone detail, 2016

- g) Existing Condition – Building Cornice: The existing building cornice and dentilled entablature is made from pressed and bent tin and coated with several layers of paint. The overall condition of the cornice is good with one dentil missing and one bent out of shape cornice bracket. The bottom of the entablature is pulling away from the sandstone façade and there are signs of past tin patching.

- h) Restoration Work – Building Cornice: All restoration work will proceed as follows.
 - i) Investigate historic finish treatment of cornice at a time when safe access to samples can be provided.

- ii) Hand bend metal bracket to reshape into original orientation.
 - iii) Secure and nail back the existing entablature areas that are peeling away from the façade using mechanical fasteners. Caulk all connections on the sandstone façade with paintable exterior caulking.

- iv) Prime and paint the existing cornice and entablature fastener heads with a color that matches the earliest known color using zinc-rich primers and exterior grade metal paint.
