111 NOBLE RESIDENCES

111NOBLE STREET
BROOKLYN, NY 11222

LPC PRESENTATION
2016

Re: Structural Observation
111 Noble Street (Block 2566 – Lot 74 – BIN# 3064932)
Brooklyn, NY 11222

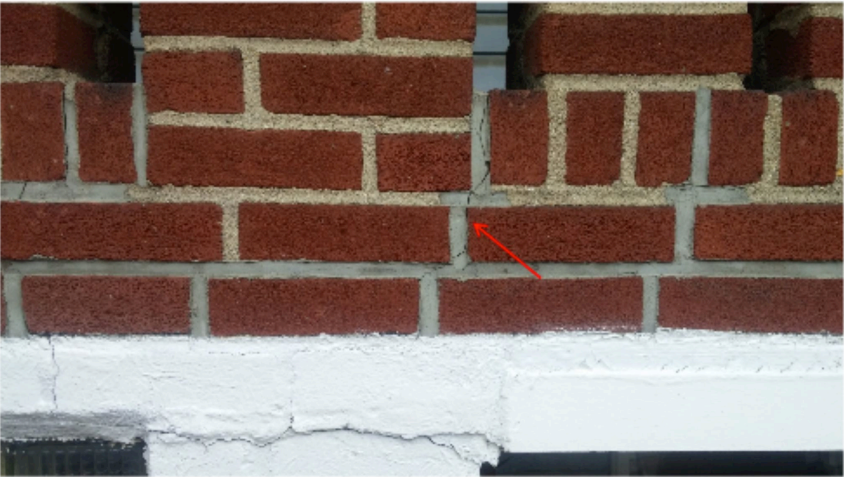
Photo 9: Porch Barrier Crack (Detail)

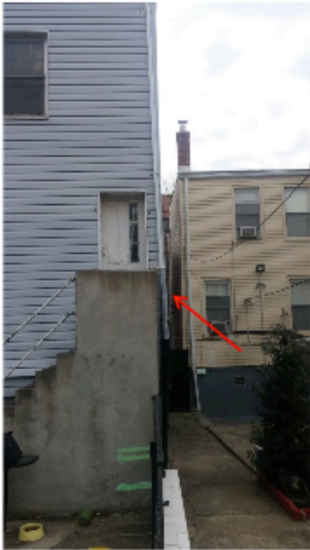
Photo 10: Deformed Corner Wall

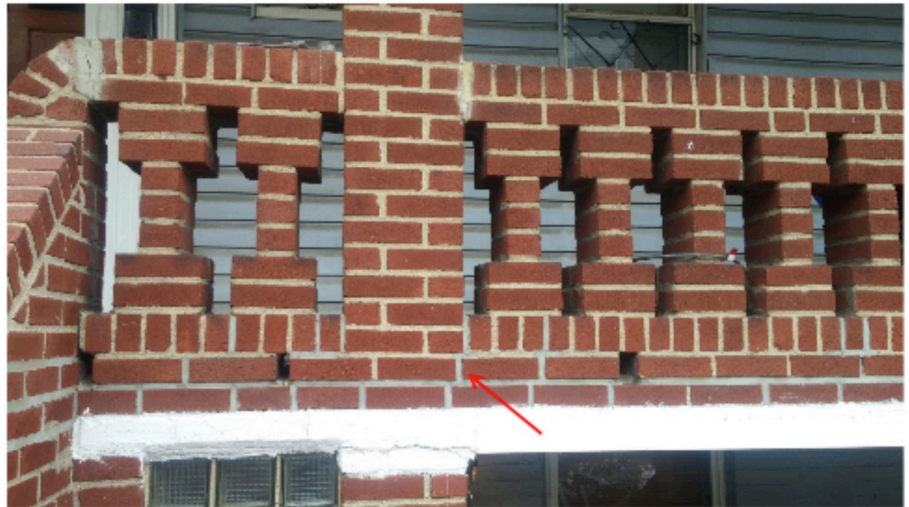
Photo 8: Porch Barrier Crack

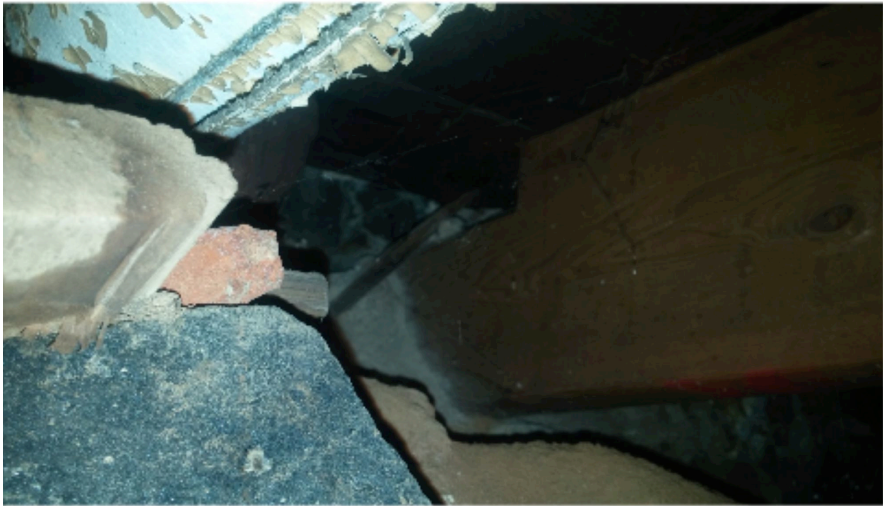
Photo 5: Bearing Condition at Wood Joists Supporting Basement Floor

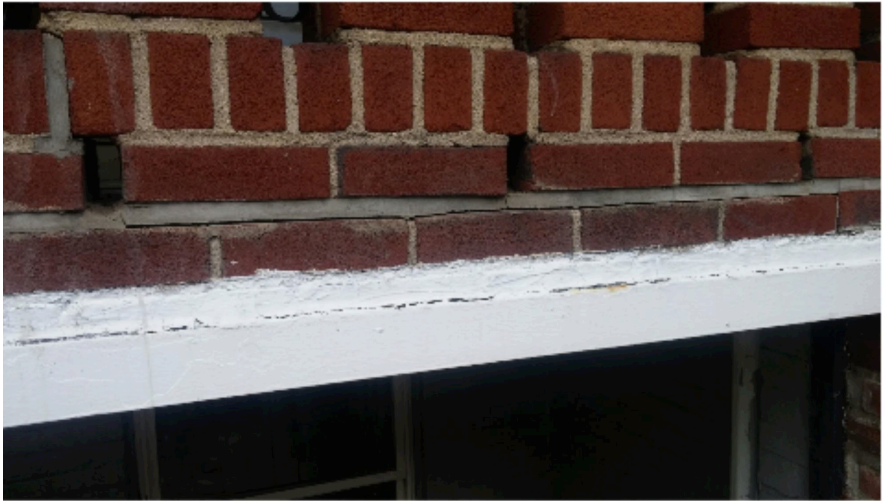
Photo 6: Brick Requiring Repointing

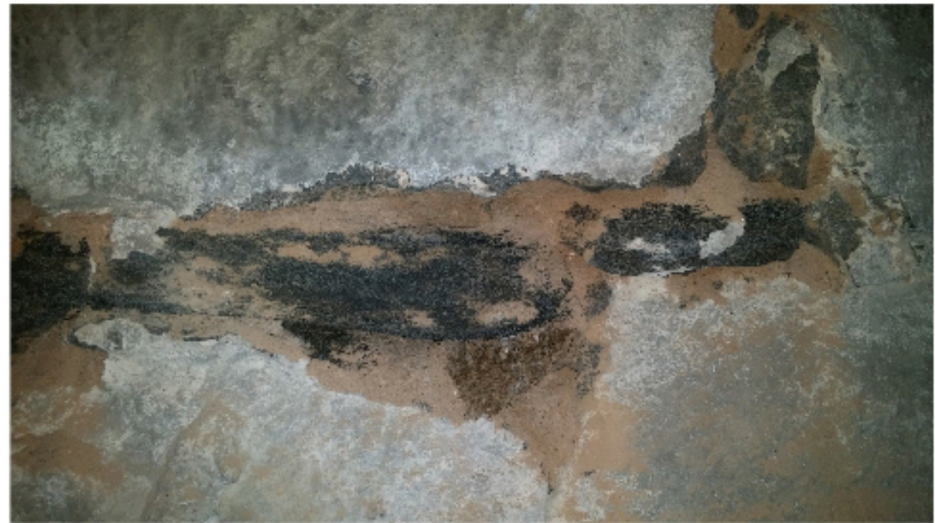
Photo 4: Rubble Foundation Wall

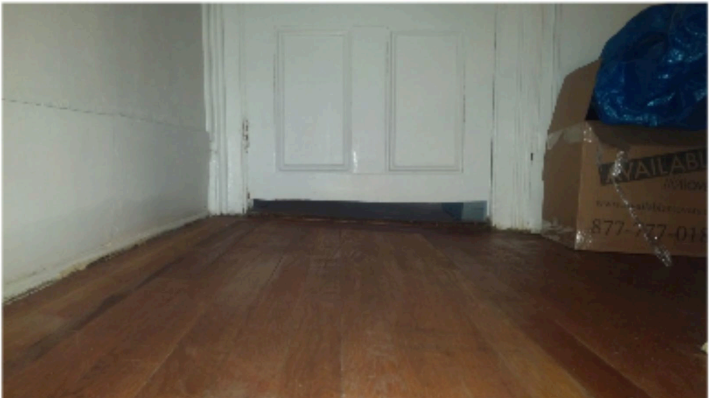
Photo 12: Sloped Floor at West Wall

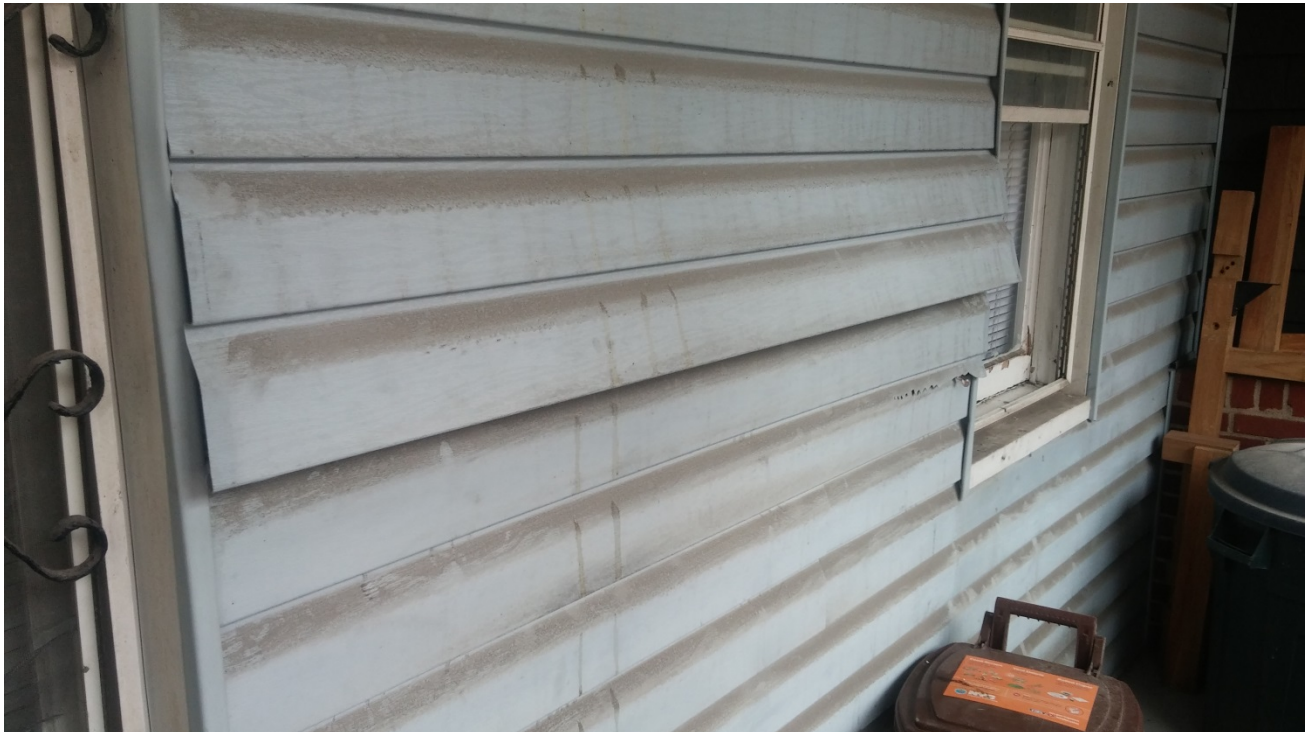
The façade of the building generally consists of vinyl siding that covers several layers of older siding. Some areas of siding was observed to be loose or damaged. See Photo 2 below. To the front of the building is a concrete porch at the 1st floor level covered by a metal canopy. The porch slab and canopy are supported by steel headers and brick piers. There is a concrete and brick stair leading to the porch. The porch and front yard are bounded by brick barriers. The porch and masonry at the front was not part of the original construction of the building. See Photo 3 below.

Photo 2: Vinyl Siding

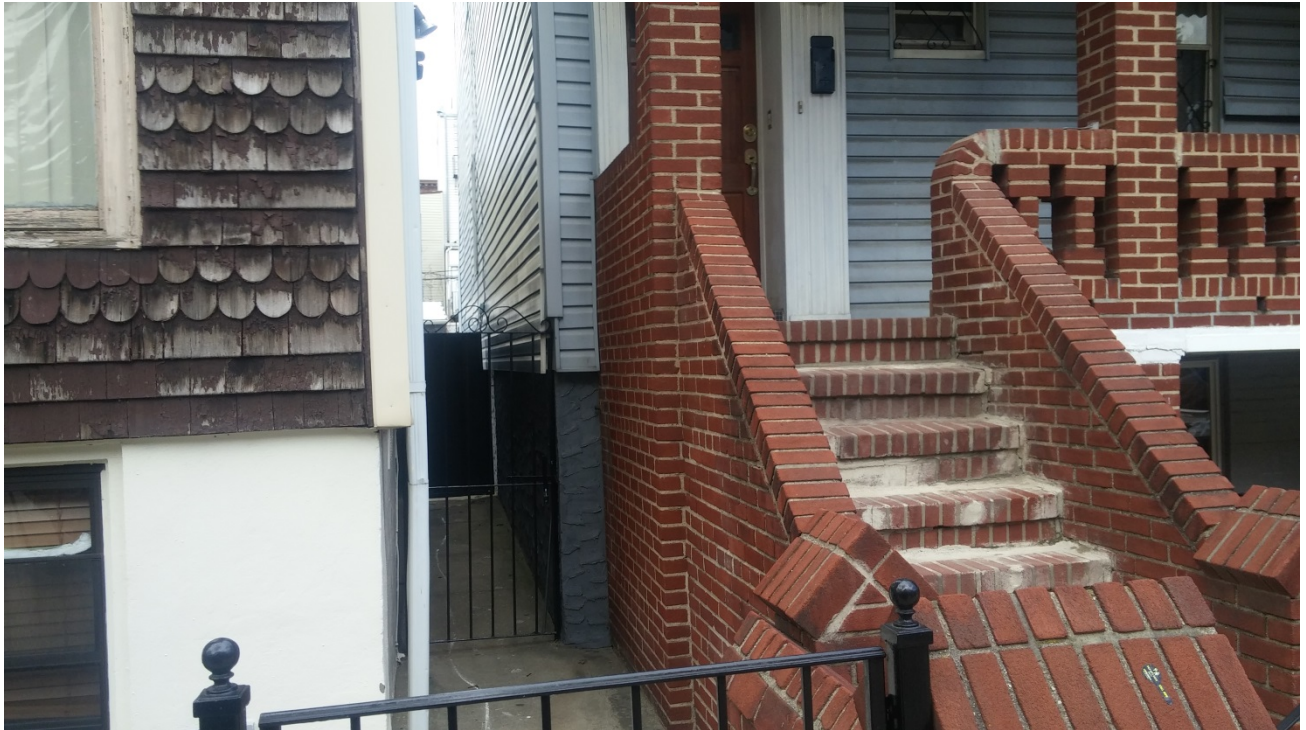
Photo 3: Front Porch and Brick Barriers

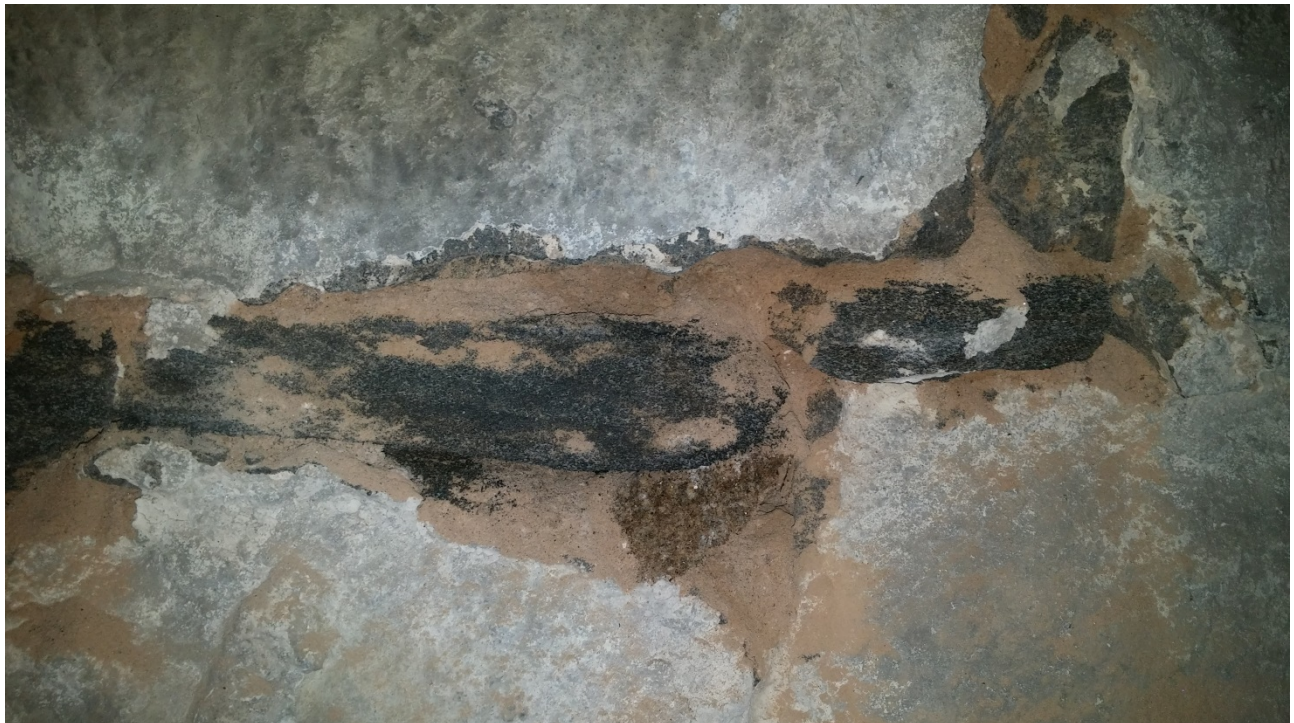
In the cellar level, the rubble foundation walls were observed. The rubble walls did not have any solid mortar connecting the stones together, and some of the smaller stones were loose when touched. Due to water infiltration, sand was observed to be seeping out from the crevices between the stones, indicating that any existing mortar has become loose and ineffective. See Photo 4 below. Please note that these foundation walls are not adequate to safely support the building in the event of a code prescribed seismic or wind event.

Photo 4: Rubble Foundation Wall

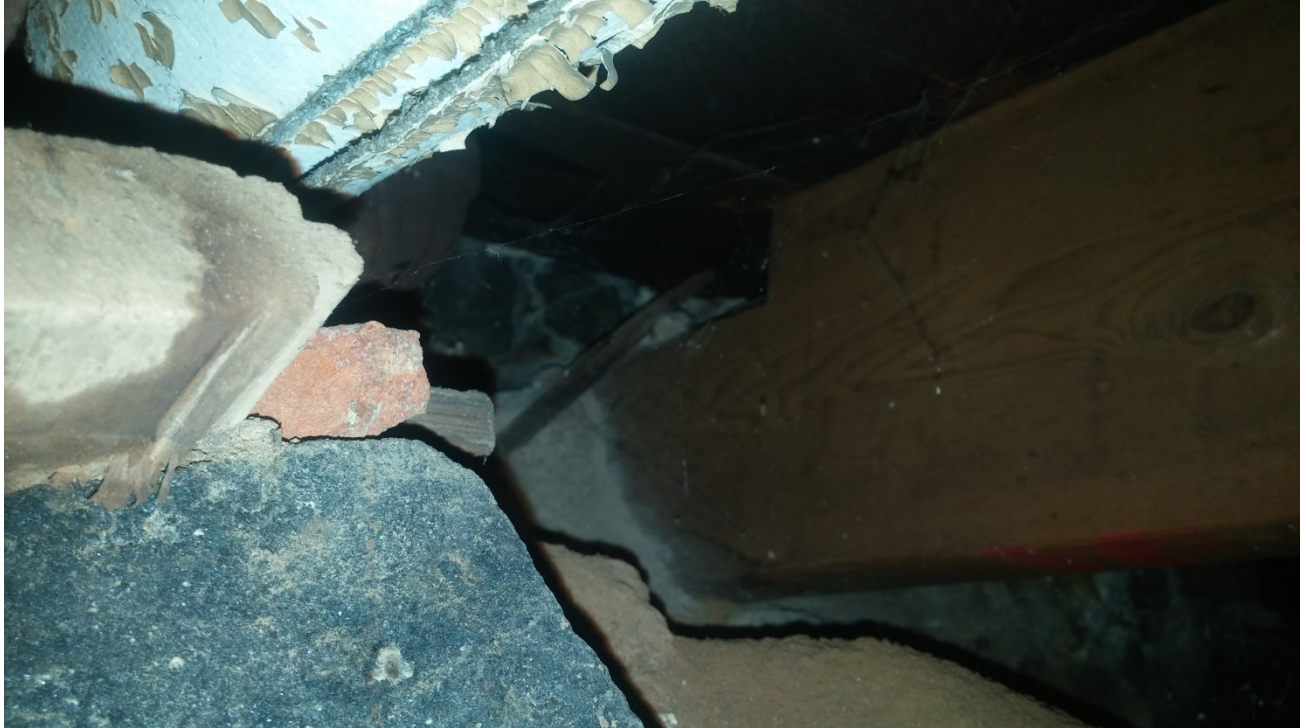
The wood joists supporting the basement floor were viewed from the cellar space. The bearing condition of these wood joists on the rubble foundation wall on the east side was found to be unacceptable for two reasons: 1) No blocking is provided between the joists to restrain them from rotation; and 2) the joists do not have full area bearing on the foundation wall. Some of the joists are only bearing on a small, uneven surface. See Photo 5 below. Due to this condition, the joists supporting the basement are not capable of safely supporting code prescribed distributed and concentrated loads.

Photo 5: Bearing Condition at Wood Joists Supporting Basement Floor

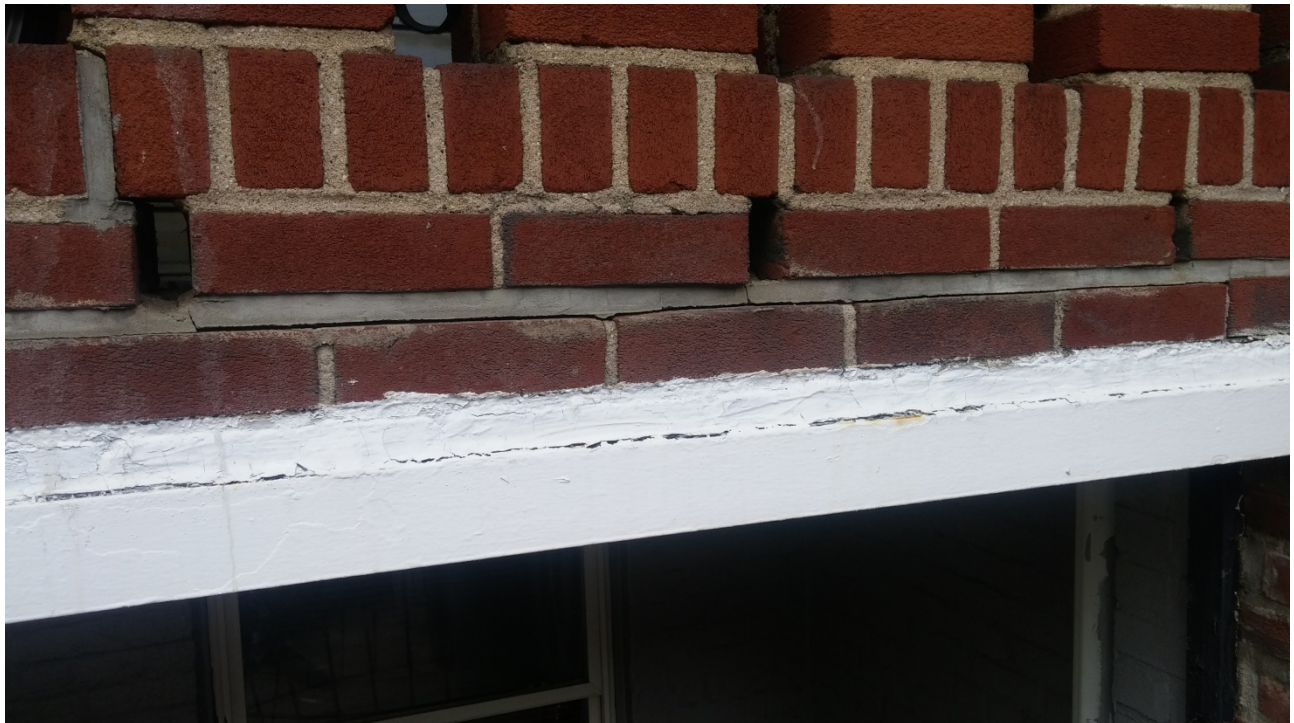
The brick piers and dividers in the front of the building were observed. The brick on the stairs and the dividers require repointing. See Photo 6 below. The brick divider between the front yard and the sidewalk is unstable and loose to the touch. See Photo 7 below. This divider needs to be repaired or replaced. In addition, a fine crack was observed on the porch barrier at the bearing end. See Photos 8 and 9 below. As a result, the construction of the header that supports this barrier and the stability of this porch barrier are questionable.

Photo 6: Brick Requiring Repointing

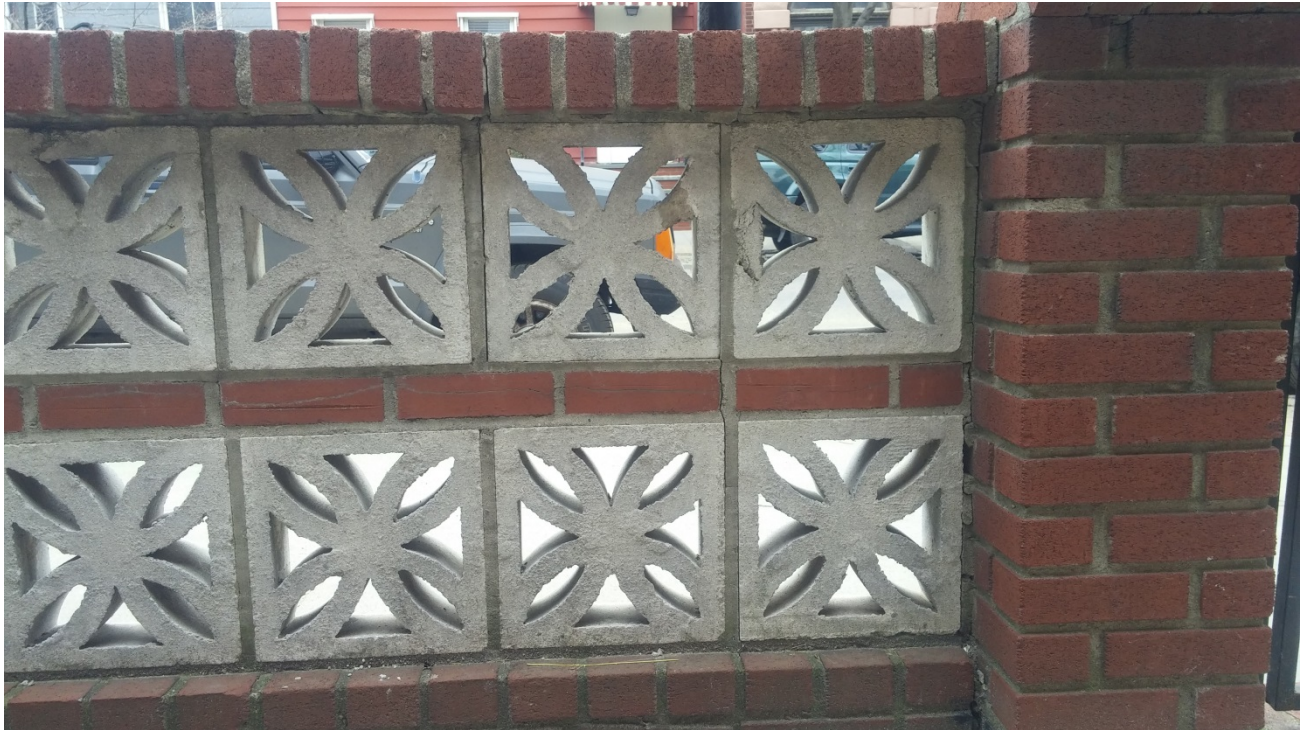
Photo 7: Front Divider

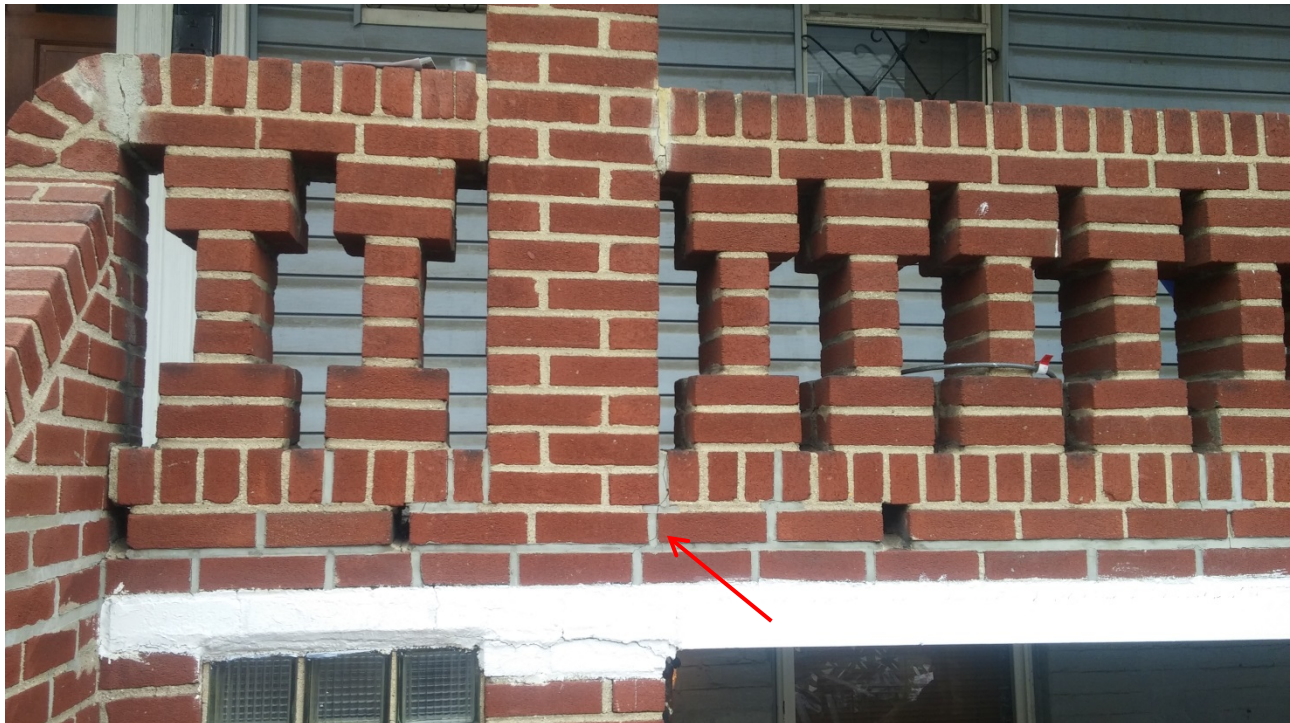
Photo 8: Porch Barrier Crack

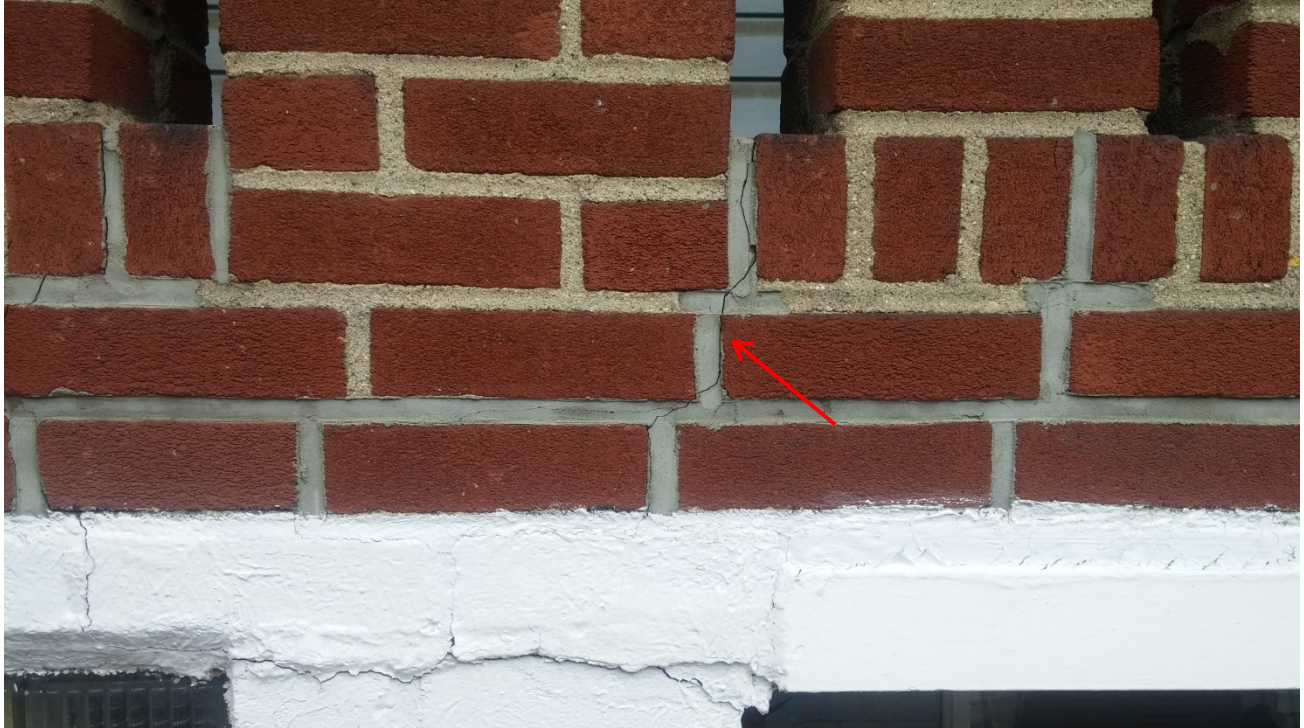
Photo 9: Porch Barrier Crack (Detail)

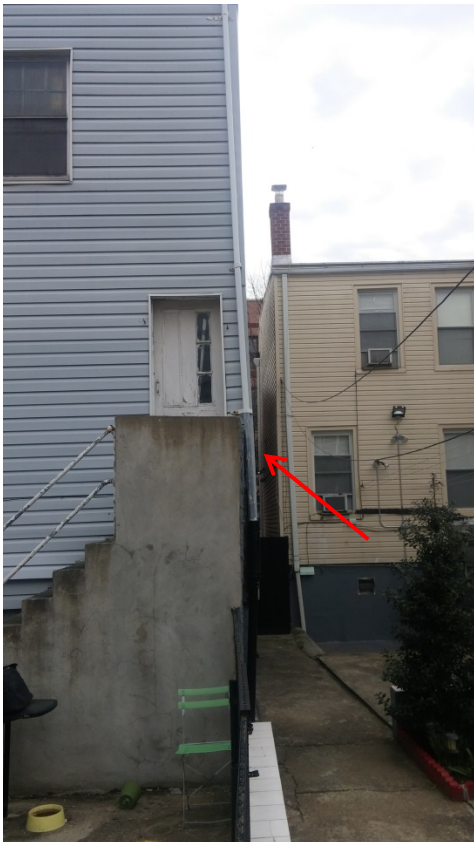
The exterior of the building was observed. At the rear of the building, the north west corner of the building was observed to be bowing out significantly to the outside face, with the maximum deformation occurring at the 1st floor level. The north west corner wood stud was also observed to be exposed to the elements. See Photos 10 and 11 below. The 1st floor level adjacent to the west bearing wall was also observed from the inside, and was found to be to be significantly warped. See Photos 12 and 13 below. Due to the deformation of the floor and the wall, there is a concern that the connection of the floor framing to the west wall is compromised. The floor joists may slip off the west bearing wall and cause the building to collapse.

Photo 10: Deformed Corner Wall

Based on these findings; due to the extent and nature of safety and stability issues encountered, as well as the observed signs of deformation and stress, we recommend that the building be rebuilt.
