Supplement to DEC Required EAP Post-Incident Report Form
Gilboa Dam EAP Activation, 12:15 pm, 8/28/11

SUBJECT: Gilboa Dam EAP Activation, 12:15 hours, 8/28/11
(Hurricane Irene Flood Event)

DATE: August 30, 2011

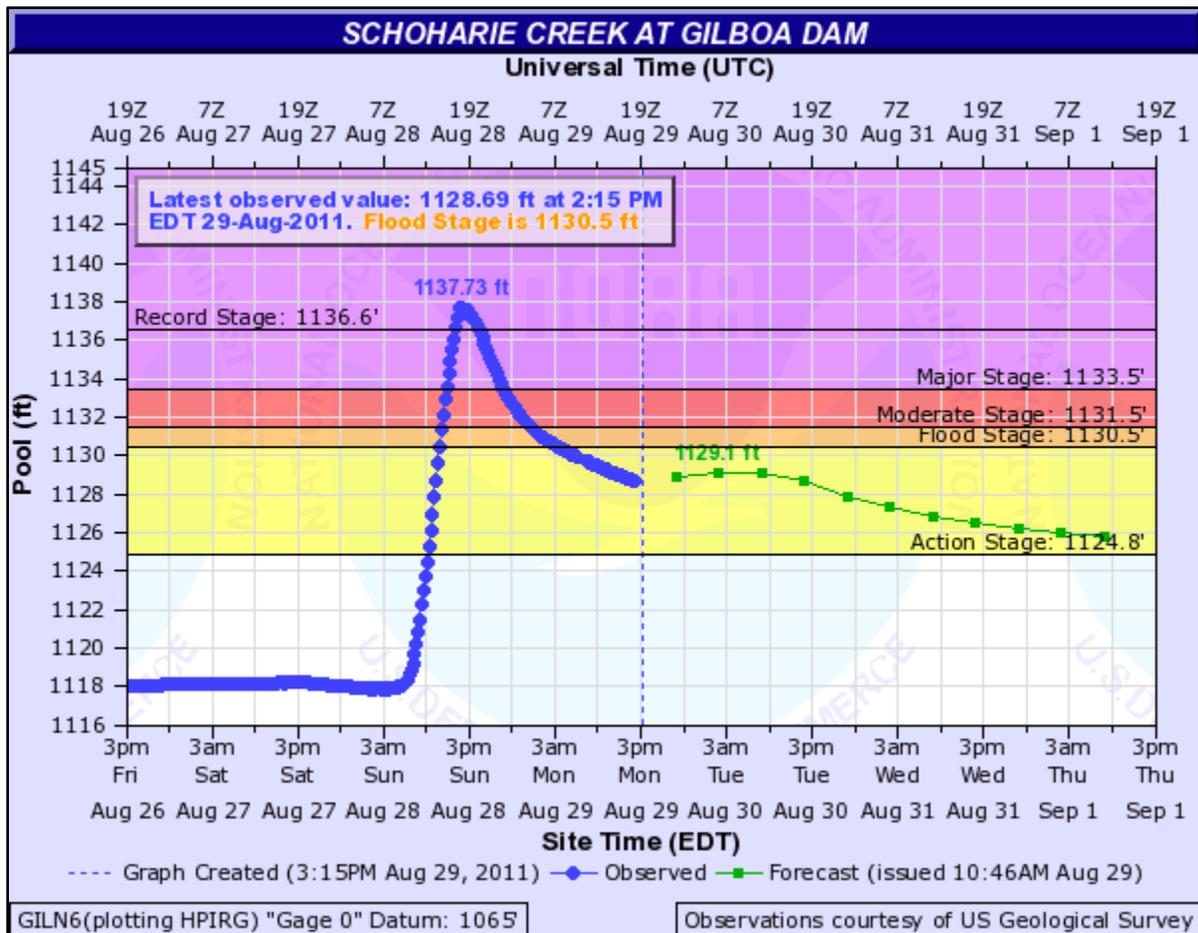
Upon arrival, the reservoir level was observed to be below El. 1130 feet (primary spillway crest level) and steadily receding as shown in the outflow hydrograph for the spillway (Figure 1) published by the US Geological Survey based on onsite electronic level sensor readings.

Figure 1: This outflow hydrograph provides a plot of the pool level at Schoharie Reservoir versus time. This is publicly available on the USGS website. It demonstrates that the reservoir level rose and peaked very quickly, within approximately a nine-hour-period. The plot indicates that peak level occurred around 14:00 hours on Sunday, August 28th. Readings taken at the Schoharie Tunnel Intake Chamber (STIC) on the west side of the reservoir showed a peak elevation of 1137.97 feet from 14:35 to 14:55 hours.

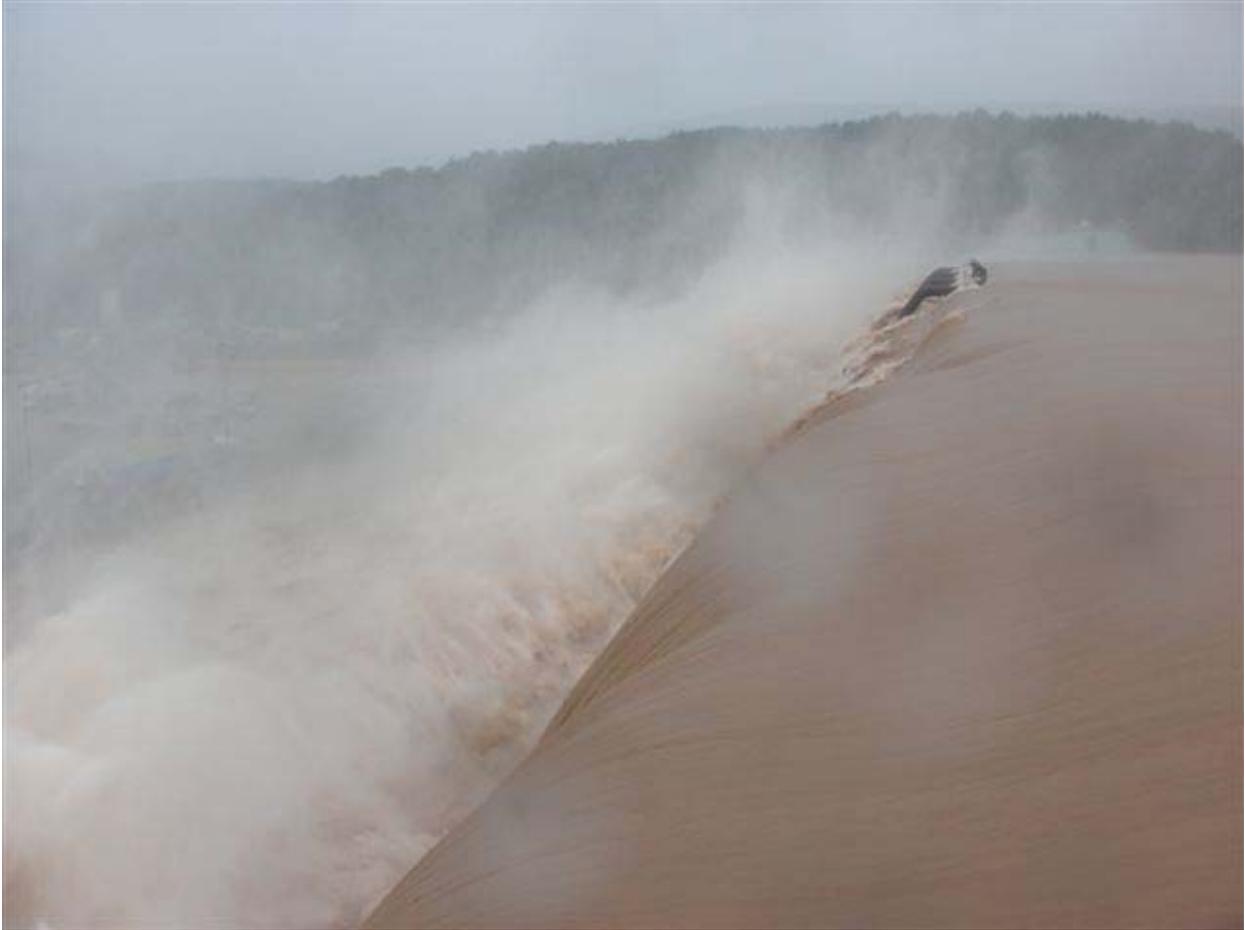
Figure 3: This photo shows the Control Section Crest at approximately peak spill elevation (STIC Gauge 1137.94 ft) at 14:20 hours. The photo was taken from the West Parapet above the dam's control section (west end of the spillway) looking east. During this event the STIC gauge recorded a peak reservoir elevation of 1137.97 feet from 14:35 to 14:55 hours.

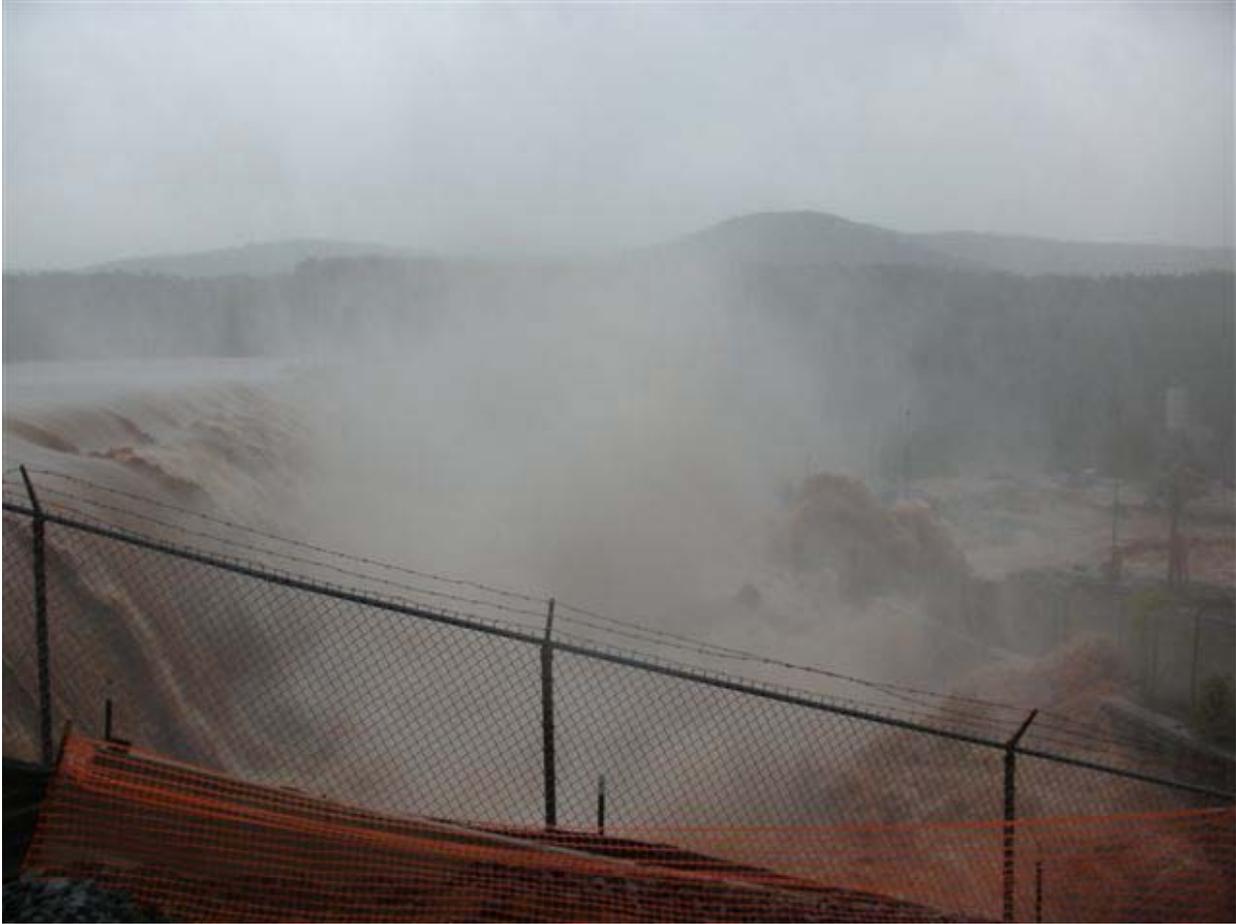
Figure 4: This photo shows the Control Section Crest on the left and the spillway channel in center. Flows are still near peak spill elevation (STIC Gauge 1137.93 ft) at 15:15 hours. The photo was taken from the downstream section of the East Training Wall above the dam's spillway channel (east end of the spillway) looking west.

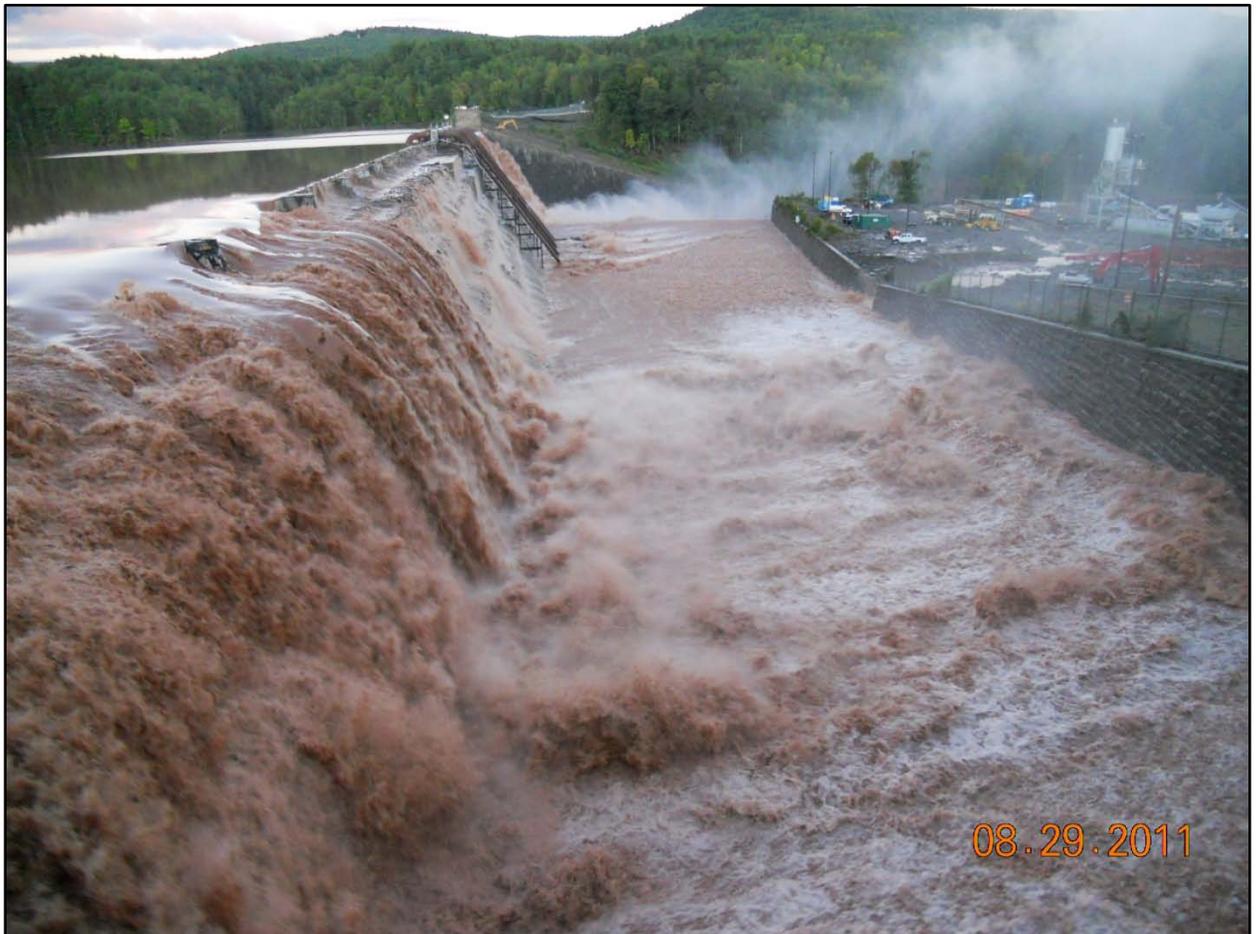
1. **Concrete Spillway (Crest Length 1,324 ft):** Given the approximately 200-ft-long crest notch (El. 1124-25 ft) formed at the east end of the spillway from stone masonry demolition operations and the 221-ft-long gated crest notch (El. 1125.07 ft) at the west end of the spillway, the notch areas, spillway face directly underneath each notch, and the side channel is still obscured by spillway flows (See Figure 5).

Figure 5: This photo shows the spillway on Monday morning, August 29th. The view is from the East Training Wall facing west. In the foreground, the crest notch at the east end of the spillway created by recent stone masonry demolition activities as part of the reconstruction project is visible. Flows from the gated crest notch at the opposite end of the spillway is also visible. Flows over the stair-stepped spillway (control section) and within the side channel appear normal for this type of flow situation.

1. Since large portions of the spillway are still inaccessible and obscured, albeit to a much lesser degree than during peak record flow conditions, due to continuing receding flow discharges it is recommended that a more comprehensive inspection of the spillway be conducted as soon as conditions allow (no flow discharges from the crest notches). This near-term inspection should further assess the overall condition of the spillway as well as concentrate efforts on a more detailed assessment of the condition of the floor of the side channel and plunge pool areas, crest notch areas, and stair-stepped control sections below each crest.

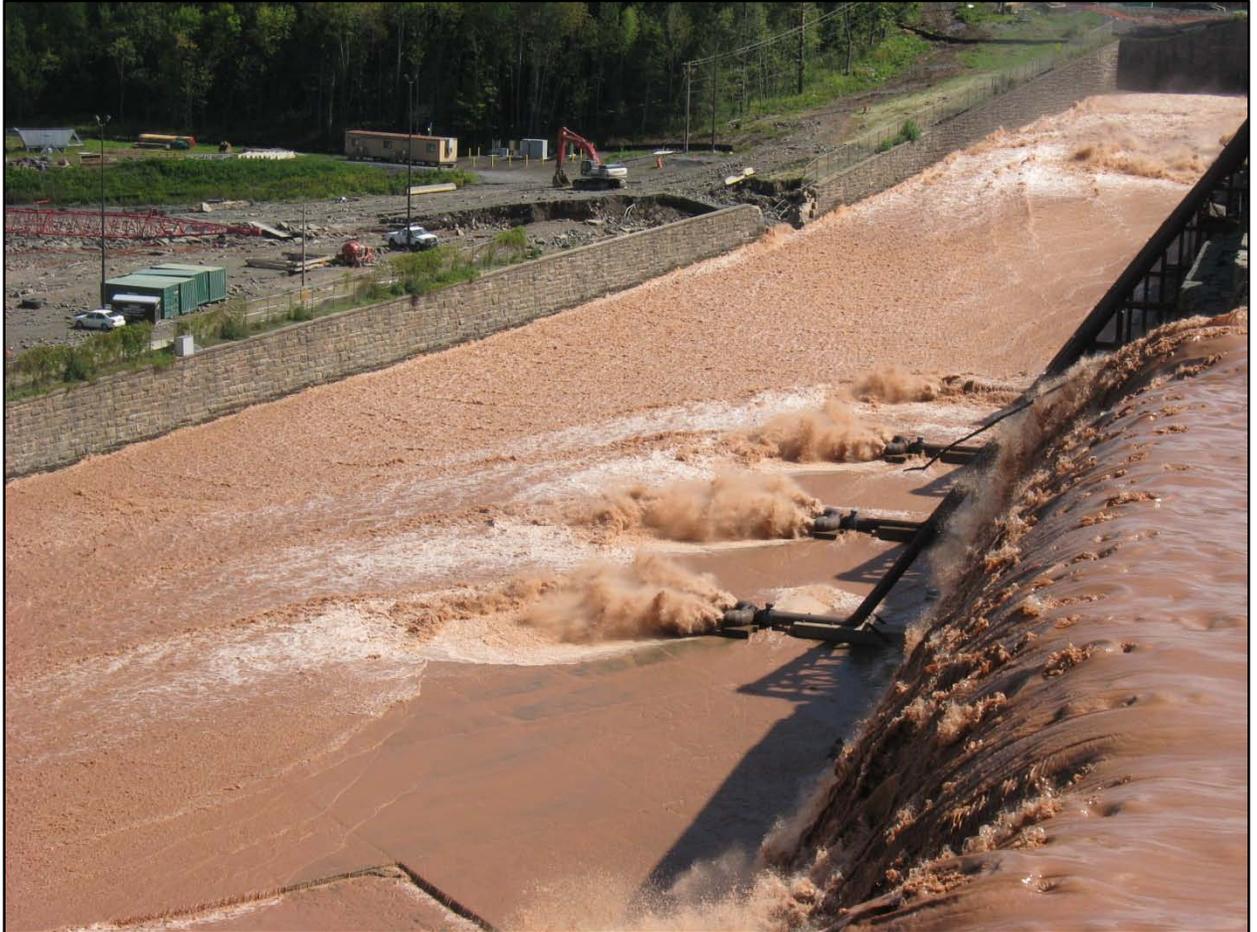
However, the flow patterns observed (see Figure 6) suggest that no significant damage occurred in the side channel floor that could expose foundation rock materials and

undermine the foundation of the spillway control section (stair-stepped weir). If significant erosion had occurred, flow patterns would be highly non-uniform at such locations.

Figure 6: This photo shows the side channel which runs below and parallel to the stair-stepped spillway (control section). The view is from the west end of the spillway. Again flows within the side channel appear normal for this type of flow situation.

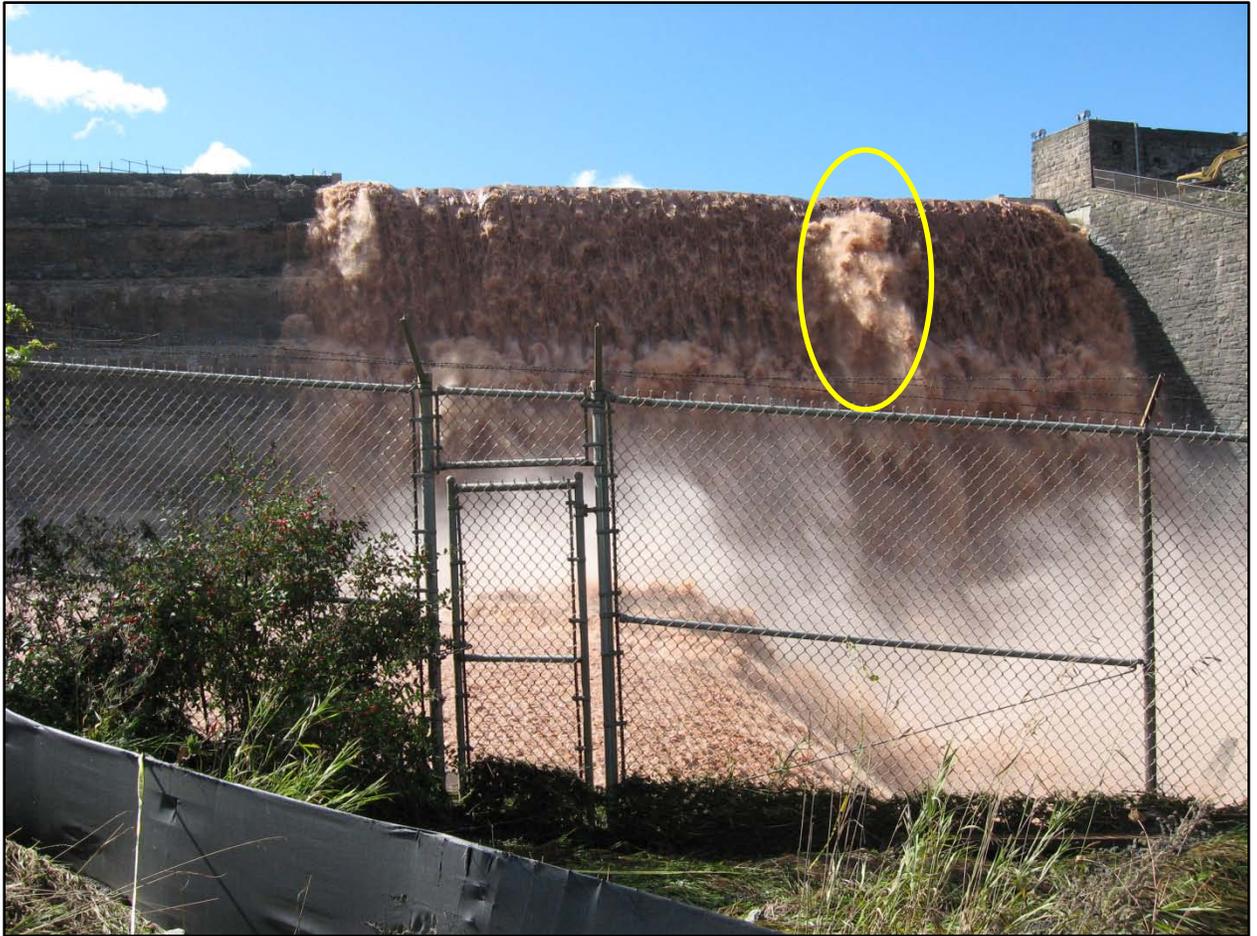
There is evidence of a non-uniform flow pattern (see Figure 7) on the stair-stepped spillway control section directly below the gated crest notch which has been observed when prior flow discharges have occurred at this notch. This pattern is likely due to the partial loss of the stone masonry façade in this area.

Figure 7: This photo shows the overflow at the gated crest notch (west end) as viewed from the north side of the spillway. The anomaly (highlighted by yellow circle) in the flow pattern appears to be due to an irregular step surface that pre-existed before the hurricane. At this flow level, even a fairly minor irregularity in the spillway surface can cause a very distinct and dramatic change in the flow pattern.

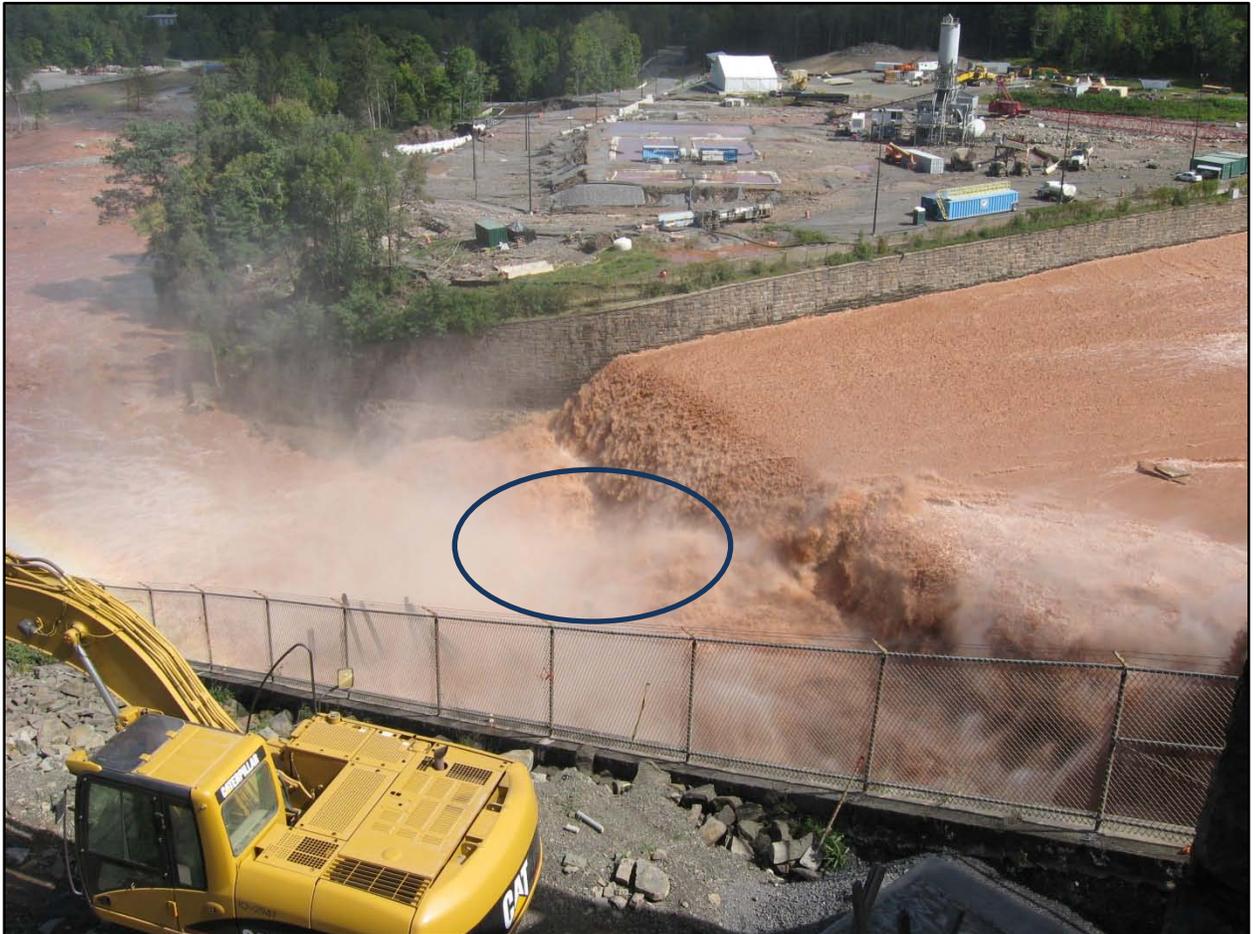
The only visible damage to the spillway appears to be isolated to the intermediate step of the side channel and one channel slab unit. Even though the intermediate channel step has undergone demolition of its stone masonry façade, a portion of the step (see Figure 8) appears to have been dislodged and pushed against the temporary steel frame structure

intended for post-tensioned anchor drilling operations for the West Training Wall. The missing portion of the intermediate step is located a reasonable distance away from the stair-stepped control section such that it is not believed to impact the structural integrity of the control section. In addition to loss of material at the intermediate channel step, it appears that one of the channel slab units near the downstream end of the channel has become dislodged (see Figure 9). There was no evidence of erosion of the underlying materials at this location.

Figure 8: The side channel meets the plunge pool area at the west end of the spillway. All spillway flows enter the natural creek downstream of the dam from the plunge pool area. At this location the side channel floor steps down by two 18-ft-high steps to reach the same level of the plunge pool floor. As highlighted by the blue circle in the photo, the intermediate step (18-ft below the end of the side channel floor and 18-ft above the plunge pool floor) appears to have suffered loss of a portion of its concrete and rock mass that forms the step due to erosion damage from spillway high flows. The dislodged portion of the intermediate step is located towards the north end of the step which is located favorably further away from the stair-stepped spillway control section. Further assessment of this damage is needed once spillway flows fully subside.

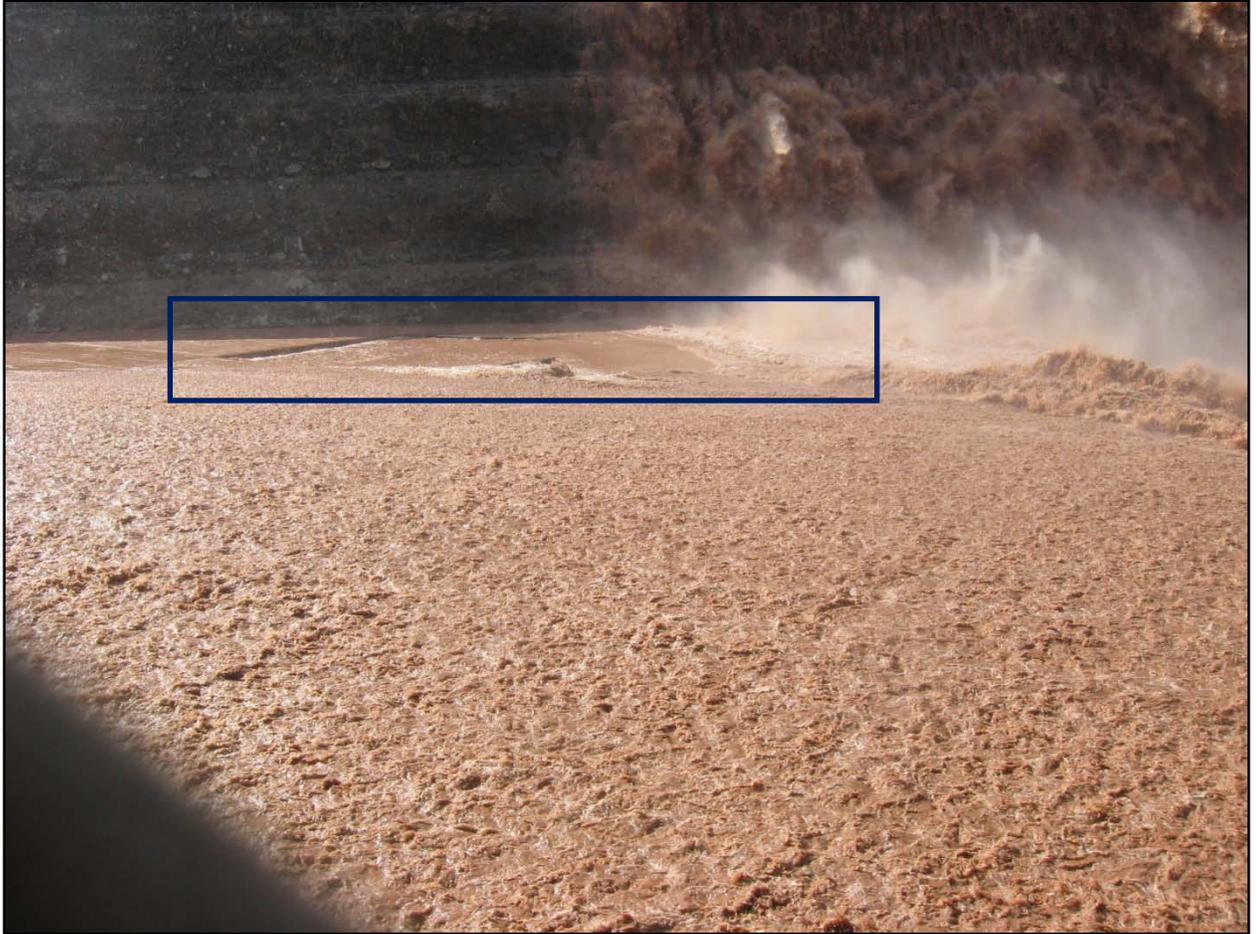
Figure 9: This photo depicts a location at the southwest corner of the side channel floor where a thin (approx. 8 inches thick) approximately 20 ft by 20 ft concrete slab has been displaced by the high spillway flows. This damage is very minor in nature and can be easily repaired once spillway flows subside.

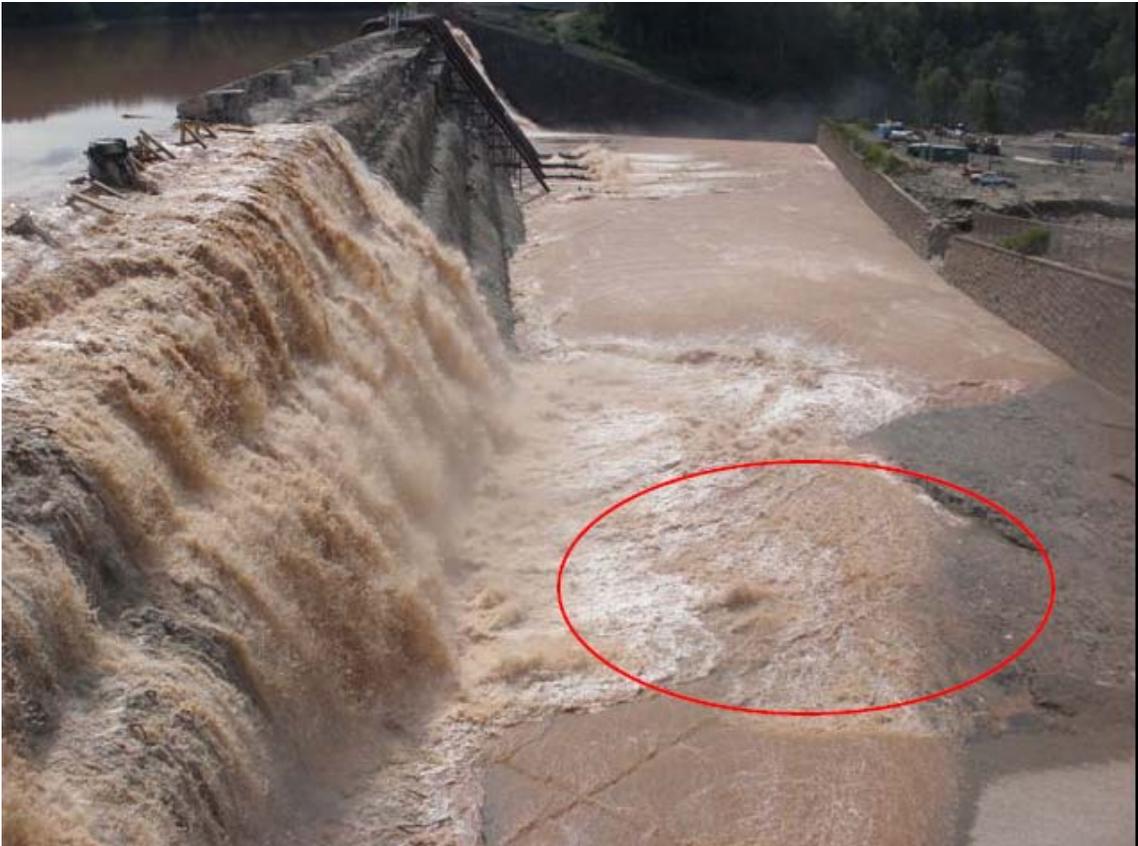
1. **Concrete Spillway (Crest Length 1,324 ft):** Given flow elevations having receded in the spillway channel, flow patterns still suggest no damage on the channel floor to bedrock. However, there are indication of damage to two of the diamond slabs at the east end to approximately one foot depth and a possible deeper scour hole just downstream of that (see Figure 10)

Figure 10: This photo shows the Spillway Control Section (crest) and left and the side channel at center from the east Overlook Area looking west. Note the edge of one of the concrete channel slabs within the circle and the irregular flow pattern just downstream. This may indicate a deeper scour section

1. Since large portions of the spillway are still inaccessible and obscured, due to continuing receding flow discharges it is recommended that a more comprehensive inspection of the spillway be conducted as soon as conditions allow (no flow discharges from the crest notches). This near-term inspection should further assessments as recommended in Monday's inspection.
2. Initiate measures for emergency evaluation and repair work at the dam, dam access, and construction staging areas as well as all supporting systems.

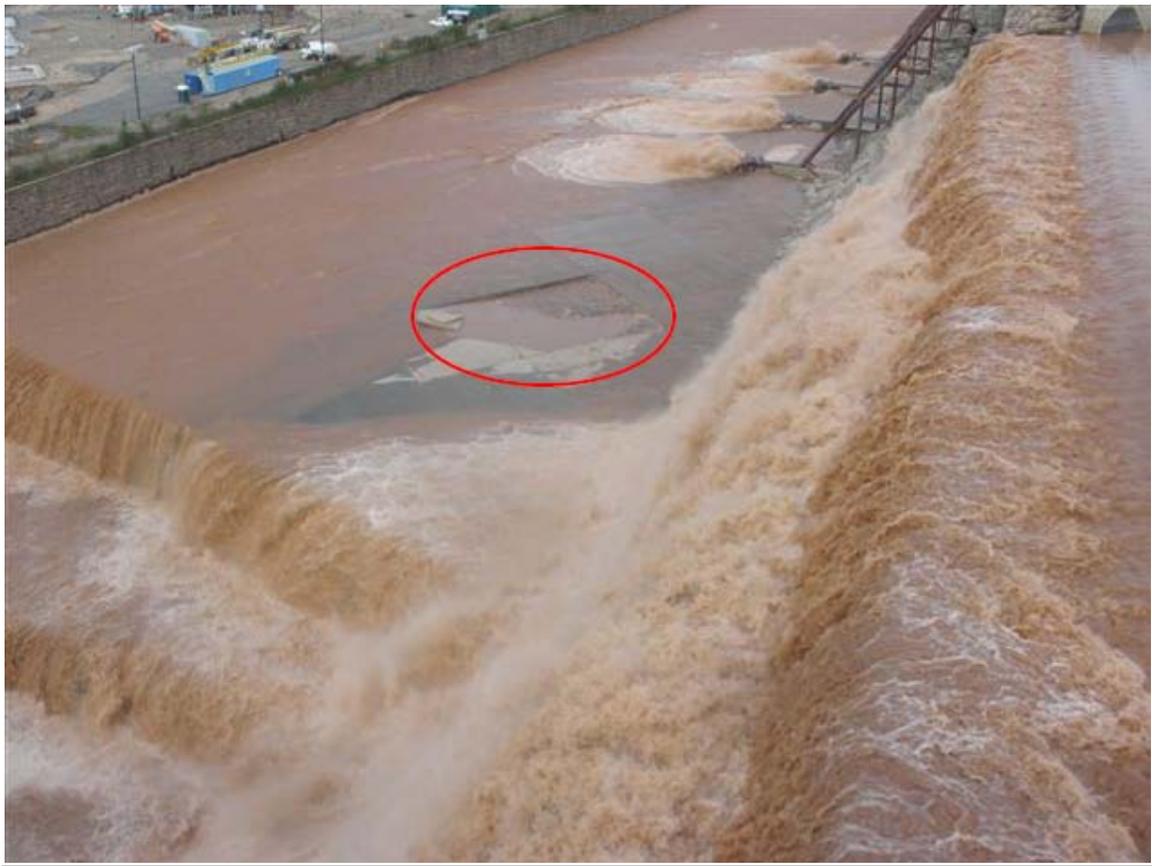
Flow patterns at the lower water elevations continue to suggest no significant damage occurred in the side channel floor that could expose bedrock. However, flows at the east end of the channel are still obscuring the possible scour hole previously discussed. Also, the possible damage to the 20' x20' concrete slab towards the western end of the side channel discussed in Figure 9 can now clearly be seen here and confirmed (see Figure 11). This damage appears to be minor and can easily be repaired once flows subside.

Figure 11: This photo shows the Spillway Side Channel from the West Parapet looking east. Note the loss of the channel slab indicated within the circle at center.

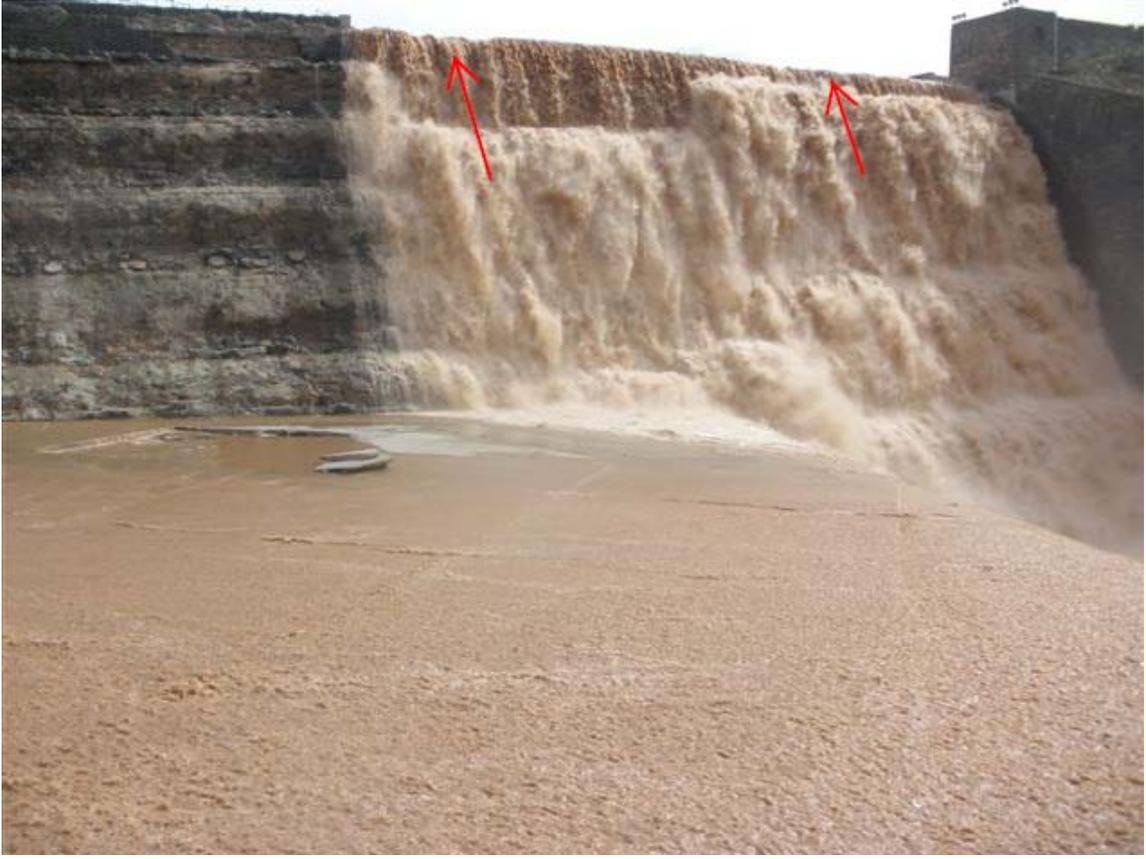
Evidence of non-uniform flow patterns on the stair-stepped spillway control section discussed in Figure 7 are not observed at the lower flows. This suggests that the anomalies were formed at the higher flows and from irregularities previously observed in the gated notch crest (see Figure 12 and Figure 13).

Figure 12: This photo shows the Gated Notch Crest from the north side of the side channel looking southwest. Note the slight flow irregularities indicated by the red arrows. These were noted in previous inspections and are scheduled for repair under the current construction contract.

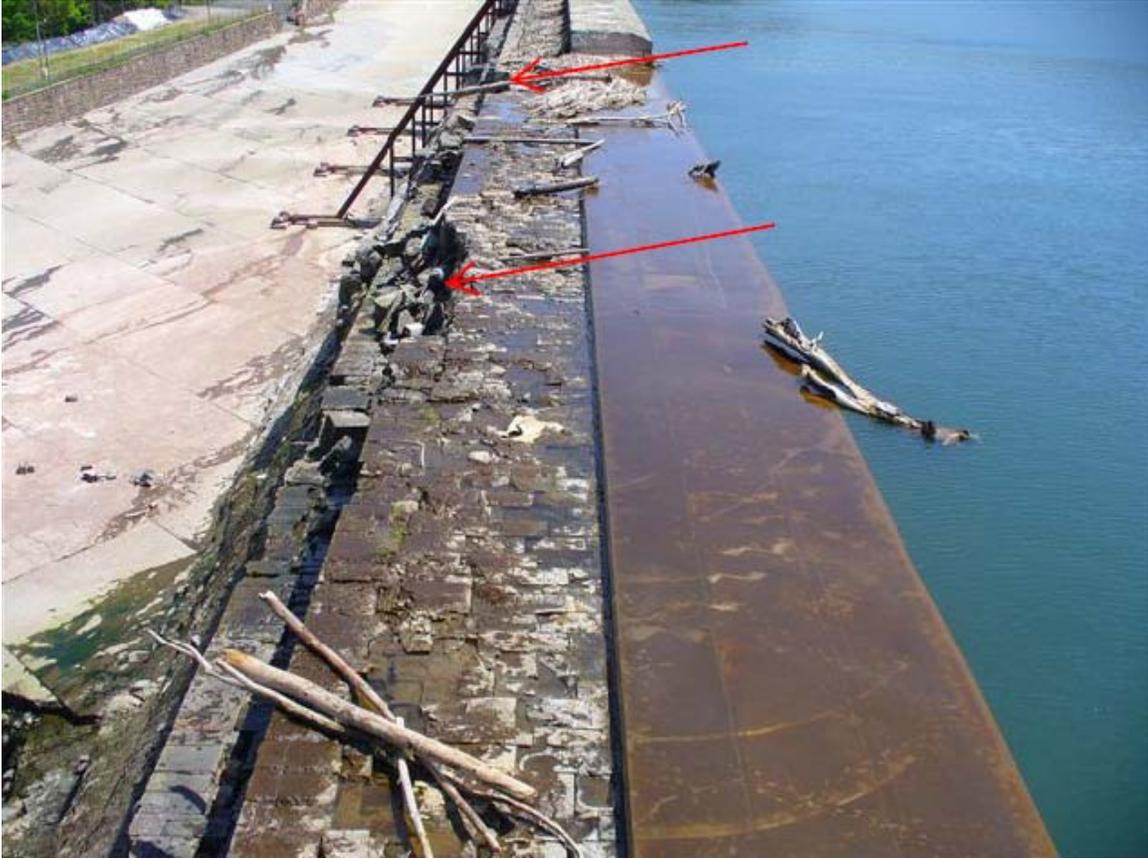
Figure 13: This photo shows the Notch Crest from the West Parapet in May 2008. Note the same points (again indicated by red arrows) where material is missing and as indicated in Figure 12. The higher flows on Monday are believed to have caused the flow anomalies observed.

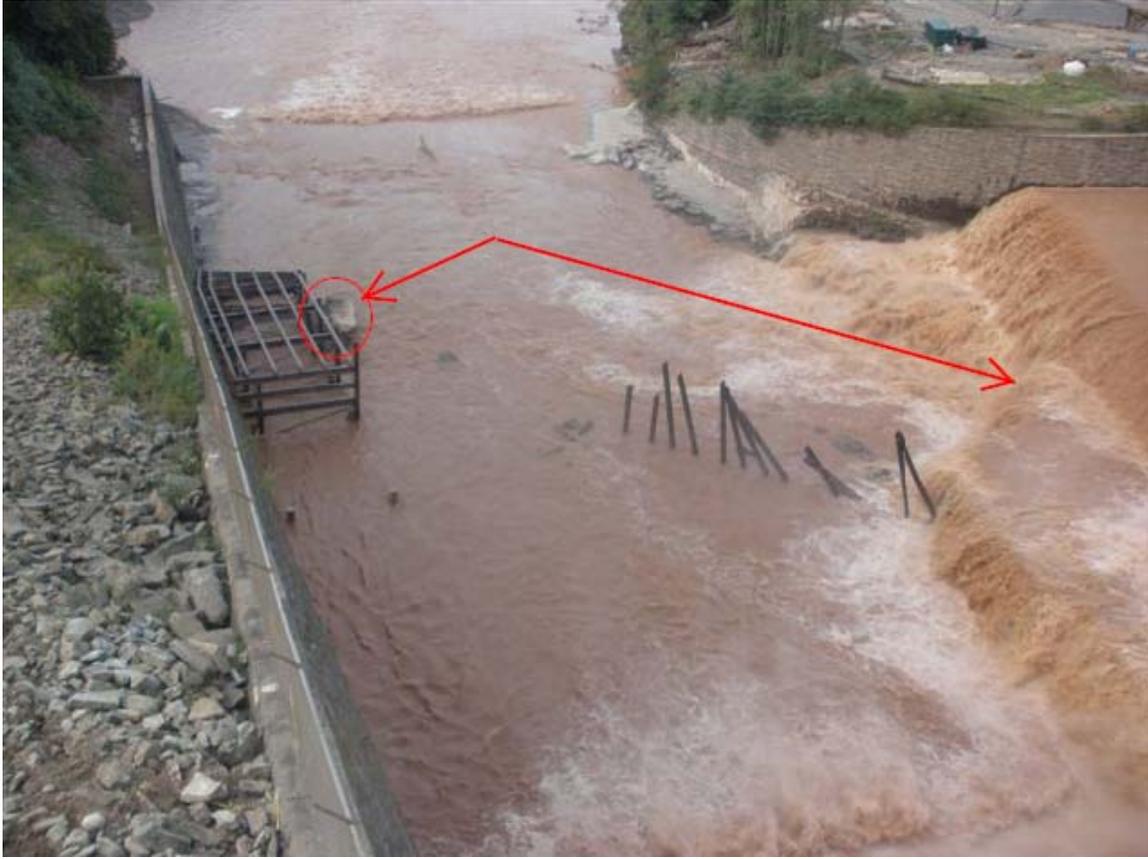
A clearer view of the plunge pool than was allowed on Monday reveals the movement of a section of demolition debris from the intermediate step of the side channel. This loss of material however does not present a near-term risk to the safety or stability of the dam itself (see Figure 14).

Figure 14: This photo shows the Plunge Pool from the West Parapet looking north. Note the large piece of debris lodged against the framework of the drilling platform in the red circle on left. It is believed to be from the Intermediate Step on right.
