**New York City Department of Transportation
Office of School Safety Engineering**

School Safety Engineering Project

FINAL REPORT: I.S. 2 (George L. Egbert School), Staten Island

September 27, 2006

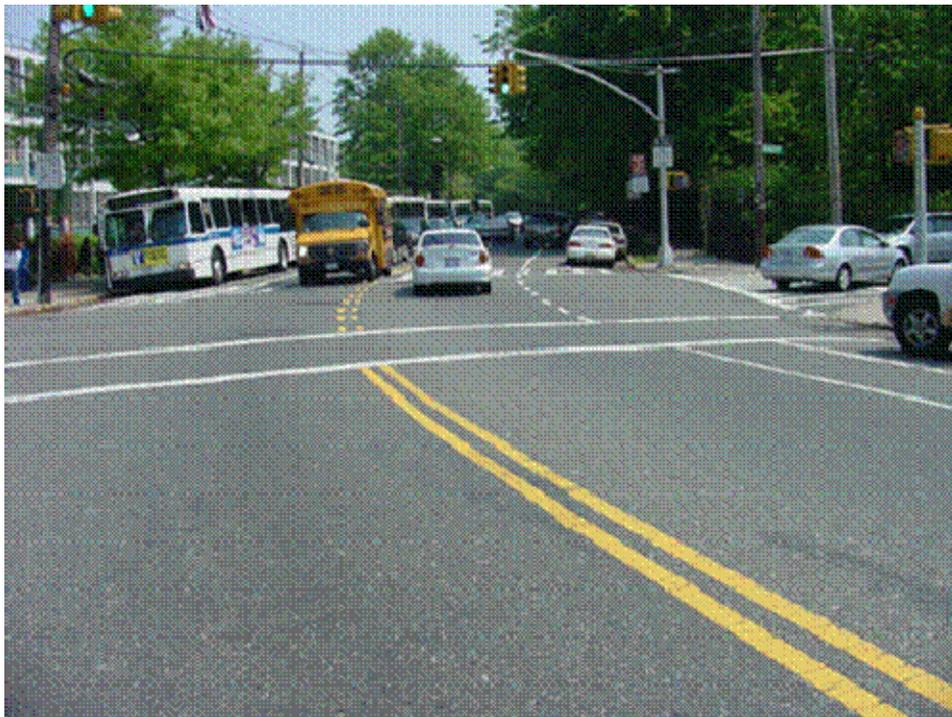
Figure 2: Looking east on Midland Avenue across the intersection with Boundary Avenue (note school bus and MTA buses).

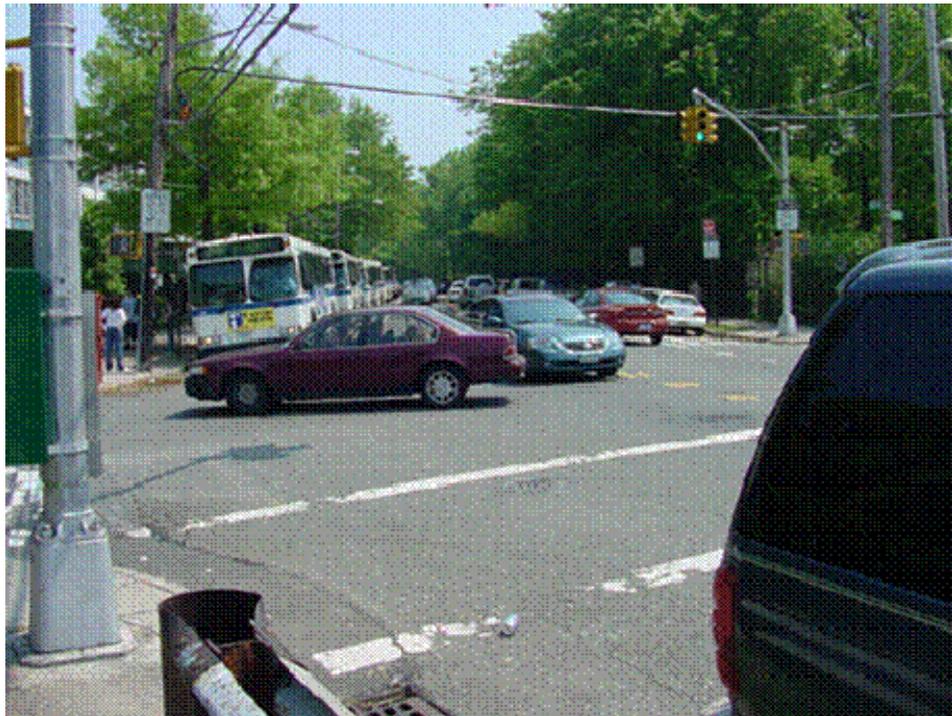
According to school representatives, approximately five percent of the students are dropped off. Parents typically double park across the street from the school entrance on Midland Avenue while dropping off students in the morning or awaiting the afternoon student dismissal. The double-parked vehicles temporarily block the existing bicycle lane and a portion of the eastbound travel lane of Midland Avenue.

Figure 3: Looking east on Midland Avenue from the intersection with Boundary Avenue.

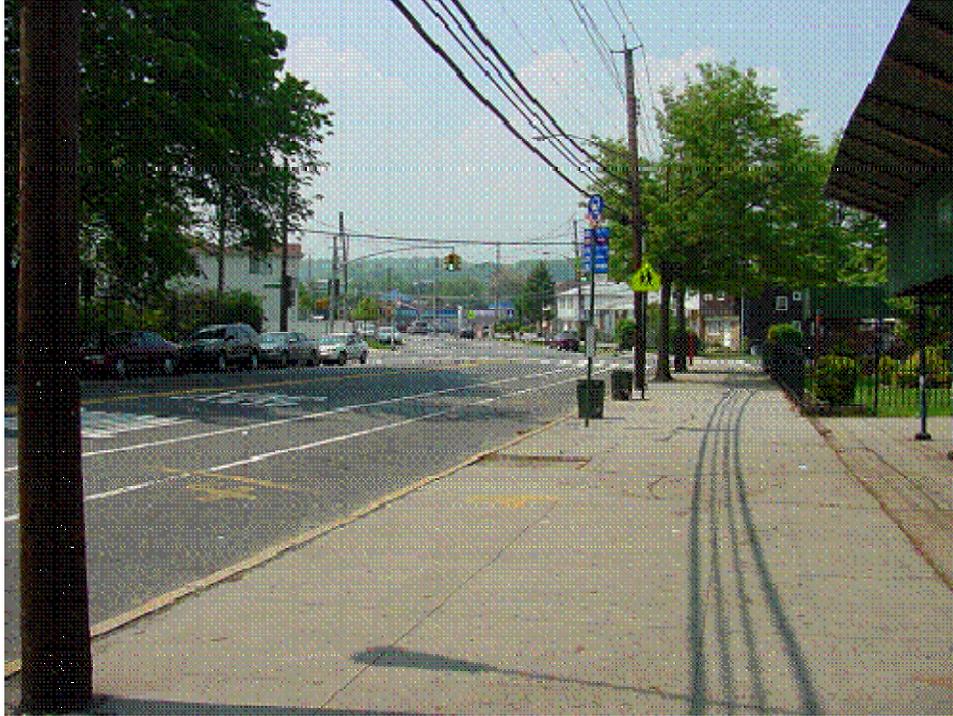
Figure 4 shows pavement markings and signs in front of the school’s main entrance on Midland Avenue.

Figure 4: Looking west on Midland Avenue toward the intersection with Boundary Avenue (the main entrance to I.S. 2 is shown to the right).

Replace the existing “NO PARKING 7AM – 4PM SCHOOL DAYS” signs on the north side of Midland Avenue with “NO STANDING 7AM – 4PM SCHOOL DAYS” for 30 feet in front of the school’s main entrance. (This is a typical requirement for all NYC schools in order to provide for emergency access to and from the school).

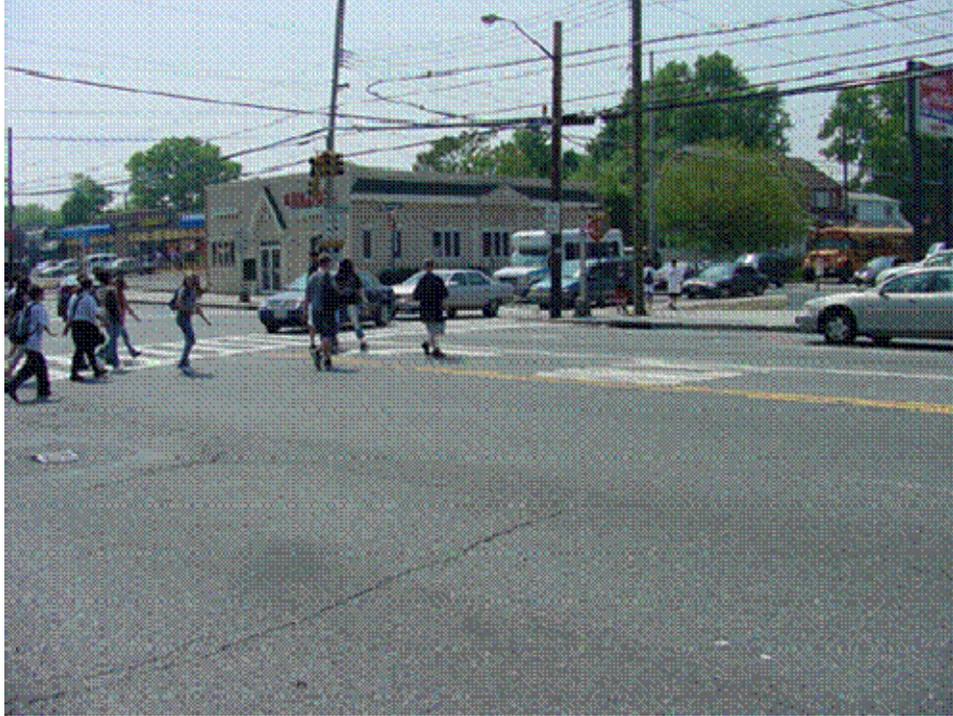
Figure 5: Students are shown crossing the north leg of Hylan Boulevard at its intersection with Midland Avenue against a “DON'T WALK” indication. Note that conflicting eastbound left-turn vehicle movements from Midland Avenue are also taking place.

This is a controlled intersection with high volumes of cars and pedestrians. During the field visit, it was observed that significant numbers of students are crossing against the walk signal at this intersection. It is therefore recommended to:

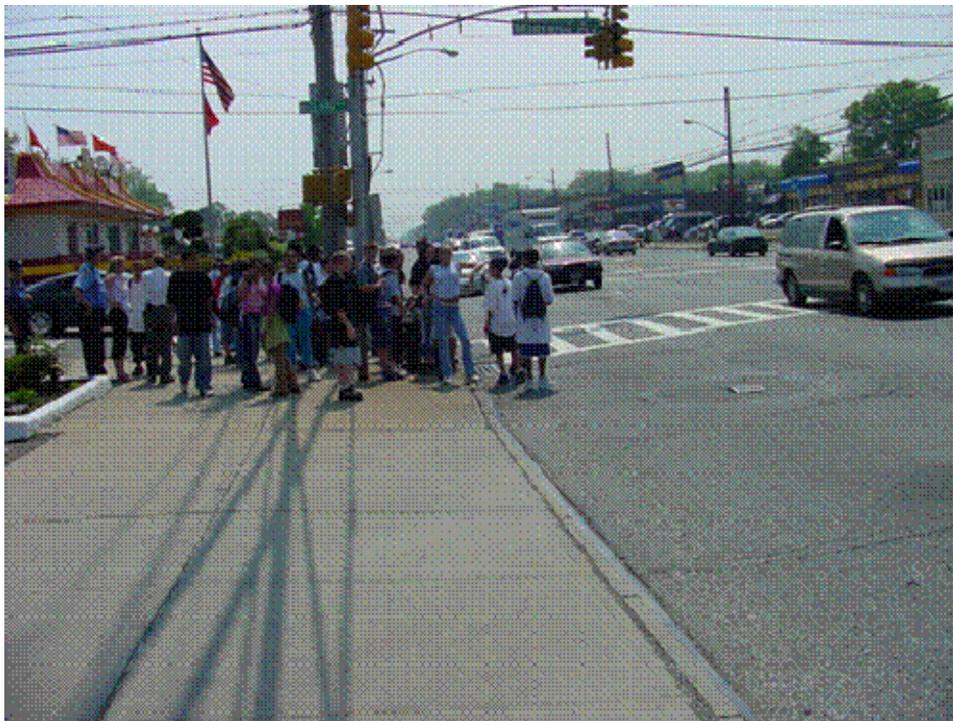
Figure 6: Students waiting to cross Hylan Boulevard on the northeast corner of the intersection with Midland Avenue.

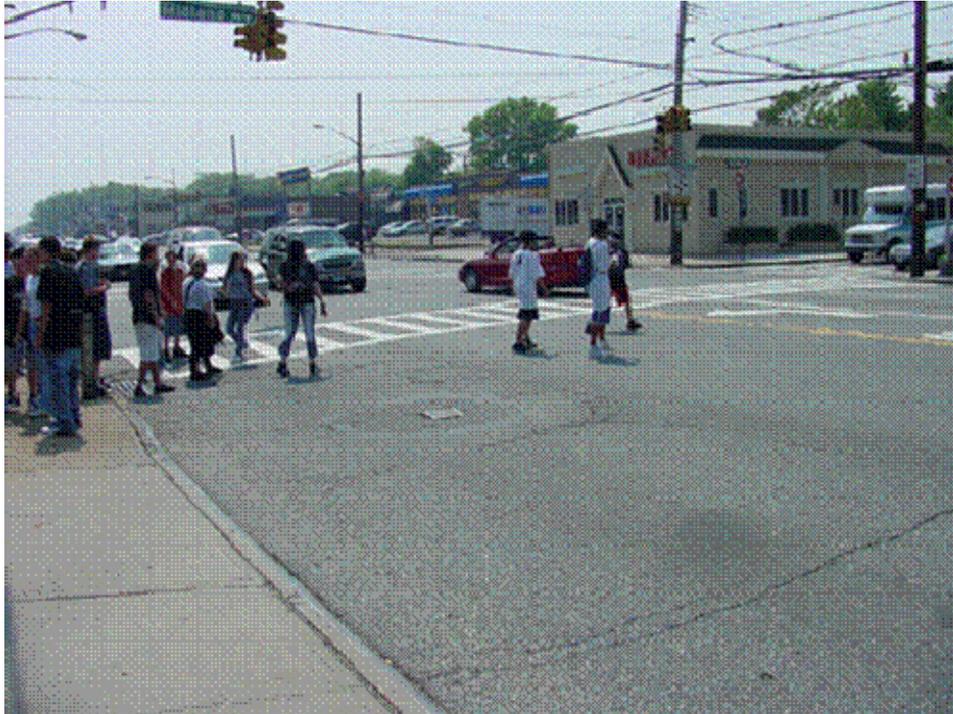
Figure 7: Students attempting to cross the north leg of the Hylan Boulevard/Midland Avenue intersection against the “DON’T WALK” signal.

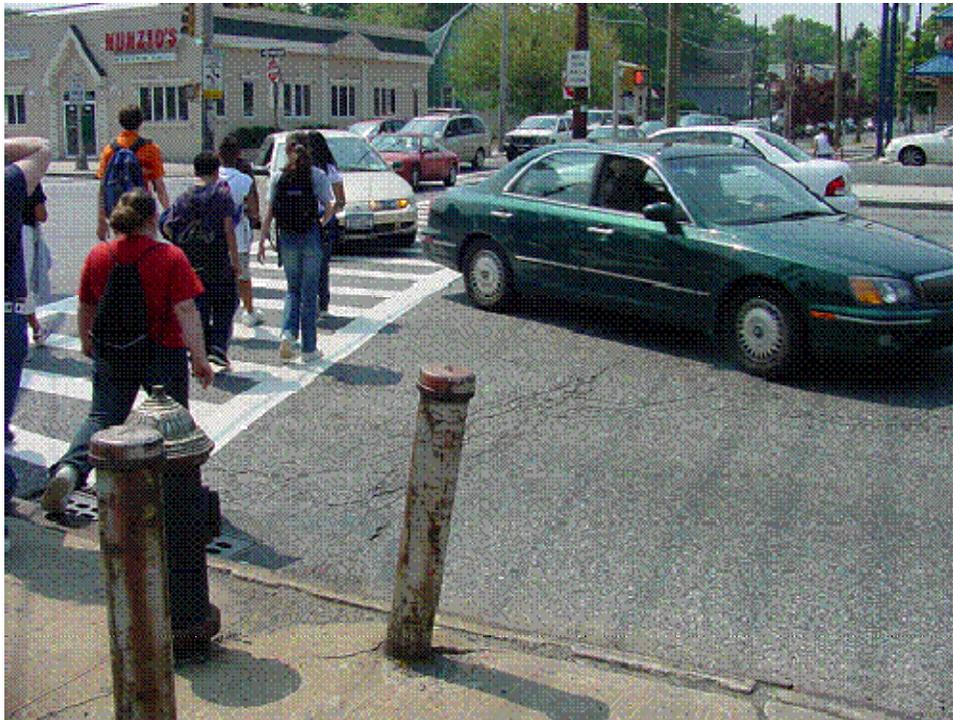
Figure 8: Students crossing the north leg of the Hylan Boulevard/Midland Avenue intersection during the leading eastbound green interval. Note the “DON’T WALK” signal display and conflicts with eastbound left-turning vehicular traffic.

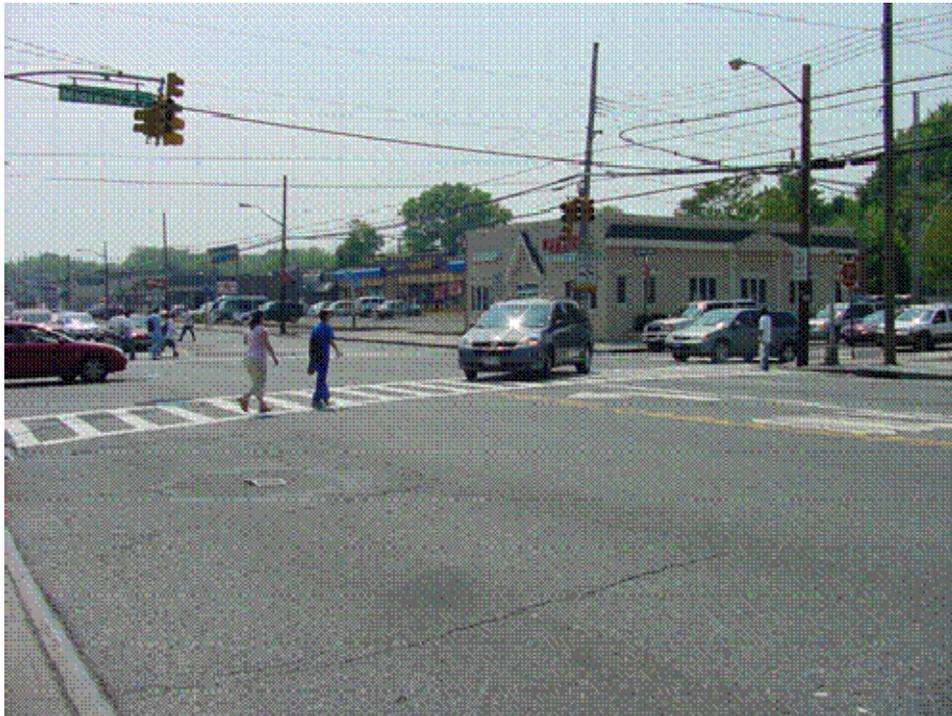
Figure 9: Students crossing the north and south legs of the Hylan Boulevard/Midland Avenue intersection using the school and pedestrian crosswalks, respectively.

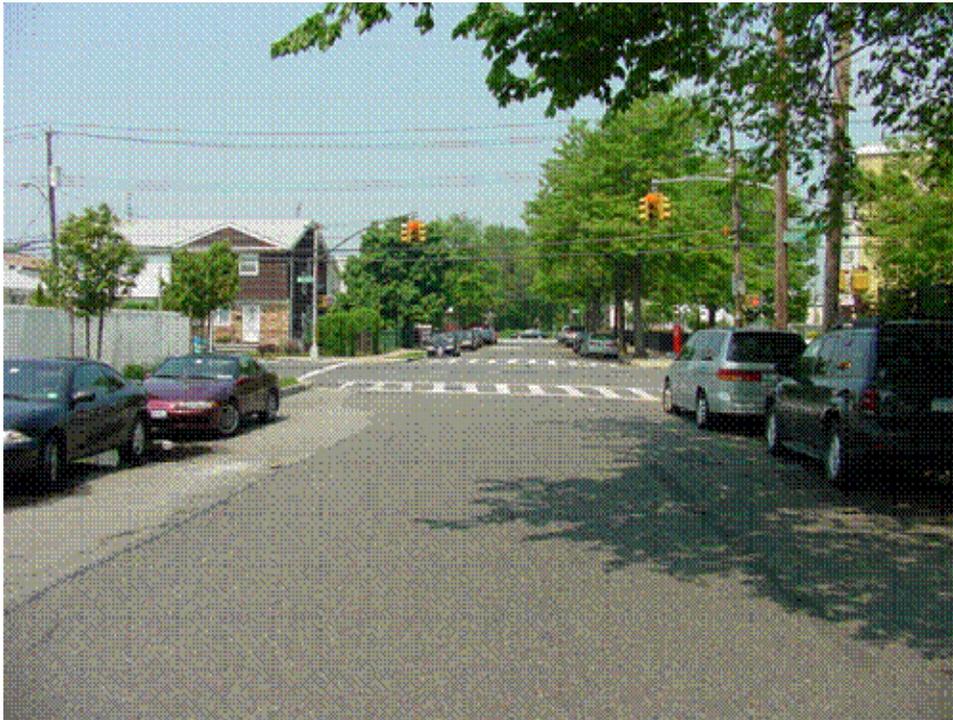
Figure 10: Looking north on Boundary Avenue to the intersection with Midland Avenue.

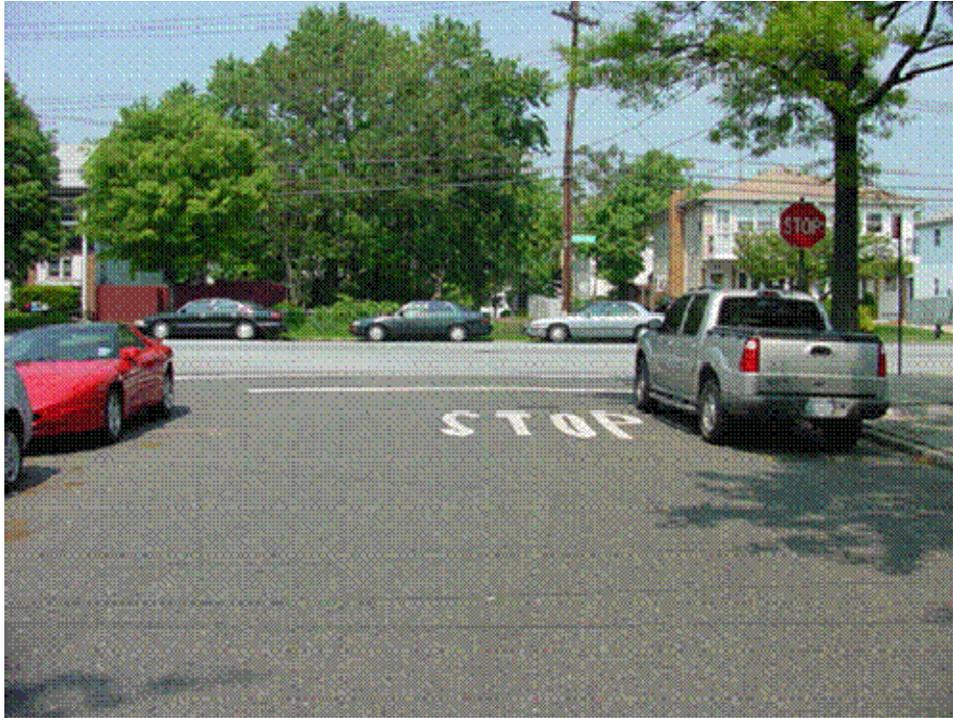
Figure 11: Looking north on Boundary Avenue to the intersection with Bedford Avenue.

Students from I.S. 2 were observed using the existing pedestrian crosswalk located across the south leg of the Boundary Avenue and Bedford Avenue intersection, which is adjacent to the school. Therefore, it is recommended to:

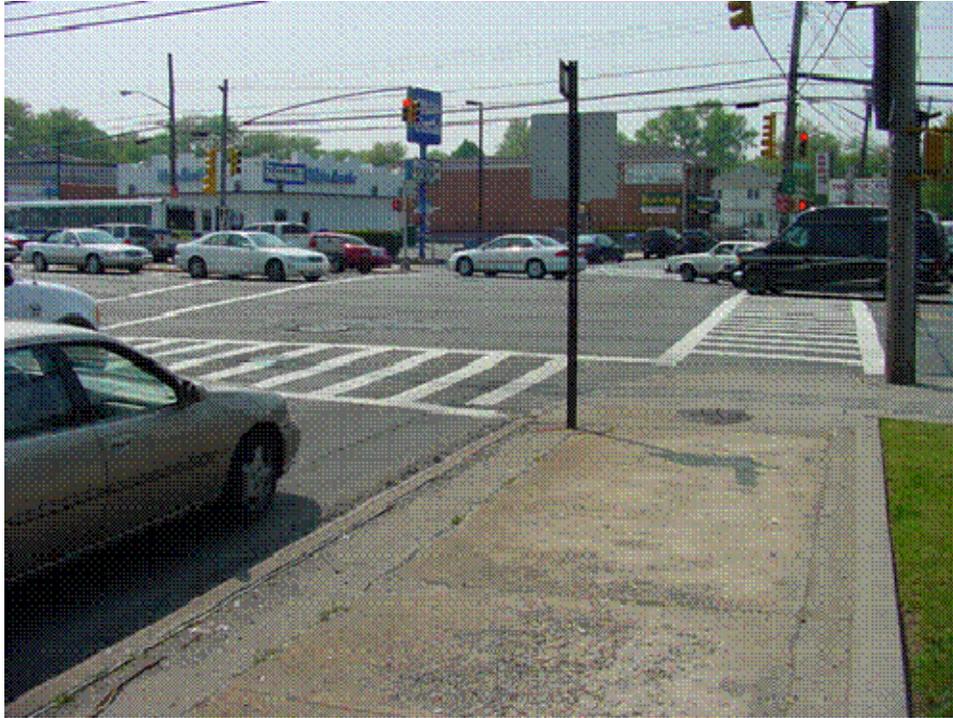
Figure 12: Looking west on Lincoln Avenue to the intersection with Hylan Boulevard.

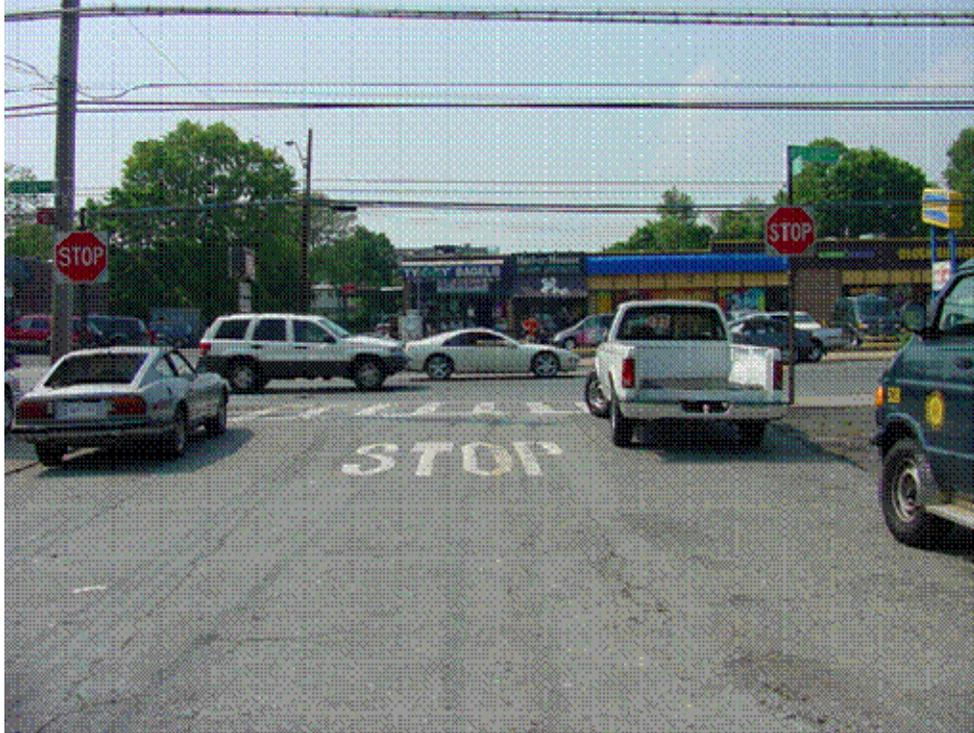
Figure 13: Looking west on Zwicky Avenue to the intersection with Hylan Boulevard.

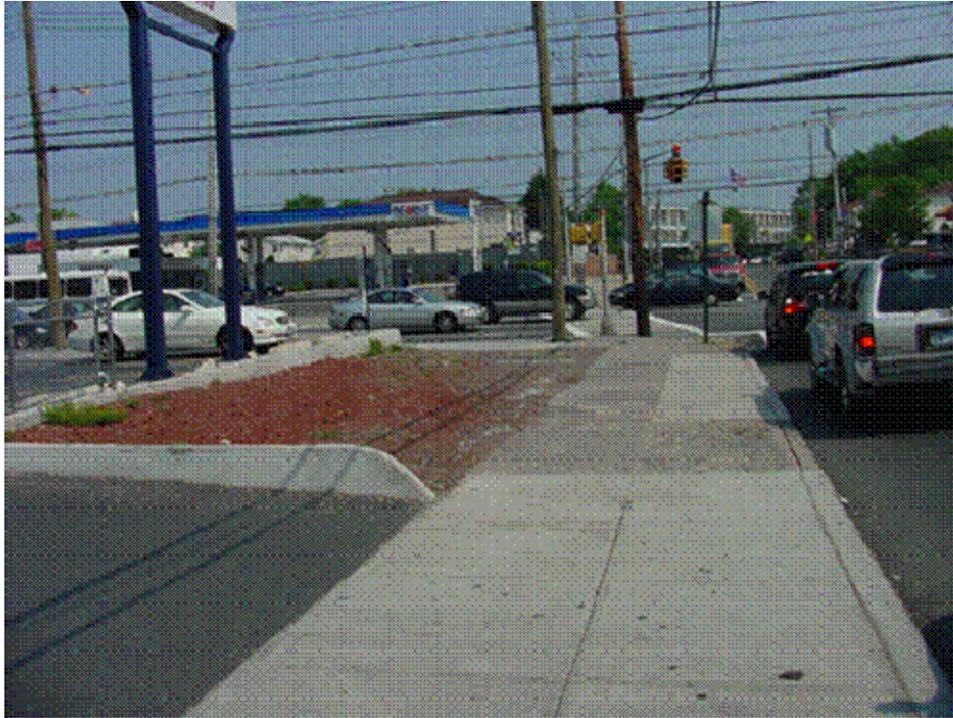
- The existing pedestrian ramp on the northwest corner of the Midland Avenue and Hylan Boulevard intersection is obstructed by utility poles (see Figure 14).
- The existing pedestrian ramp on the northeast corner of the Midland Avenue and Hylan Boulevard intersection is too narrow and not properly located (see Figure 16).
- Pedestrian ramps are missing for the crosswalk located across Boundary Avenue at the intersection with Bedford Avenue (see Figure 1).
- Pedestrian ramps are missing for the school crosswalk located across the east leg of Midland Avenue at the intersection with Boundary Avenue (see Figure 2).

Figure 14: Looking east on the north side of Midland Avenue to the intersection with Hylan Boulevard.

- Relocate the utility poles and any associated crosswalk obstructions located on the northwest corner of the Hylan Boulevard and Midland Avenue intersection.

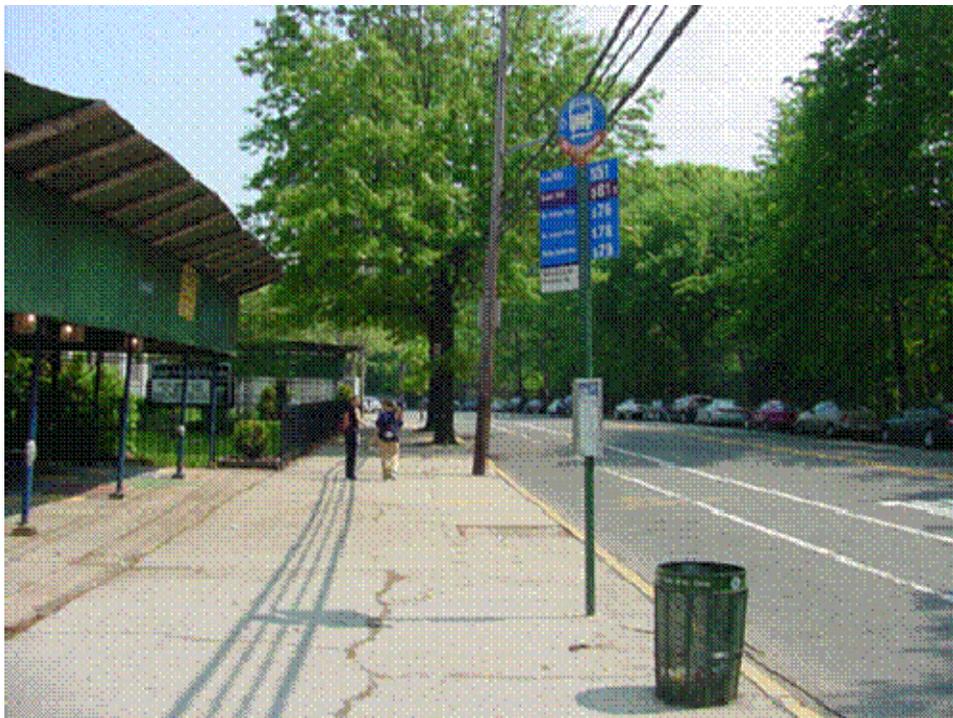
Figure 15: Looking east on the north side of Midland Avenue at the sidewalk in front of I.S. 2.

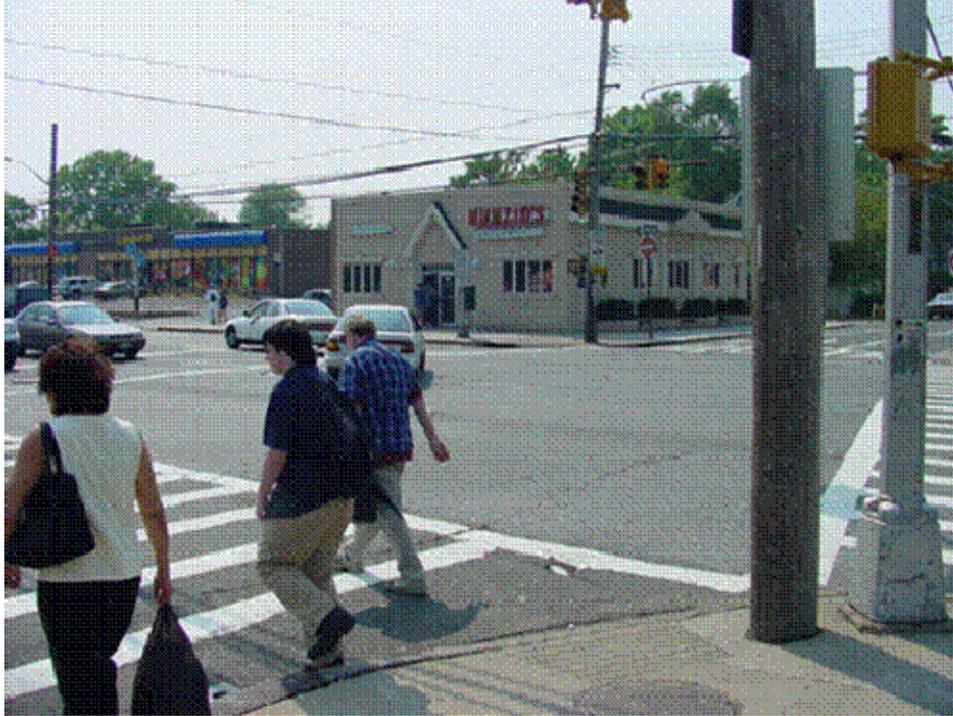
Figure 16: Looking southwest from the northeast corner of the Hylan Boulevard and Midland Avenue intersection (note narrow pedestrian ramp on northeast corner).

- Reconstruct the existing pedestrian ramp located on the northeast corner of the Hylan Boulevard and Midland Avenue intersection in accordance with current design standards.
