5 June 2020

Re: Investigation of Structural Fire Damage to Existing Structure, 70 Mulberry Street, NY, NY

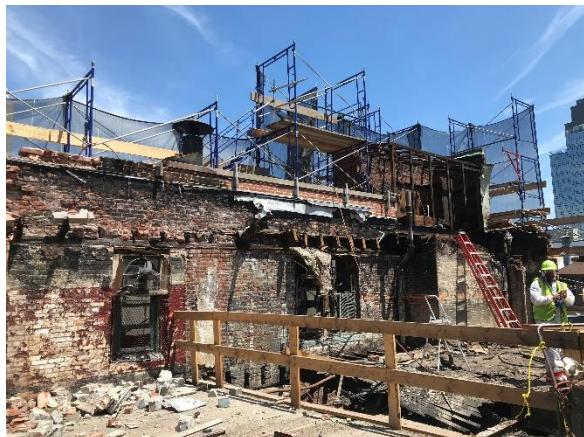
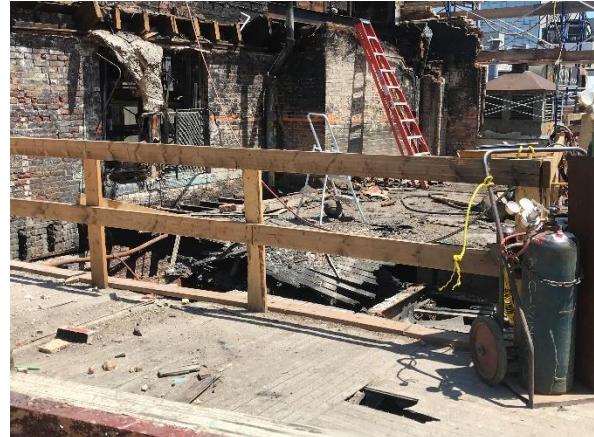
- 5th Floor:

- Portions of walls and floors were missing due to collapse during the fire resulting demolition. Remaining flooring was severely charred and fire damaged.

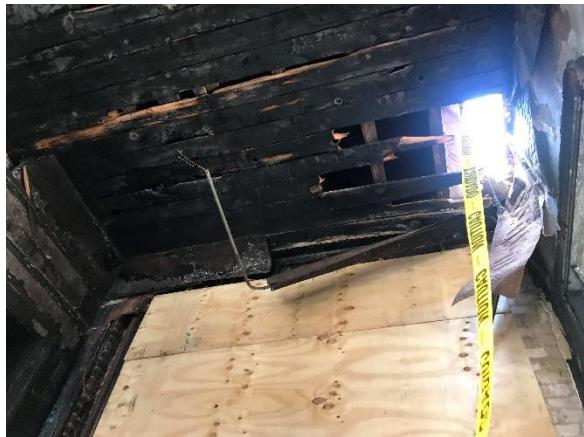
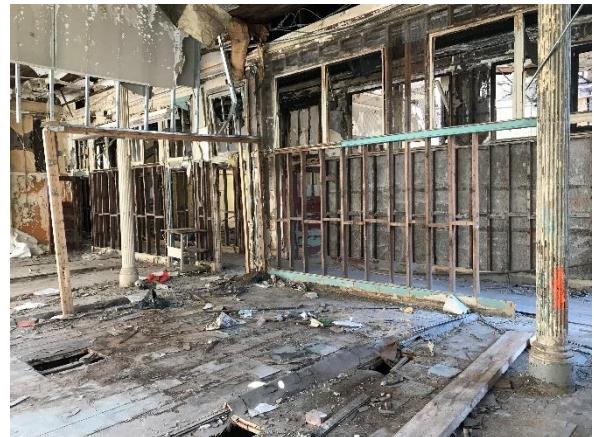
- 4th Floor:

- Sections of ceilings and flooring throughout the building were either fire or water damaged or missing due to the collapse of the roof. Throughout the remaining portions of the floor ceilings, flooring and walls were missing and severe water damage was noticed at this level

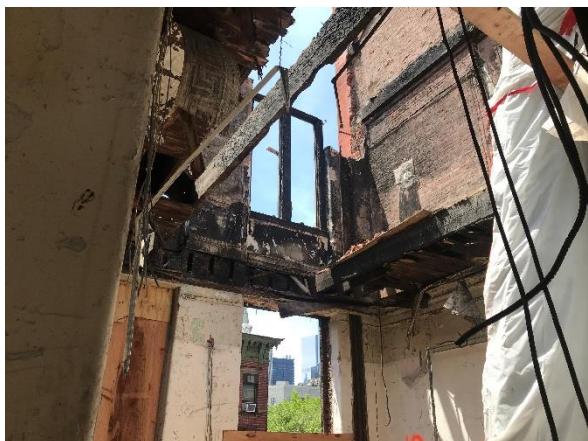
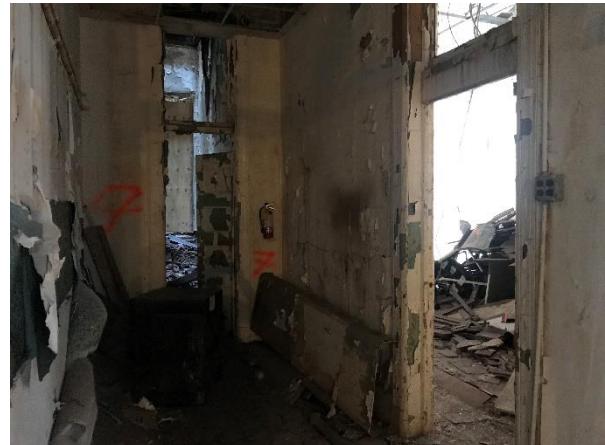
- 3rd Floor:

- In many locations, portions of ceilings, flooring and walls were missing throughout this level. Our team observed severe water damage and some mold growth due to water damage on many surfaces.

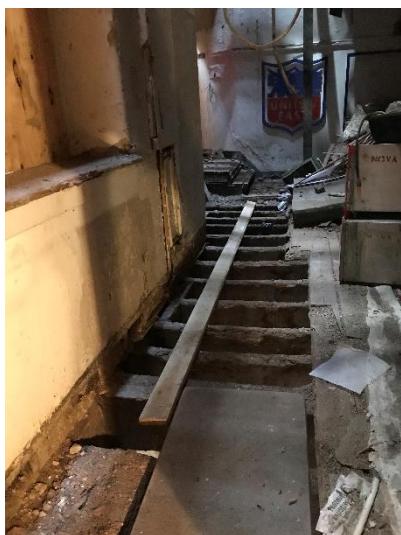
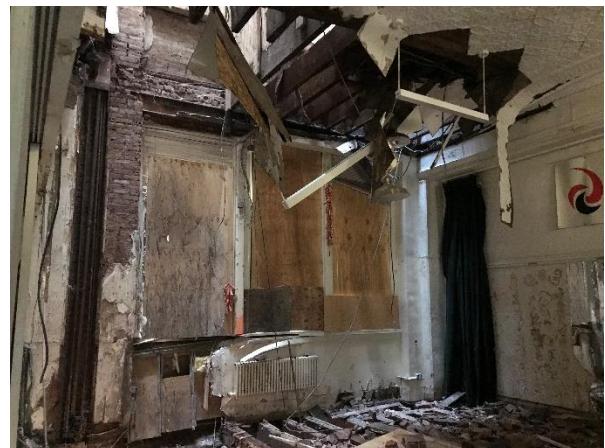
- 2nd Floor:

- In many locations, portions of ceilings, flooring and walls were missing throughout this level. Our team observed severe water damage and some mold growth due to water damage on many surfaces.

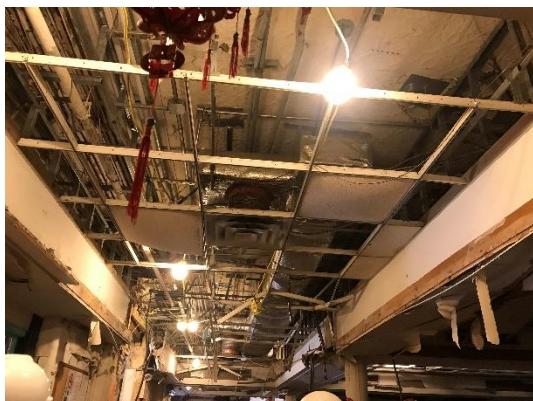
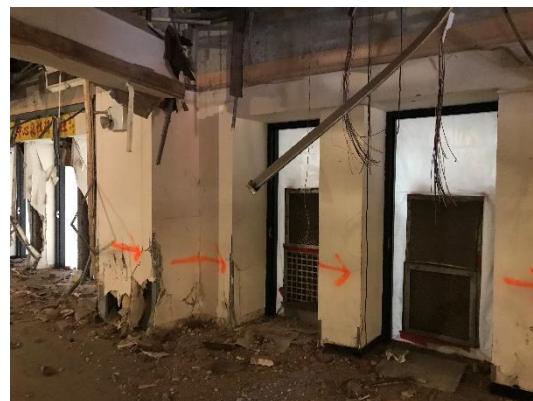
- 1st Floor:
 - In many locations, portions of ceilings, flooring and walls were missing throughout this level. Our team observed severe water damage and some mold growth due to water damage on many surfaces.

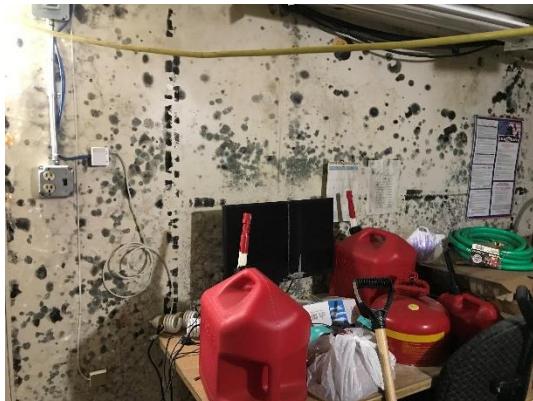
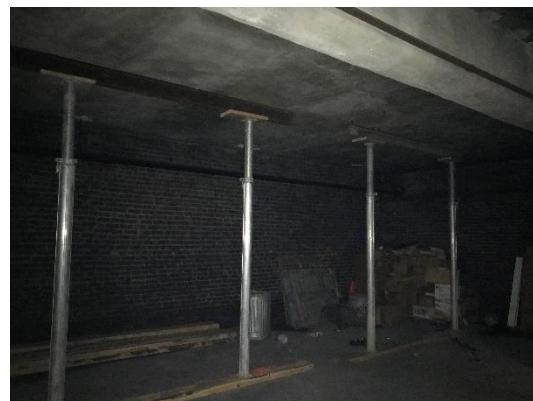
- Basement:
 - Our team observed mold growth due to water damage on most surfaces and temporary support measures in some areas.

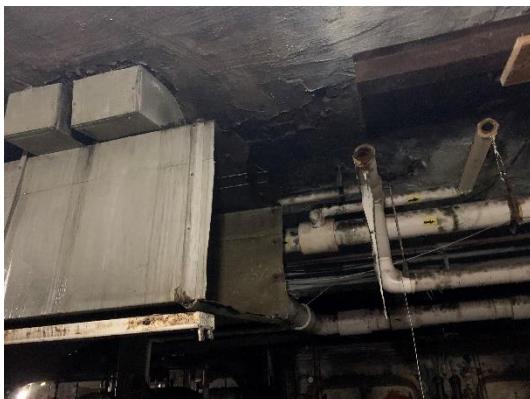
The heating system for the building consists of a single natural gas fired boiler located in the basement, with distribution piping running throughout the building. The boiler, burner, and gas train showed signs of water damage, with visible rust and corrosion. The heating distribution piping was damaged and cut in multiple areas throughout the basement, with

Damaged Ductwork and Piping

The heating system for the building suffered significant damage due to the fire event. To bring the system back to operation, a new piping distribution system would need to be installed to run throughout the building, with new local heating equipment installed on all floors. It is believed that the boiler can be brought back to operating condition, however the burner would need to be further tested by a service technician to determine if there was any internal water damage to wiring and components. It is possible that a new burner would need to be installed to ensure proper operation of the boiler, along with new controls components. Given the age of the boiler (30 years), it would be recommended for a complete replacement of the boiler system.

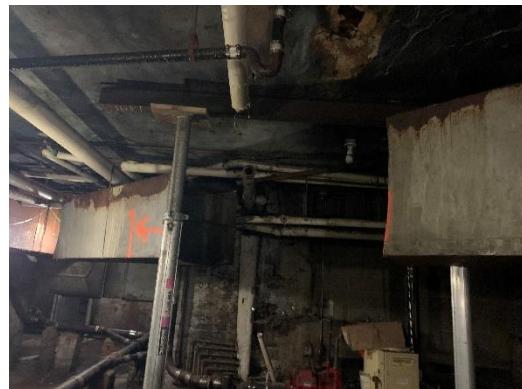
The basement also contained the building ventilation exhaust system, with a central exhaust fan and ductwork distribution. The fan showed signs of water damage, physical damage and corrosion, and was not in operable condition. Ductwork associated with the fan system was also physically damaged, with sections missing in multiple areas within the basement to allow for structural supports, and assumed completed destruction on the upper floors damaged by fire.

Damaged Ductwork

The building ventilation exhaust system would require a full replacement, as the existing exhaust fan did not appear that it can be brought back to operation. New exhaust equipment and ductwork would need to be installed throughout the building.

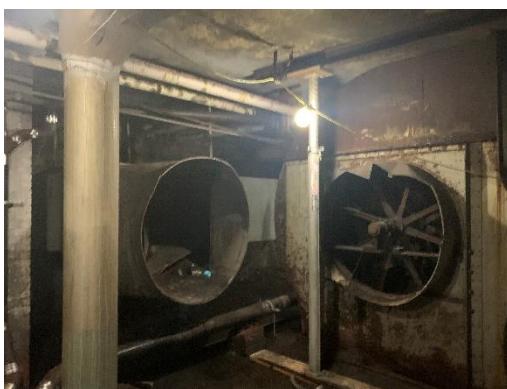
Damaged, Rusted & Corroded Ventilation Fan

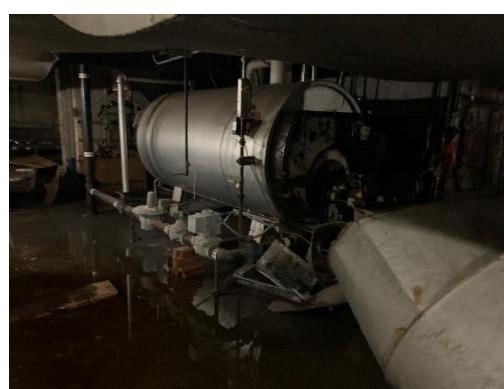
Existing Boiler Water Damage & Corroded Pipe

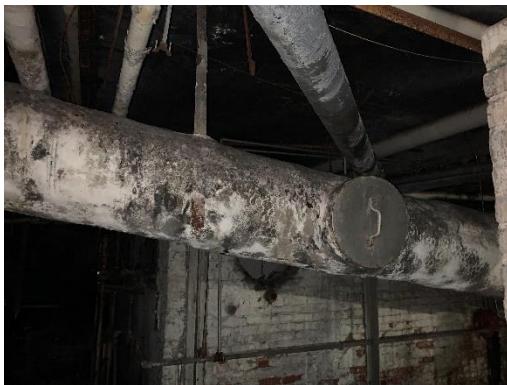
complete destruction on the upper floors damaged by fire. Mold was also present on piping insulation and flue insulation associated with the boiler. The basement also contained additional abandoned boilers which were decommissioned prior to the fire event.

Mold on Flue Insulation

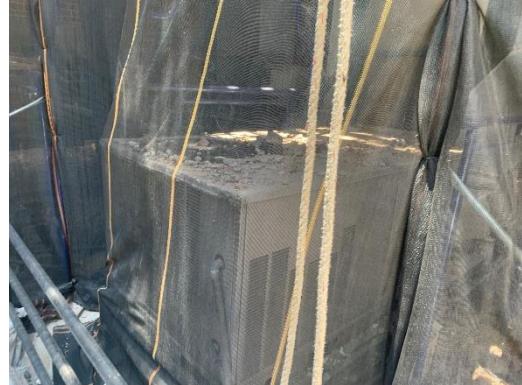
Packaged Rooftop Unit – Debris Damage

The packaged rooftop unit is expected to be able to be brought back to pre-fire operation. Debris would need to be removed from the unit, and a final inspection from a service technician would be required to ensure there was no physical damage to any operational components of the unit. The outdoor condensing units are expected to be currently operational, however new indoor equipment would need to be installed and connected to these units. Given the age of the existing outdoor units, it is possible that they would require replacement to be compatible with any new indoor equipment that is installed.

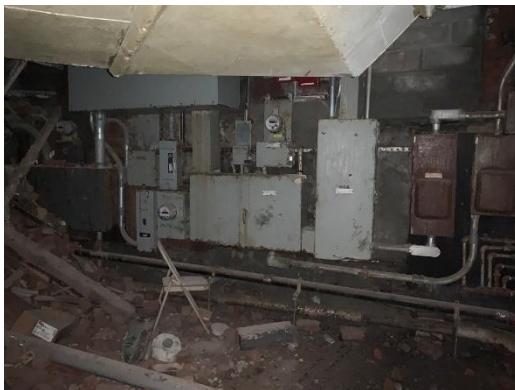
The Building incoming service is routed underground from Bayard Street to the electrical room located in the basement on the south side of the building. There are multiple service meters which serve various floors of the building. The existing electrical service and distribution system for the building are in poor condition showing major deterioration and

corrosion to the electrical equipment. The panelboard located on the first floor was found detached from the wall showing severe damage. The panelboards on floors 2 through 5 are no longer existing due to the damage caused by the fire. The fire also damaged a significant amount other electrical equipment, conduit and wiring throughout the building.

Electrical Service severe deterioration and corrosion.

The existing electrical service and the power distribution throughout the building are damaged beyond repair and cannot be re-energized. Similarly, all conduit and wiring is assumed to have been exposed to fire and/or water and cannot be reused. It is recommended that a new Electric Service be installed and the entire Electrical Distribution System, including all equipment, feeder circuits, and branch circuits be removed and replaced as part of an overall building replacement.

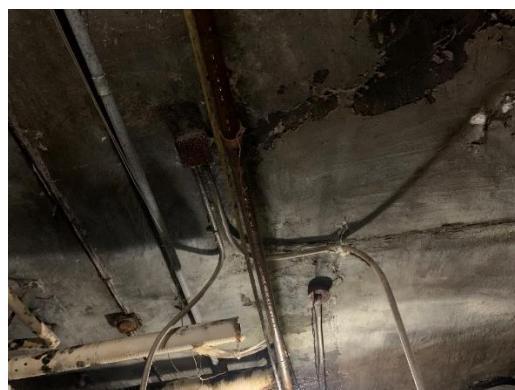
Electrical conduit major corrosion typical

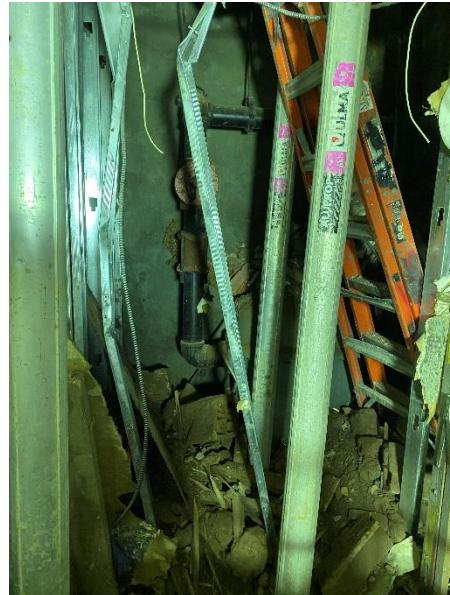
The natural gas service enters the building from the east (Bayard Street) side with a gas meter in the basement adjacent to the service entry. Debris had not been cleared and the meter and piping was not accessible, but the service appeared to be 3", low pressure, as pressure reducing valves were not apparent.

Existing Gas Service – Debris Damage

The gas service is expected to remain serviceable, given the fact that it is buried, however the meter(s) and gas distribution piping were damaged by debris from the fire event and would require repair and replacement.

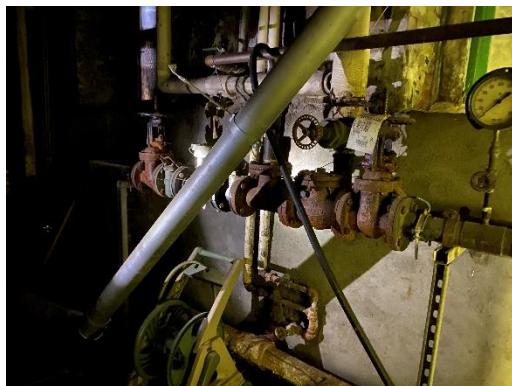
The water services are expected to be functional, however, the valves and fittings must be checked as heat from the fire or water could damage the valves and appurtenances rendering these unusable. The water distribution piping throughout the building appears to be damaged beyond repair.

Existing Water Service – Rust and Corrosion

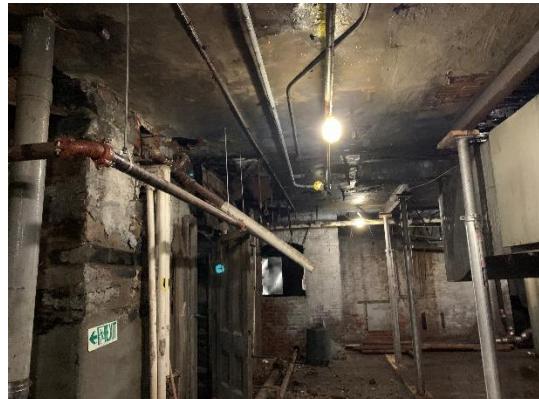
Damaged Piping

Based upon the observations made during the field visit, it is apparent that, with few exceptions, the plumbing piping systems that served the building sanitary waste and vent, storm lines, domestic hot and cold water and natural gas, are severely damaged and cannot be repaired to the point where they are fully functional without replacements of the systems. The existing building services are expected to be utilized after being further tested, however new piping distribution and equipment would be needed throughout the building.

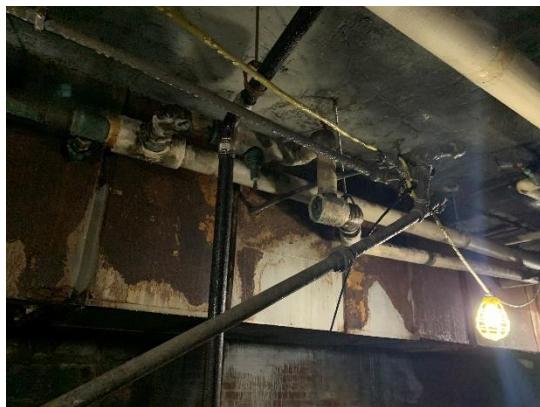
Damaged Piping

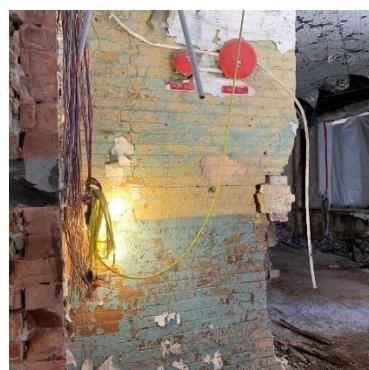
The existing Fire Alarm System located on the first floor no longer exists (See photo# 04). The associated fire alarm devices that are remaining in the building have been damaged due to the fire.

Building Fire Command Station missing

It is recommend that a new Fire Alarm System be installed with the renovation of the building.
