5 June 2020
(Revised 15 June 2020)

SIMPSON GUMPERTZ & HEGER

Project 200714 – Investigation of Structural Fire Damage to Existing Structure,
70 Mulberry Street, New York, NY

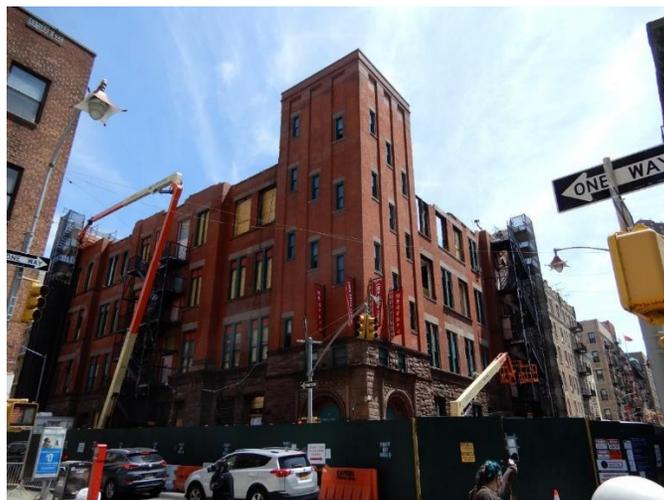
The building located at 70 Mulberry Street is five-stories with a full basement as shown in Photo 1. According to available public records, the building was constructed prior to 1895 and has a maximum of 13,350 sq ft per floor. The building houses a dance studio, a senior center, and storage for a museum. The primary structural system of the building is load-bearing brick masonry exterior walls with wood floor and roof framing that is supported by a series of interior steel girders and cast-iron columns. The first floor features structural steel floor framing with terracotta flat arches spanning between the steel beams. The building is a walk-up style with no elevator.

Photo 1: 70 Mulberry Street
