**CONDITIONS ASSESSMENT**

**70 MULBERRY STREET  
NEW YORK, NY**

Prepared by:  
Jablonski Building Conservation, Inc.  
40 West 27<sup>th</sup> Street, Suite 1201  
New York, NY 10001

March 2021

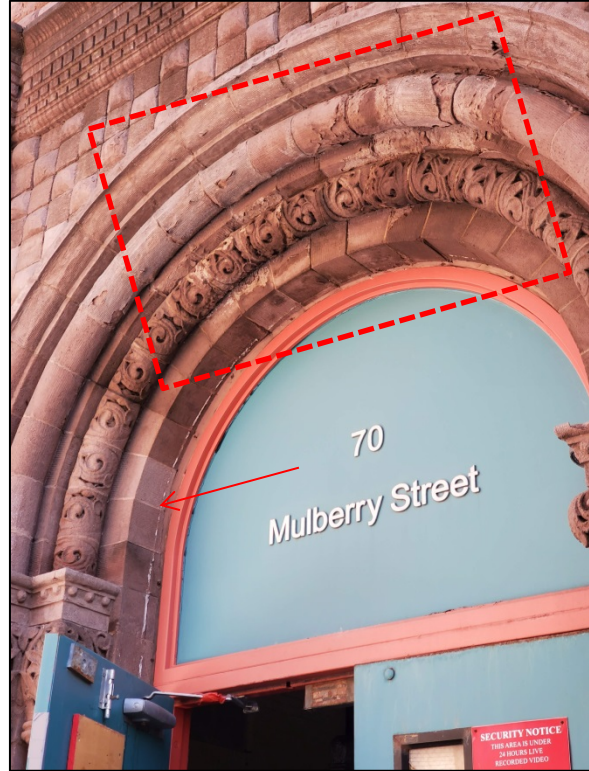
At both entrances, the middle band in the archivolt over the door is delaminating, resulting in a loss of detail in the decorative band (Figure 5 and 6). The other bands are in good condition. The column capitals on both elevations are eroded and have lost detail (Figure 7 and 8). A singular strip of caulk and abandoned anchors in two of the stones around center height of the door are present along the innermost arch of both entrances (Figure 5 and 6). It appears that this may have been the location of previous signage.

Figure 5: Spalling in decorative archivolt within dotted line and strip of caulking indicated with red arrow, Mulberry Street.

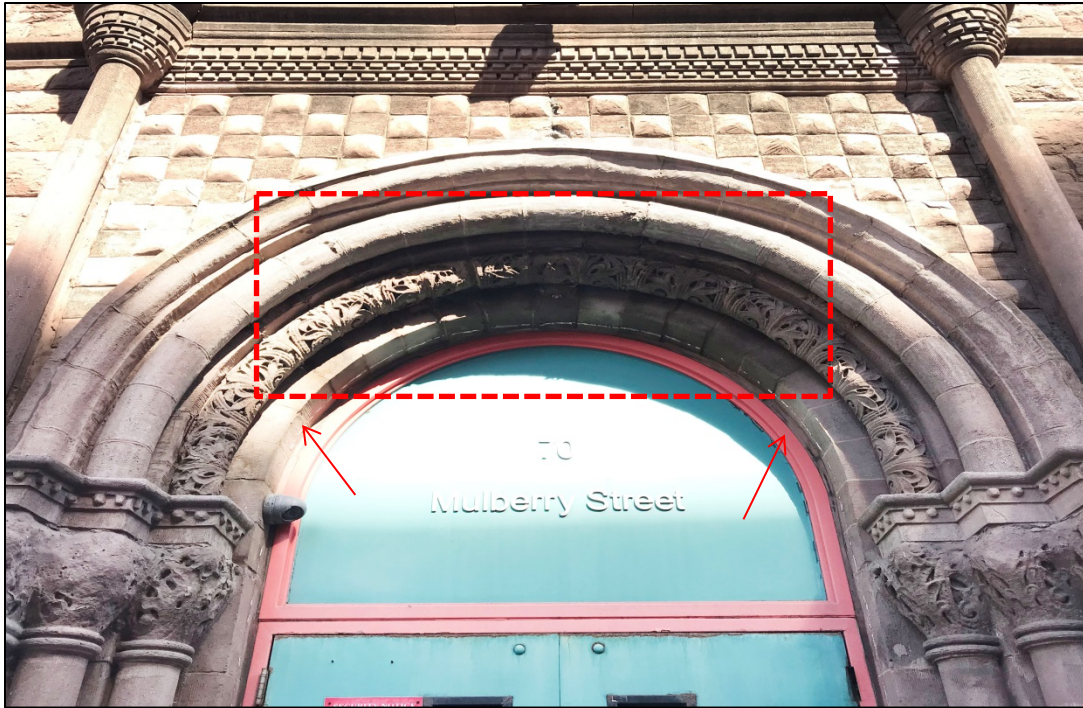
Figure 6: Spalling in decorative archivolt within dotted lines and strip of caulk indicated with red arrows, Bayard Street.

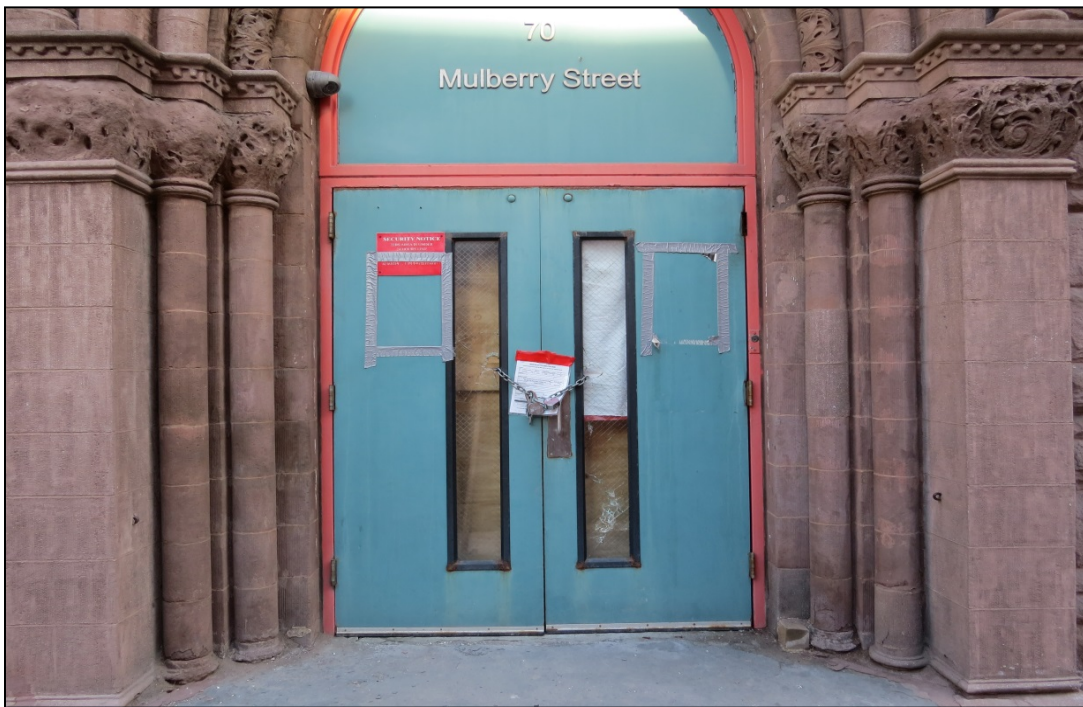
The cornice above the Mulberry Street entrance has heavy atmospheric soiling and there are cracks in a limited number of the blocks in the spandrel below (Figure 4 and 9). Below the cornice there is an area of patched brownstone that is in good condition (Figure 10). The engaged columns that frame the Mulberry Street entry door are in good condition with delamination and spalling at the base of the south side of the entrance and some minor delamination on the north side closest to the ground (Figure 11). The cornice above the Bayard Street entrance has light atmospheric soiling. The columns are in good condition with majority of spalling and delamination at the base of both sides of the door (Figure 7).

Figure 7: Bayard Street entrance loss of detail in capitals, spalling and delamination at base of engaged columns.

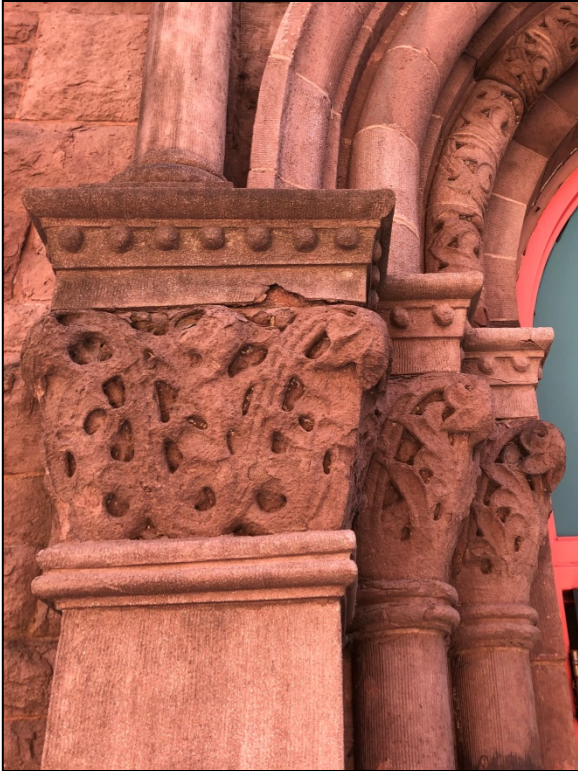
Figure 8: Engaged column, loss of detail, Mulberry Street entrance.

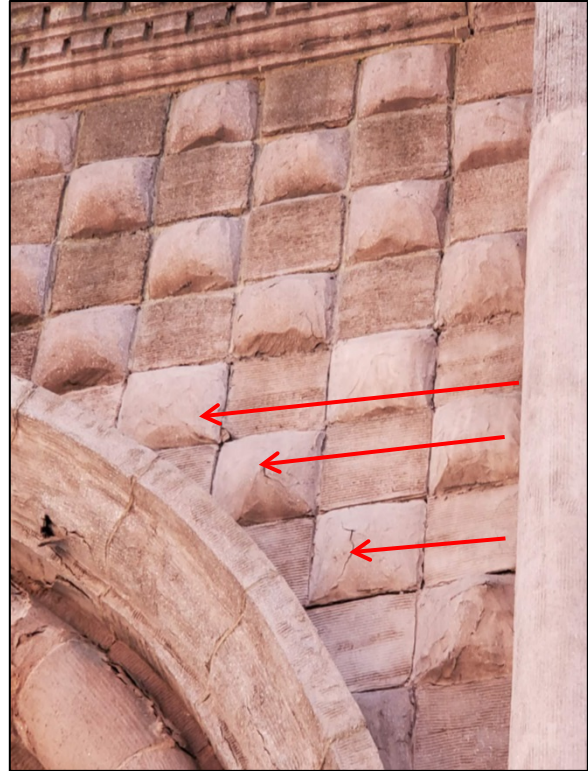
Figure 9: Cracks in blocks in spandrel indicated with arrows, Mulberry Street entrance.

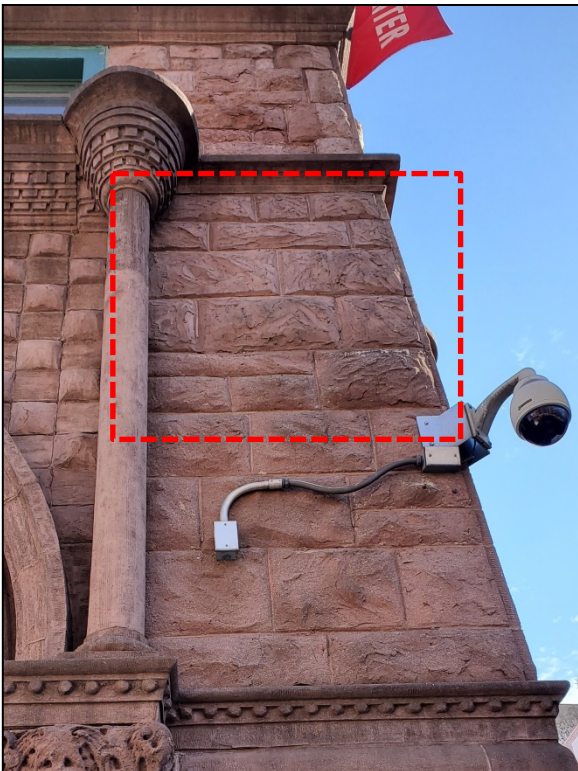
Figure 10: Brownstone patch within dotted lines in upper corner of Mulberry Street entrance.

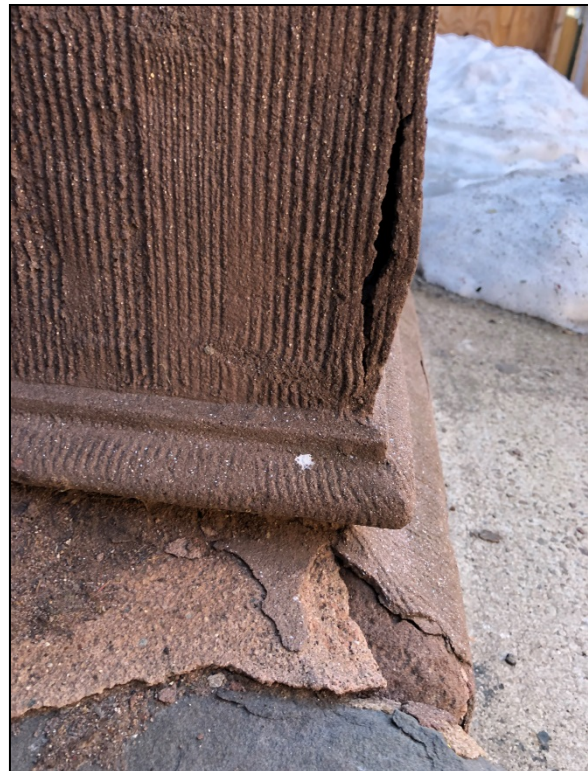
Figure 11: Spalling and delamination at bottom of column on the south side of Mulberry Street entrance.

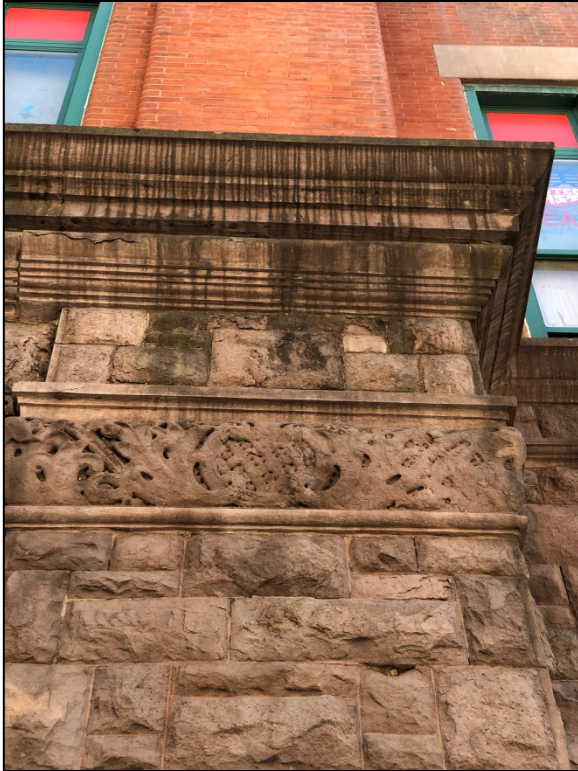
The Mulberry Street elevation has atmospheric soiling throughout with the highest concentration at the brownstone cornice (Figure 12) and behind the fire escape stairs. The stone along the base below the water table under the windows is actively wet (Figure 13). Excess moisture in the brownstone can lead to delamination from the swelling of inherent clays and freeze-thaw deterioration in winter months. On the southern side between the main entrance and the fire escape there is delamination and material loss above a small window and both side doors as well as at the base of the side doors (Figure 14). There is material loss at the bases of the stairs for the side entrances. Behind the fire escape, there are non-matching/ failing previous repairs. On the north side of the fire escape, a side door and window have been removed and replaced with plywood, and large area of efflorescence is present above areas of high water infiltration (Figure 13). At the northwest corner above the window, there is a large area of delaminated brownstone and a non-matching previous repair (Figure 15).

Figure 12: Biological growth and atmospheric soiling above side door, Mulberry Street.

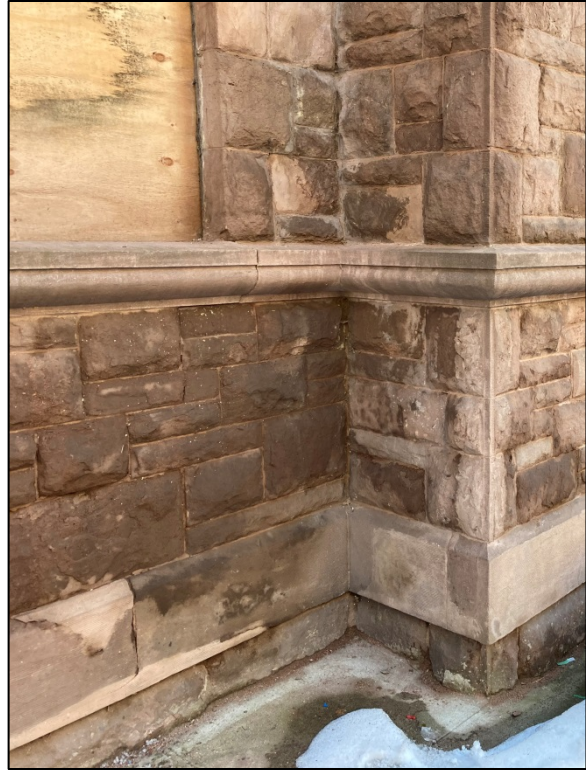
Figure 13: Water infiltration and efflorescence underneath removed window, Mulberry Street.

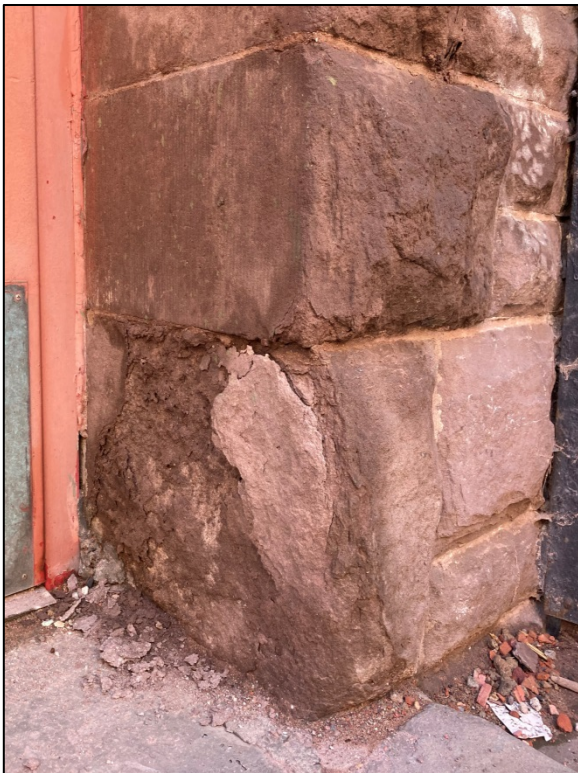
Figure 14: Delamination at base of side door entrance, Mulberry Street.

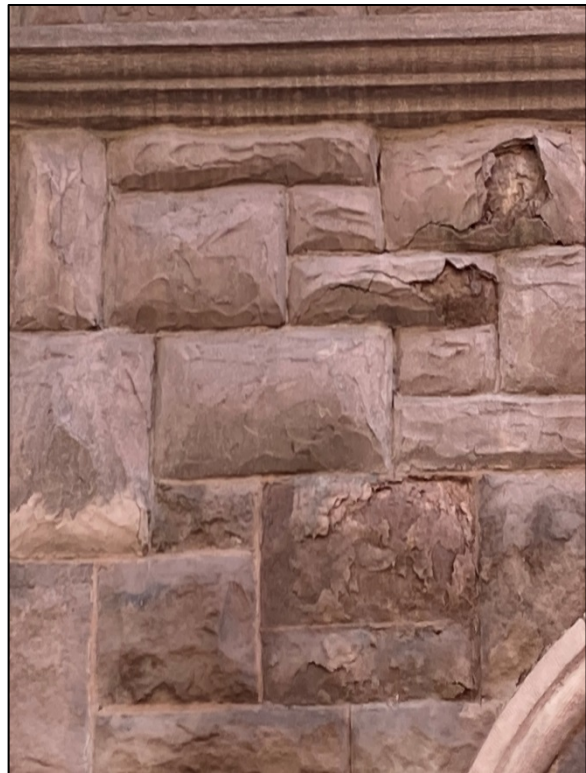
Figure 15: Northwest corner above the window delaminated brownstone and a non-matching previous repair, Mulberry Street.

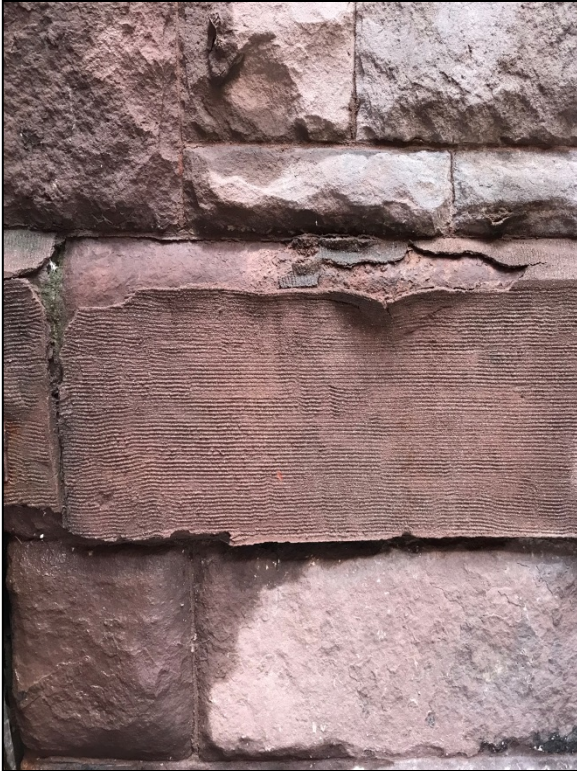
Figure 16: Delamination and water infiltration, Bayard Street.

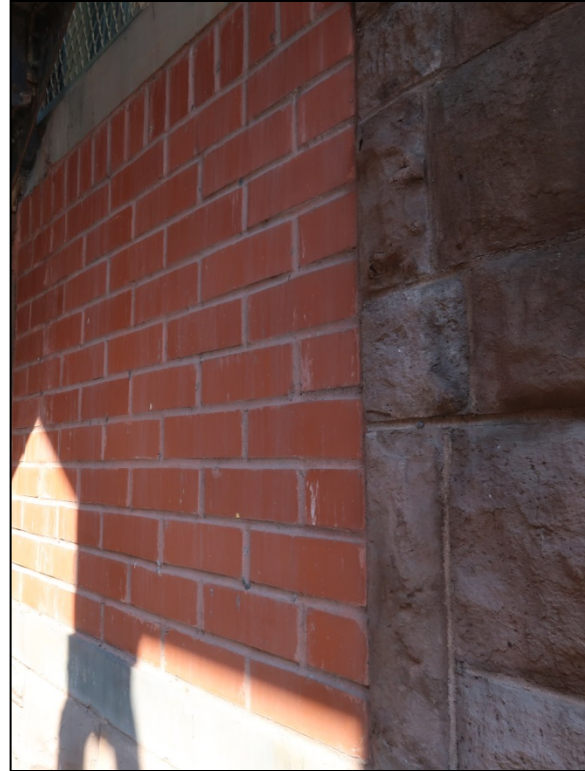
Figure 17: Non-matching infill brick repair behind fire escape, Bayard Street.

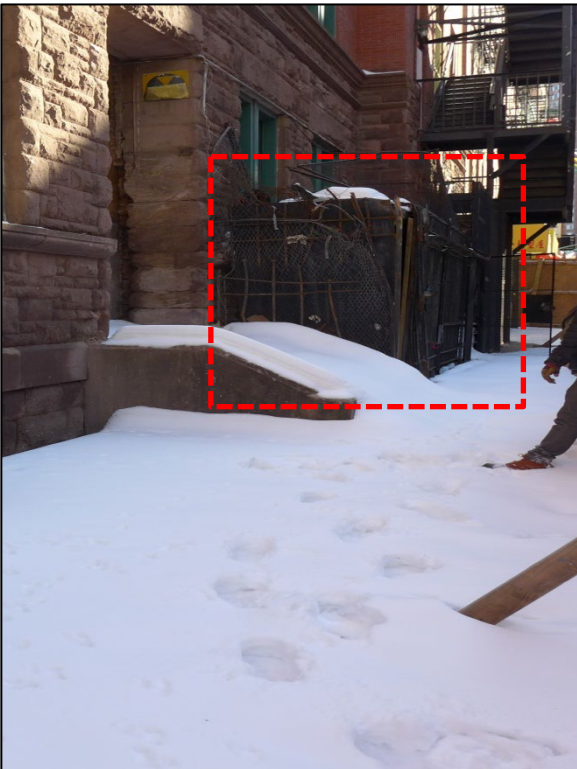
The Bayard Street elevation has many of the same conditions as the Mulberry Street elevation, with atmospheric soiling throughout and water infiltration present below the water table, which is a projection of lower masonry on the outside of a wall. There is delamination below the water table under the windows between the side door and fire escape (Figure 16), on the side door staircase, behind the fire escape, and on the southeastern corner of the building. Additionally, there are some minor cracks and graffiti at this corner. There are abandoned anchor holes throughout the elevation. Behind the fire escape stairs, directly below the brick second level, there is a non-matching infill brick repair to the brownstone (Figure 17). Below and to the left the fire escape there is a large shed-like metal structure that has been covered in construction debris (Figure 18).

Figure 18: Large shed-like metal structure within dotted line that has been covered in construction debris, Bayard Street.

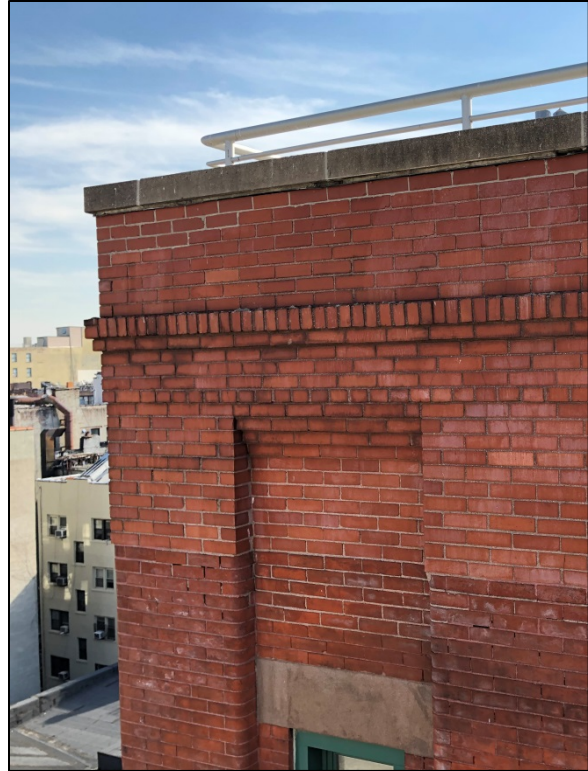
Figure 22: Replacement masonry at top of stair tower, Mulberry Street. Note the gray pointing mortar.

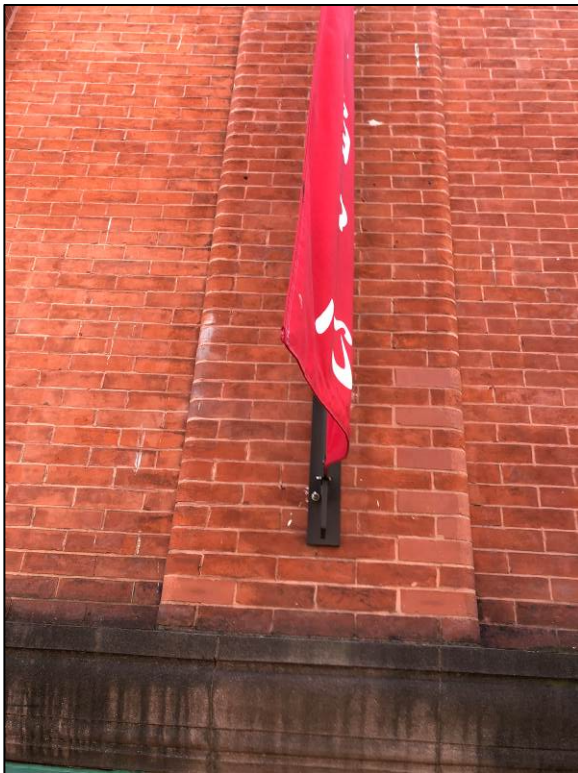
Prior to the fire<sup>7</sup>, the one-story, central element at the top of the stair tower and cornice were removed and altered and the top roofed over. The current top of the stair tower consists of a parapet wall with cast coping stone. From the cast coping stone down approximately twenty five courses is replacement masonry. The replacement brick does not replicate the bullnosed brick and therefore sticks out at the corners of the building and at the pilasters (Figure 22). In repair areas lower on the facades, such as at the base of the stair tower, the replacement bricks at the corners have been sanded down to mimic the bullnose (Figure 23).

Figure 23: Replacement bricks sanded down to rounded edge, anchored flag and abandoned anchors, Mulberry Street.

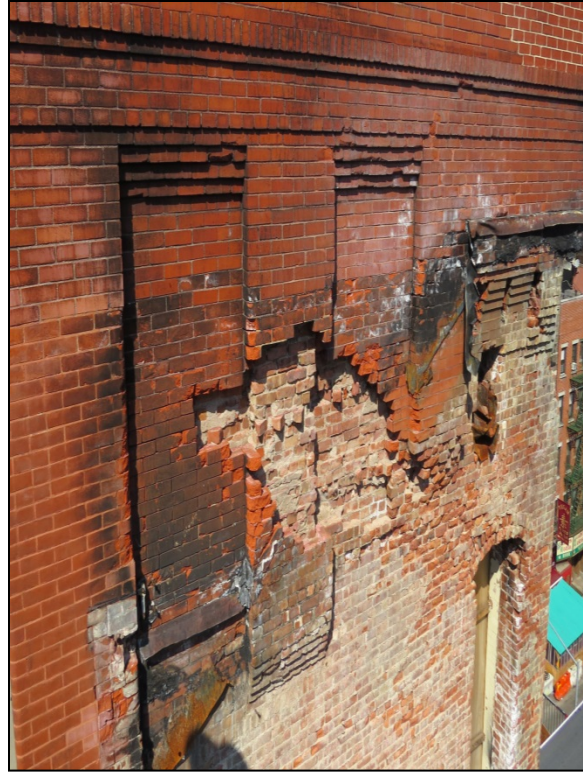
Figure 26: Fire and demolition damage, Bayard Street.

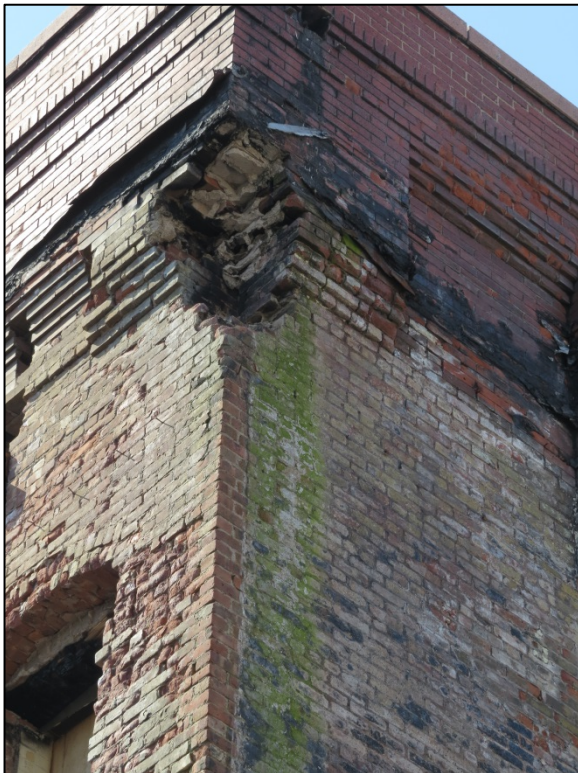
The interior walls (the north and east walls) of the stair tower have been left exposed to exterior conditions due to the demolition of the top three stories of the south and west elevations. Both interior elevations exhibit damage from this demolition throughout (Figure 24). There is broken brick spanning the entire height of the tower (above the roof) along the northwestern and southwestern edges of the stair tower where the south and west walls of the building connected to the tower (Figure 25). The fifth-floor of the stair tower has evidence of soot and charred roof flashing on the brick of both interior walls (Figure 26). The damage to brick in this area is primarily due to demolition. The brick in the top northeast corner is missing and what remains is loose, which is a potential safety issue. There is currently brick and mortar debris on the temporary roof below the damaged corner. This condition has allowed for water infiltration into the tower and resulted in biological growth along the wall (Figure 27). It may also have destabilized the parapet wall of the tower.

Figure 27: Northeast interior corner with brick loss damage and biological growth.

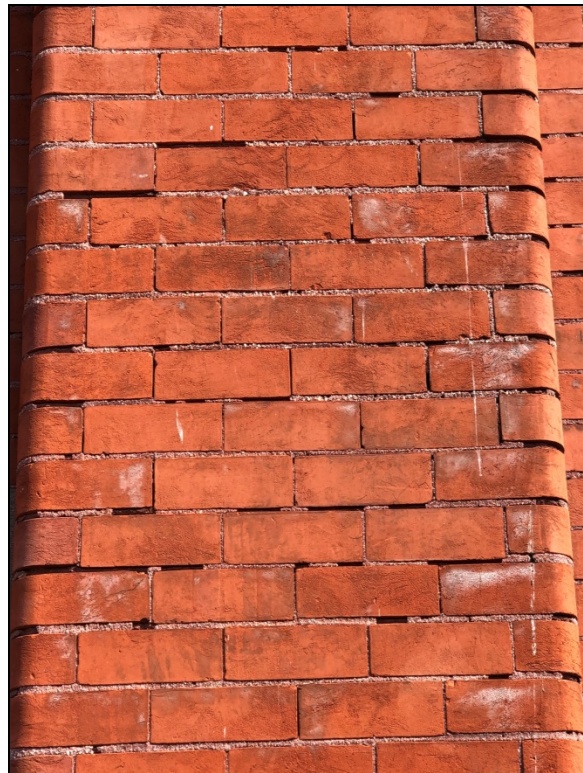
There are open joints throughout both elevations of the stair tower with significant mortar loss along the pilasters' rounded edges and in between the pilasters in the fourth level of the tower (Figure 28). There are only minor cracks on the Bayard Street elevation. The Mulberry Street elevation of the stair tower has heavy atmospheric soiling and efflorescence buildup below the stone window sills (Figure 29). Above the Bayard Street entrance, a crack along the central brick pilaster runs from just above the brownstone cornice to just below the stone sill of the window (Figure 30). Abandoned anchors and flags are currently anchored into the brick above both entrances (Figure 23).

Figure 28: Open joints stair tower pilaster, Mulberry Street.

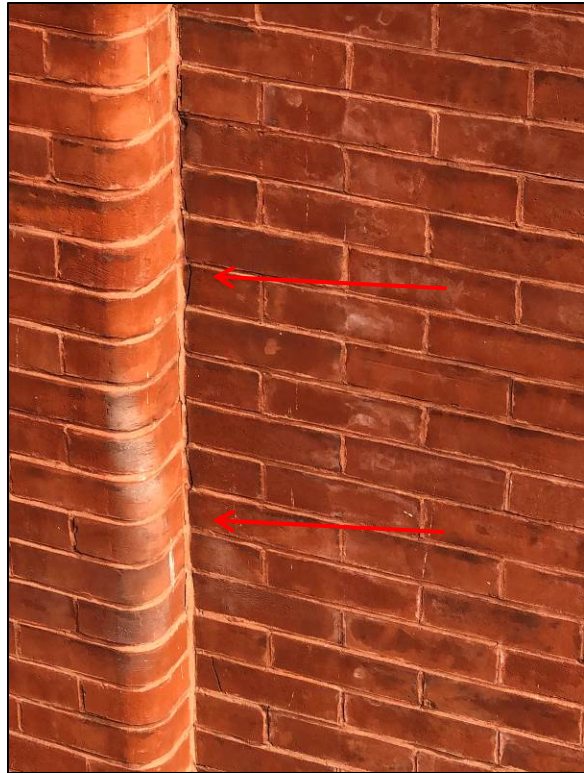
Figure 30: Crack along pilaster in masonry indicated with arrows, Bayard Street.

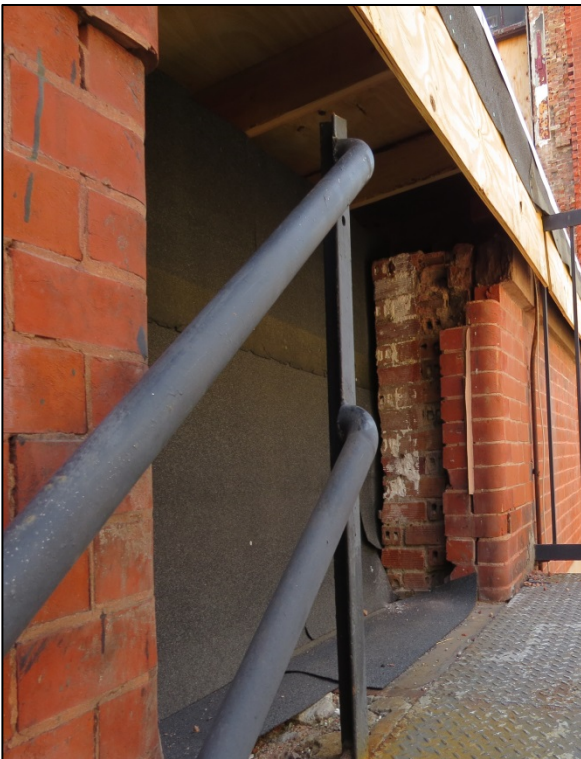
Figure 31: Masonry damage due to demolition, top of fire escape stairs, Mulberry Street.

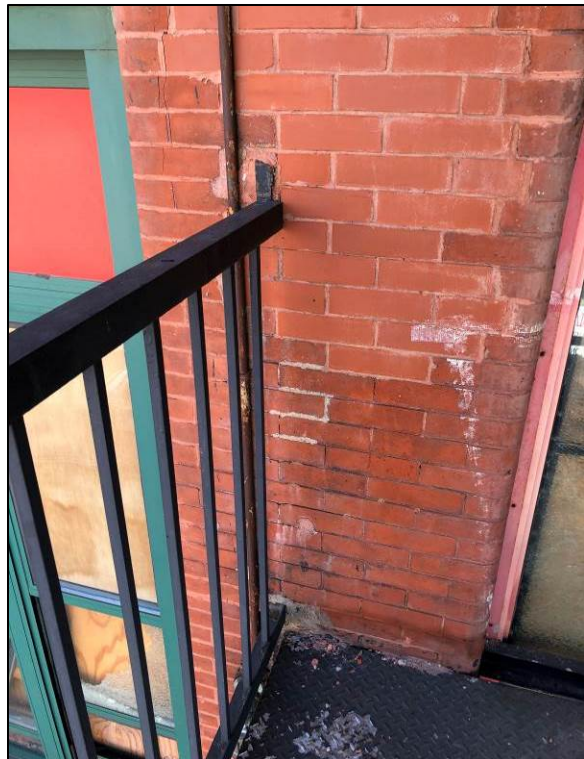
The brick behind each of the fire escapes on both the Mulberry and Bayard Street elevations is significantly damaged as a result of the demolition. There is missing brick, displaced brick, open joints, and exposed backup brick below the temporary roof at the top of the fire escapes (Figure 31). There are areas of infill masonry at the top of both fire escapes (Figure 32).

Figure 32: Infill masonry at top of fire escape stairs, Bayard Street.

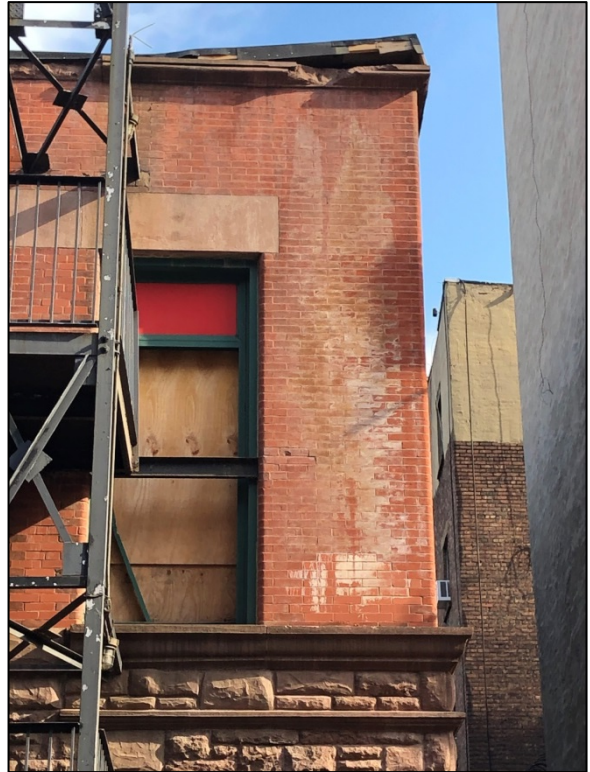
Figure 34: Damage and efflorescence, at the corner of Bayard Street.

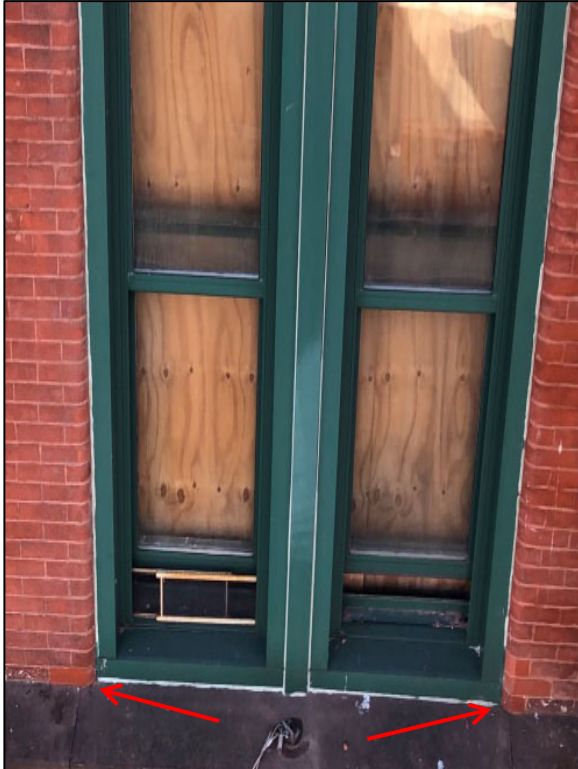
Figure 35: Replaced bricks indicated with arrows at the bottom corners of window, Mulberry Street.

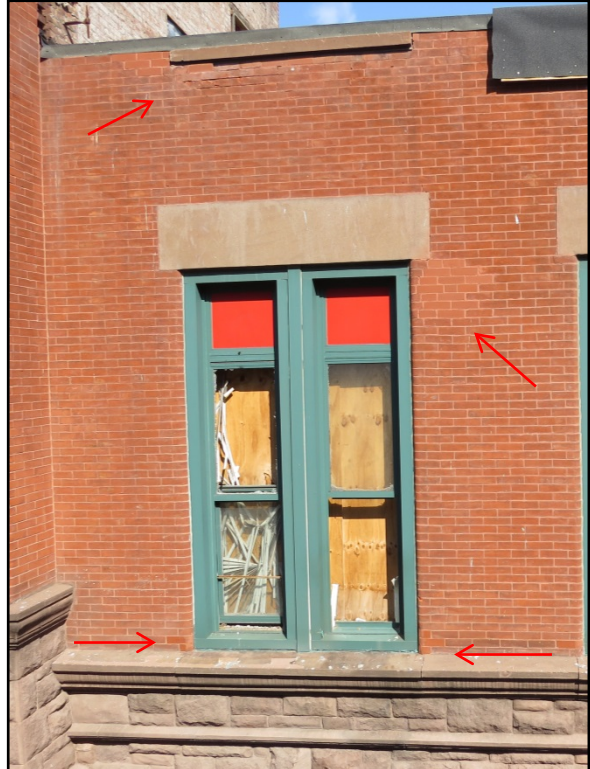
Both 2<sup>nd</sup> story elevations have atmospheric soiling and efflorescence on the brick primarily between the temporary roof and stone lintel above the windows (Figure 33 and in some areas below the windowsills on the Mulberry Street elevation. There is damage to the temporary roof and stone belt course at the northwestern corner of the Bayard Street elevation, below which there is significant atmospheric soiling and efflorescence (Figure 34). On both elevations there is either infill masonry, damaged masonry, or missing masonry at the bottom corner of most of the windows (Figure 35). The window closest to the stair tower on the Bayard Street elevation has infill masonry and is missing bricks above the window (Figure 36).

Figure 36: Infill, damaged, and missing masonry indicated with arrows, Bayard Street.

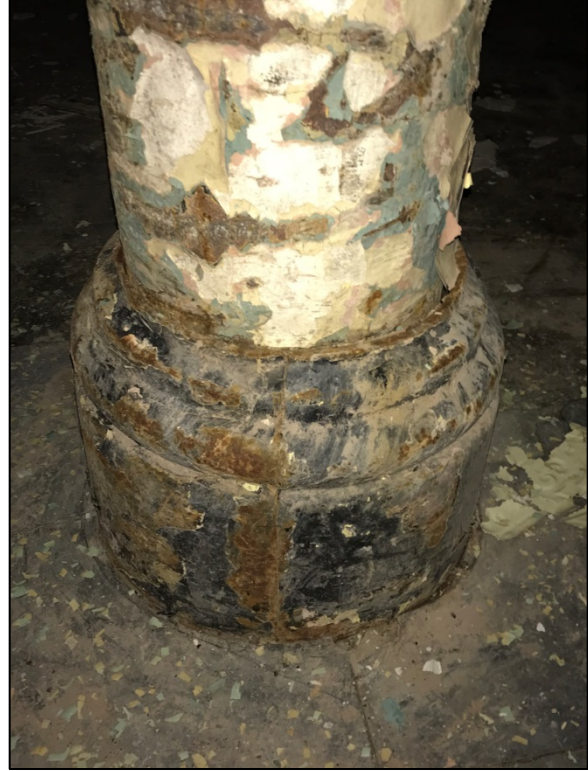
The cast iron columns, consisting of a shaft, base, and capital, are arranged in two rows of four in the middle of the central space. All eight cast iron columns are corroded with peeling paint (Figure 37). Heavy corrosion is present at the base of all columns (Figure 38). Two columns are missing bases (Figure 39). Three columns have open seams and minor separation at the base (Figure 40). In the basement, there are cast iron support columns directly below the first-story columns. The columns have many of the same conditions as the first level of rust staining and missing elements.

Figure 38: Corrosion at cast iron column base.

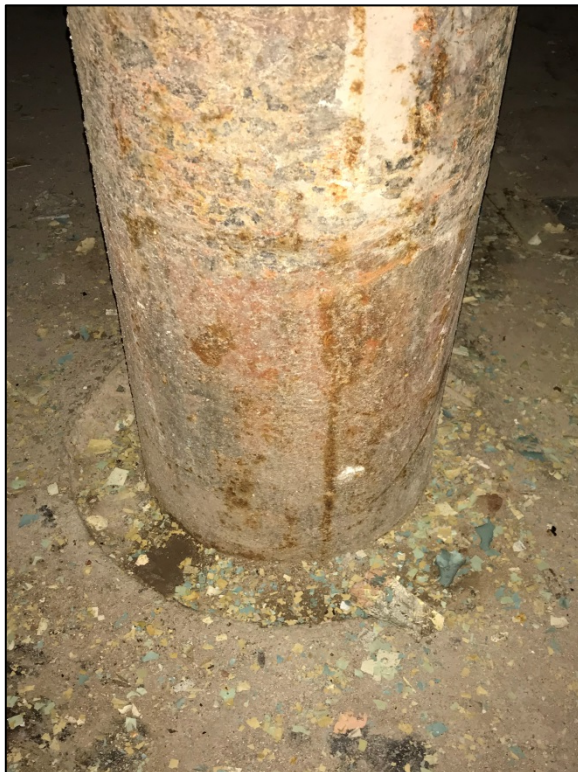
Figure 39: Missing cast iron column base.

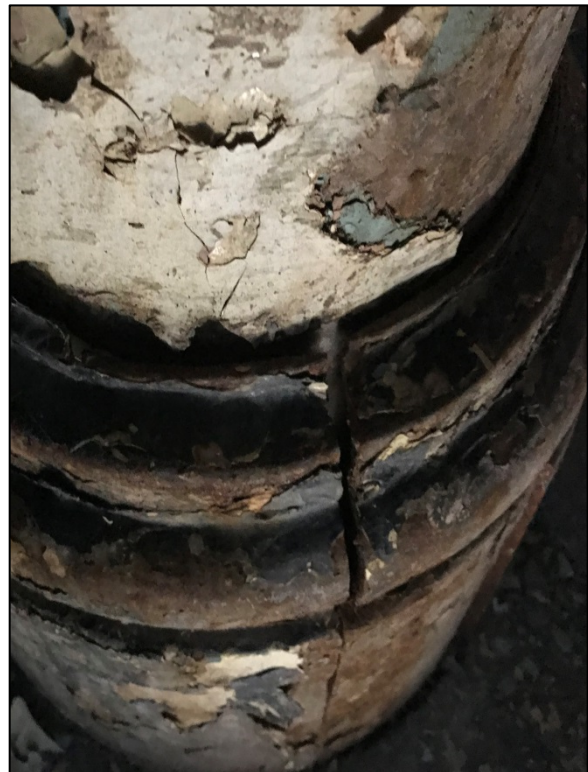
Figure 40: Open seams in cast iron column base.

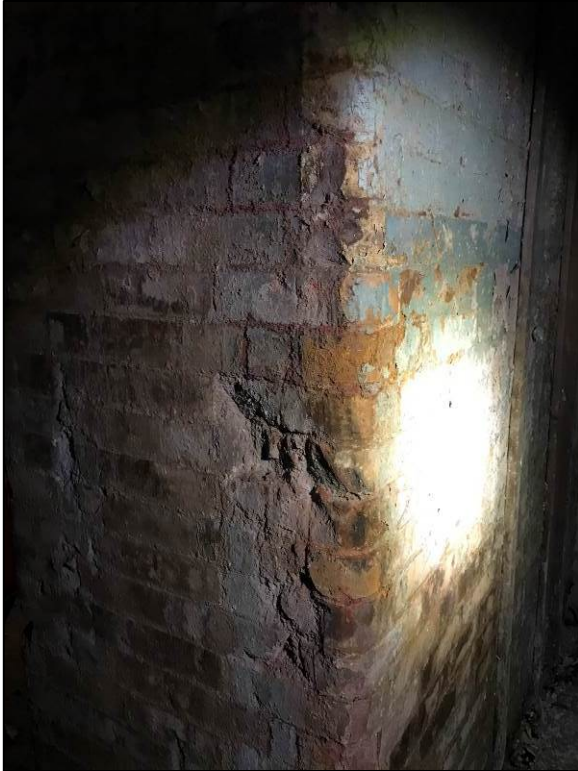
The pressed brick walls of the central space on the first story have been painted several times and have areas of peeling paint throughout, damage due to demolition, mold, and water damage (Figure 41). The brick has a red tinted mortar that can be observed under areas of peeling paint (Figure 42). The west elevation wall of the central room is the most significantly demolished with areas exposing the backup masonry wall (Figure 43). While, pressed brick was not used in the basement level, there are demolished pressed brick that have fallen into the basement level and may be salvaged for reuse (Figure 44). The basement has water infiltration and mold throughout.

Figure 41: Pressed brick with peeling paint, mold, water infiltration, and demolition damage.

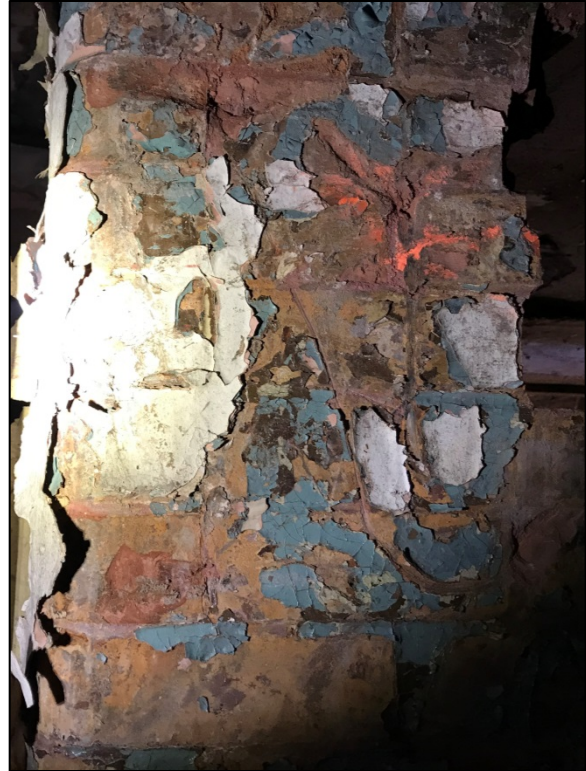
Figure 42: Pressed brick with red tinted mortar beneath peeling paint.

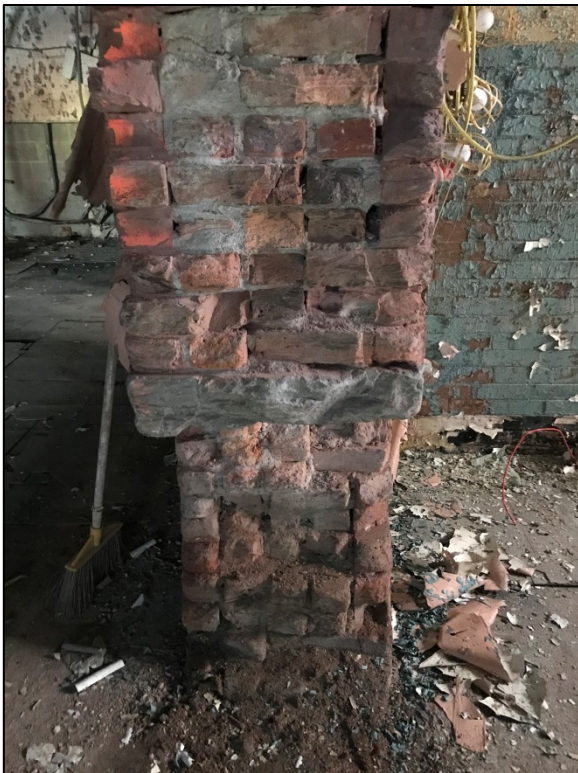
Figure 43: West elevation wall demolition damage.

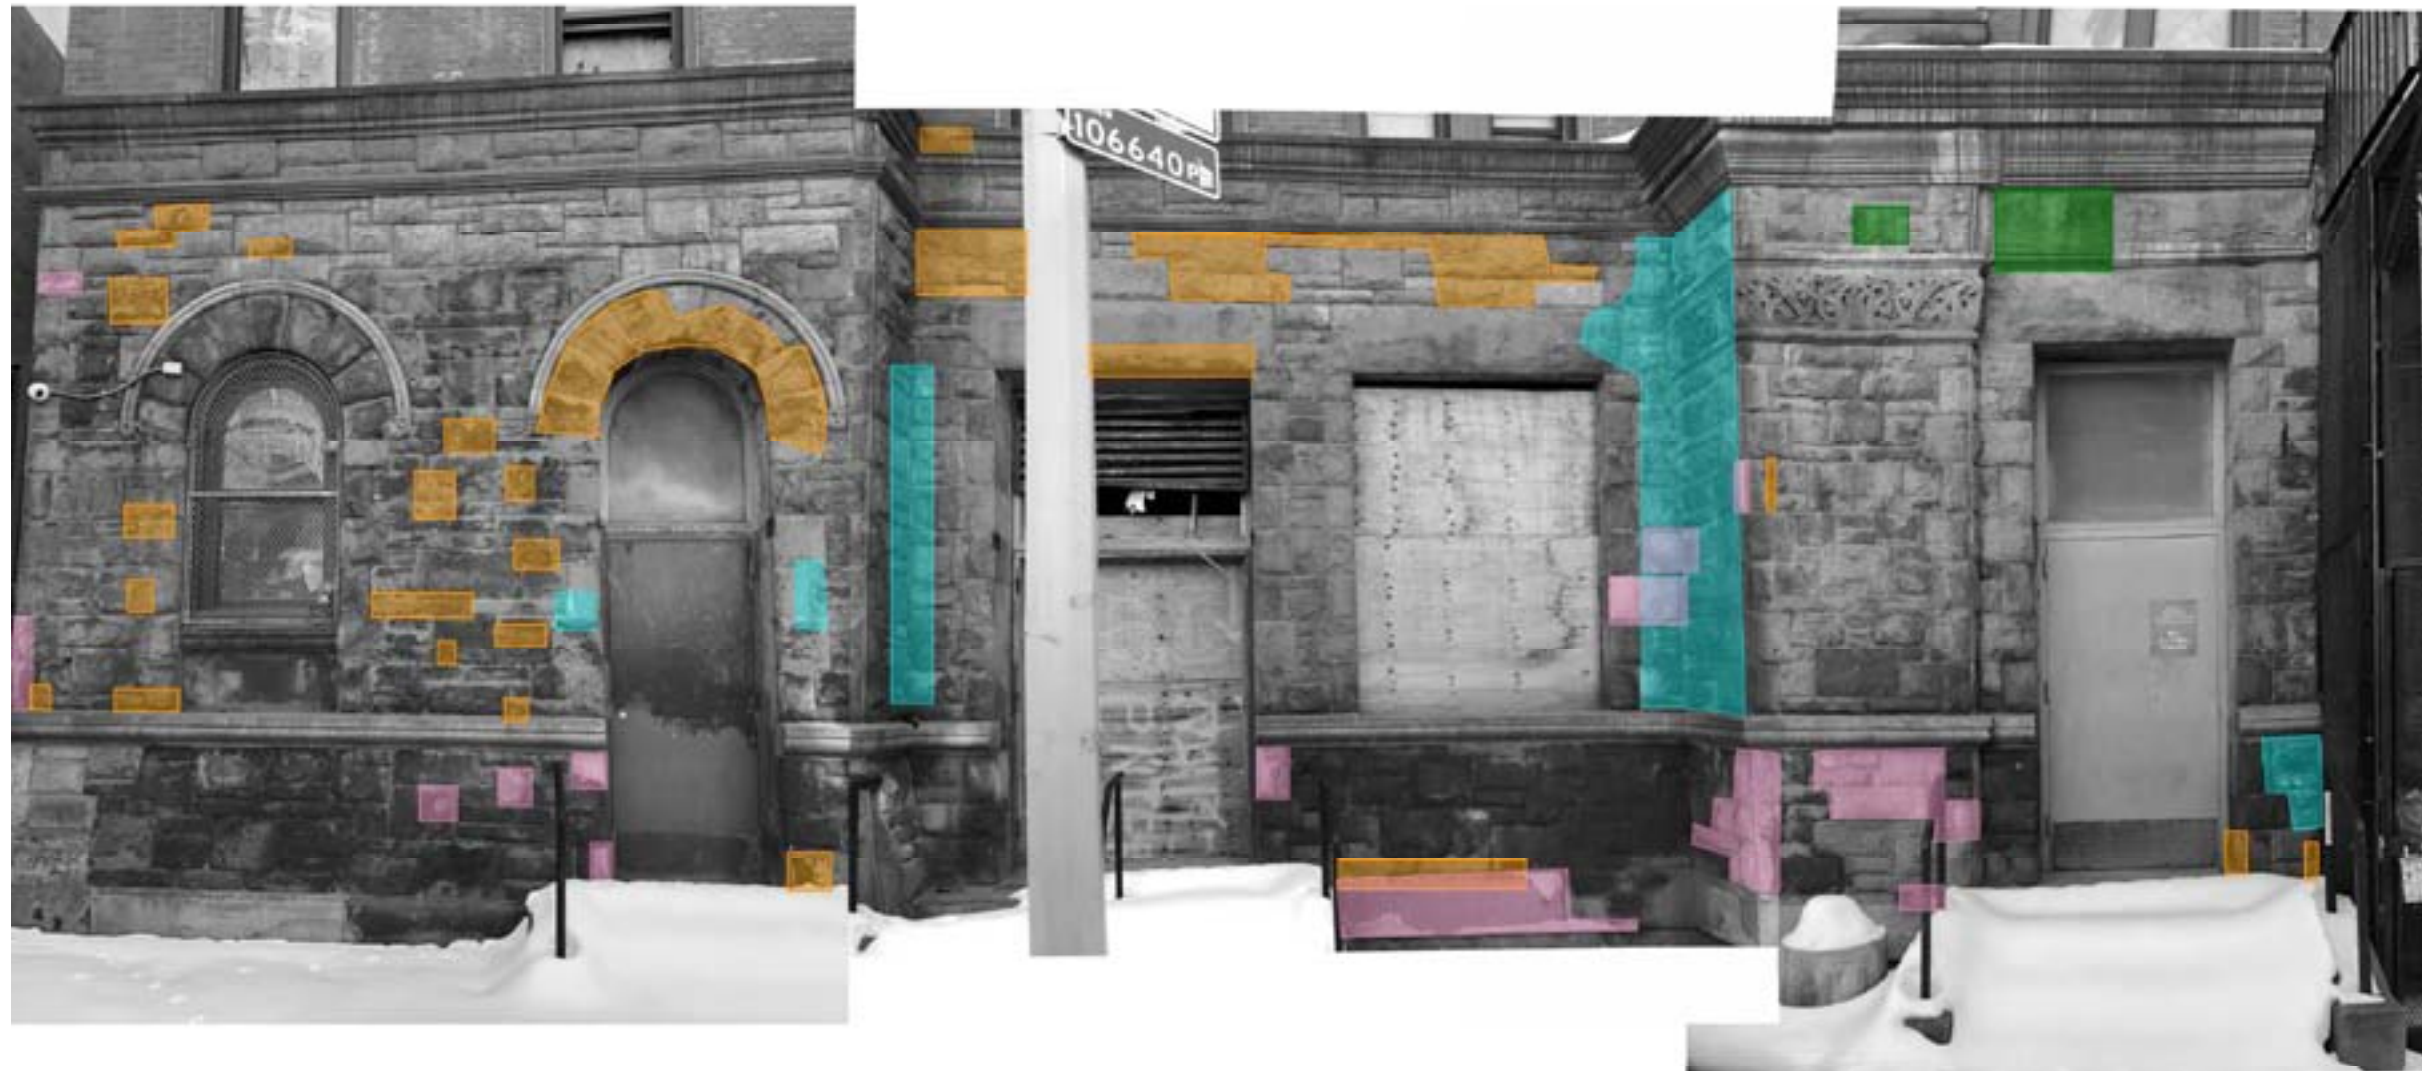
MULBERRY STREET ELEVATION

- Atmospheric soiling on the exterior, typ.
- Abandoned anchor holes, typ.
- Loss of details in the decorative band and engaged column capitals, typ.
- Water infiltration from ground, rising as high as the water table, typ.
- About 25% of the brownstone facade is patched, mostly in good condition.
