**CONDITIONS ASSESSMENT**

**70 MULBERRY STREET  
NEW YORK, NY**

Prepared by:  
Jablonski Building Conservation, Inc.  
40 West 27<sup>th</sup> Street, Suite 1201  
New York, NY 10001

March 2021

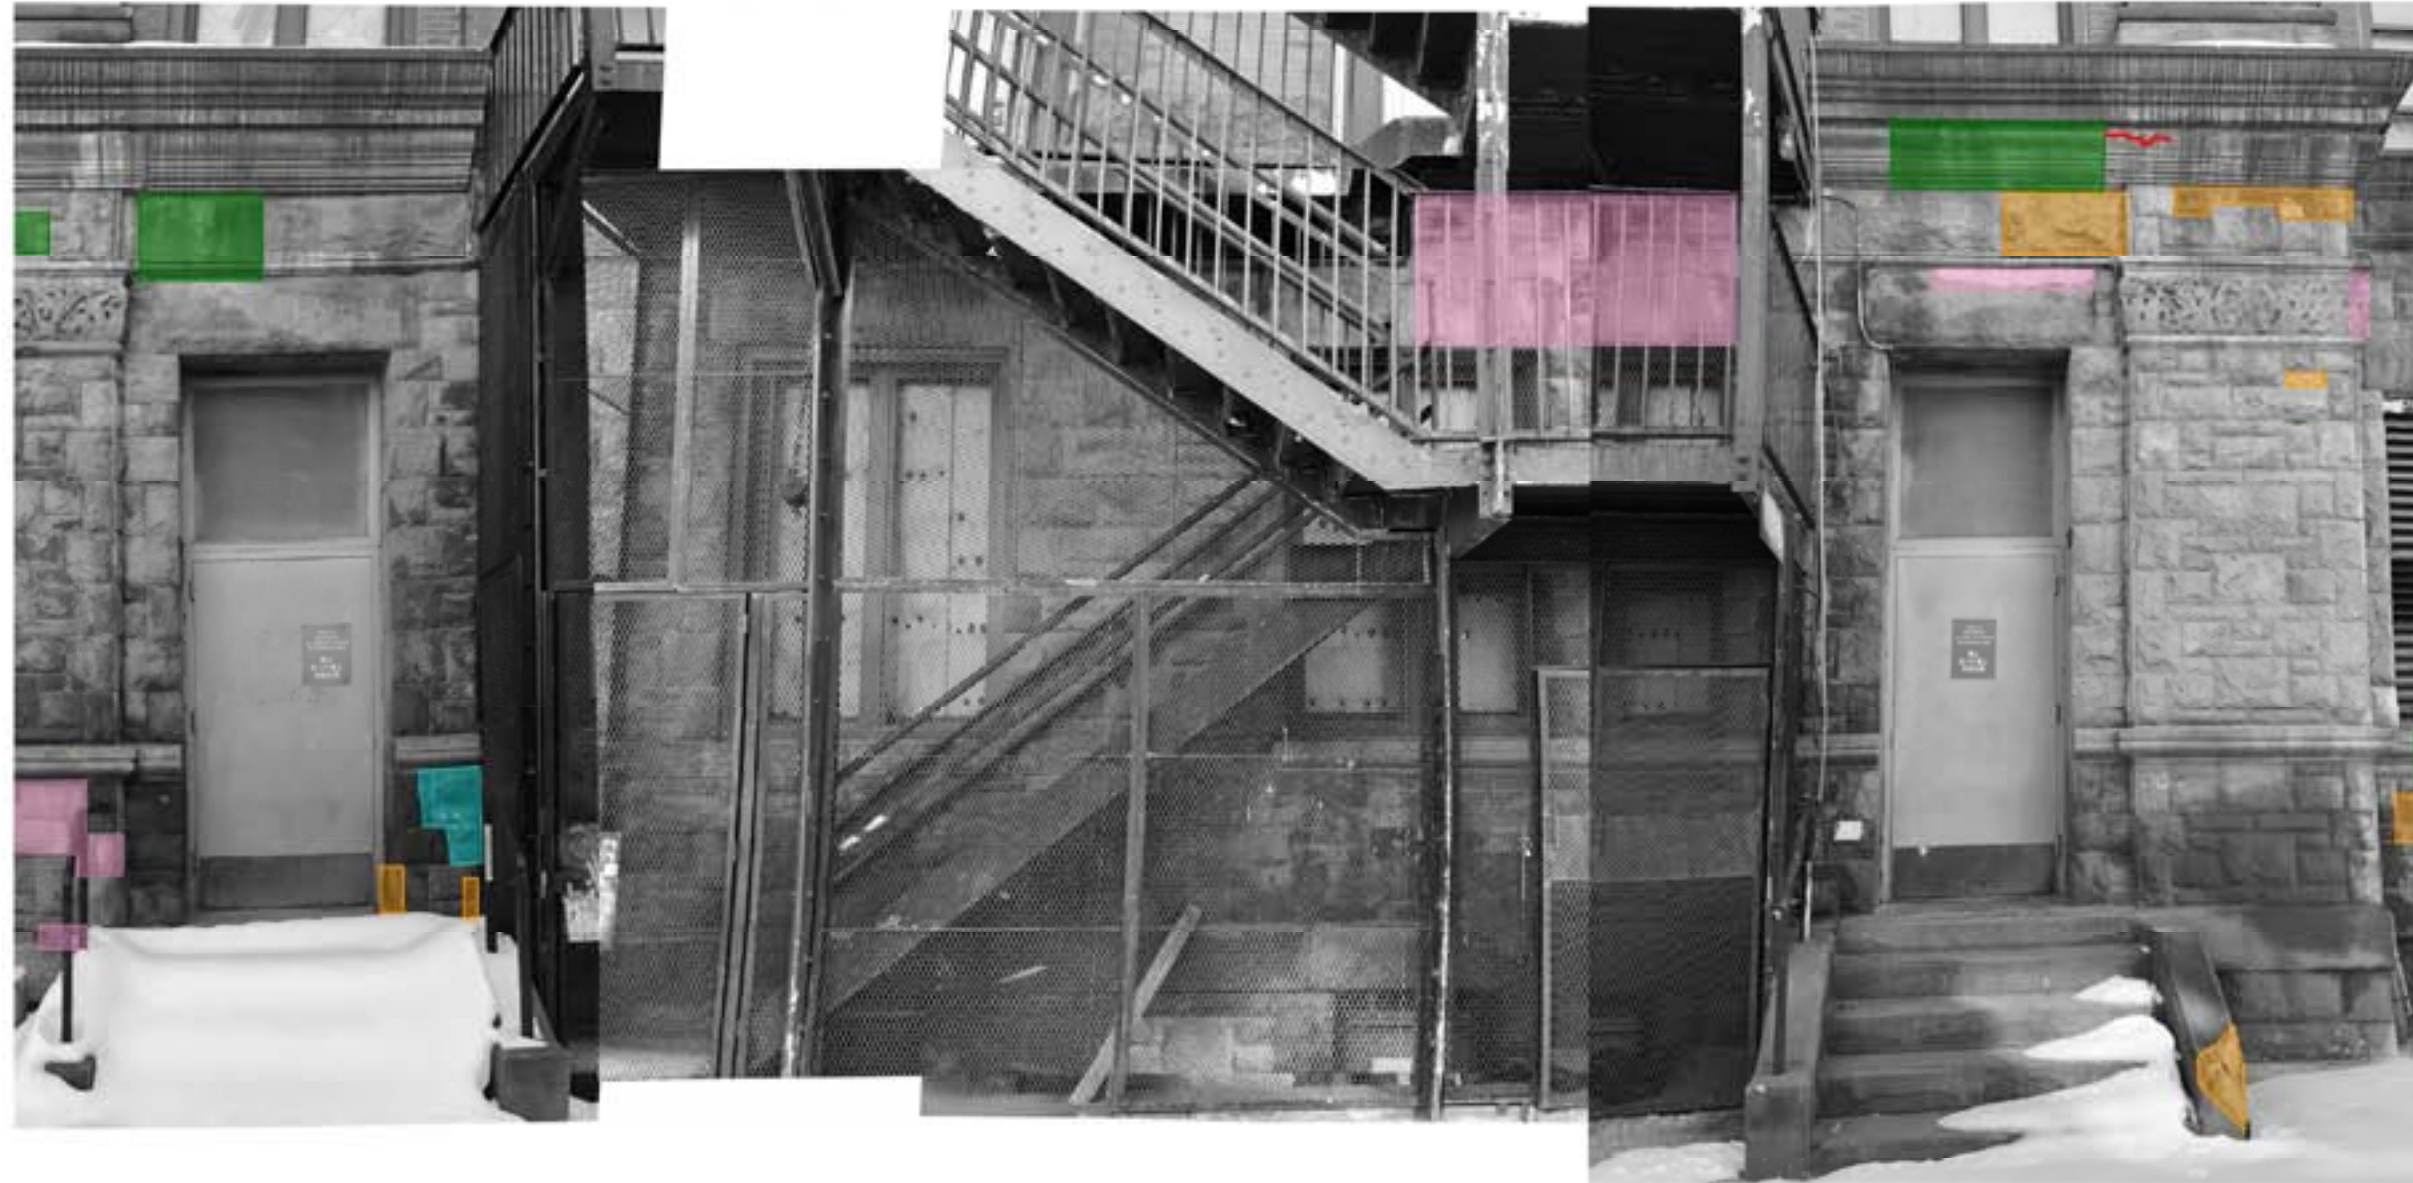
MULBERRY STREET ELEVATION

- Atmospheric soiling on the exterior, typ.
- Abandoned anchor holes, typ.
- Loss of details in the decorative band and engaged column capitals, typ.
- Water infiltration from ground, rising as high as the water table, typ.
- About 25% of the brownstone facade is patched, mostly in good condition.

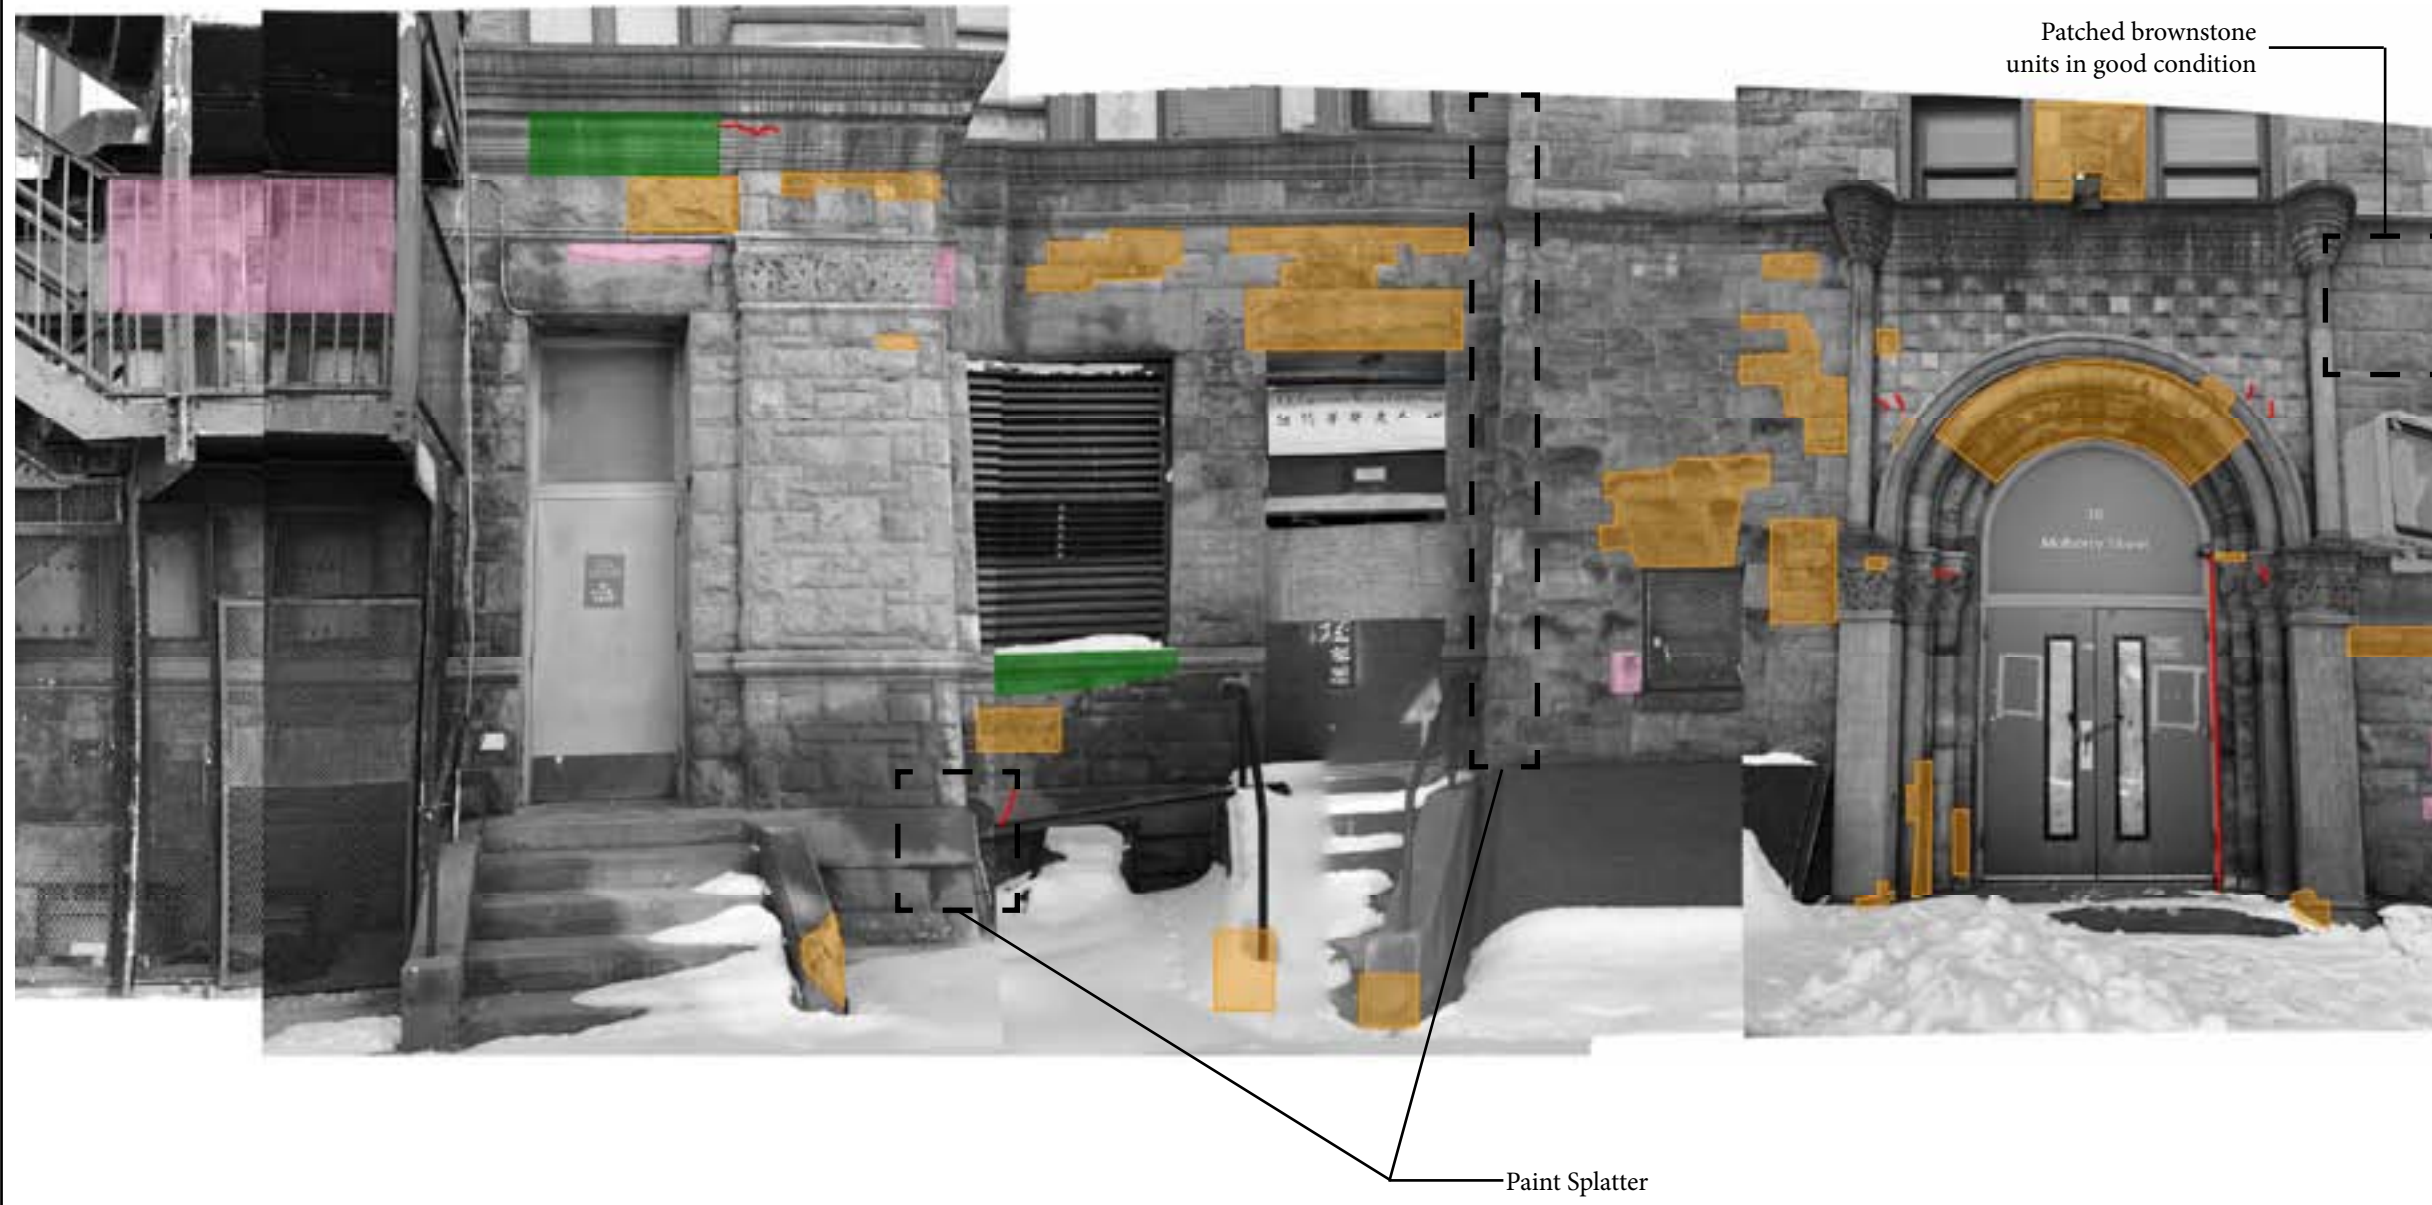
**MULBERRY STREET ELEVATION**  
First Story - Exterior  
March 2021

- Atmospheric soiling on the exterior, typ.
- Abandoned anchor holes, typ.
- Loss of details in the decorative band and engaged column capitals, typ.
- Water infiltration from ground, rising as high as the water table, typ.
- About 25% of the brownstone facade is patched, mostly in good condition.

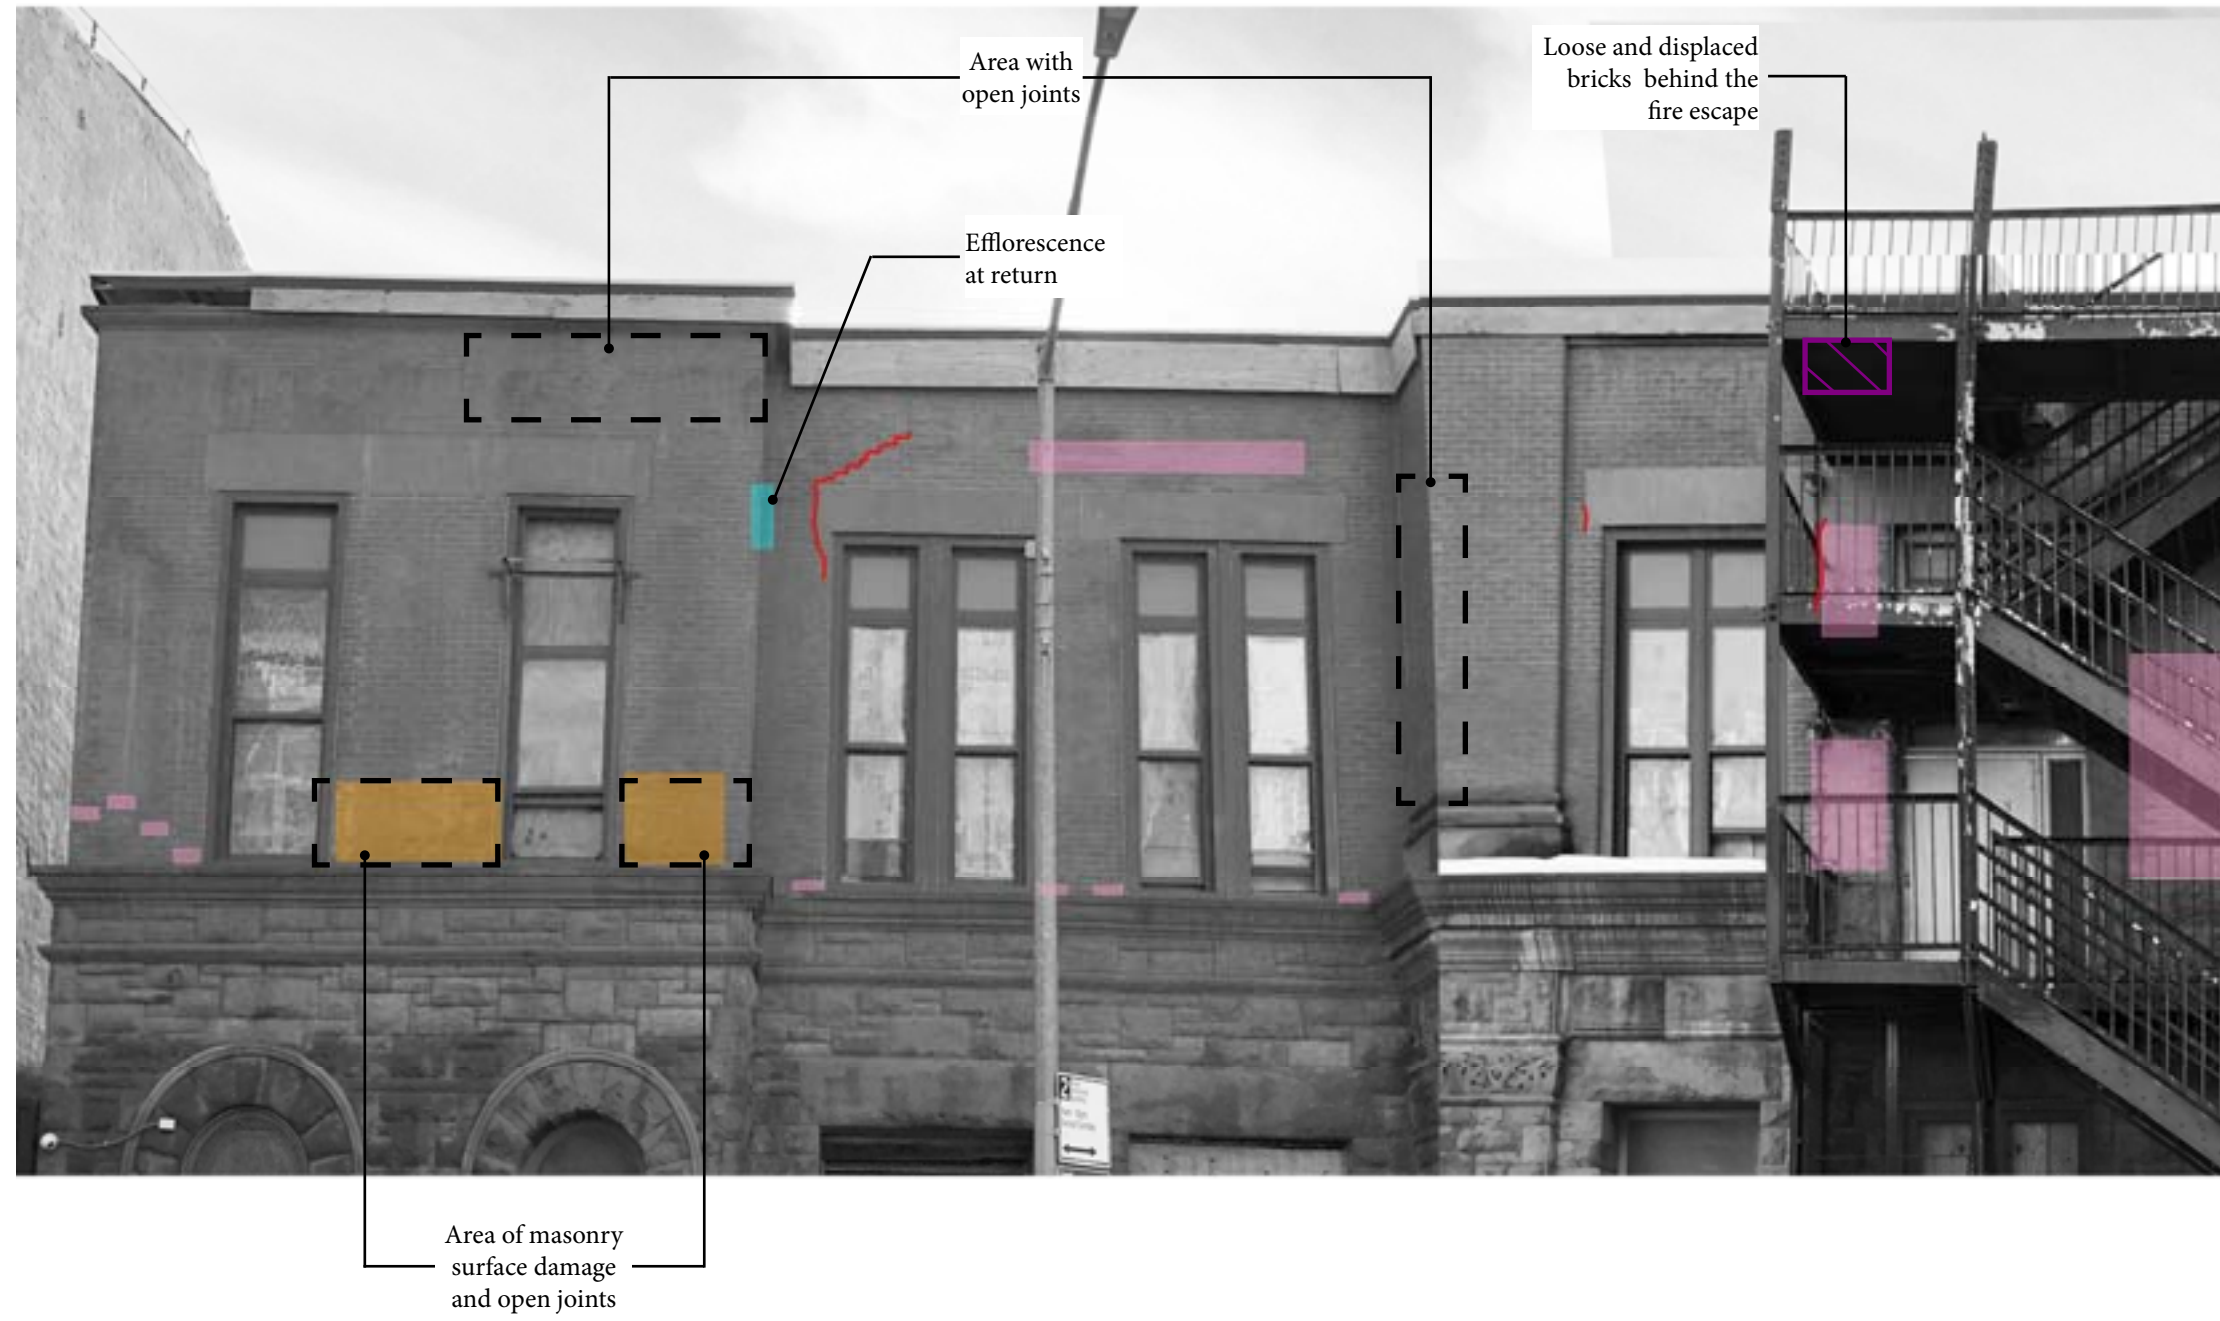
- Bricks are mostly in good condition
- Atmospheric soiling on the exterior, typ.
- Open joints, typ.
- Multiple repair areas
- Bricks at the bottom corners of windows have been replaced, typ.

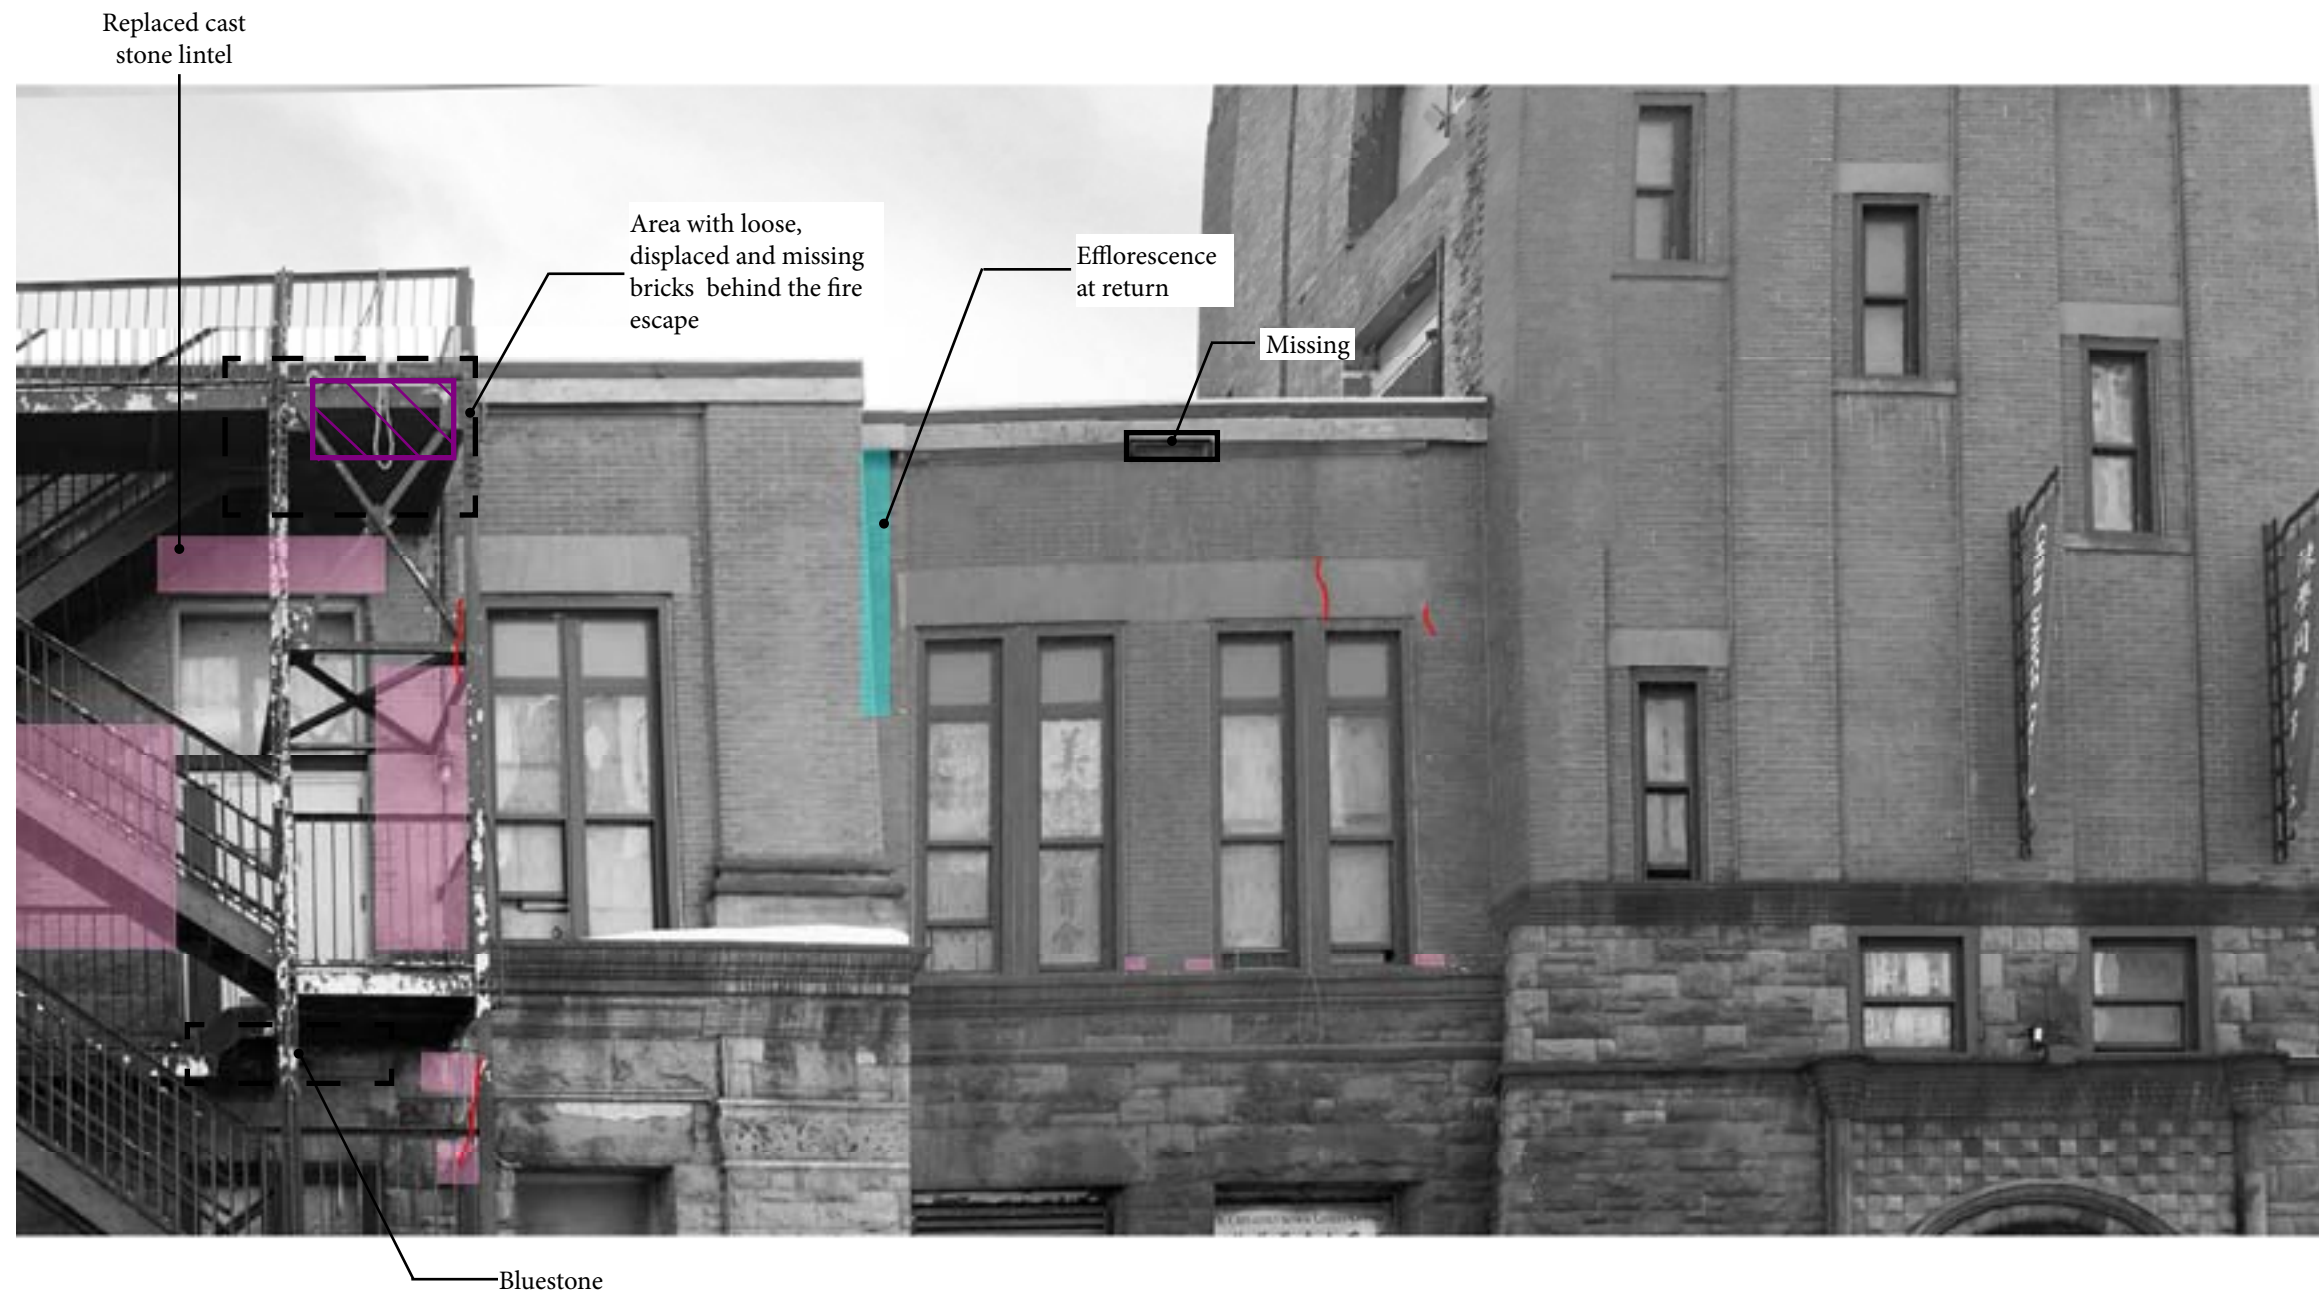
- Bricks are mostly in good condition
- Atmospheric soiling on the exterior, typ.
- Open joints, typ.
- Multiple repair areas
- Bricks at the bottom corners of windows have been replaced, typ.

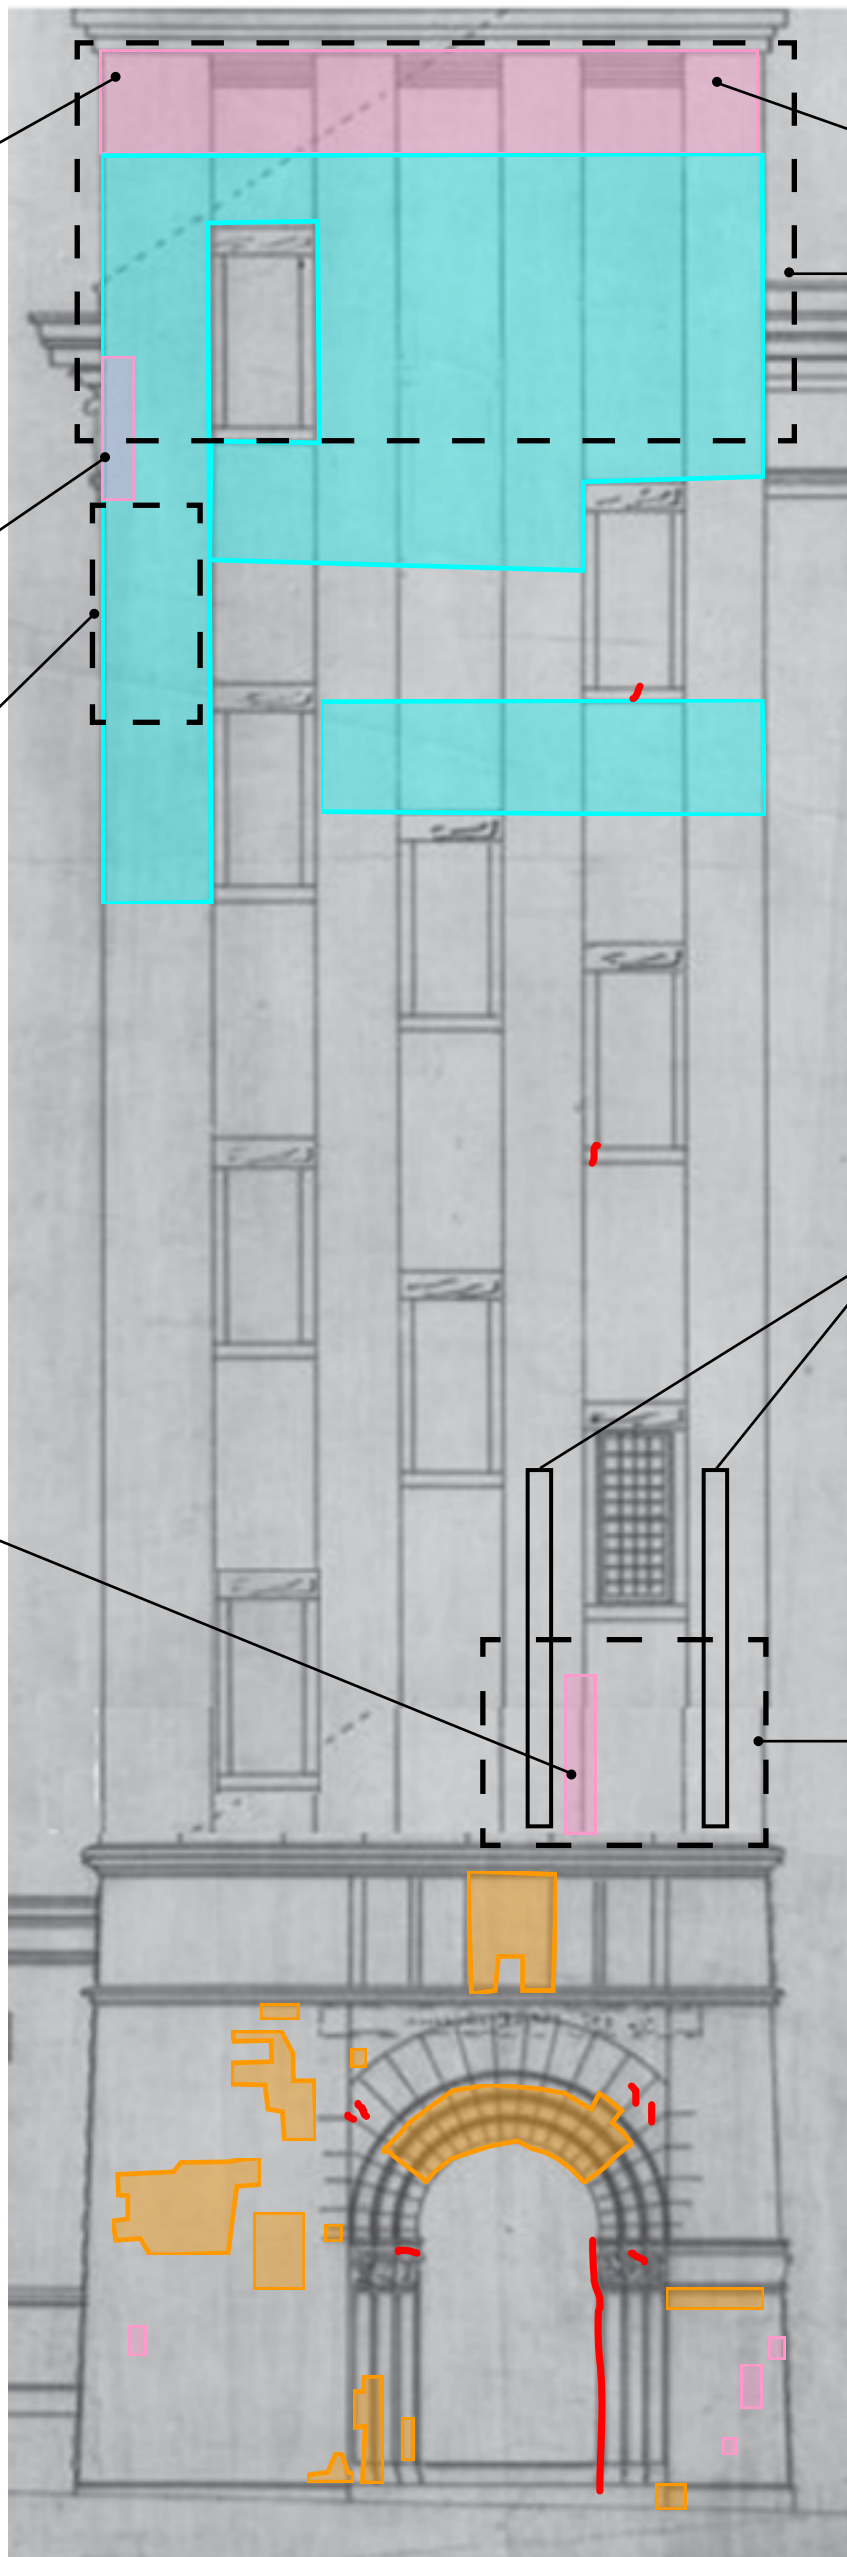
Abandoned anchors and anchor holes present around the metal flagpoles

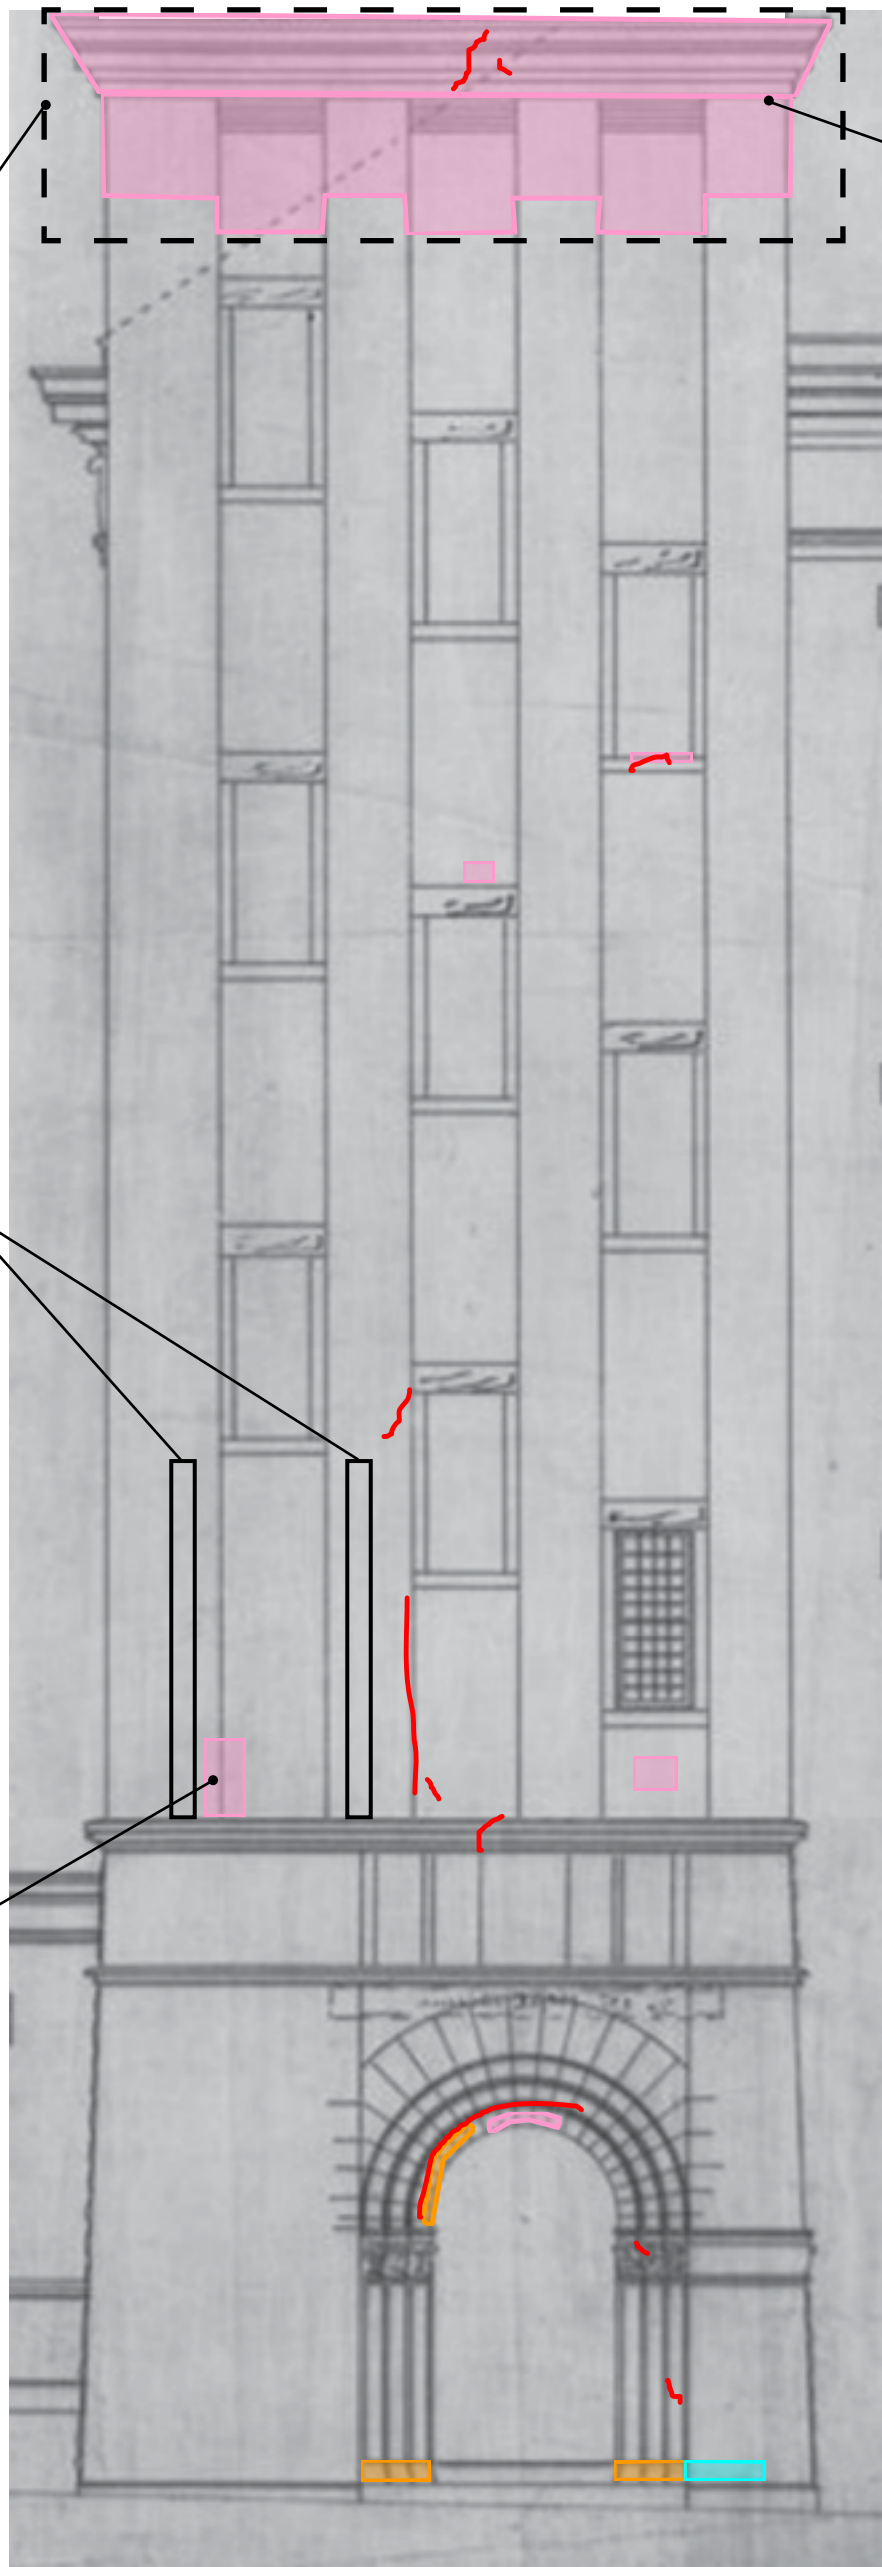
Regular rectangular bricks instead of the bullnosed bricks at edges of repaired pilasters

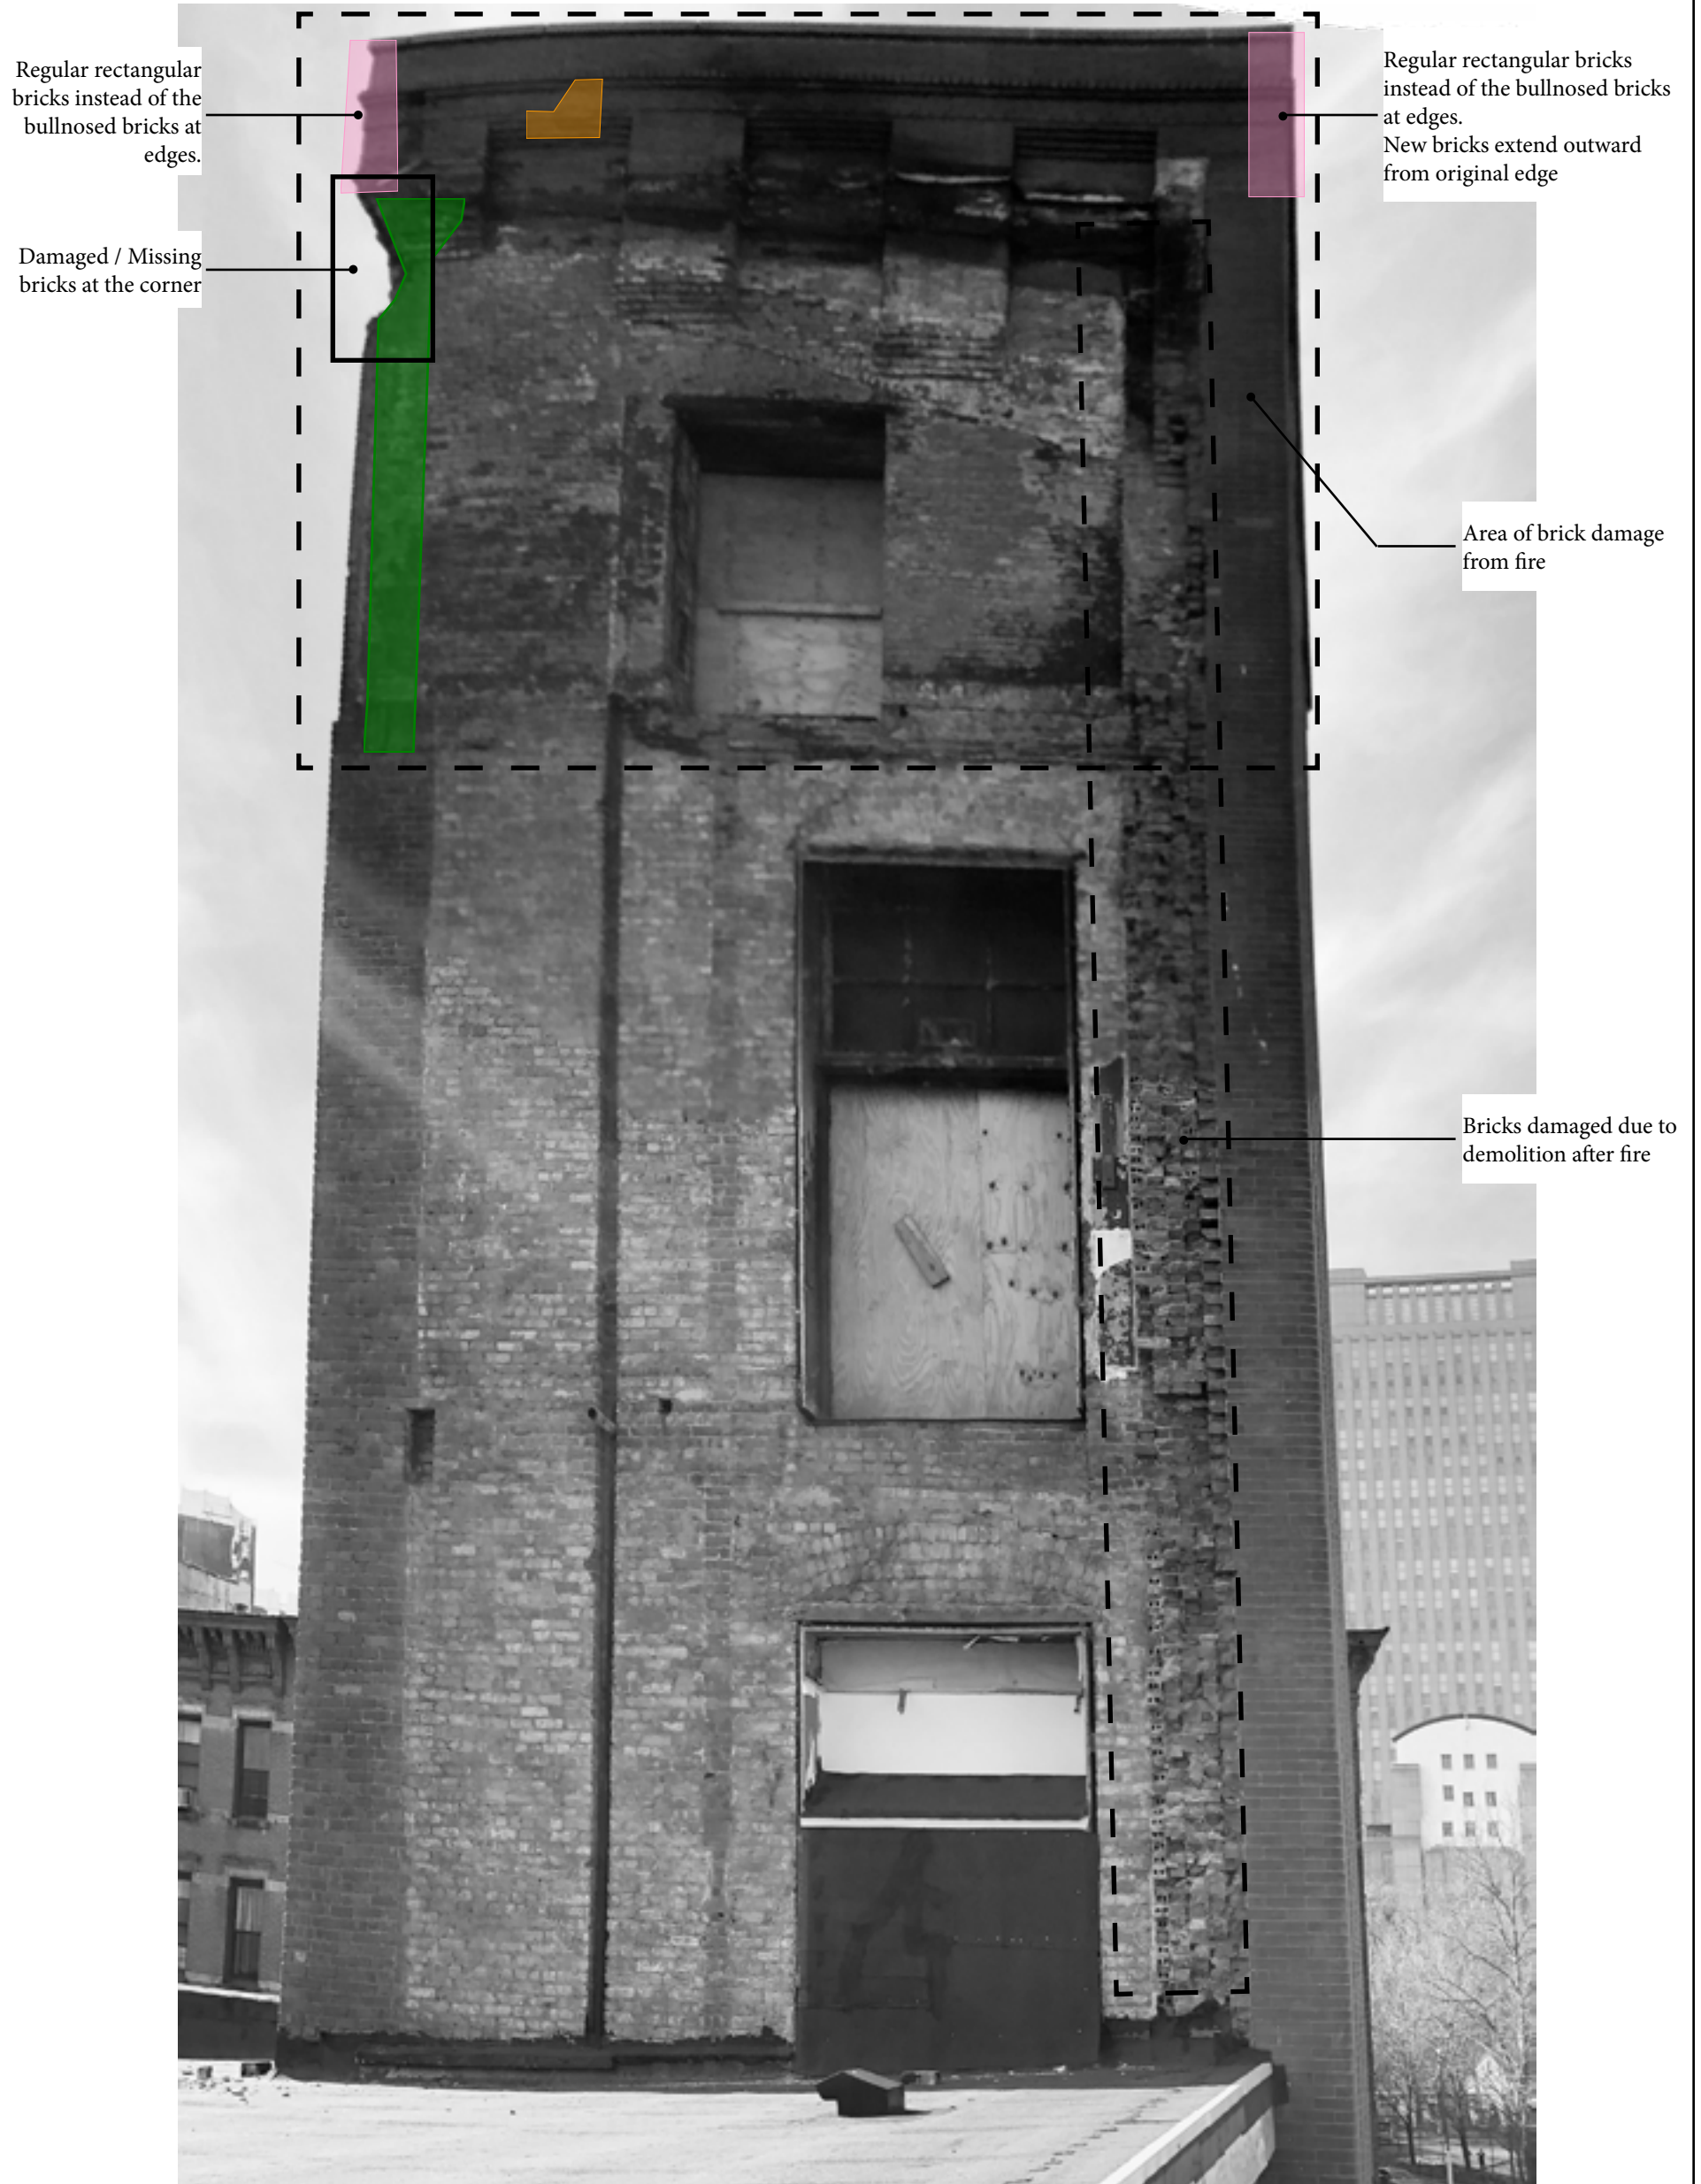
Regular rectangular bricks instead of the bullnosed bricks at edges.
