**DOI REPORT ON THE FATALITY OF A NYCHA CARETAKER FOUND IN A GARBAGE HOIST
CALLS FOR NYCHA TO PERMANENTLY DECOMMISSION THESE UNITS**

New York City Department of Investigation

**Safety Issues Relating to Garbage Hoists
Utilized at Certain NYCHA Facilities**

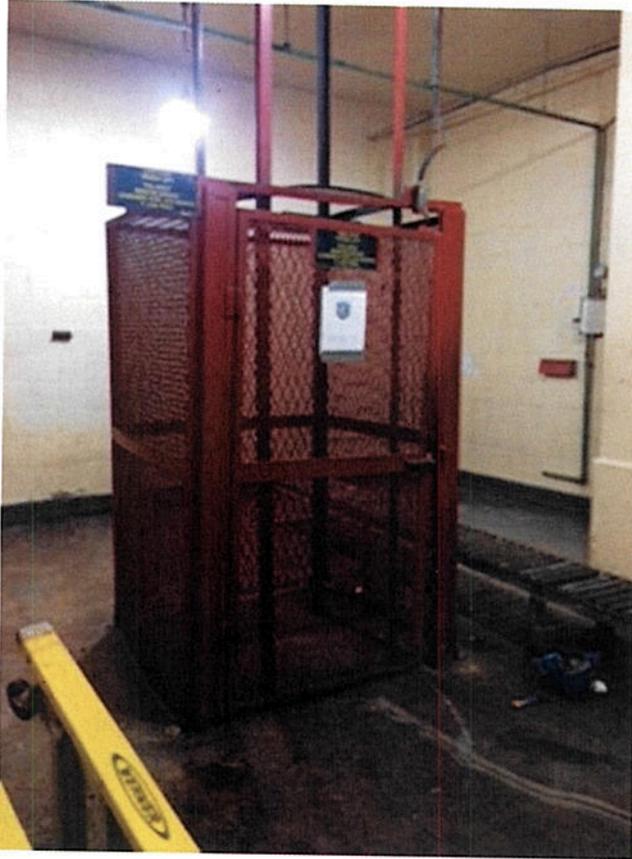
PHOTO #1

On April 6, 2015, DOI investigators visited and inspected the basement compactor room, the garbage hoist system, and the ground level transfer room. During this inspection, DOI made the following observations: at the basement level, the hoistway terminates in a red metal mesh cage with a door designed to be secured with a bolt, but the locking mechanism is broken. The cage is marked with two identical signs warning in English "CAUTION - TRASH LIFT," and in Spanish

“PELIGRO - MONTACARGAS (CUIDADO CON LAS MANOS Y LOS PIES).”⁴ See Appendix A, Photos #1 and #2. The cage is equipped with a safety cage interlock switch that is designed to break the electrical circuit and prevent the hoist car from moving when the cage door is open. However, the cage door is damaged and bent so that it does not make contact with the safety cage switch. See Appendix A, Photos #3 and #4. The hoist car travels up from the basement level, through a hole in the basement ceiling/ground level floor. See Appendix A, Photo #5. DOI observed that there is no operating switch for the hoist at the basement level.
