Beaux Arts Apartments • 307 & 310 East 44th Street Manhattan
Proposed window replacement

Landmarks Preservation Commission • 21 November 2017

WINDOW REPLACEMENT AT A LANDMARK BUILDING

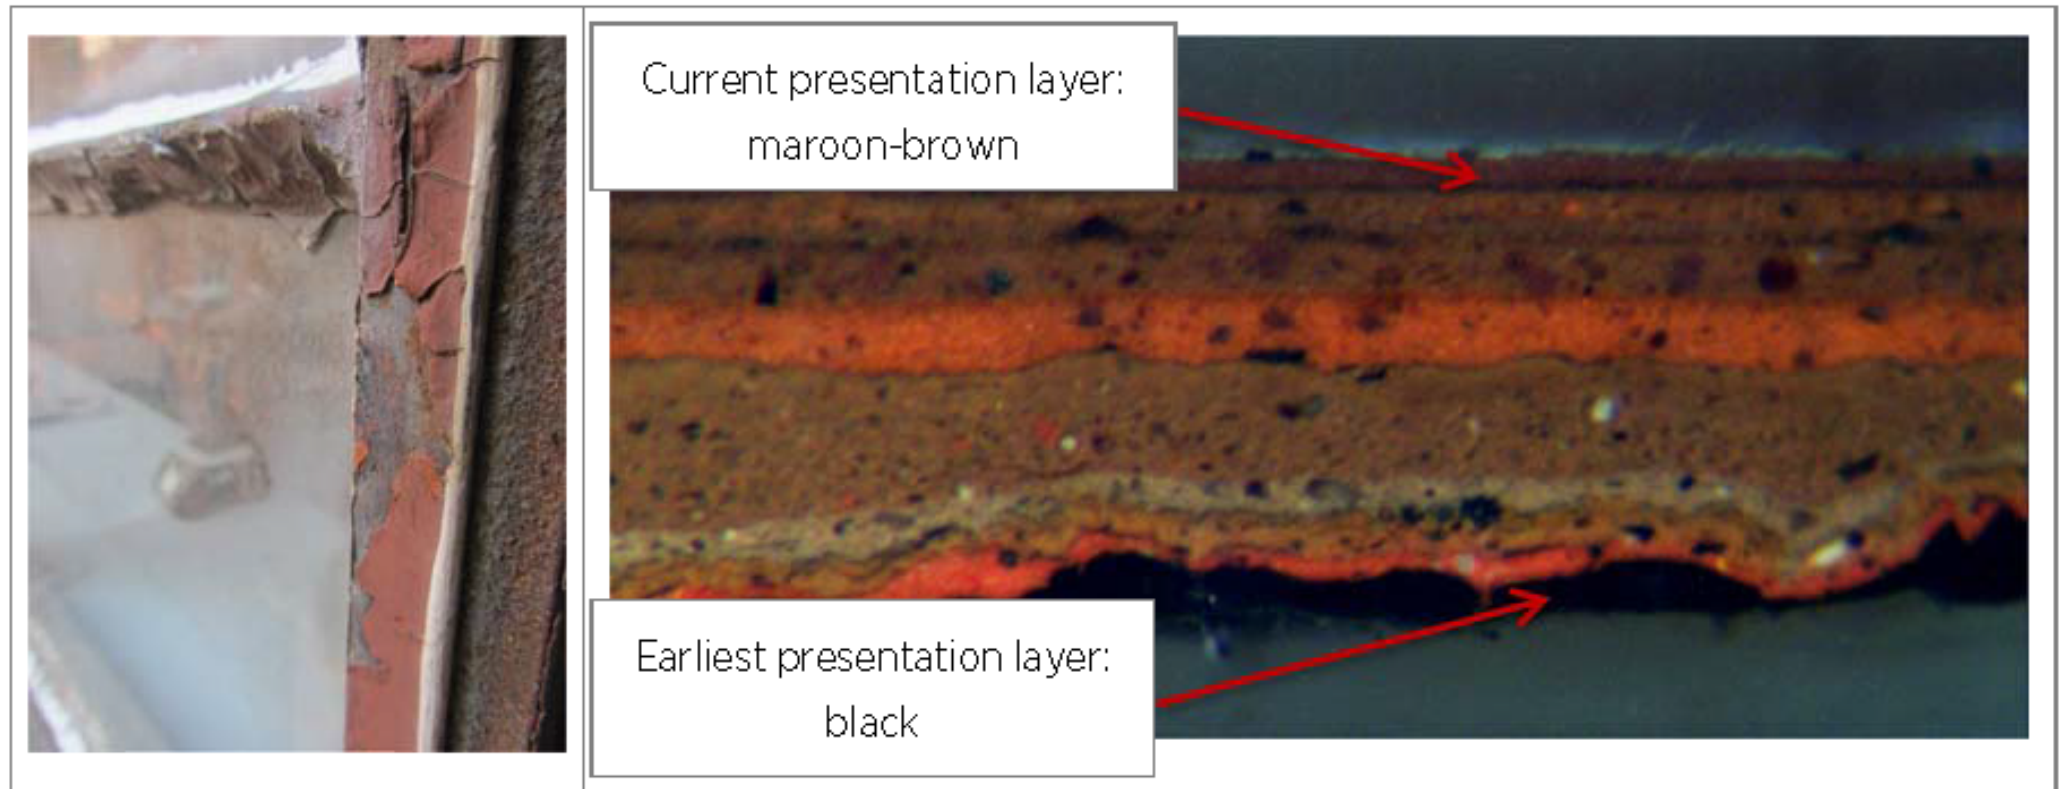
Sample 05 - 310 E. 44th Street, Apartment 713

Paint scraping at exterior window frame of apartment 310, room 713 (left) and photomicrograph of embedded sample in cross section indicating several paint campaigns with a lustrous black as the earliest evidenced layer (right)

Color: Benjamin Moore “Carbon Copy” 2117-10

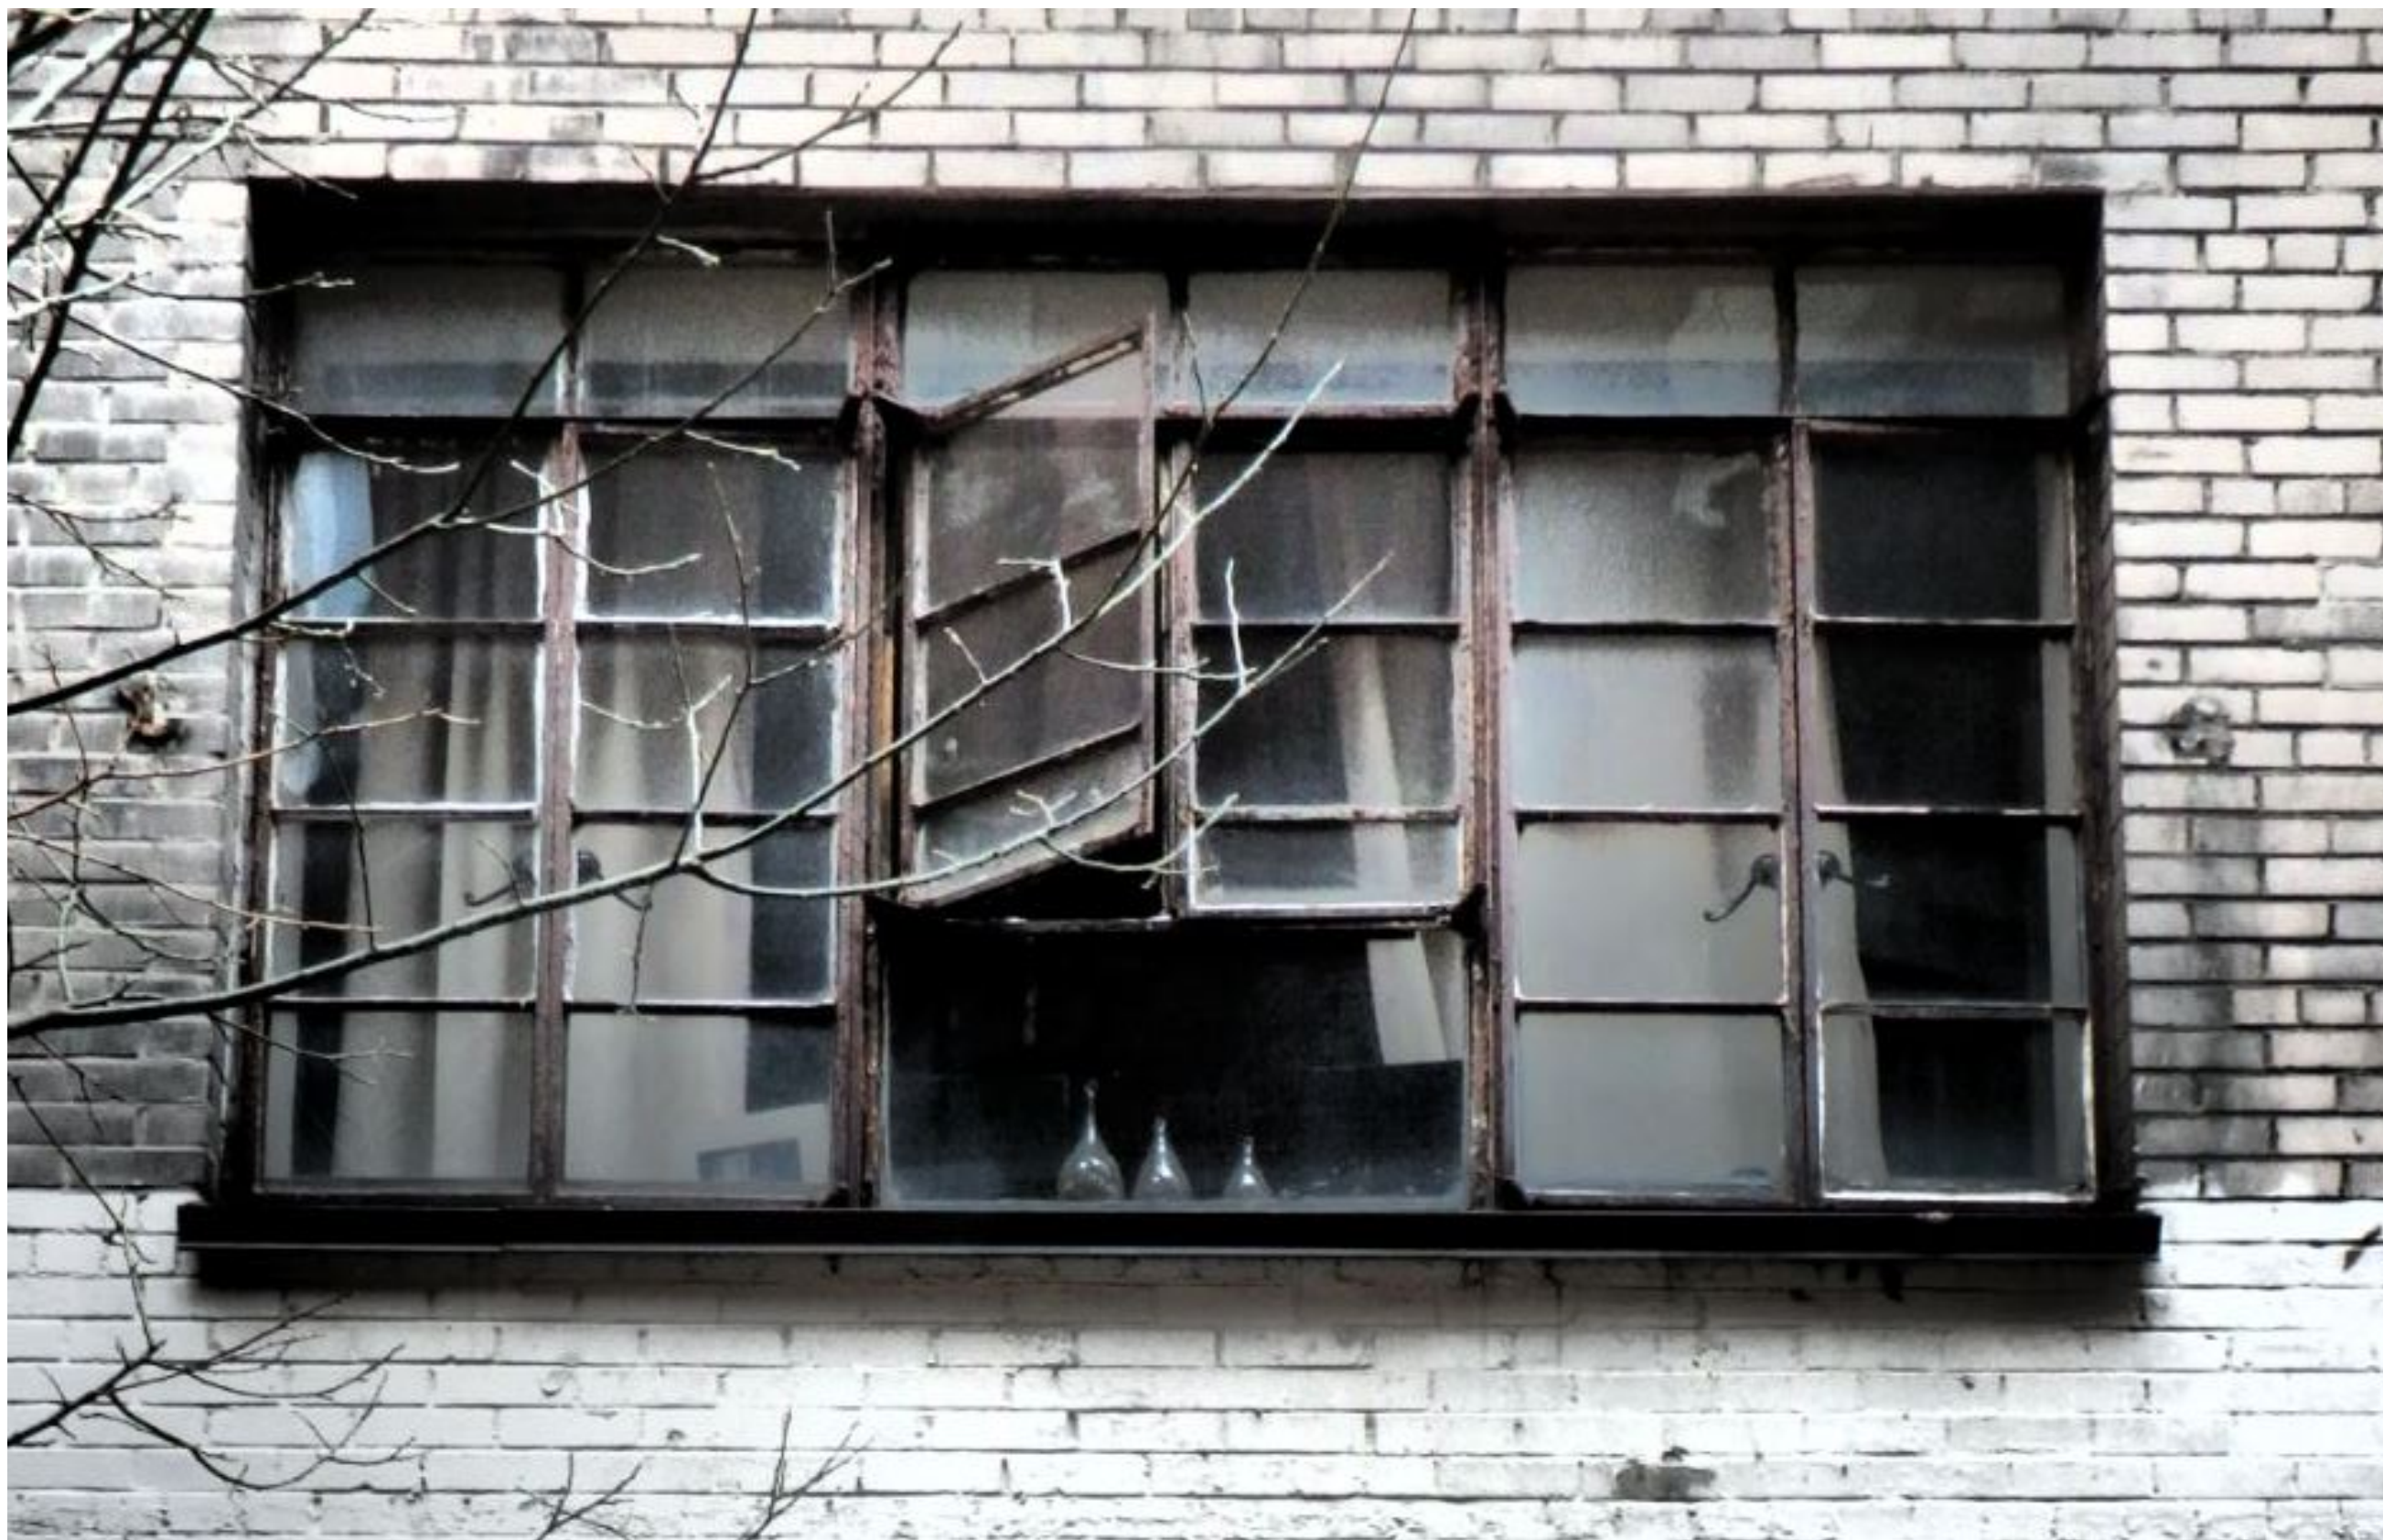
EXISTING TYPICAL “TYPE A” (PRINCIPAL TYPE) WINDOW

- Industrial window type elegant details
- Very light structure and muntions
- Operable sashes predominate
- Standard studio apartment window is six casements below a heavier mullion with three awning sashes above
- High transparency / Single glazing
- Poor energy efficiency

- Frame embedded in the structure
- Clean interior reveals
- Mutilated for ad-hoc AC installation

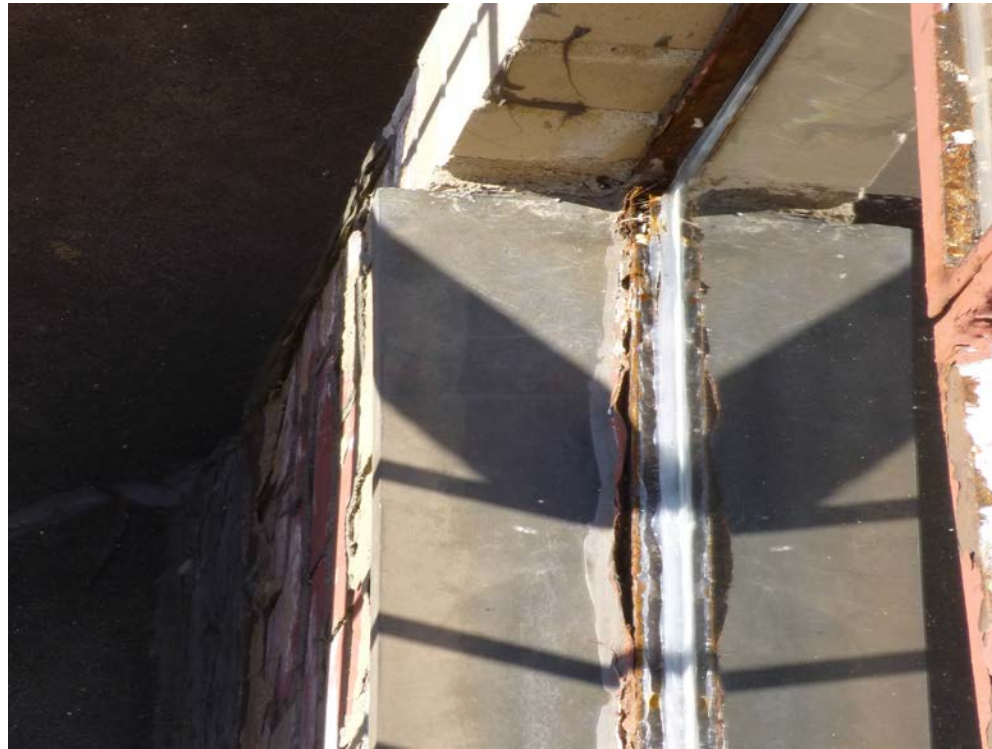
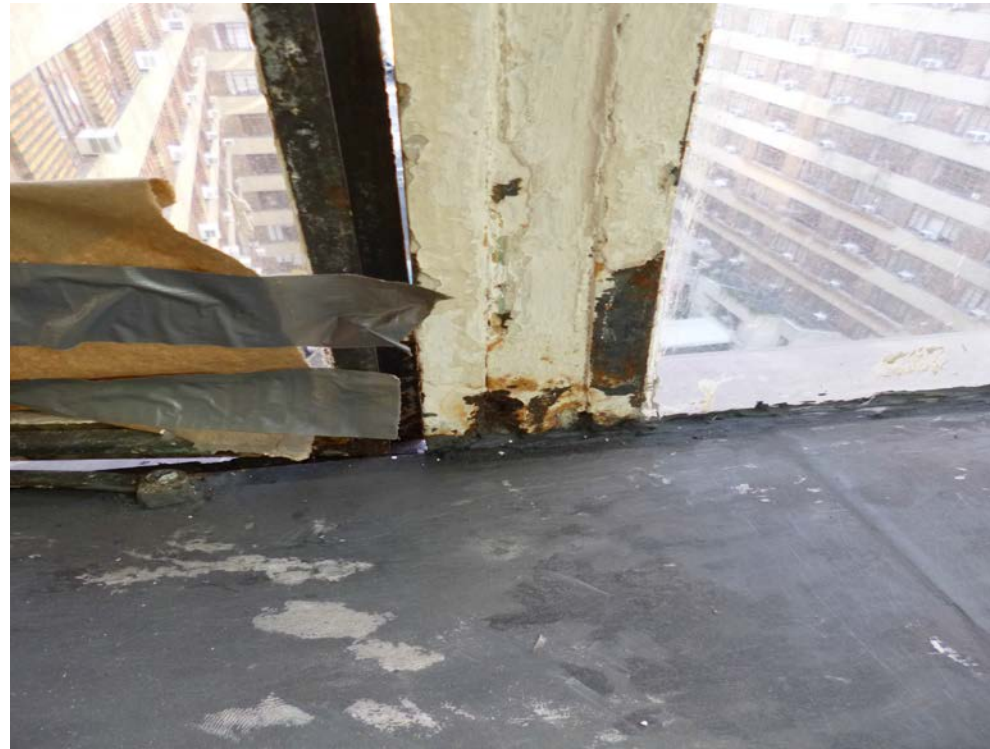
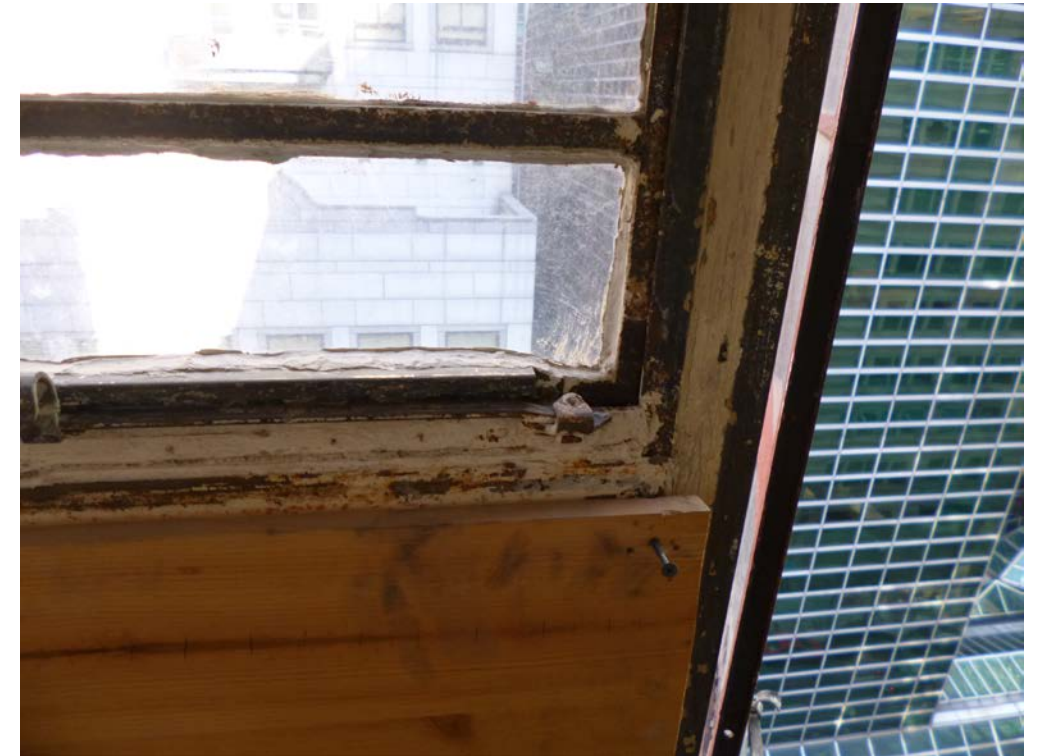
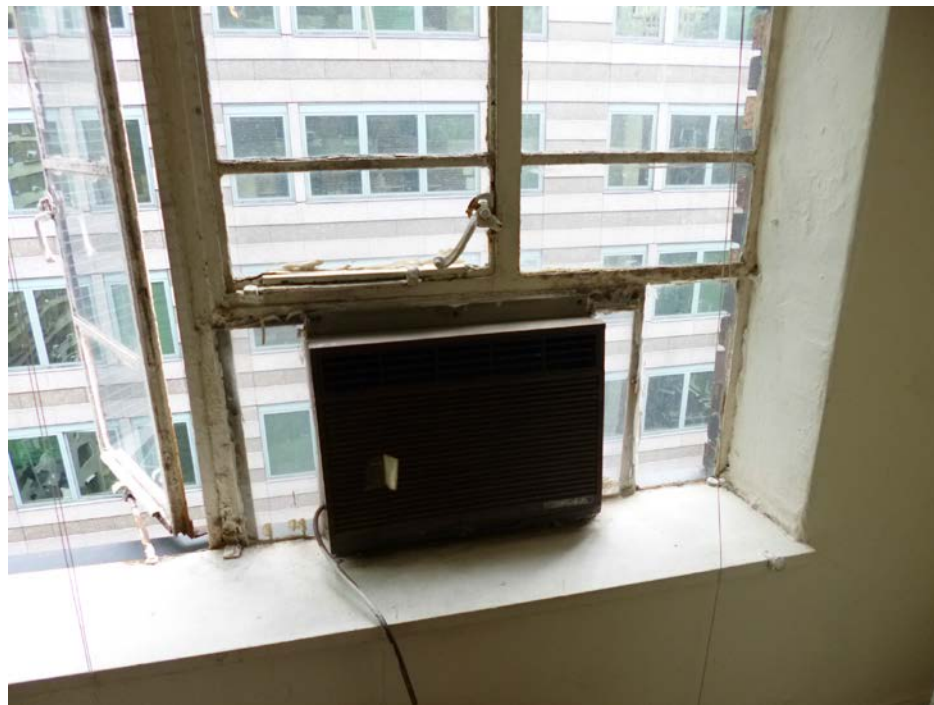
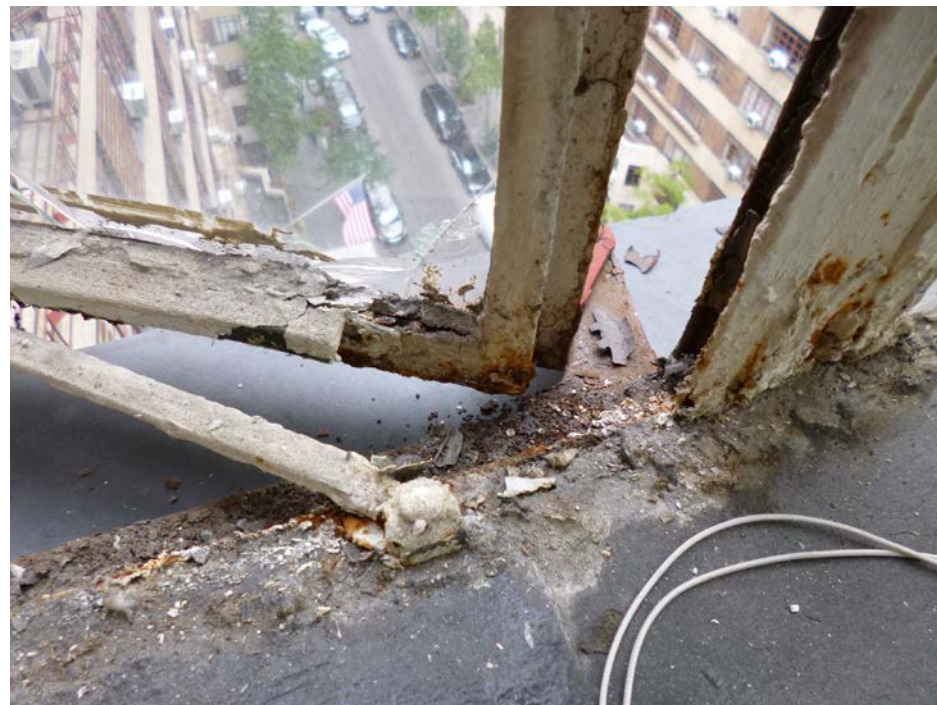
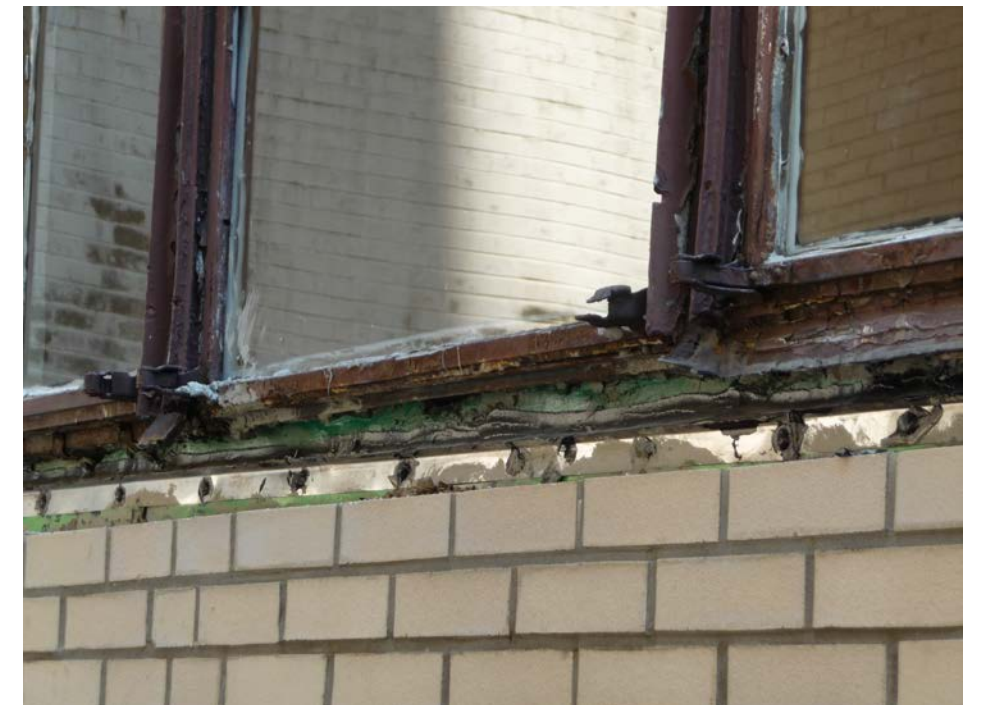
SELECTION OF PHOTOS FROM THE CONDITIONS SURVEY

Ad-hoc openings for window air conditioners have mutilated most windows
Corrosion • Poor condition of paint
Bowing and misalignment of sashes • Glazing compound missing or deteriorated

- Ad-hoc openings for window air conditioners have mutilated most windows
- Corrosion
- Poor condition of paint
- Bowing and misalignment of sashes
- Glazing compound missing or deteriorated
- Deteriorated masonry surrounds, sills and lintels were only recently restored and contributed to deterioration for decades

100%:	All windows show some signs of deterioration.
55%	are suffering from misalignment of sashes. Many sashes are inoperable as a result. In some instances the only cure for deteriorated and misaligned sashes is caulking them when they cannot be made operable.
40%	have extensive corrosion. We have done a random sampling of windows in both buildings and this finding is consistent with ours. In house the staff describe the worst of these as “Swiss cheese” windows. Repairs can only be effected by caulking corroded openings in the steel itself. At about 12 locations steel has been welded and sistered to address structural failure of the windows.
90%;	of lights are estimated to have caulking in poor or missing condition
75%	have interior paint in poor condition. Where possible interiors of windows are stripped of paint during apartment renovations, but many are in a condition that makes this impossible.

100%	have exterior paint in poor condition
85%	have ongoing material air infiltration issues. Many of those can be mitigated temporarily with caulking. About 20% of the apartments have windows that make heating the units to minimum required statutory limits on coldest days of the year impossible.
16% per annum:	Maintenance logs show that substantial repairs are required to 16% of apartment units’ windows per annum on average over the past two years.
Energy consumption: Replacement should achieve at least a 30% reduction in energy use.

Conclusion: Based on our experience and following NPS Technical Services Bulletin 13, replacement of these windows is mandated.
