Coney Island Theater Building, 1301 Surf Avenue, Brooklyn

View to northwest from Surf & Stillwell Avenues

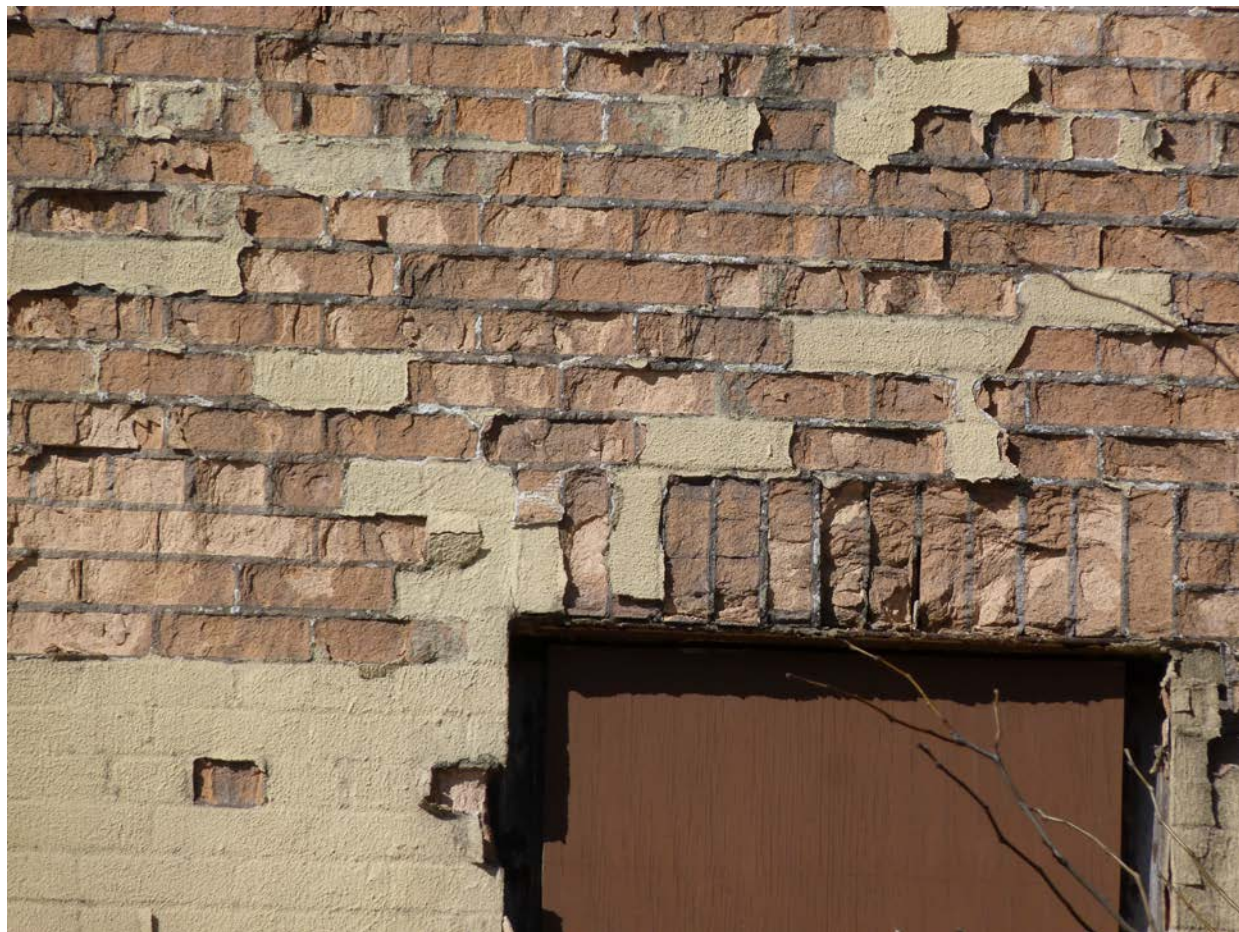
Roof View from rear of office building roof

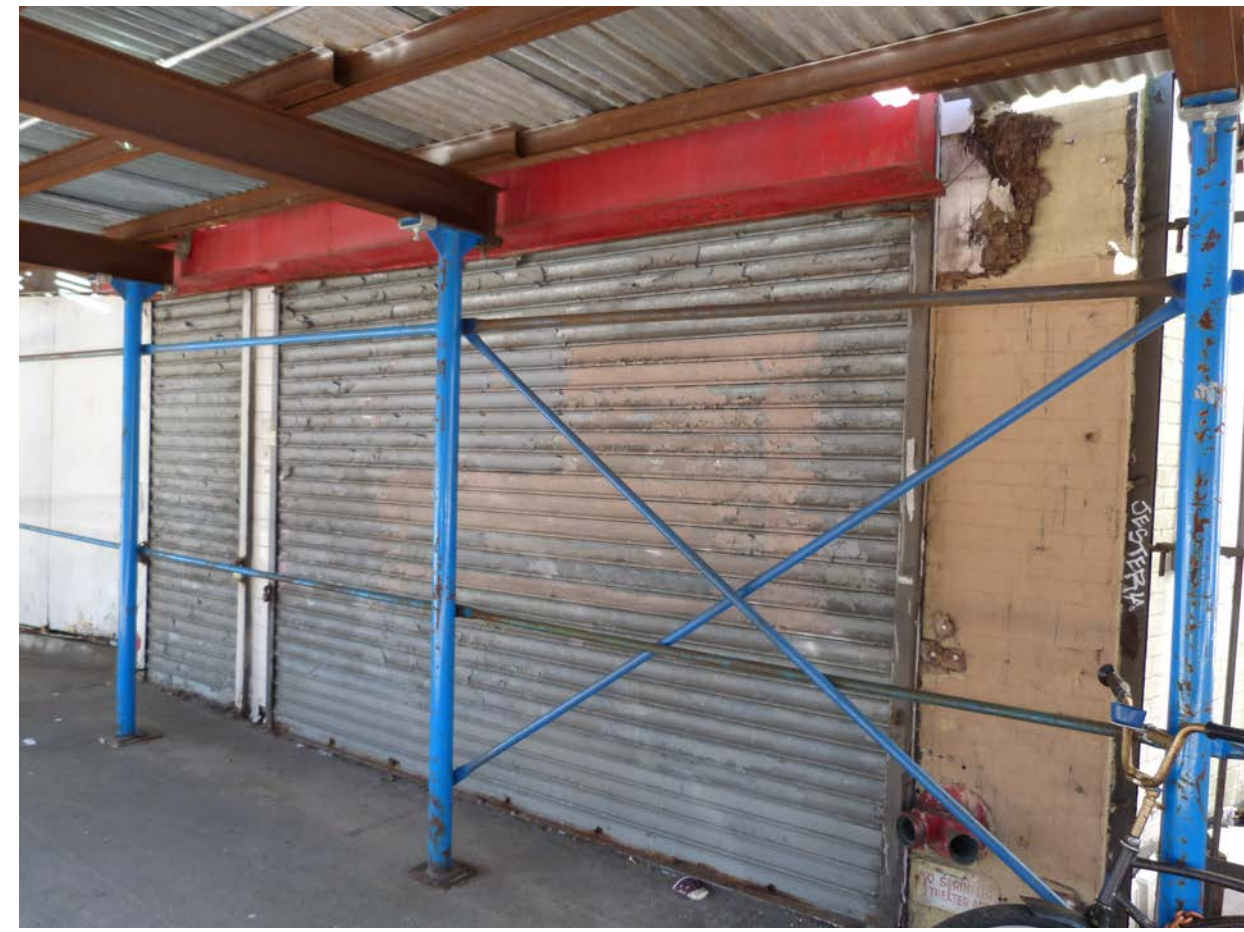
Openings at street level of theater on Stillwell Ave.

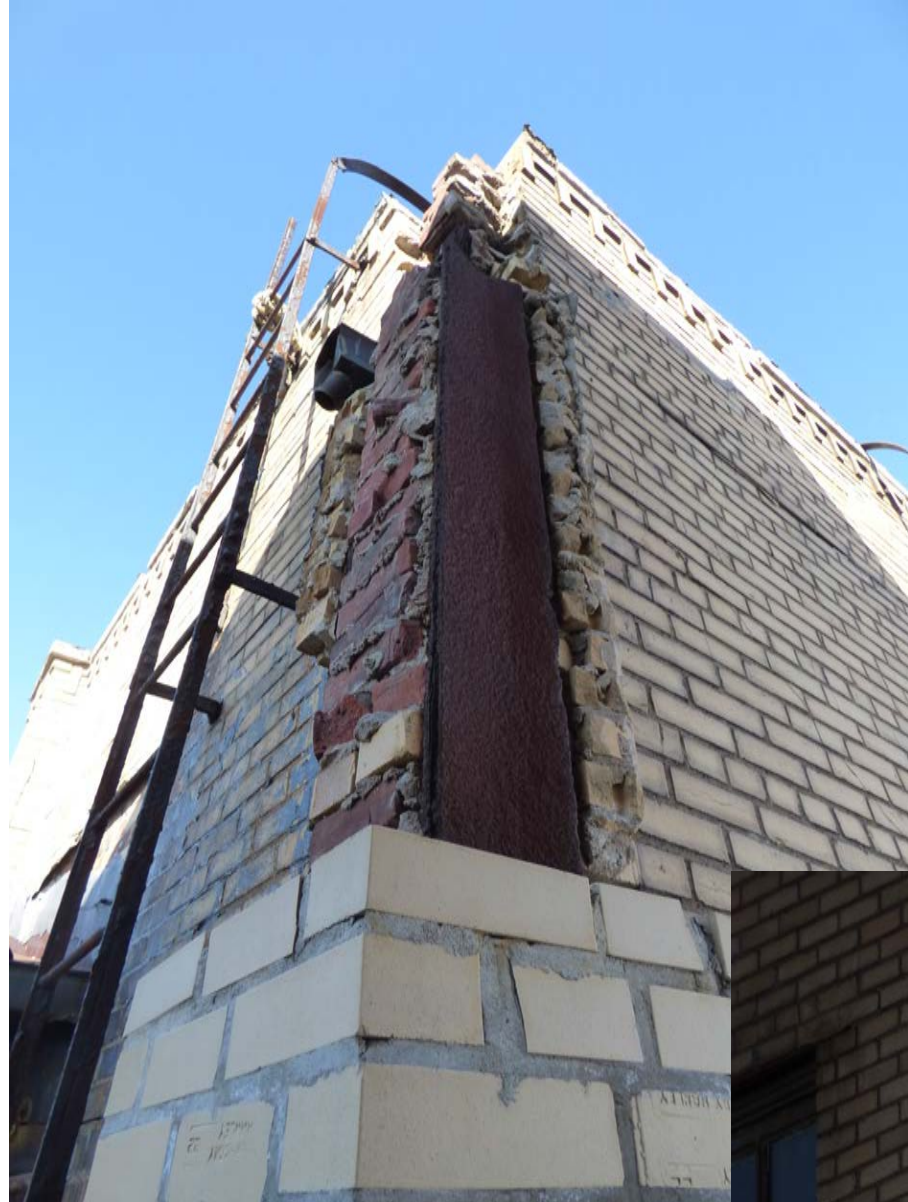
Masonry damage at corners

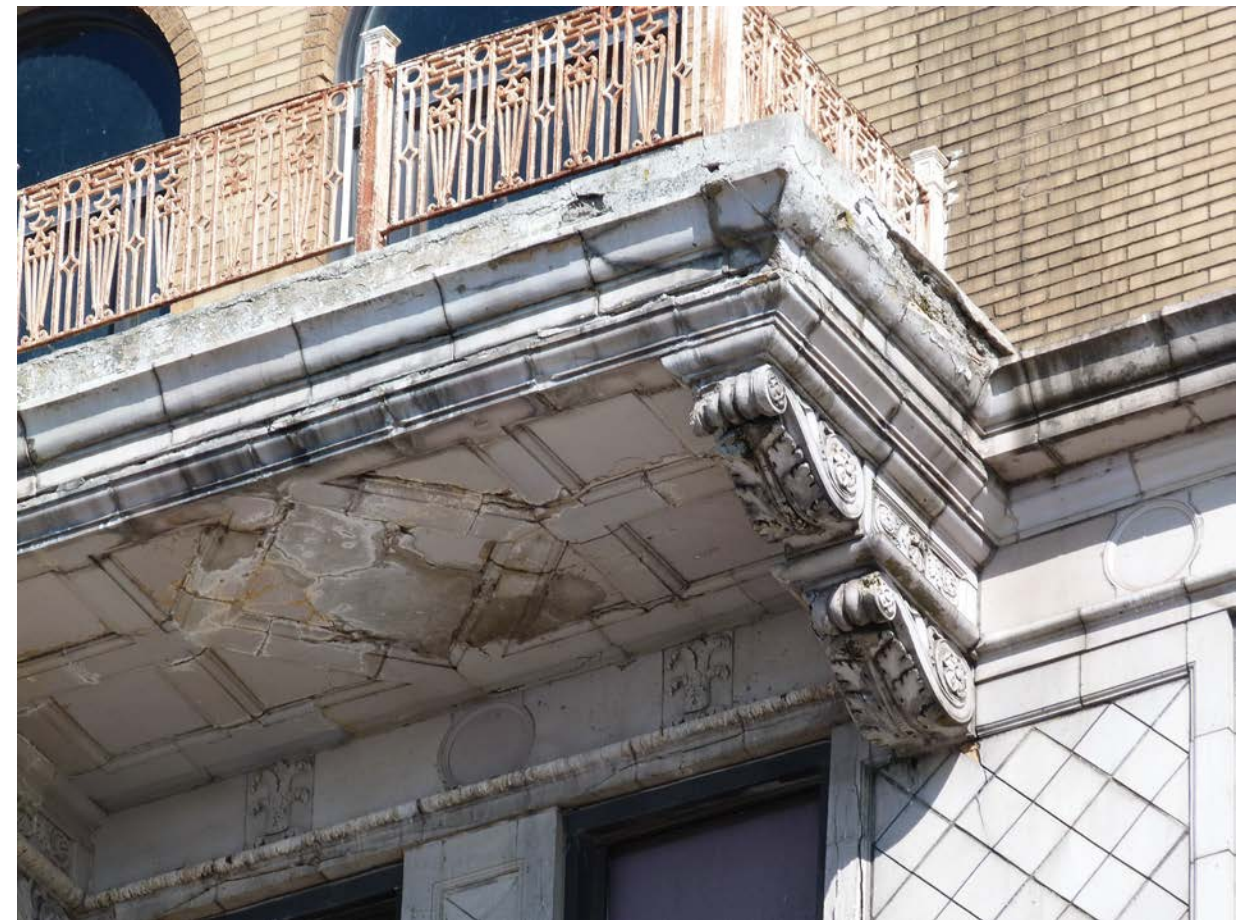
Balcony at Seventh Floor

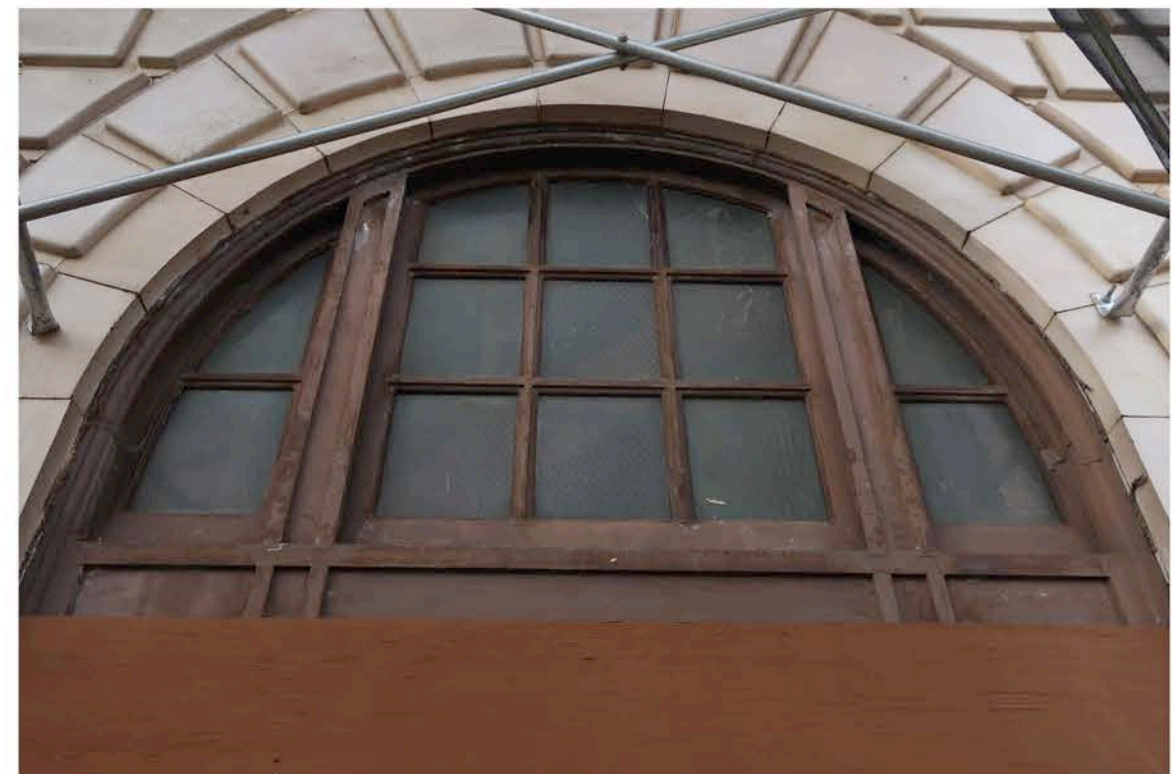
EXISTING CONDITION OF WINDOW

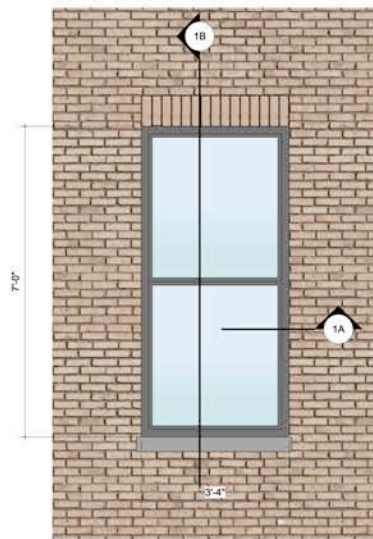
HISTORIC 1 OVER 1 CONFIGURATION

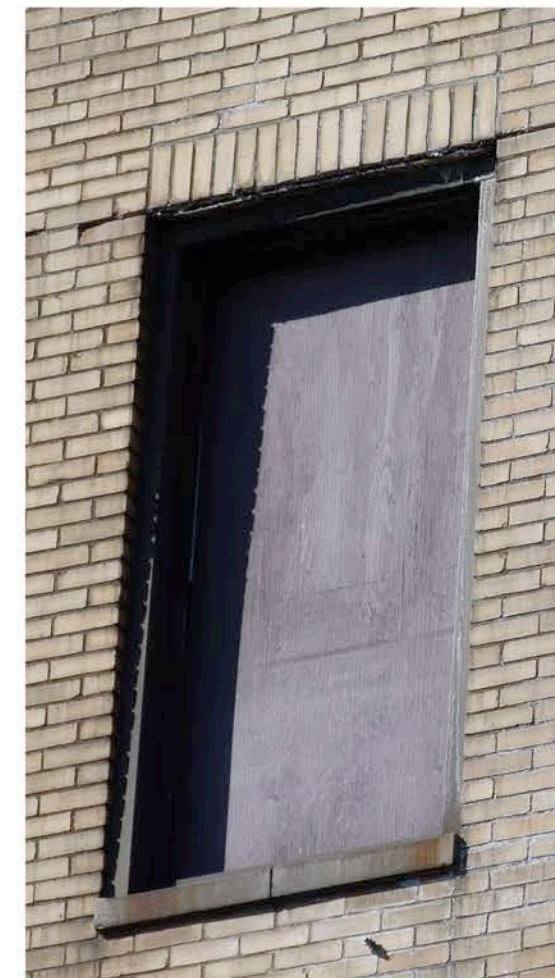
EXISTING CONDITION OF WINDOW

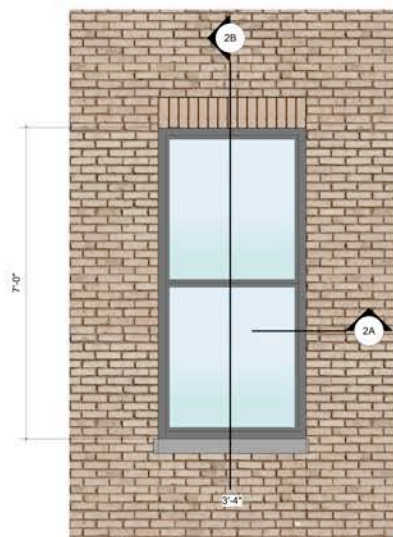
PROPOSED 1 OVER 1 CONFIGURATION

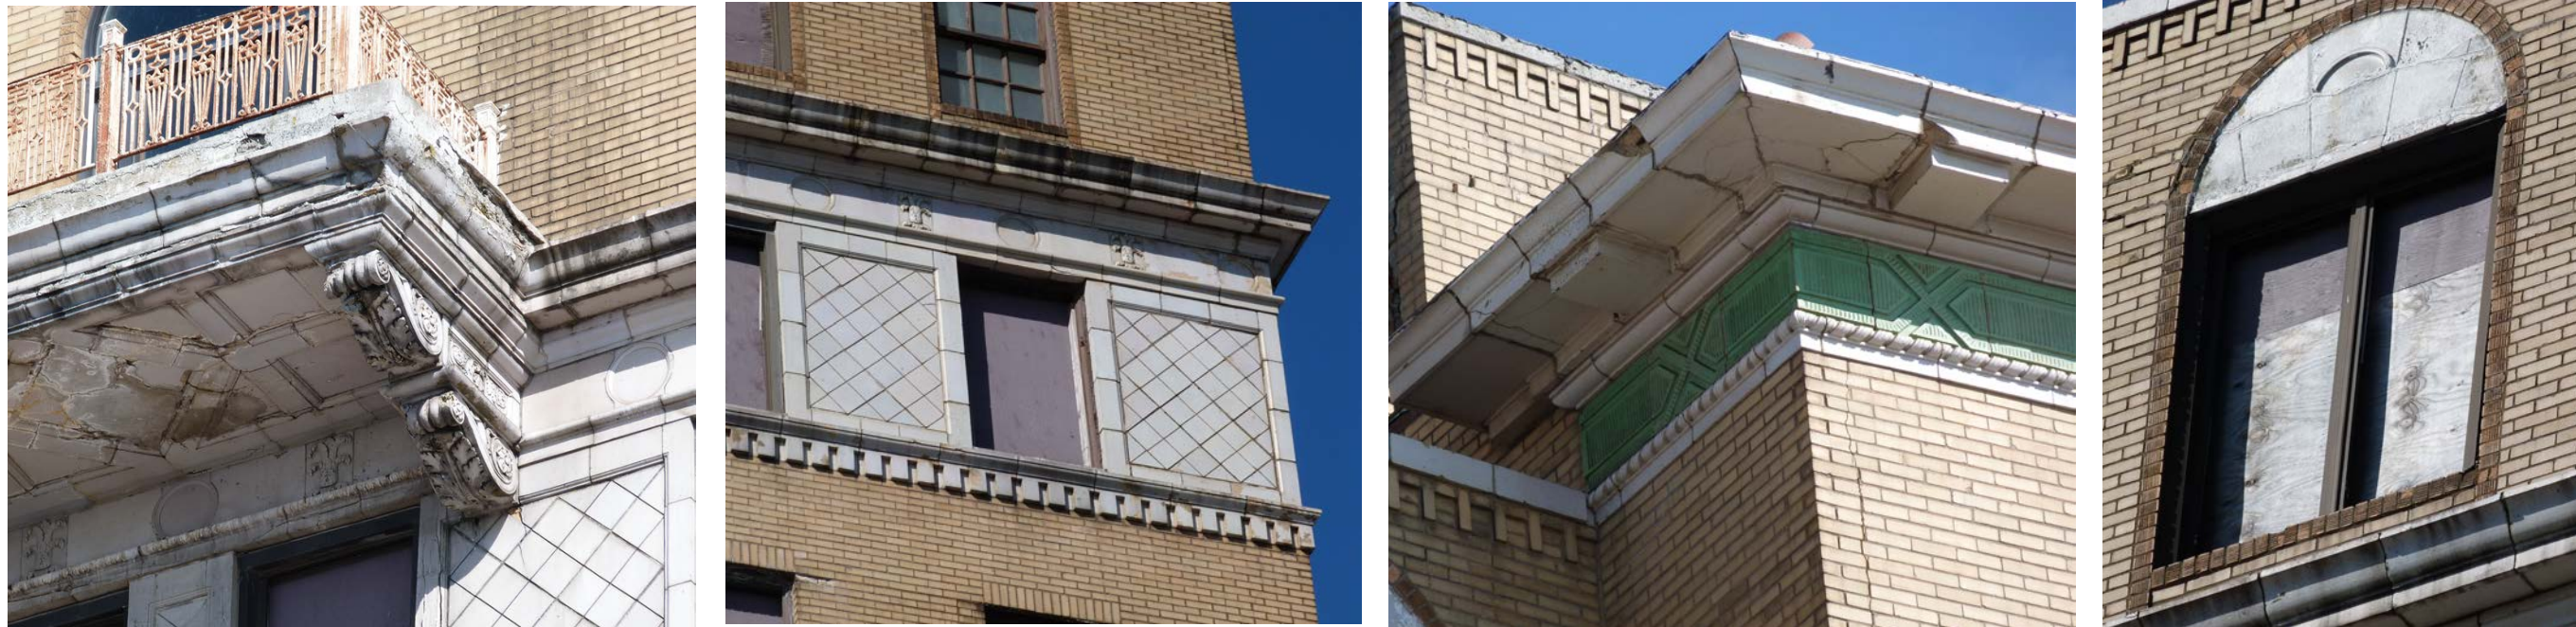
EXISTING CONDITIONS OF TERRA COTTA

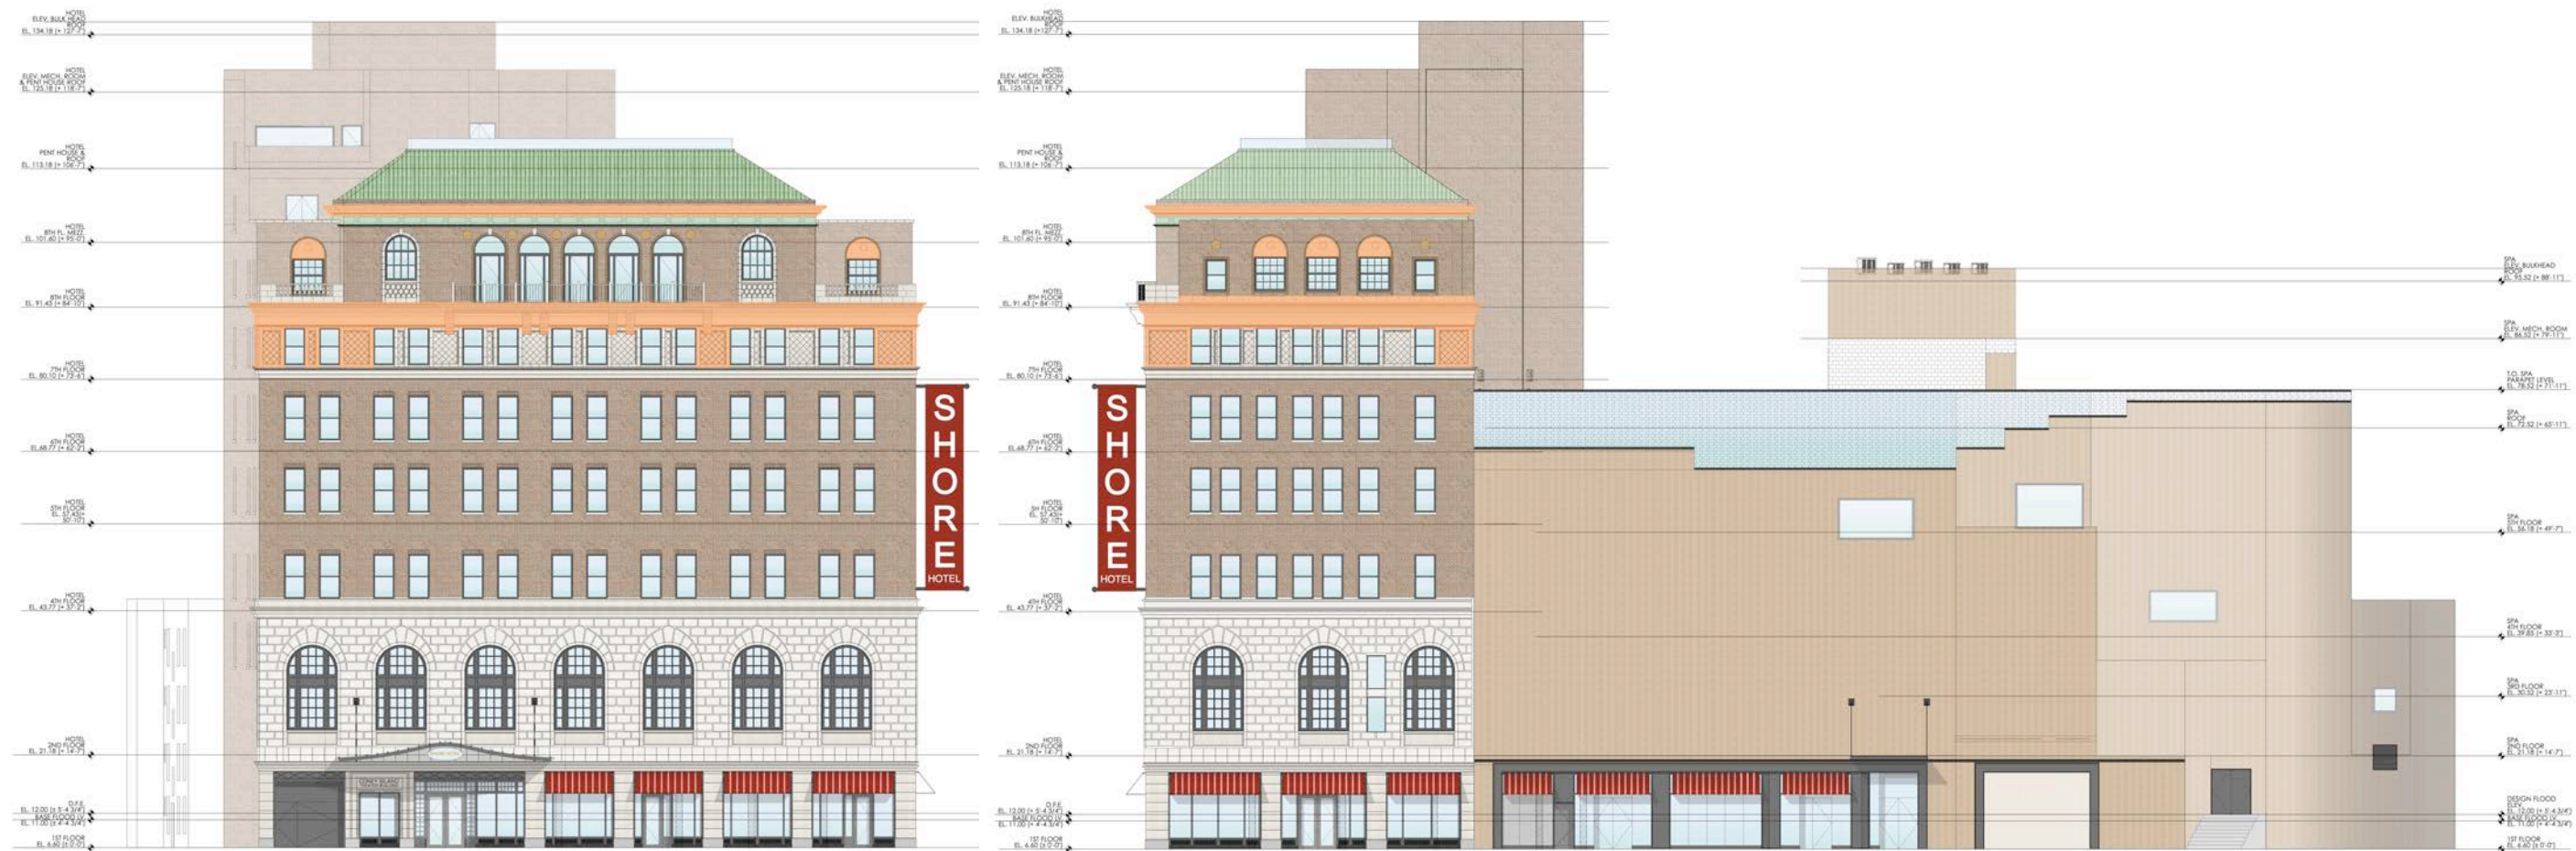
PROPOSED AREAS OF GFRC REPLACEMENT

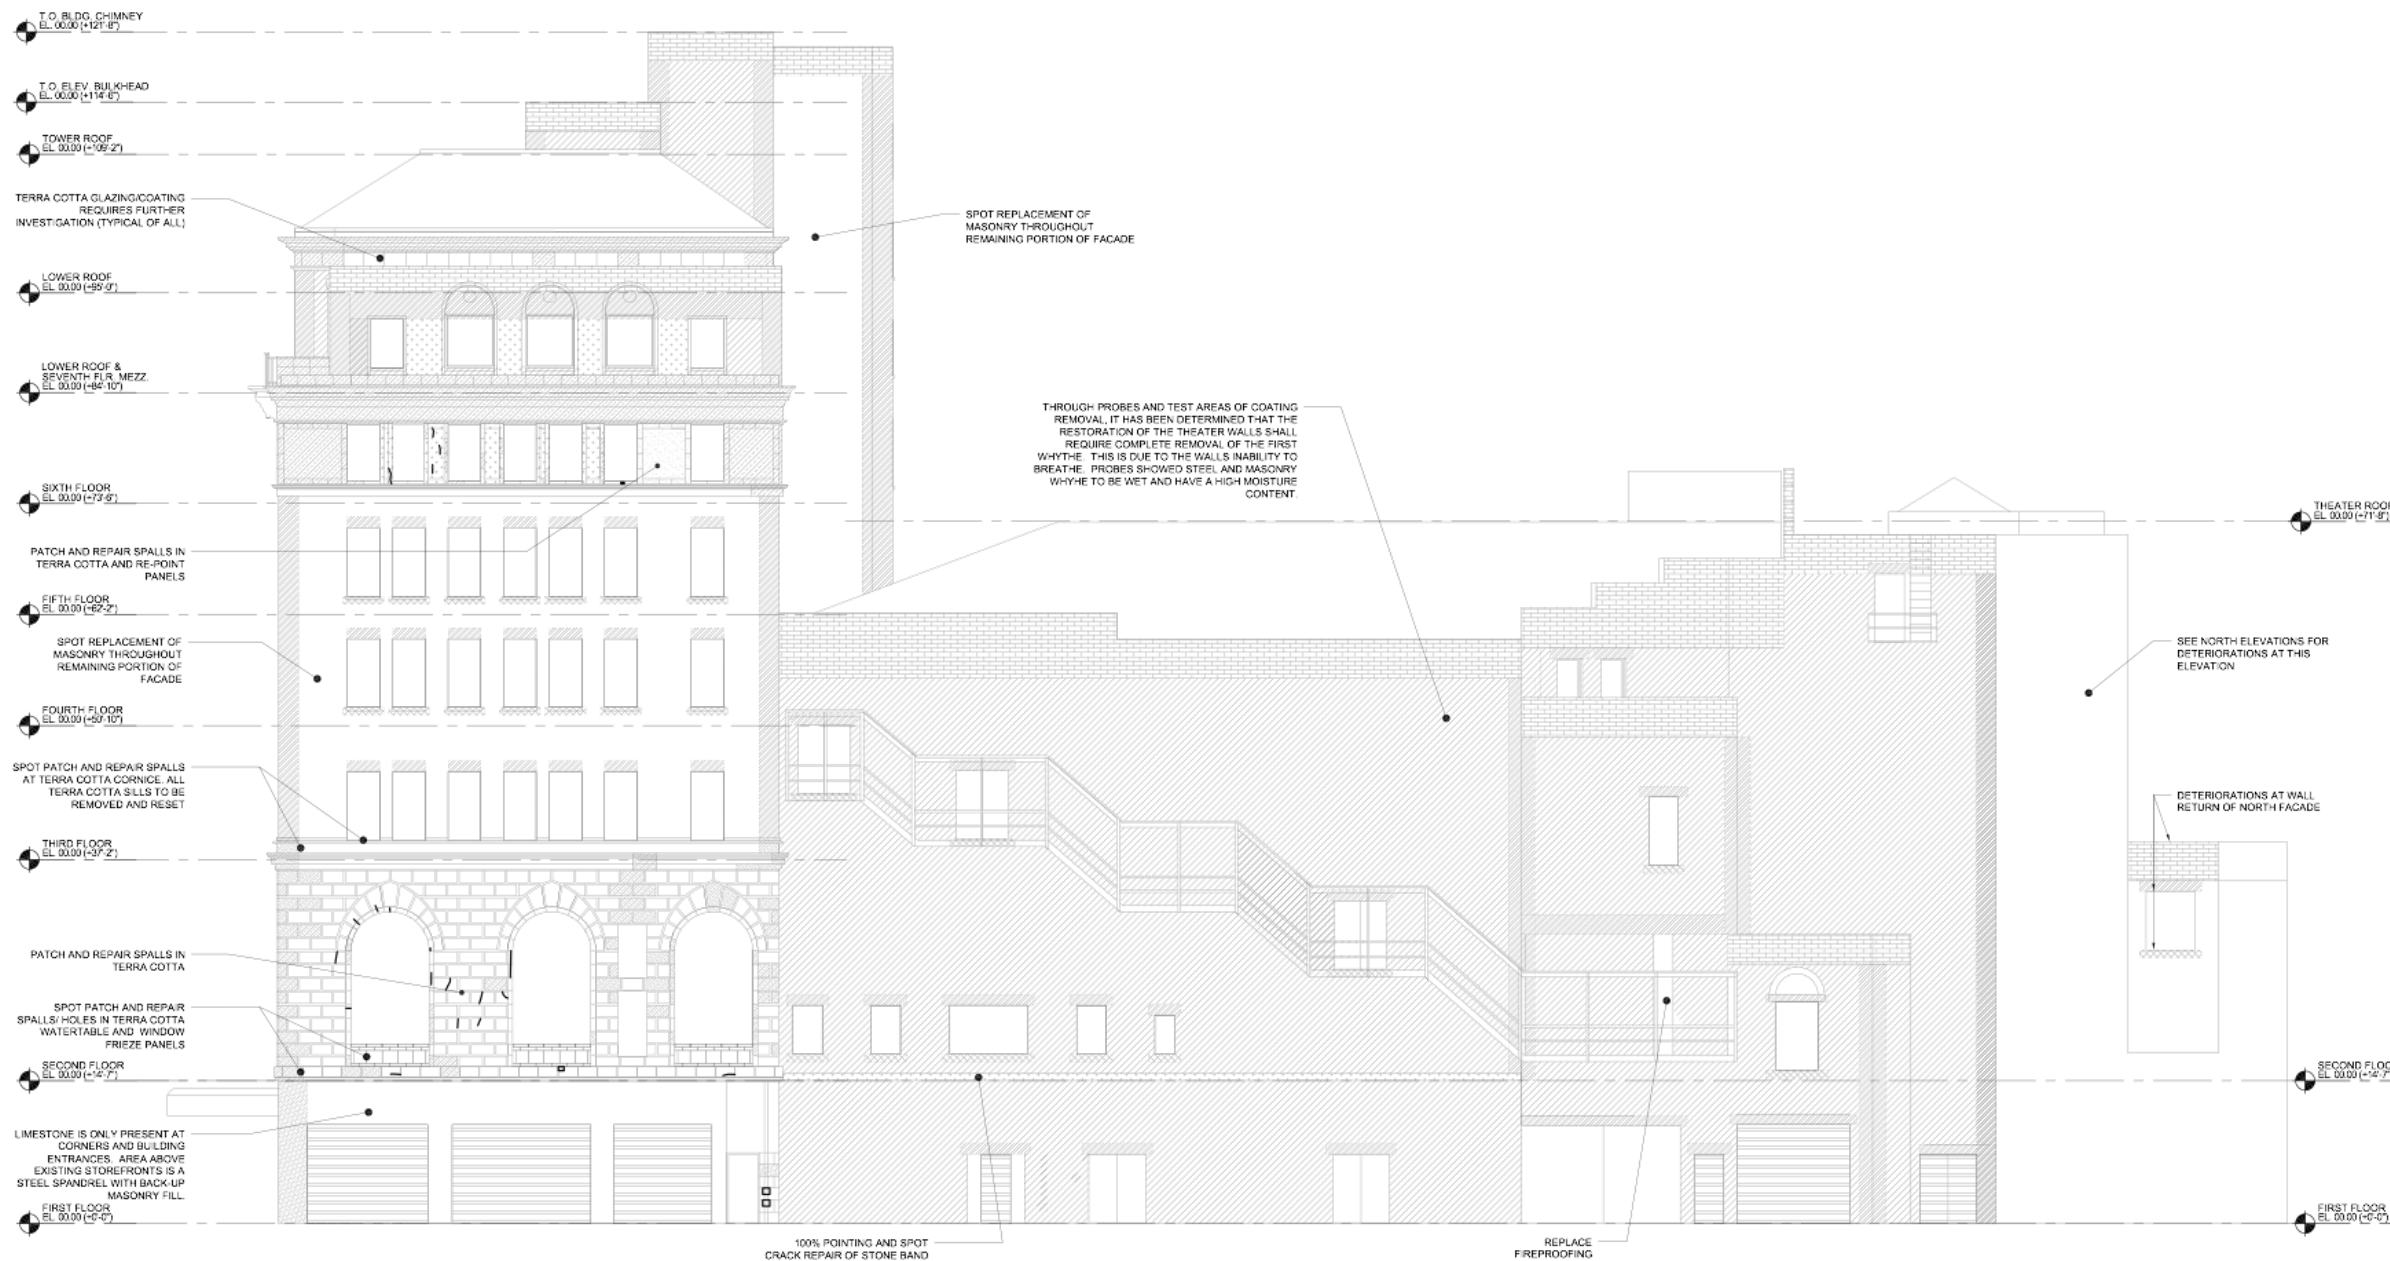
1 EAST ELEVATION - DETERIORATIONS
Scale: 1/8" = 1'-0"

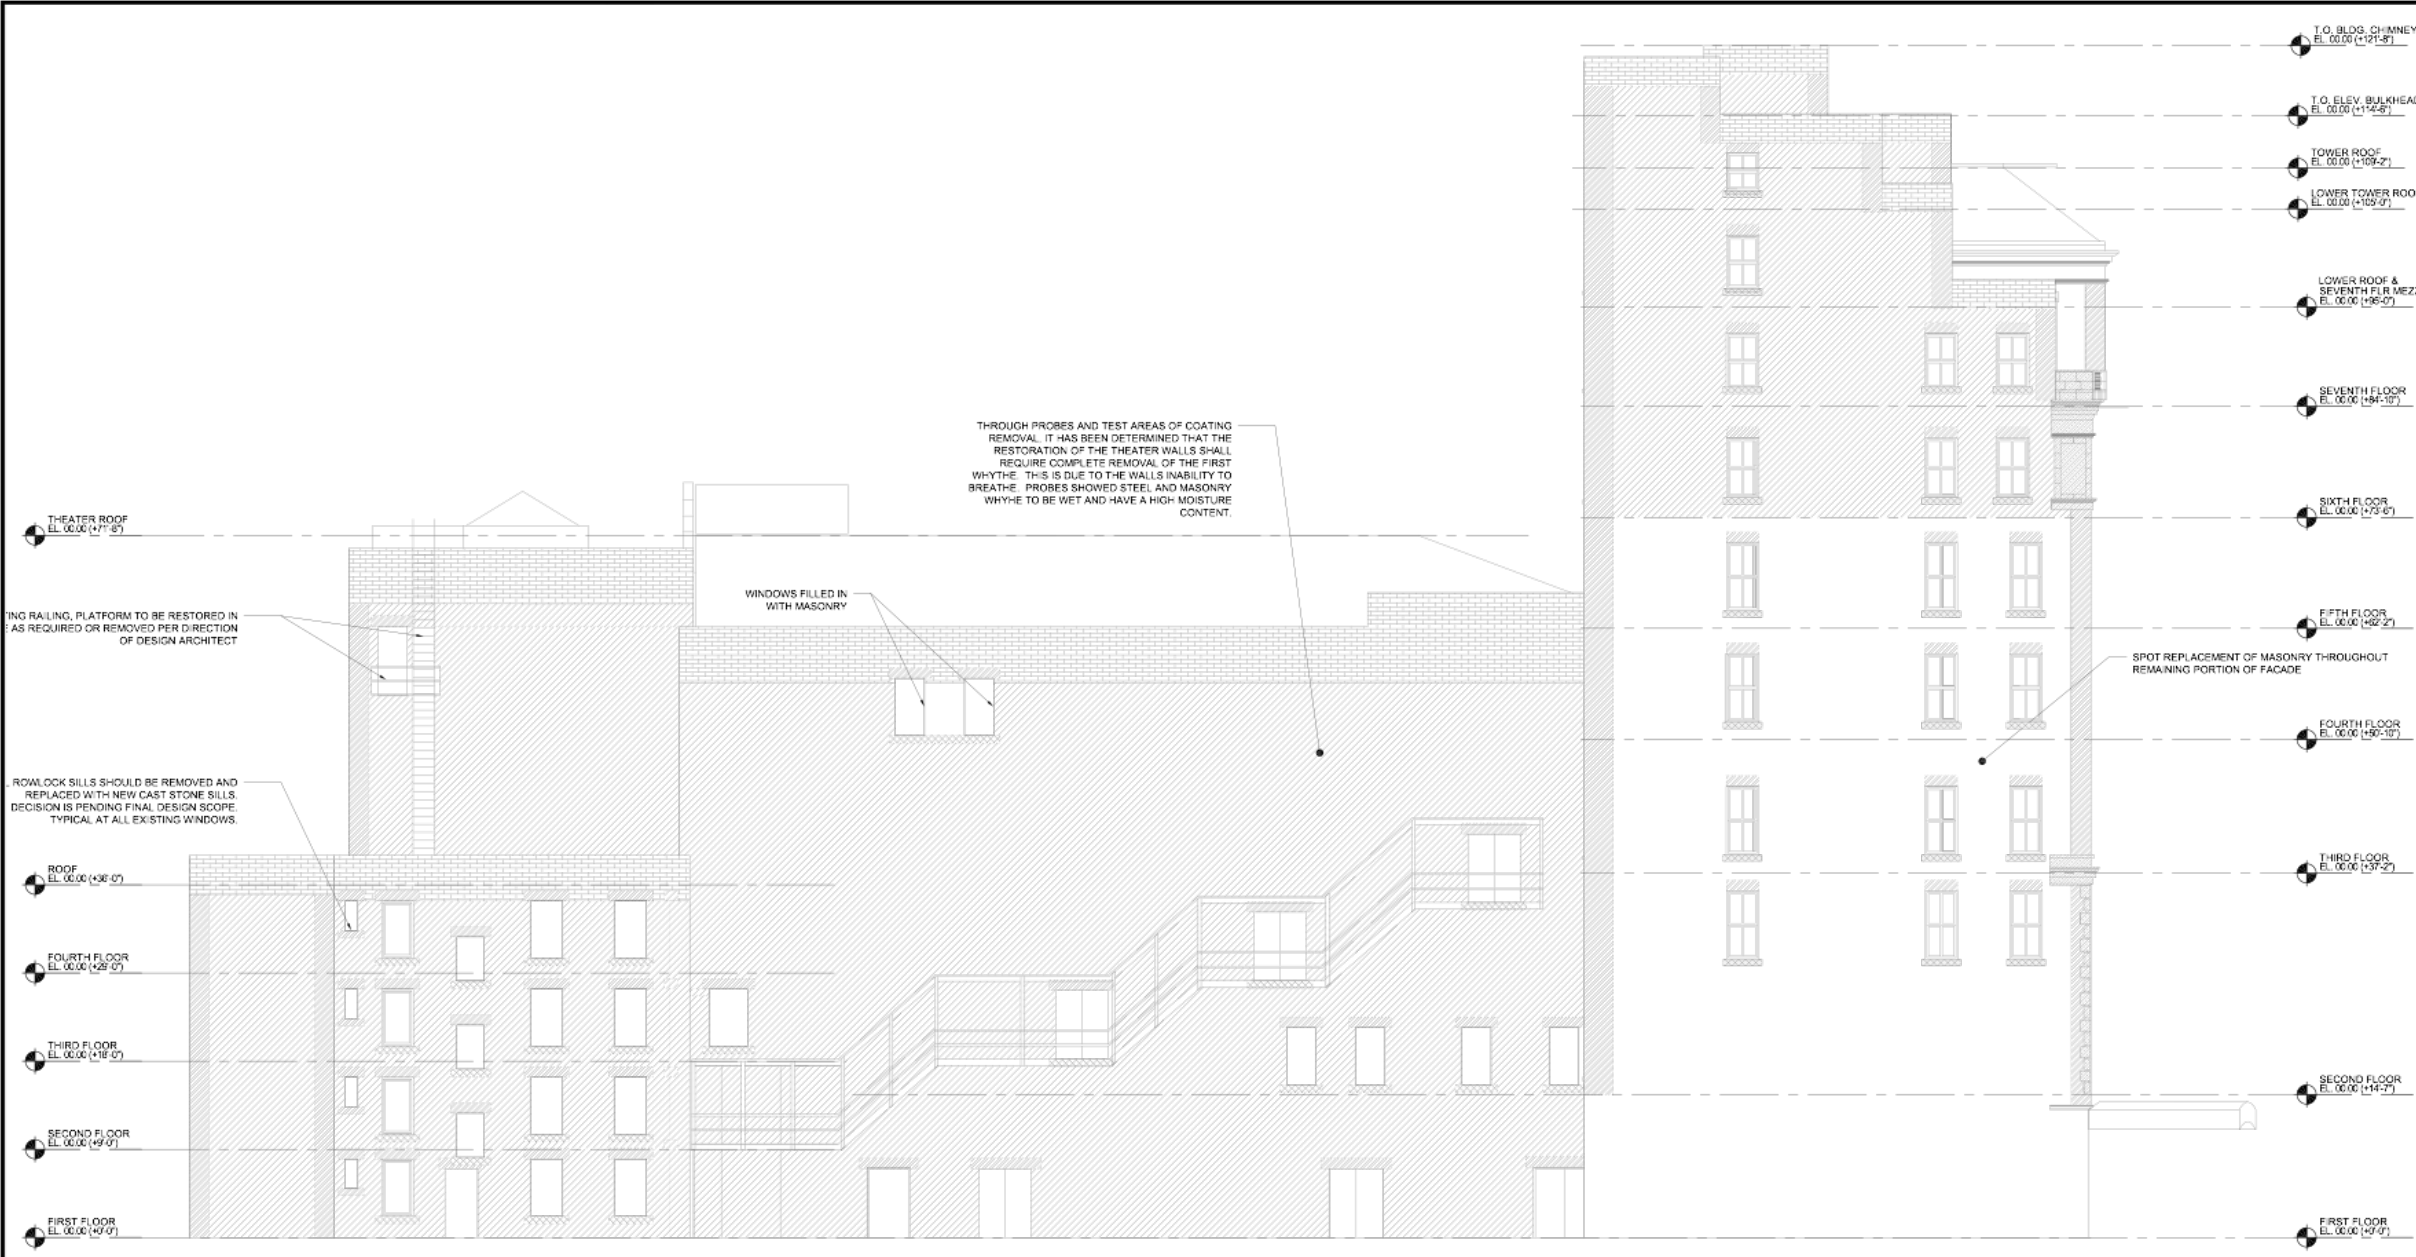
2 WEST ELEVATION - DETERIORATIONS
A-102.00 Scale: 1/8" = 1'-0"

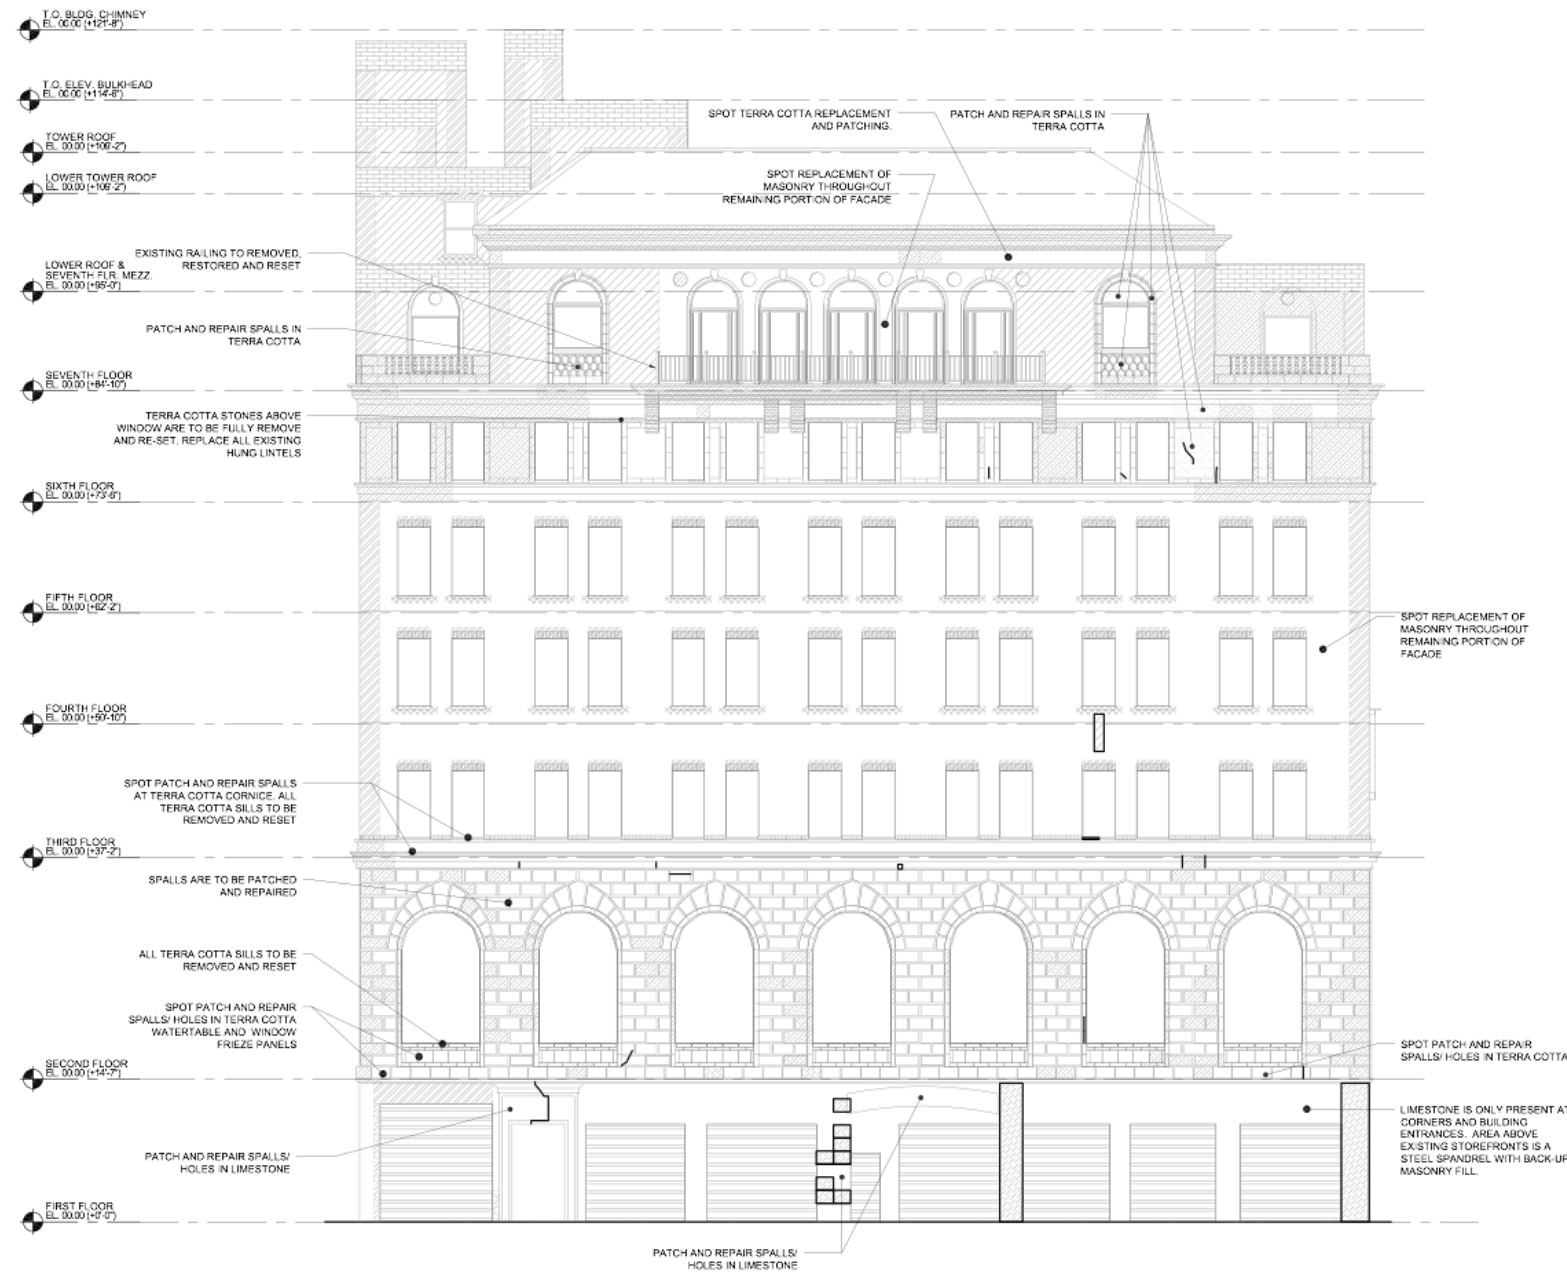
3 SOUTH ELEVATION - DETERIORATIONS
A-103.00 Scale: 1/8" = 1'-0"

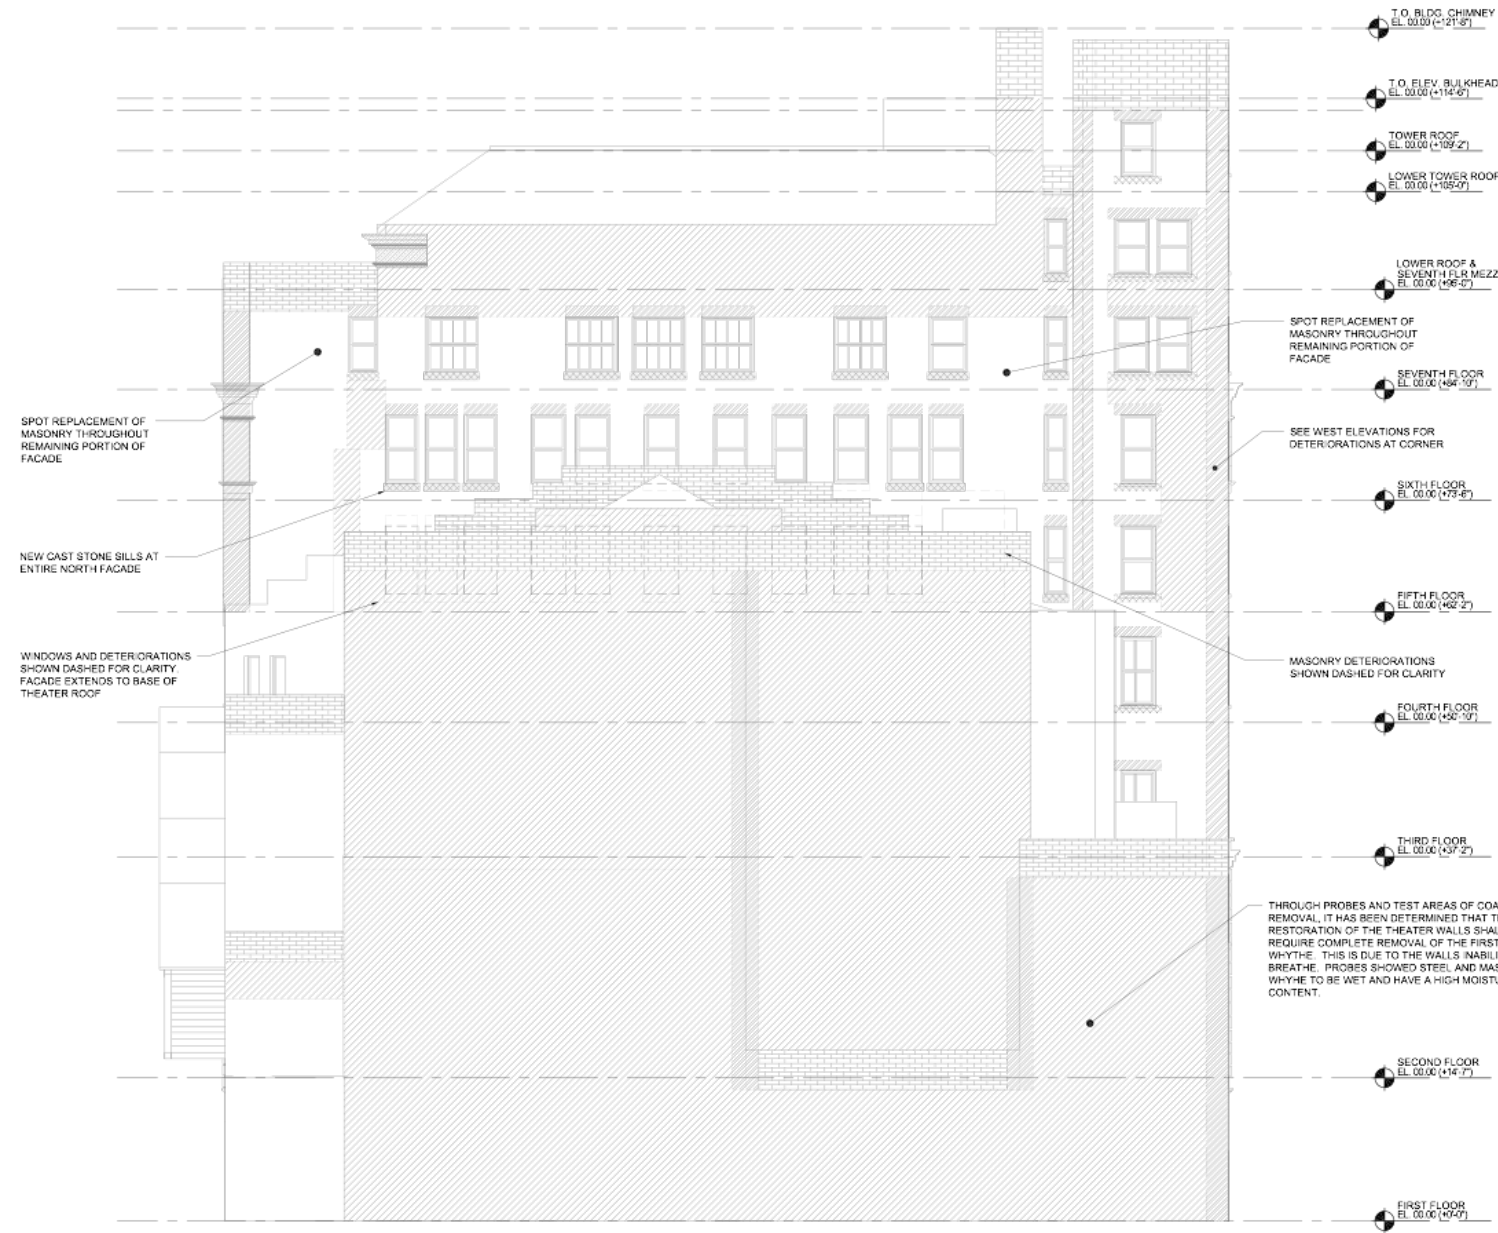
4 NORTH ELEVATION - DETERIORATIONS
 A-104.00 Scale: 1/8" = 1'-0"

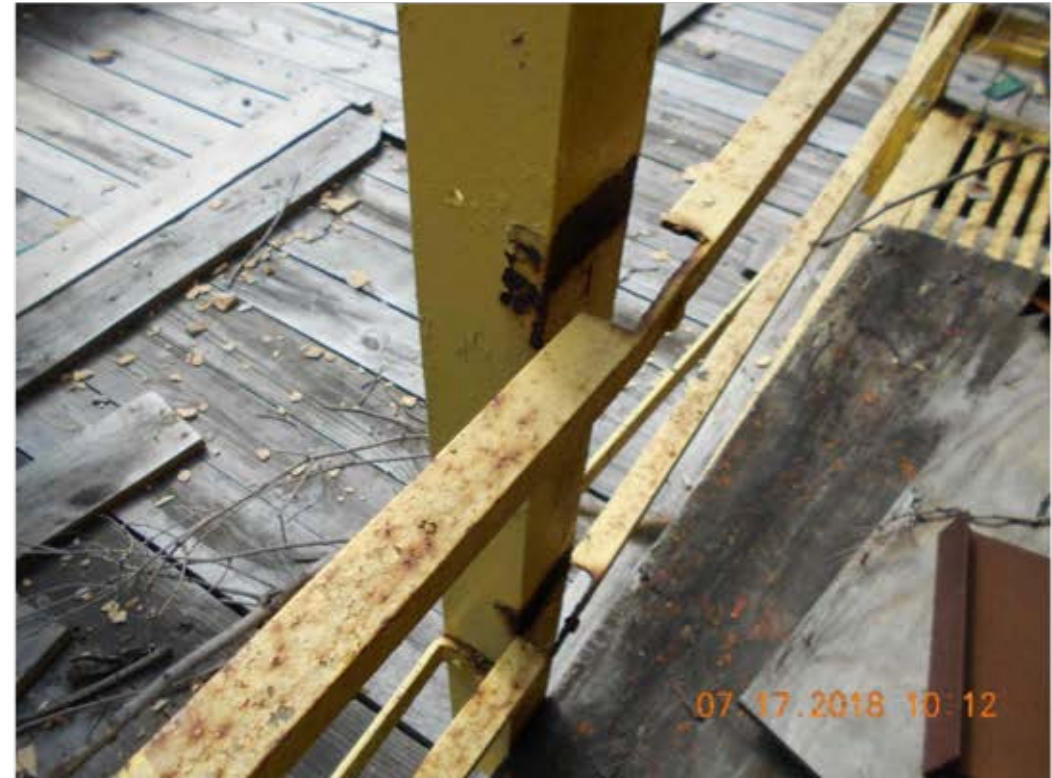
Figure 3 – Main landing. Failure of railing connection to support.

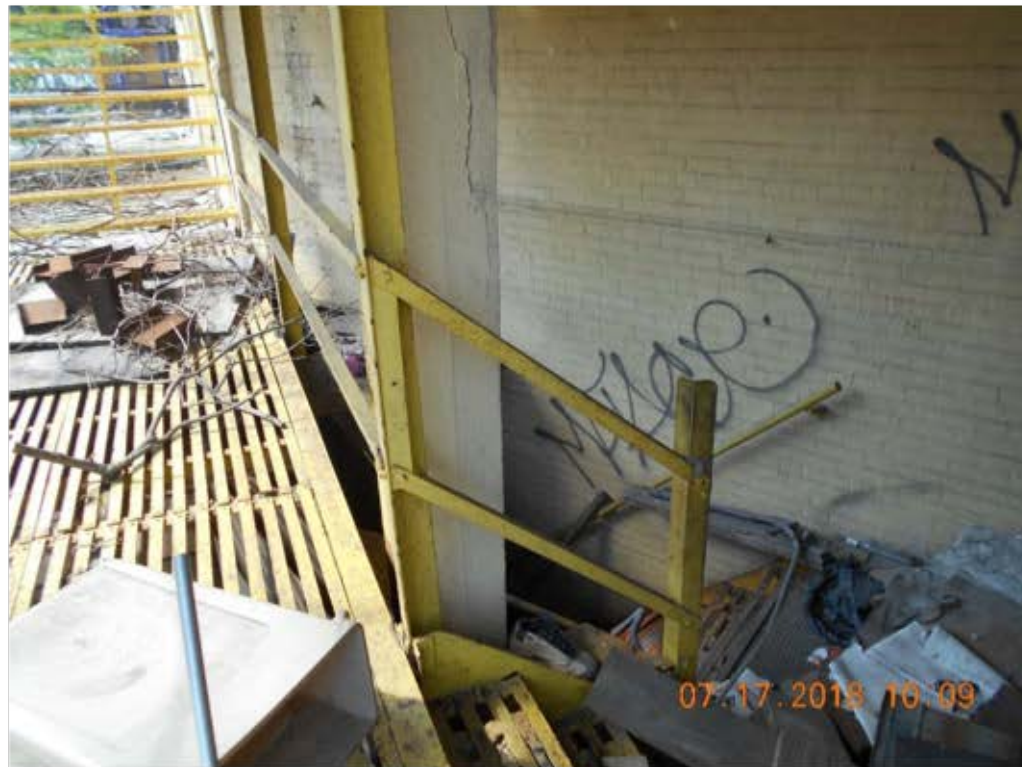
Figure 2 – Main landing of stairway, looking south.

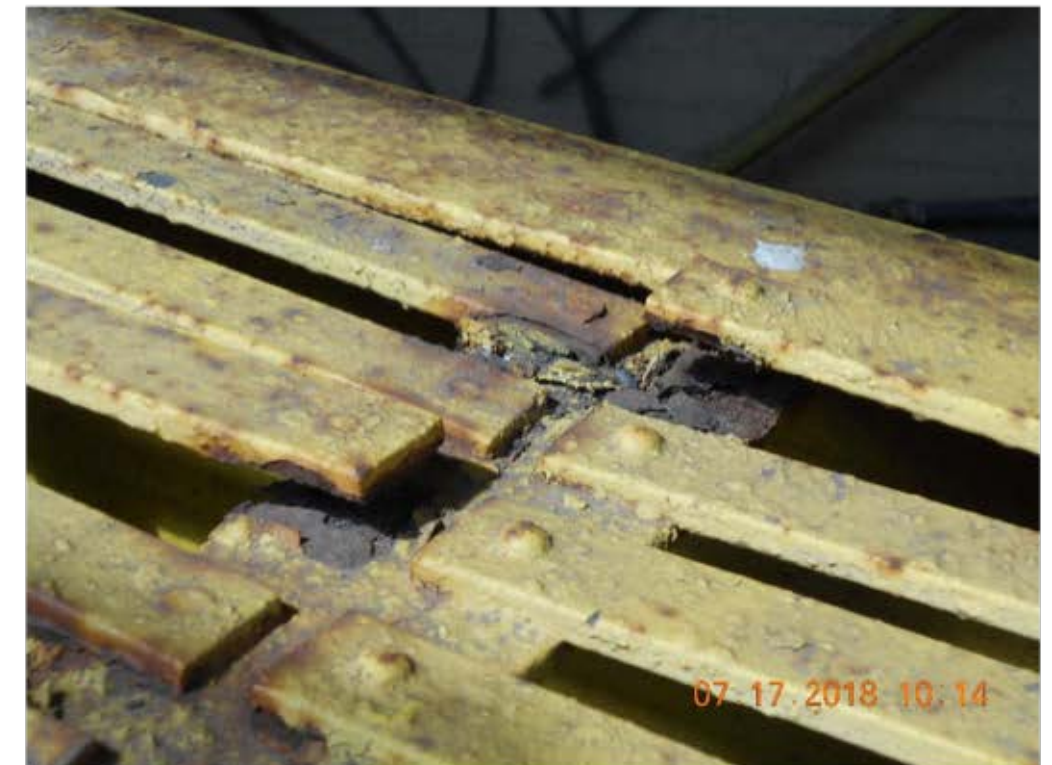
Figure 4 – Main landing. Failure of bar connection to support.
