Coney Island Theater Building, 1301 Surf Avenue, Brooklyn

View to northwest from Surf & Stillwell Avenues

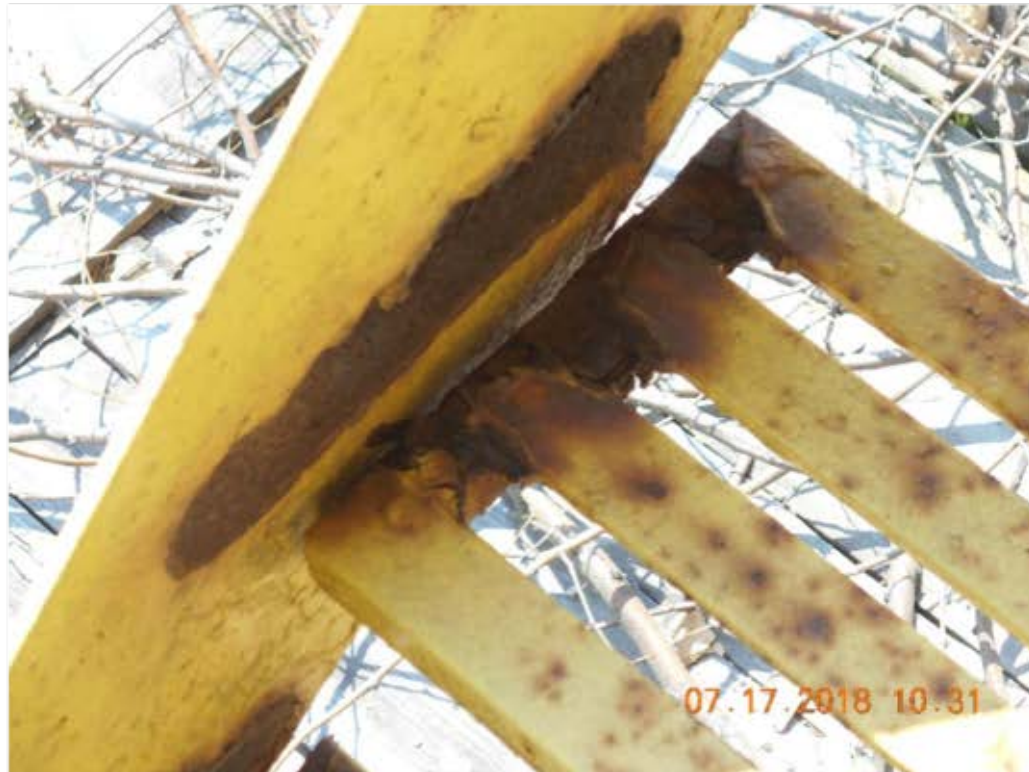
Figure 5 – Stair stringer and stair tread. Failure of tread connection to the stringer.

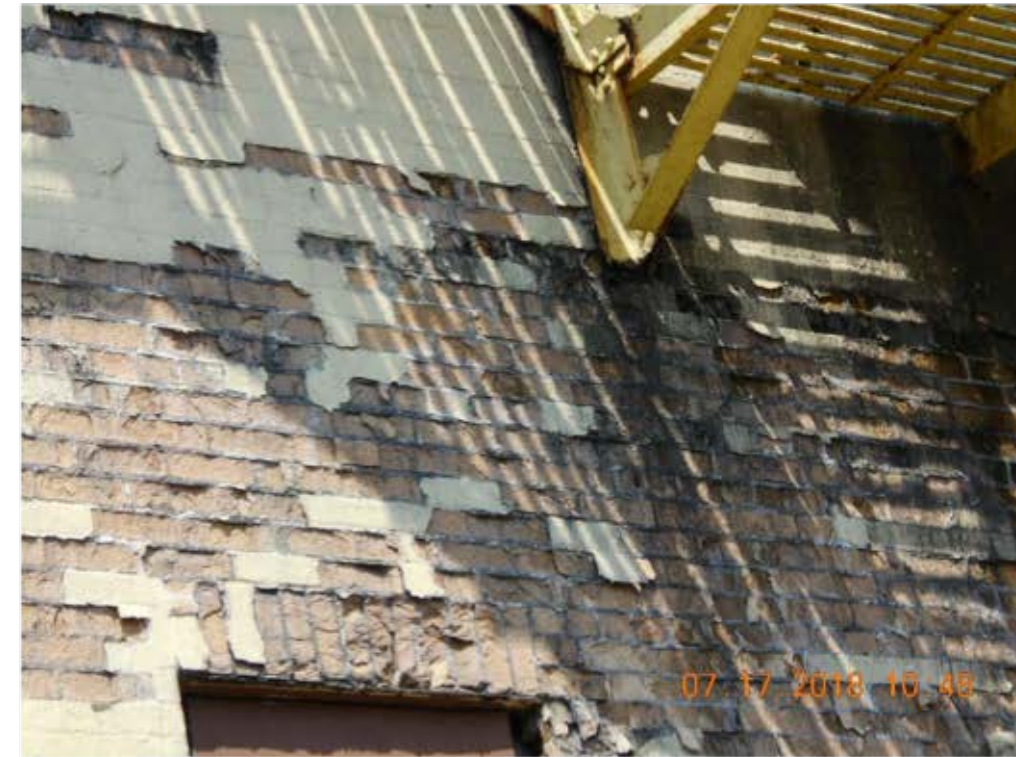
Figure 7 – Deterioration and spalling of masonry wall in area of stair support bracket.

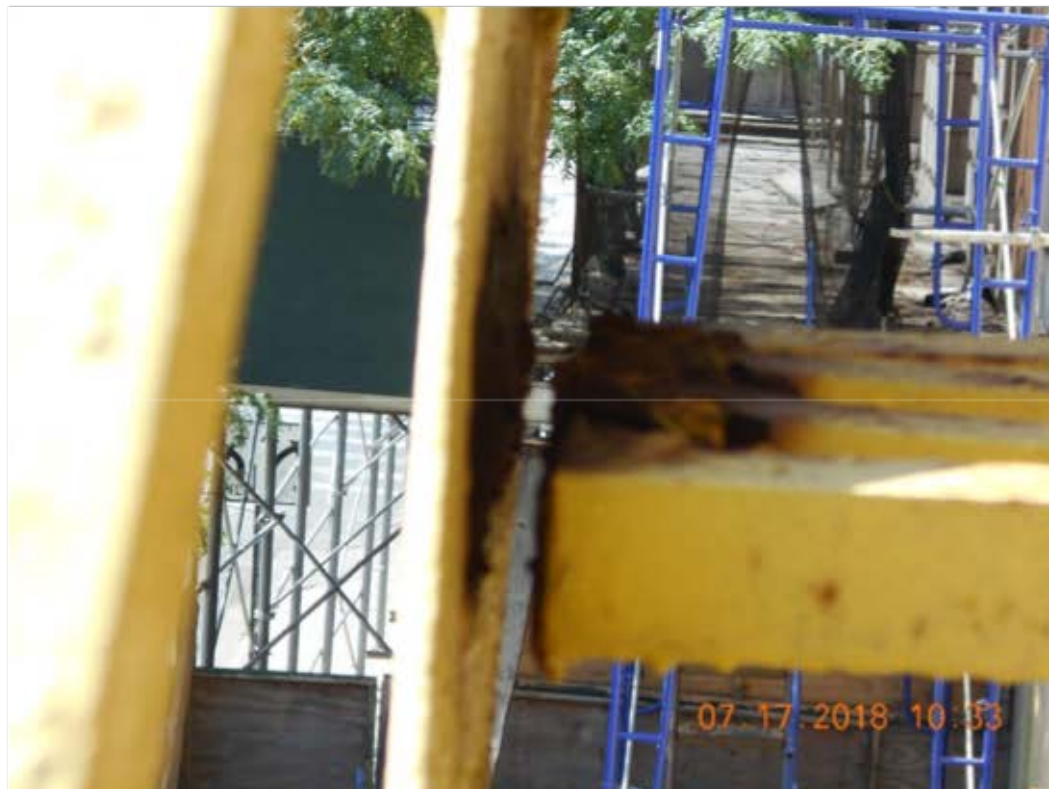
Figure 6 – Note complete separation and lack of load path between stair tread and stringer.

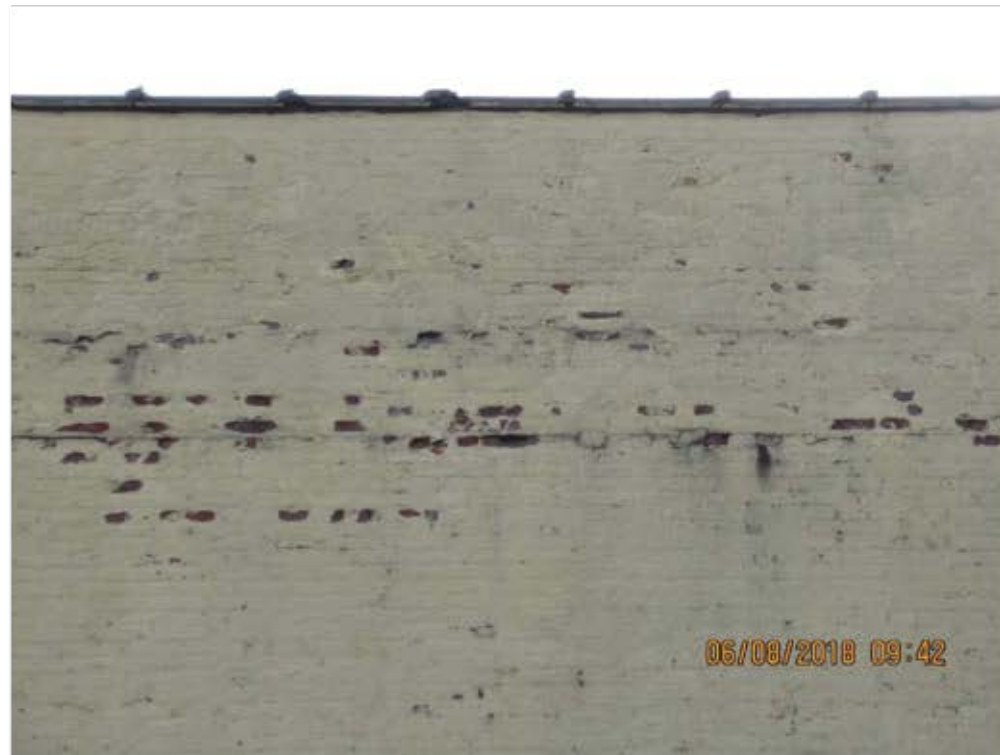
Figure 2 – Close-up of spalling conditions of West theater exterior wall.

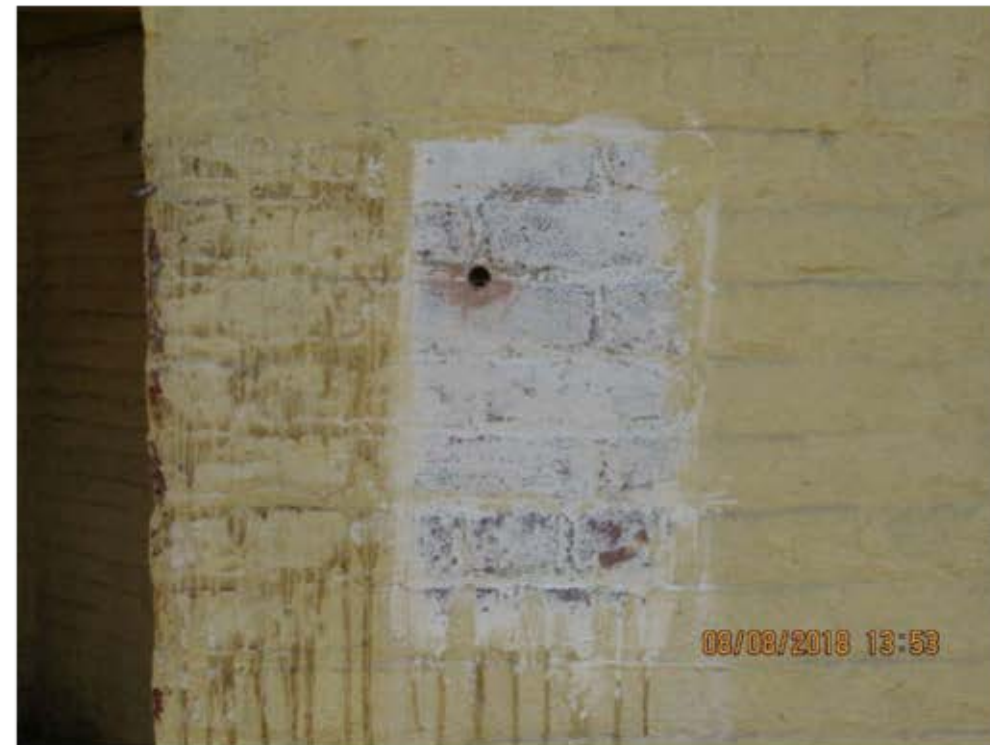
Figure 4 – Additional testing location where both Light (Left) and Heavy Cleaner (Right) were applied and cleaned with a pressure washer and brush.

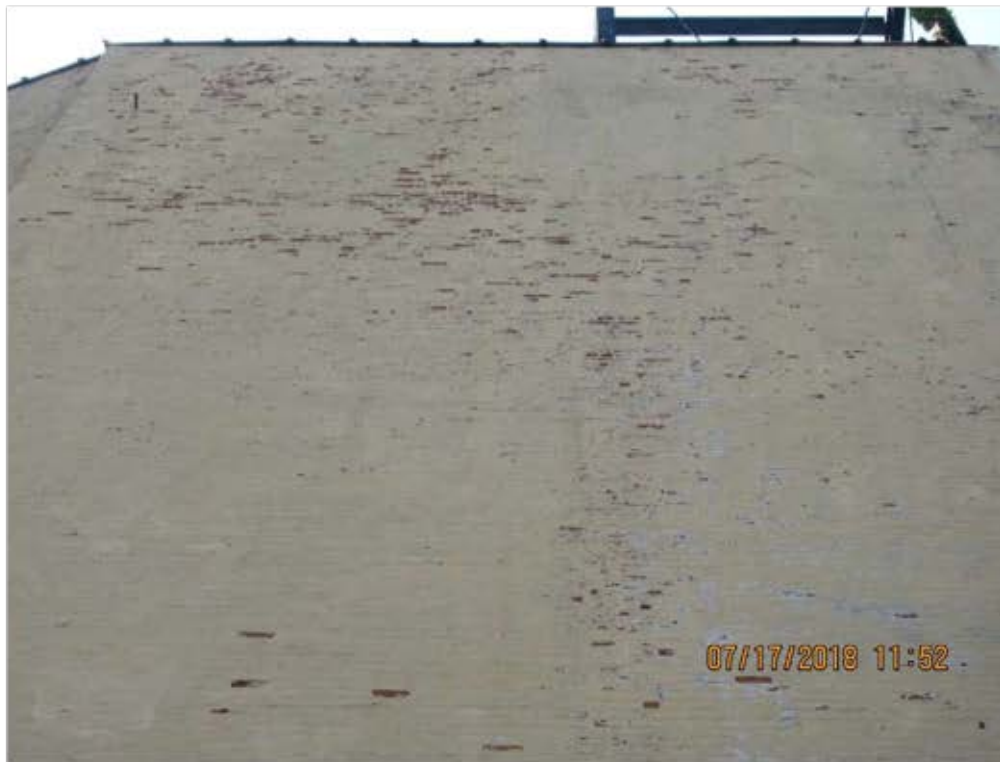
Figure 6 – Close-up of spalling conditions of North theater exterior wall.

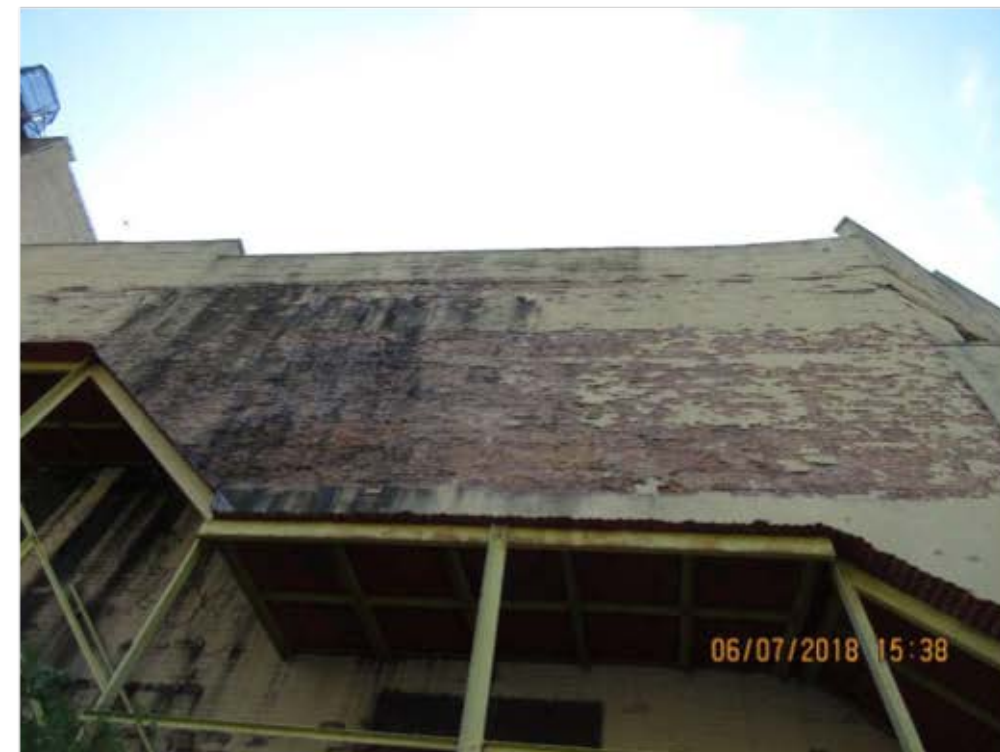
Figure 8 – Close-up of spalling conditions of East theater exterior wall.

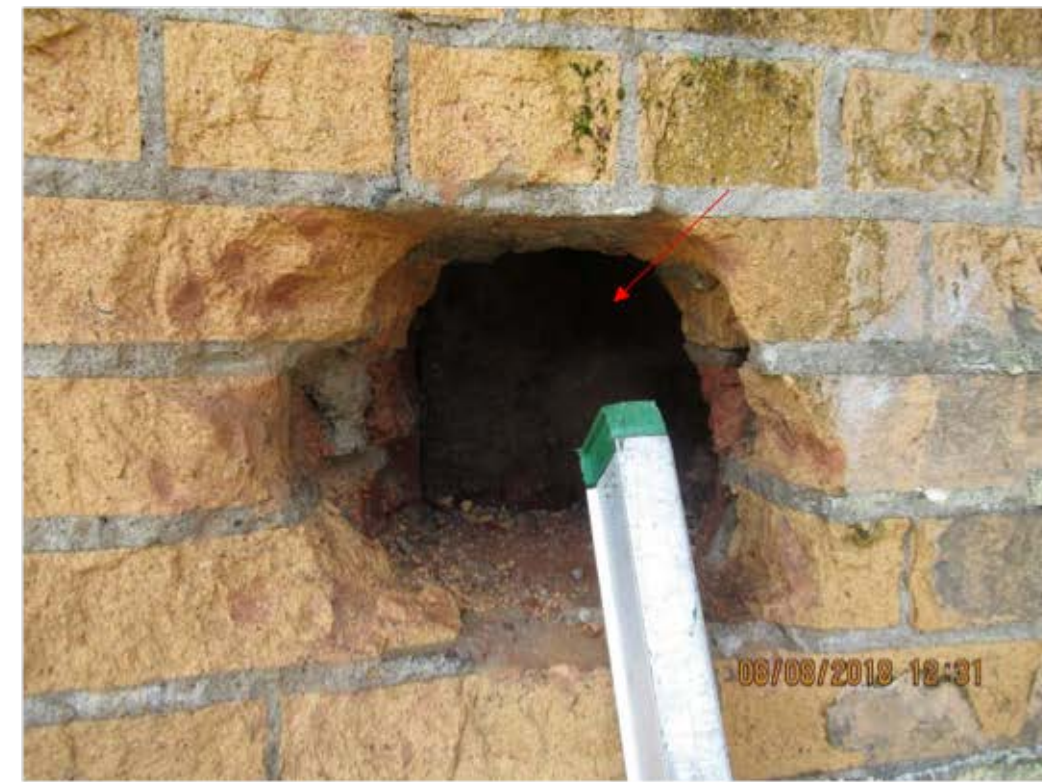
Figure 11 – Additional East wall probe within heavily spalled masonry with steel column beyond which was also observed to be wet.

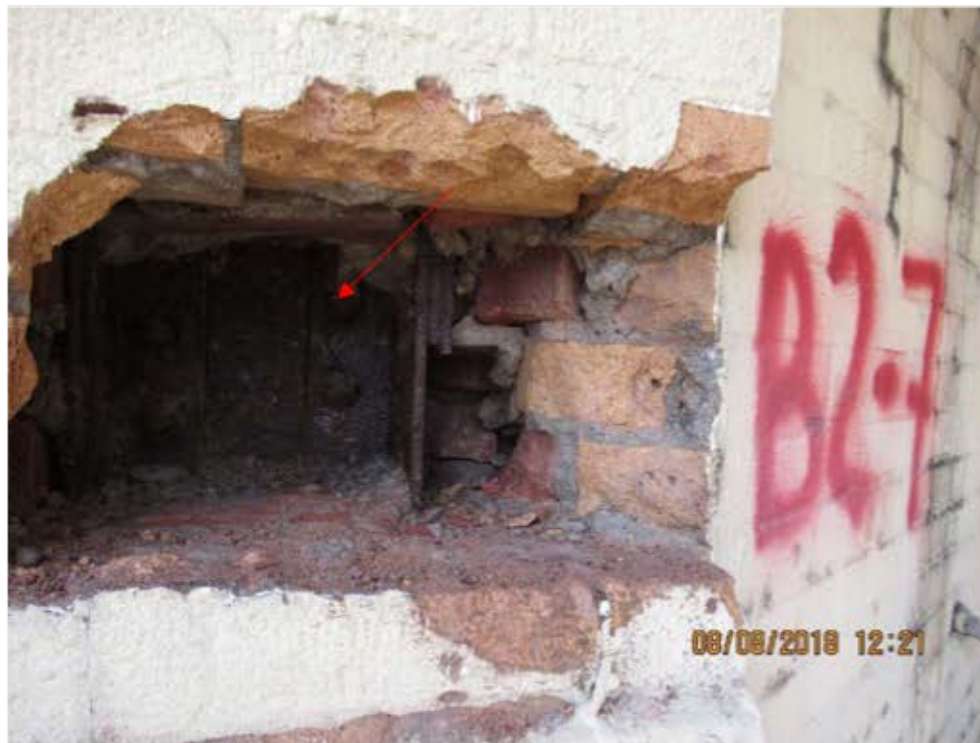
Figure 10 – East wall corner probe with steel column beyond which was observed to be wet.
