**1 West 29th Street, aka 270-272 Fifth Avenue – Marble  
Collegiate Church – Individual Landmark  
Borough of Manhattan**

# Marble Collegiate Church Visible West Façade

Public Meeting February 13, 2024

Project: MARBLE COLLEGIATE CHURCH  
1 WEST 29<sup>TH</sup> STREET  
NEW YORK, NY 10001  
EXTERIOR RESTORATION

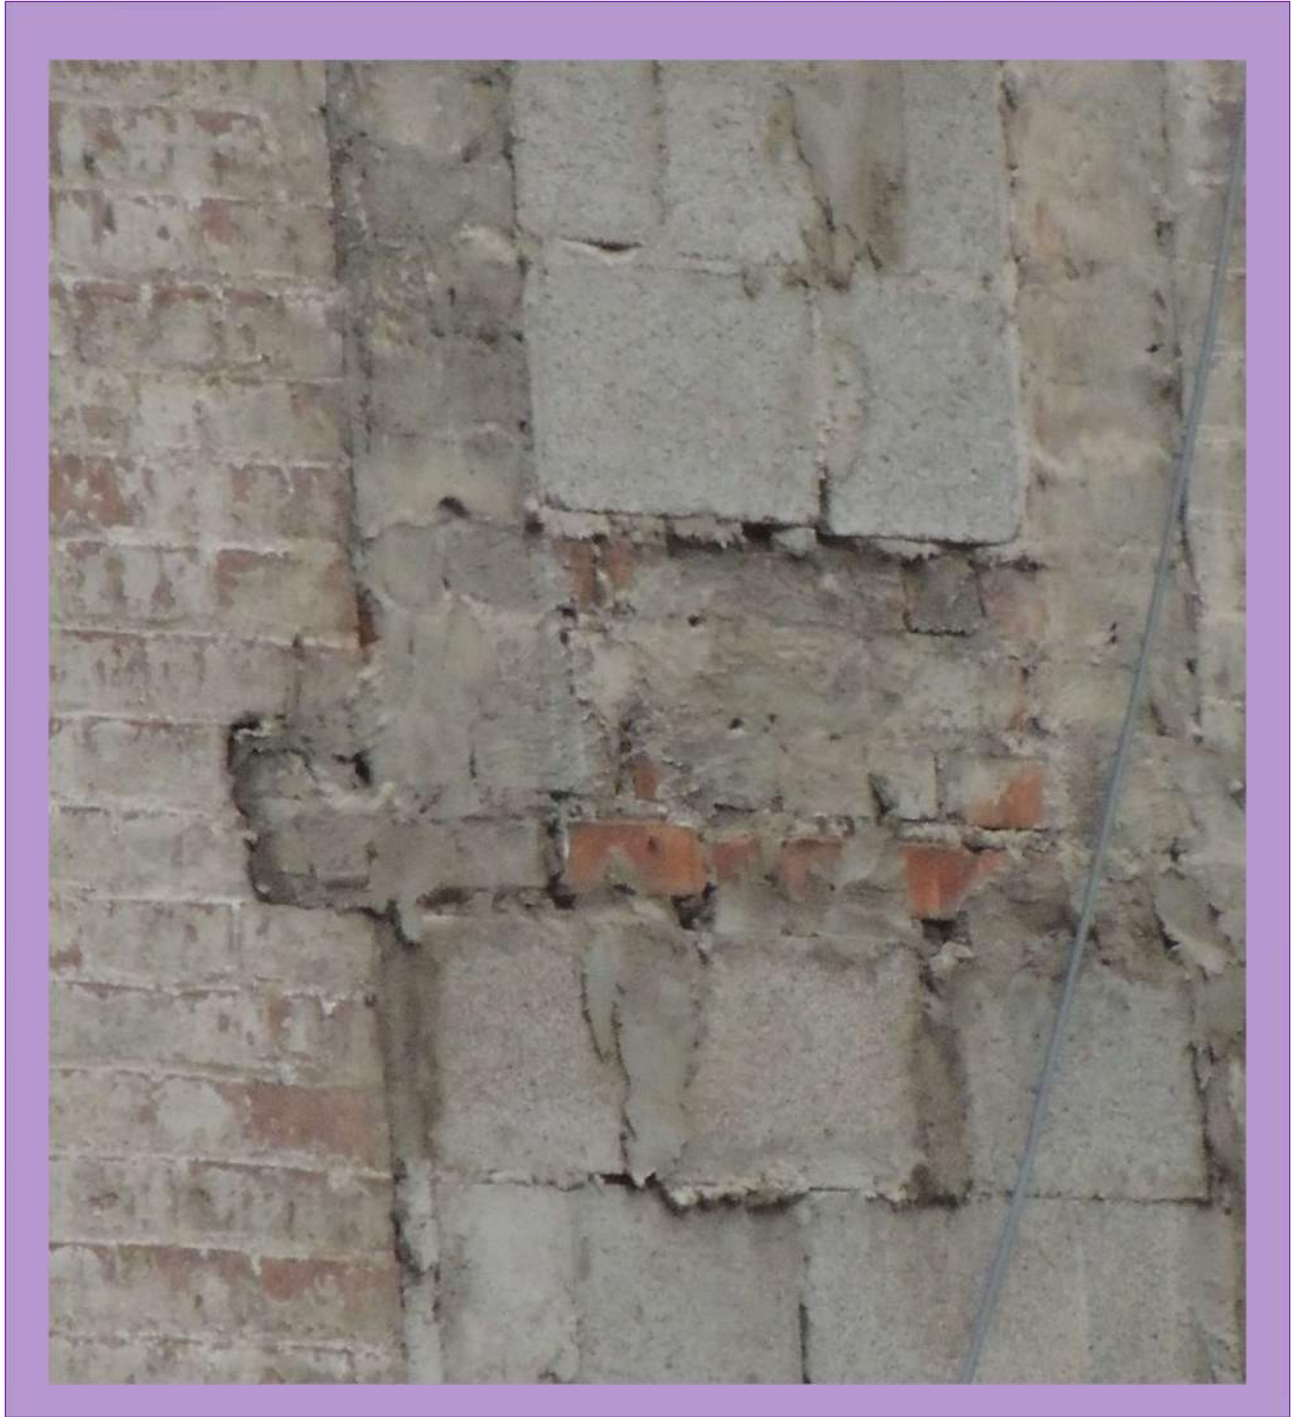
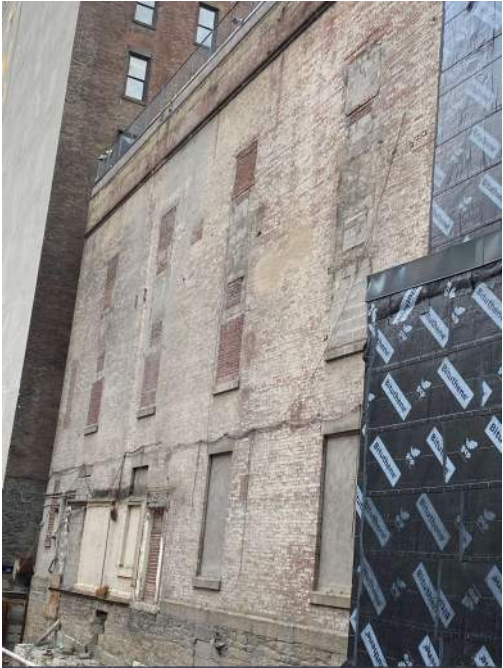
Close-up of mismatched masonry infill

There is mismatched window and door masonry infill present throughout the West Elevation. The infill consists of a mix of brick masonry, CMU, and recessed CMU finished with a cementitious coating.

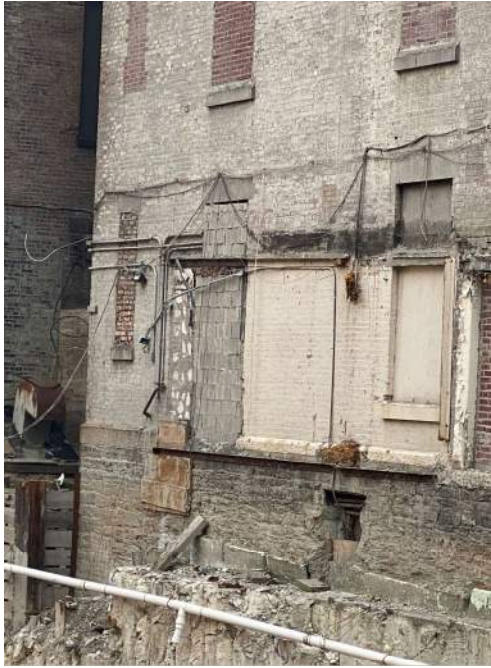
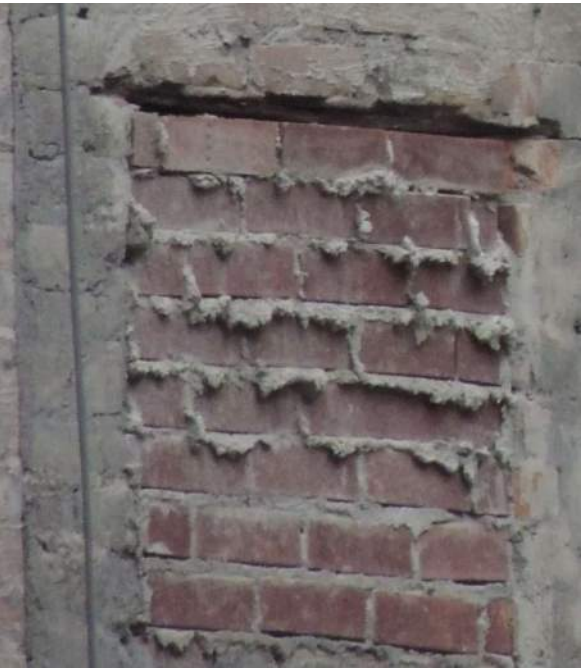
Overviews of mismatched window and door infill

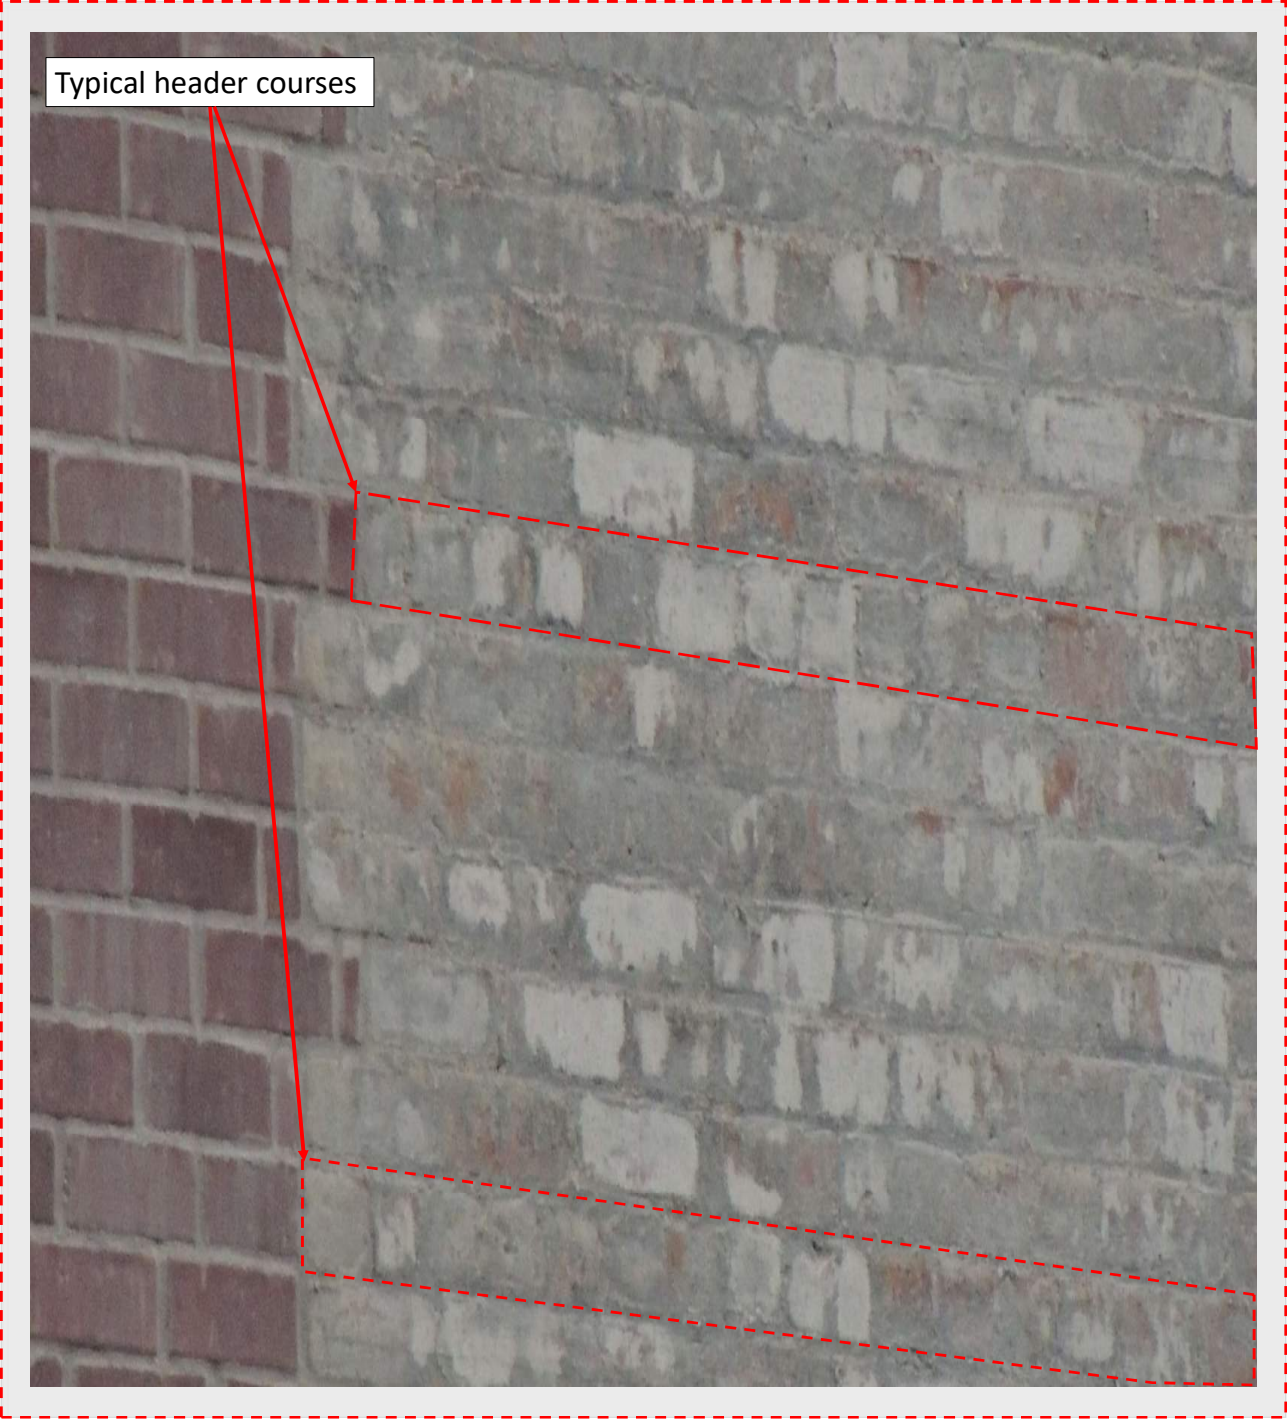
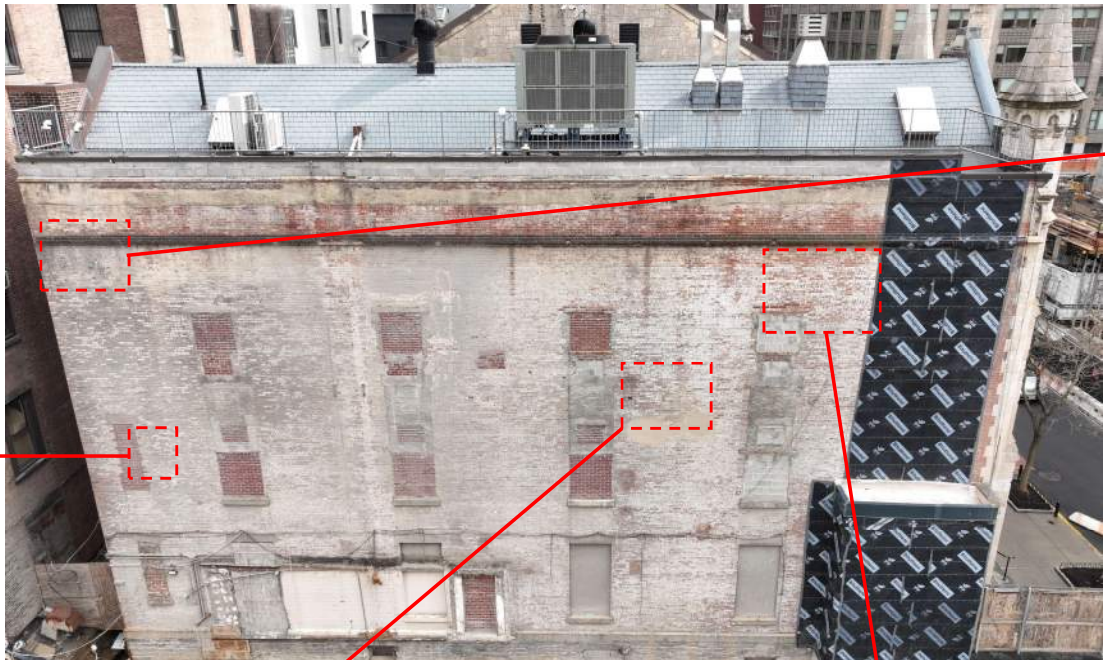
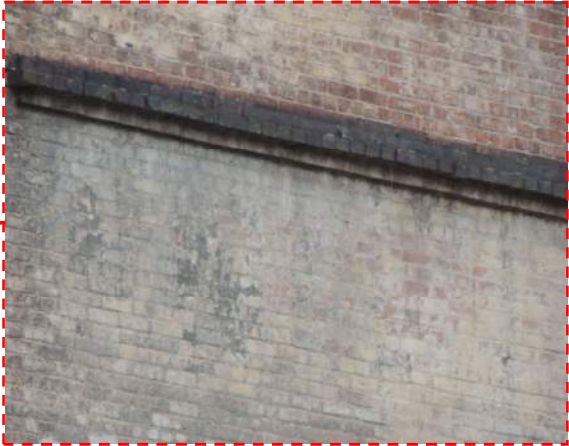
The West Elevation was previously coated with a fluid-applied waterproofing. It looks as if the wall has been coated at least two coats the latest being in the 1990's.

The coatings are heavily deteriorated throughout the West Elevation. At areas where the coatings have fully deteriorated, there are clear signs of failed brick finishes.

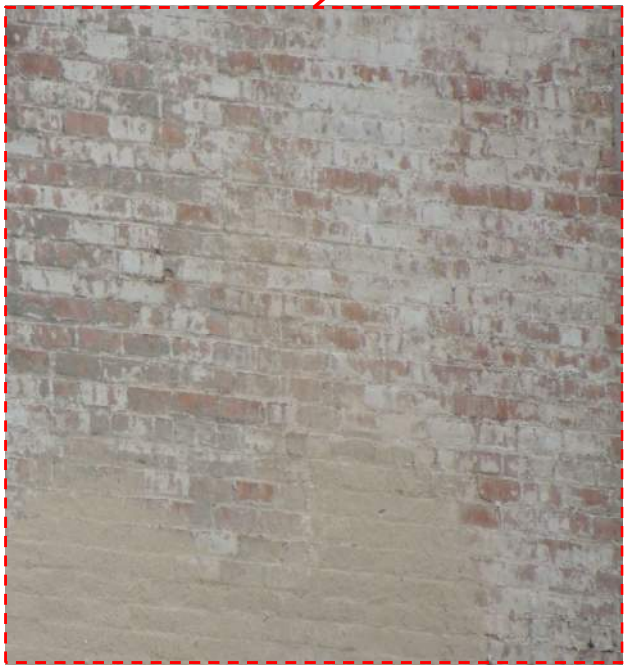
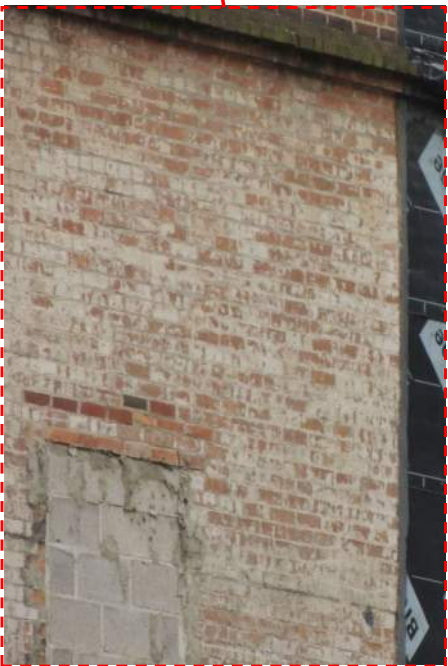
Close-ups of Coated Wall

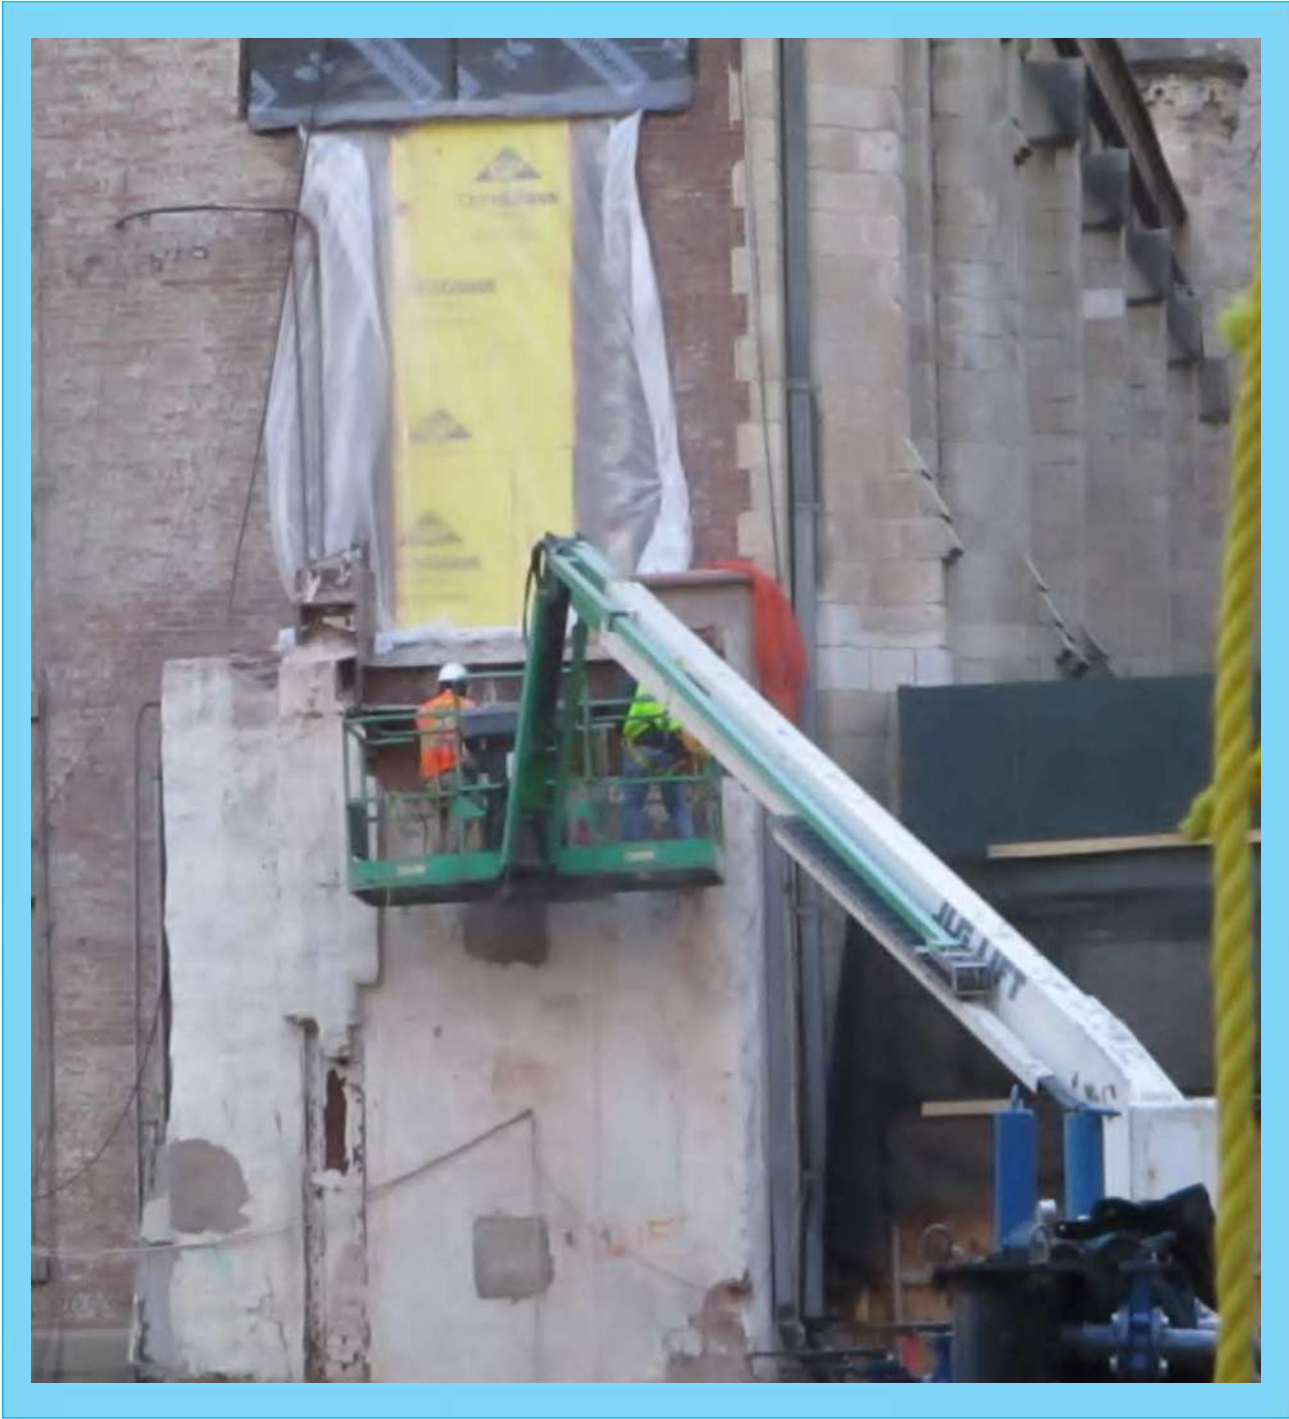
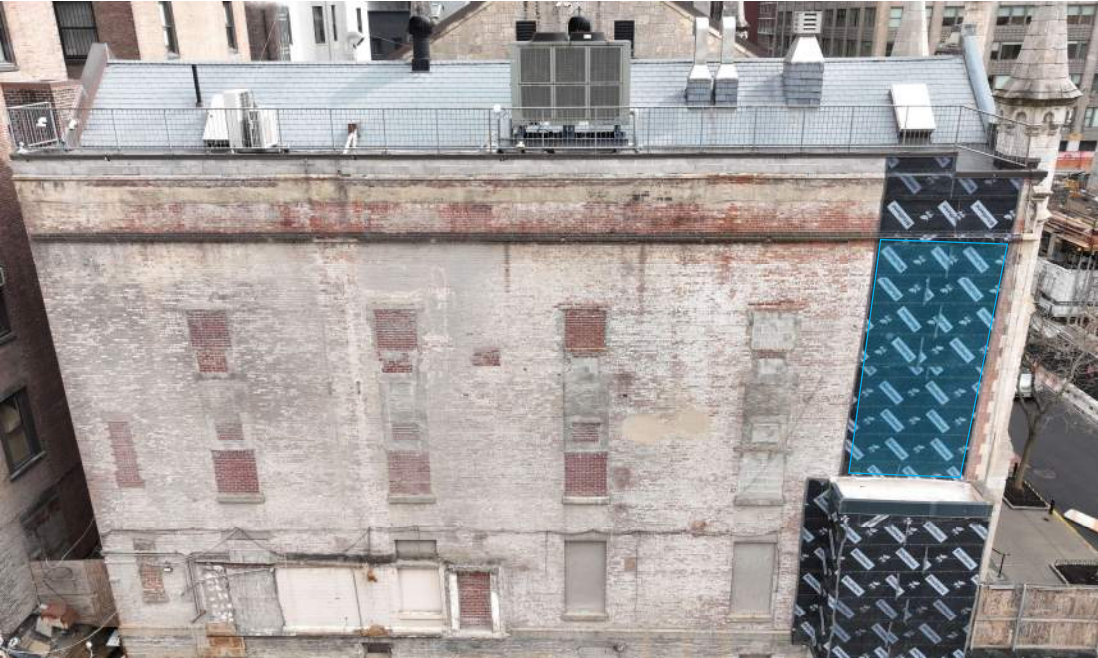
Non-masonry infill at previous building tie-ins

In 2019 the building tie-in corridors were demolished at the second and third floors and infilled with a wall assembly installed flush with the surrounding original brick. This assembly leaves no space for a layer of face brick to be installed in front of the wall assembly without projecting off the existing plane of the brick façade.

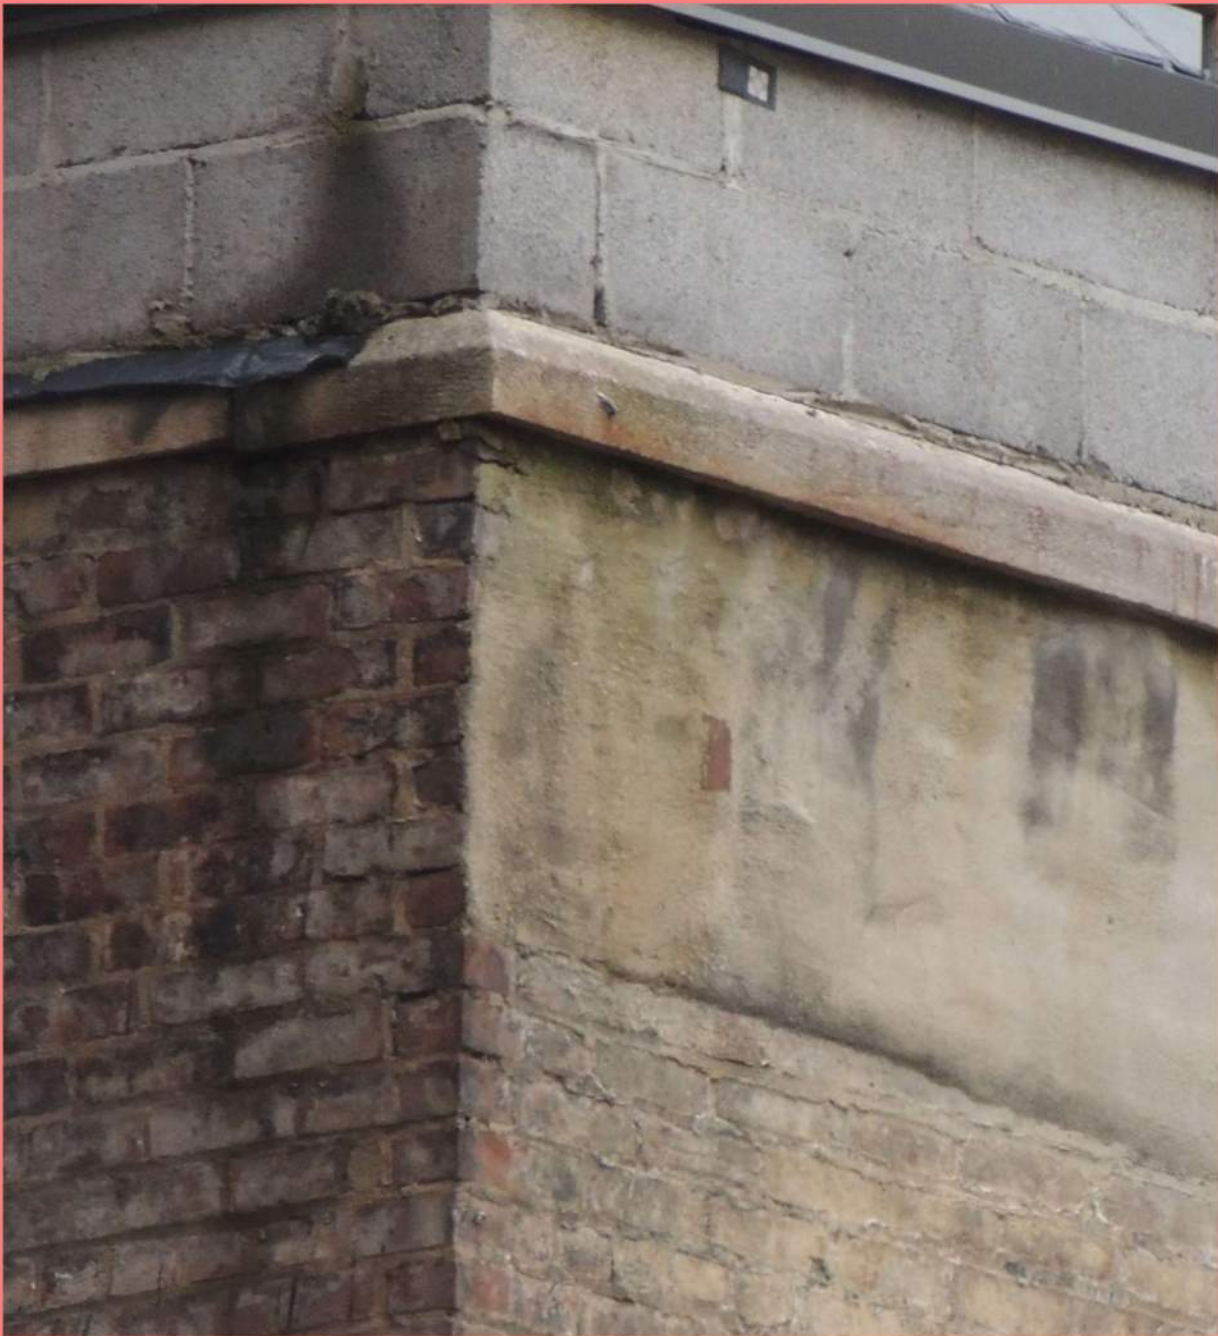
Close-up of CMU Parapet

The existing non-historic CMU parapet was installed in 2012, to allow for the existing code compliant roof pitch. Railings were also installed at this time atop the CMU parapet in accordance with fall protection requirements. There appears to be an original stone coping or band course below the CMU material.

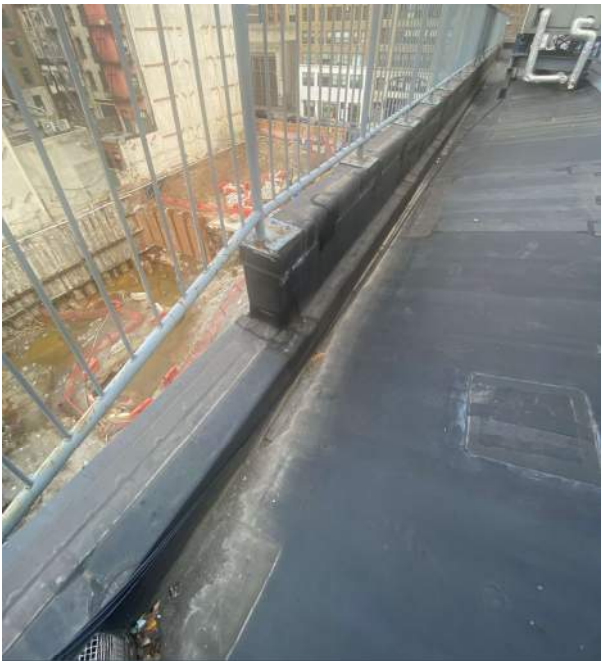
Overview of West Elevation CMU parapet

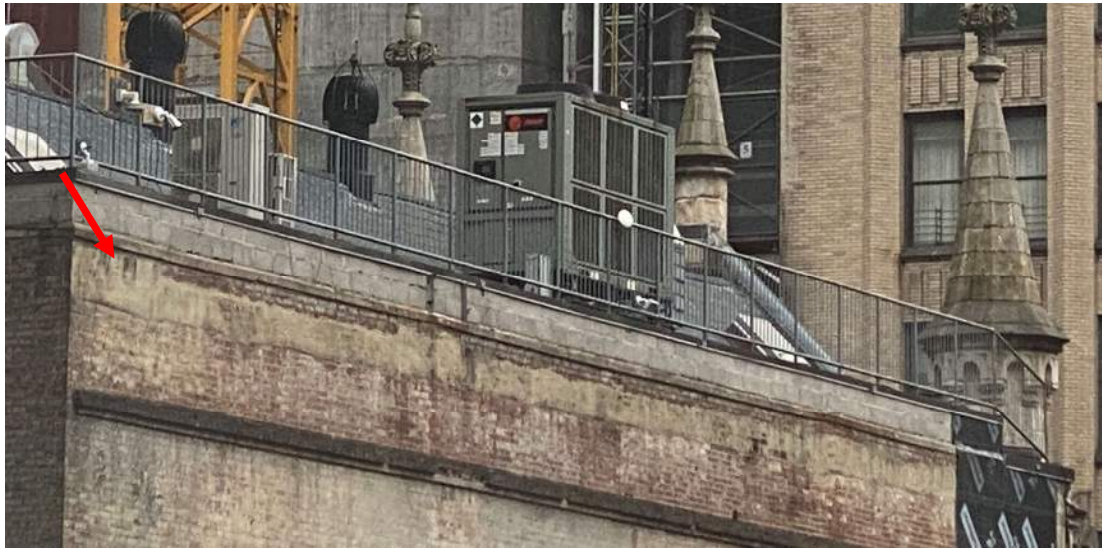
There is an existing cementitious parge coat on the full length of the upper portion of the West Elevation, this cannot be removed without further damaging the existing brick masonry.

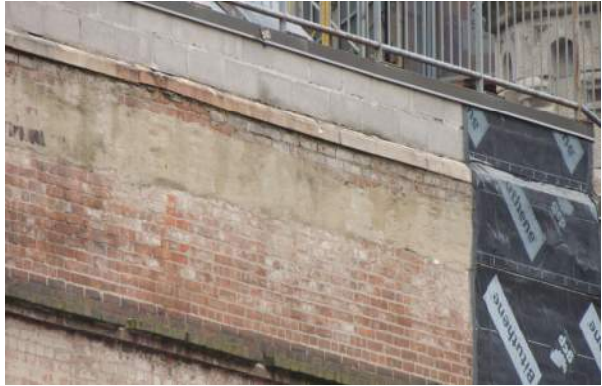
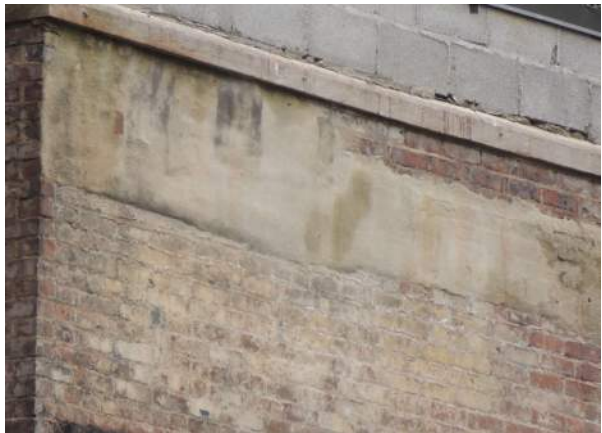
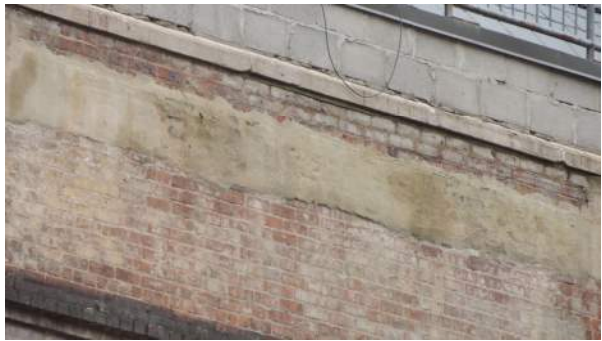
Overview of West Elevation Cementitious Coating

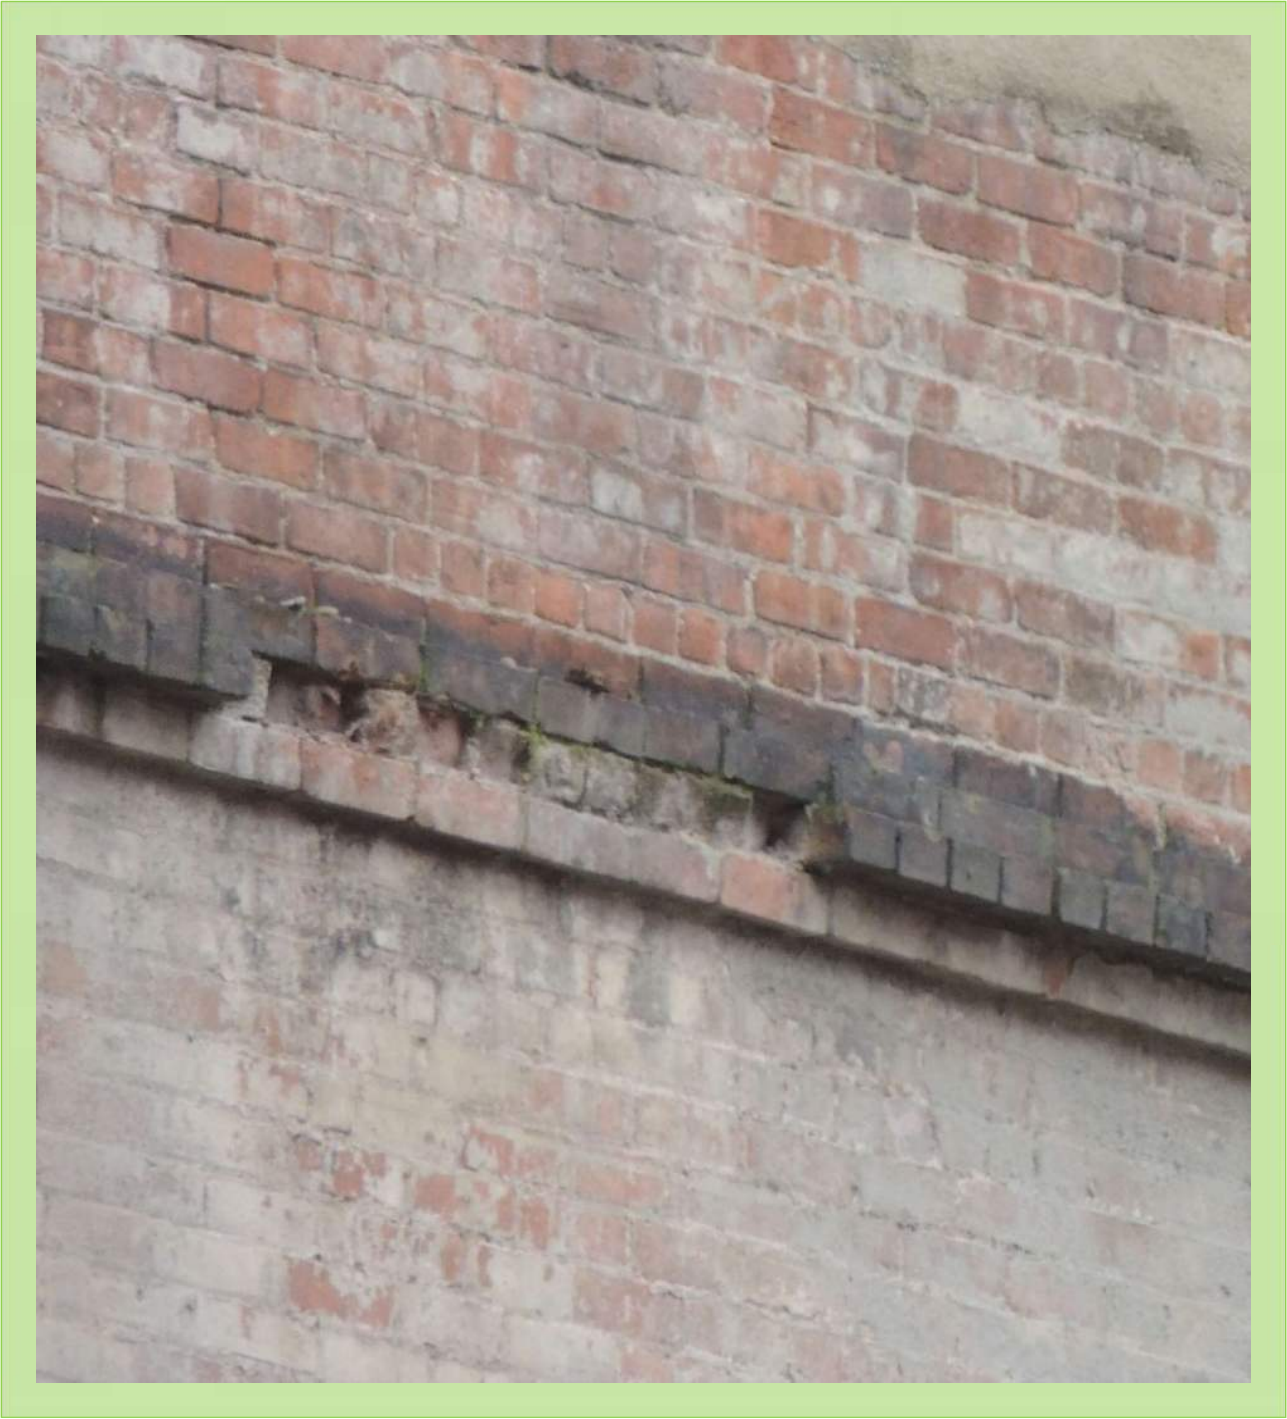
Close-up of damaged/ missing masonry at band-course

Damaged and spalled brick masonry is present throughout the façade primarily at the projecting brick band-course present at the upper portion of the West Elevation.

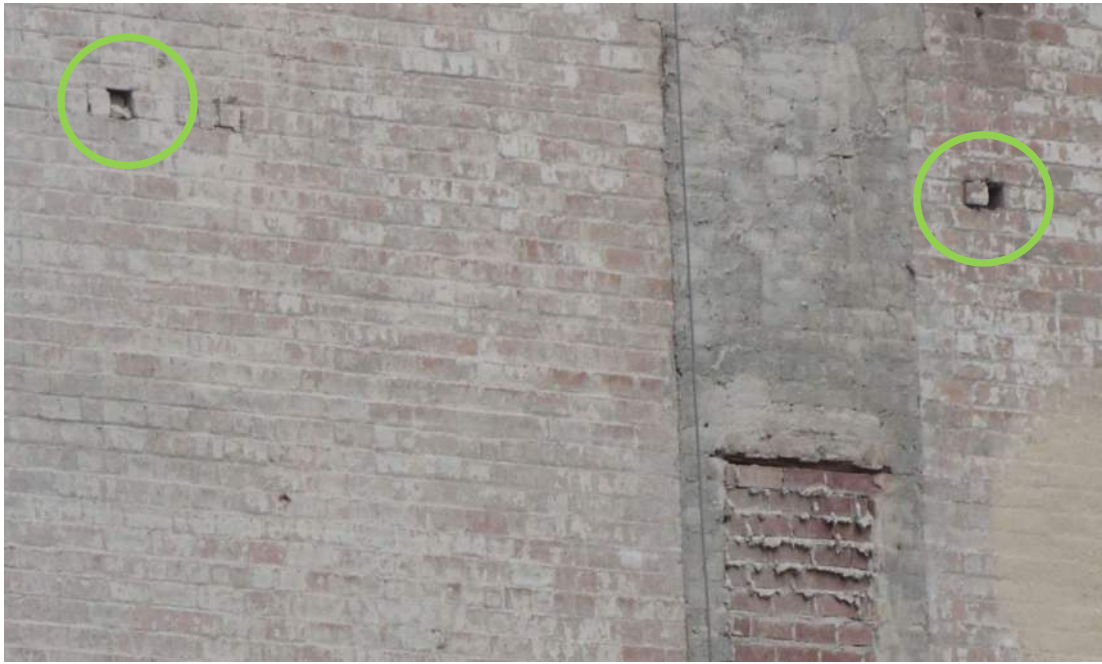
Overview of damaged/ missing masonry at wall area

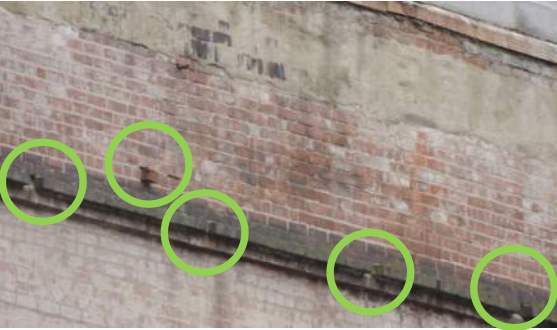
Additional missing/damaged brick
