# Environmental Health and Safety Department

Lead Compliance Assurance Report Field Oversight

June 16, 2023 – December 15, 2023

# EH&S Lead Oversight Activity Summary June 16, 2023 – December 15, 2023

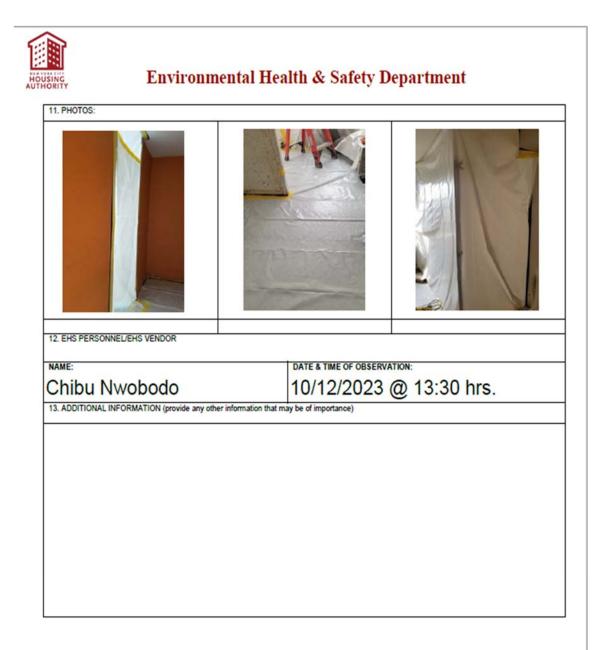
| | EHU | OVERSIGHT ESCALAT | ION RE | PORT | |
|---|--|--|--|---|--|
| | | batement work at Van Dyke Houses<br>wing on 10/12/2023 at about 13:30 I | | ad Oversigi | ht Team Specialist (LOTS) |
| activities, and an abatement su<br>arrival. Upon inquiry, the worke<br>the supervisor on whether to p<br>to another Development for a just<br>stated that he was in the Bronx<br>supervisor's directive on how to<br>The deficiency violates NYCHA<br>SP050201 Lead Safe Standard<br>Section VII.H.i.1(b).i Performin<br>i. Performing an Abatement<br>(1) Personnel<br>(b) A certified abatement super | perviso<br>r state<br>roceed<br>ob. LO<br>to com<br>proce<br>'s Lead<br>d Proce<br>g an Al<br>visor:<br>area p | d Safe Standard Procedure as follows | g the conta<br>ntainment s<br>urther state<br>upervisor 1<br>ed the work | inment set<br>set-up and<br>d that the a<br>formmy Villa<br>er to stop fi | -up at the time of LOTS<br>waiting on instruction from<br>abatement supervisor went<br>arroel on the phone, and he<br>urther work and wait for the |

| | EHU | OVERSIGHT ESCALAT | ION RE | PORT | |
|---|--|--|--|---|--|
| 10. CORRECTIVE ACTION TAKEN:<br>(Describe what was done after yo<br>implemented, did you remain onsi | | ved the deficiency, was this reported to ecompletion?) | the job supe | rvisor, were | the corrective actions |
| LOTS contacted LHC Pro | ject Ir | spector Vitalis Francois, who<br>it the observed deficiency. | is assigne | ed to mor | nitor the vendor at this |
| arrived on site; he compli-<br>that there will be no furthe | ed wit<br>er wor | stop further containment set-up<br>h the directive. Abatement sup<br>k in the unit for the day and the<br>n-site at the time of departure. | ervisor T<br>at work w | ommy Vi | illarroel informed LOTS |
