# sanitation

**DENNIS DIGGINS**

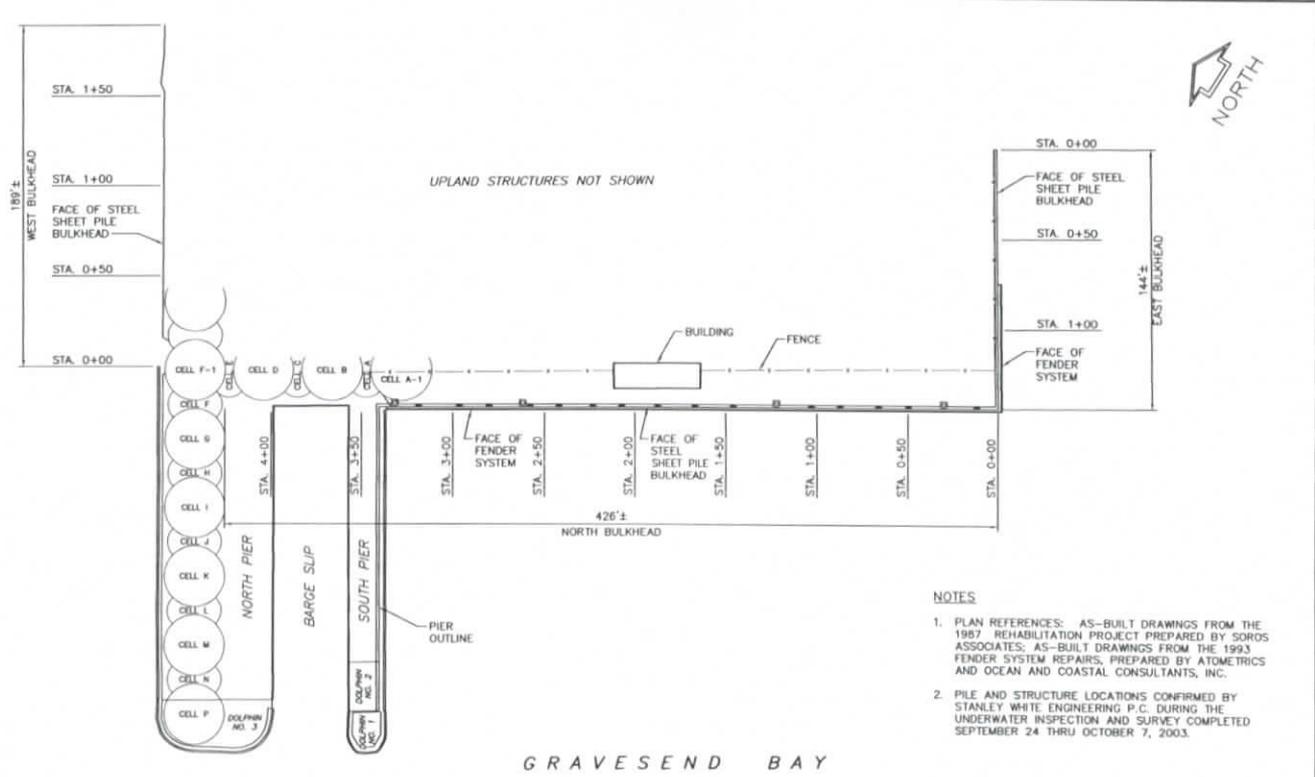
UPLAND STRUCTURES NOT SHOWN

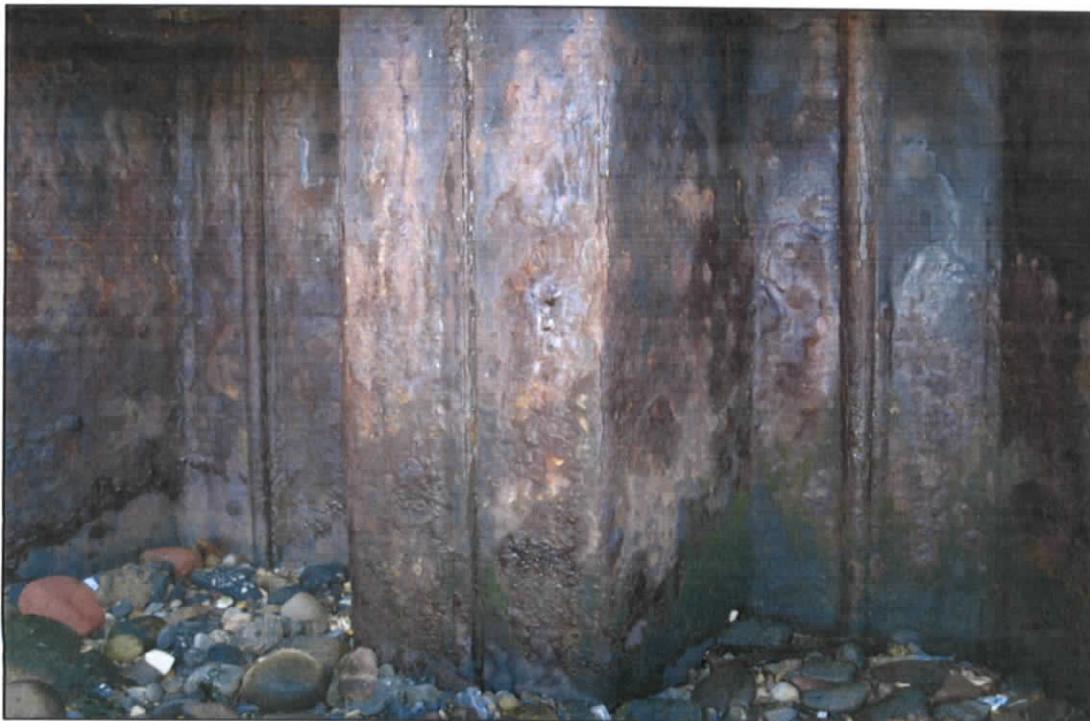
Photograph 6: West Bulkhead - Typical coating failure and moderate corrosion in the splash/tidal zone

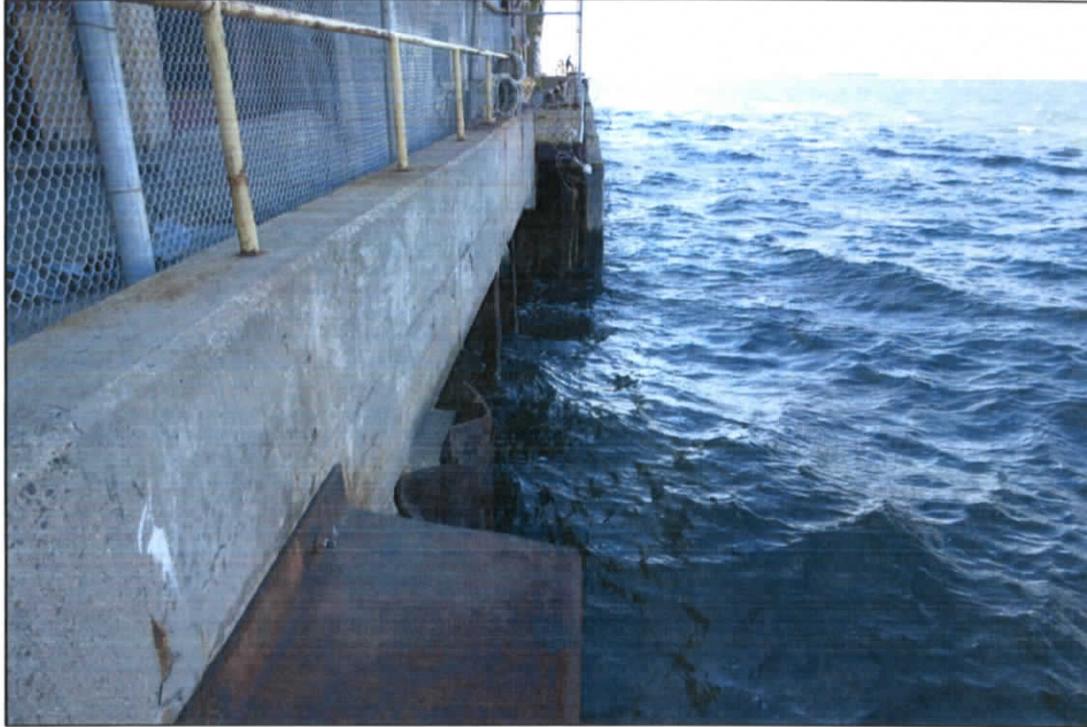
**Photograph 7: West Bulkhead - Missing steel pile cap (Looking west)**

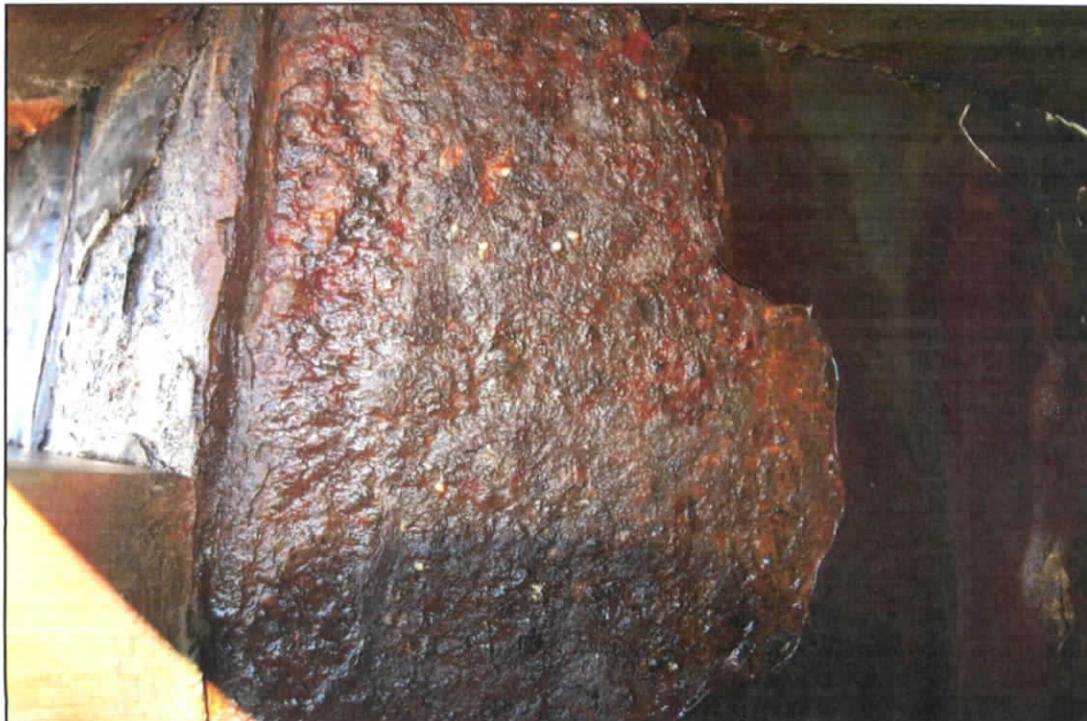
**Photograph 8: North Bulkhead - Typical coating failure with moderate corrosion of steel sheet pile in splash/tidal zone**

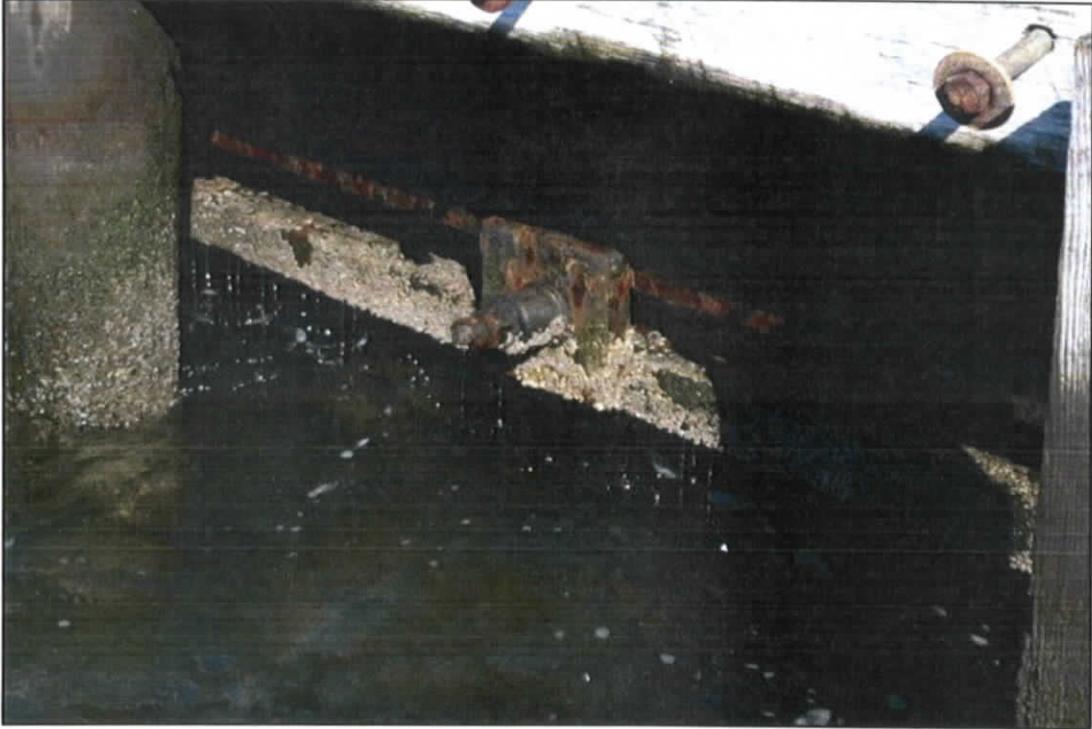
**Photograph 9: North Bulkhead - Typical moderate corrosion to steel anchor rod and hardware**

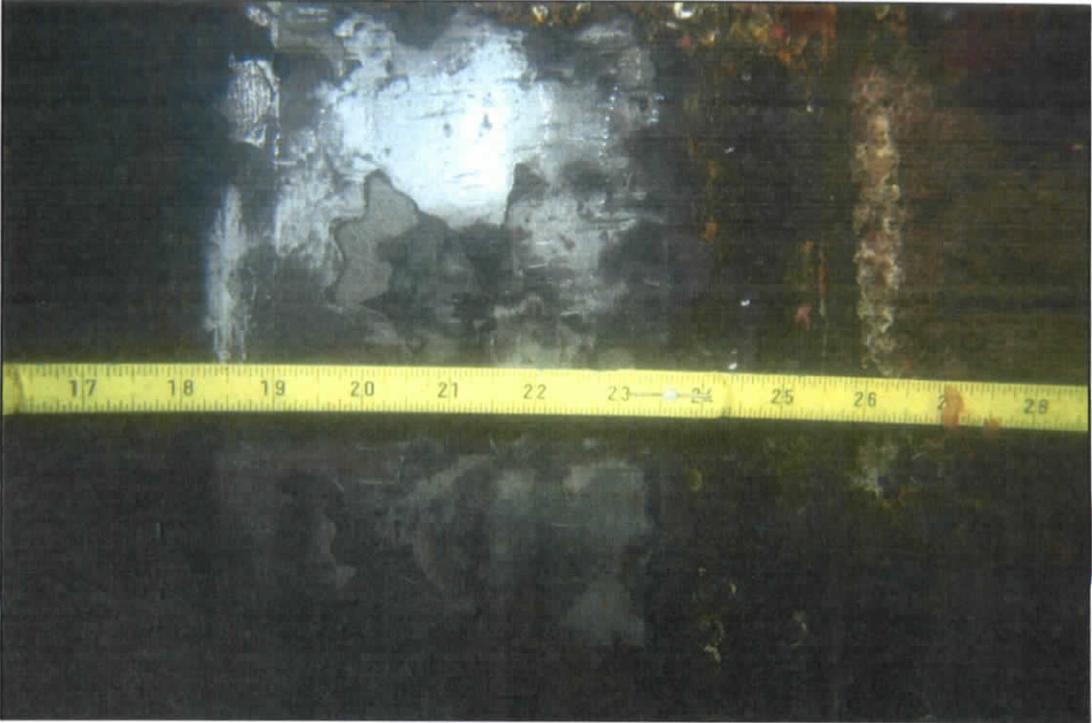
**Photograph 10: North Bulkhead - Typical steel behind brittle coating**

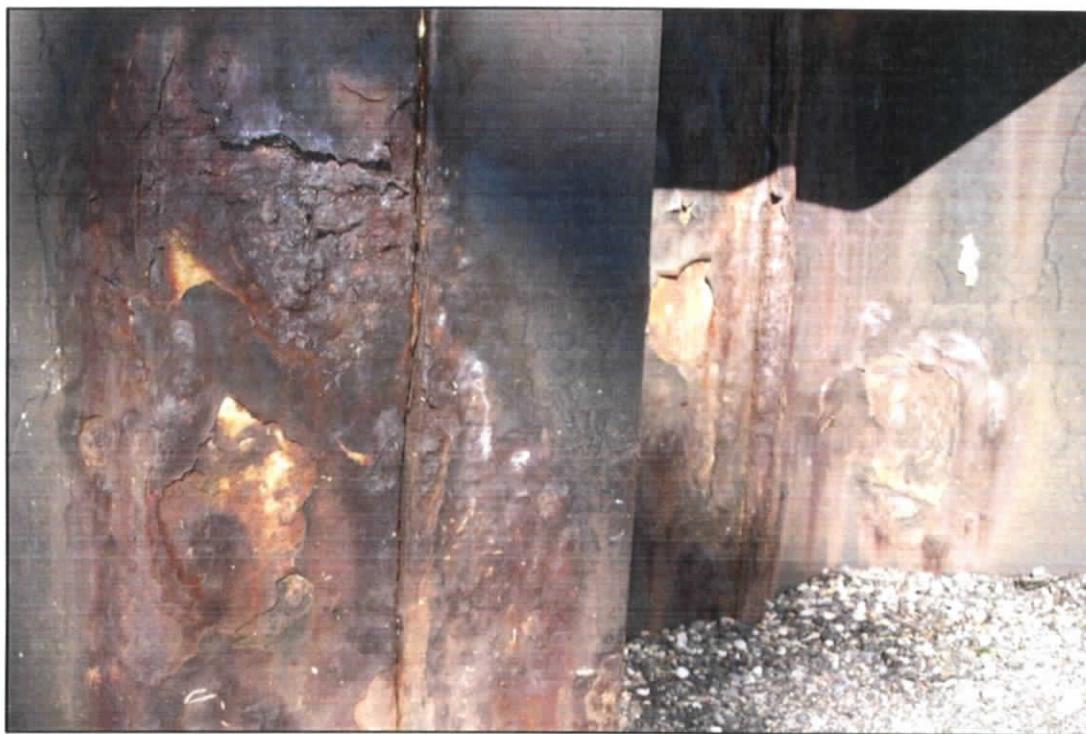
**Photograph 11: East Bulkhead – Typical coating failure with moderate corrosion of steel sheet pile in splash/tidal zone**

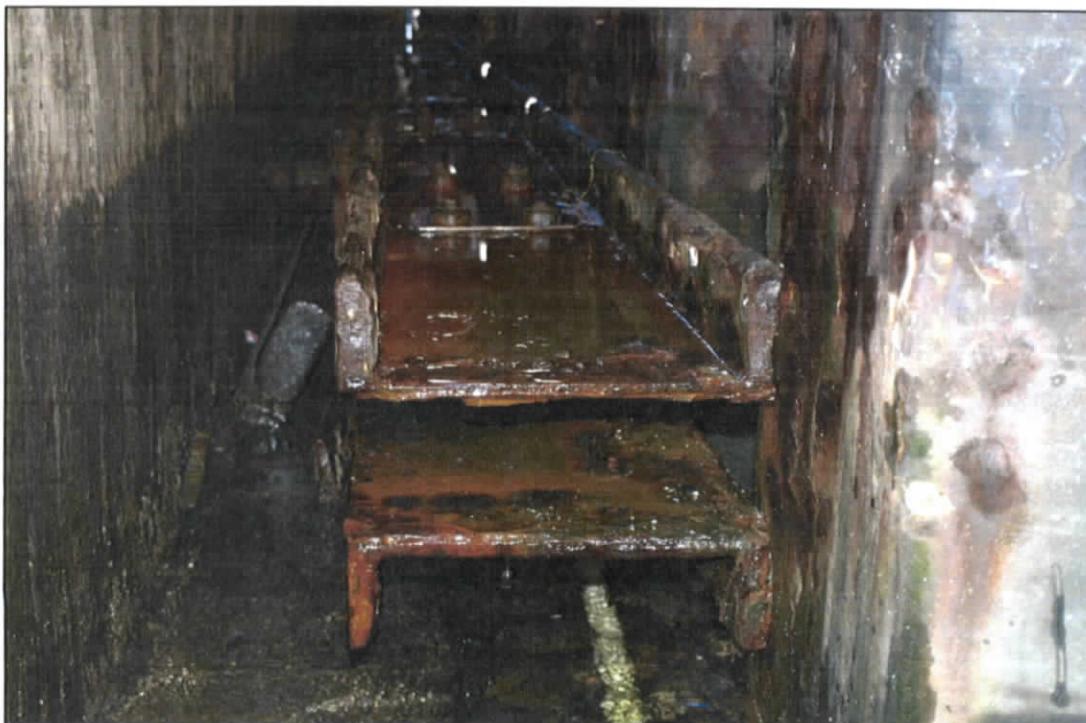
**Photograph 12: East Bulkhead - Typical heavy corrosion of the external steel double channel wale**

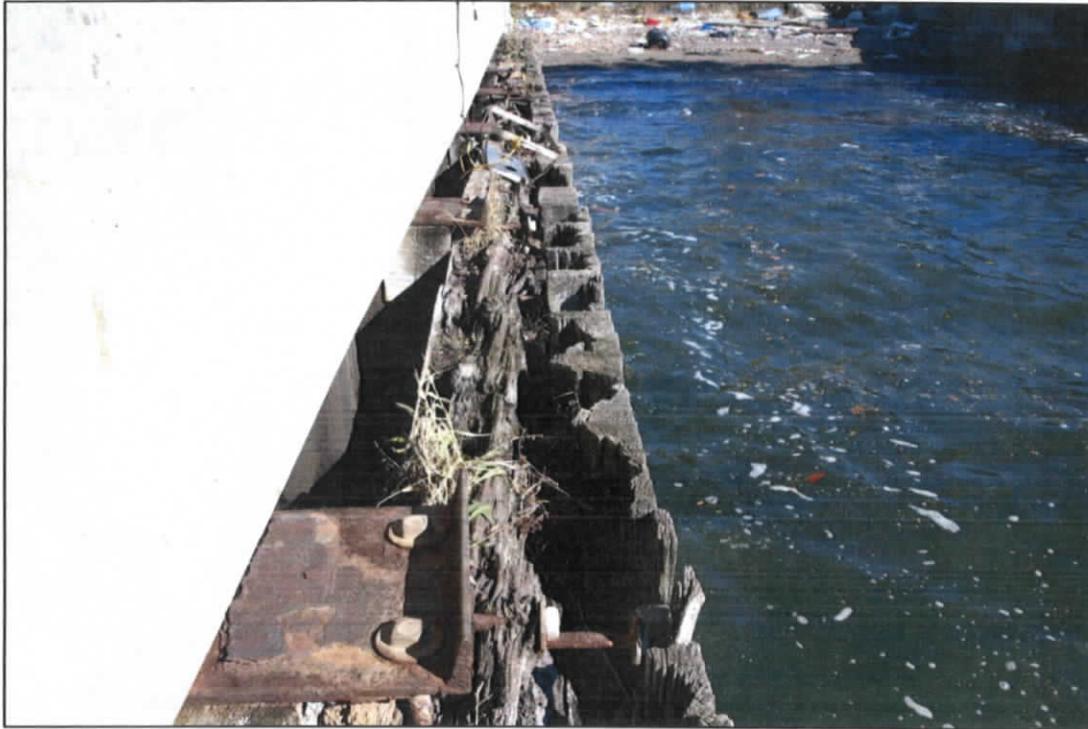
**Photograph 13: East Bulkhead - Heavy rot of the upper timber horizontal wale**

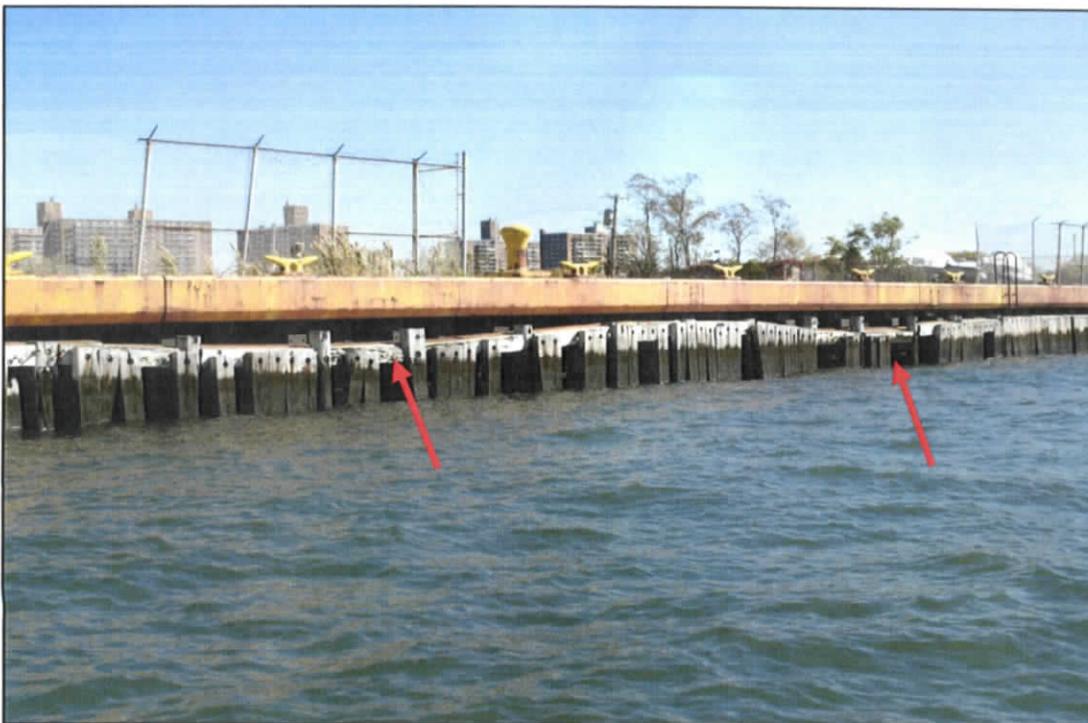
**Photograph 14: West Bulkhead - Failed timber sections of the fender system**
