## APPENDIX 1: SHARED-USE SIDEWALK

### Introduction

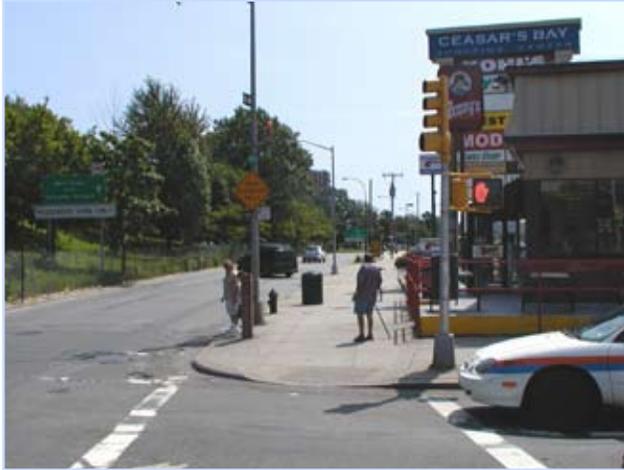
### 1. Corner of Caesar's Bay

Segment Length: 20 feet  
 Pavement Condition: Good  
 Sidewalk Width: 11-15 feet  
 Driveways: 0  
 Cross Streets: 0  
 Photo: Looking south

Issues: Sidewalk narrows at corner from 10 feet at the traffic signal metal pole, 13 feet at the corner of Wendy's outdoor seating, to 15 feet heading east. Bay Parkway is the street in the foreground and serves as the main entrance to the mall.

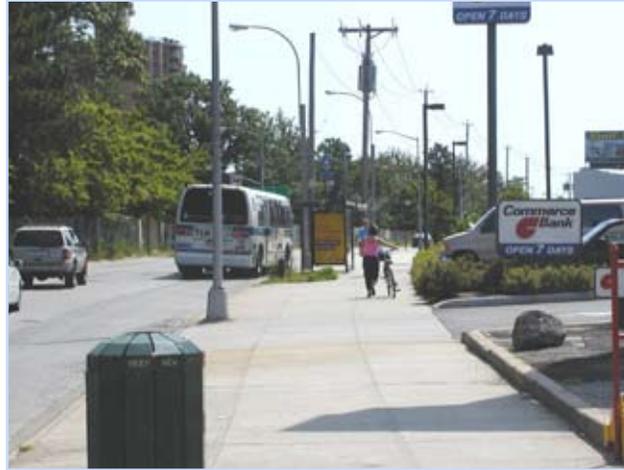
### 2. Bus Shelter

Segment Length: 220 feet  
 Pavement Condition: Good  
 Sidewalk Width: 15 feet  
 Driveways: 1  
 Cross Streets: 0  
 Photo: Looking south

Issues: Sidewalk clearance at bus shelter is only 7 feet. The driveway is a one-way entrance only for the banks. Note bicyclist walking bike.

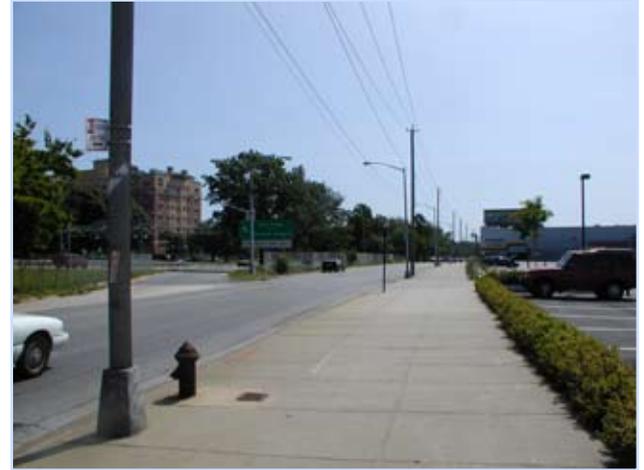
### 3. Caesar's Bay Sidewalk

Segment Length: 660 feet  
 Pavement Condition: Good  
 Sidewalk Width: 16-17 feet  
 Driveways: 2  
 Cross Streets: 0  
 Photo: Looking south

Issues: There are 2 exit/entrances to the mall along Shore Road South. A Shore Parkway on-ramp is on the left of the photo. The majority of vehicles on Shore Road South exit onto the Parkway at this on-ramp. Note the clear sightlines on the sidewalk.

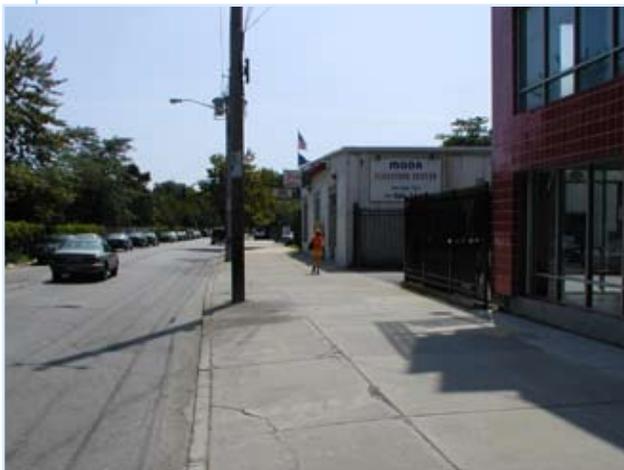
### 4. Stop & Stor

Segment Length: 105 feet  
 Pavement Condition: Good  
 Sidewalk Width: 17-18 feet  
 Driveways: 1  
 Cross Streets: 0

Issues: The driveway has an electric gate that all vehicles must enter and exit through ensuring that vehicles are traveling at slow speeds. Currently people on the sidewalk do not have 100 percent visibility around the corner of the building.

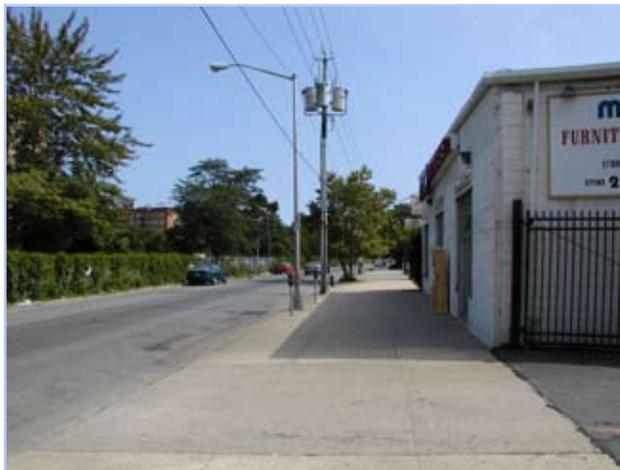
### 5. Moda Furniture

Segment Length: 65 feet  
 Pavement Condition: Good  
 Sidewalk Width: 18 feet  
 Driveways: 0  
 Cross Streets: 0

Issues: Visibility around the corner of the building.

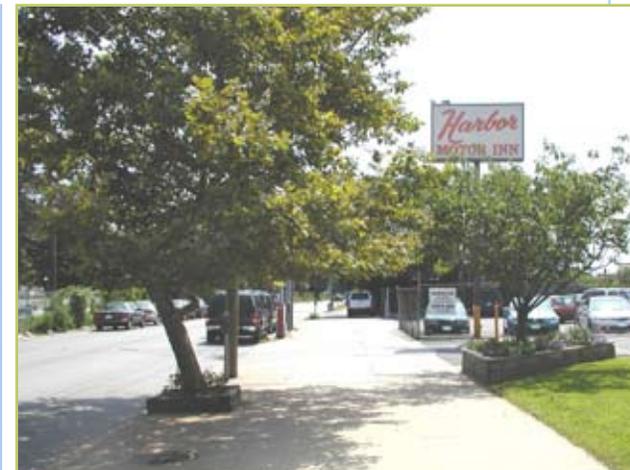
### 6. Harbor Motor Inn

Segment Length: 100 feet  
 Pavement Condition: Good  
 Sidewalk Width: 18 feet  
 Driveways: 1  
 Cross Streets: 0

Issues: Tree/pit located on sidewalk.

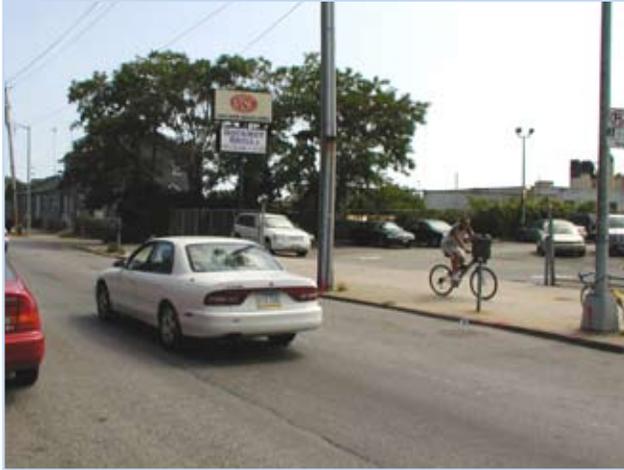
### 7. *New York Sports Club*

Pavement Condition: Fair

Issues: Sidewalk conditions start to degenerate heading east. Note bicyclist riding on the sidewalk.

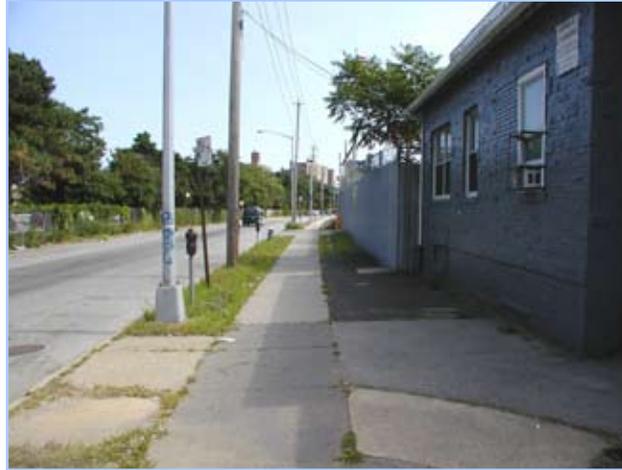
### 8. *Atlantic Bus Terminal*

Pavement Condition: Poor

Sidewalk Width: 15 feet (5 paved)

Issues: Sidewalk is in poor condition with cracked and uneven pavement. There are unpaved portions of the sidewalk consisting of trash, dirt and weeds. The first driveway is an entrance only that might be an unmapped street. The second driveway is an exit only with a electric sliding gate.

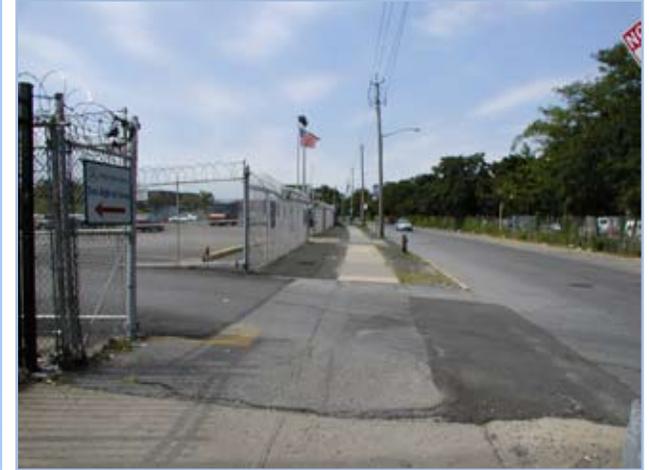
### 9. *Bayside Oil*

Pavement Condition: Poor

Issues: Sidewalk is in poor condition with cracked and uneven pavement. There are unpaved portions of the sidewalk consisting of trash, dirt and weeds and portions paved of different material. Chain-link fencing separates the property from the sidewalk.

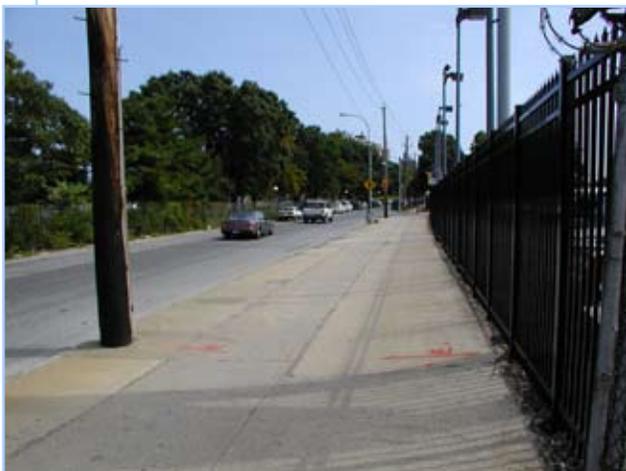
### 10. Mercedes-Benz

Issues: The car dealership has slatted wrought iron fencing the length of their property. Twenty-fifth Avenue and Shore Road South create a “T” intersection.

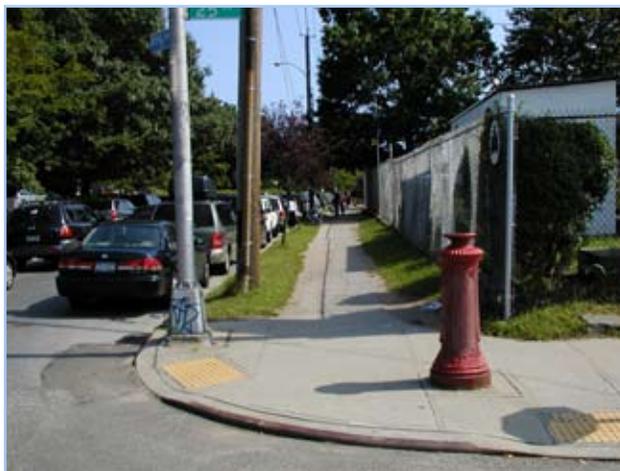
### 11. Nellie Bly Amusement Park

Pavement Condition: Fair/Good

Sidewalk Width: 15 feet (5 paved)

Issues: The sidewalk in front of the park typically has 5 feet of pavement sandwiched by a 5-foot amenity strip with 7 small trees and a 5-foot strip of grass along the the fence fronting the park. Twenty-fifth Street creates a “T” intersection with Shore Road South.

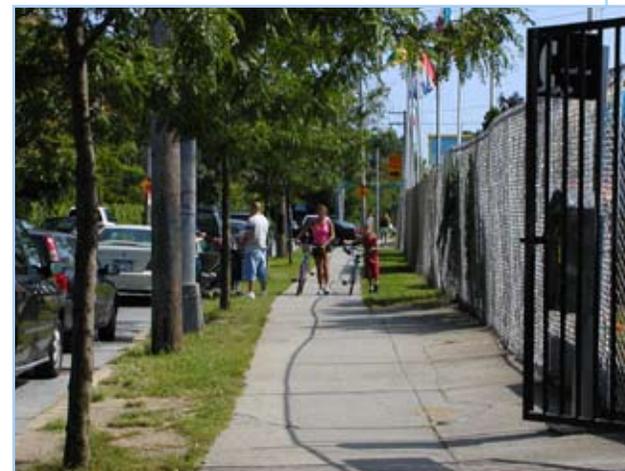
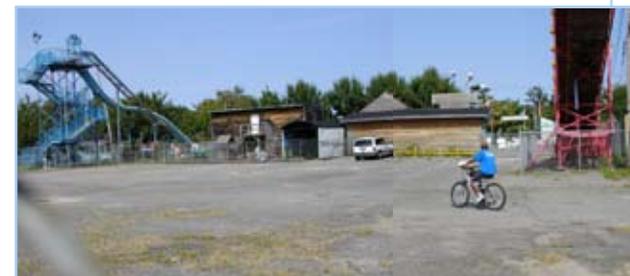
### 12. & 13. Additional Photos - Nellie Bly

Above photo (12) shows the sidewalk in front of the park entrance along Shore Road South. Cars tend to park illegally on the curb at this entrance when the park is open. Photo below (13) shows a section of the available but unused parking lot behind the park.

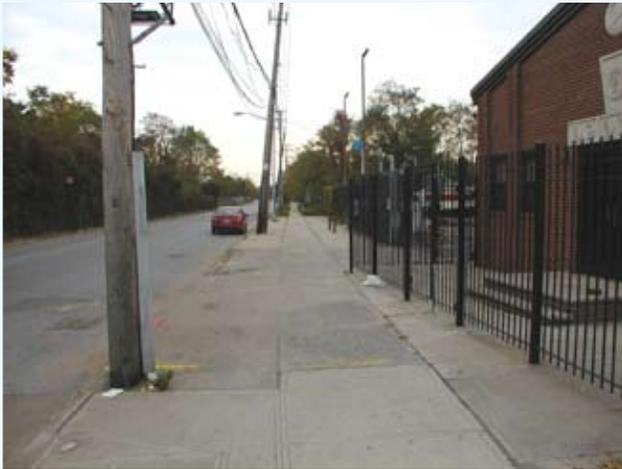
### **18. Excelsior Yacht Club**

Sidewalk Width: 11-15 feet

Issues: The slanting iron gate of the yacht club creates a pinch point along the sidewalk. The driveway to the yacht club has an electric gate to access their large parking area.

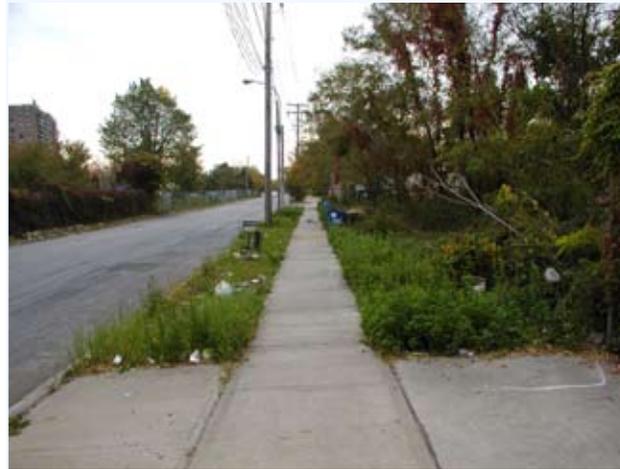
### **19. Defunct King's Bay Development**

Pavement Condition: Poor

Sidewalk Width: 15 feet (5 paved)

Issues: Site is overgrown and littered with debris. There is only 5 feet of paved sidewalk but there is sufficient space to widen the sidewalk by paving over the dirt and weeds.

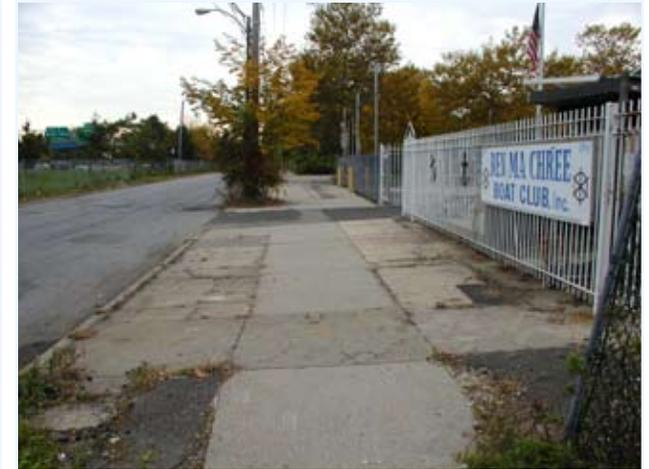
### **20. Ben Ma Chree Boat Club**

Pavement Condition: Poor

Issues: The yacht club has a 15-foot wide driveway.

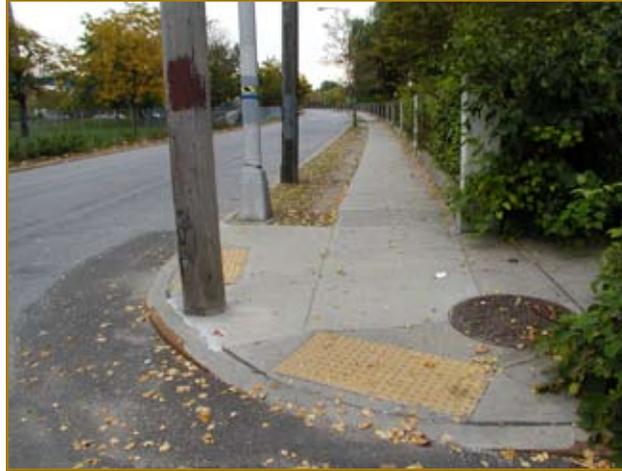
### 22. Dreier-Offerman Park 1

Issues: The sidewalk along the park is 11 feet wide with 5 feet paved. There are trees and utilities along the unpaved parts of the sidewalk. Currently, there is one access point to the park (see photo 23). The roadbed is still 29 feet wide and functions as a single motorized vehicle travel lane.

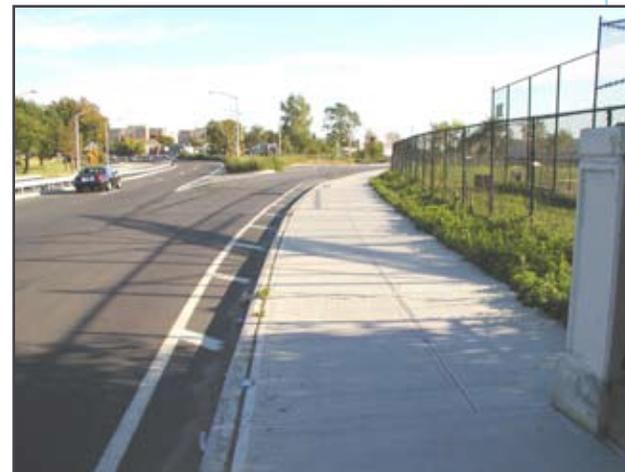
### **27. Additional Photo - Pinch point**

Looking south where the shared-use sidewalk diverges from Shore Road South and continues on West 22nd Street. The sidewalk is paved at 11 feet wide, but there is a pinch point at the corner stanchion between Dreier-Offerman Park and Six Diamonds Park where the sidewalk is 7 feet wide.

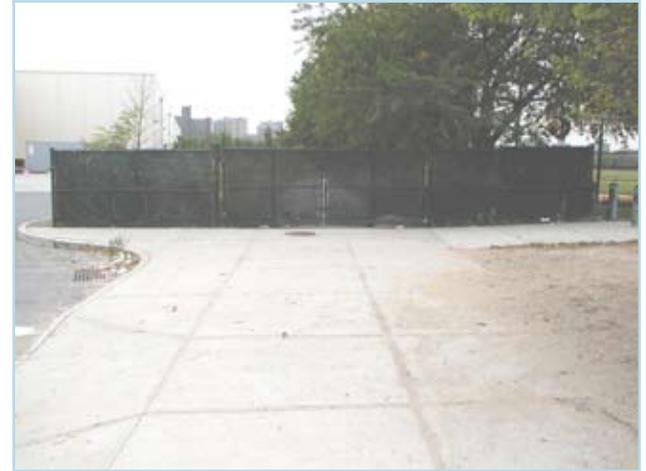
### **30. Additional Photo - Closed Gateway**

The shared-use sidewalk connects to the existing pathway behind this locked gate. Similar to the Home Depot Pathway, this path is often gated and locked.
