Children's Museum of Manhattan

Landmarks Preservation Commission Application

Special Windows Conditions Assessment 6 December 2019

361 CPW – SPECIAL WINDOWS CONDITIONS ASSESSMENT (STAINED GLASS)

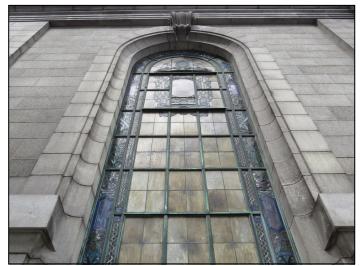
Staining & rust on window 1

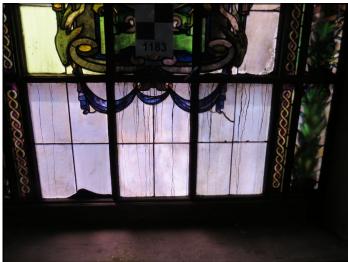
Typical condition of stained glass window (window 7 shown)

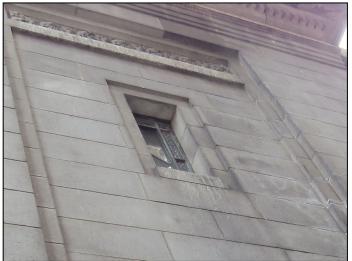
Broken glass at window 21

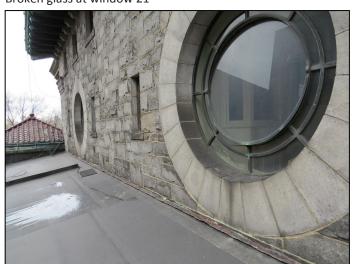
Typical overall window condition (window 19 shown)

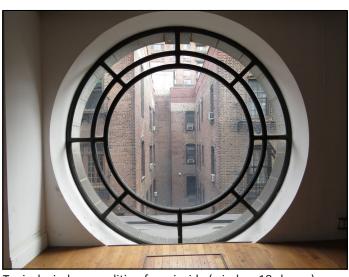
Typical window condition from inside (window 18 shown)

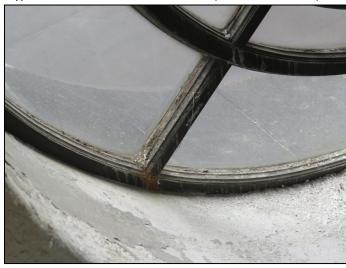
Rust & staining on bronze from inside (window 20 shown)

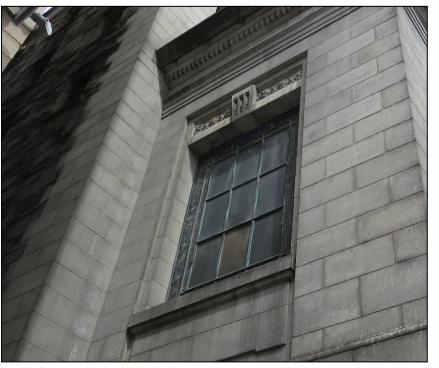
View of window 25

The stained glass window is set in bronze frames and are held in place with bronze glazing stops. This West facing window has a center-pivot ventilating sash at the bottom and has protective glazing on the inside of the windows. The window is in poor condition. It is soiled, and dirt has built up in the space between the glass and the protective glazing. Some of the border panels are bowed outward, especially at the bottom. There is slight rusting observed on the bronze and oxidation on the patina.
