**109 Halsey St
Brooklyn, NY
Renovations**

109 Halsey St Renovations

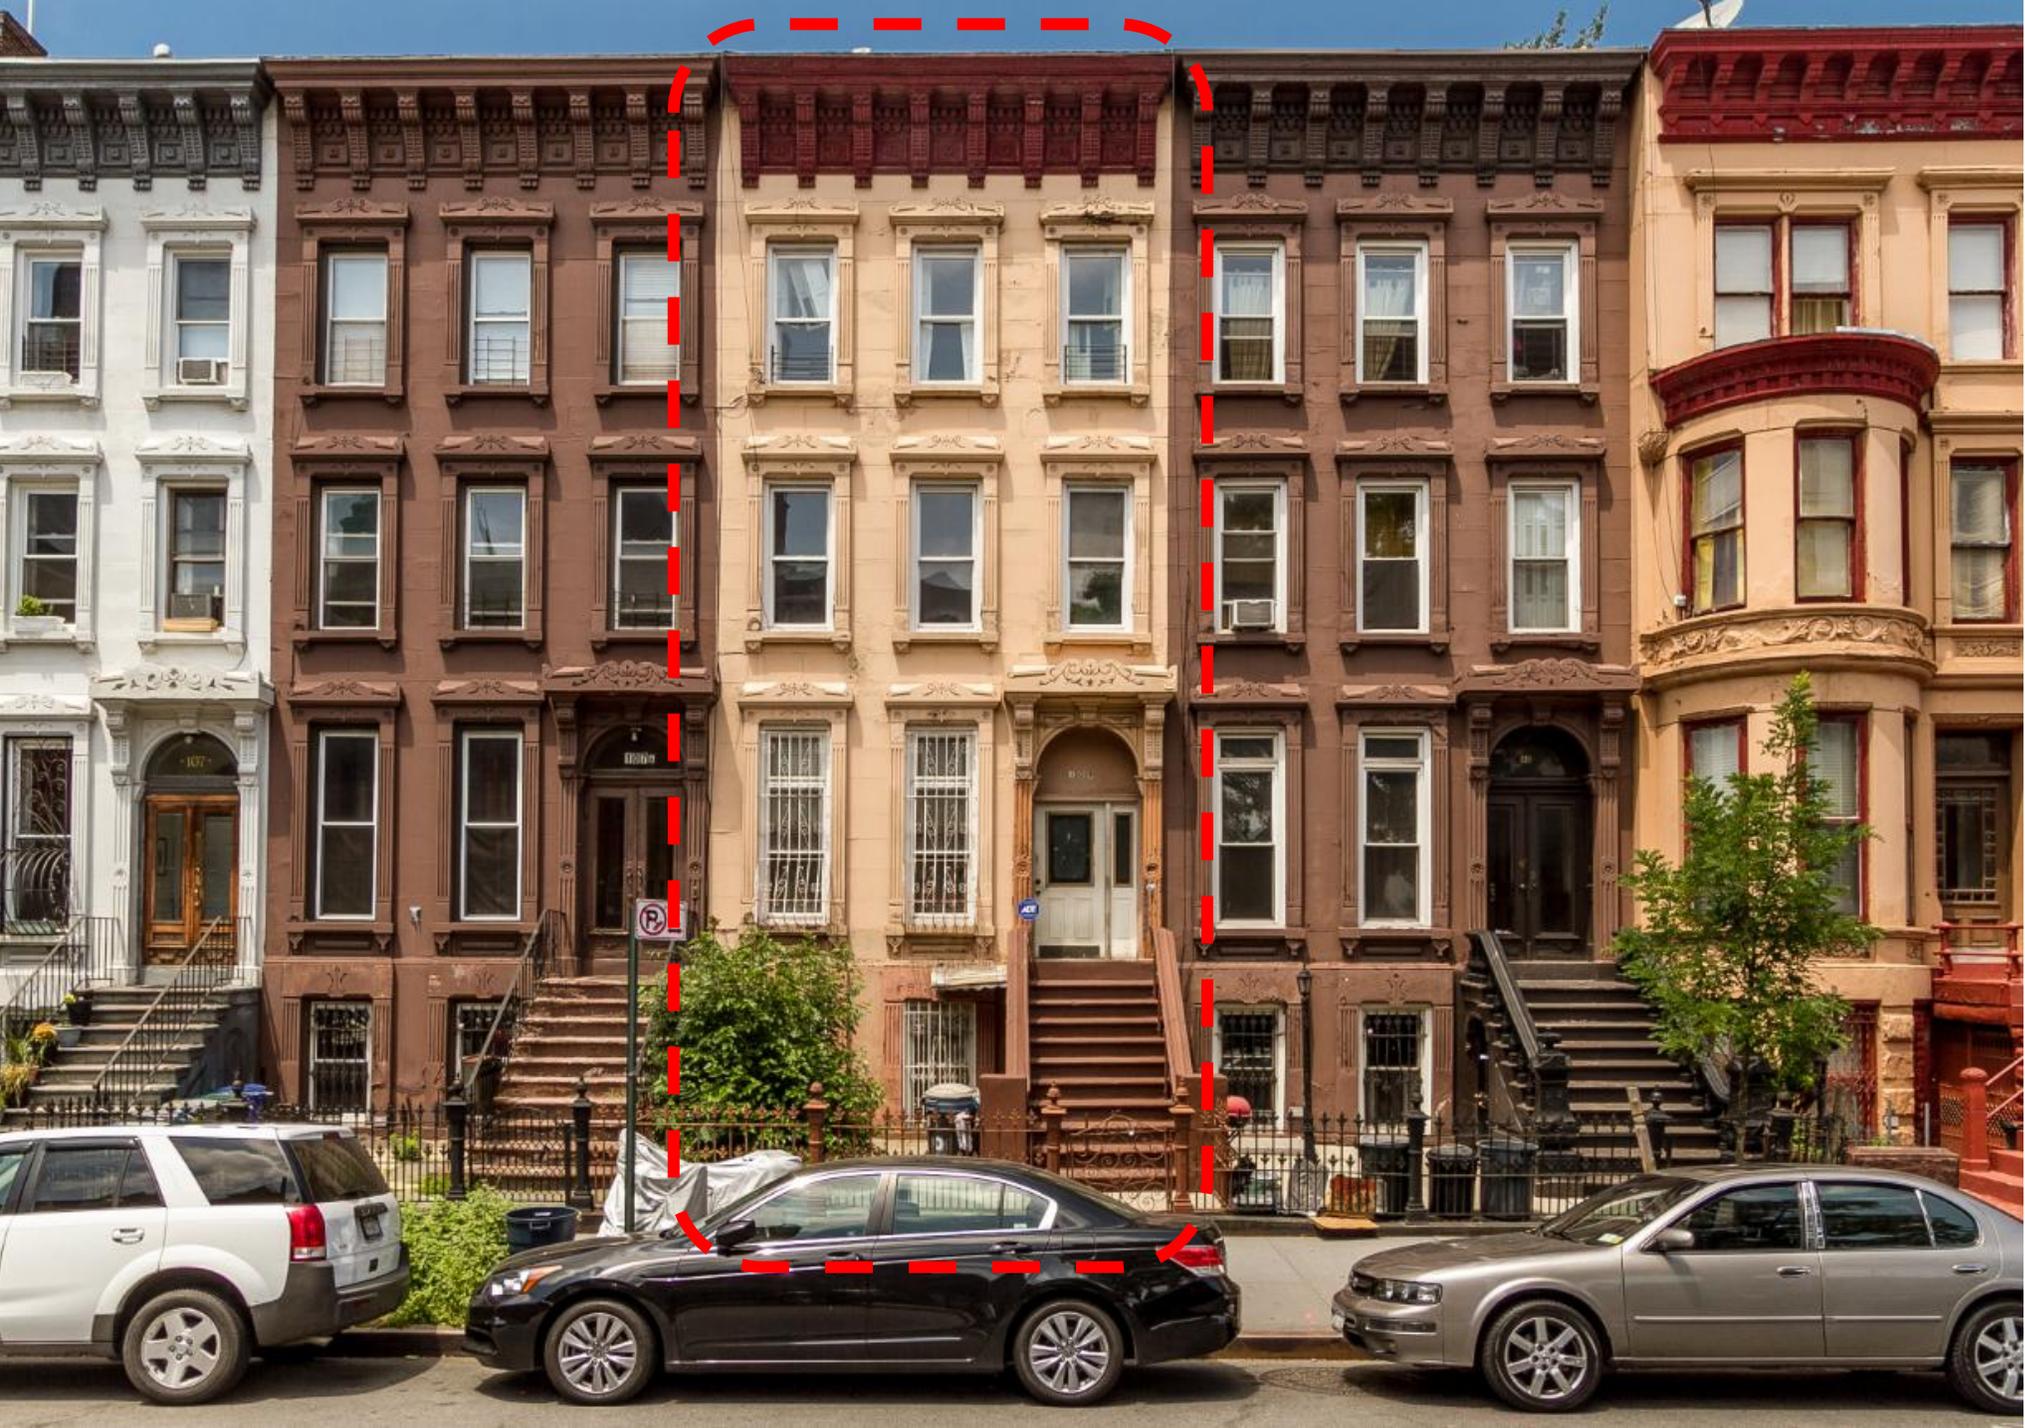
Pre-construction view
of street façade

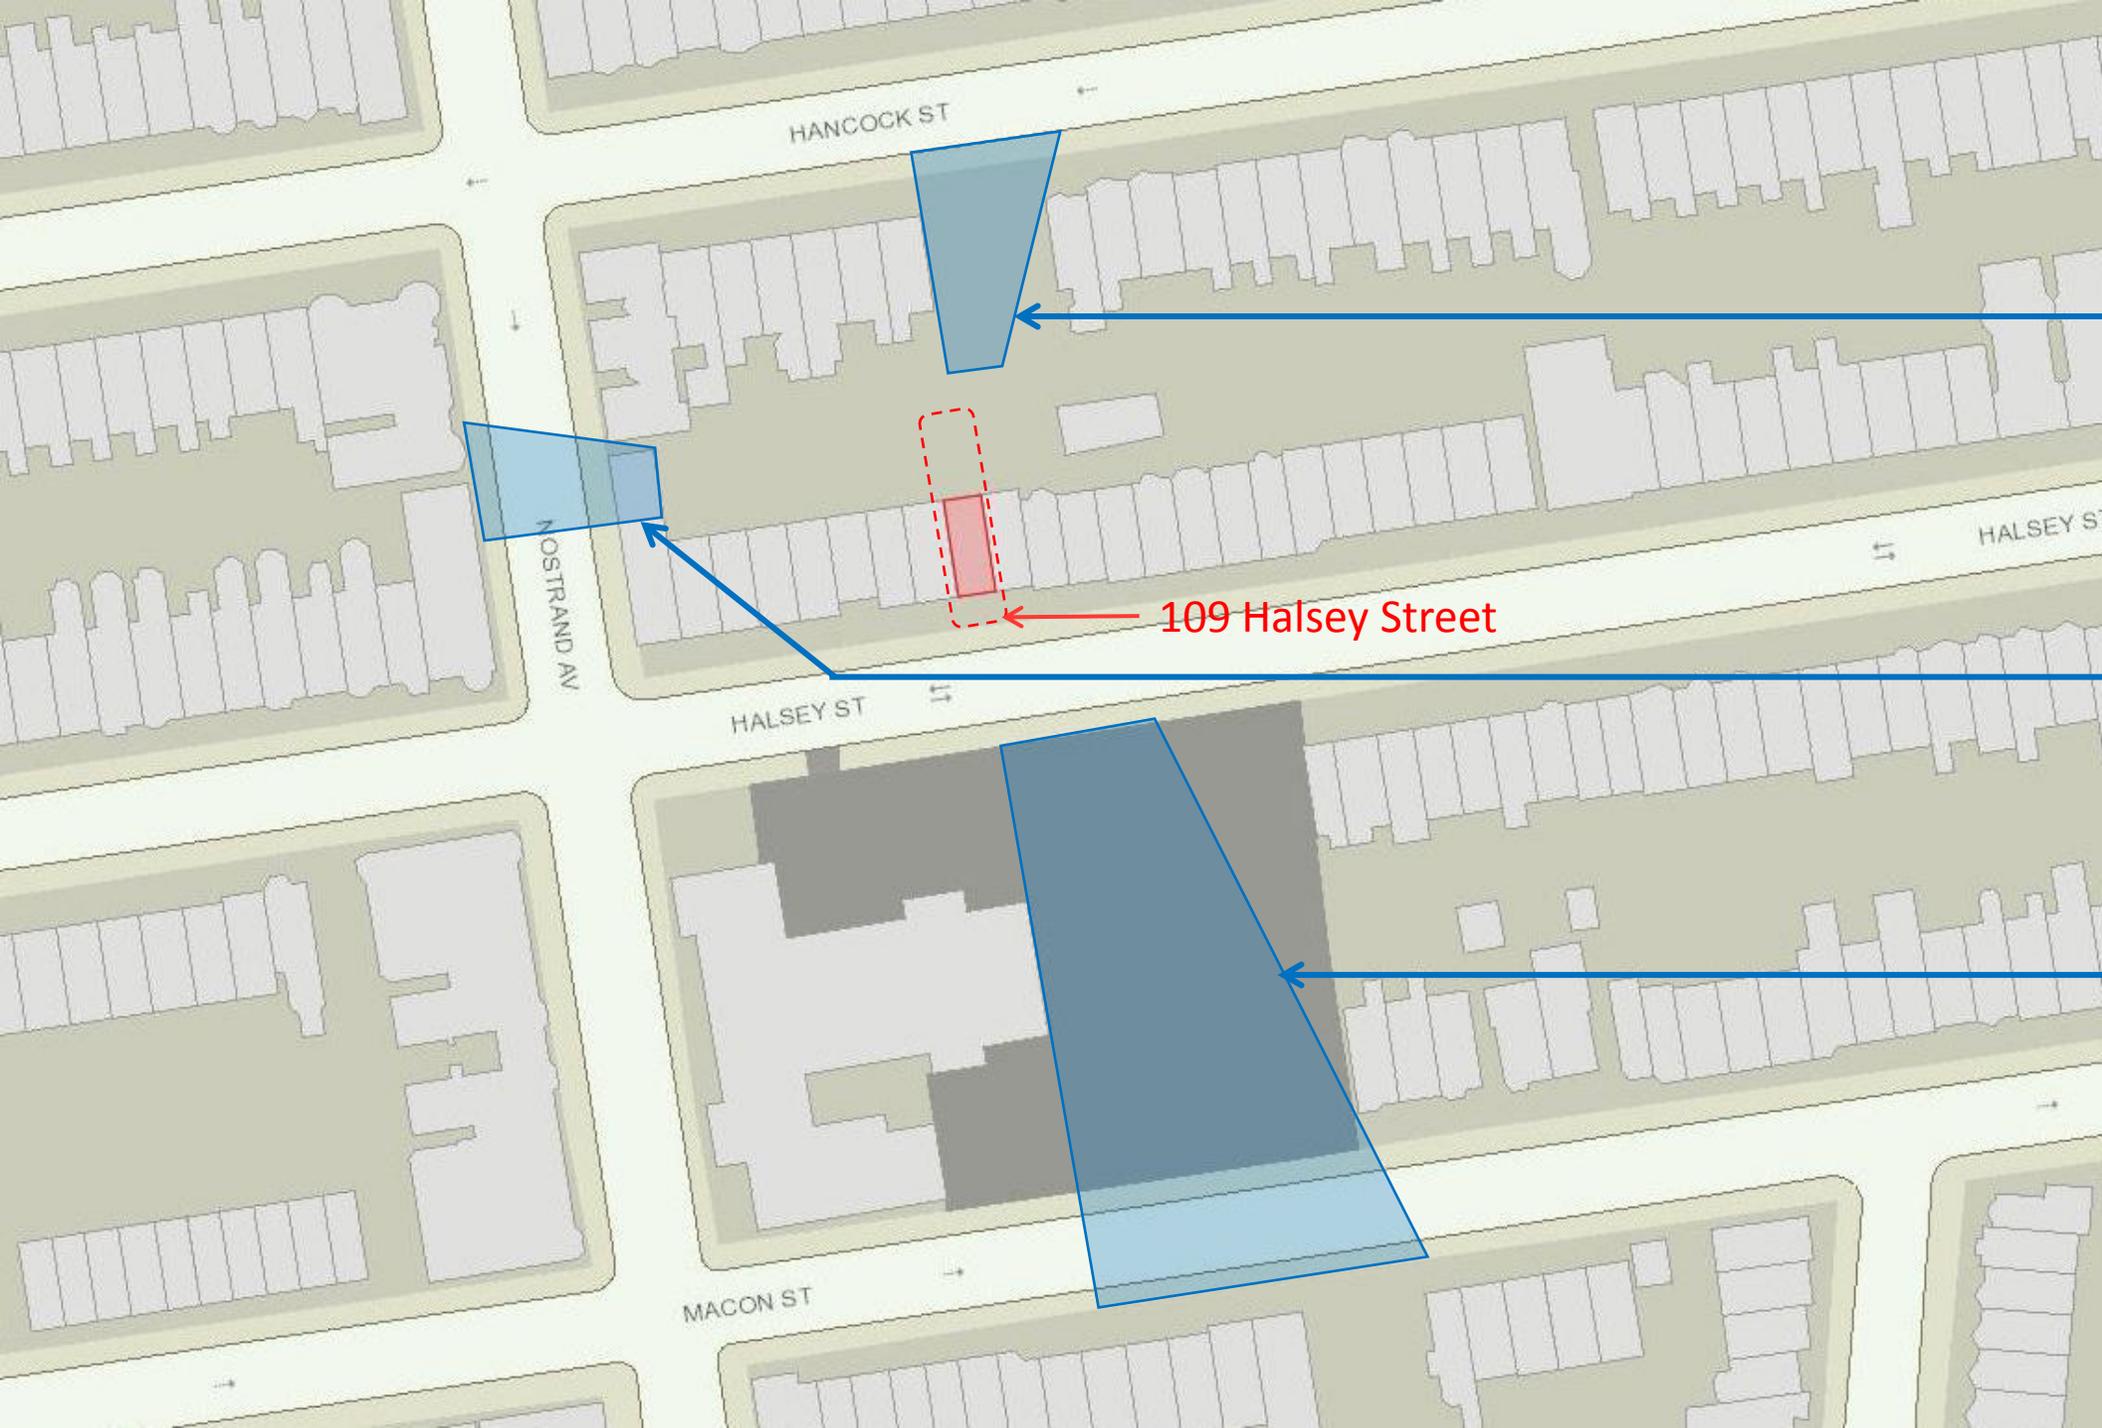
Visibility of work at rear façade and bulkhead from Hancock St from lot used as parking area

Visibility of bulkhead from Nostrand Ave over single story portion of building

Visibility of bulkhead from Macon St from church parking lot

Location plan with visibility corridors indicated

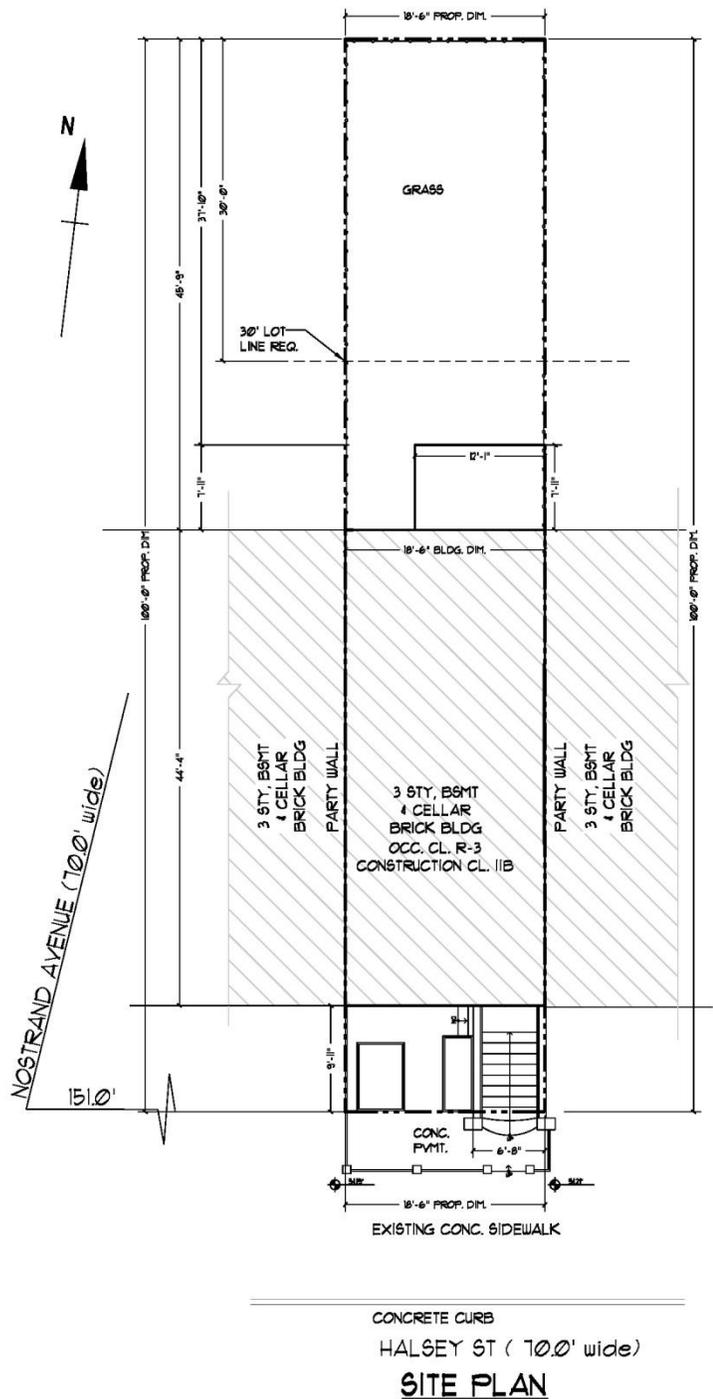
Pre-Construction Site Plan

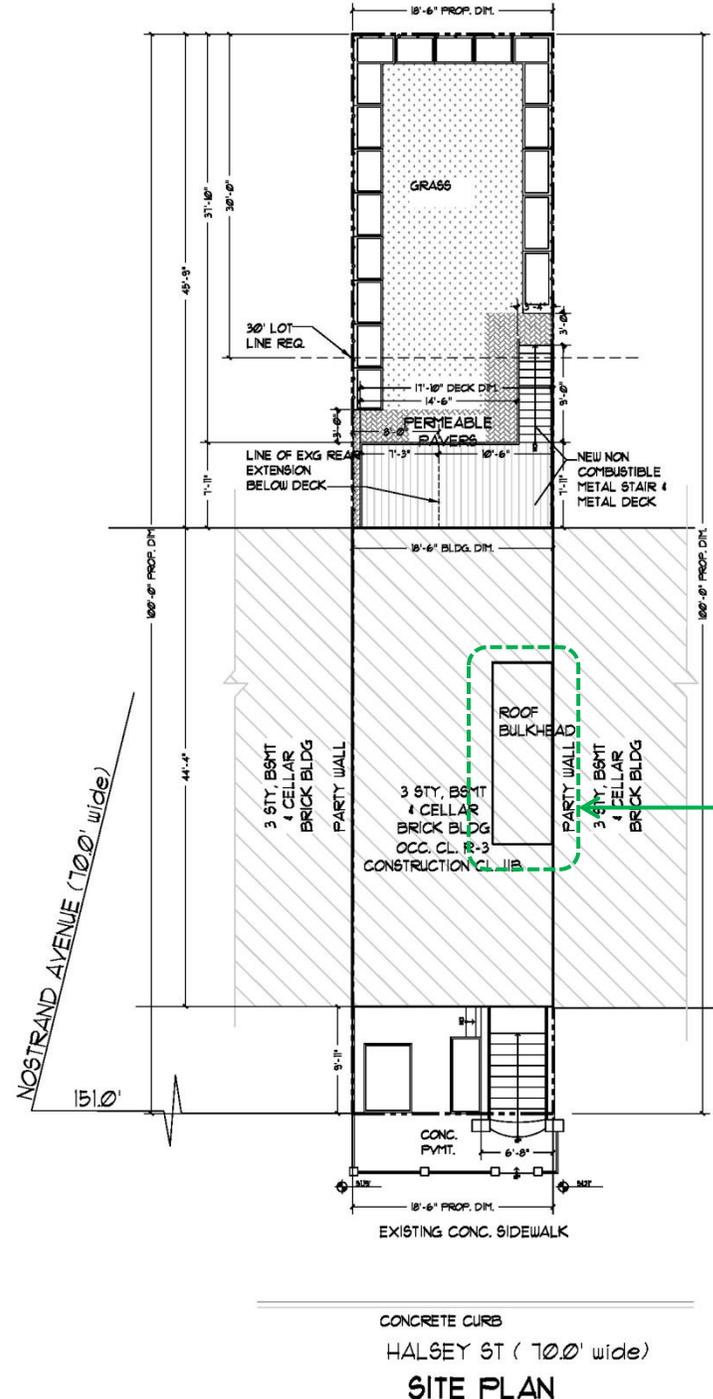
Proposed Site Plan (work in progress indicated in green)

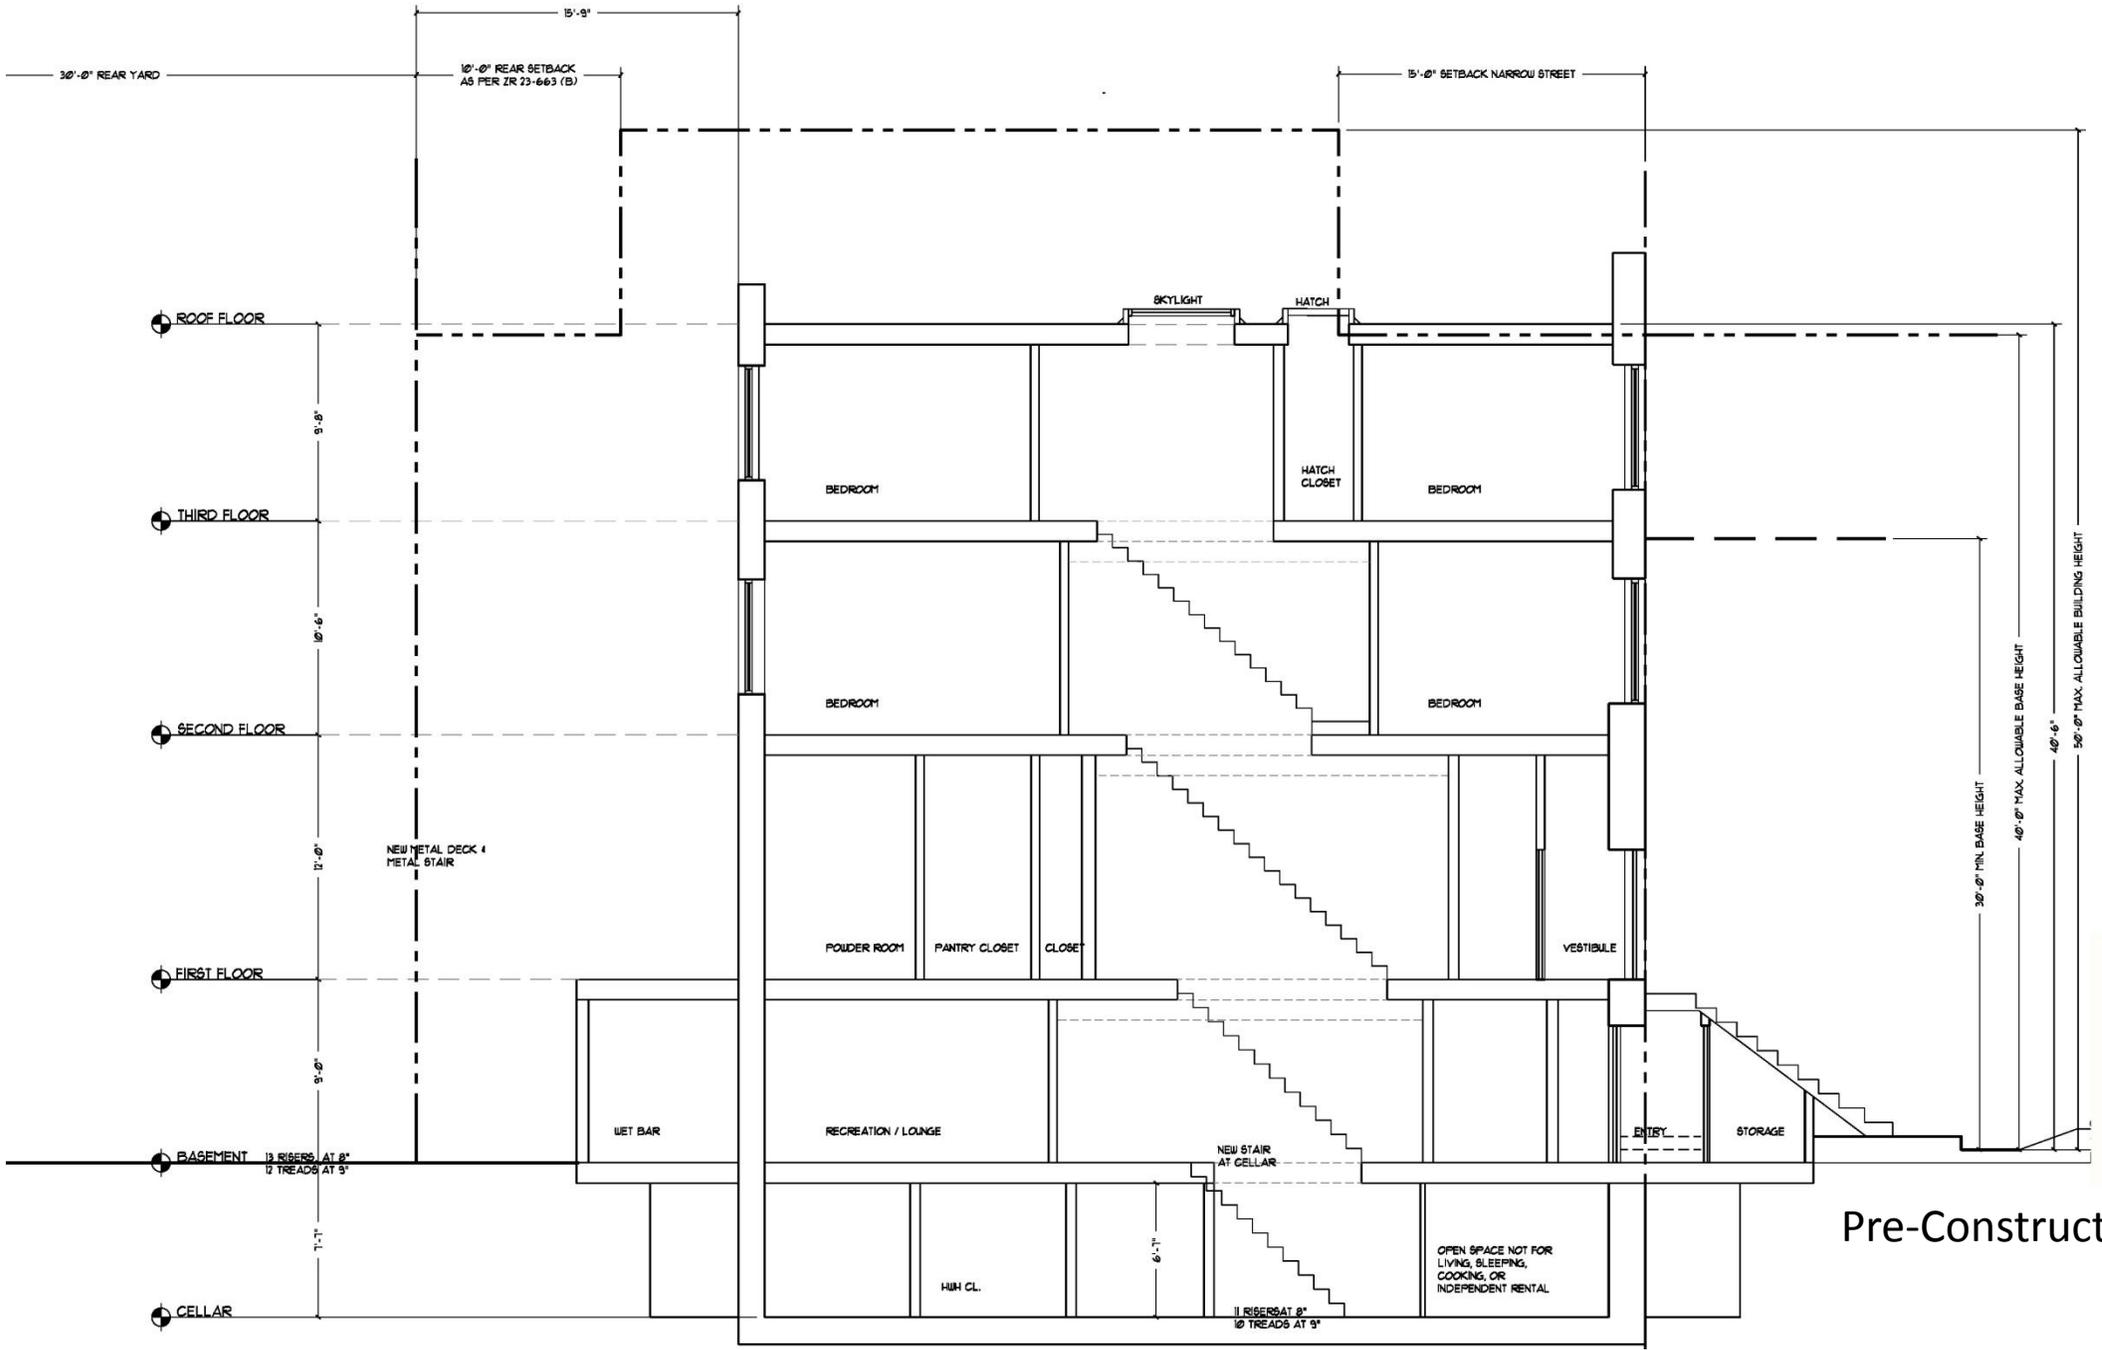
Pre-Construction Building Section

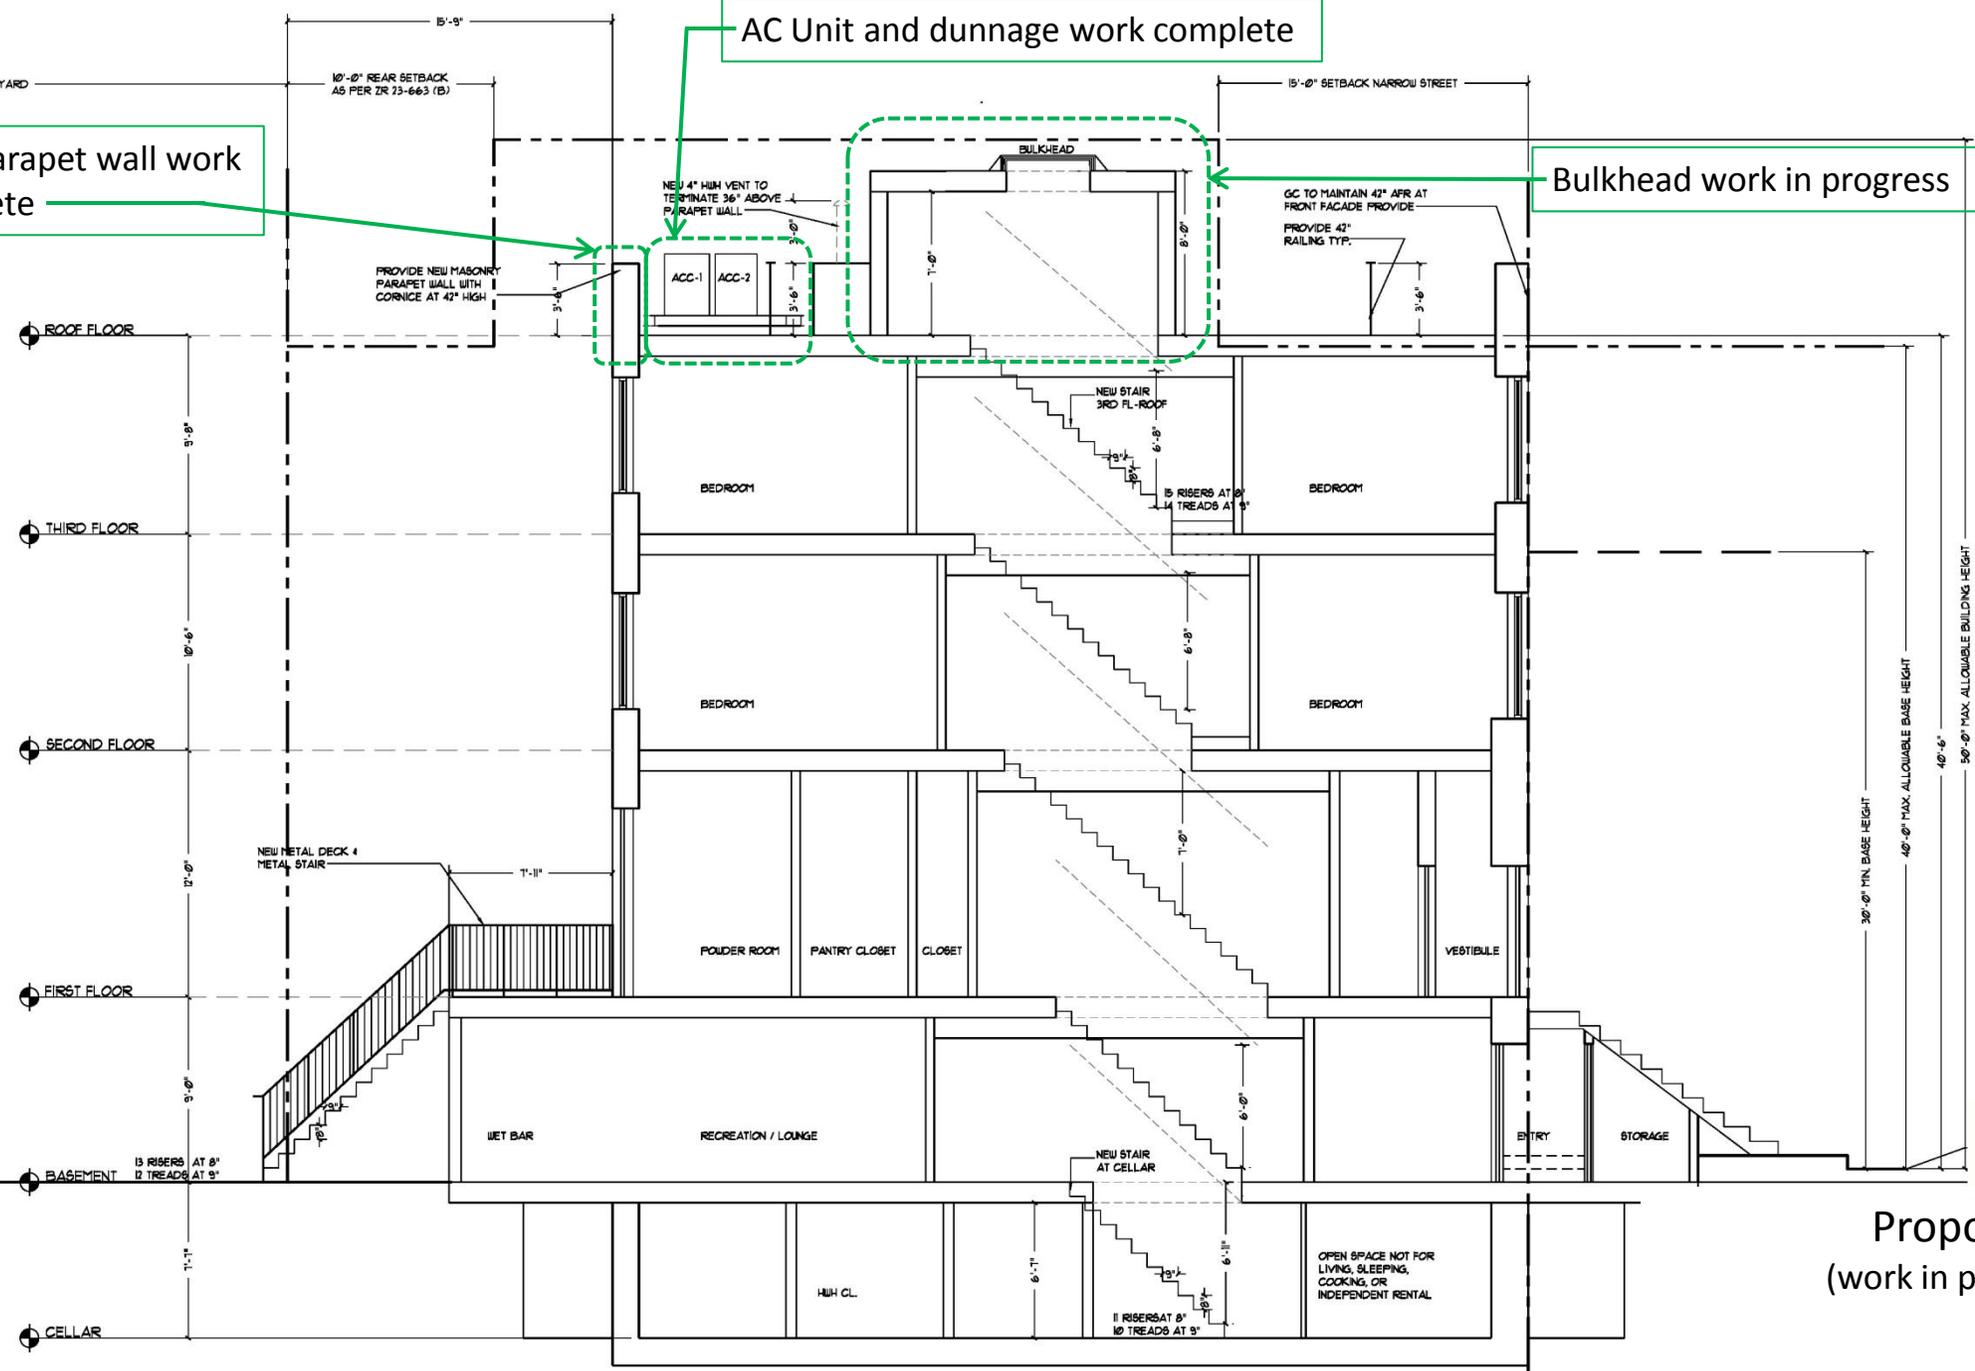
Rear Parapet wall work complete

AC Unit and dunnage work complete

Bulkhead work in progress

Proposed Building Section
(work in progress indicated in green)

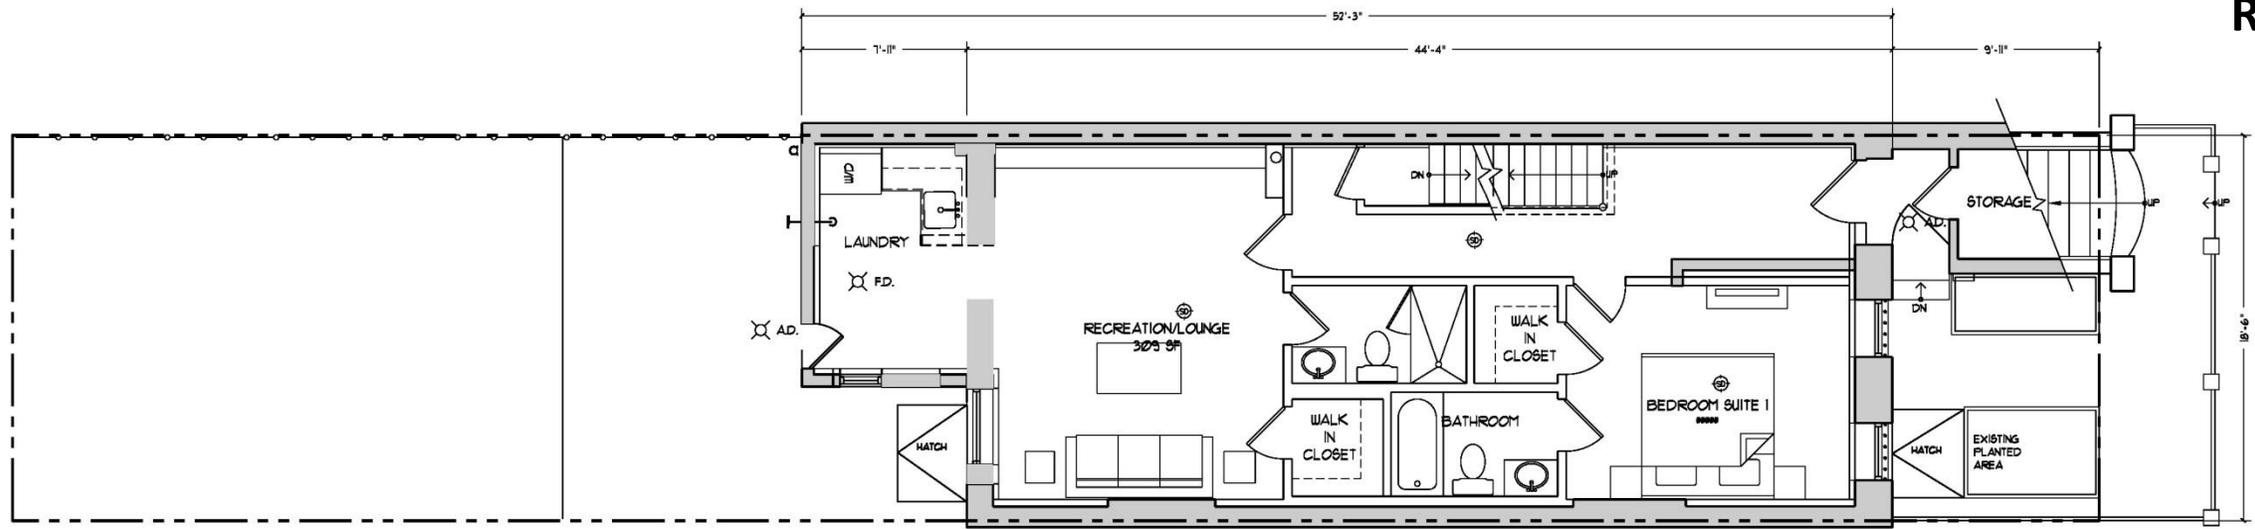
Pre-Construction Basement Plan

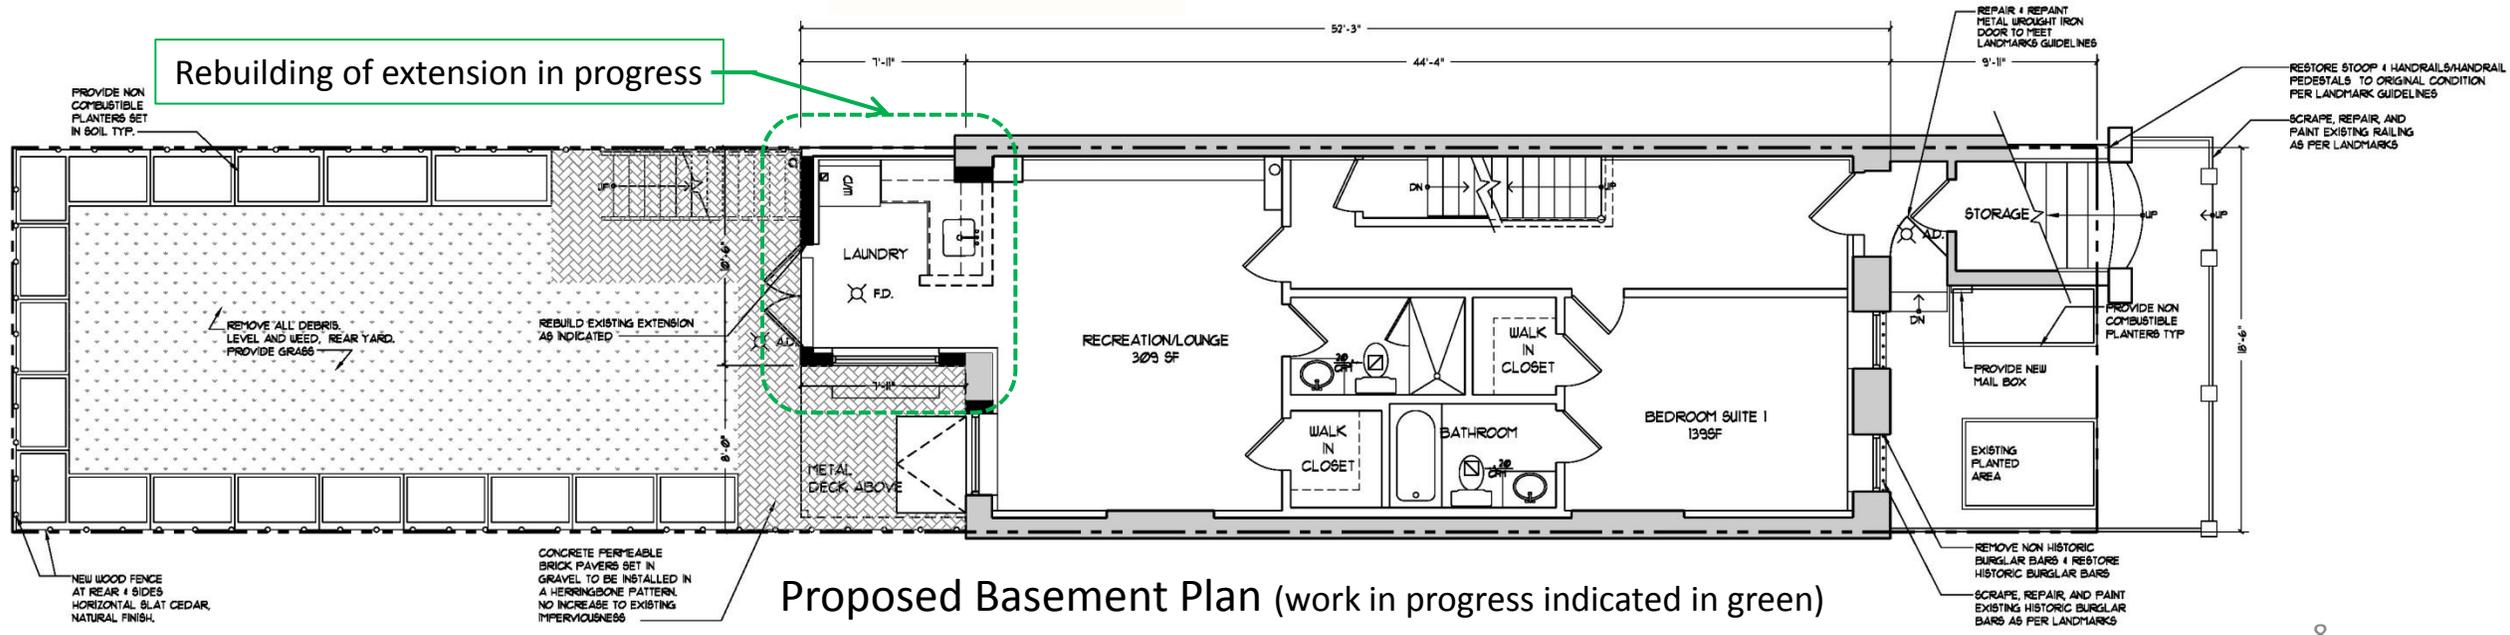
Proposed Basement Plan (work in progress indicated in green)

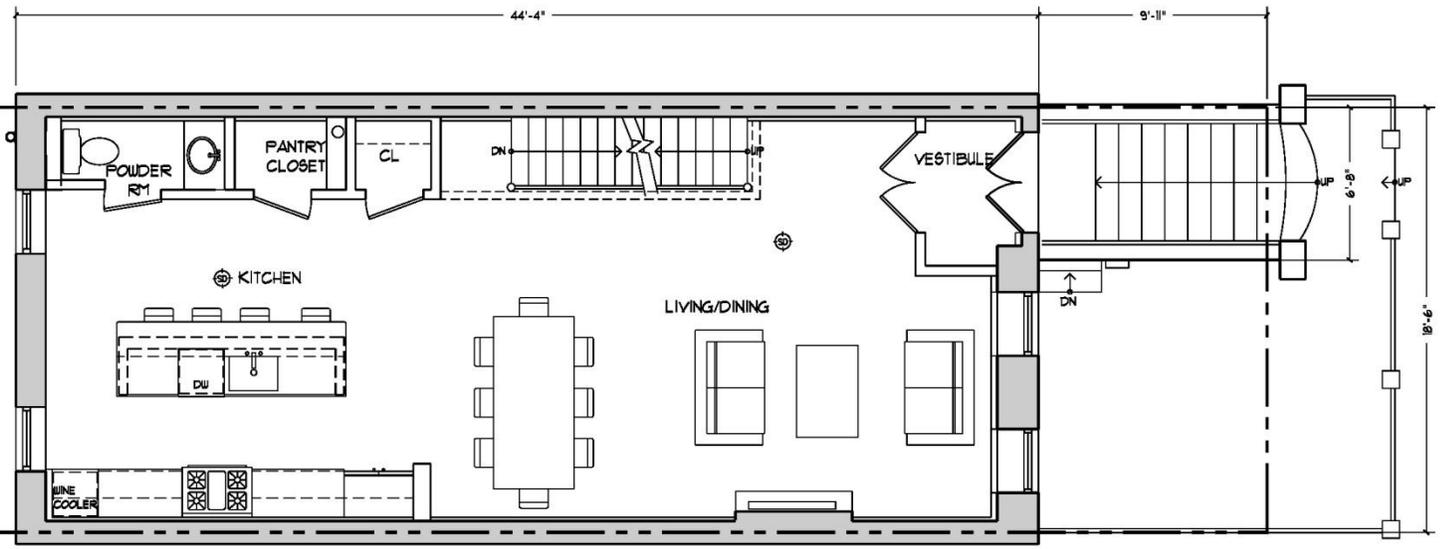
Pre-Construction First Floor Plan

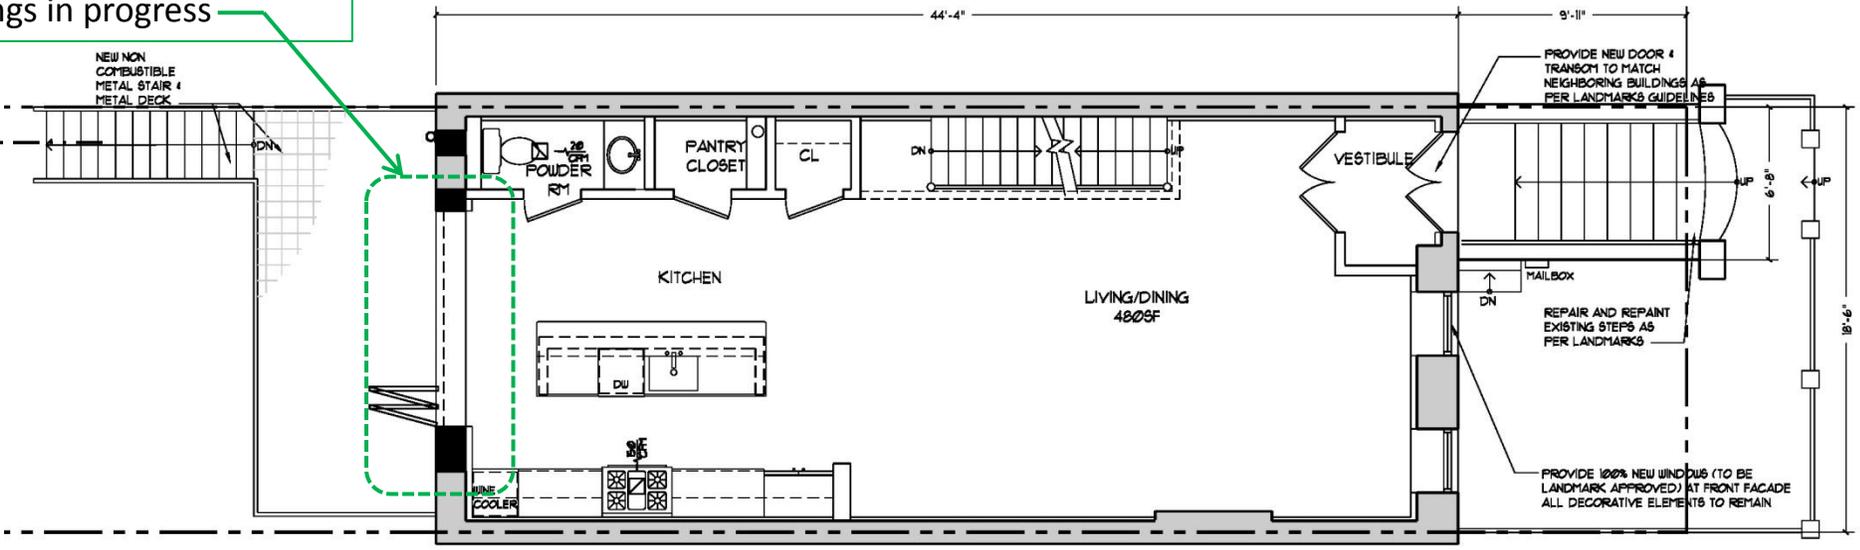
Modification of rear openings in progress

Proposed First Floor Plan (work in progress indicated in green)

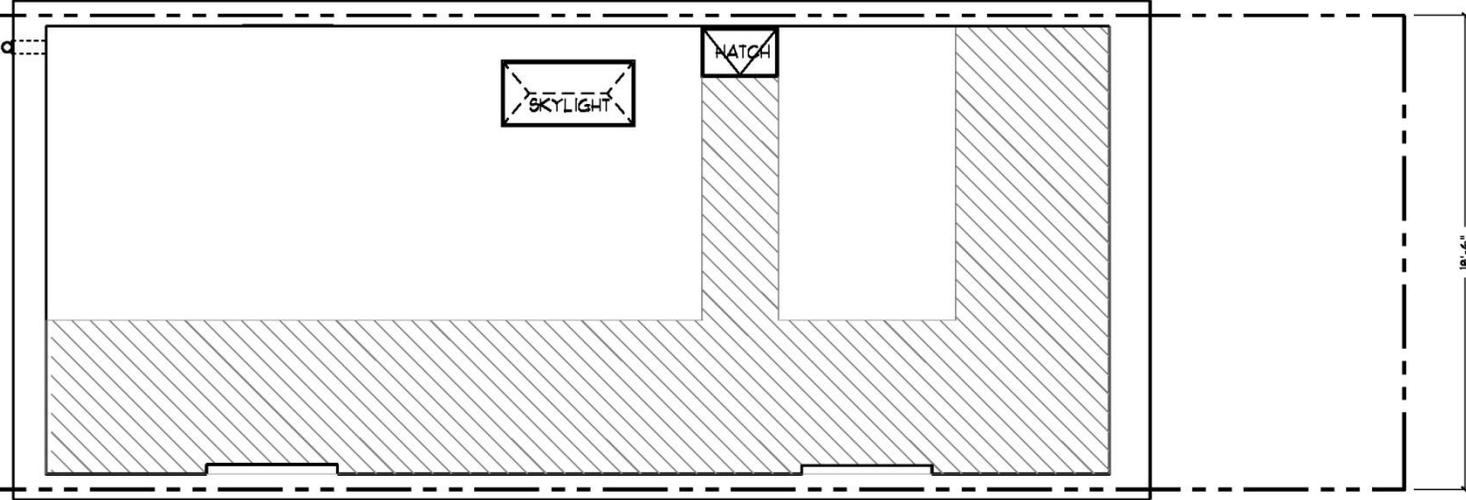
Pre-Construction Roof Plan

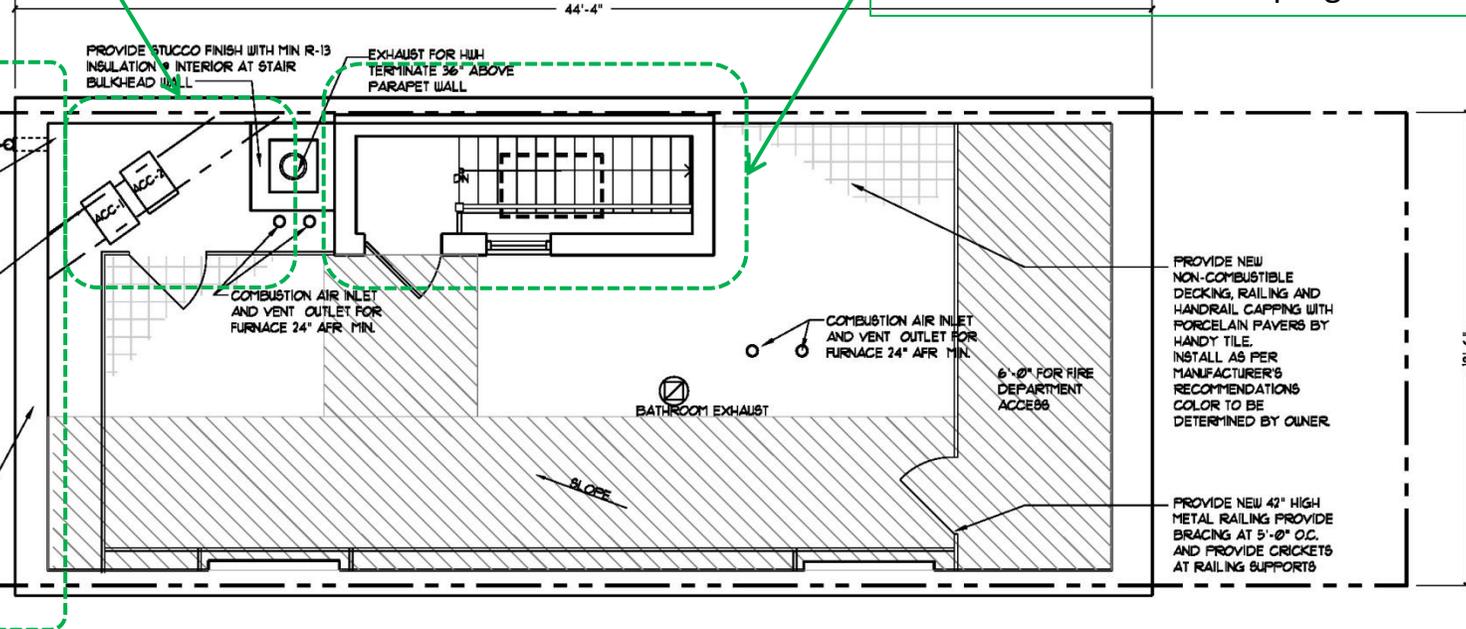
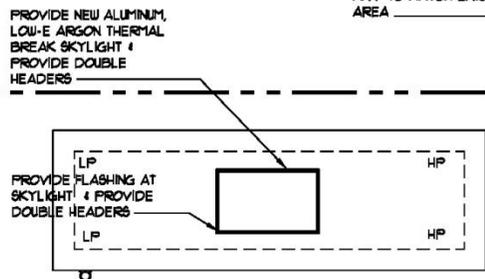
BULKHEAD PLAN

AC Unit and dunnage work complete

Bulkhead construction in progress

Rear Parapet wall work complete

Proposed Roof and Bulkhead Plan
(work in progress indicated in green)

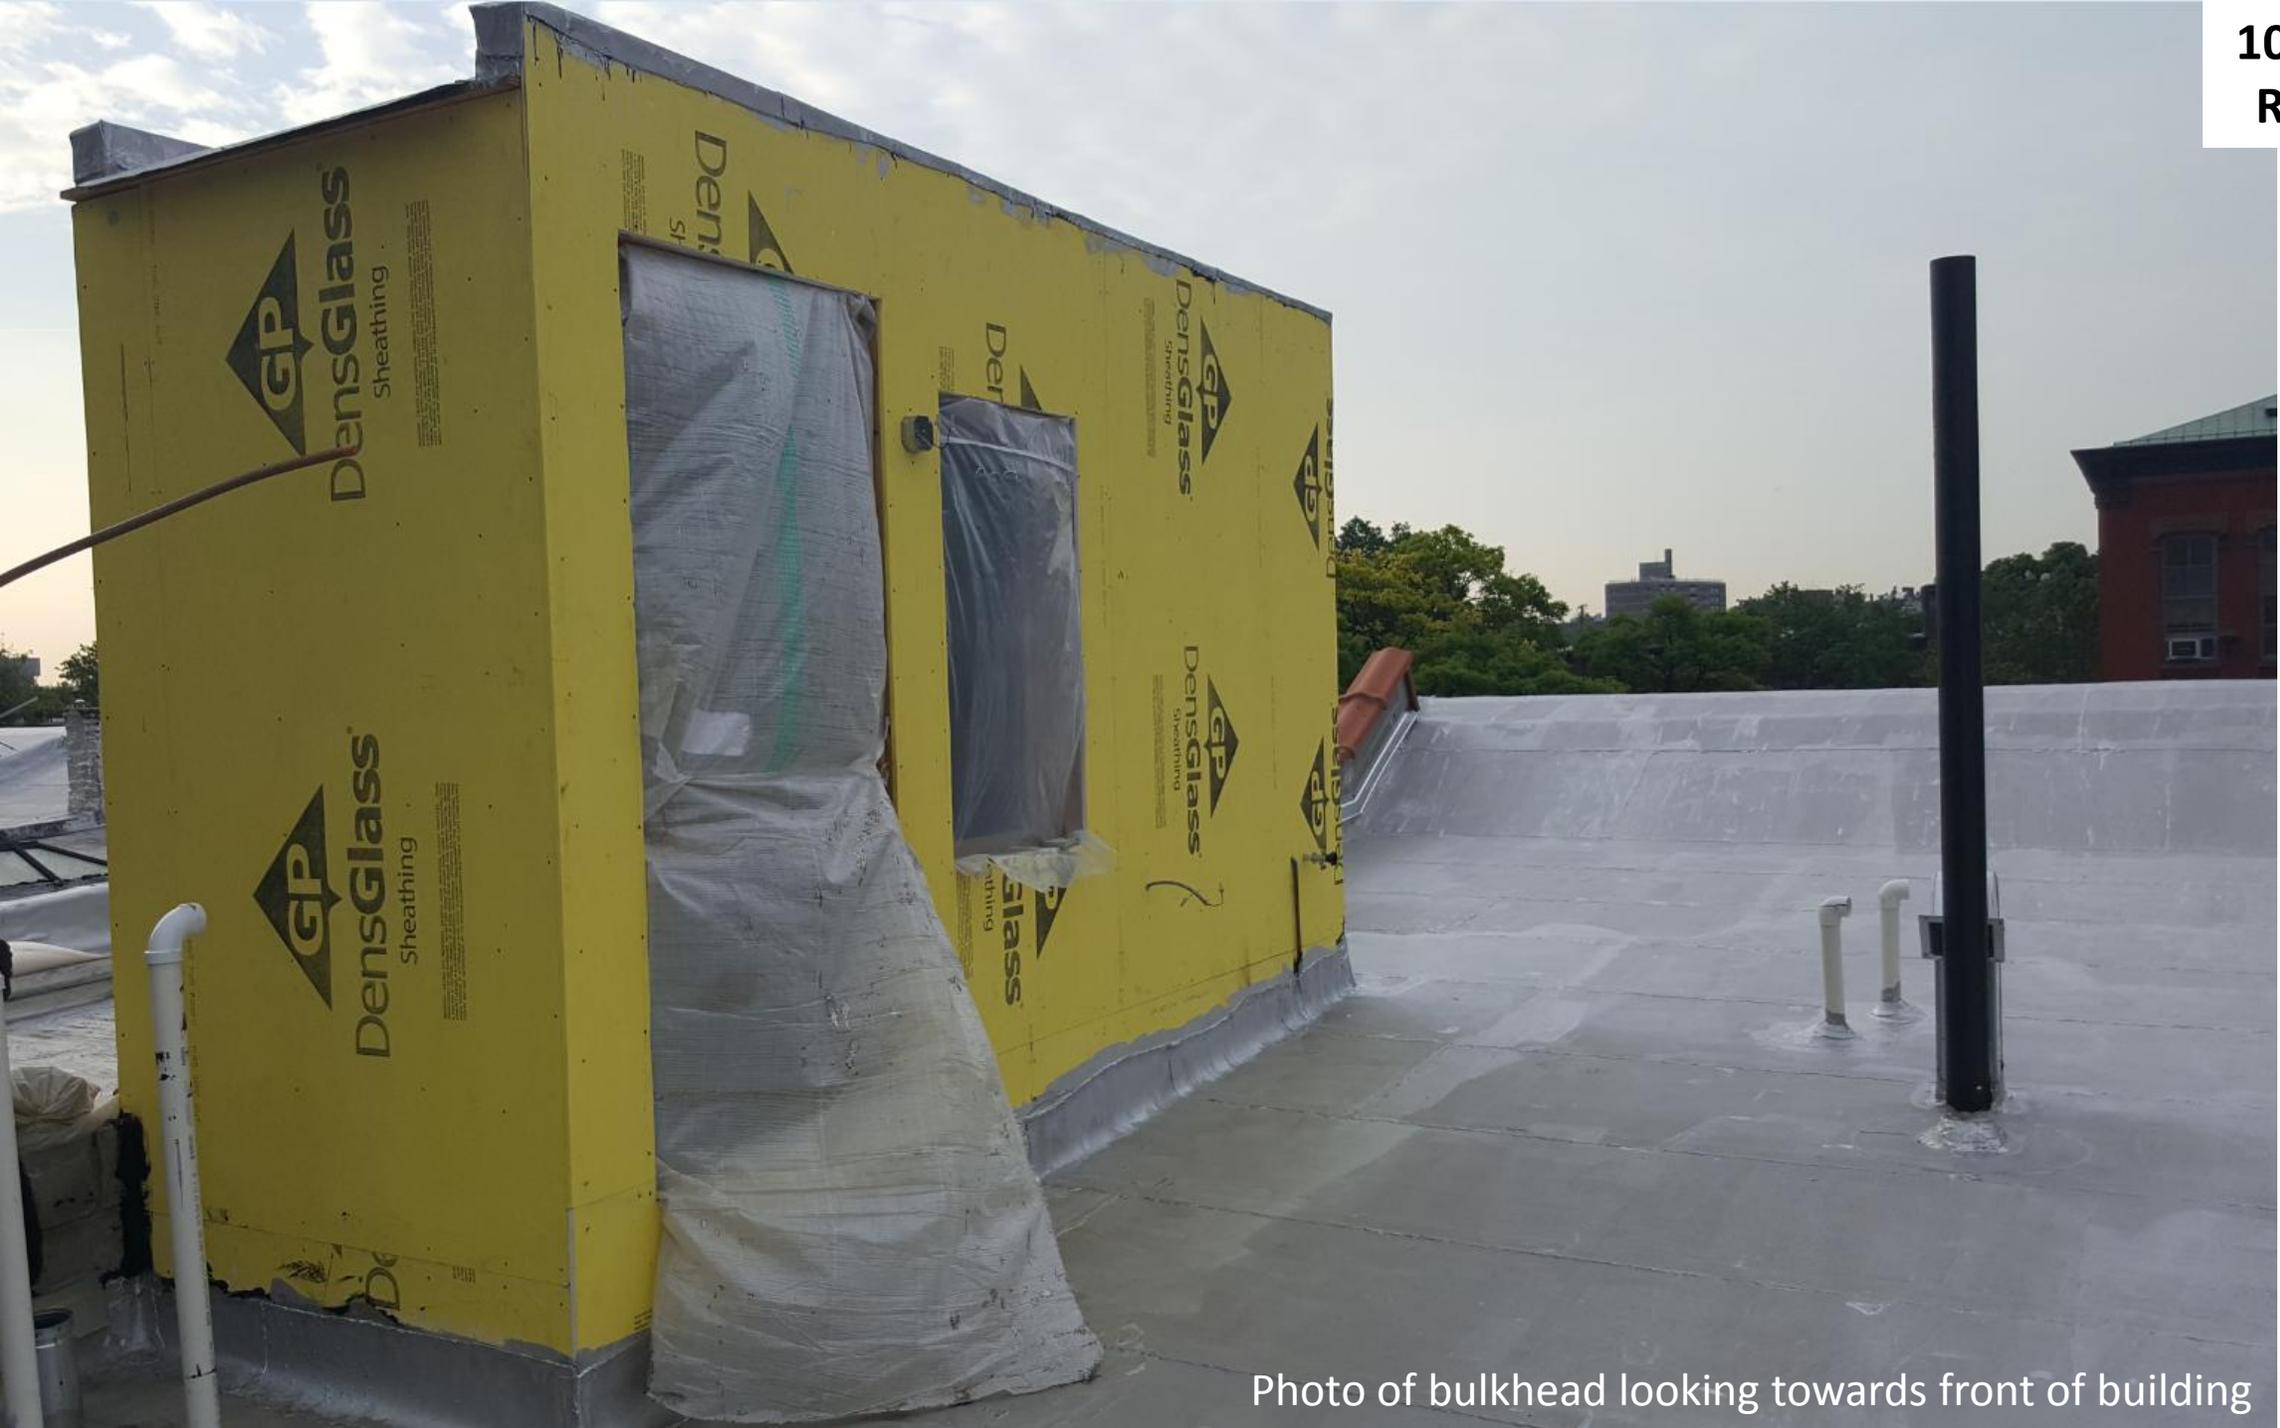
Photo of bulkhead looking towards front of building
