**109 Halsey St
Brooklyn, NY
Renovations**

109 Halsey St Renovations

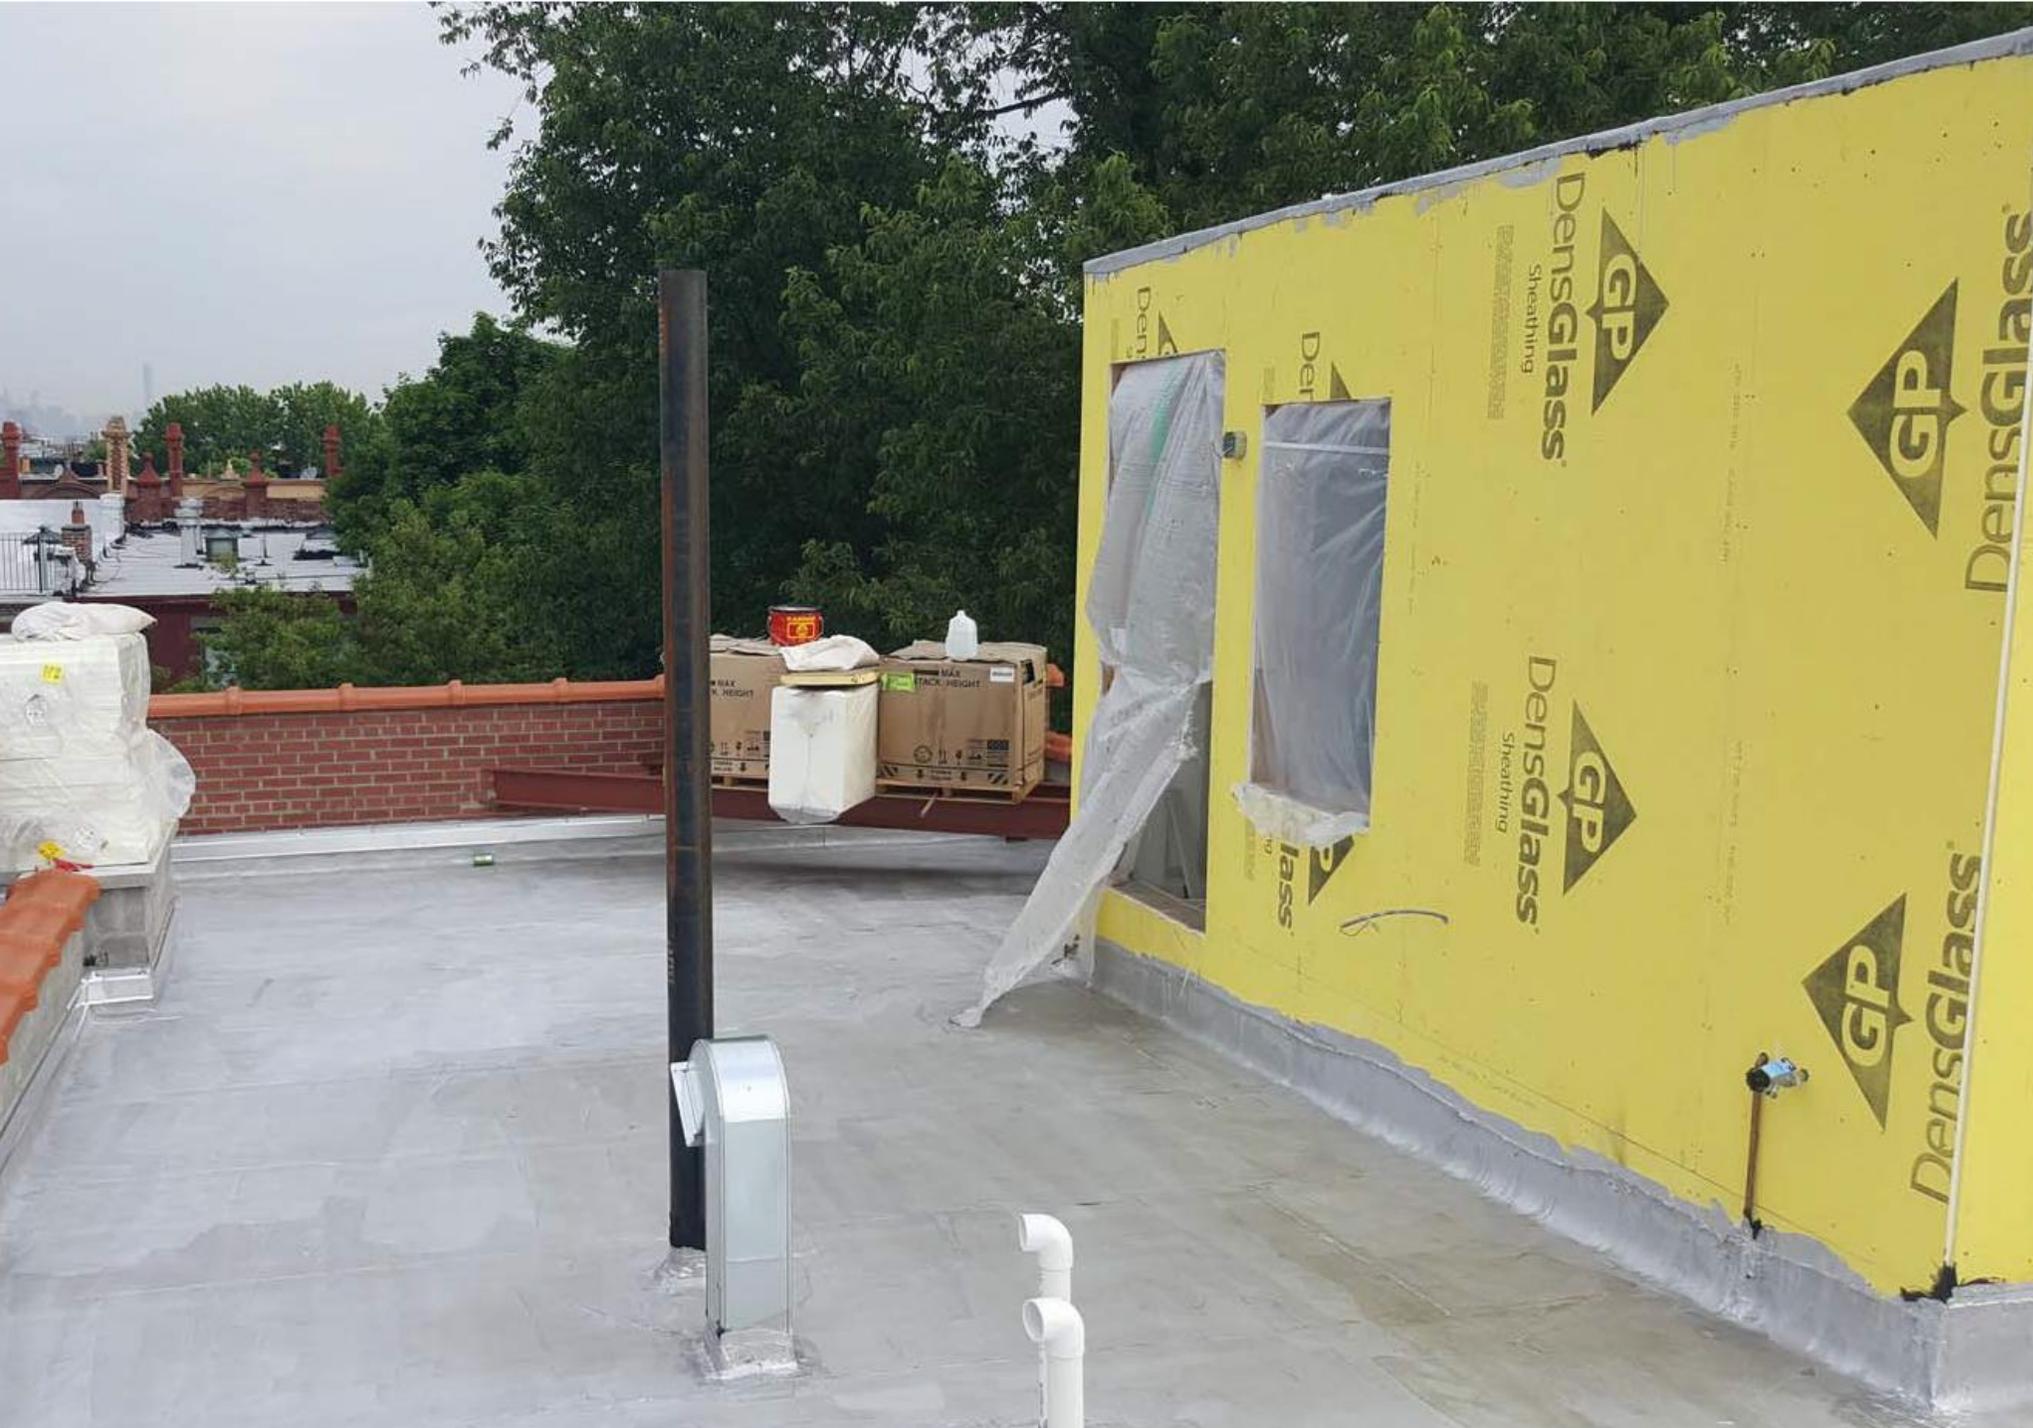
Photo of Bulkhead and raised parapet looking towards rear of building

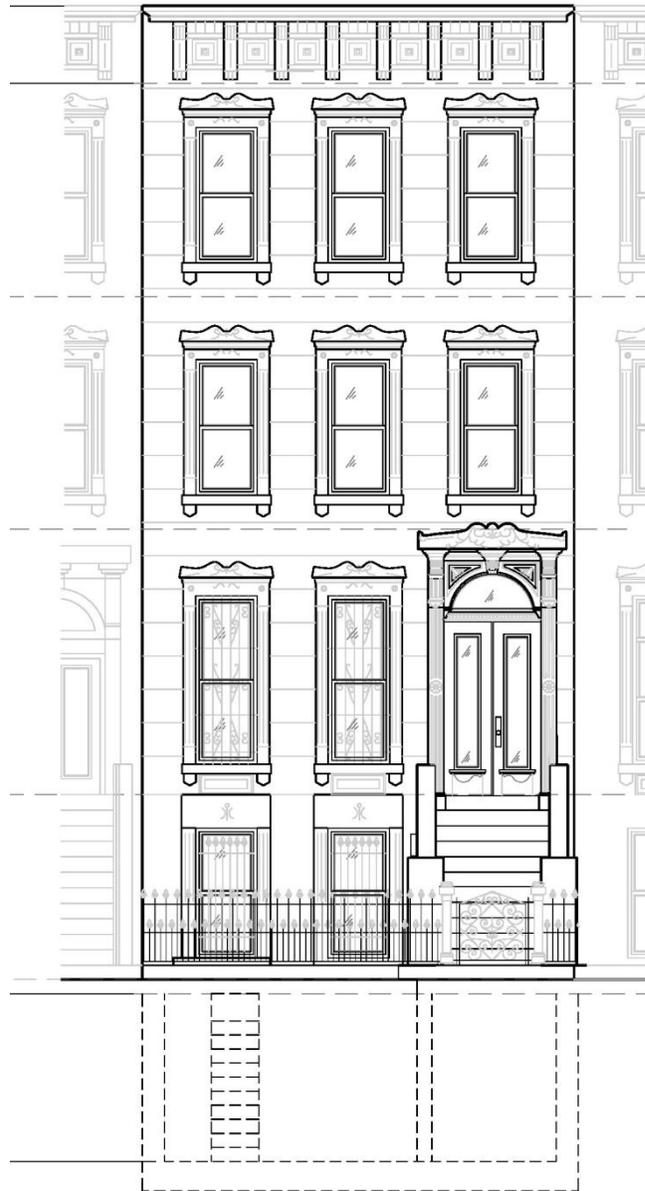
Pre-Construction Front Facade

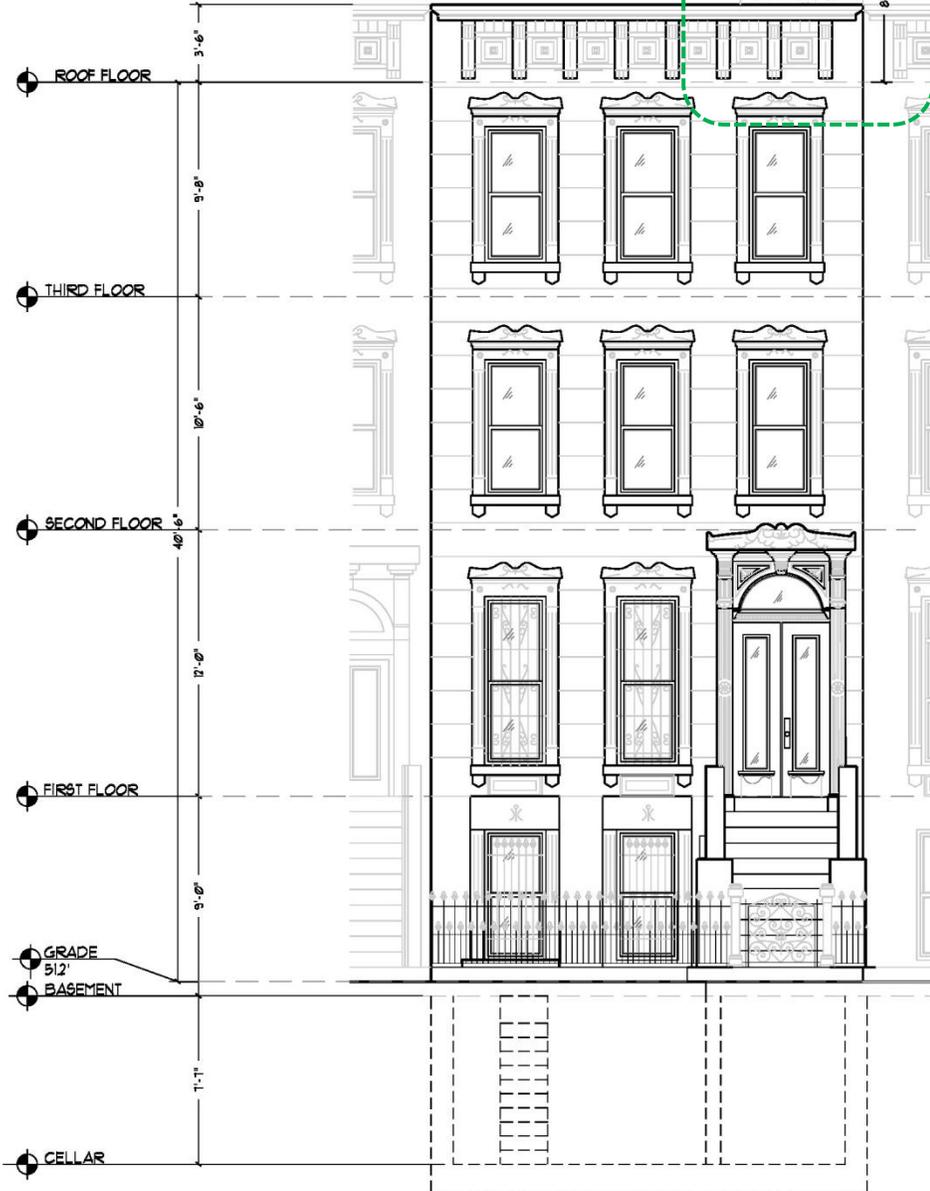
Proposed Front Facade

NEW STAIR BULKHEAD WITH STUCCO FINISH AND MIN R-13 CONTINUOUS INSULATION AT INSIDE

Bulkhead construction in progress

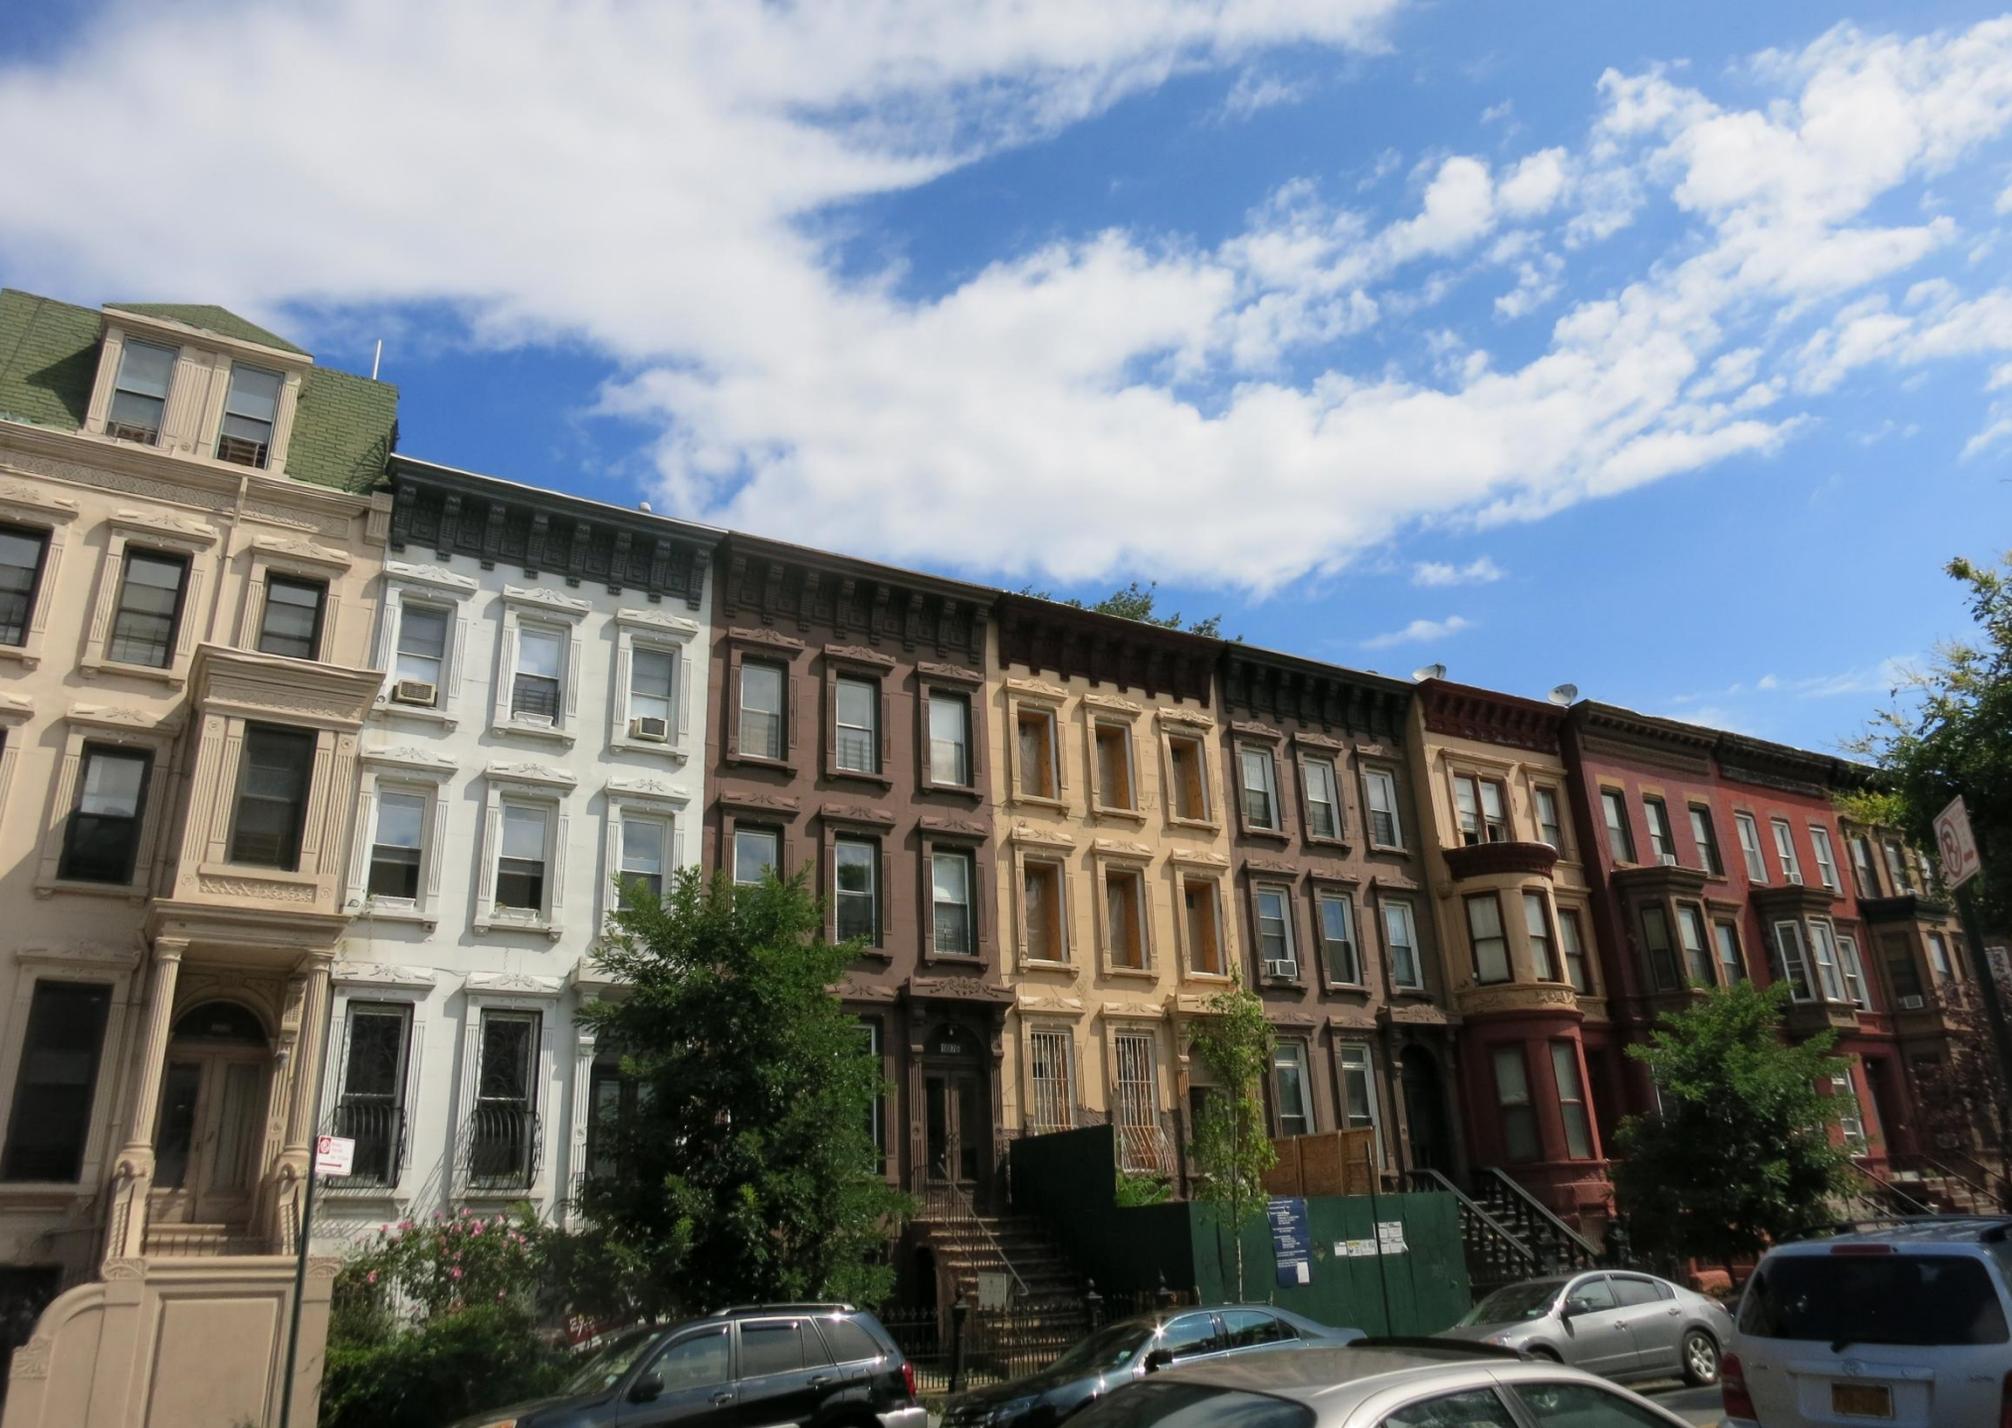
Current view of Building
at Halsey St indicating
no visibility of bulkhead

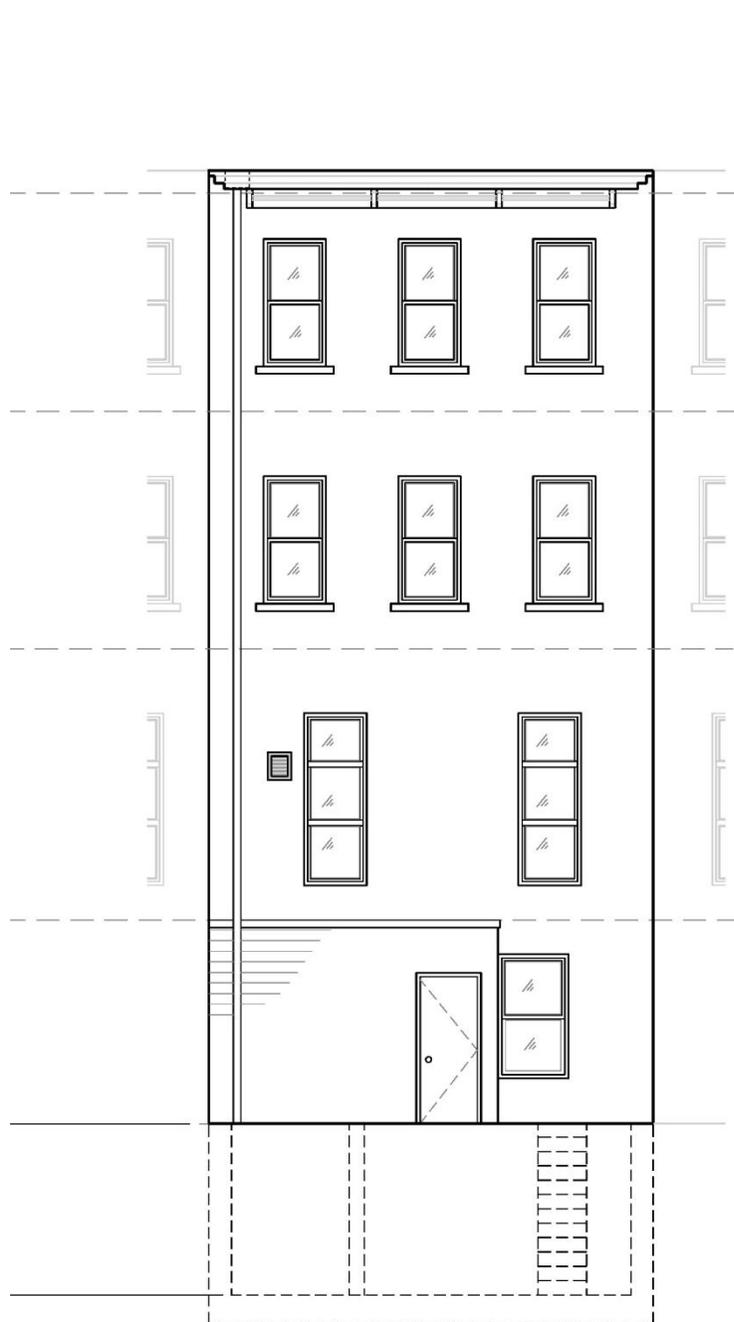
Pre-Construction Rear Facade

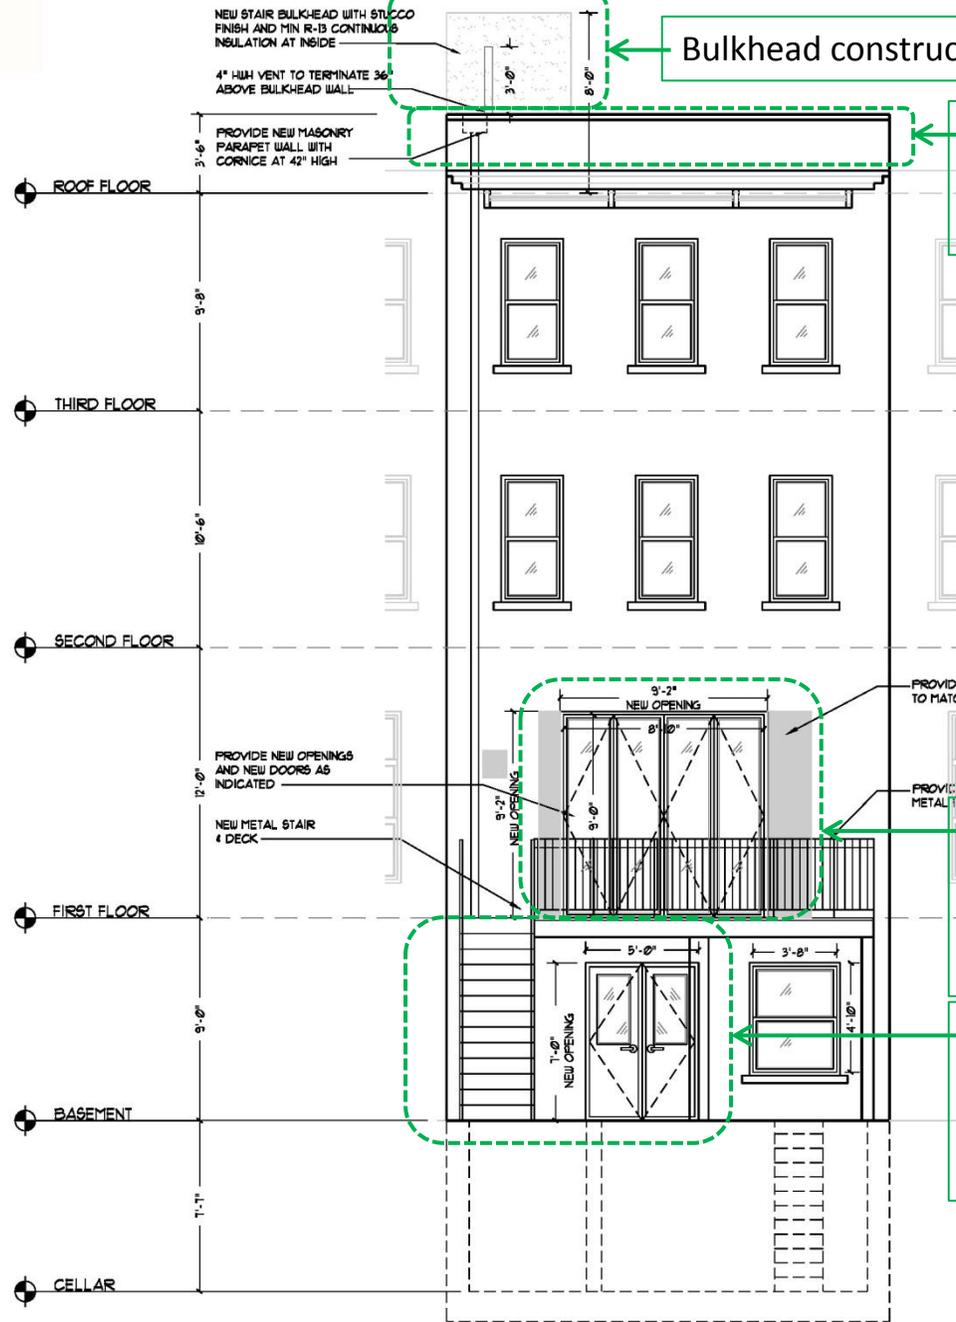
Proposed Rear Facade

Bulkhead construction in progress

Rear Parapet work complete

Modification of rear openings ongoing

Rear extension work ongoing

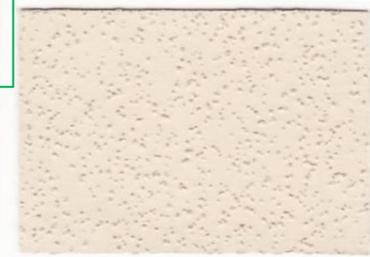
Clear Linen 10431(81)
Proposed Stucco Finish at Bulkhead and Extension

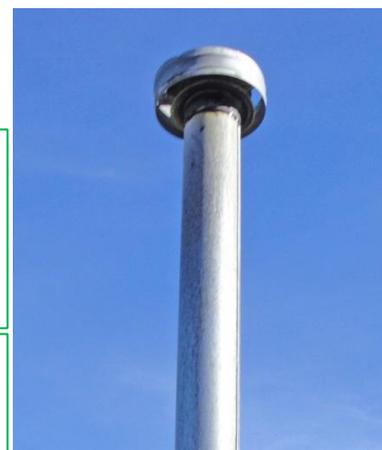
Sample Exhaust Flue

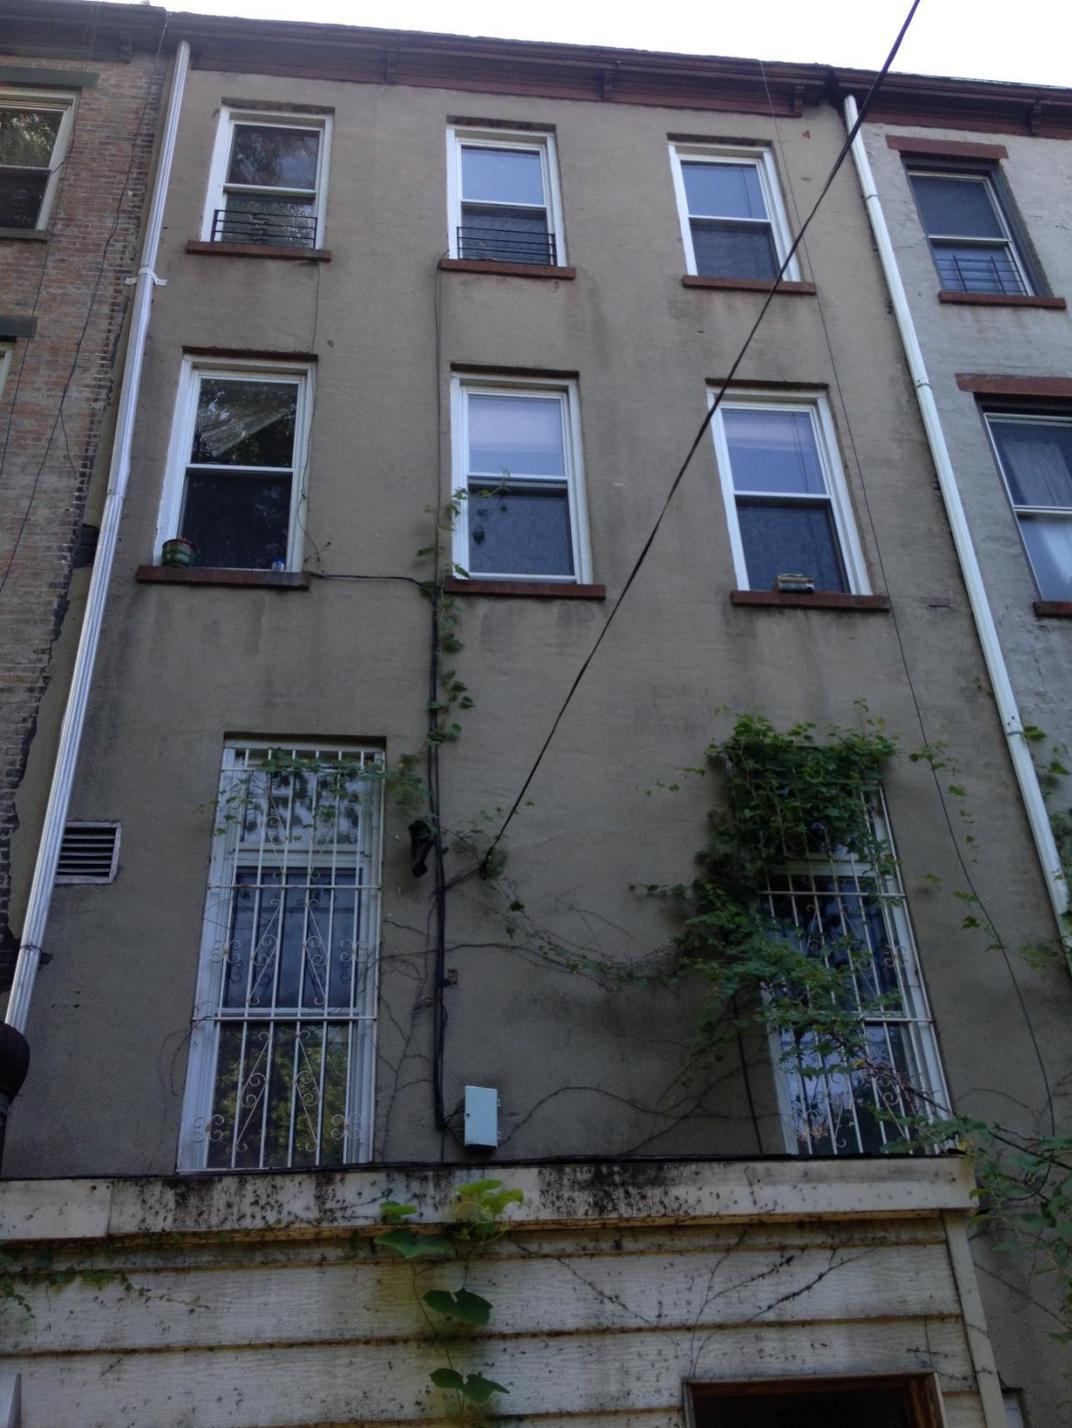
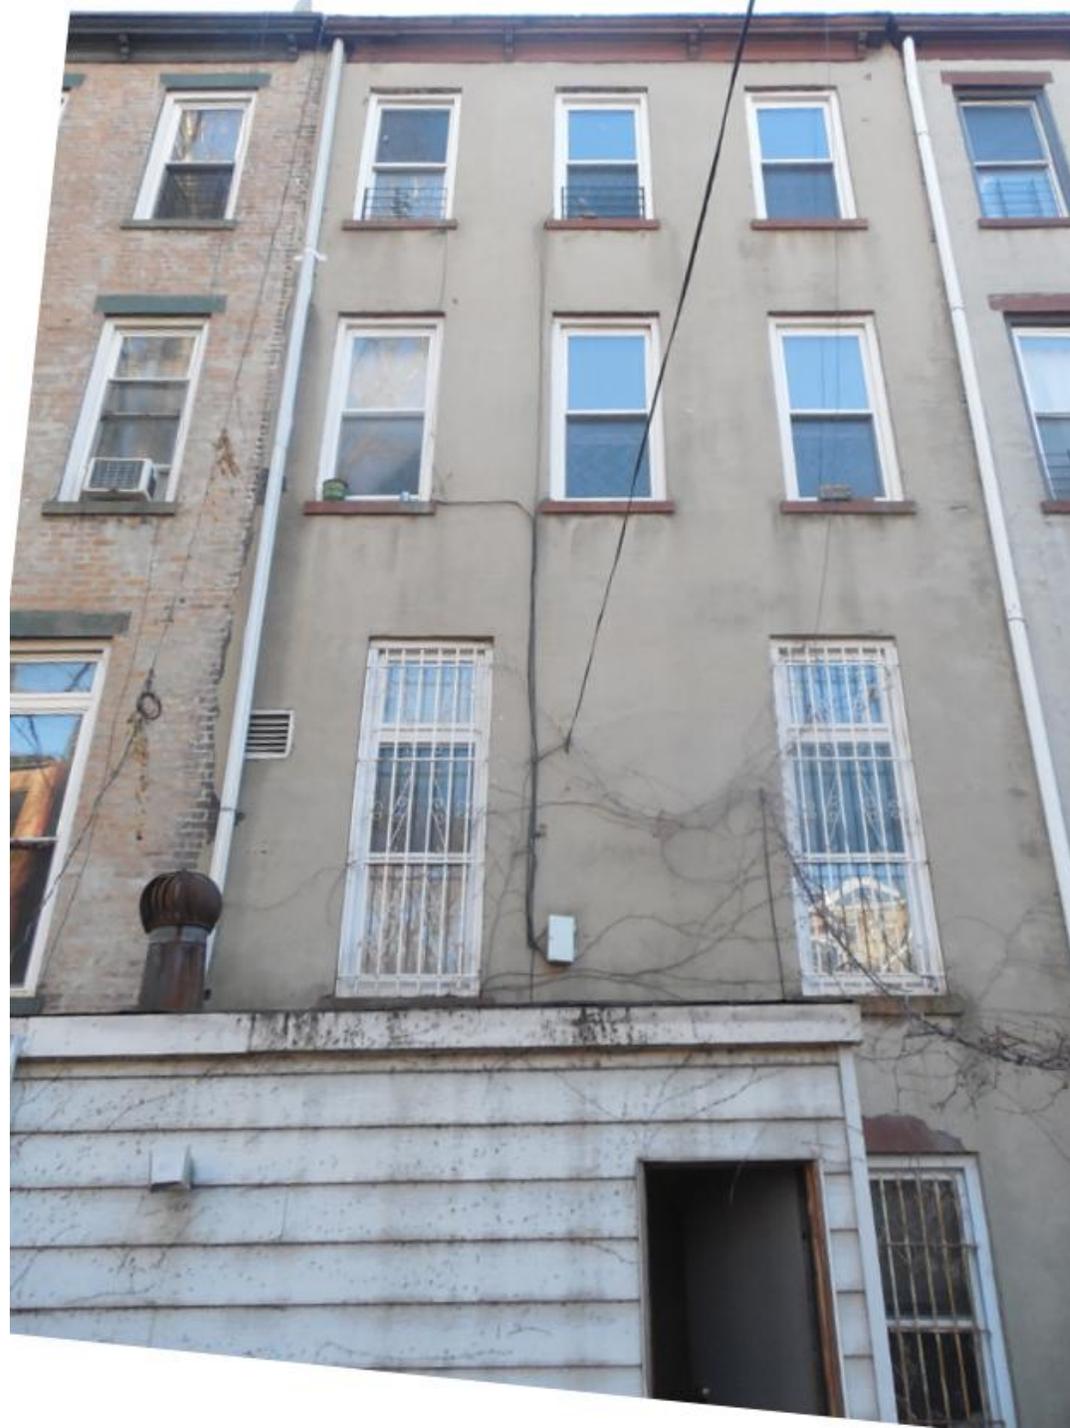
Photos of rear
façade prior to
construction

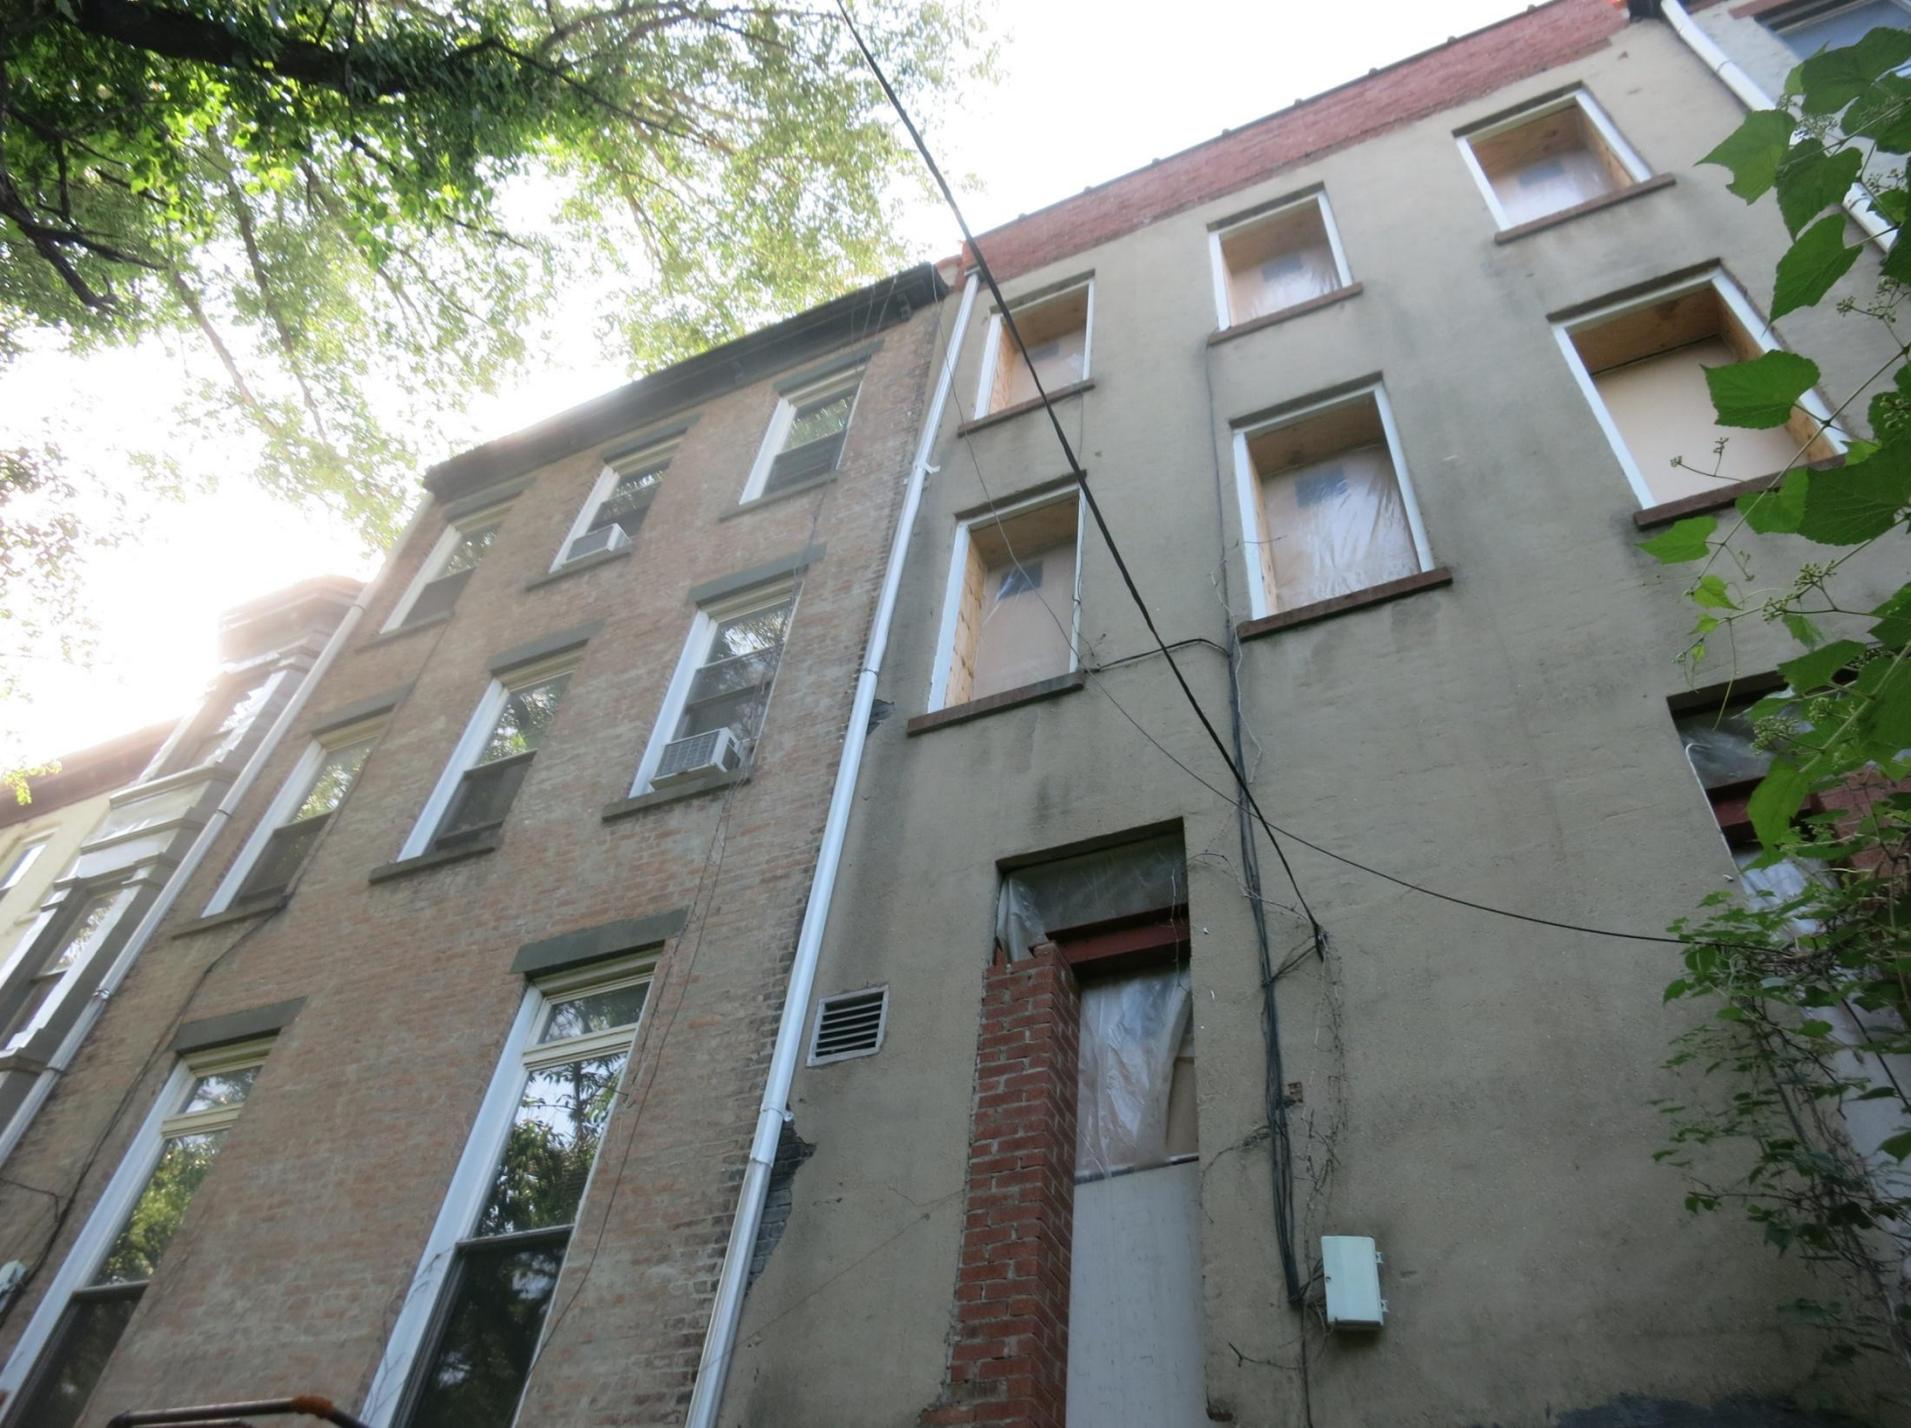
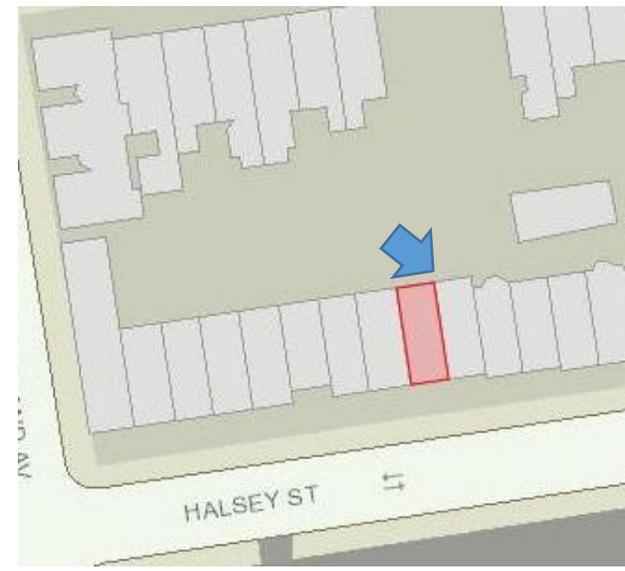
Photo of rear showing raised parapet, no AC visibility, modification of rear openings in progress, and neighboring building

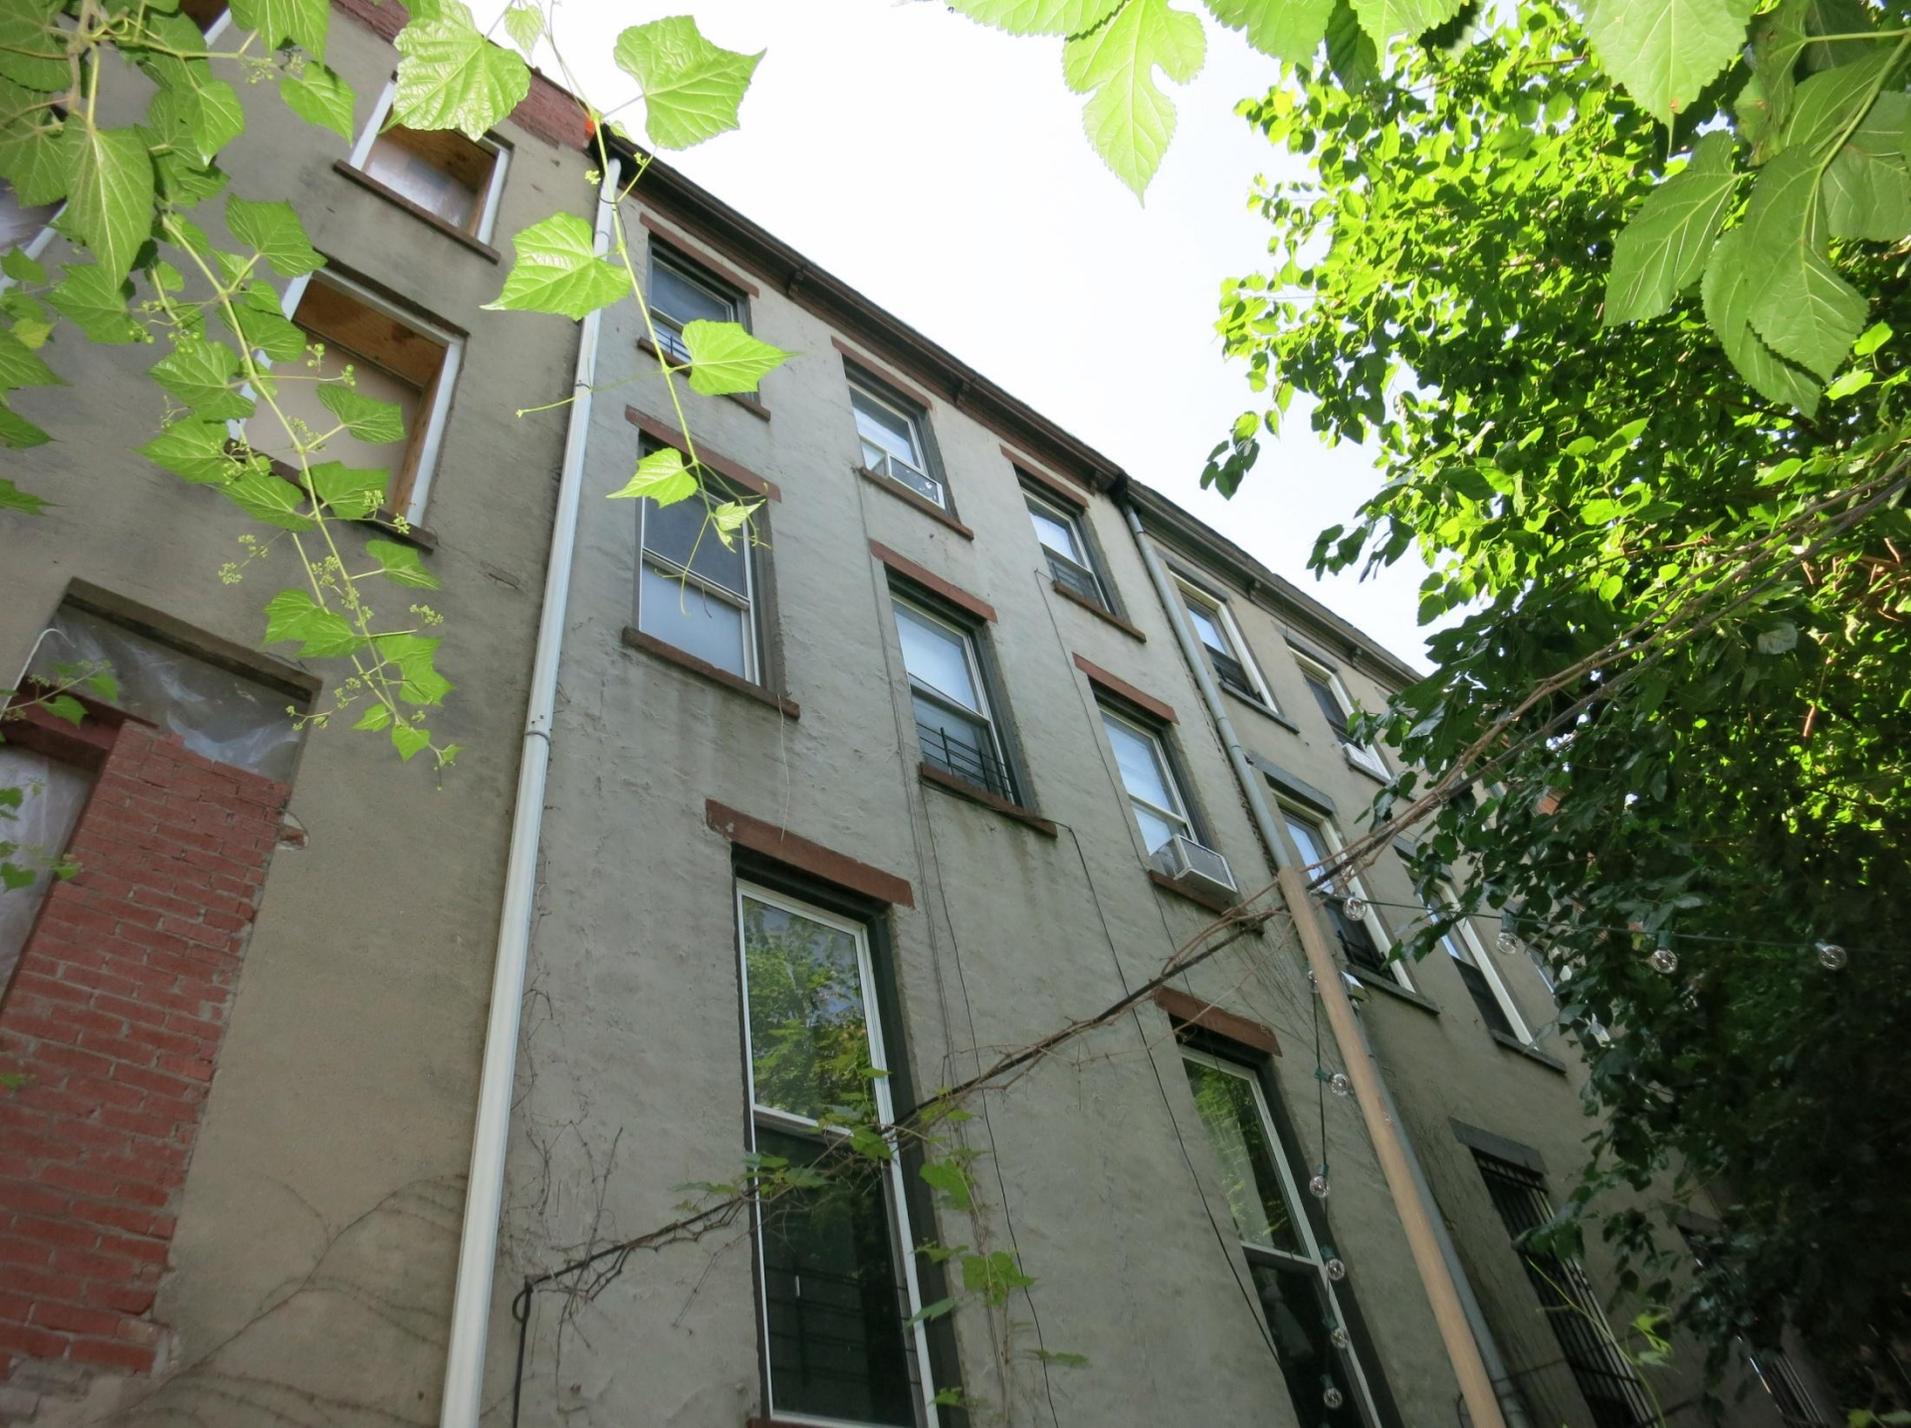
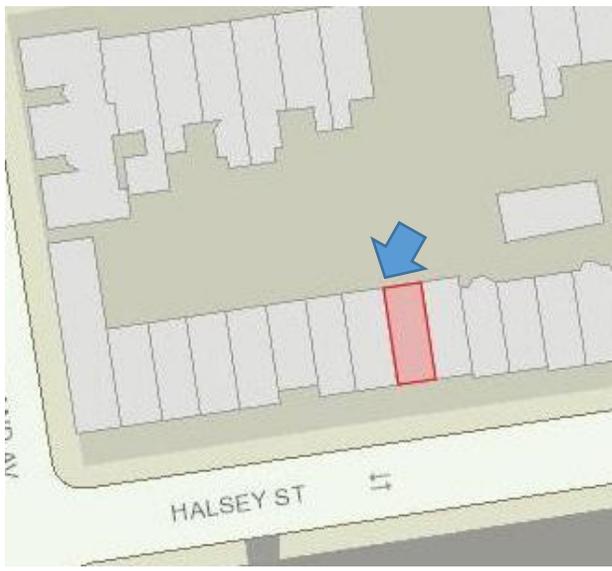
Photo of rear showing raised parapet, modification of rear openings in progress, and neighboring building

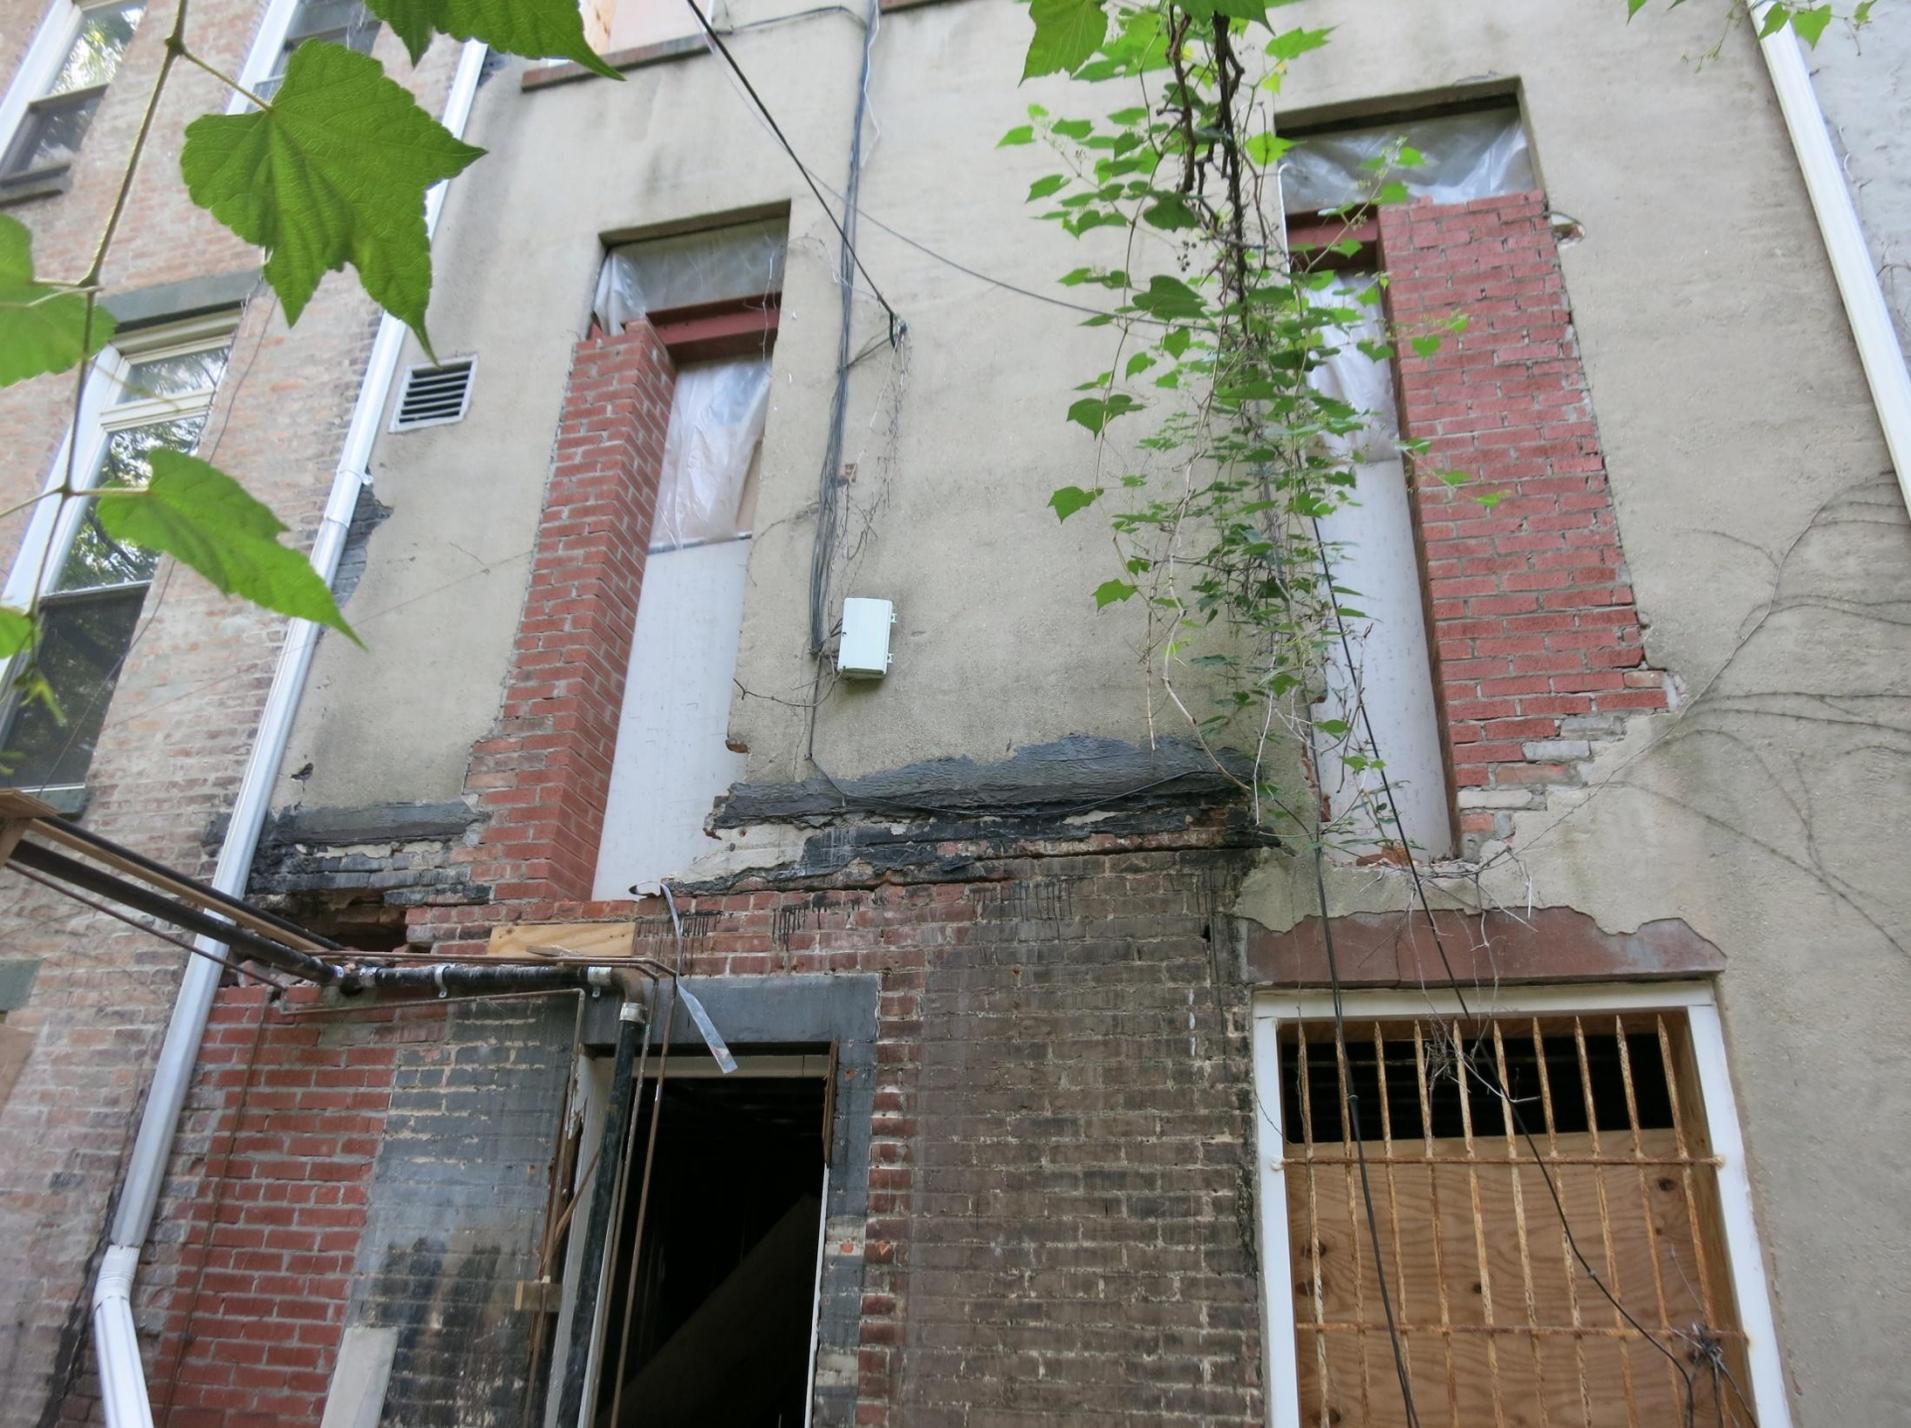
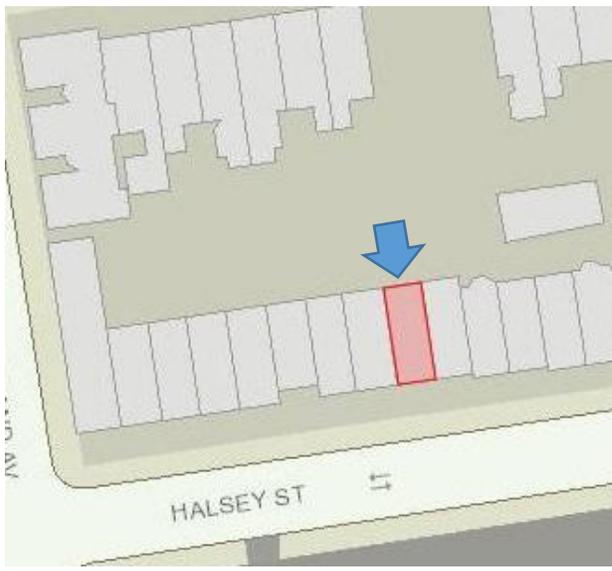
Photo of rear showing modification of rear openings in progress at 1st floor and removed extension at basement level
