**109 Halsey St
Brooklyn, NY
Renovations**

109 Halsey St Renovations

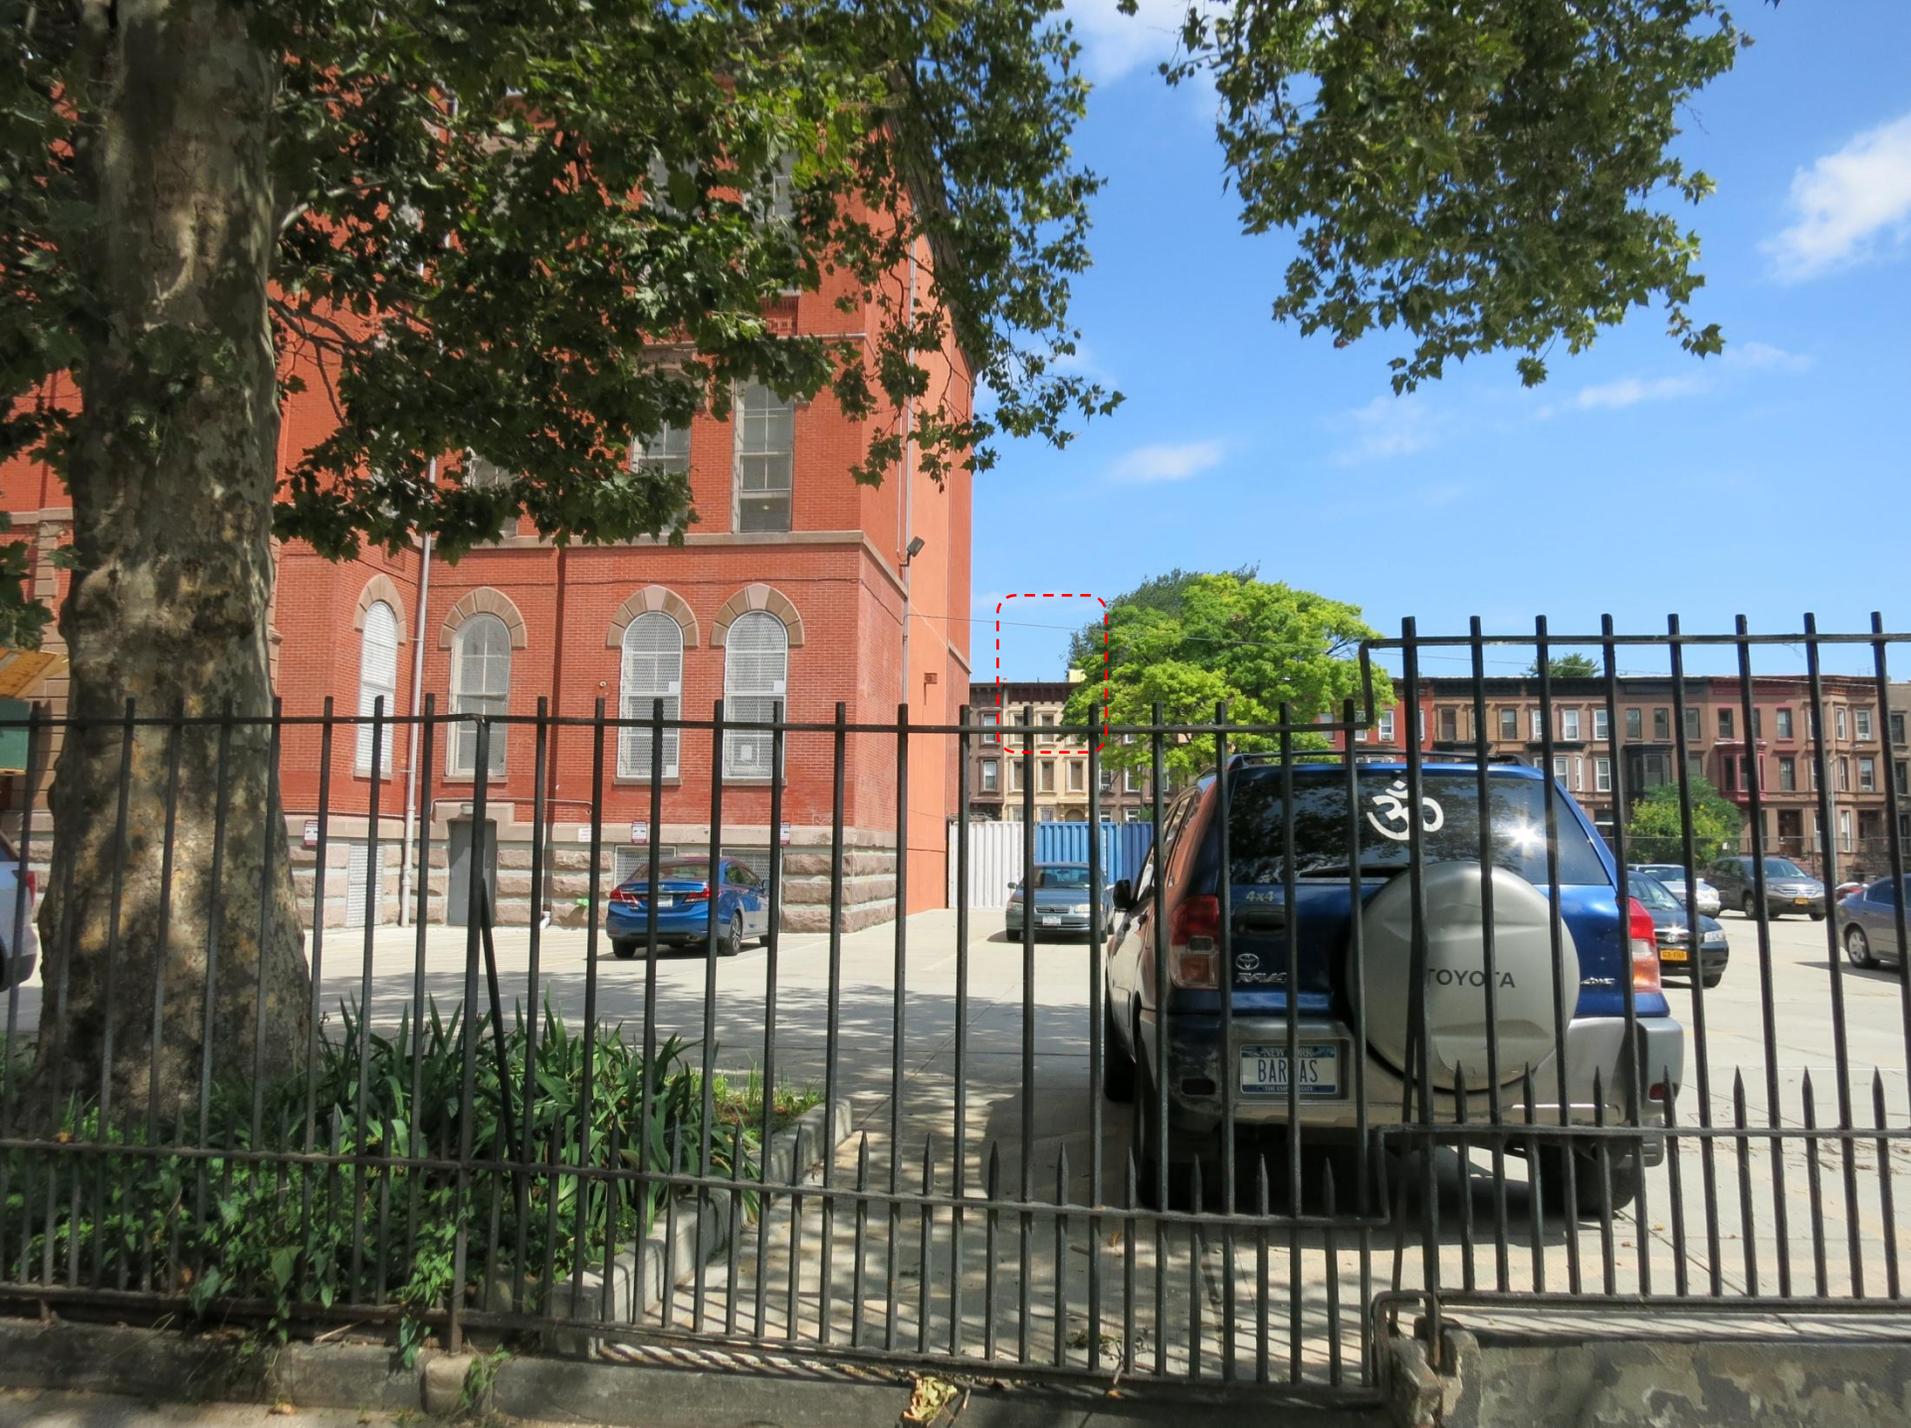
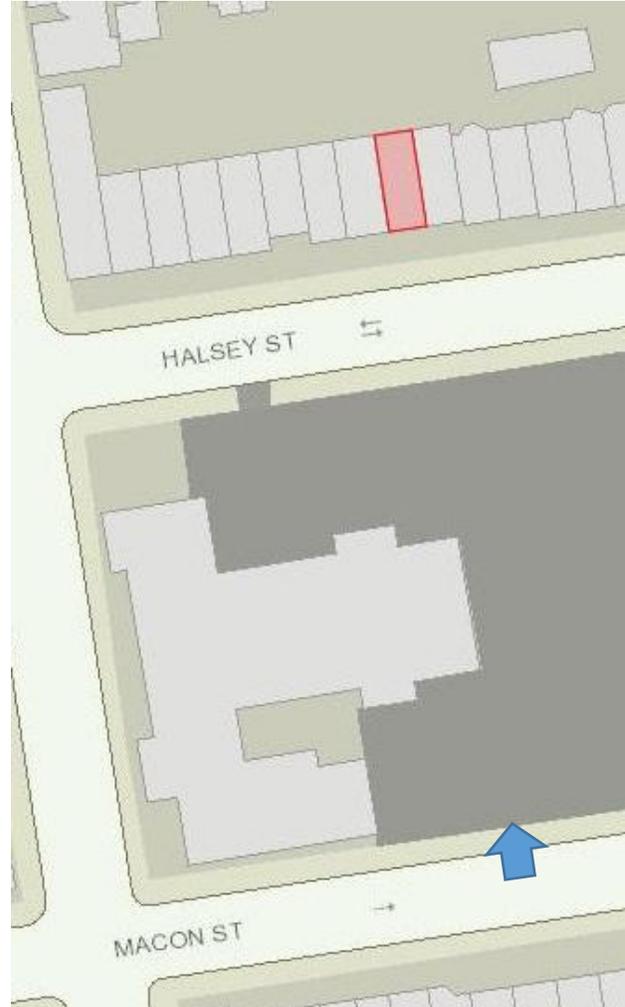
Visibility of Bulkhead
from Macon St

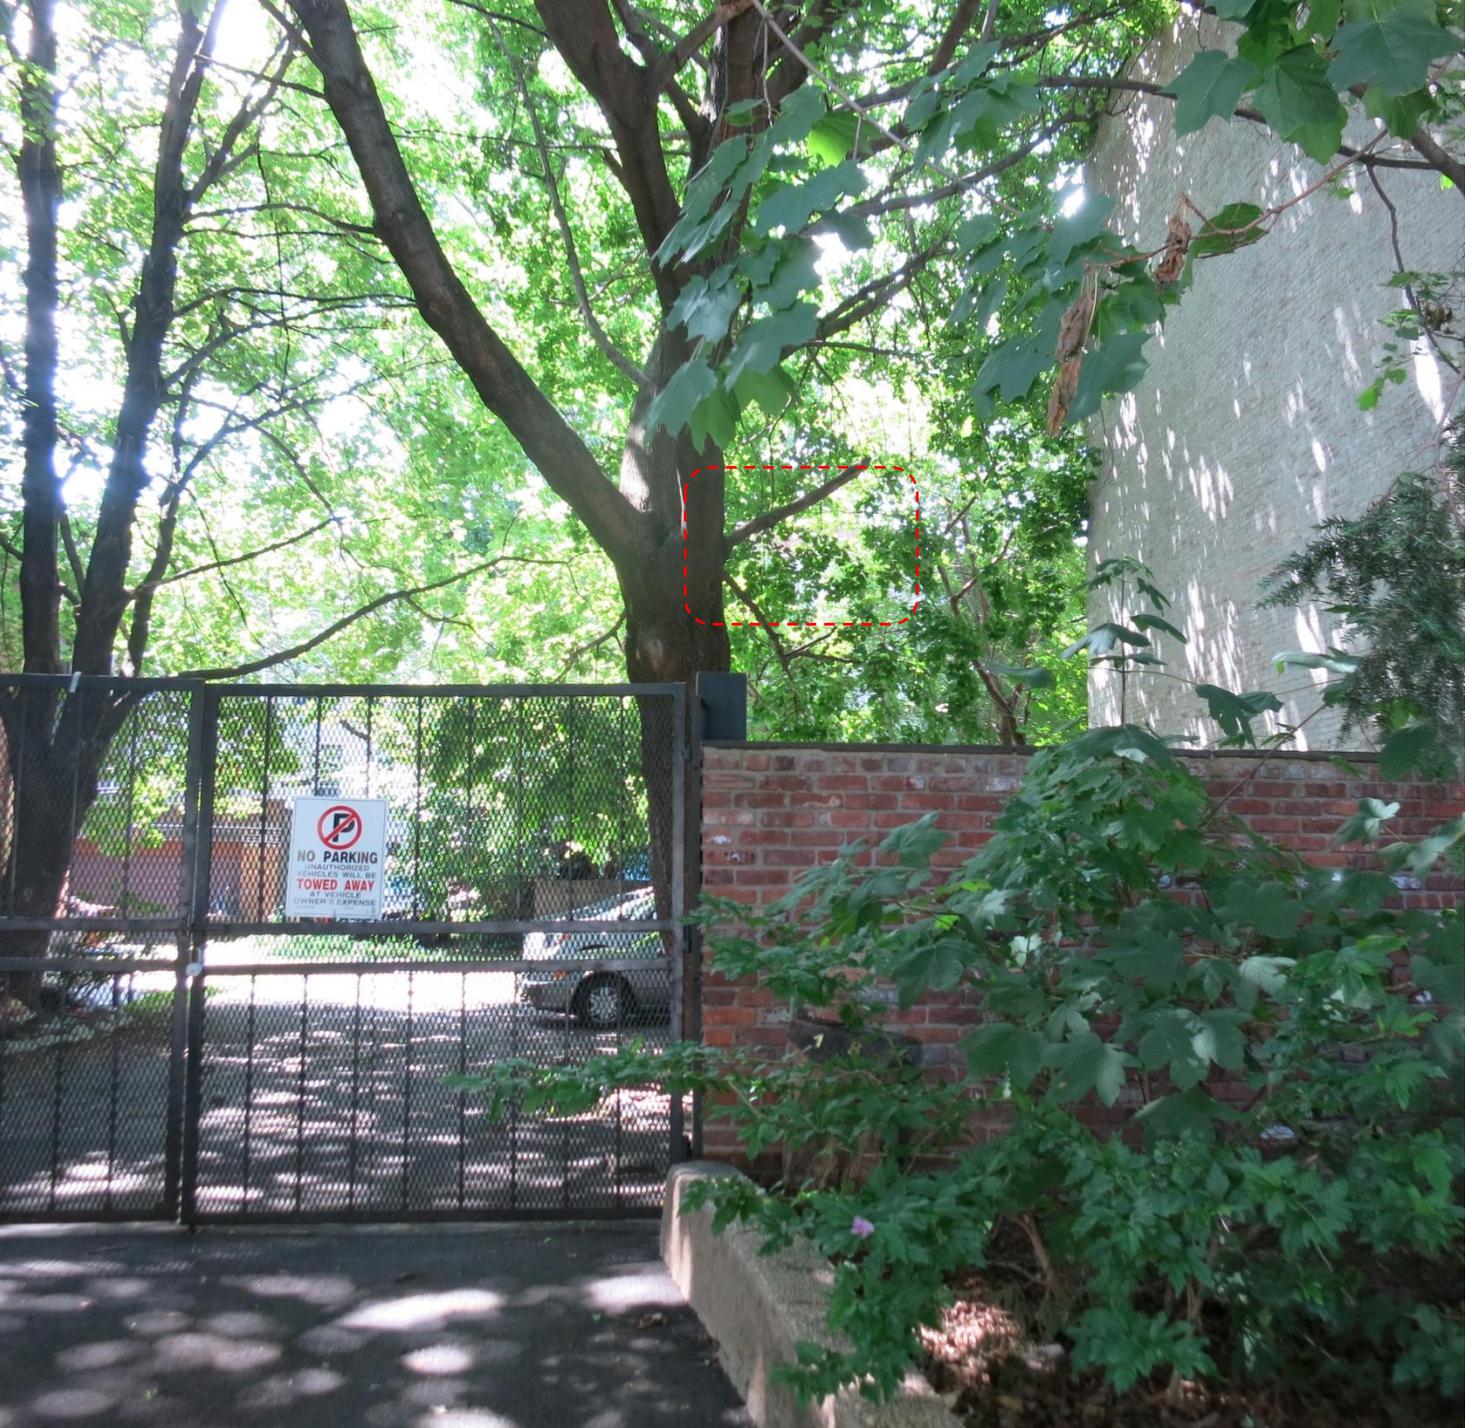
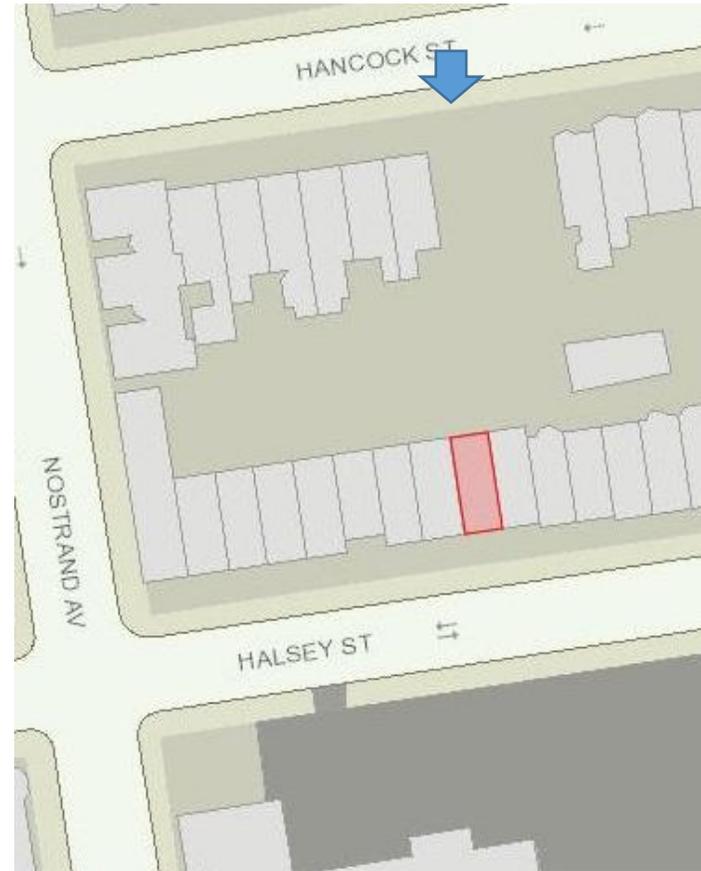
Visibility of Rear Parapet & Bulkhead from Hancock St

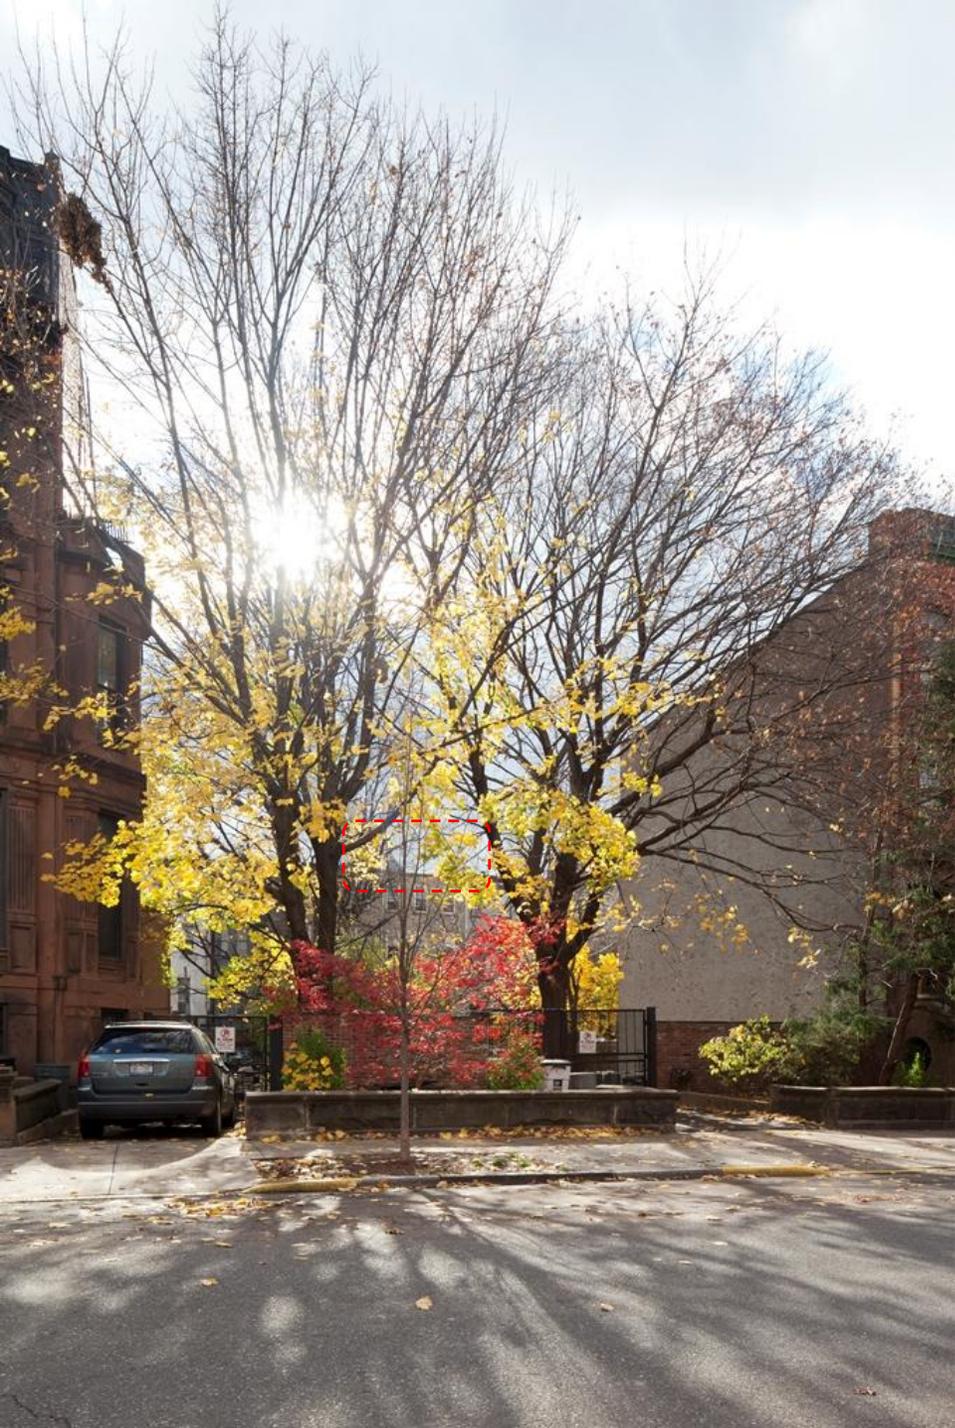
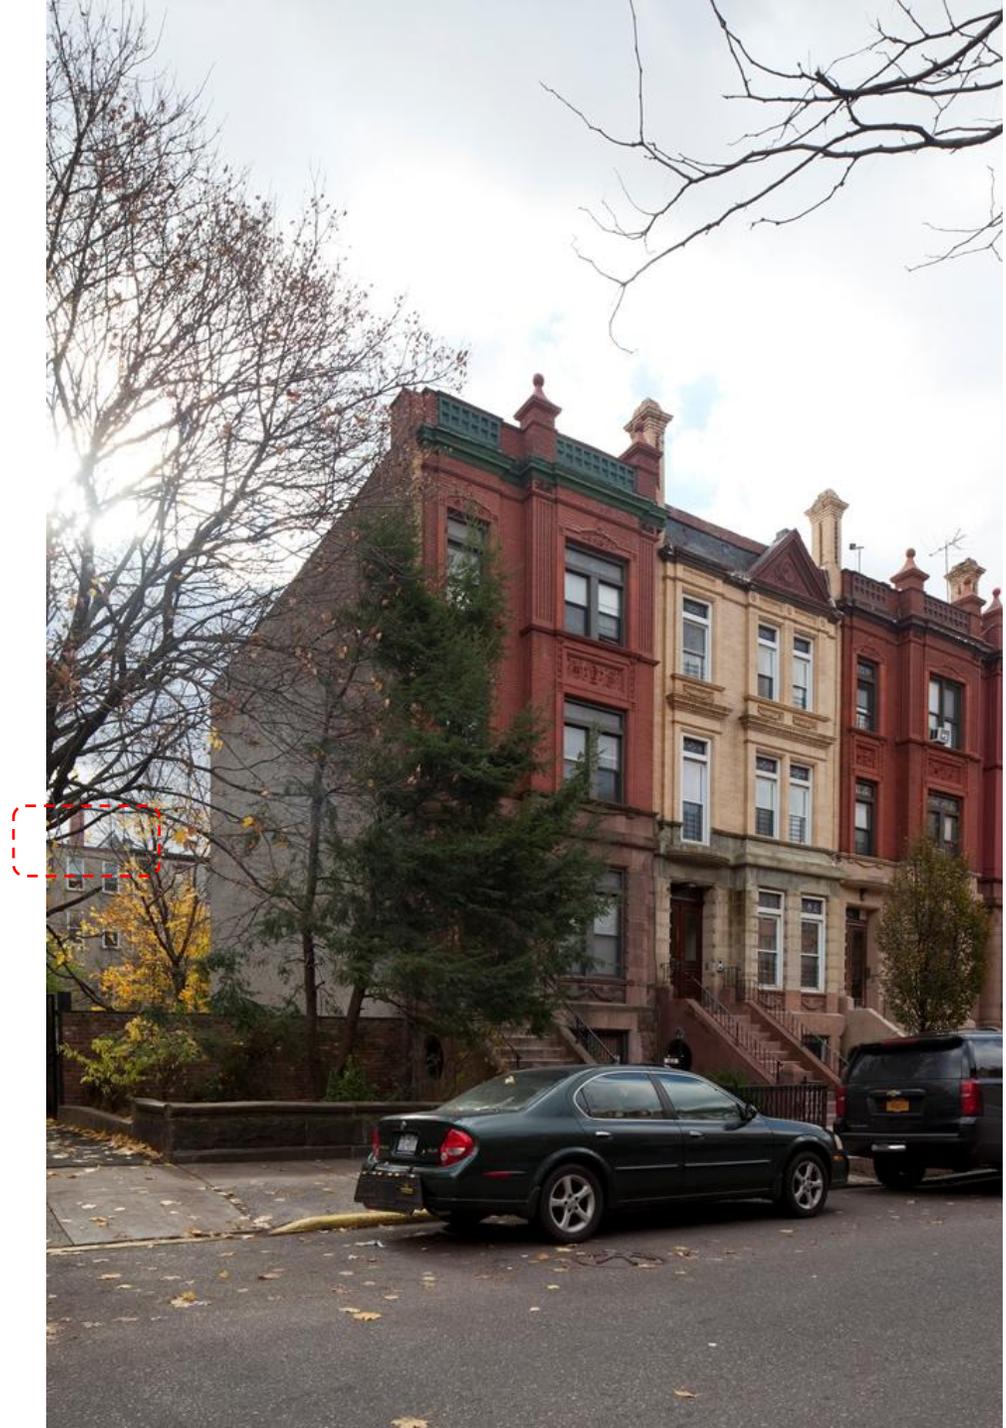
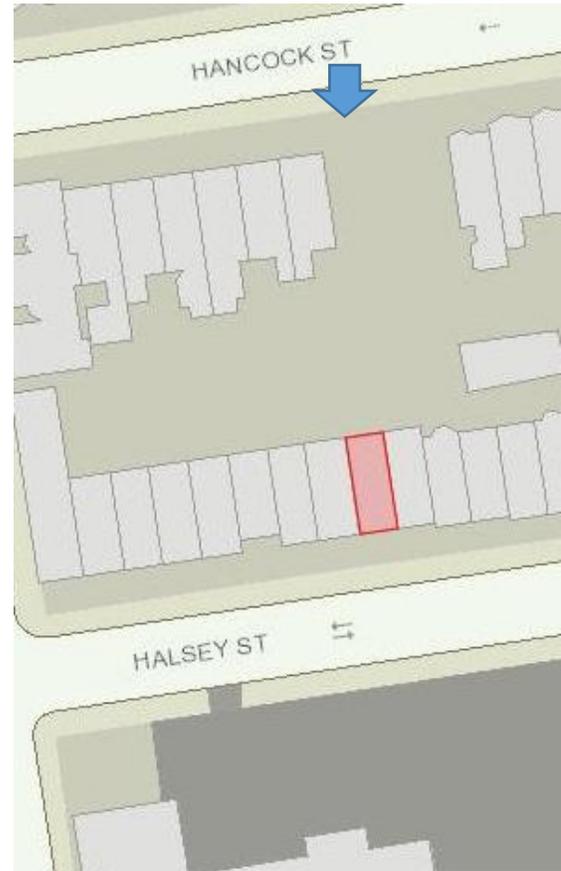
Designation photos
indicating seasonal visibility
from Hancock St

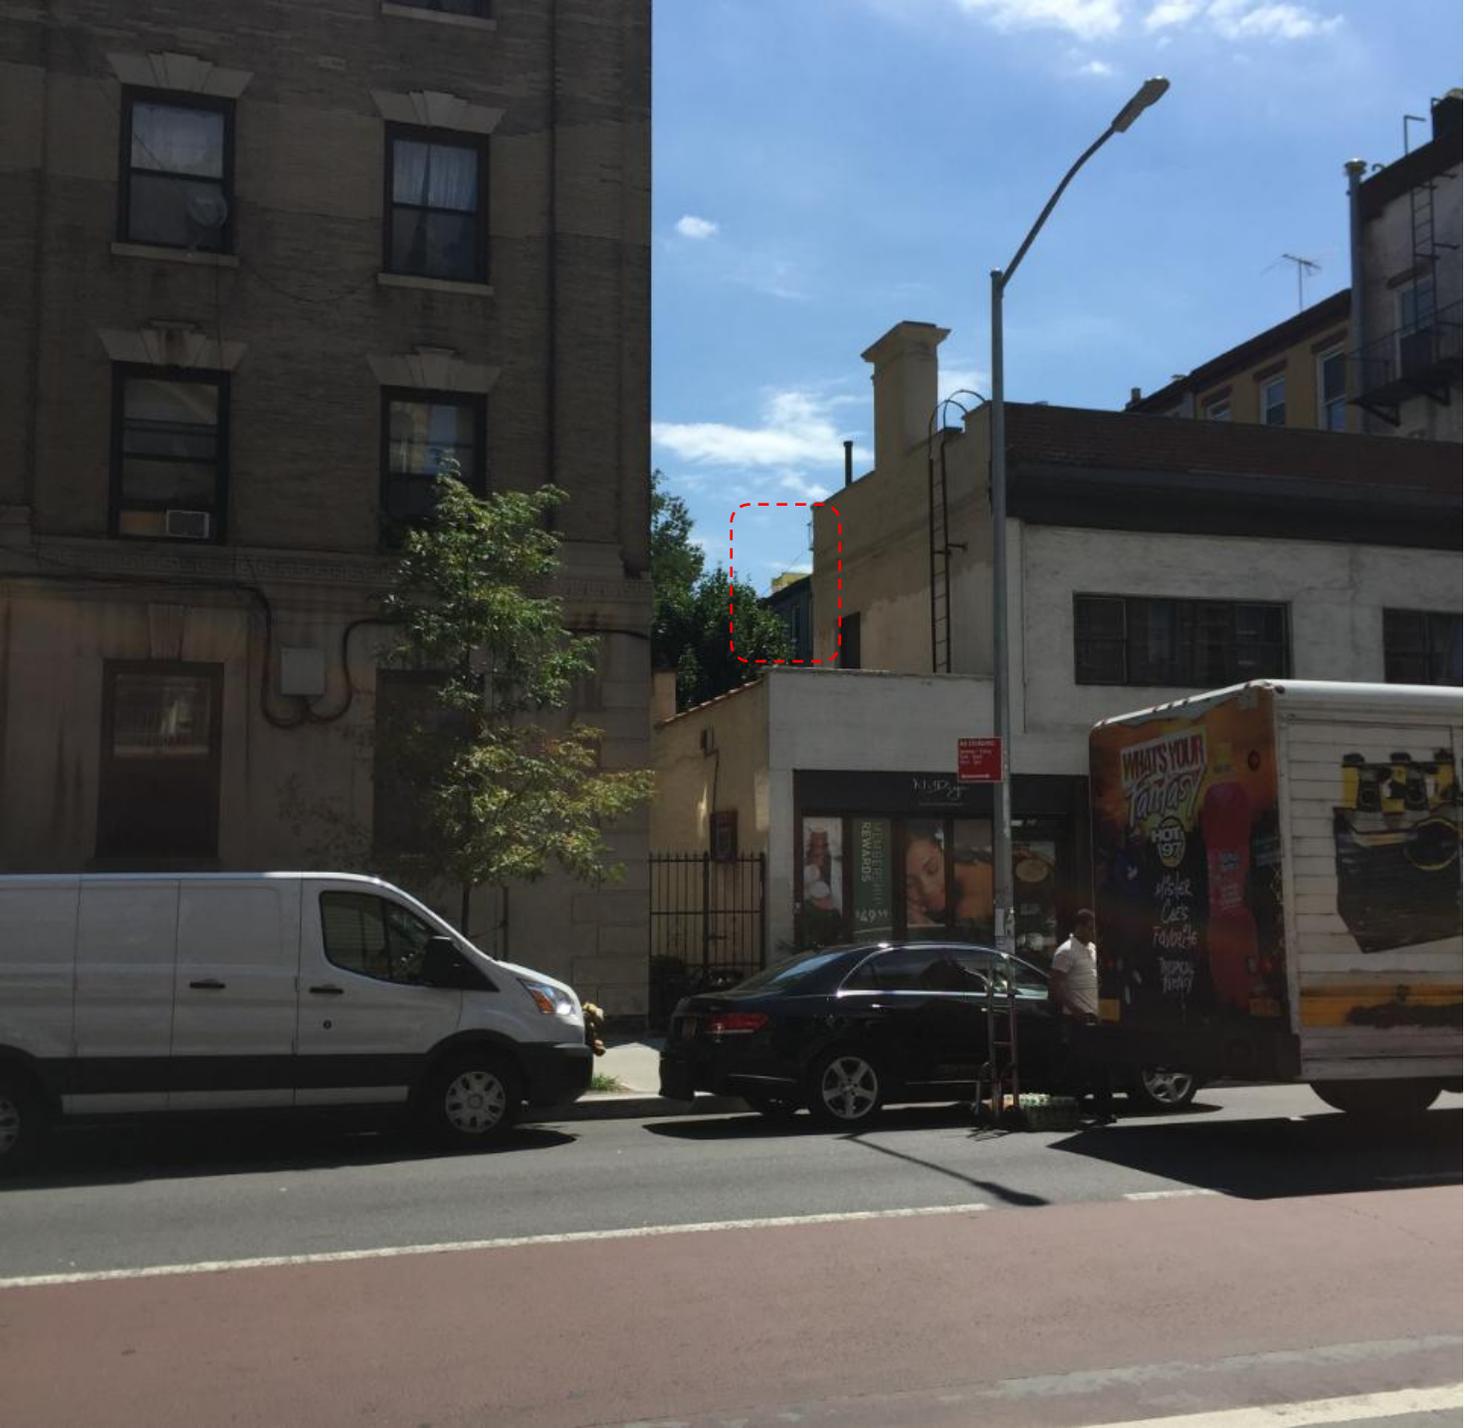
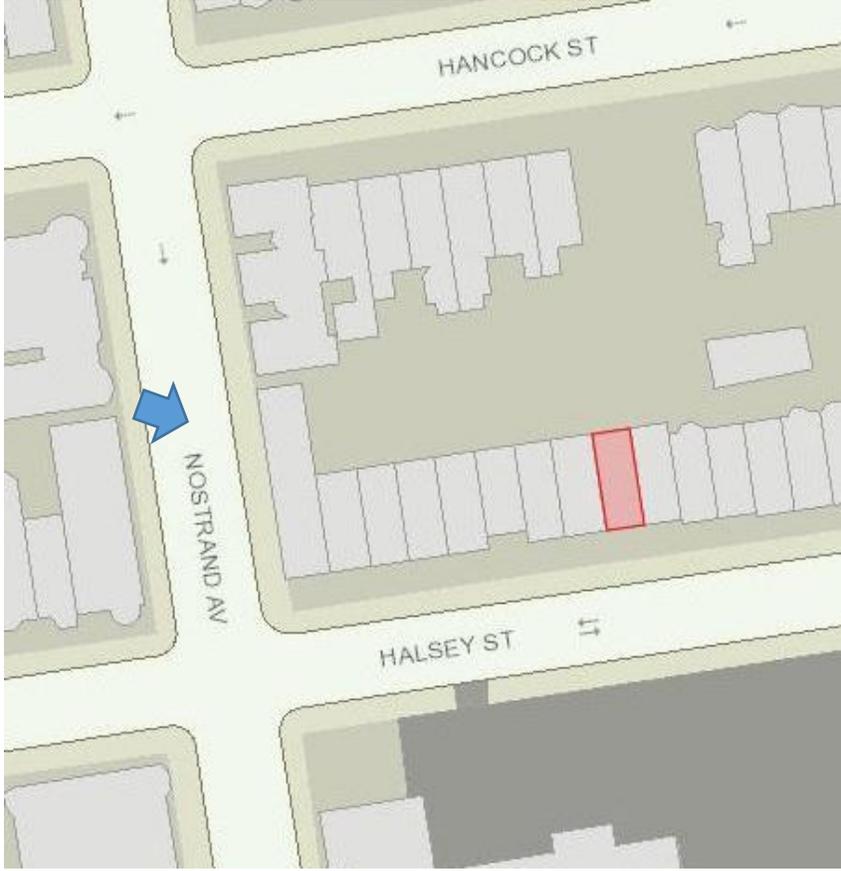
Visibility of Bulkhead from
Nostrand Ave
