Nostrand Avenue (A, C)

NOSTRAND AVENUE FULTON LINE

DEPARTMENT OF CITY PLANNING
TRANSPORTATION DIVISION
2 LAFAYETTE, RM 1200
NEW YORK, NY

SURVEYED: MARCH 27, 2000

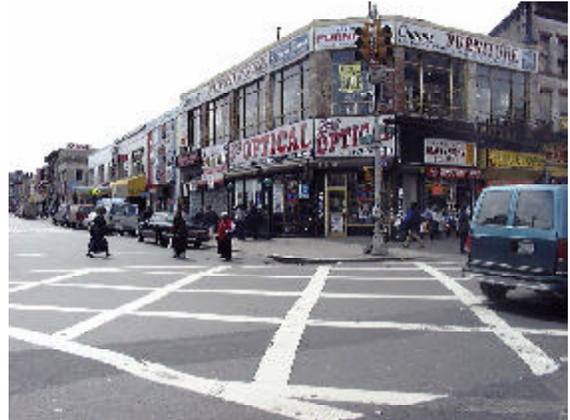
Vehicular navigation is difficult due to the irregular street geometry at Nostrand Avenue station.

Buses swerve into the middle travel lane when pulling away from the bus stop on the north side of Nostrand Avenue as a result of the irregular street geometry at this intersection. We recommend relocating the bus stop to the south side of Nostrand Avenue, which would eliminate this difficult maneuver through the intersection. Five metered parking spaces eliminated on the south side of Nostrand Avenue would be replaced on the north side.
