Sheepshead Bay (Q)

Sheepshead Bay is an elevated and intermodal station, with an entrance located in a building. The primary issues at this station are channelization, bus routes, and queuing space at bus stops.

SHEEPSHEAD BAY SHEEPSHEAD BAY ROAD ENTRANCE BRIGHTON LINE

DEPARTMENT OF CITY PLANNING
TRANSPORTATION DIVISION
2 LAFAYETTE, RM 1200
NEW YORK, NY 10007

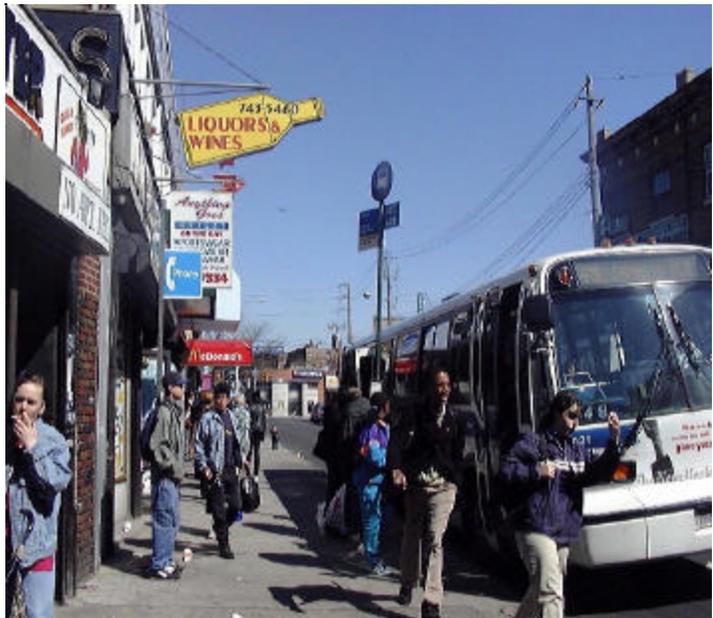
Passengers entering/exiting the B49 bus at Sheepshead Bay Road station have very little queuing space.

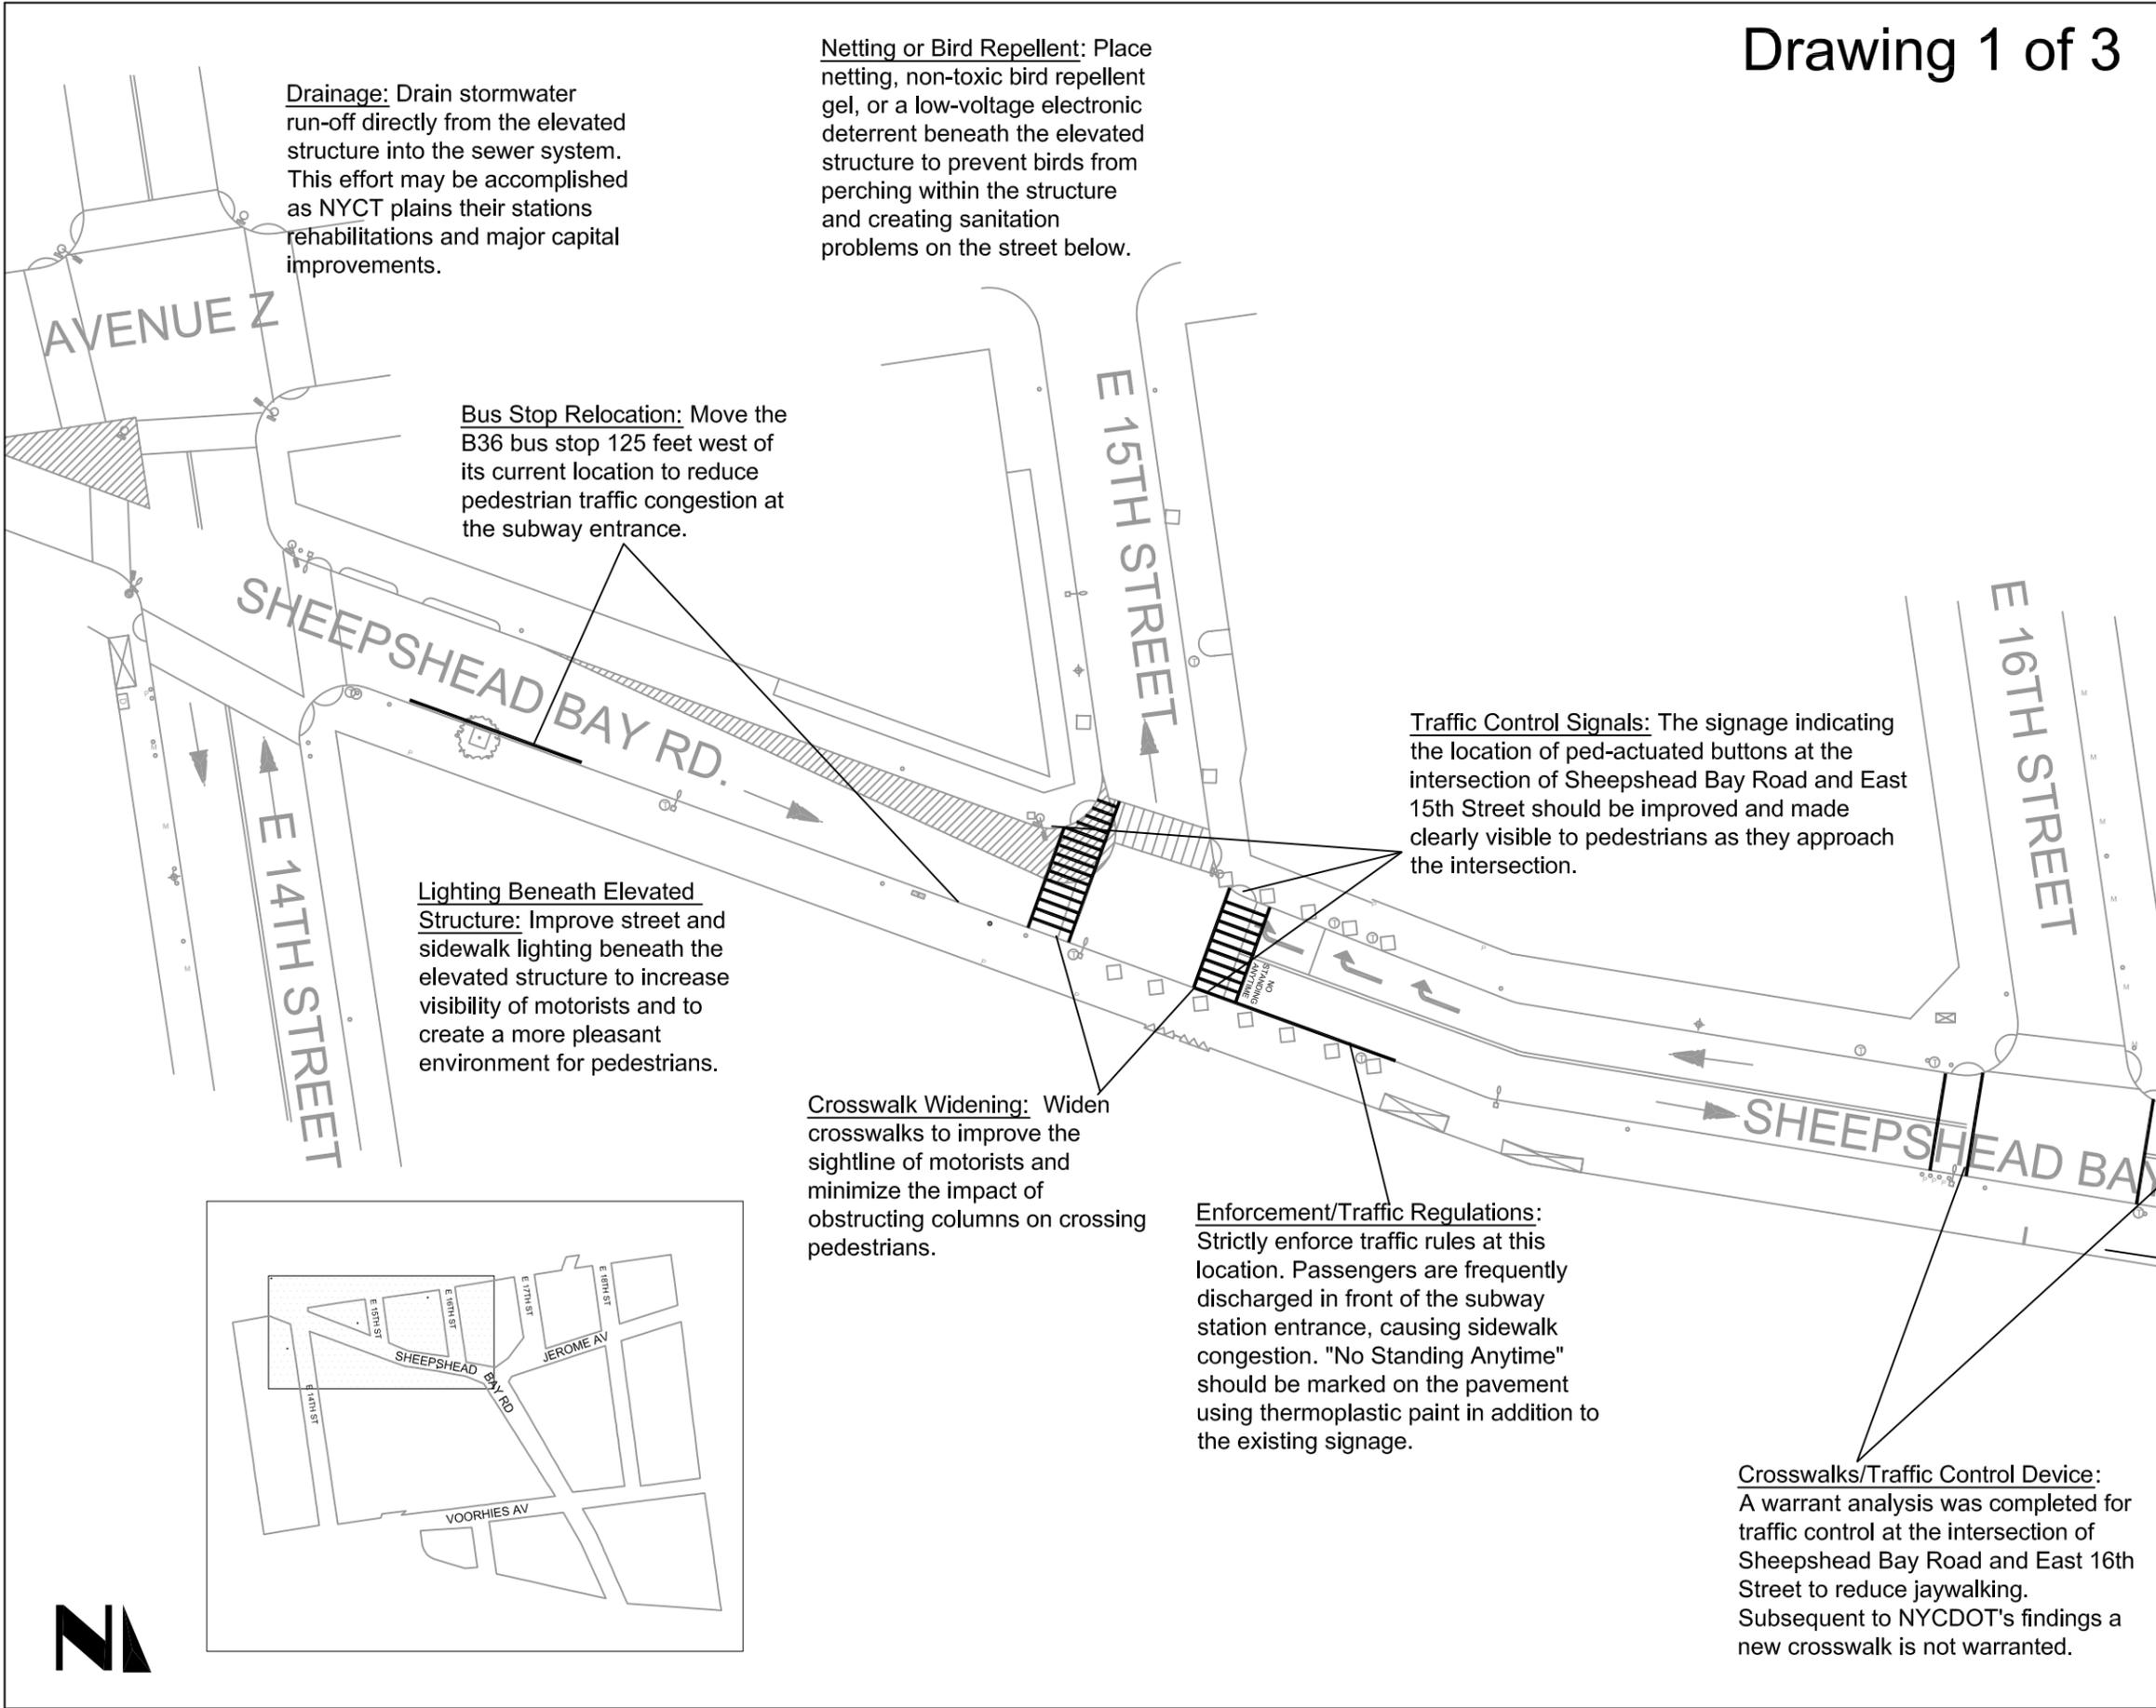
Drawing 1 of 3

Passengers are frequently discharged in front of the southern station entrance at Sheepshead Bay Road and East 15th Street, causing sidewalk congestion. “No Standing Anytime” should be marked on the pavement using thermoplastic paint to further reinforce traffic rules.

The B36 bus stop on Sheepshead Bay Road and East 15th Street becomes congested due to high volumes of passengers at the subway entrance. Additionally, the bus loads and unloads passengers in the middle of the roadway due to the narrow roadbed and pedestrian congestion. Moving the bus stop 125 feet west from its current location would reduce pedestrian traffic at the subway entrance.

Drainage: Drain stormwater run-off directly from the elevated structure into the sewer system. This effort may be accomplished as NYCT plans their stations rehabilitations and major capital improvements.

Netting or Bird Repellent: Place netting, non-toxic bird repellent gel, or a low-voltage electronic deterrent beneath the elevated structure to prevent birds from perching within the structure and creating sanitation problems on the street below.

Bus Stop Relocation: Move the B36 bus stop 125 feet west of its current location to reduce pedestrian traffic congestion at the subway entrance.

Lighting Beneath Elevated Structure: Improve street and sidewalk lighting beneath the elevated structure to increase visibility of motorists and to create a more pleasant environment for pedestrians.

Crosswalk Widening: Widen crosswalks to improve the sightline of motorists and minimize the impact of obstructing columns on crossing pedestrians.

Enforcement/Traffic Regulations: Strictly enforce traffic rules at this location. Passengers are frequently discharged in front of the subway station entrance, causing sidewalk congestion. "No Standing Anytime" should be marked on the pavement using thermoplastic paint in addition to the existing signage.

Traffic Control Signals: The signage indicating the location of ped-actuated buttons at the intersection of Sheepshead Bay Road and East 15th Street should be improved and made clearly visible to pedestrians as they approach the intersection.

Crosswalks/Traffic Control Device: A warrant analysis was completed for traffic control at the intersection of Sheepshead Bay Road and East 16th Street to reduce jaywalking. Subsequent to NYCDOT's findings a new crosswalk is not warranted.

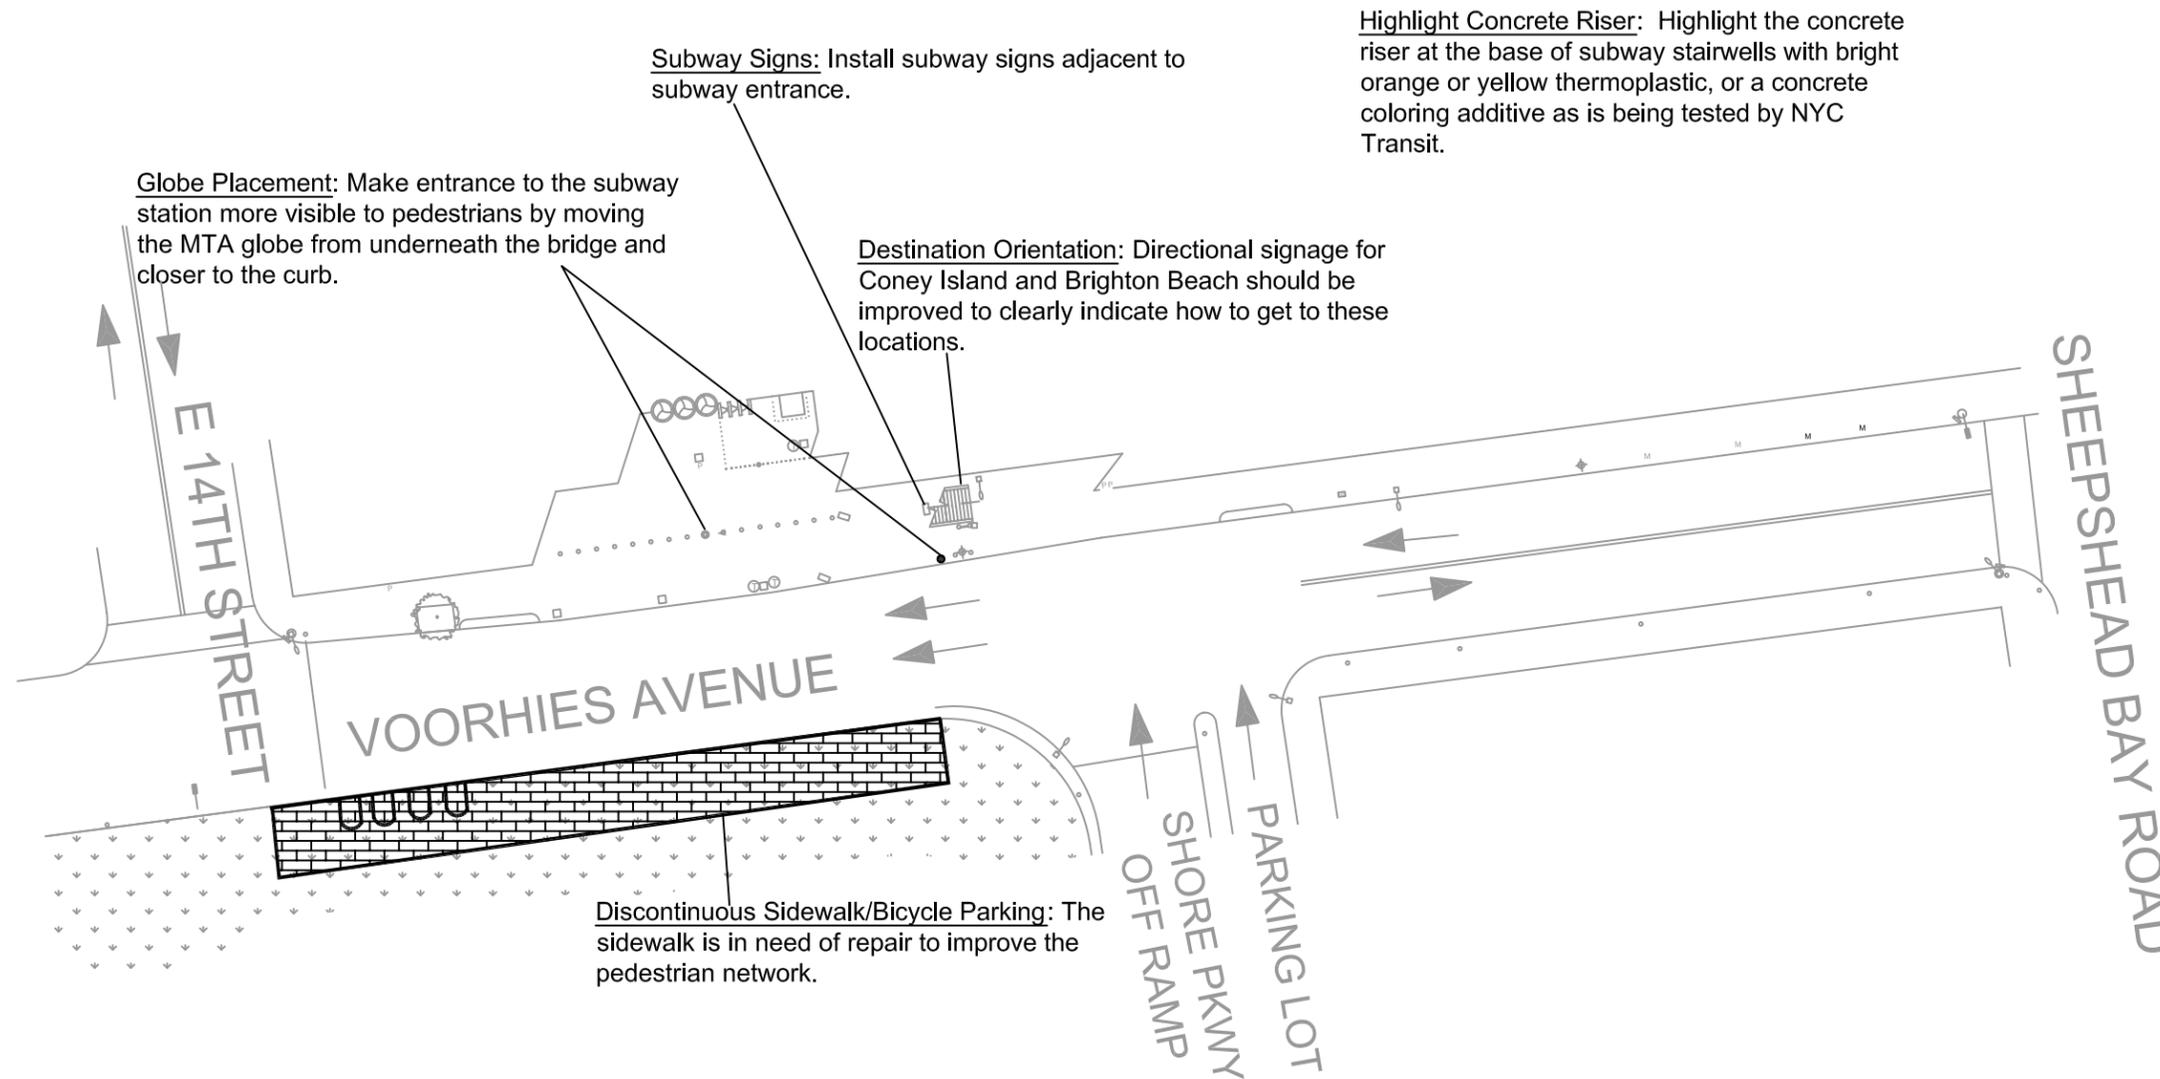
Drawing 3 of 3

The Voorhies Avenue station entrance is located midblock and is not visible to pedestrians. Moving the MTA globe from underneath the elevated structure and placing it closer to the curb would better orient intermodal passengers.

There are significant sidewalk circulation issues throughout the study area. There is a missing sidewalk on the southern side of Voorhies Avenue. Creating a new sidewalk would improve the pedestrian network. In addition, bicycle parking should be installed on the new sidewalk due to its close proximity to the Bicycle Master Plan's recommended Avenue Y route. The sidewalk in front of the Sheepshead Bay Road station entrance is narrow due to the columns on the sidewalk. Widening the sidewalk and decreasing the excess striped roadbed at the northwest corner would allow for greater pedestrian mobility.
