Brooklyn Retail Corridors

Technical Memorandum 4: Recommendations and Traffic Analysis

July 2003

New York City
Department of City Planning
Amanda M. Burden, Director

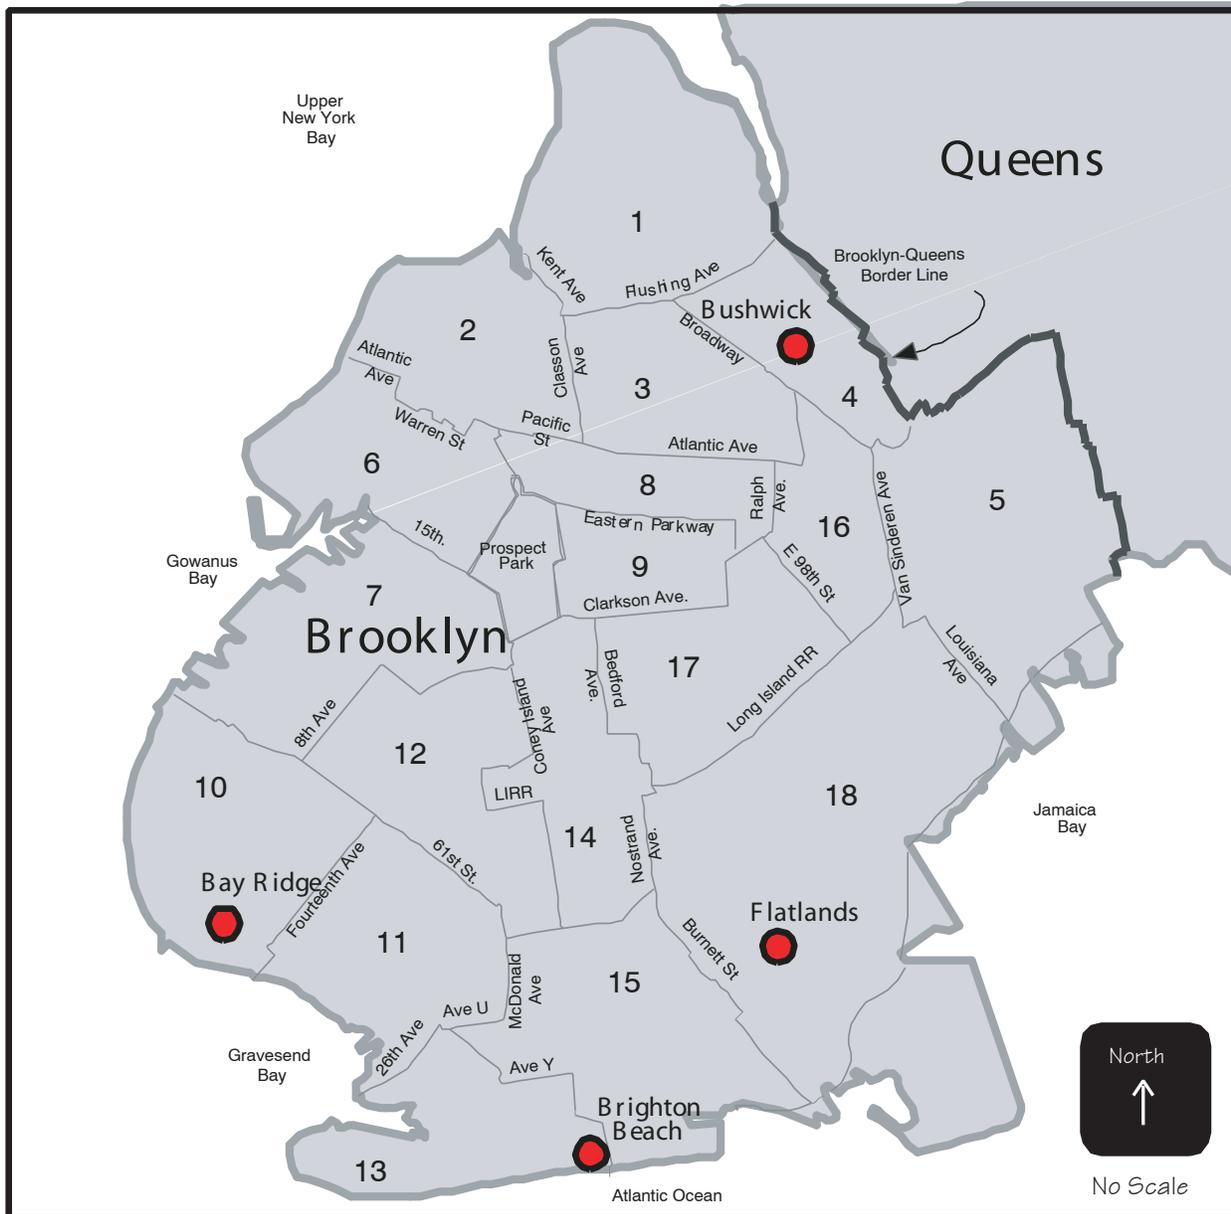
Figure 1
Locations of Study Areas
(Within Brooklyn Community Districts)

Bay Ridge:	85 th and 86 th Streets from 4 th Avenue to Fort Hamilton Parkway
Brighton Beach:	Brighton Beach Avenue from Ocean Parkway to Coney Island Avenue
Bushwick:	Knickerbocker Avenue from Dekalb Avenue to Menahan Street
Flatlands:	Kings Plaza Shopping Center at Flatbush Avenue and Avenue U

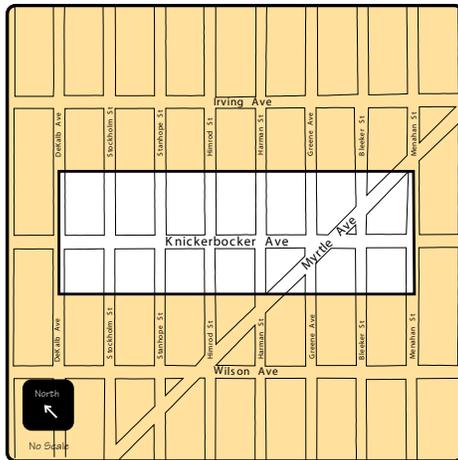
Figure 4
Bushwick Study Area
 Knickerbocker Avenue from
 Dekalb Avenue to Menahan Street

While new development is not expected to impact the Bushwick study area, recommendations include a sidewalk extension designed to improve traffic operations and an upgrade of an existing channelization island at an intersection with irregular geometry. Various traffic calming/gateway treatments designed to not only distinguish the retail corridor, but improve its overall operation are also recommended.

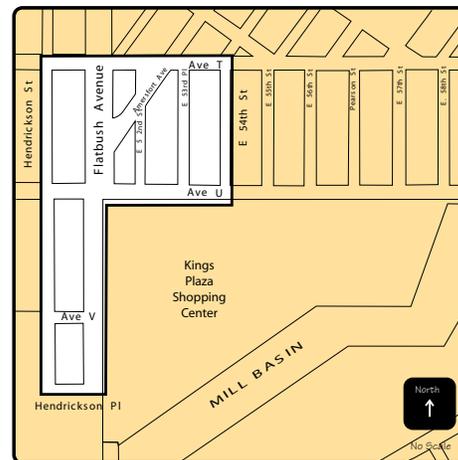
Figure 5
Flatlands Study Area
 Kings Plaza Shopping Center
 Avenue U and Flatbush Avenue

In the Flatlands study area, at the intersection of Flatbush Avenue and Avenue U, the Kings Plaza expansion project includes 241,000 square feet of retail space and a new 770-space accessory parking facility that is expected to bring new vehicle trips to the already busy intersection. Recommendations include signal timing changes, lane re-channelization, bus stop relocation designed to prevent midblock crossings at this high accident location, and the redesign of the bus turnaround area adjacent to the Kings Plaza Shopping Center. This redesign is expected to improve the intersection’s overall operation. The designation of commuter van pick-up and drop-off points is also recommended. Additionally, traffic and pedestrian safety issues were examined by the Office of the President of the Borough of Brooklyn. *The Pedestrian/Traffic Safety Mitigation Project*, funded through a grant from the Governor’s Traffic Safety Committee, resulted in recommendations that augment those cited in this report.

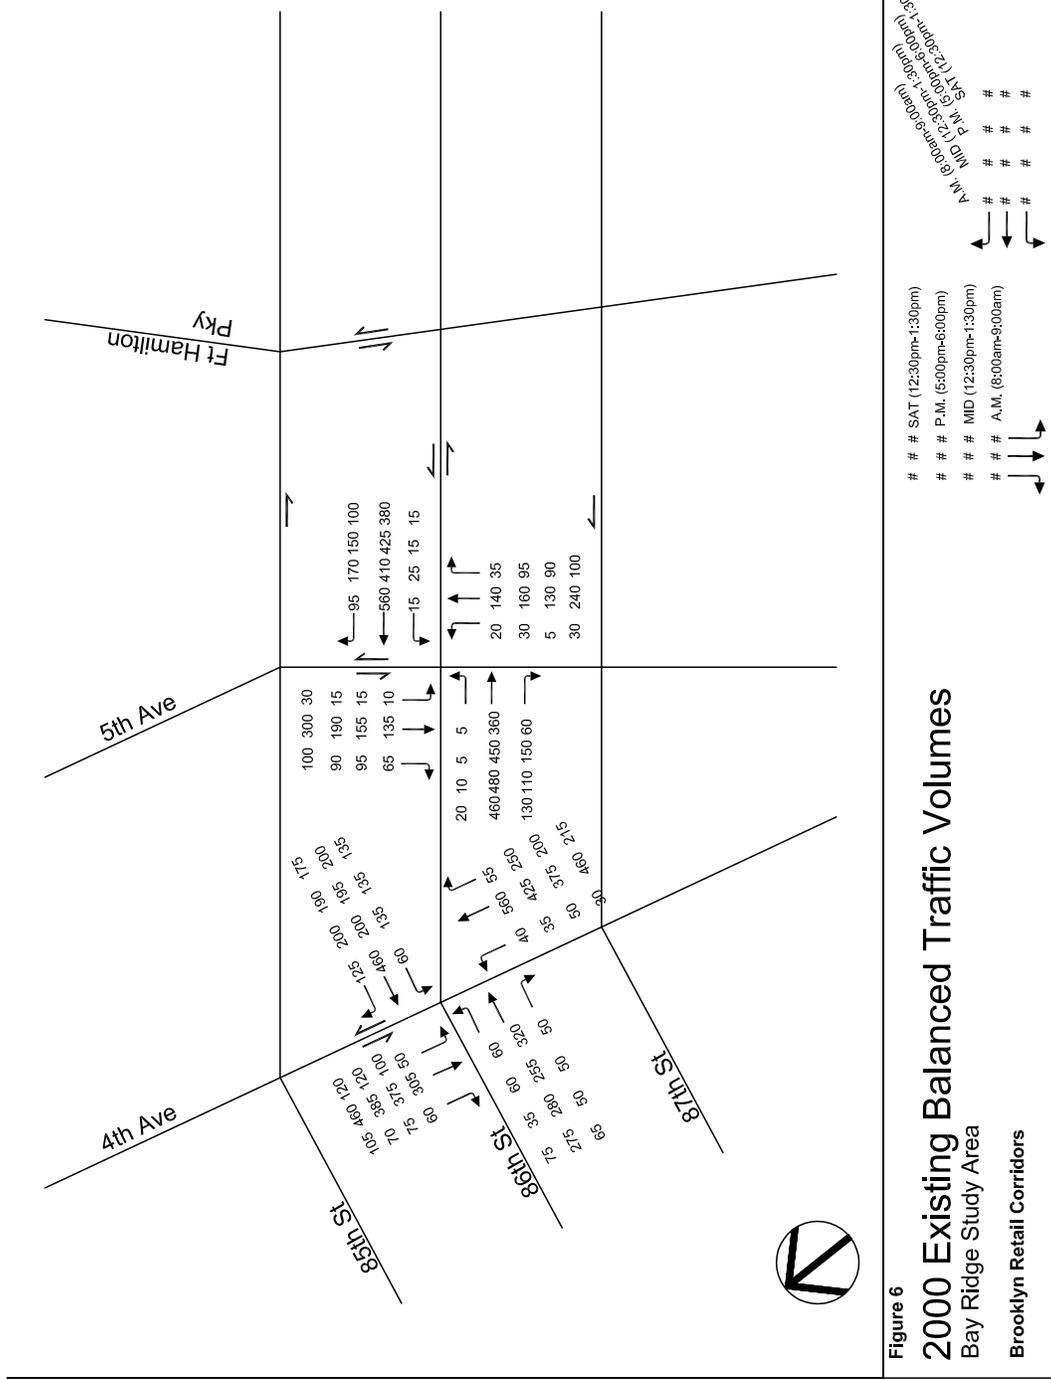
A traffic and pedestrian level of service (LOS) analysis was conducted at two signalized intersections, 86th Street at 4th and 5th Avenues. Figures 1 and 2 show existing and future balanced traffic volumes for the AM, midday, PM, and weekend peak periods. Table 7 illustrates severity of accidents by time of day. Table 8 details existing and future levels of service and delays for both intersections. Recommended actions for this study area are shown in Drawing 1.

Overall, the intersection operates at an acceptable LOS C for the AM and PM peak periods, and LOS B during the midday and weekend periods, with delays ranging from 13.6 to 19.1 seconds per vehicle. All lane groups for each peak period operate at LOS D or better, with delays ranging from 9.0 to 34.6 seconds per vehicle.

Overall, the intersection operates at an acceptable LOS B for all peak periods, with delays ranging from 10.4 to 12.4 seconds per vehicle. Each lane group operates at LOS C or better, with delays ranging from 7.7 to 21.5 seconds per vehicle.
