Existing Conditions

New York City Department of City Planning

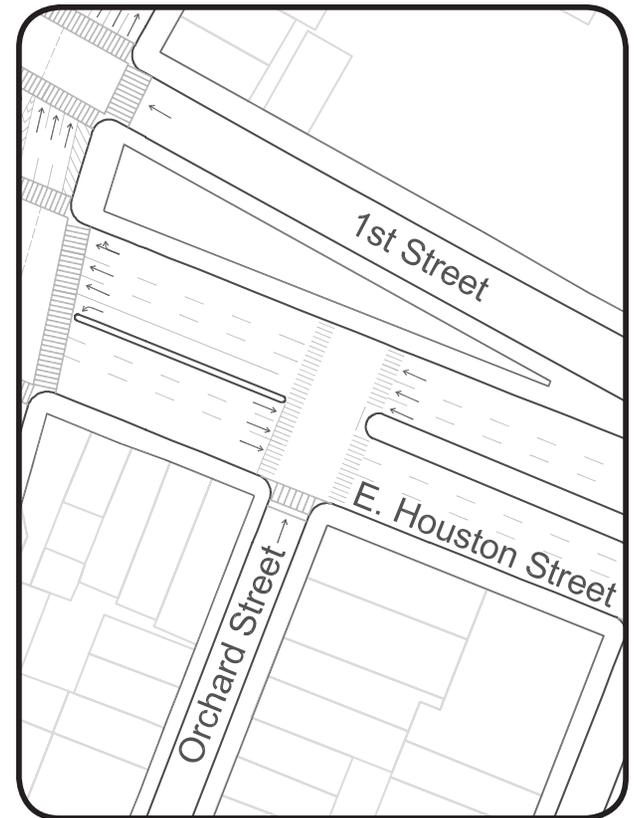
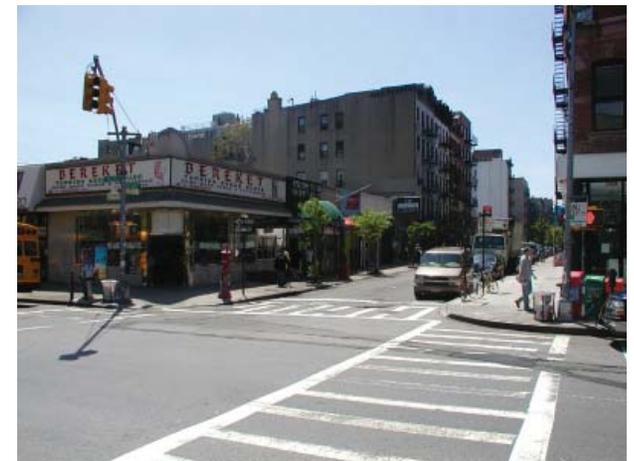
A view of Orchard Street.

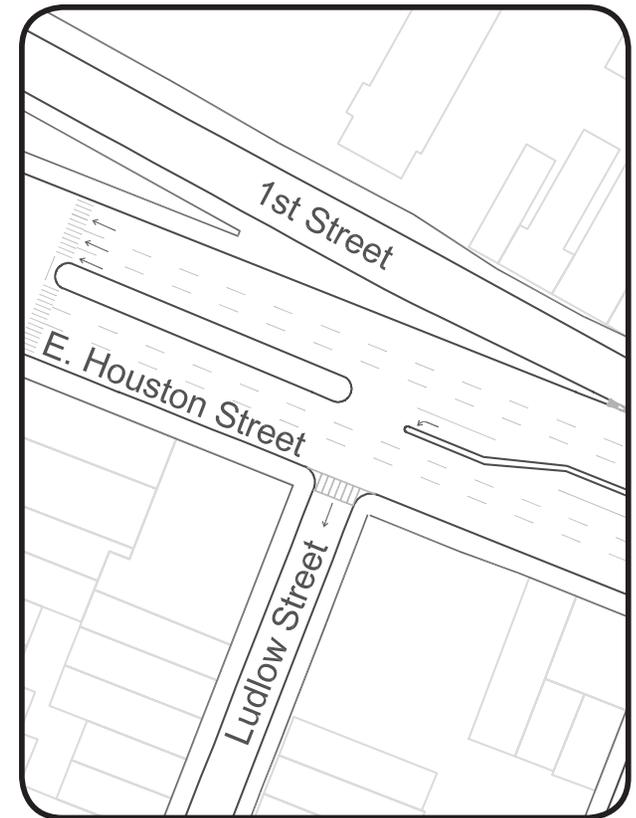
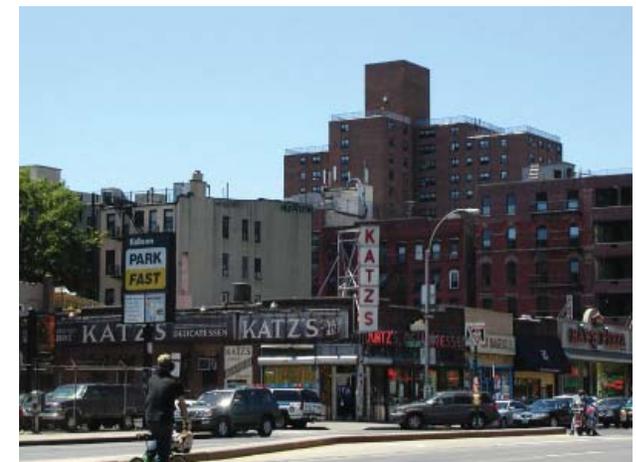
Katz's Deli on the corner of Ludlow Street and East Houston Street.

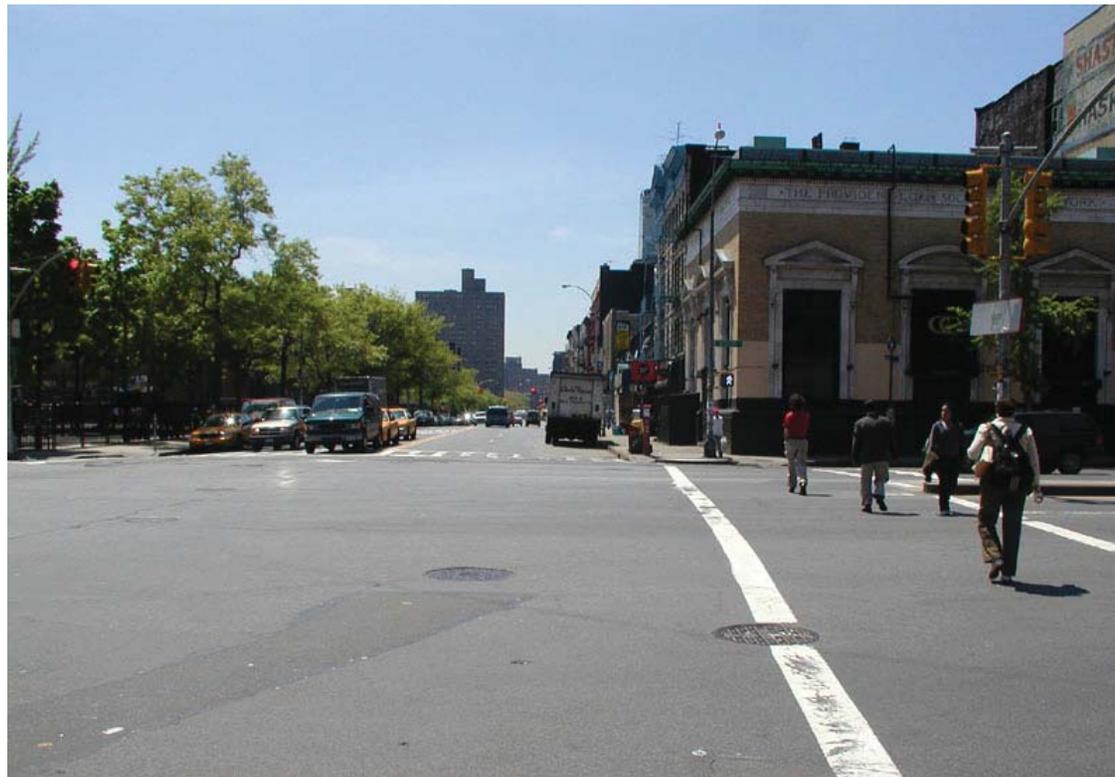
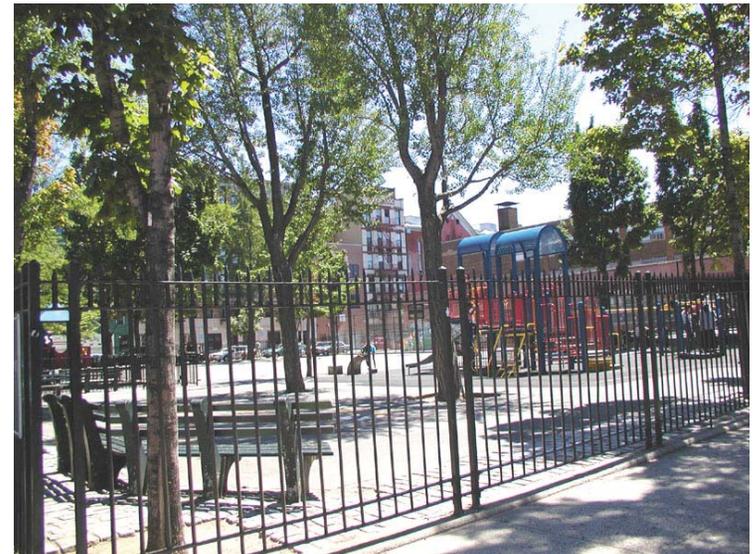
Opposite page: A pedestrian using the north crosswalk (left); A view of East Houston Street and East 1st Street; looking west (middle). A pedestrian crossing East 1st Street (right). This page: A view of ABC Playground (above) and Essex Street (left).

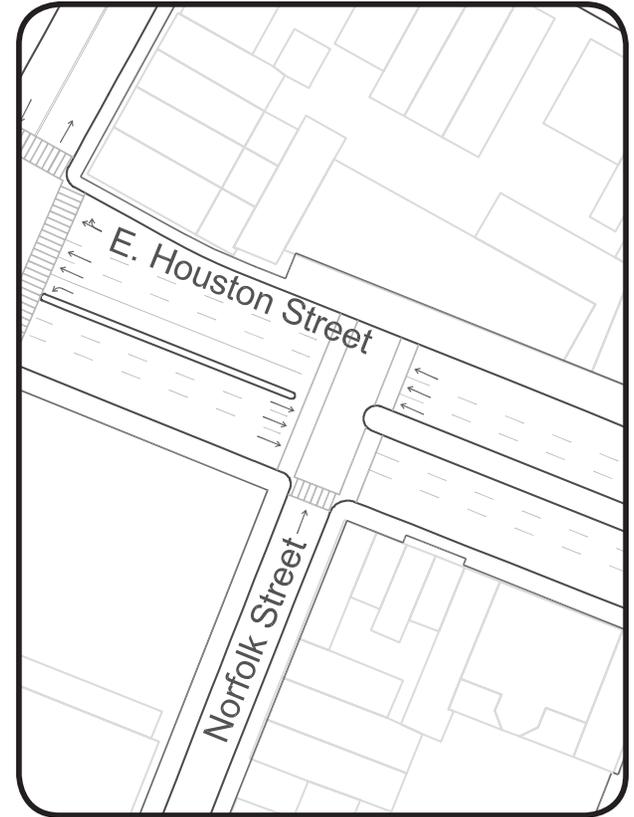
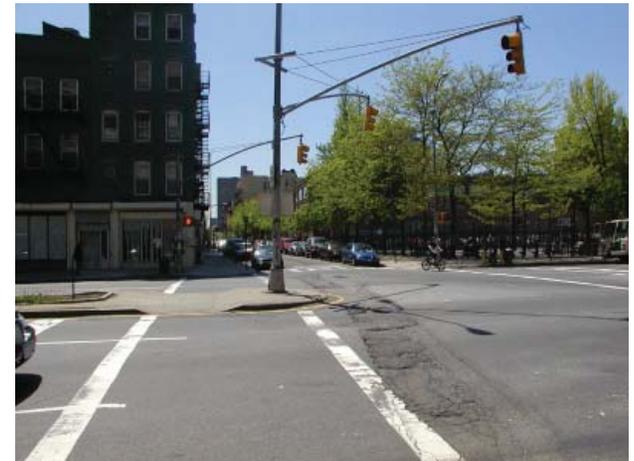
Norfolk Street and ABC Playground.

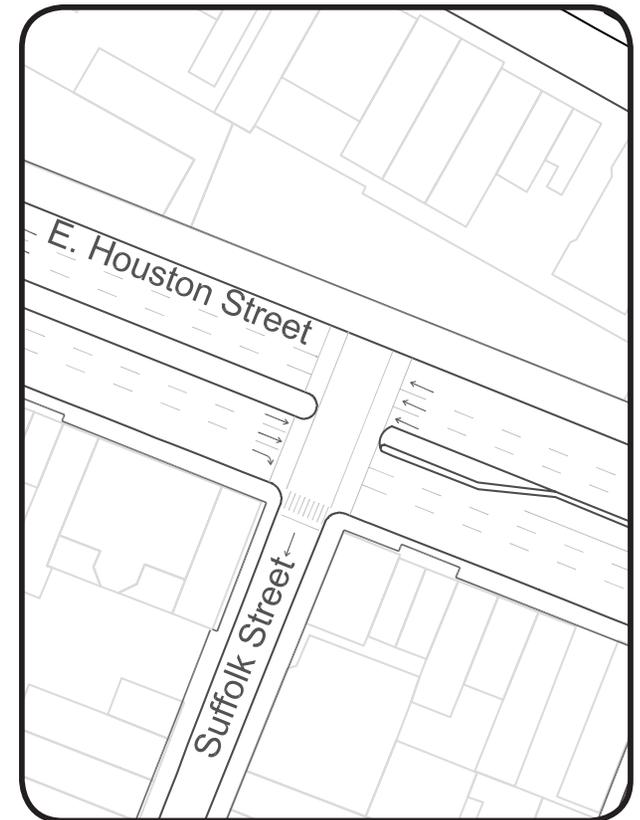
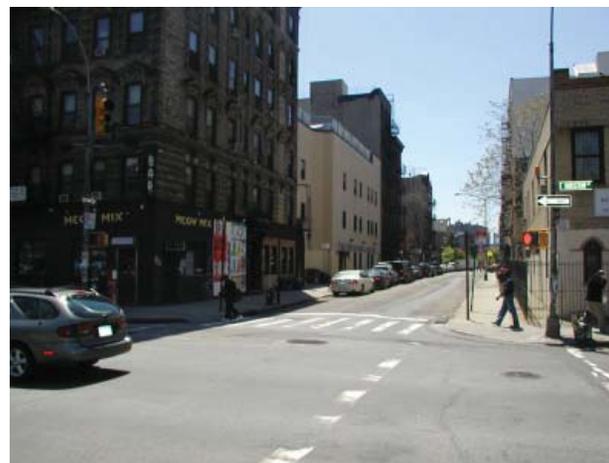
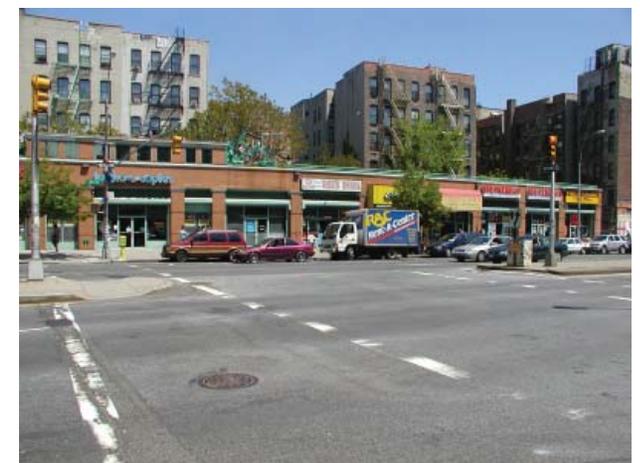
The left turn bay on East Houston Street was initially closed off as a result of Suffolk Street being reversed from a southbound to a northbound street due to the Williamsburg Bridge reconstruction. Since the restoration of Suffolk Street to a southbound street, the left turn bay has remained closed.

A view of Suffolk Street (left) and the west crosswalk traversing East Houston Street (right).

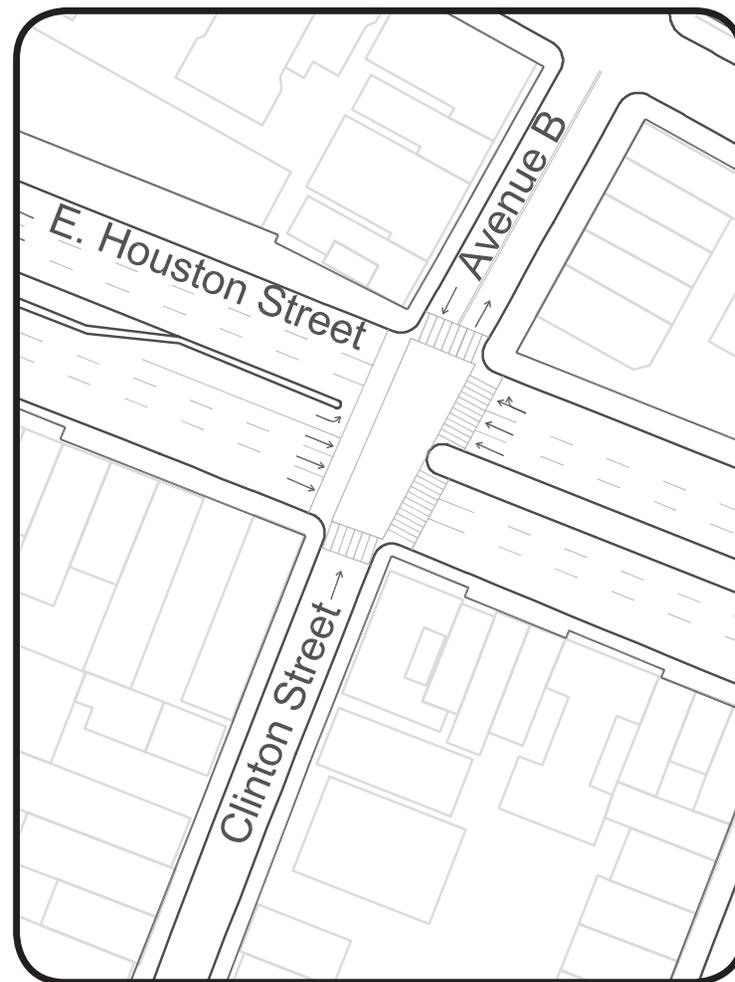
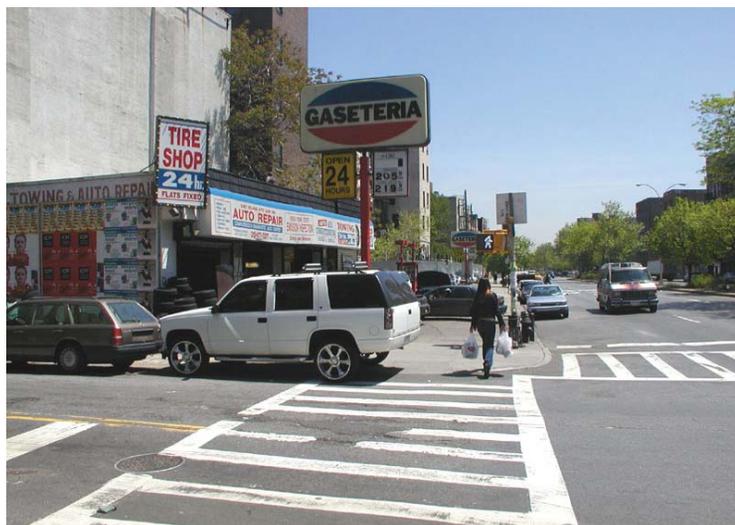
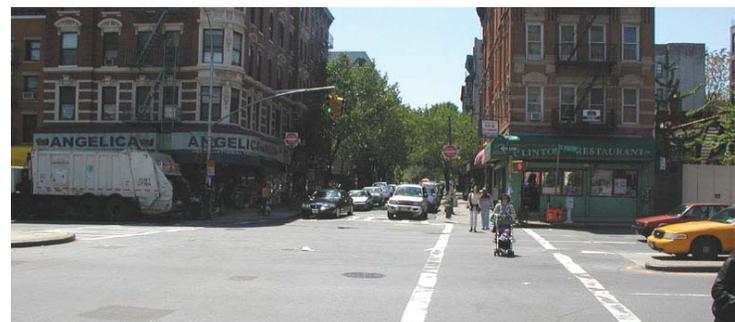
A view of the north crosswalk and Gaseteria gas station at the intersection of Avenue B and East Houston Street (left). Pedestrians using the west crosswalk (right).

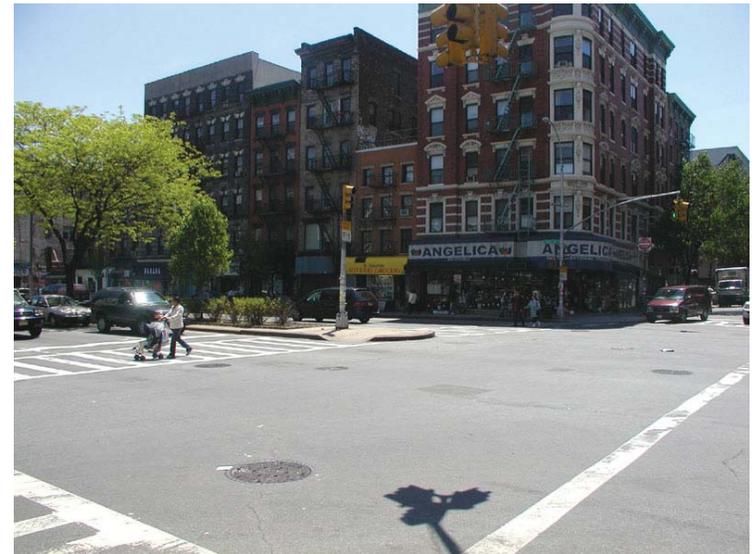
A view from the northwest corner of Avenue B and East Houston Street.

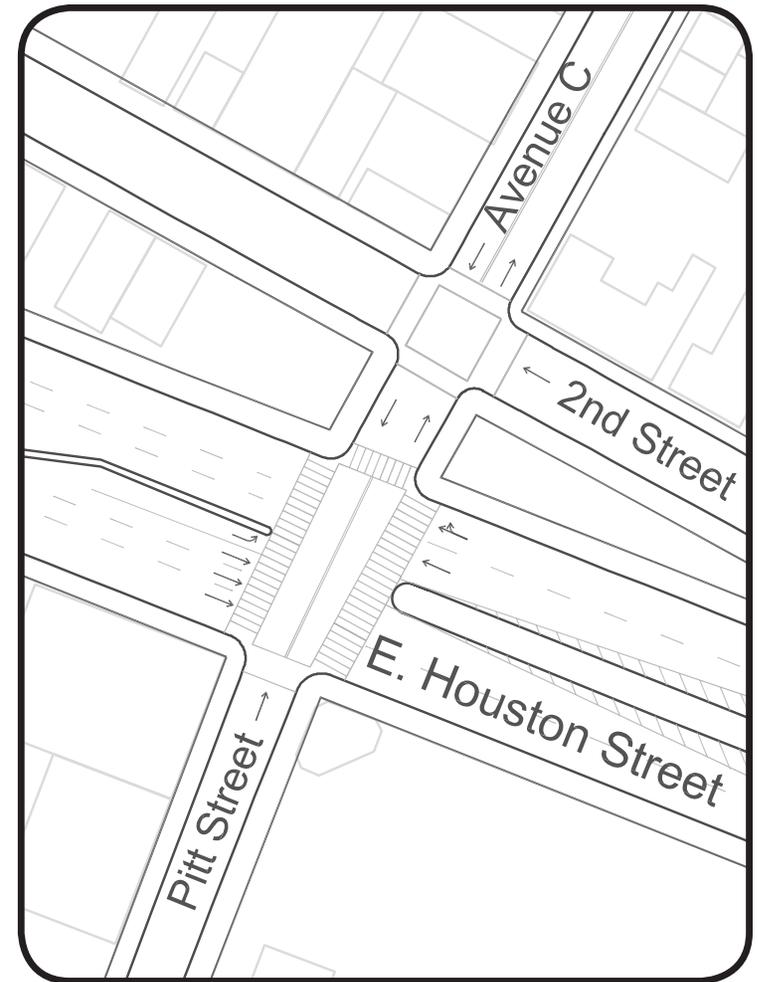
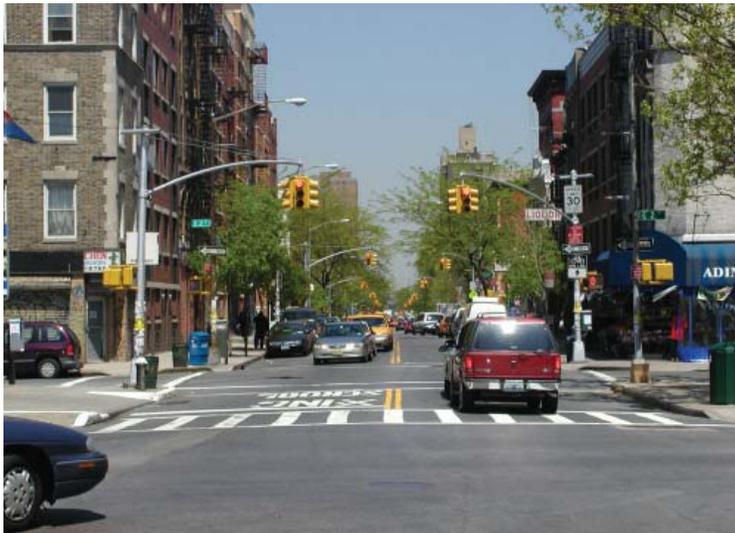
Left: Looking north up Avenue C. Top: Hamilton Fish Park, at the southeast corner of the intersection. Bottom: Hartman Square, at the northeast corner of the intersection.

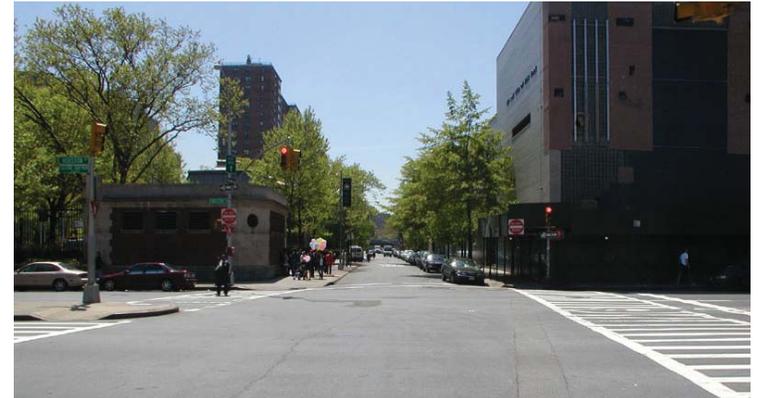
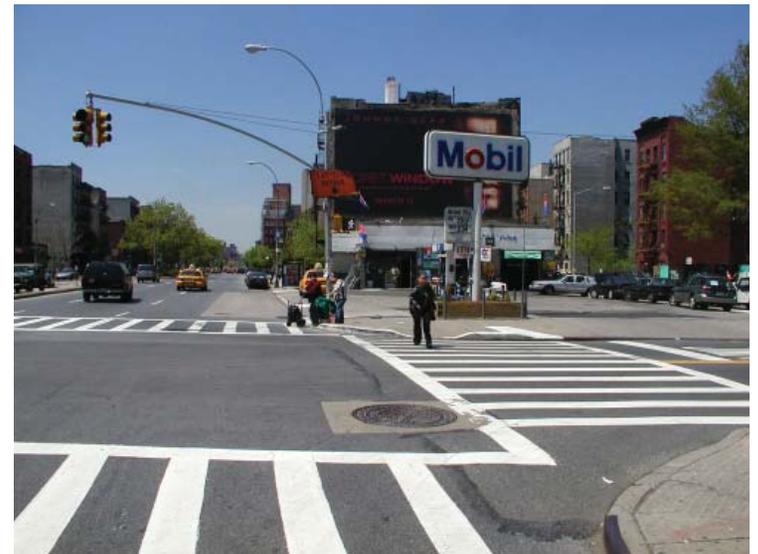
Top: Looking south down Pitt Street. Above: Mobil gas station, at the northwest corner of the intersection.

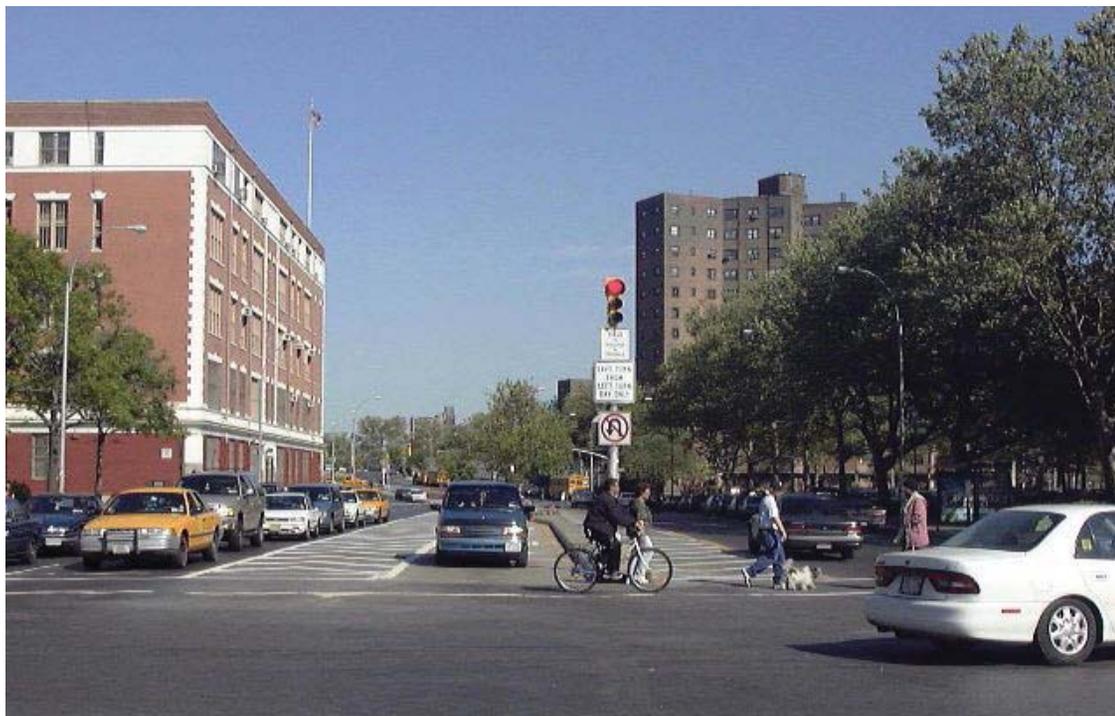
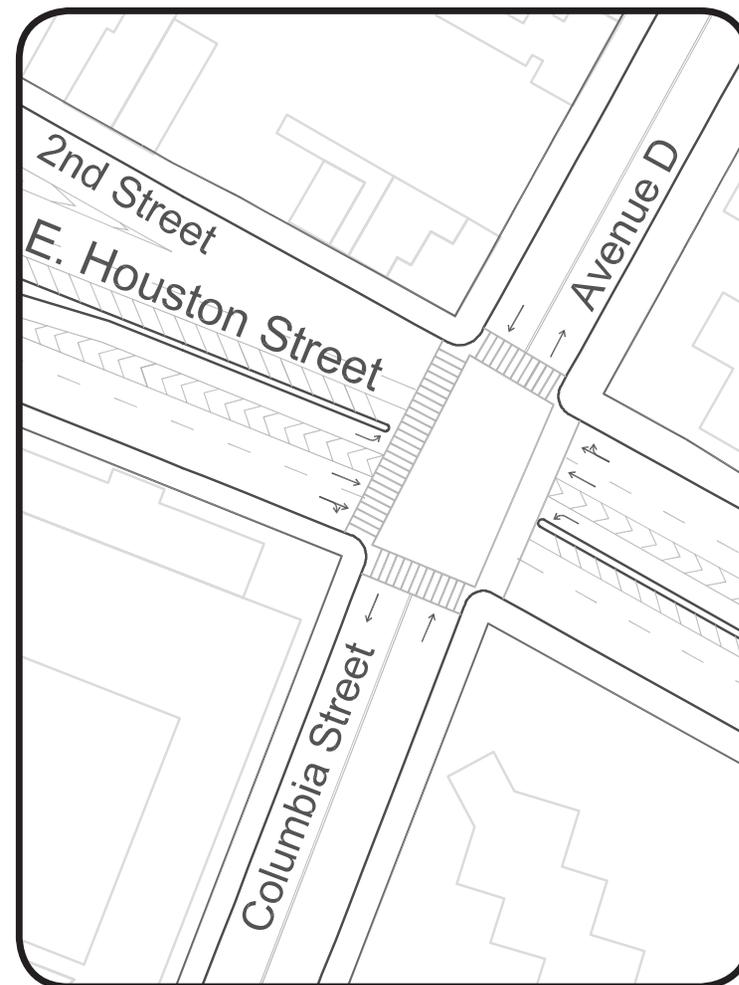
Looking east at Houston Street.

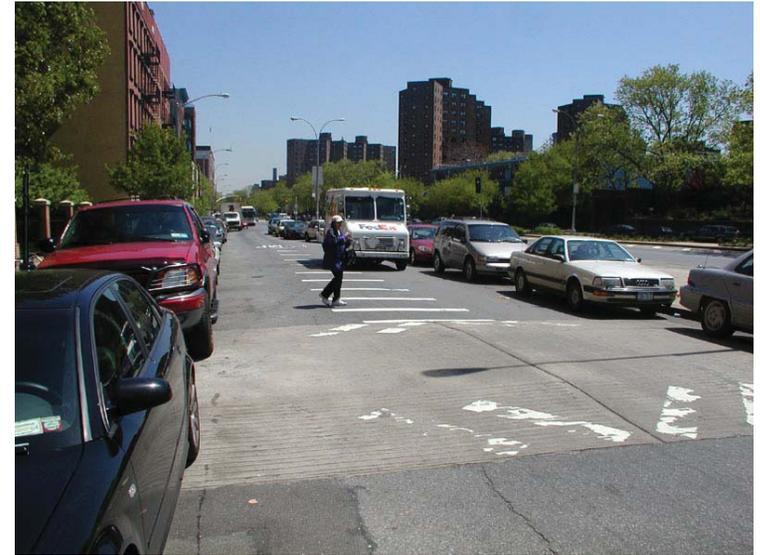
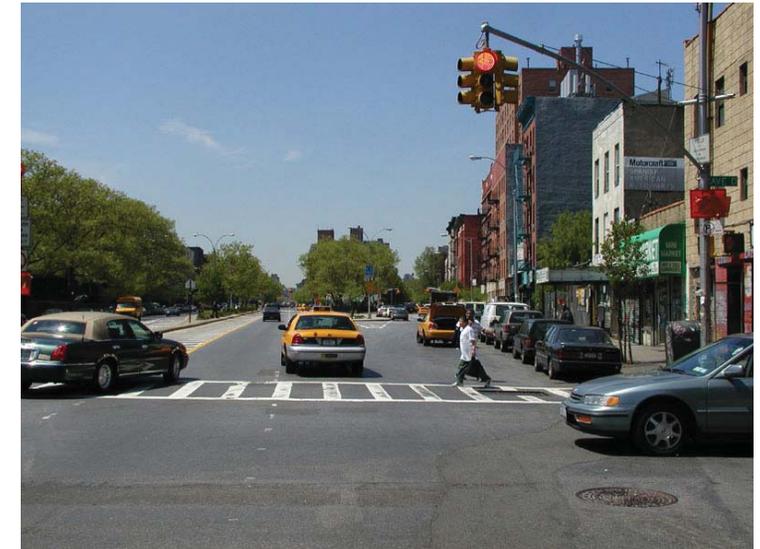
Top: Looking east, a pedestrian crossing East 2nd Street. Above: Looking west at Houston Street and East 2nd Street.

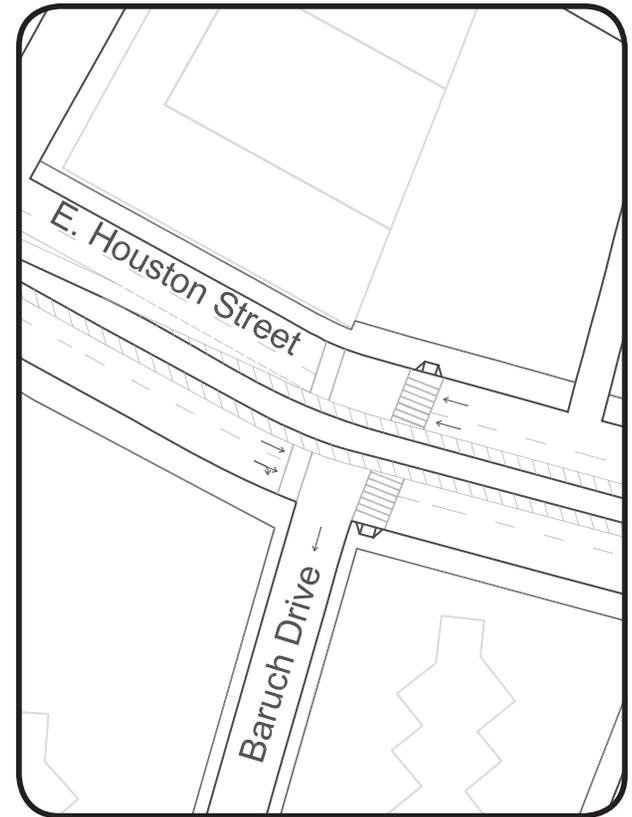
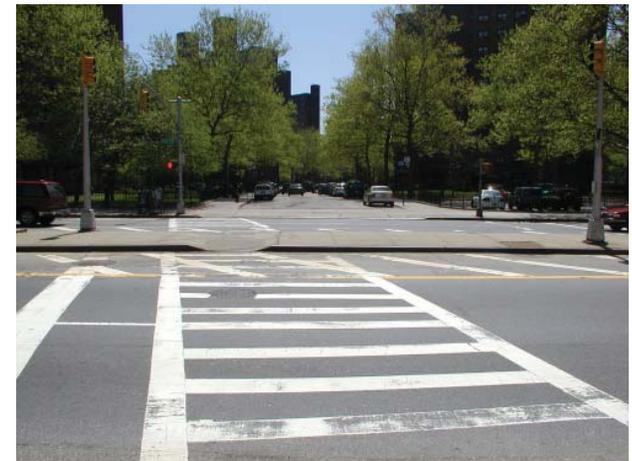
Looking south, the east crosswalk at Baruch Drive and East Houston Street.

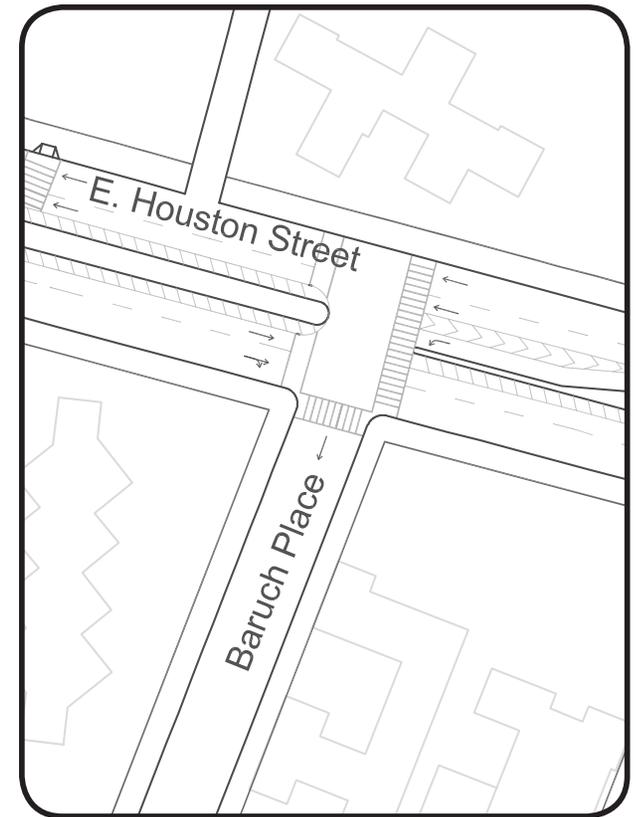
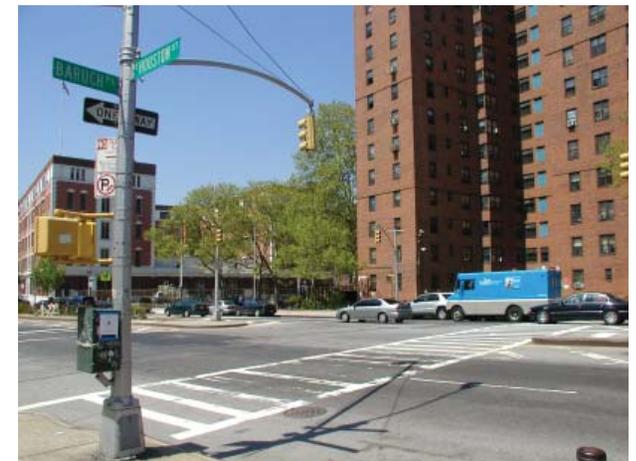
Looking north, the east crosswalk at Baruch Place and East Houston Street.

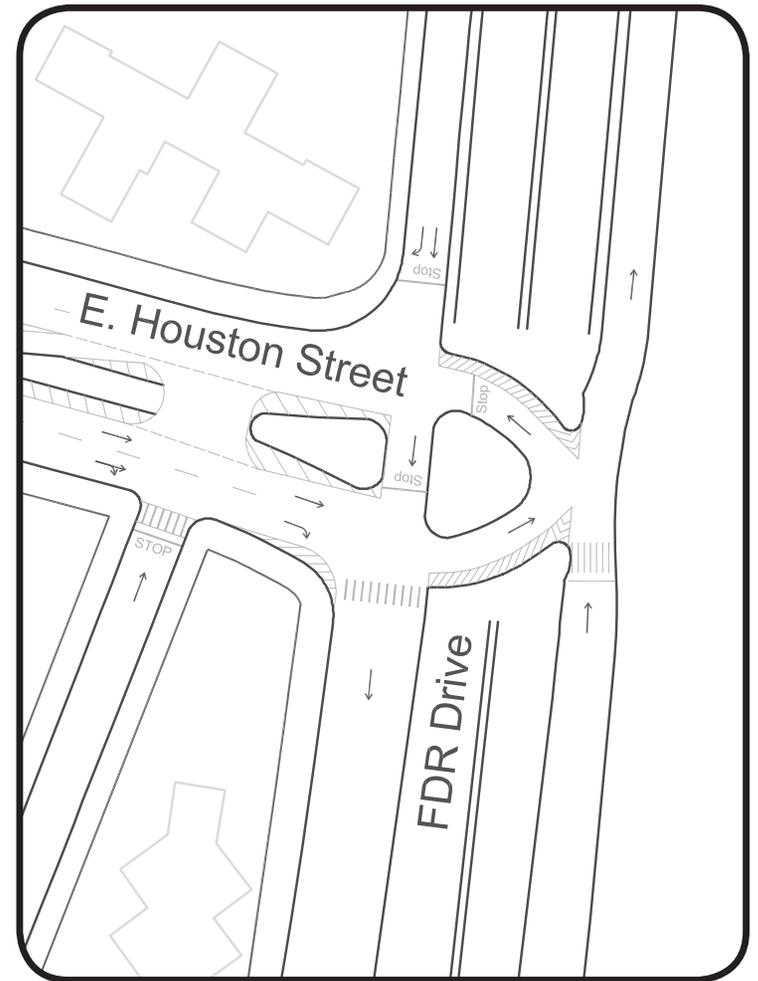
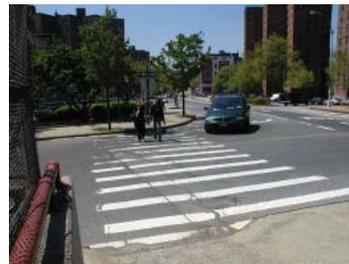
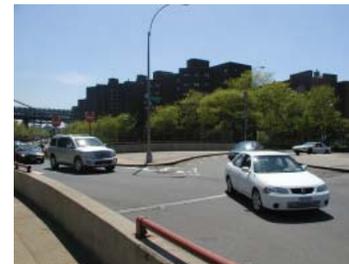
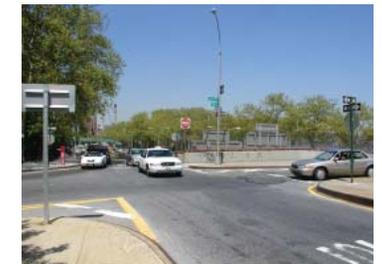
Left to right: Pedestrians crossing the south crosswalk of the southbound FDR Drive entrance ramp; northbound FDR Drive exit ramp; southbound FDR Drive exit ramp traffic.

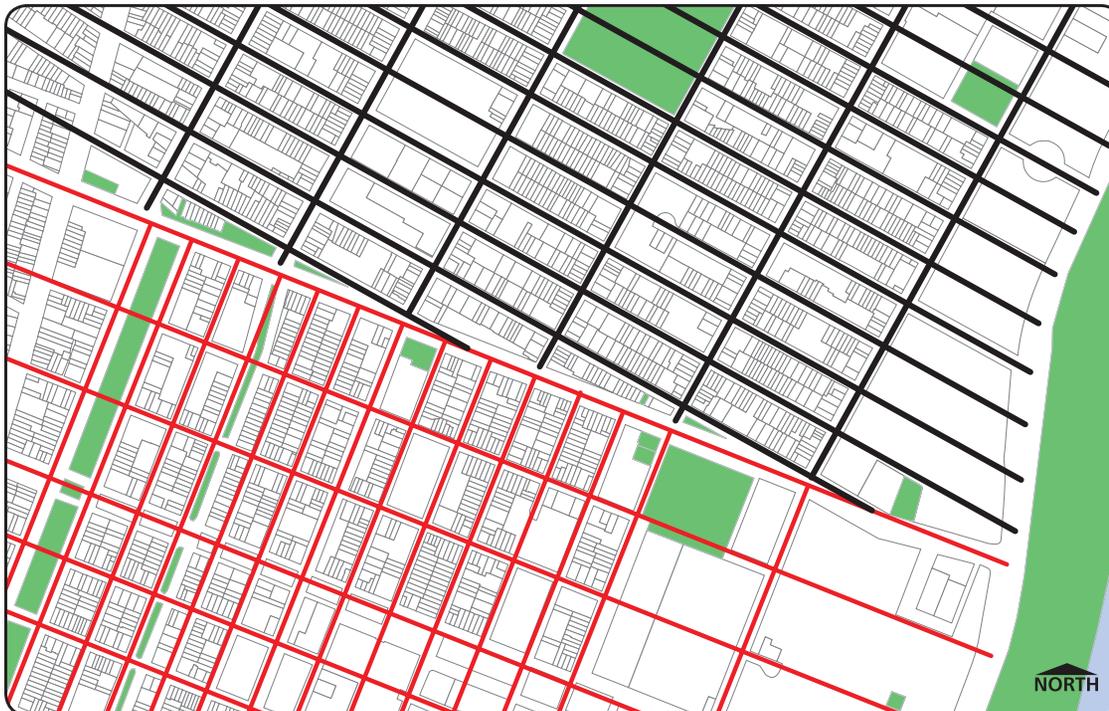
Figure 8: Irregular Street Geometry

East Houston Street functions as the border where the disjointed street geometry of early development meets the modern, symmetric geometry of the grid. Prior to 1811, streets in Manhattan were laid out haphazardly, as still evident today in many neighborhoods south of Houston Street. The *Commissioner's Plan of 1811* established a street grid of north-south avenues and east-west streets starting north of Houston Street but not exactly parallel to it. As a result, certain cross streets begin at East Houston Street, then skew away from it, causing discontinuities in pedestrian circulation and forcing pedestrians to cross streets against traffic.

In addition, the 1811 Plan mapped fewer north-south streets. As a result, there are a number of T-intersections where streets begin or terminate, and intersections where two-way streets meet one-way streets, resulting in a disruption of the continuity of north-south traffic along the corridor. This poses problems for both pedestrians and motorists when trying to determine the direction of oncoming traffic.

The street plan to the south of East Houston Street (left, in red) was established prior to the *Commissioner's Plan of 1811* (right), which proposed a grid that would extend from Houston Street north to regulate the development of Manhattan as its population expanded.

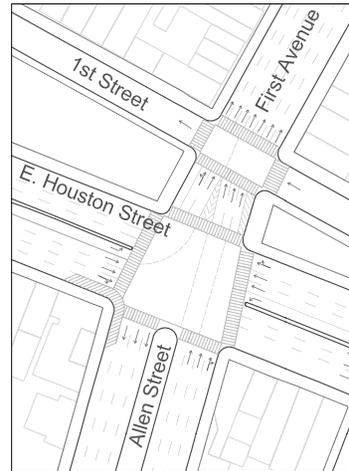
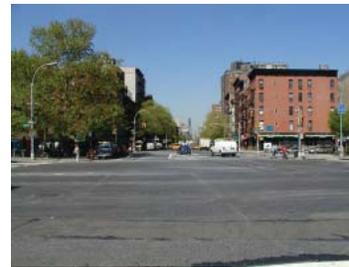
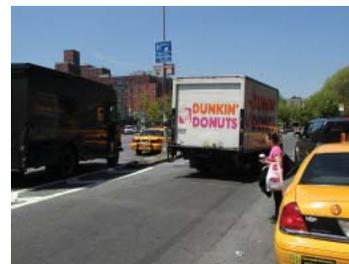
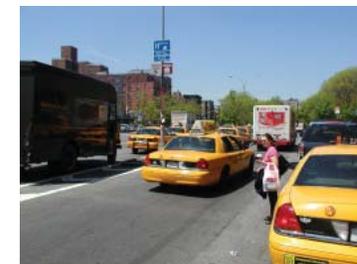
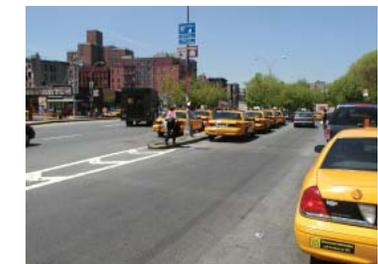
Irregular street geometry is an issue at East Houston Street where two-way Allen Street meets one-way, northbound First Avenue. The intersection of Allen Street at East Houston Street is extraordinarily wide. Pedestrians crossing either East Houston Street or Allen

Street must walk across six lanes of traffic in just 35 seconds of pedestrian walk time, only four seconds of which is designated exclusively for pedestrians.

Avenue A/Essex Street at East Houston Street had the highest number of pedestrian accidents (16) in the period studied. Westbound First Street begins at this intersection, where it angles away from East Houston Street, creating a traffic triangle, and leaving pedestrians on the north side of the corridor to cross the street without the benefit of a crosswalk. The street geometry permits fast-moving vehicles to bear right onto First Street without slowing, creating unsafe conditions for pedestrians. Excess roadbed at the northwest corner of Avenue A at First Street affords opportunities to recapture a portion of the street for the use of pedestrians.

From the top: the irregular street geometry of First Avenue and East Houston Street; the long crossing at the north crosswalk of East Houston Street at First Avenue; the irregular street geometry of Second Avenue and East Houston Street; the end of the Second Avenue bike lane; a woman trying to cross First Street near Avenue A and East Houston Street.

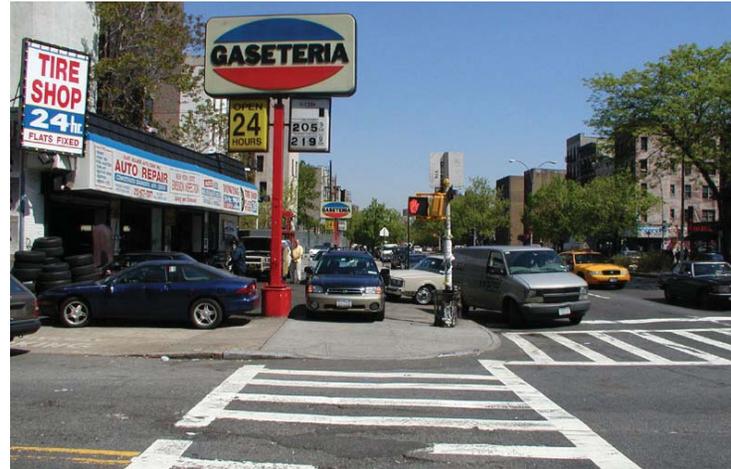
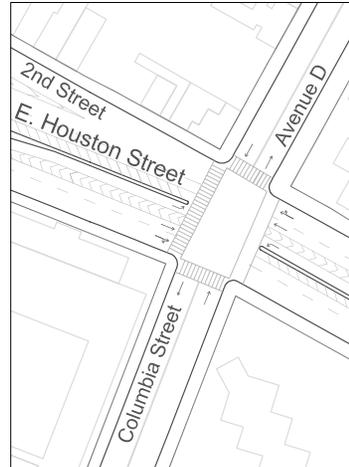
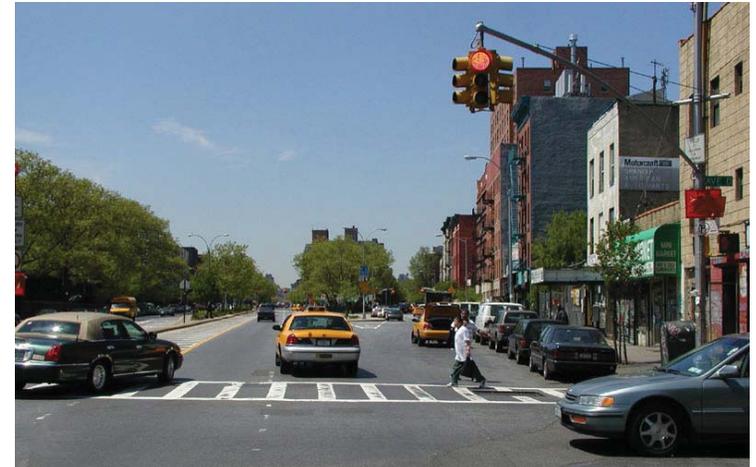
One-way Pitt Street meets two-way Avenue C at East Houston Street, creating issues of non-continuous traffic flow and irregular street geometry. Vehicles turning left onto eastbound East Houston Street conflict with pedestrians in the crosswalk. As with Avenue B, backs of buildings fronting East Houston Street at this intersection have been neglected. The buildings are boarded up in the back and are covered in graffiti; the property lines are fenced by unattractive corrugated metal.

Left: Cars blocking the sidewalk at the service station. Below: A view looking west at the intersection of Avenue D and East Houston Street and a diagram displaying the street geometry of the intersection.

At this intersection, as with Avenue A/Essex Street at East Houston Street, Second Street diverges from East Houston Street, creating a traffic triangle, and leaving pedestrians on the north side of the corridor to cross the street mid-block without the benefit of a traffic signal or a crosswalk. The street geometry permits fast-moving vehicles to bear right onto Second Street without slowing, creating unsafe conditions for pedestrians. As a result, this intersection has had a relatively high number of pedestrian accidents (7).

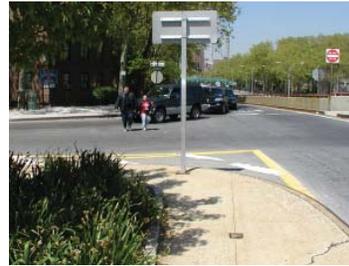
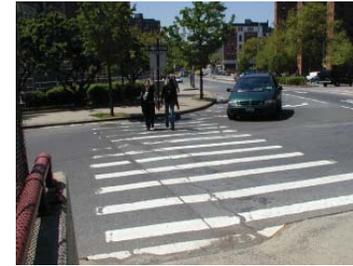
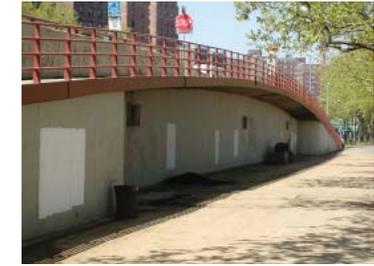
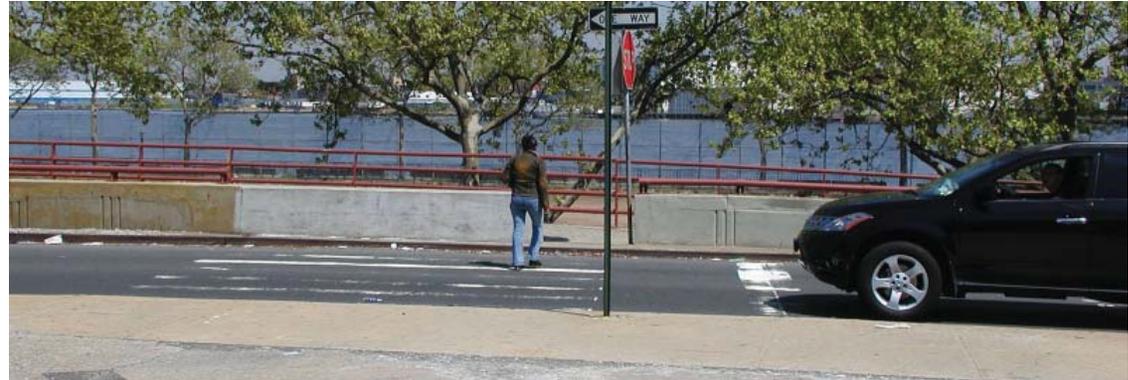
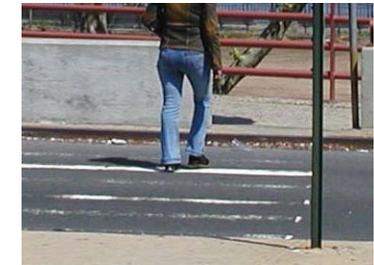
Pedestrians at the northwest corner of the FDR Drive at East Houston Street are unable to safely cross either the FDR Drive or East Houston Street. The lack of signage, change in grade, presence of jersey barriers along the eastern side of the FDR, and difficulty of crossing an unsignalized intersection result in constricted access to East River Park for both pedestrians and cyclists. Eastbound Houston Street traffic has the right-of-way at its intersection with the FDR Drive; the left turn to the northbound FDR Drive entrance ramp or the right turn to southbound FDR Drive entrance ramp is uncontrolled. Because there is no traffic control device, cars traveling eastbound on East Houston Street make right turns at high speeds onto the southbound FDR Drive entrance ramp, conflicting with pedestrians using the crosswalk to get to and from East River Park. The lack of a traffic control may contribute to confusion amongst pedestrians, cyclists and motorists as to who has the right-of-way. Also, it is difficult for crosswalk users seeking to access the park to see approaching eastbound traffic because they must look behind them for traffic.

There is limited queuing space for vehicles exiting northbound FDR and turning west onto East Houston Street. However, in the peak hours, vehicles use the painted roadway to effectively turn one marked travel lane into two lanes and thereby maximize traffic flow. Poor sight lines make it difficult to see oncoming traffic, so vehicles inch out into the intersection in order to have a clearer view.

Top-left: Pedestrians crossing from the northwest corner of the intersection of East Houston Street and the FDR Drive. Top-center: Pedestrians crossing the southbound FDR Drive entrance ramp. Top-right: Ramp to East River Park, east of the FDR Drive. Above: The entrance to the East River Park across the northbound FDR Drive exit ramp. Right: A detail showing the lack of pedestrian ramps at the crossing.
