Flatbush Avenue Pedestrian Study Final Report

Amanda M. Burden, AICP, Director
New York City Department of City Planning

FINAL REPORT
May 2008

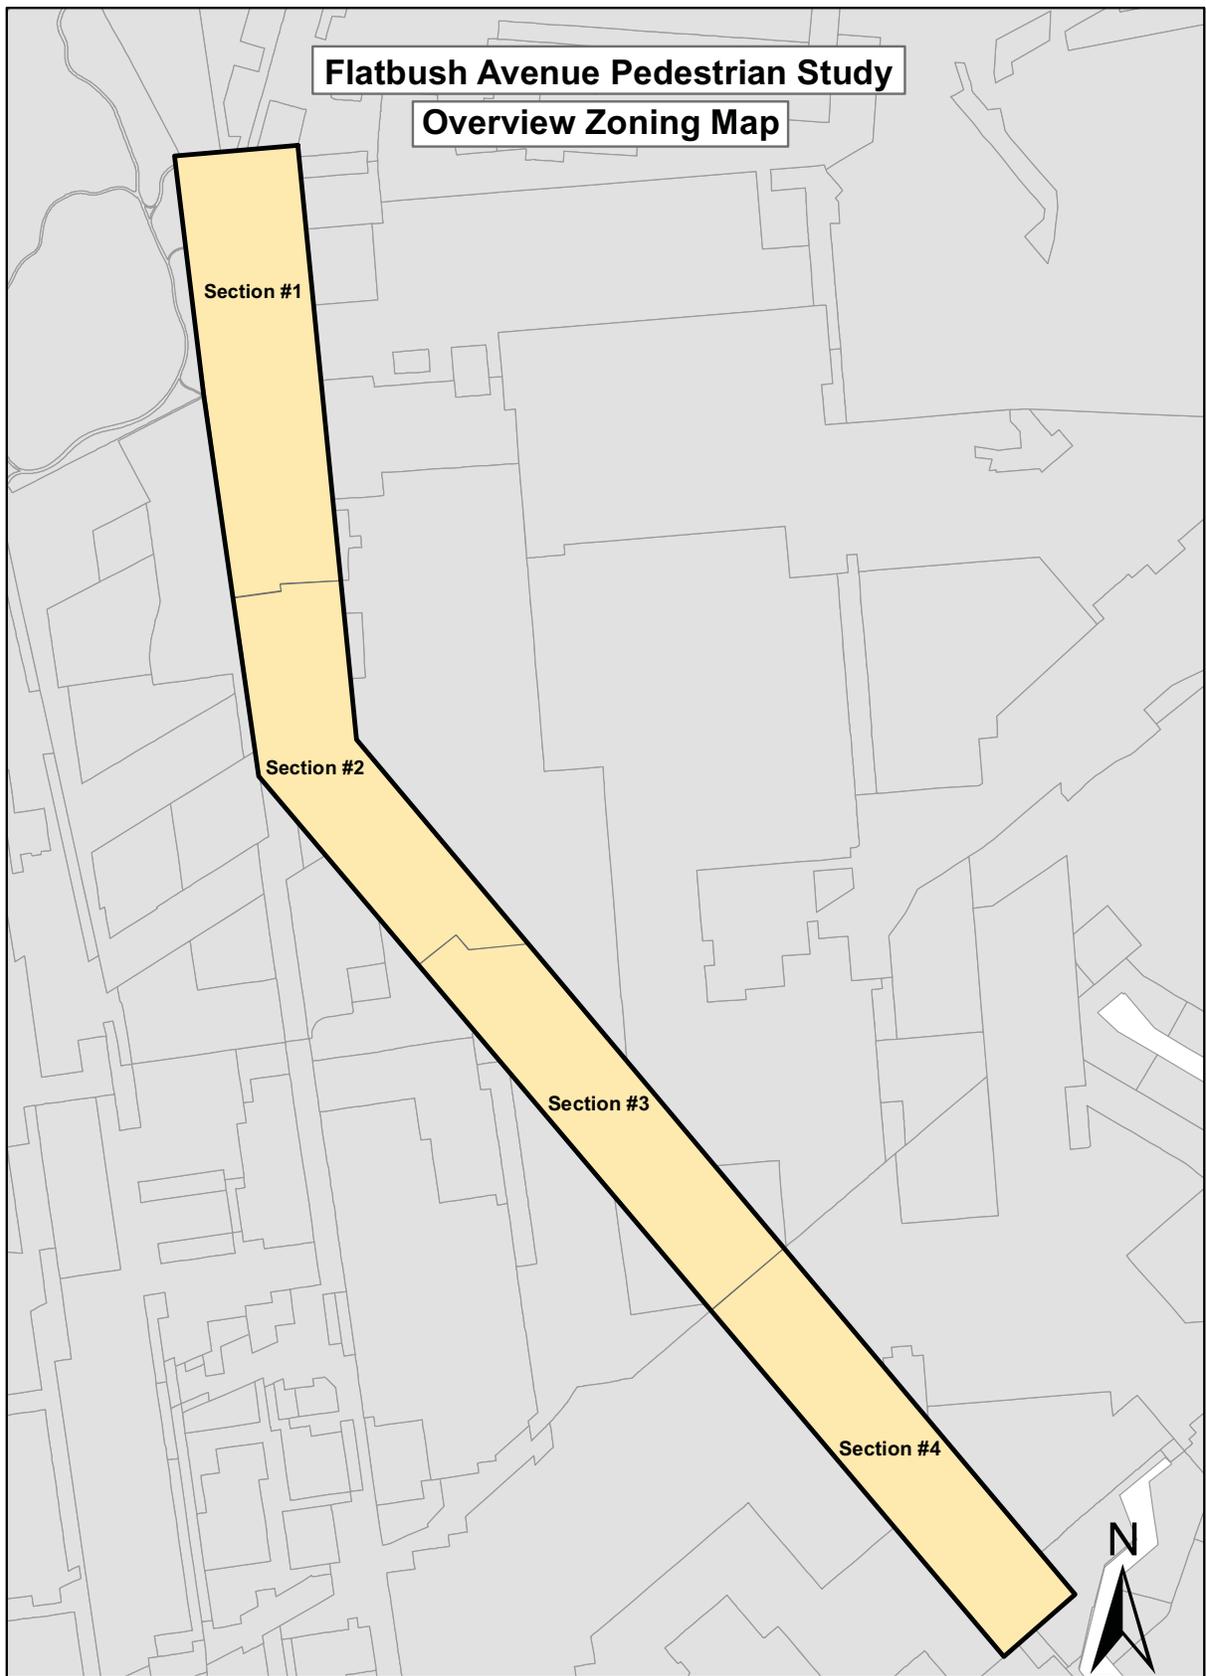
Figure B-1 represents the study area, a large area that has been divided into four sections in this report to better understand the zoning and land use configurations within the area of study. Section 1 stretches along Flatbush Avenue from Empire Boulevard to Albermarle Road, Section 2 from Albermarle Road to Glenwood Road, Section 3 from Glenwood Road to Flatlands Avenue and Section 4 from Flatlands Avenue to Avenue V.

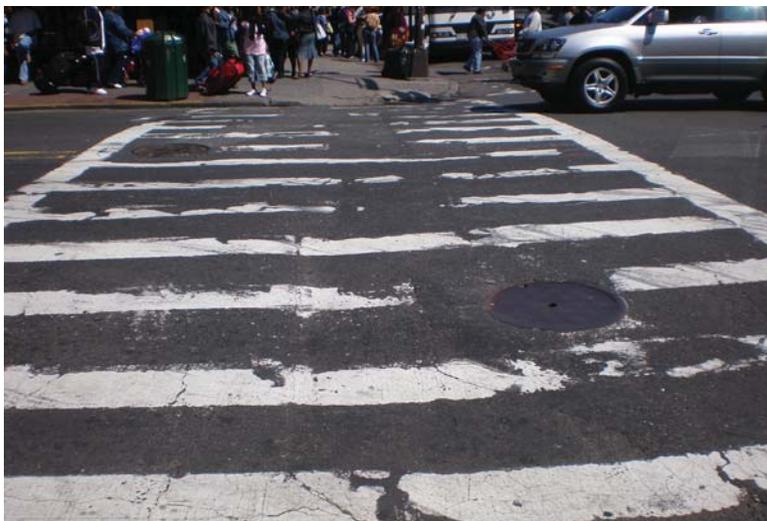
In general the pavement of both streets is in poor condition and covered with potholes which vehicles avoid by slowing down and swerving around them. This can be dangerous for pedestrians since drivers do this without warning and sometimes nearly miss pedestrians crossing at the intersection.

Also the pavement markings “high visibility crosswalks and stop bars” have faded and are also in poor condition.

Poor Pavement Conditions on Church Avenue

- **Improve Pavement Conditions**
Repair the potholes and the roadway defects at this location. In addition, the restriping of the crosswalks and stop bars is necessary to be clearly visible to motorists and pedestrians.

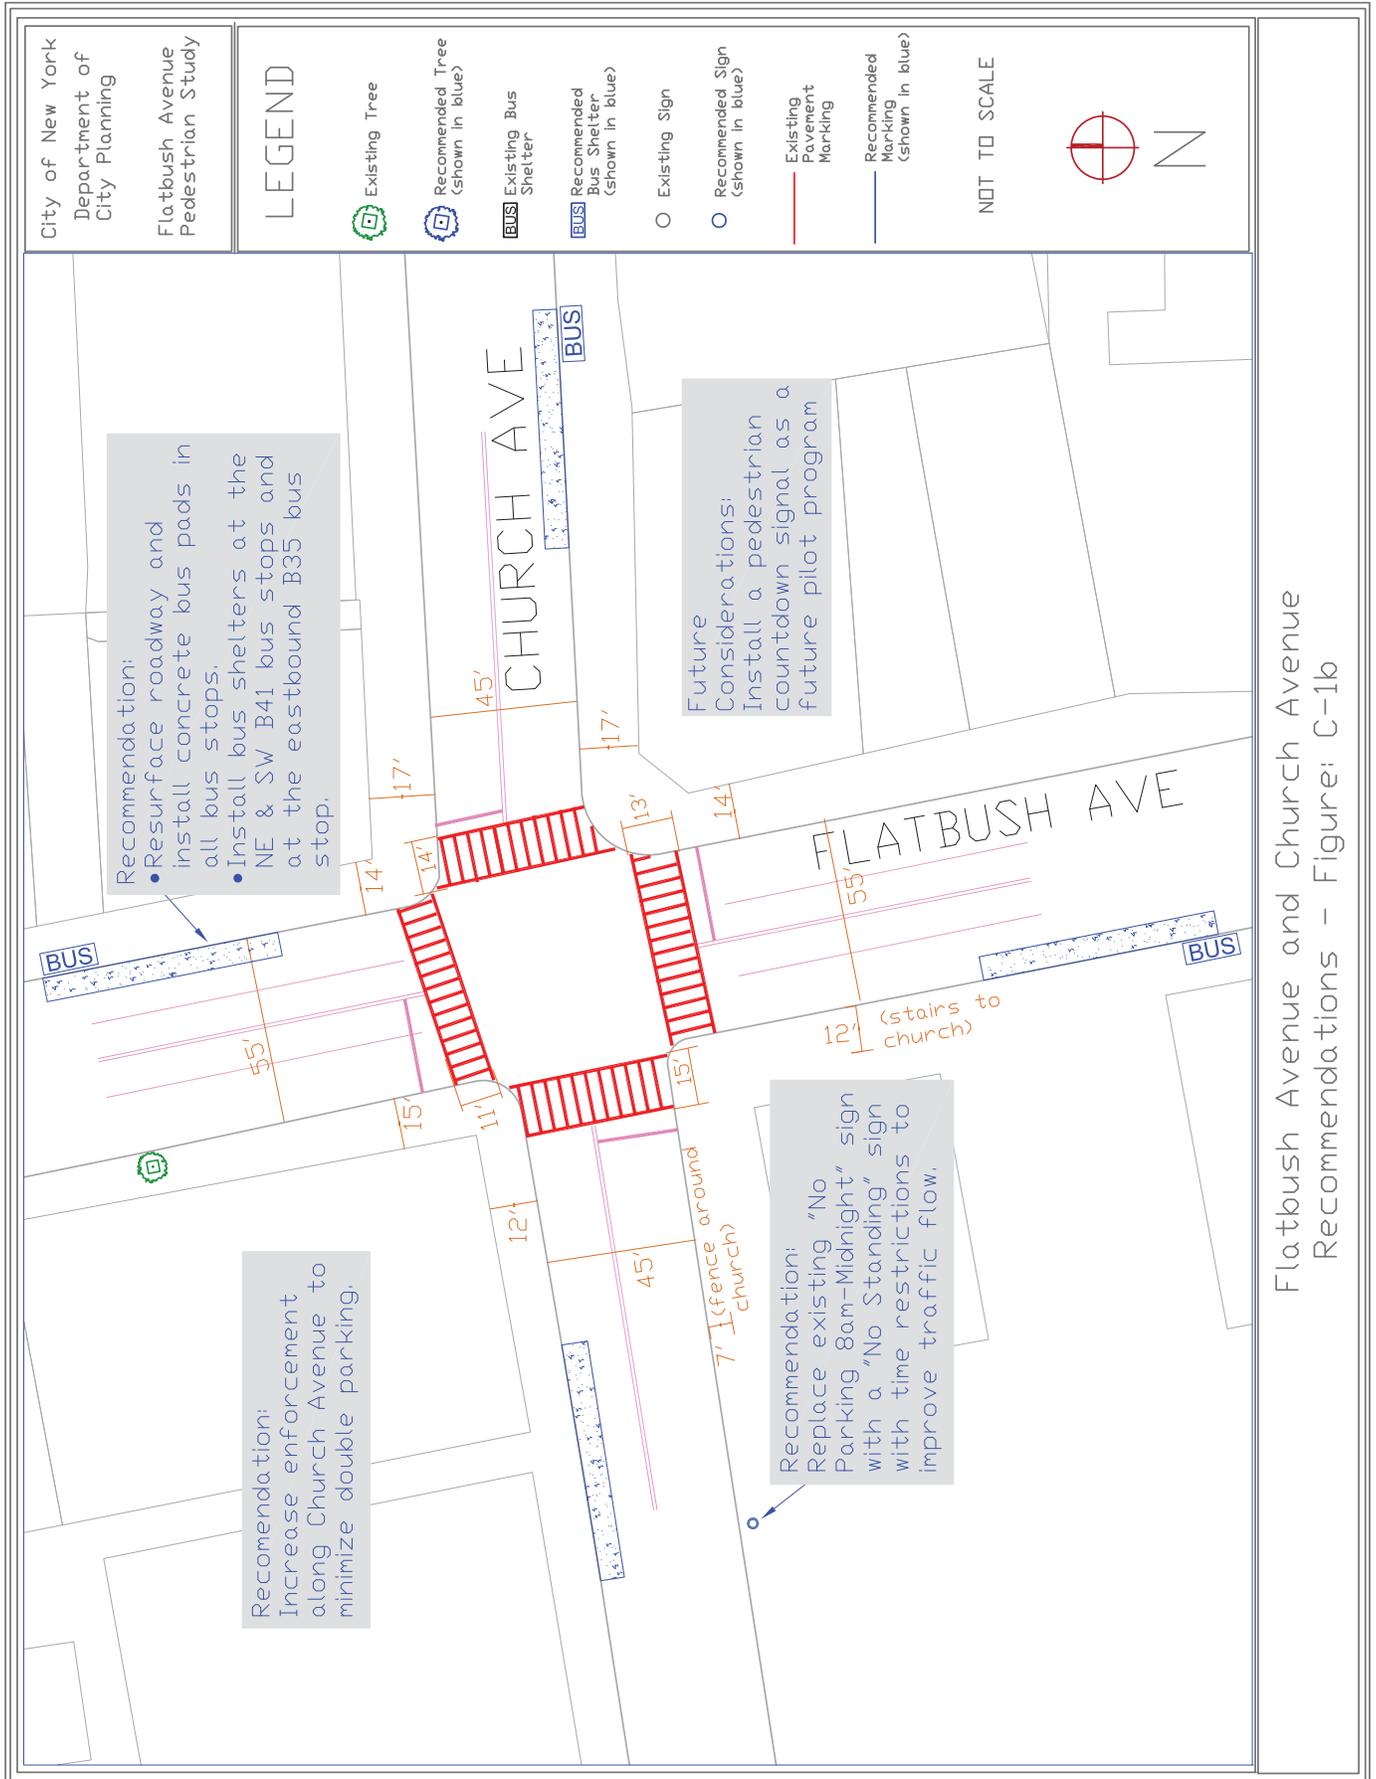
Flatbush Avenue and Church Avenue Recommendations - Figure: C-1b

- **Increase Enforcement**
An increase in police presence at this location particularly on Church Avenue is recommended for enforcement of traffic regulations.

- **Signage**
In order to reduce pedestrians jaywalking in between delayed vehicles, a “No Standing Anytime” sign is proposed on Church Avenue at the south curb and west of the intersection. This new sign would replace the existing “No Parking Regulation” sign. The “No Standing Anytime” sign usually discourages loading and unloading of trucks and standing at the curb by motorists in general.

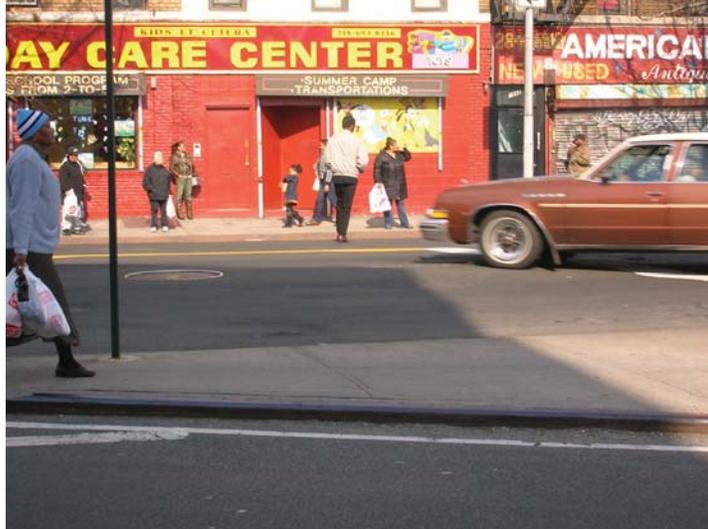
In addition, the passengers getting off at the bus stop on the east side of Flatbush Avenue (B41, BM2 and B103 buses) and heading westbound to Foster Avenue or southbound to Bedford Avenue often cross or jaywalk midblock to continue their route or to make a connection with the B49 going westbound which is a dangerous crossing location for pedestrians. The distance from the bus stop to the nearest crosswalk is at least 200 ft and often these pedestrians/bus passengers cross midblock and do not take the time to cross at the crosswalks (See following map of intersection).

Pedestrian crossing Flatbush Avenue midblock just north of Foster Avenue

The existing signs “No Ped Crossing Use Crosswalks” are not very useful based on their placement and orientation. First of all, install double-sided signs that face all pedestrian approaches and can be seen from any direction as you approach the midblock location. Secondly, install an additional sign adjacent to or above the “No Ped Crossing Use Crosswalks” sign. This sign should be an image of a pedestrian with a red interdiction symbol over it (MUTCD manual “R9-3a” sign; see image in Appendix D-2: Standards for Signs Recommended). The graphic reinforces the first sign’s message that pedestrians are prohibited from crossing the roadway at this undesirable location.

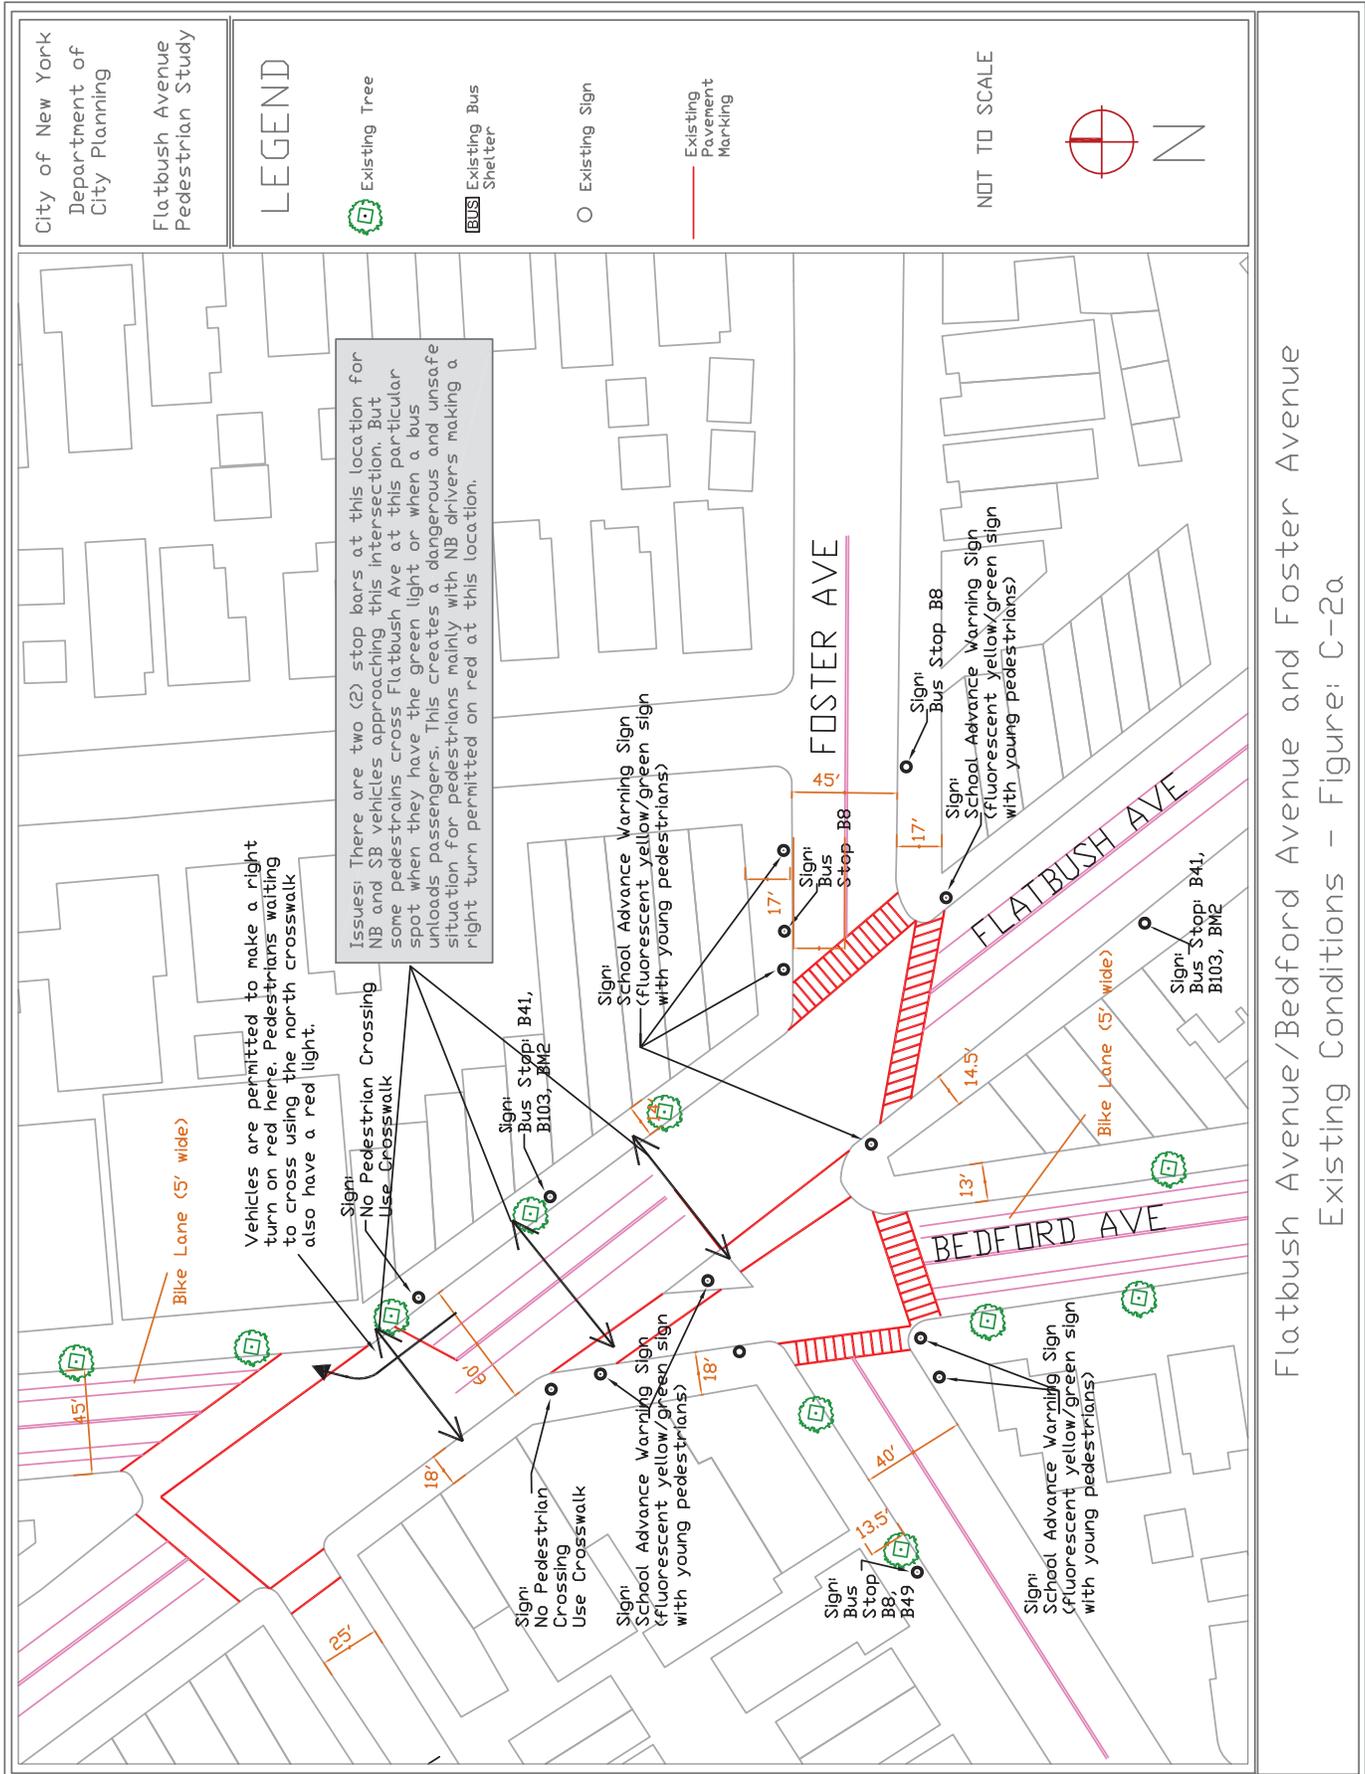
Flatbush Avenue/Bedford Avenue and Foster Avenue Existing Conditions - Figure: C-2a

- Pedestrian Crossing Midblock and at “Stop Bar” locations
 Flatbush Avenue, Foster Avenue and Bedford Avenue all meet at this point. These streets do not align and are at an angle to each other. In addition “Stop bars” have been placed north of Foster Avenue to indicate where vehicles arriving at this location should stop in the middle of the block. Pedestrians were observed crossing at that particular spot. It was observed at that midblock location during the peak hours of a typical weekday that 41 pedestrians cross in the morning (7:00 - 9:00 am), 56 in the midday (12:00 – 2:00 pm) and 71 pedestrians cross in the evening (4:00 – 6:00 pm). During the weekend between 1:00 and 3:00pm 62 pedestrians typically cross Flatbush Avenue at that midblock location. In addition northbound traffic on Flatbush Avenue as it approaches Bedford Avenue often does not stop since it is permitted to make a right turn on red onto Bedford Avenue. There are signs to inform pedestrians not to cross at that particular location: “No Ped Crossing Use Crosswalks”. But these signs are ignored by pedestrians arriving at the intersection. See following map of intersection, Figure C2-a: Existing Conditions.

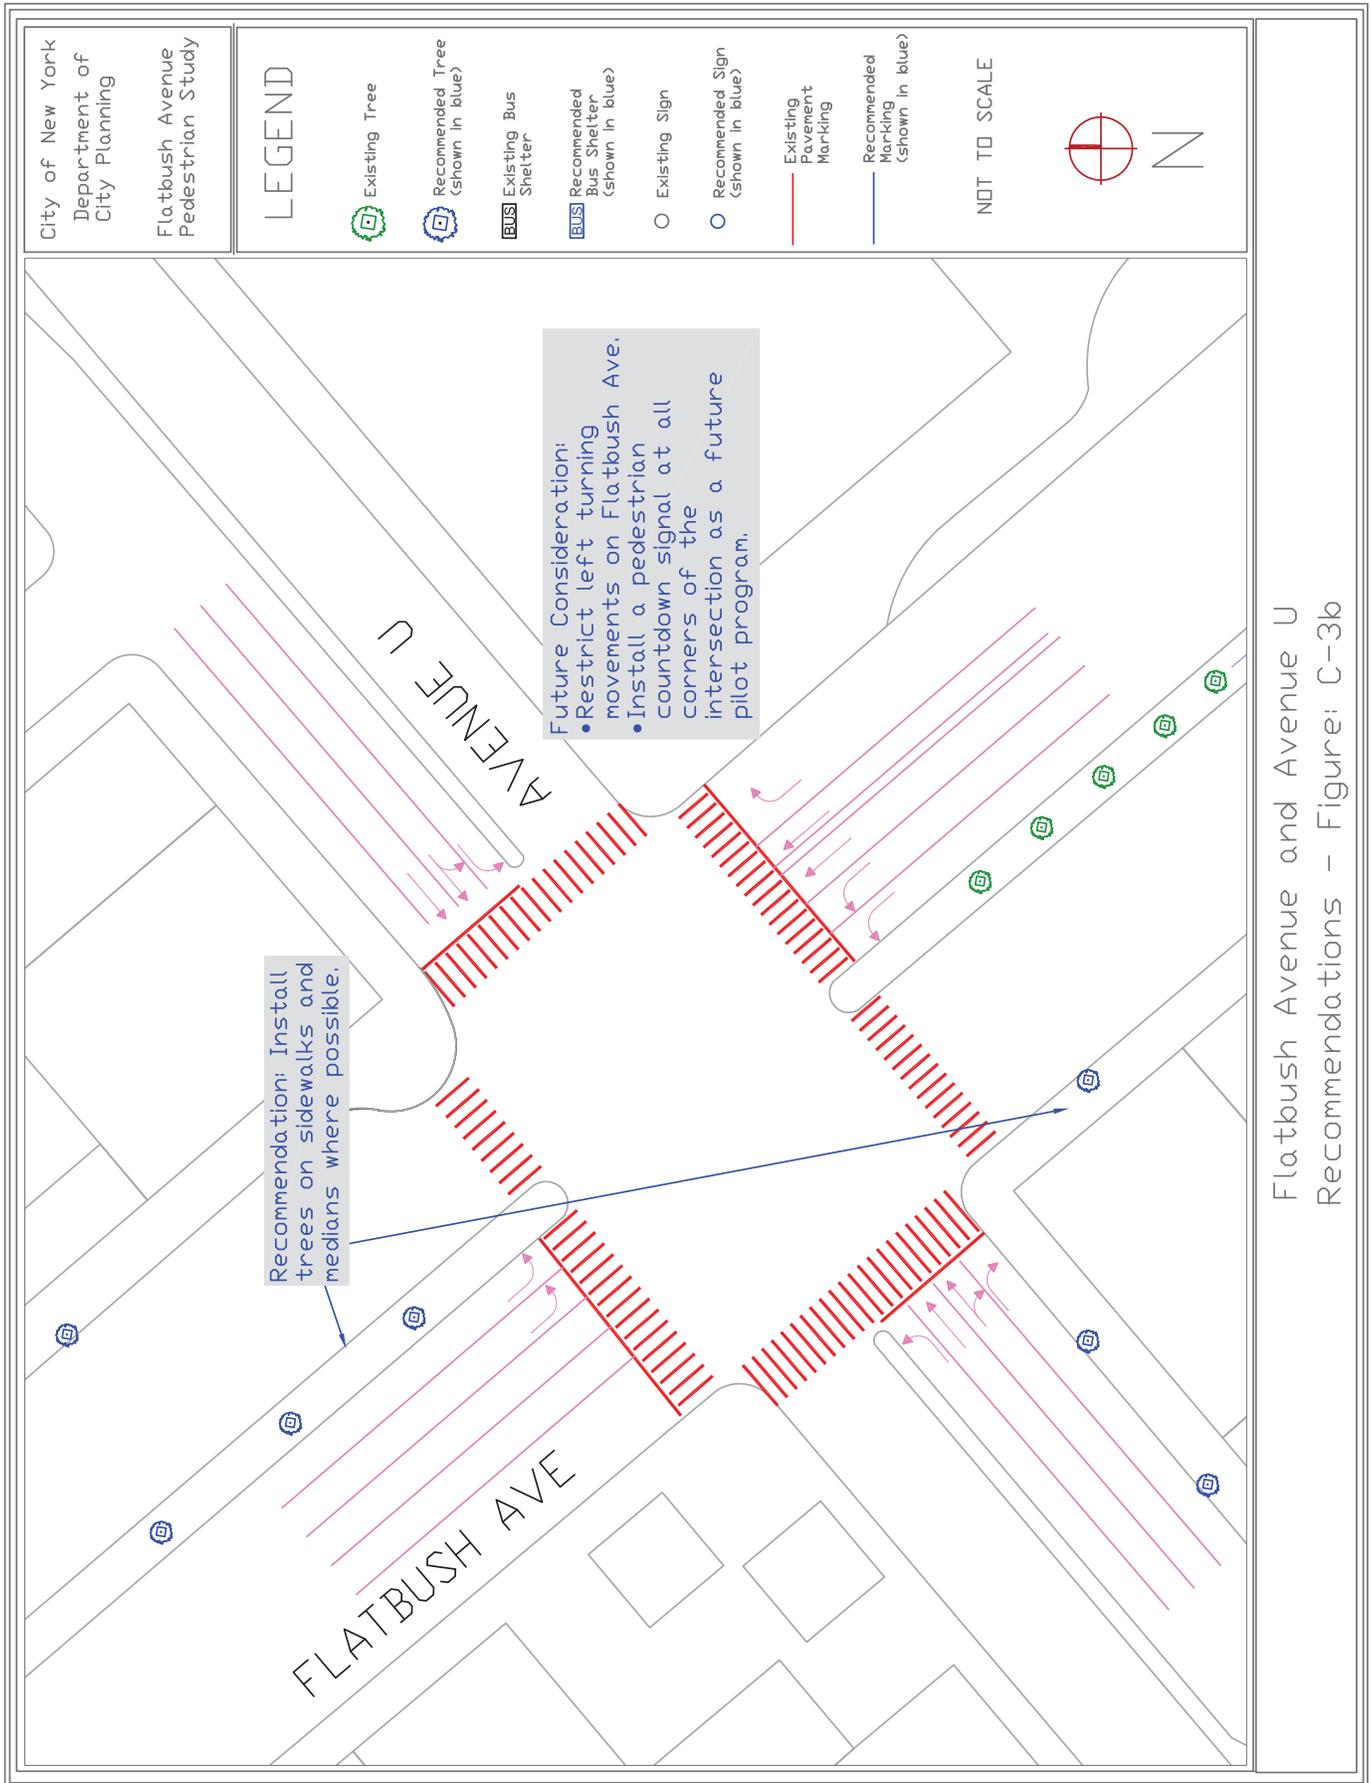
Flatbush Avenue and Avenue U
Recommendations - Figure: C-3b

- **Future Restriction of Turns**
Due to major vehicular and pedestrian conflicts affecting pedestrian's safety at this intersection, it is possible that left turns by vehicles may have to be restricted in the future, especially on Flatbush Avenue. This would require reconfiguration of the intersection and new signal timing.
- **Increase Enforcement**
An increase in police presence is recommended for this location for enforcement of traffic regulations.
- **Improve Pavement Markings**
Repair and restripe pavement markings of the northbound travel lanes south of the intersection
- **Provide Additional Pedestrian Amenities**
Have trees/planters and landscaping along the medians and on the sidewalks where possible.

The installation of a countdown pedestrian signal is recommended for consideration at Flatbush Avenue and Avenue U, to reduce conflicts between pedestrians crossing and vehicles making turns. This type of traffic signal can provide pedestrians with information about the amount of time remaining in a crossing interval and can improve pedestrian signal compliance. This pedestrian countdown signal is recommended as a future pilot program.

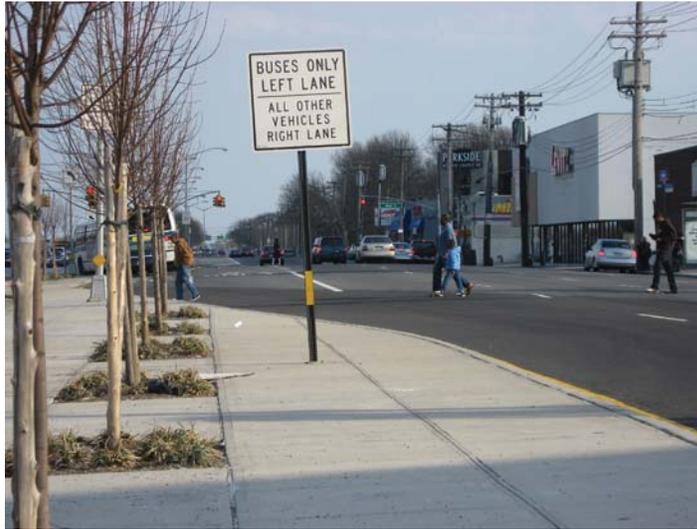
This is an unsafe practice for pedestrians who jaywalk in the area. With the high volume of vehicles (NB = 285 and SB = 245 vehicles on average/ 15-minute peak volumes) traveling daily along Flatbush Avenue, accidents are bound to happen at this midblock location. A total of eight pedestrian accidents have already occurred at this location between 2004 and 2006 (see above accident table). A survey was done regarding the volume of pedestrians crossing midblock: AM Peak Period (7:00 – 9:00AM) = 7, MD Peak Period (12:00 – 2:00 PM) = 11 and PM Peak Period

(4:00 – 6:00 PM) = 10 pedestrians. During the weekend peak period (1:00 – 3:00 PM), the midblock crossing volume = 20 pedestrians.

Pedestrians crossing Flatbush Avenue midblock between Avenue U and Avenue V

- **Install a barrier**
Plant shrubs along the median in between Avenue U and Avenue V to block and discourage pedestrian from jaywalking. In addition, have some of the following signs installed midblock “Cross only at Crosswalks” and “Use Crosswalk (with a directional arrow)” directing pedestrians to the crosswalks at Avenue U or Avenue V (MUTCD Manual R9-2 and R9-3b signs; see Appendix D-2: Standards for Recommended Signs).
- **Provide Additional Pedestrian Amenities**
Place trees/planters on the sidewalks where possible. In terms of the medians on Flatbush Avenue, they recently as of December 2007, had small trees planted.

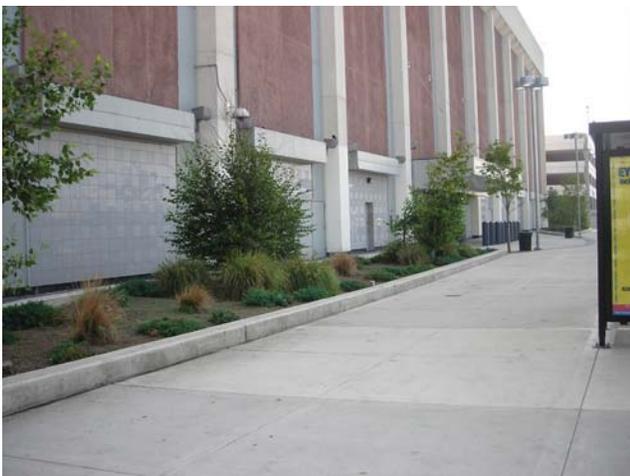
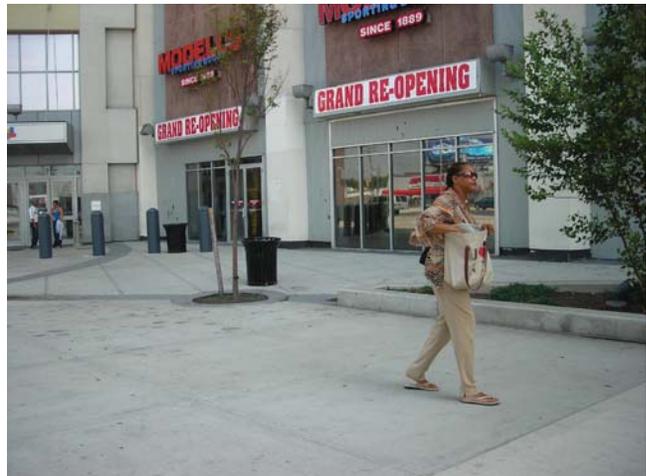
Also the plaza in front of the shopping mall lacks benches and sitting areas for the Kings Plaza patrons waiting for a bus.

Plaza in front of Kings Plaza Mall lack sitting area and benches

Additional sitting areas at the entrance of the Kings Plaza shopping mall would be convenient for patrons waiting for the arrival of the bus.

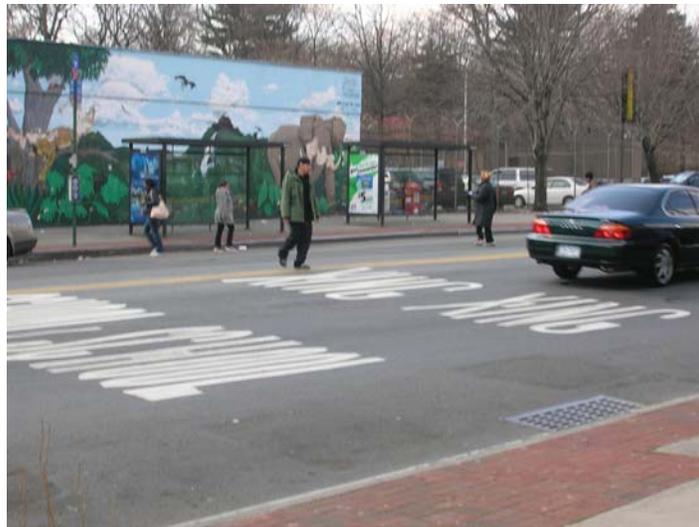
A sample data collection of pedestrian volumes crossing midblock for this location was done on Tuesday, December 11, 2007 from 9:15 – 9:30 AM and included subway riders crossing midblock to/from the subway station. A total of 69 people were observed crossing during those 15 minutes.

In addition there are pavement markings indicating a traffic island on Flatbush Avenue that pedestrians use to cross midblock. This traffic island is south of the intersection with a length of approximately 100 ft from the intersection in between the northbound and southbound travel lanes.

Pedestrians crossing Flatbush Avenue midlock between Empire Blvd and Sterling Street

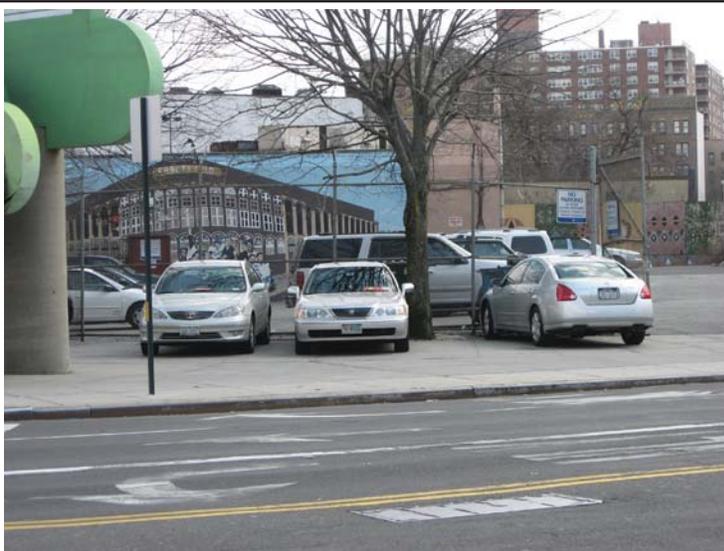
The southwest corner has three concrete posts with signage announcing Flatbush Avenue for motorists and pedestrians traveling through the area. This corner also has a wide sidewalk, but it is empty and barren. The MTA has an existing parking lot at that corner for employees with private vehicles and extends their parking activity onto this sidewalk space at the corner beyond the fence, which is unattractive compared to the other three landscaped corners.

The illegal parking on the sidewalk also creates conflicts with pedestrians, with cars pulling in and out of that public space while pedestrians are present.

Vehicles parked on sidewalk at southwest corner of intersection

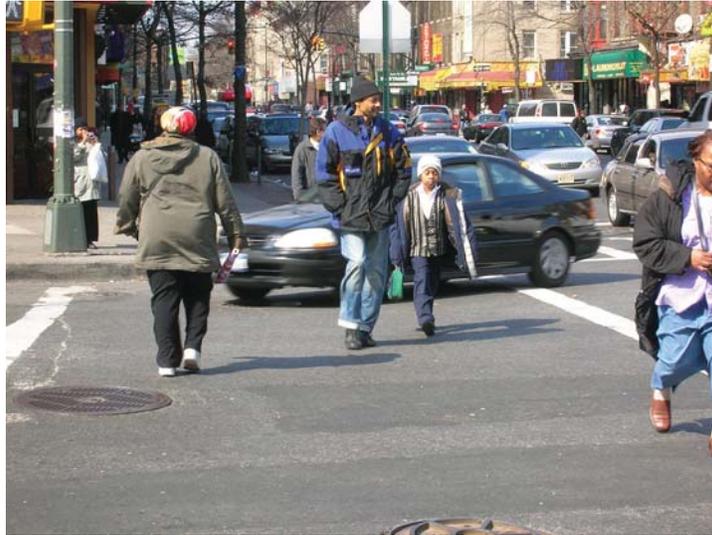
In addition, 50% of the pedestrian accidents that occurred from 2004 to 2006 at this intersection happened while pedestrians were crossing with the signal.

Pedestrians are often in conflict with vehicles making a turn at the intersection of Flatbush Avenue and Parkside Avenue

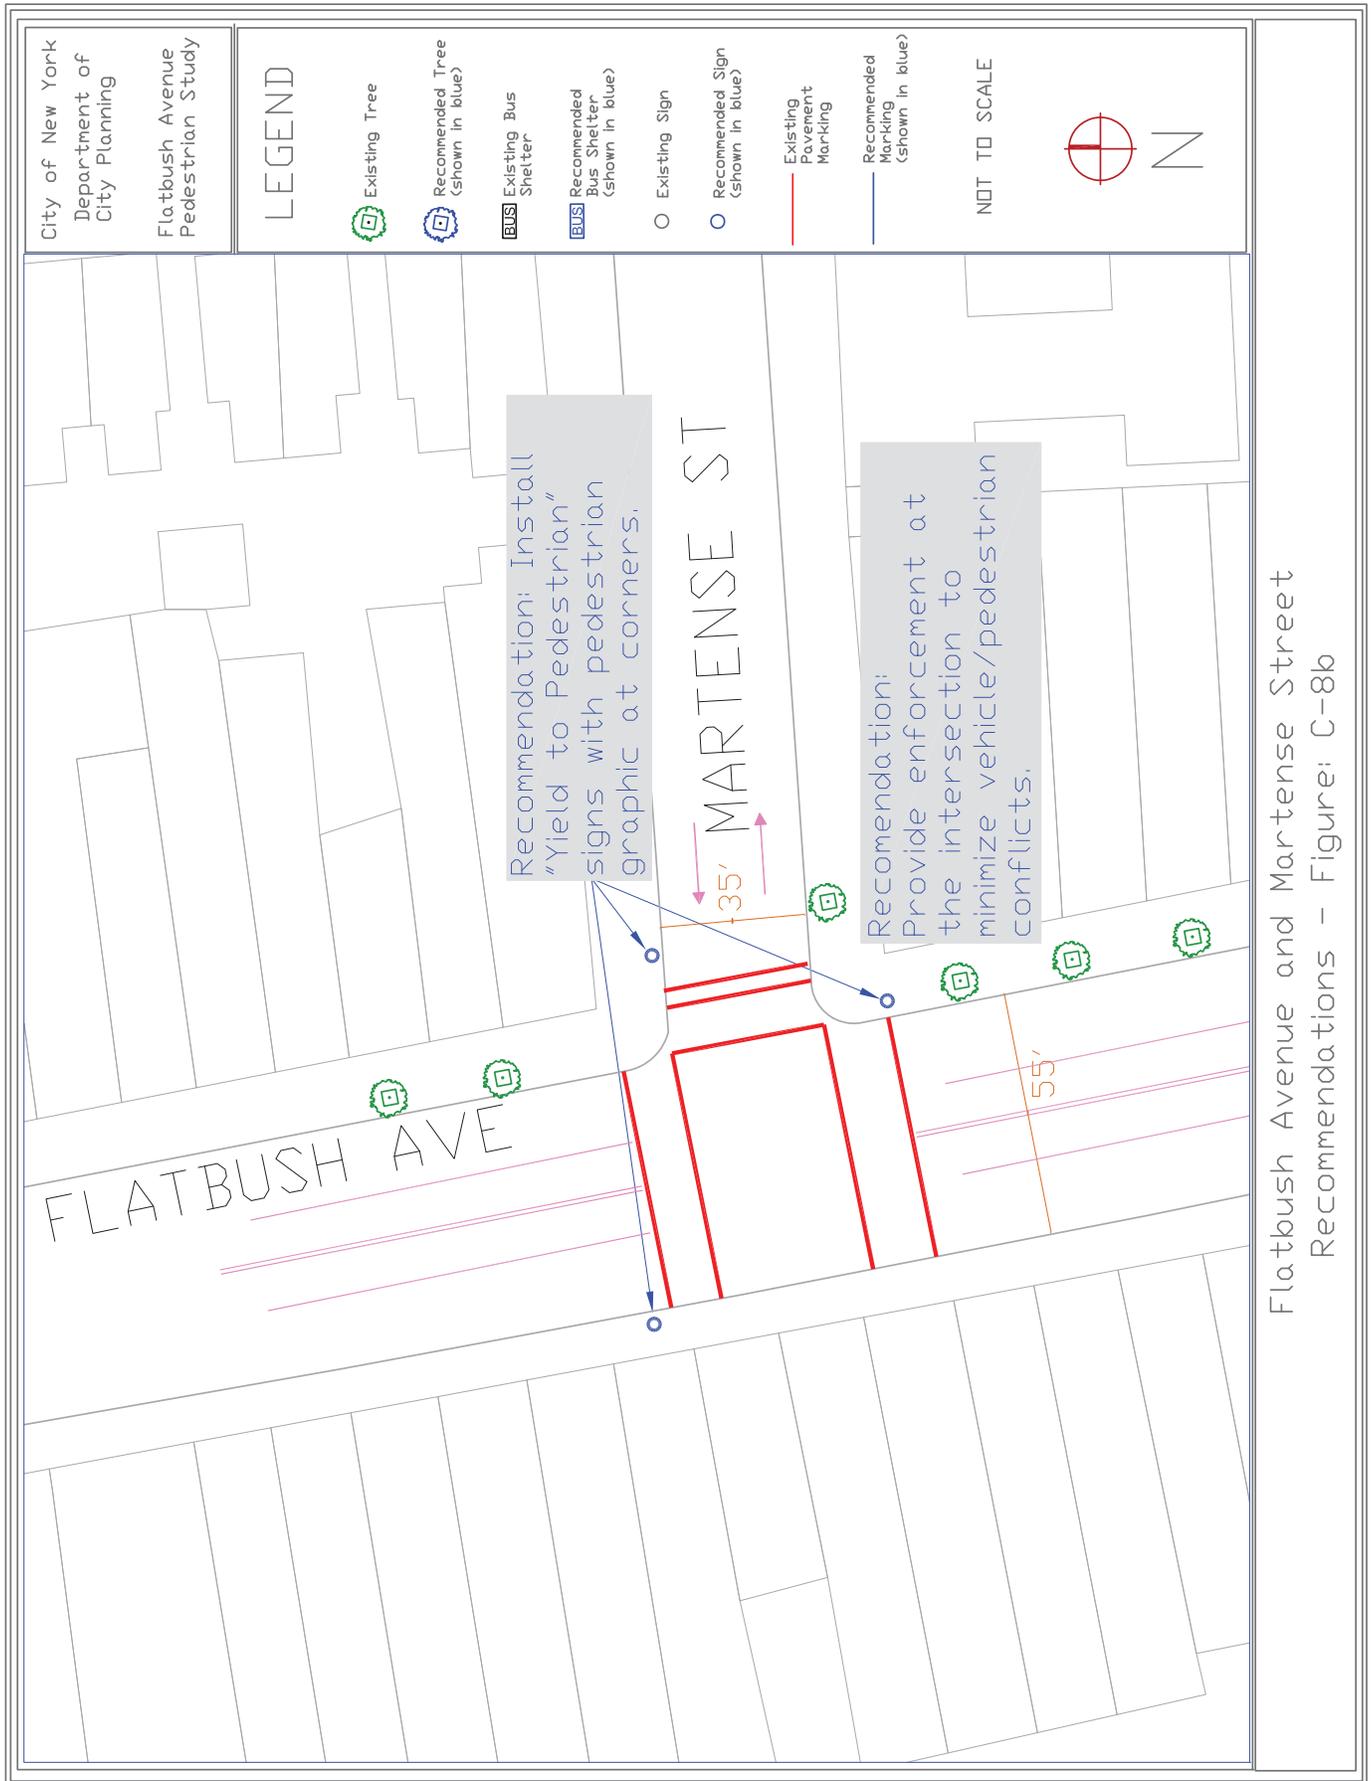
Flatbush Avenue and Martense Street
Recommendations - Figure: C-8b

An increase in police presence on Flatbush Avenue is recommended to enforce observance of the New York State law which requires vehicles to yield to pedestrians legally using a marked crosswalk.

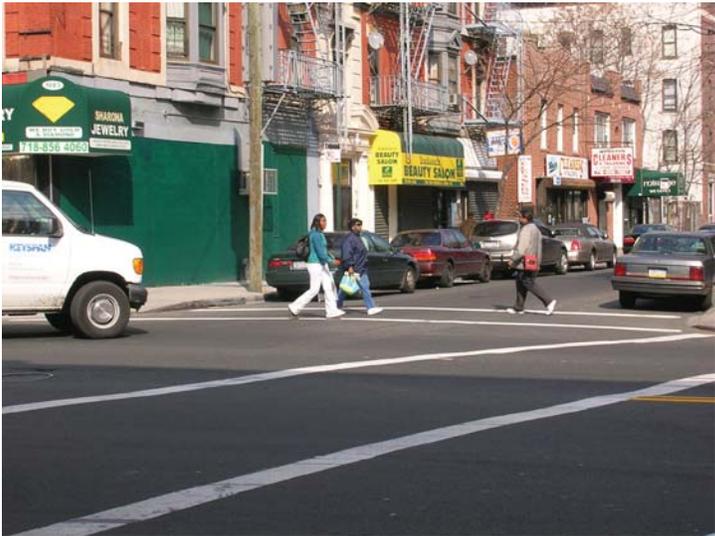
- Pedestrian/ Vehicle Conflicts
 Conflicts occur with vehicles making turns at the intersection and pedestrians crossing with the green light. Motorists do not always yield to pedestrians crossing at this location. Vehicles from Cortelyou Road in general turn onto Flatbush Avenue.
- Illegal Crossing by Pedestrians
 Many pedestrians using the east crosswalk often do not wait for the green light when crossing at this location. When there is a gap in traffic on Cortelyou Road pedestrians often take a chance and cross the one-way segment of Cortelyou Rd even though the light is red for pedestrians.

Pedestrians often cross Cortelyou Road east of Flatbush Avenue on red.

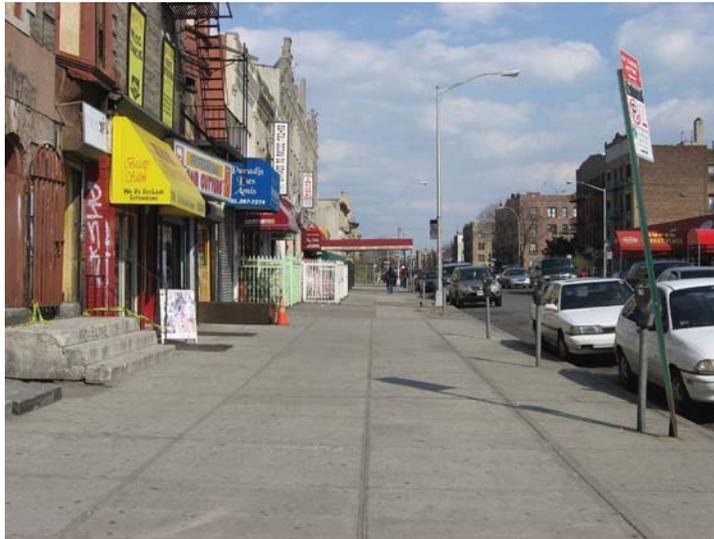
The wide sidewalks on Clarendon and Dorchester Roads are empty and have very light pedestrian activity. Space is available on these streets for pedestrian amenities such as trees, planters, etc.

Sidewalks on Clarendon Road are empty with no trees

Have trees planted at this location along Clarendon Road according to the standards and minimum distances set by the New York City Department of Parks and Recreation (NYCDPR). Add landscaping or streetscape elements on the sidewalk where possible. Narrow bus shelters are also recommended on Flatbush Avenue at the bus stops for bus passengers.

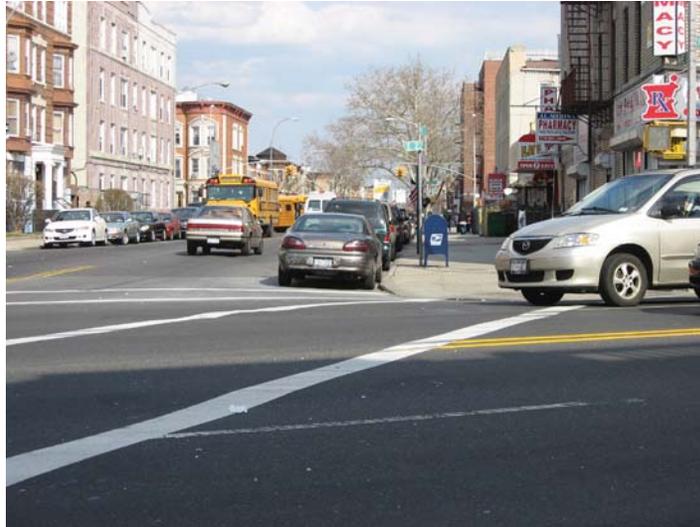
- **Vehicles and Crosswalks**
The awkward shape of the intersection often has vehicles on Flatbush Avenue waiting for the green light partially in the crosswalk which is at an angle. This creates conflicts between drivers and pedestrians and reduces visibility due to a shorter sight distance at the intersection for the driver.

Vehicles on Flatbush Avenue partially block crosswalk as they wait for the green light

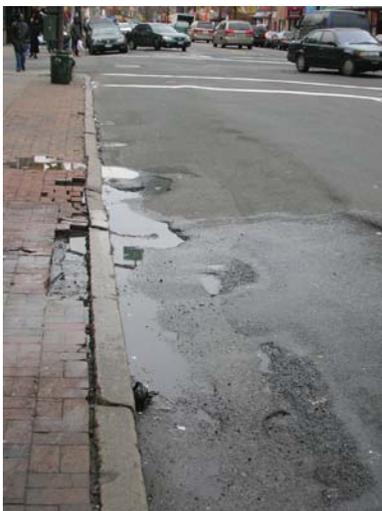
Poor pavement conditions on Flatbush Avenue

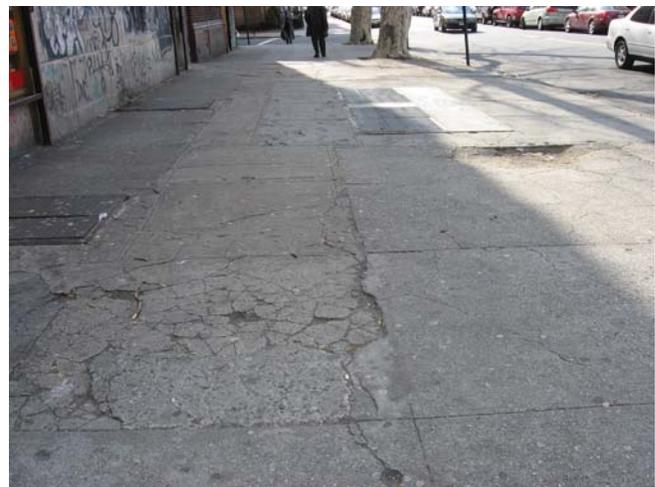
In addition, the south sidewalk on Ditmas Avenue is in poor condition.

Poor sidewalks on Ditmas Avenue

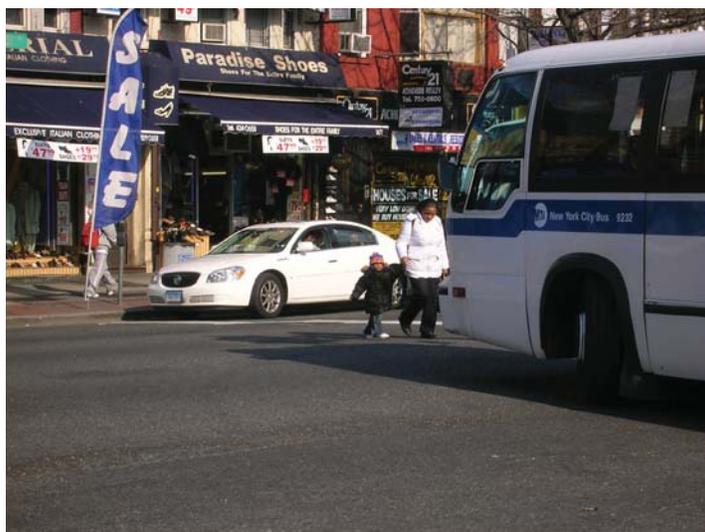
The midblock pedestrian crossing volumes collected for this location are: 28 pedestrians for the AM peak period (7:00 – 9:00 AM), 35 pedestrians for the MD peak period (12:00 – 2:00 PM), 35 pedestrians for the PM peak period (4:00 – 6:00 PM), and 73 pedestrians for the Weekend peak period (1:00 – 3:00 PM).

Pedestrians unsafely cross Flatbush Avenue near Glenwood Road at a stop bar while traffic from Glenwood Road have the green light and turn onto Flatbush Avenue.

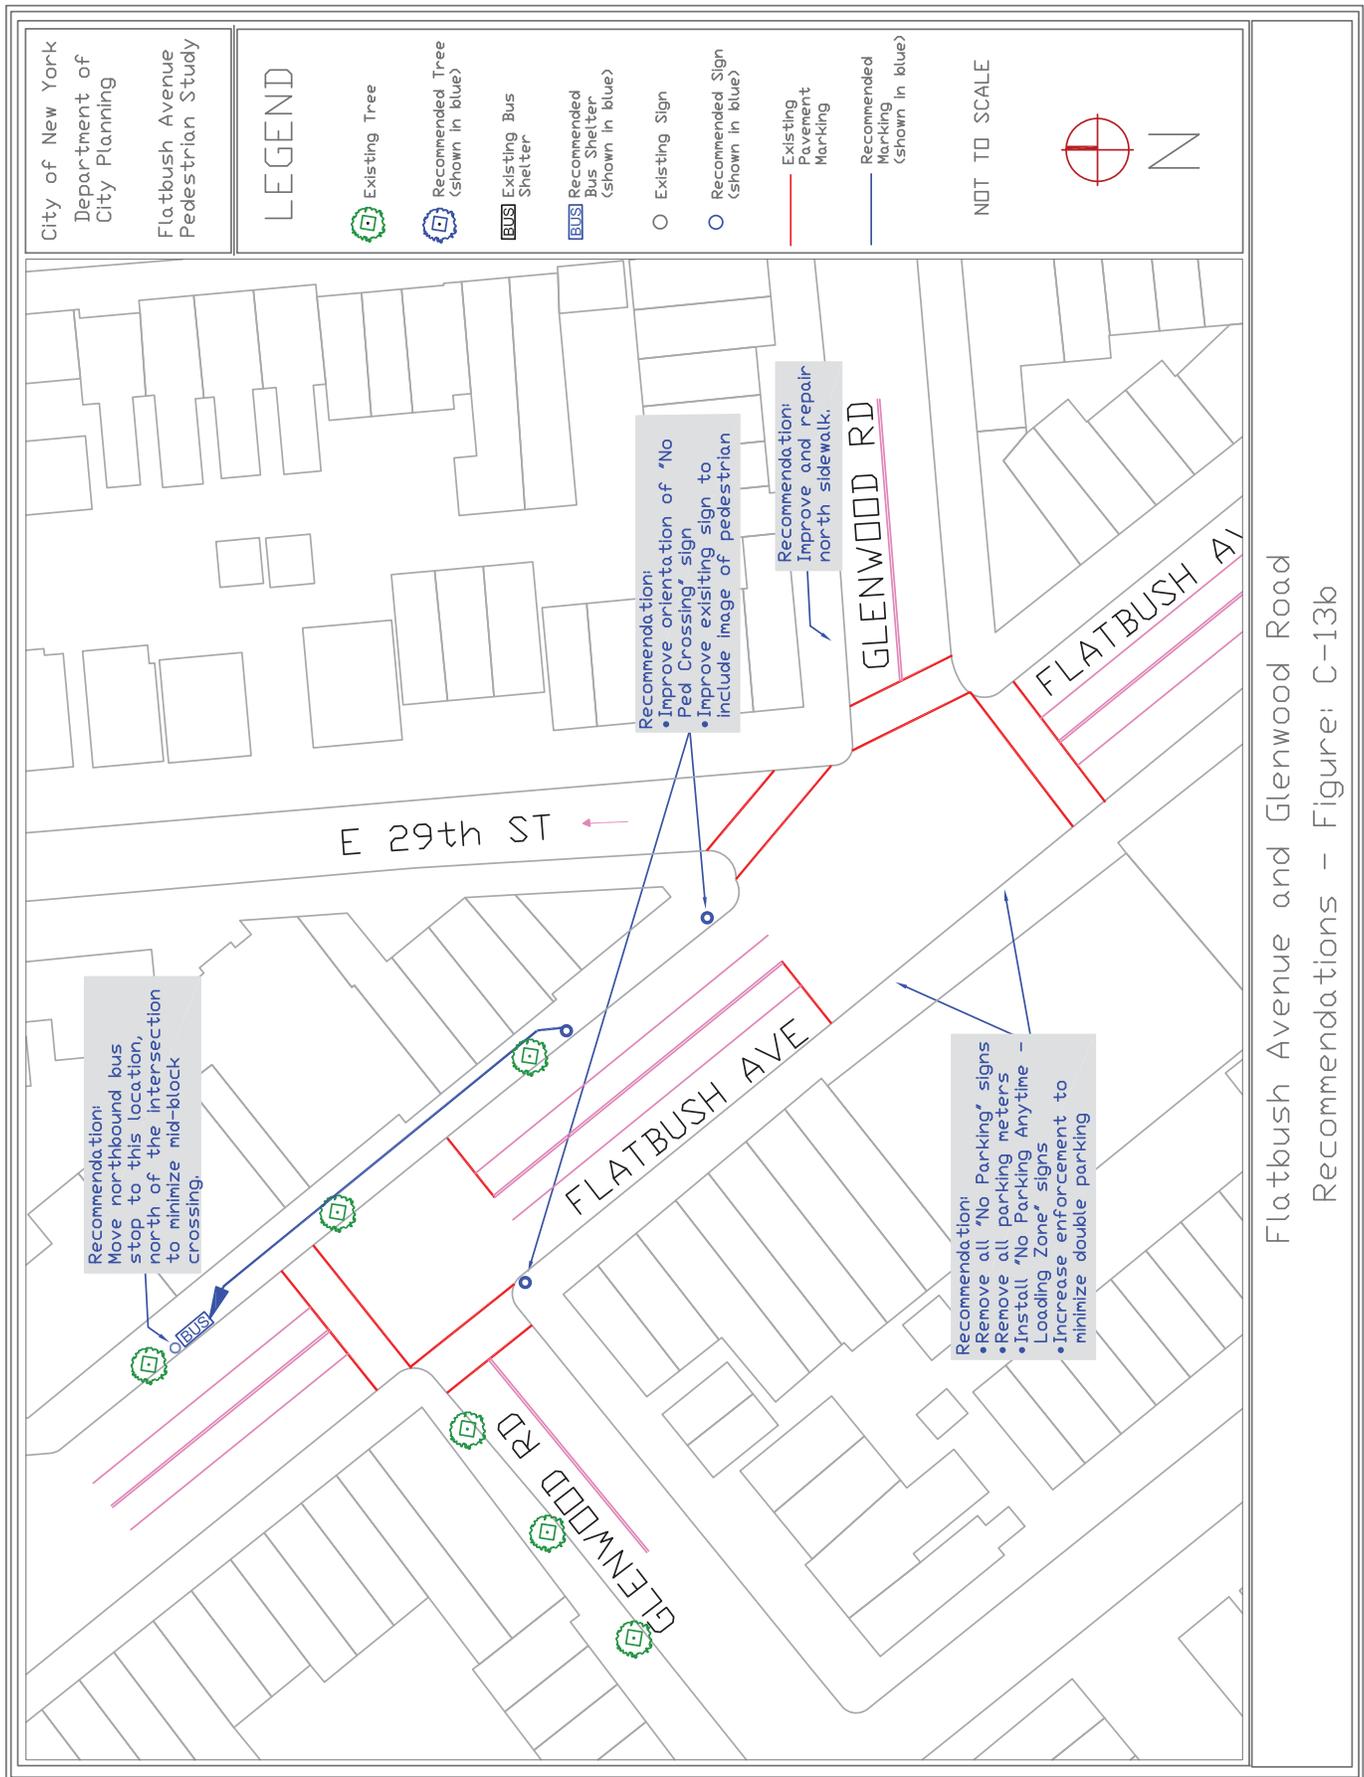
Flatbush Avenue and Glenwood Road
Recommendations - Figure: C-13b

An increase in enforcement presence can help cut back on illegal double parking in the area.
- **Improve Pavement Conditions**
Repair the pavement at this intersection including the north sidewalk of the segment of Glenwood Road south of E 29th Street in order to enhance the street environment for pedestrians walking in this area.

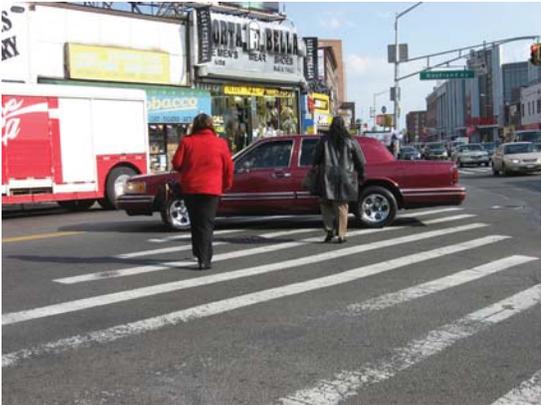
- Pedestrian/ Vehicular Conflicts
 Some pedestrians crossing at the intersection of Flatbush / Nostrand Avenue instead of waiting for the “Barnes Dance” phase, go ahead and cross with vehicular traffic when the vehicles have the green light. These pedestrians end up in the path of turning vehicles which is a dangerous situation. In general, vehicles go through the intersection without slowing down knowing that pedestrians have a red phase at the time at all approaches.

Pedestrians often cross when vehicles have the green light putting them in the path of turning vehicles
