Flatbush Avenue Pedestrian Study Final Report

Amanda M. Burden, AICP, Director
New York City Department of City Planning

FINAL REPORT
May 2008

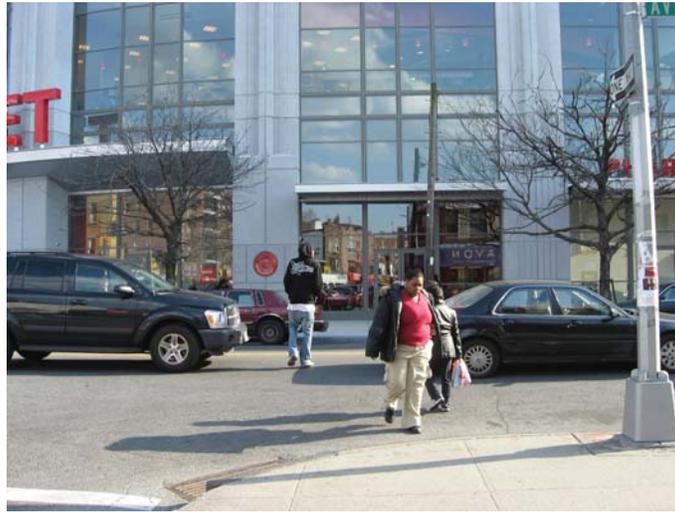
- With the opening of the Target store at the southwest corner and an increase in the number of pedestrians at this intersection, a new pattern of pedestrian crossing movements is observed. During the second week of March many pedestrians were observed crossing Avenue H from/to the south sidewalk in front of the Target Store instead of using the traffic island where the crosswalk is located.

Pedestrians often cross Avenue H from south sidewalk instead of from the southwest corner

This new facility would evidently require at this intersection the installation of a new pedestrian signal and a “Stop Bar” for eastbound vehicular traffic.

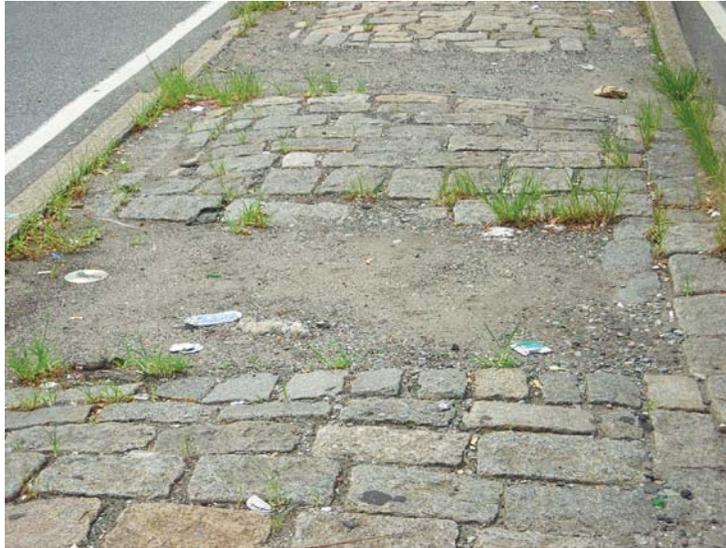
There is also a lack of trees and plantings near this intersection on the sidewalks and along the medians. A few trees exist only south of the intersection along the medians.

Medians on Kings Highway in poor condition

- Rebuild and extend medians to better accommodate pedestrians who often use the pedestrian refuge as they wait to cross King Highway.
- Install adequate bus shelters at all bus stops to ensure that pedestrians waiting for a bus have shelter during inclement weather. Bus pads can also be installed to minimize the wear and tear of the pavement at the bus stops. See following Map C-16b: "Recommendations" and Appendix D-3: "Standards for Bus Shelters" at the end of the document for details.
- Plant trees where possible on the sidewalks or along the medians of Kings Highway to make this location more attractive for pedestrians based on the standards of NYCDPR (see Appendix D-4: Standards for Trees).

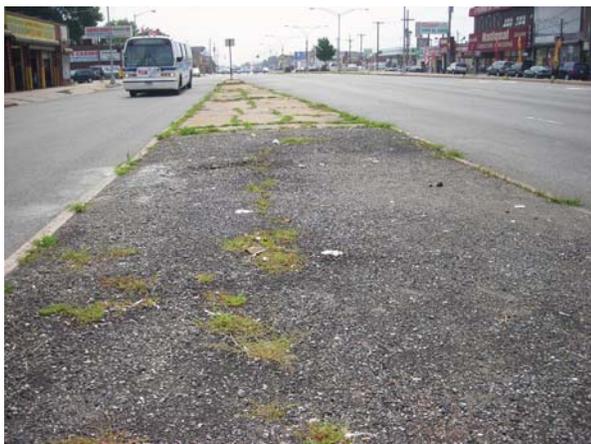
Medians on Flatbush Avenue in poor condition with no trees

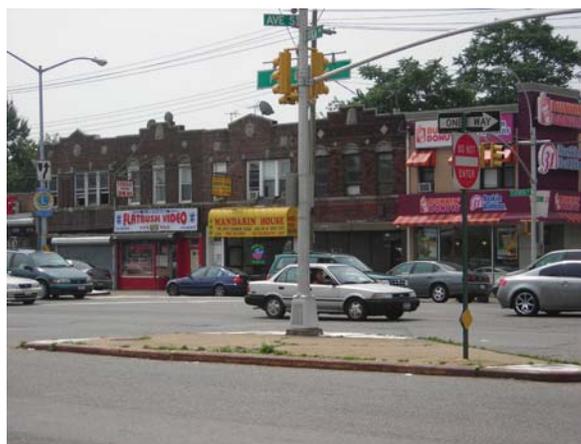
Bleak traffic island at the intersection of Flatbush Avenue and Utica Avenue

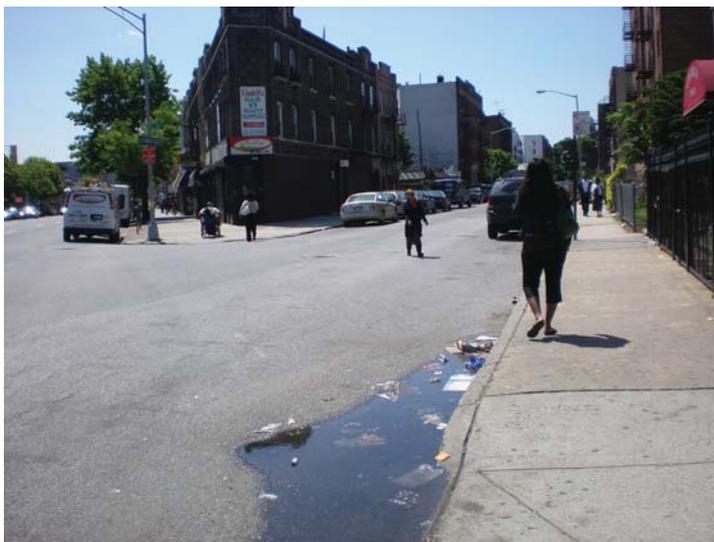
In general vehicles come or turn from Flatbush Avenue and enter these streets often without slowing down (mainly right turns) and do not always yield to pedestrians crossing at those locations. In addition, since Flatbush Avenue intersects several of these streets at an angle, pedestrians are not always visible to motorists unless the pedestrian is already in the middle of the street.

Typical one-way street intersecting Flatbush Avenue

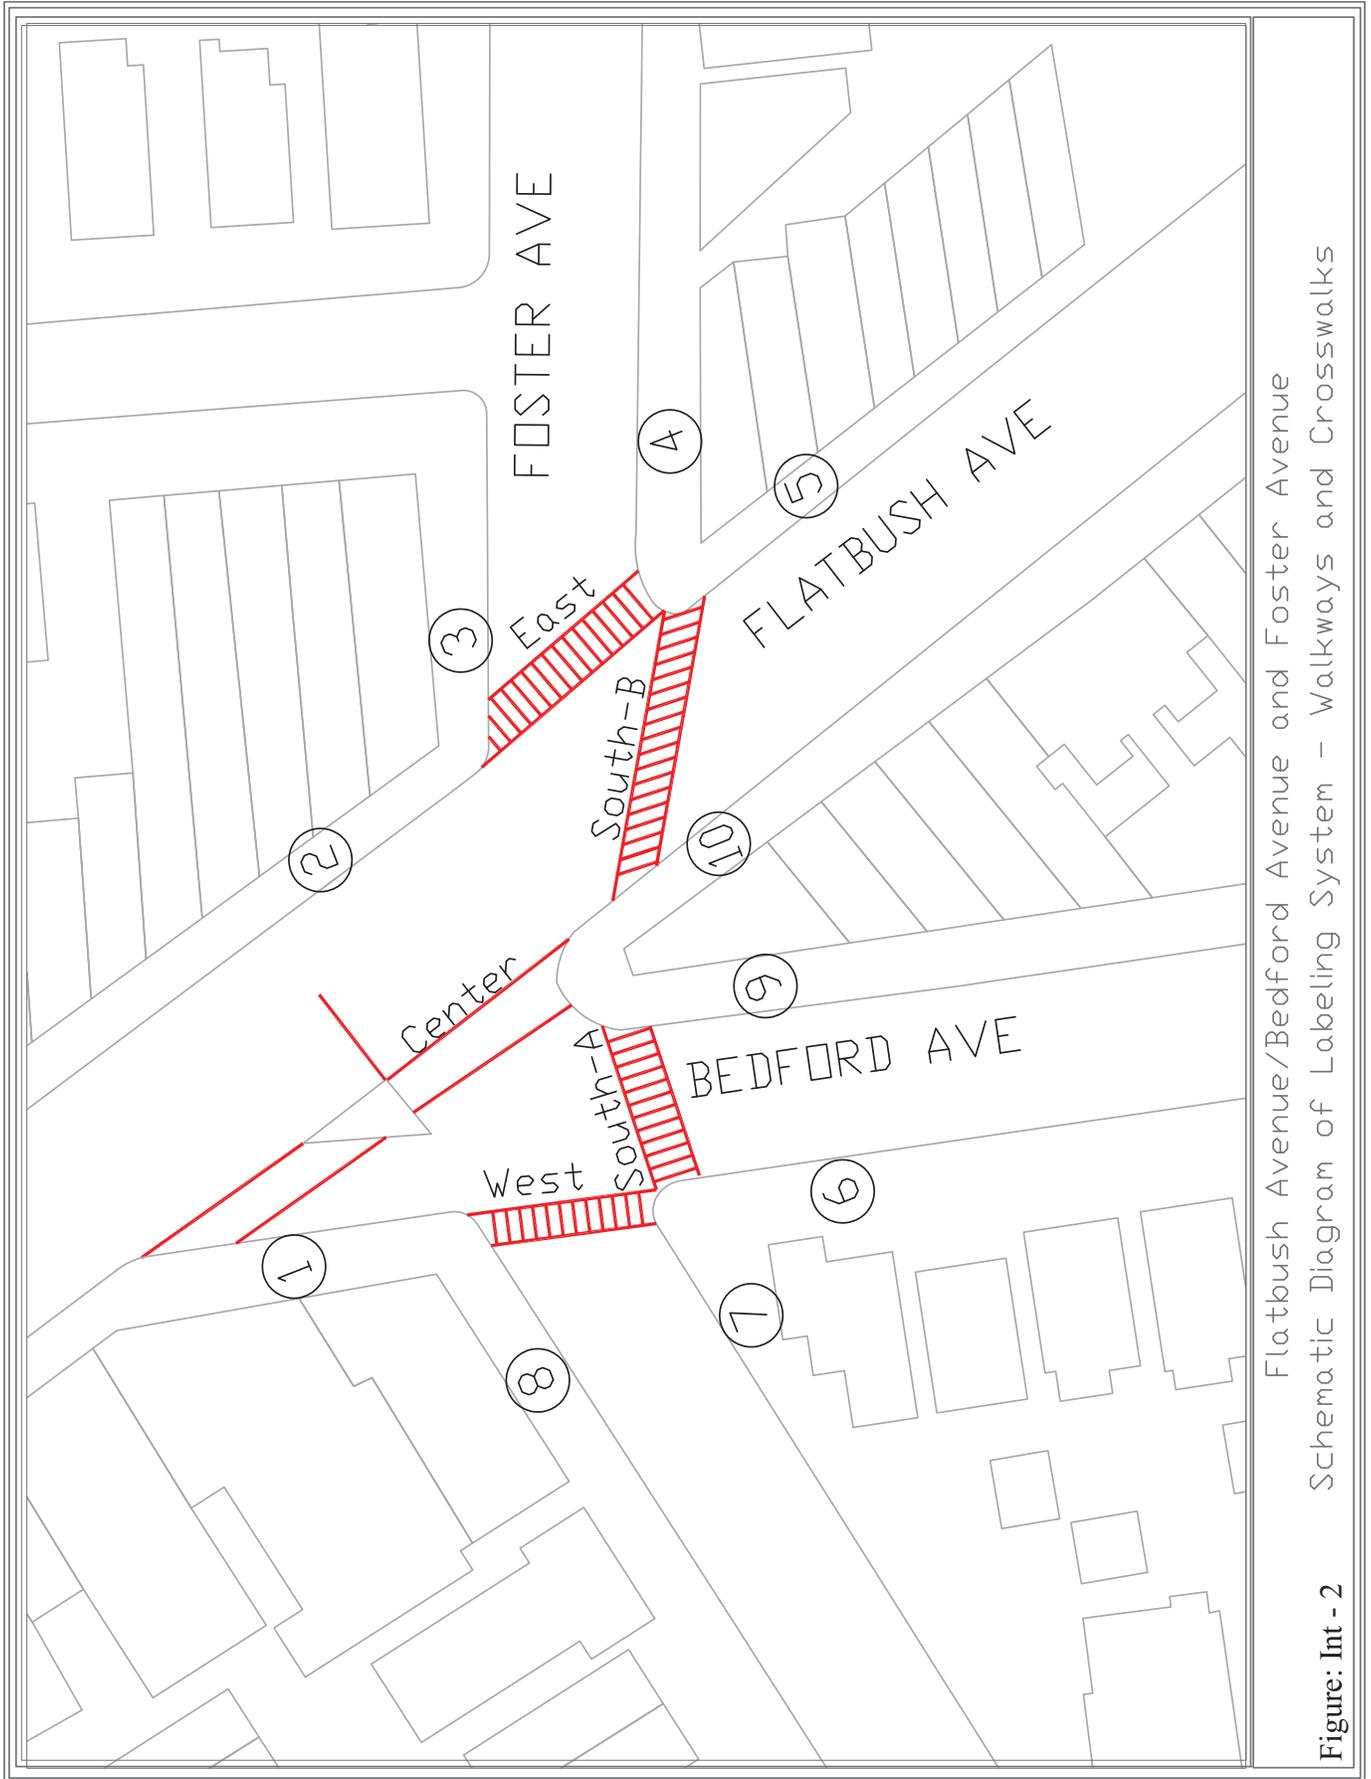
Flatbush Avenue/Bedford Avenue and Foster Avenue
Schematic Diagram of Labeling System - Walkways and Crosswalks

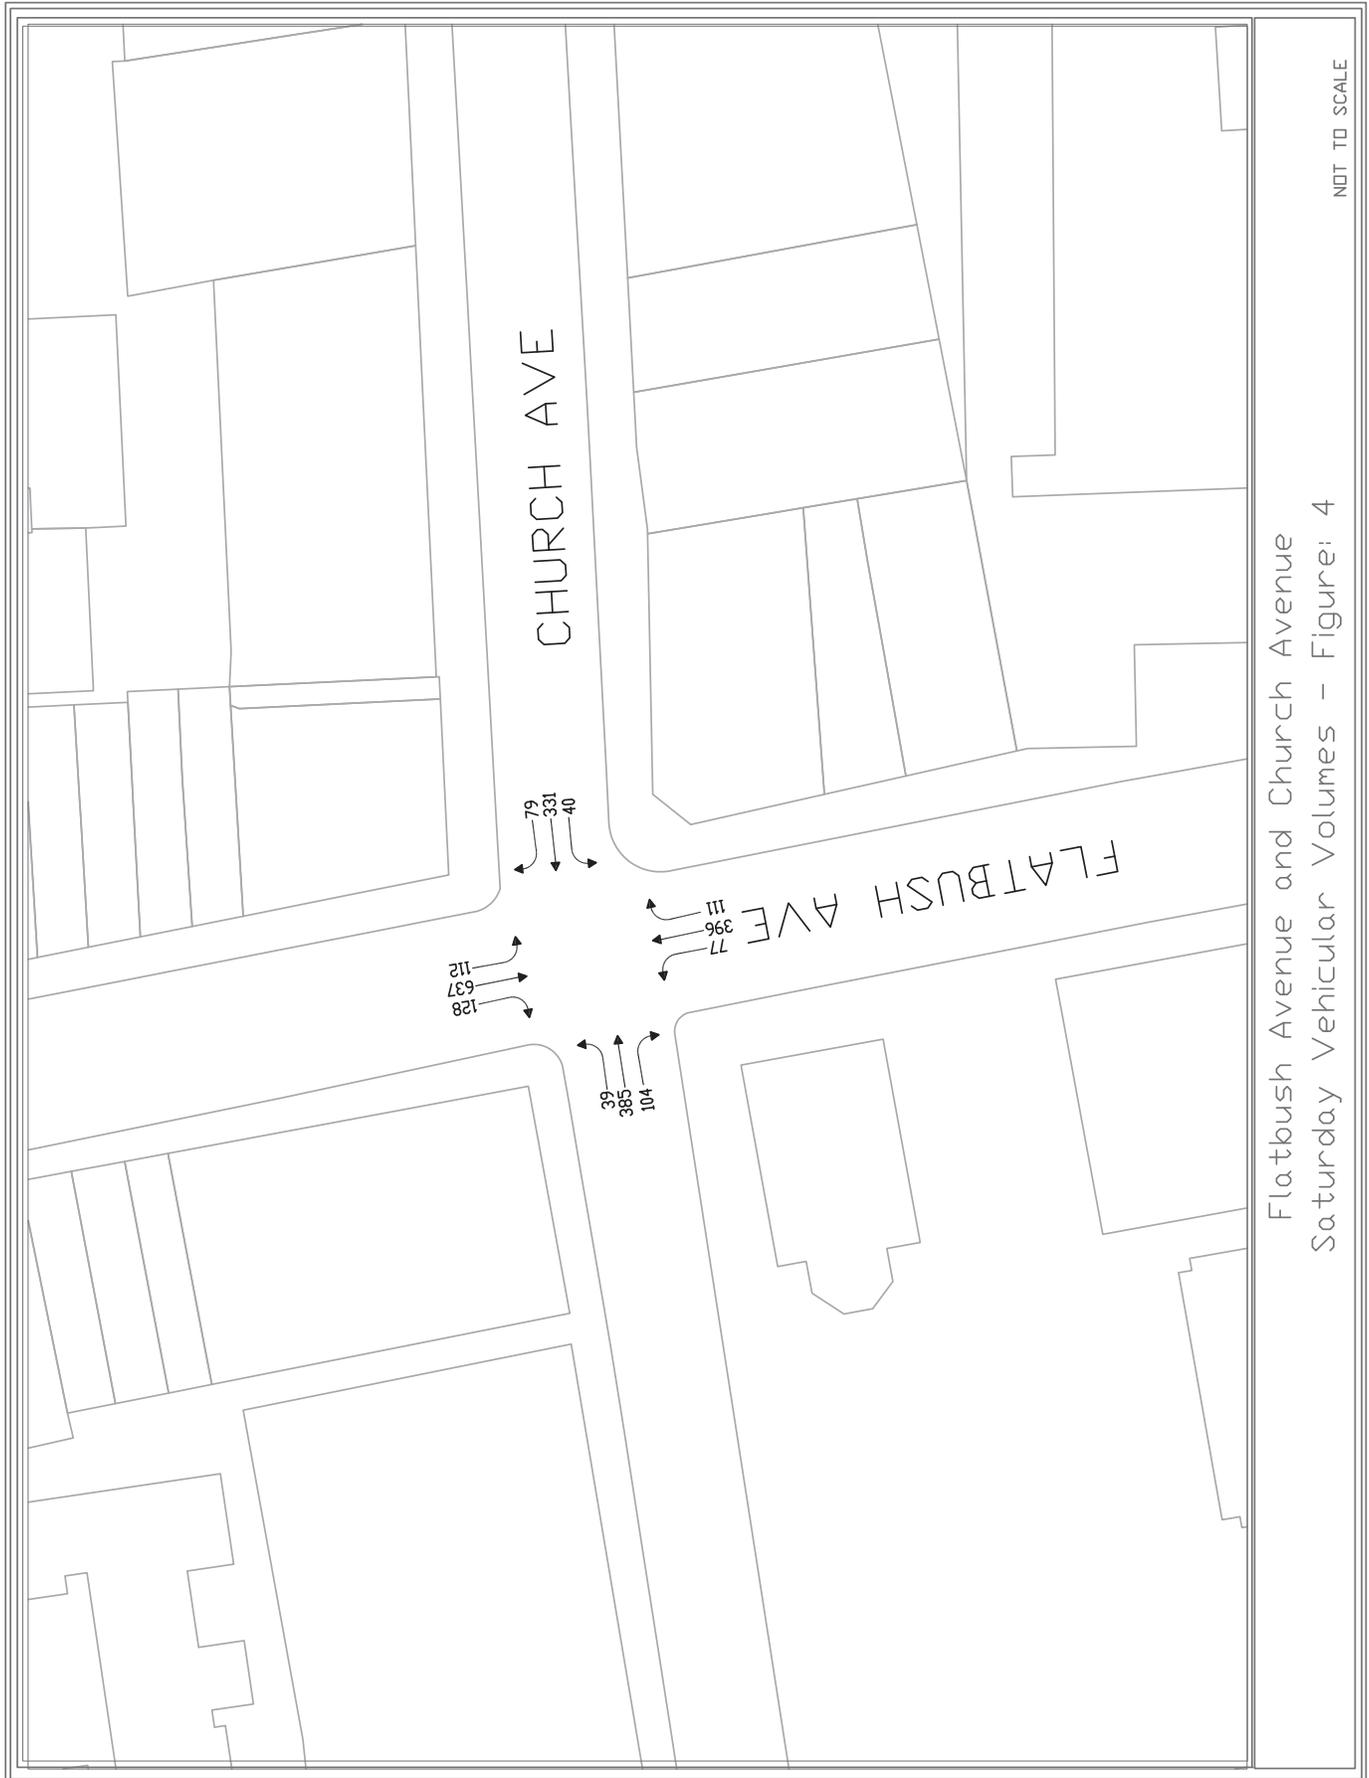
Flatbush Avenue and Church Avenue
Saturday Vehicular Volumes - Figure: 4

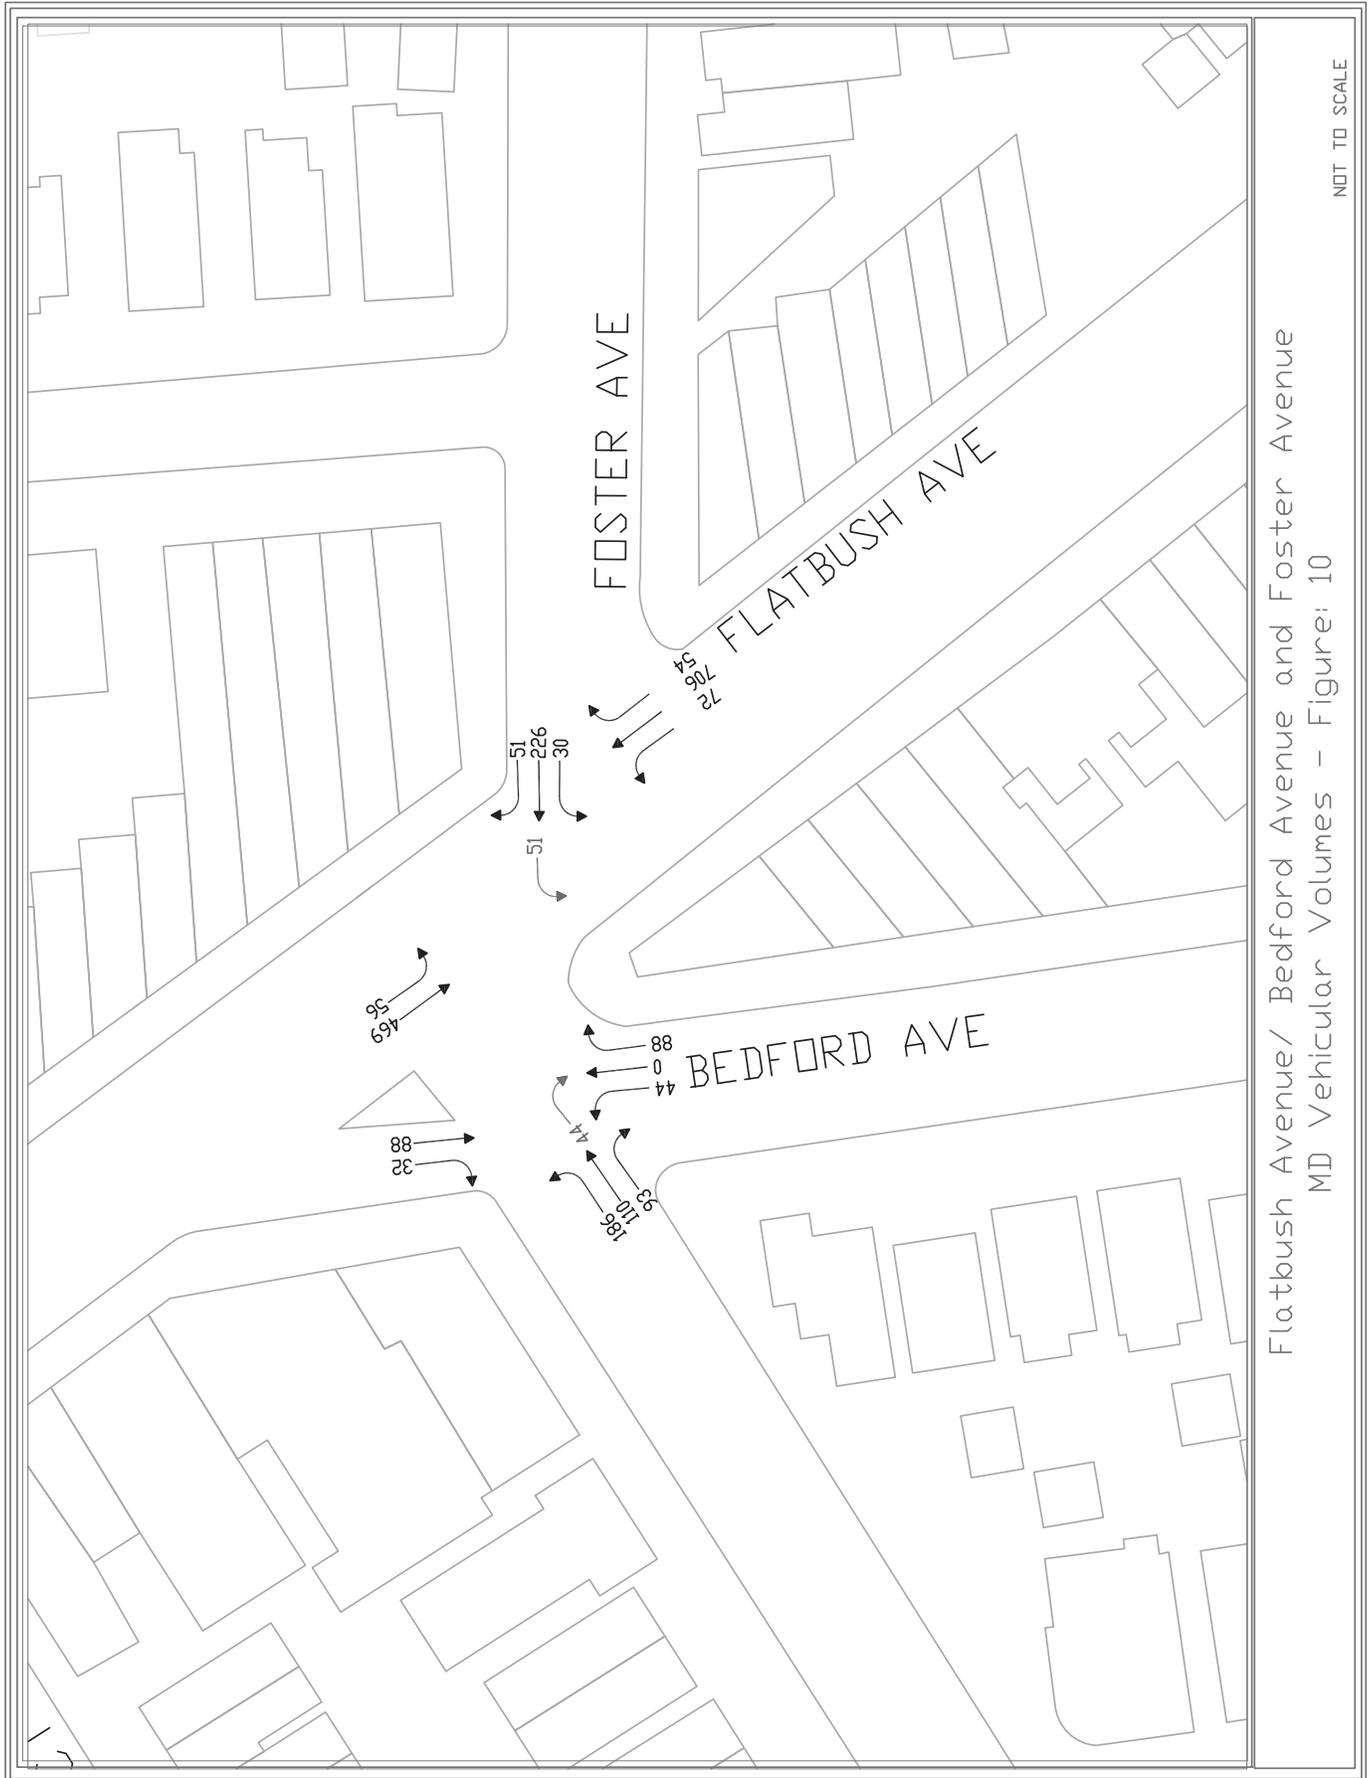
Flatbush Avenue/ Bedford Avenue and Foster Avenue
MD Vehicular Volumes - Figure: 10

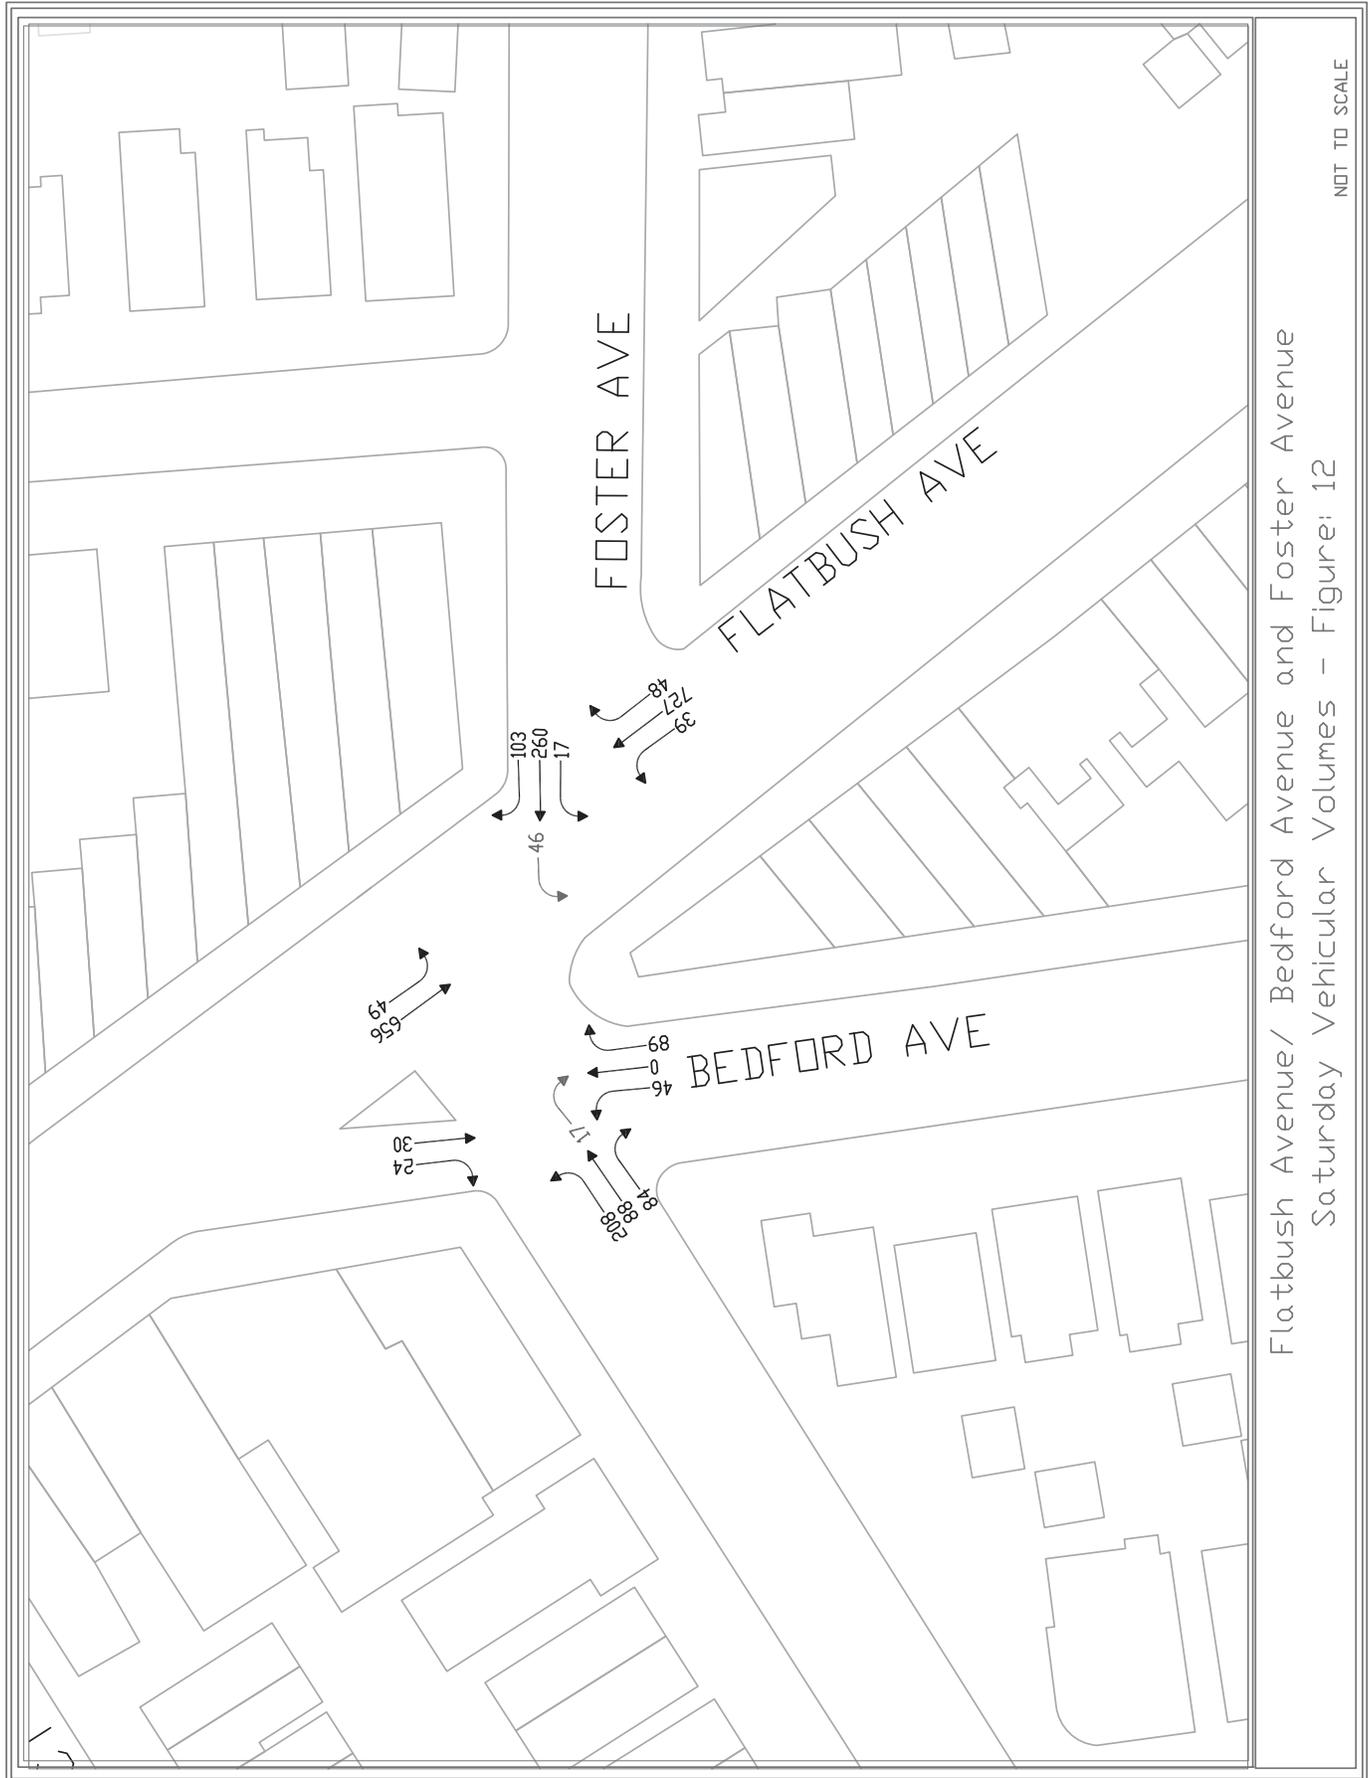
Flatbush Avenue/ Bedford Avenue and Foster Avenue
Saturday Vehicular Volumes - Figure: 12

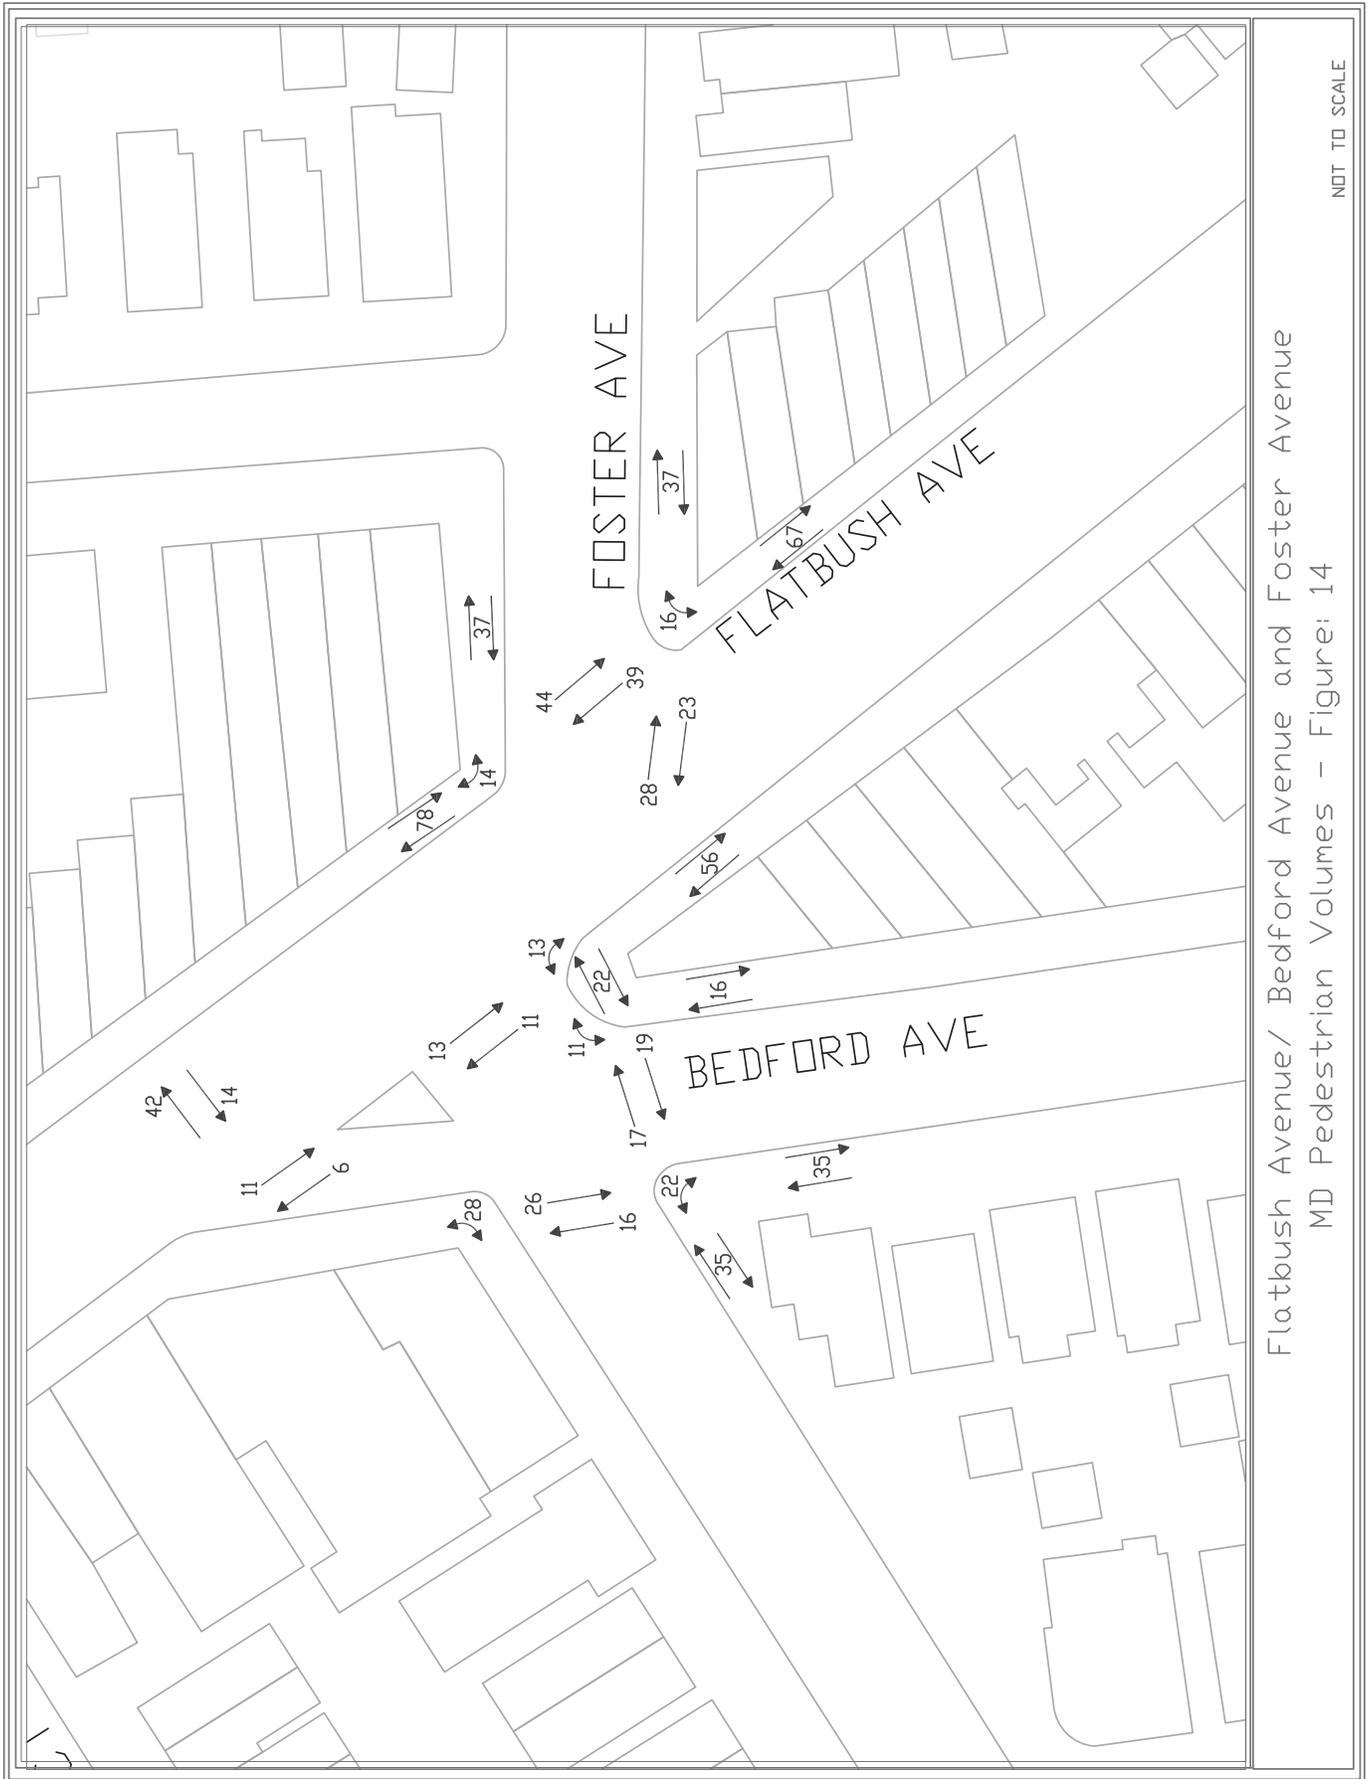
Flatbush Avenue/ Bedford Avenue and Foster Avenue
MD Pedestrian Volumes - Figure: 14

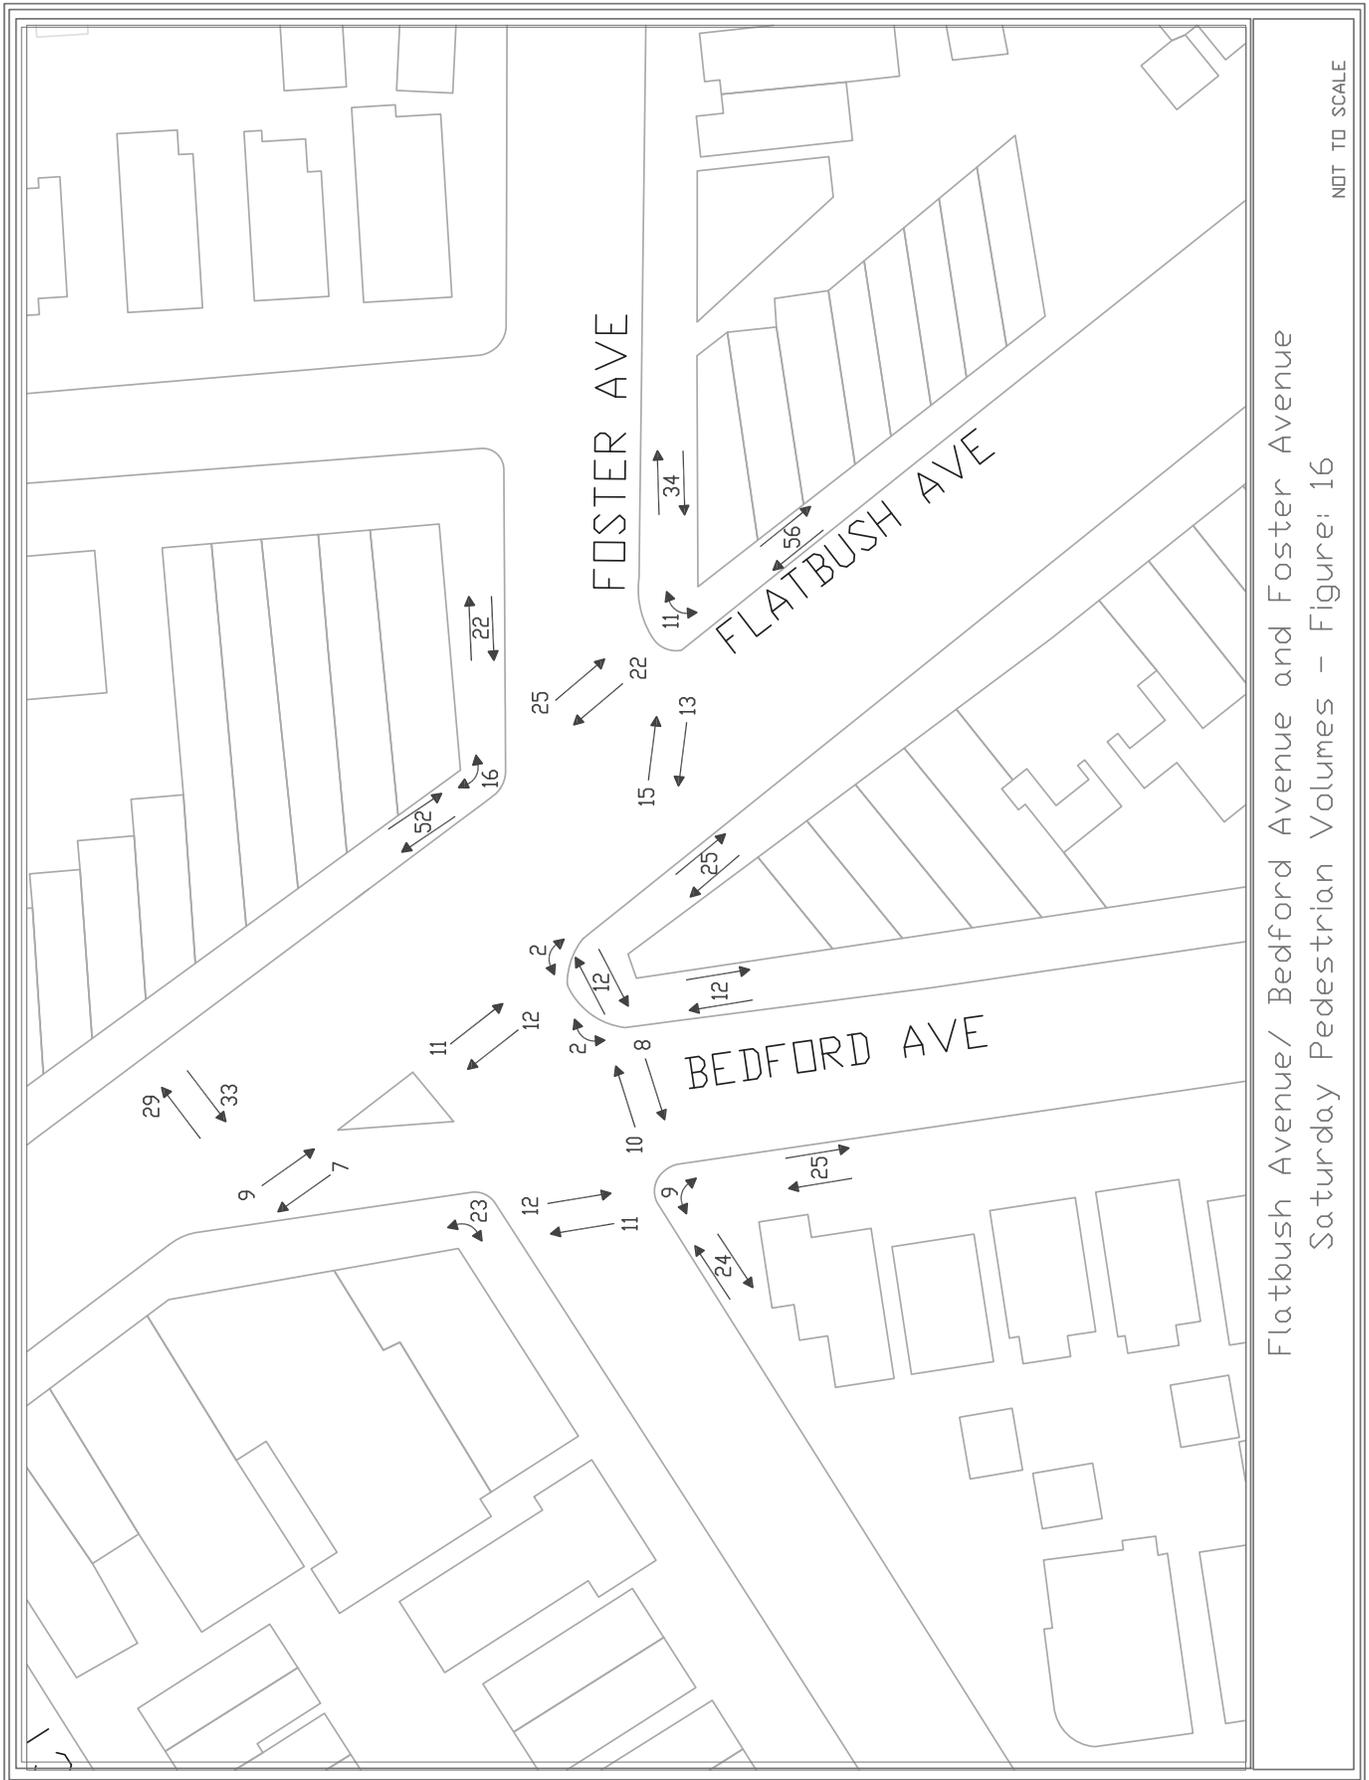
Flatbush Avenue/ Bedford Avenue and Foster Avenue
Saturday Pedestrian Volumes - Figure: 16

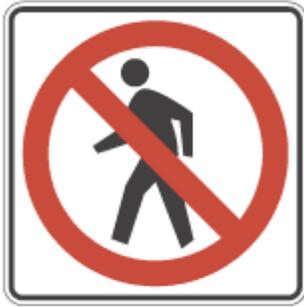
R9-3a

“No Pedestrian Crossing” Sign (Section 2B.44 of the MUTCD Manual)

The “No Pedestrian Crossing” (R9-3a) sign may be used to prohibit pedestrians from crossing a roadway at an undesirable location or in front of a school or other public building where a crossing is not designated.

- “No Ped Crossing Use Crosswalks” sign that is double-sided and can be seen from any direction as you approach the midblock location
 - “A sign that has an image of a pedestrian with a red interdiction symbol over it” (MUTCD manual “R9-3a” sign, see Appendix D-2: Standards for Signs Recommended)
