Intersection of Flatbush Avenue and Clarendon Road/Dorchester Road

Description of Existing Conditions

Flatbush Avenue
Pedestrian Study

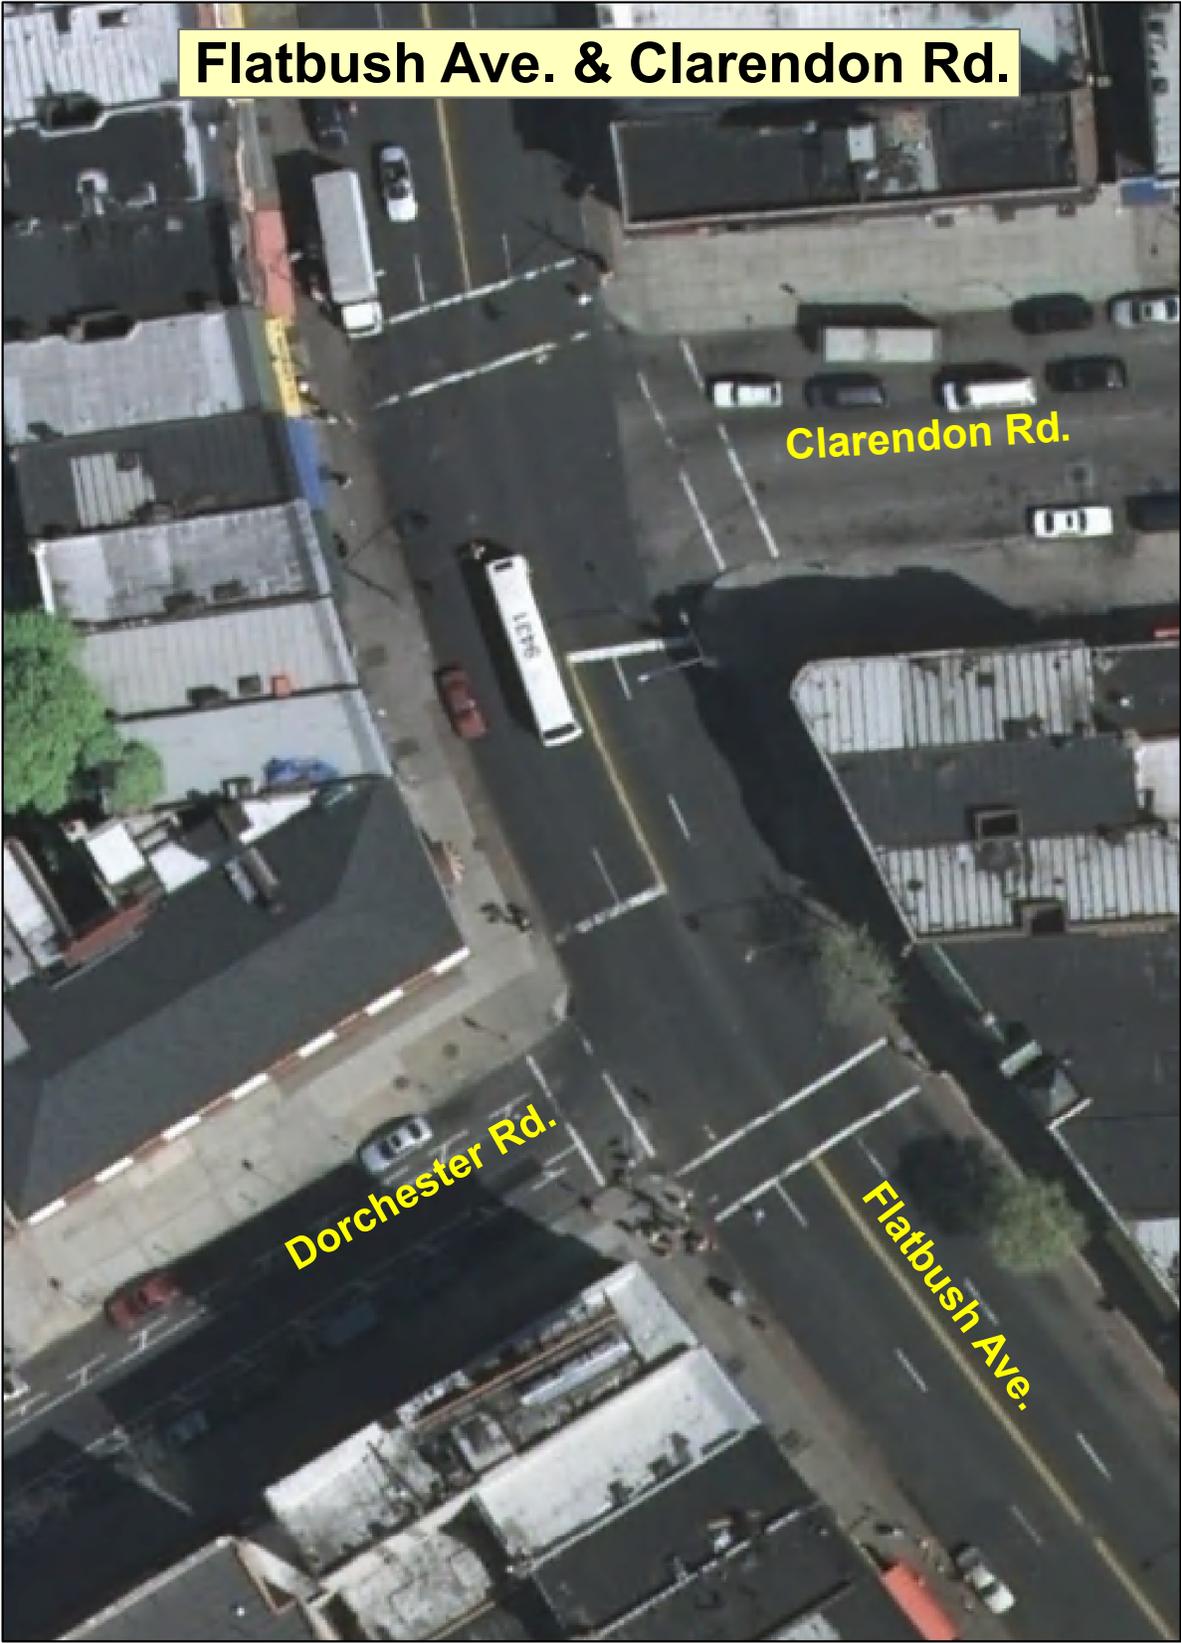
Flatbush Avenue is 55 ft wide approximately at this location, has two travel lanes and a parking lane in each direction of traffic. The sidewalks along this street are 14 – 15 ft wide.

Clarendon Road a two-way street to the east of Flatbush Avenue, is 52 ft wide while Dorchester Road a one-way street on the west side of Flatbush Avenue is 35 ft wide with traffic calming markings placed between the travel lanes and the parking lane. The sidewalks on Clarendon and Dorchester Roads are wide for this area of Brooklyn with dimensions of 22 – 23 ft.

Vehicle volumes on Flatbush Avenue at this intersection can get heavy at times. The intersecting streets have moderate vehicle volumes which can be light at times. Pedestrian volumes are light in general in this area.

Two signs near the “Stop bar” at the intersection inform pedestrians not to cross at that particular location: “No Ped Crossing Use Crosswalks”.

- Pedestrians Crossing at “Stop Bar” locations
 Clarendon Road to the east of Flatbush Avenue changes to Dorchester Road west of Flatbush Avenue. These two streets or segments do not align and in between the two segments stop bars are placed to stop vehicles as they arrive at the intersection. However pedestrians cross Flatbush Avenue at that particular spot when the light turns green which creates a dangerous and unsafe situation for pedestrians. Drivers going westbound on Clarendon Road and continuing onto Dorchester Road do not expect pedestrians to be crossing at that location especially when a right turn is permitted on red at Dorchester Road. There are signs to inform pedestrians not to cross at that particular location: “No Ped Crossing Use Crosswalks”. But these signs are smaller than the existing regulatory signs posted and are often not noticeable to pedestrians arriving at the intersection because of their size and location.

Another recommendation is to have a sign for southbound vehicles on Flatbush Avenue making a right turn on red. This sign would indicate to drivers where to position themselves in the travel lanes at the intersection approach in order to allow an easy flow of right turns on red. An improvement in these right turns can make it safer for pedestrians crossing Dorchester Rd by reducing traffic flow conflicts at this intersection.

Have trees planted at this location along Clarendon Road according to the standards and minimum distances set by the New York City Department of Parks and Recreation (NYCDPR). Add landscaping or streetscape elements on the sidewalk where possible. Narrow bus shelters are also recommended on Flatbush Avenue at the bus stops for bus passengers.

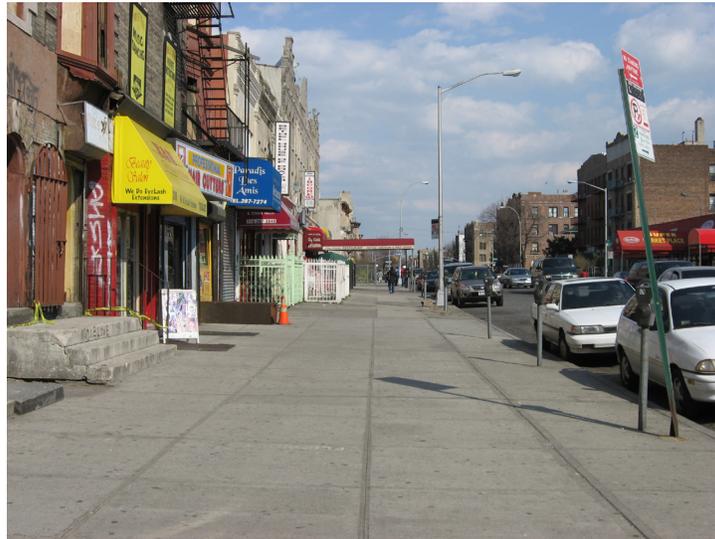
The wide sidewalks on Clarendon and Dorchester Roads are empty and have very light pedestrian activity. Space is available on these streets for pedestrian amenities such as trees, planters, etc.

Sidewalks on Clarendon Road are empty with no trees
