Intersection of Flatbush Avenue and Ditmas Avenue/ Avenue D

City of New York
Department of
City Planning

Flatbush Avenue
Pedestrian Study

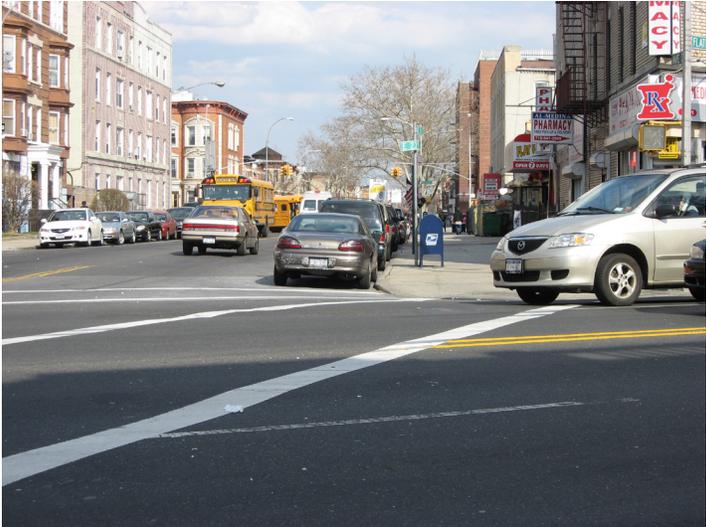
The awkward shape of the intersection often has vehicles on Flatbush Avenue waiting for the green light partially in the crosswalk which is at an angle. This creates conflicts between drivers and pedestrians and reduces visibility due to a shorter sight distance at the intersection for the driver.

Vehicles on Flatbush Avenue partially block crosswalk as they wait for the green light

It is recommended to install a stop bar or stop line about 15 ft from each crosswalk located on Flatbush Avenue to facilitate eastbound and westbound crossings. This reduces conflicts between pedestrians and motorists, allows them to have a better view of each other at the intersection and improves sight distances for the motorist. It will also make left turning movements easier from Ditmas Avenue/ Avenue D and improve safety for crossing pedestrians.

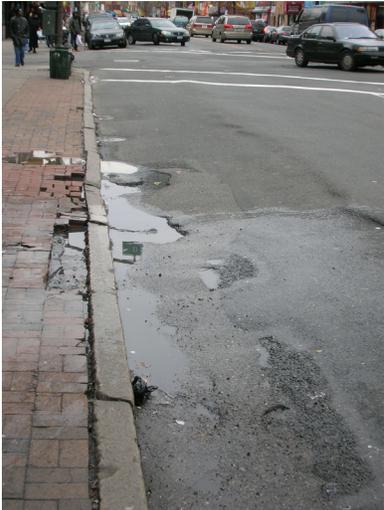
Poor pavement conditions on Flatbush Avenue

Repair and resurface the pavement at this location in order to reduce swerving movements by drivers as they travel through the intersection. The addition of concrete bus pads can help eliminate bumps created by buses coming in and out of the bus stop.

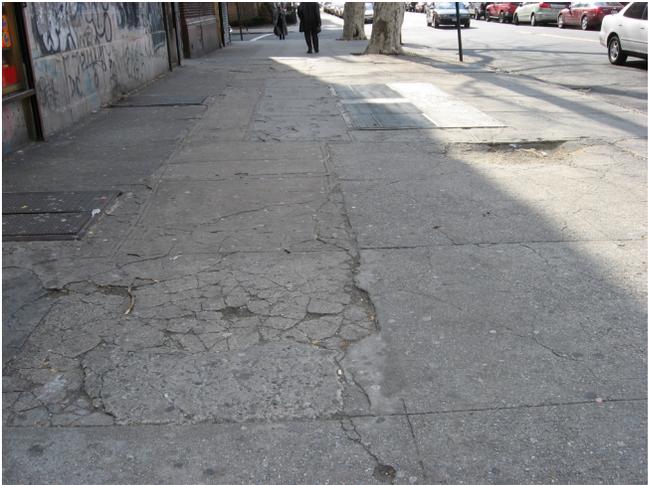
In addition, the south sidewalk on Ditmas Avenue is in poor condition.

Poor sidewalks on Ditmas Avenue

Rebuild the south sidewalk on Ditmas Avenue as an improvement to the pedestrian's environment.

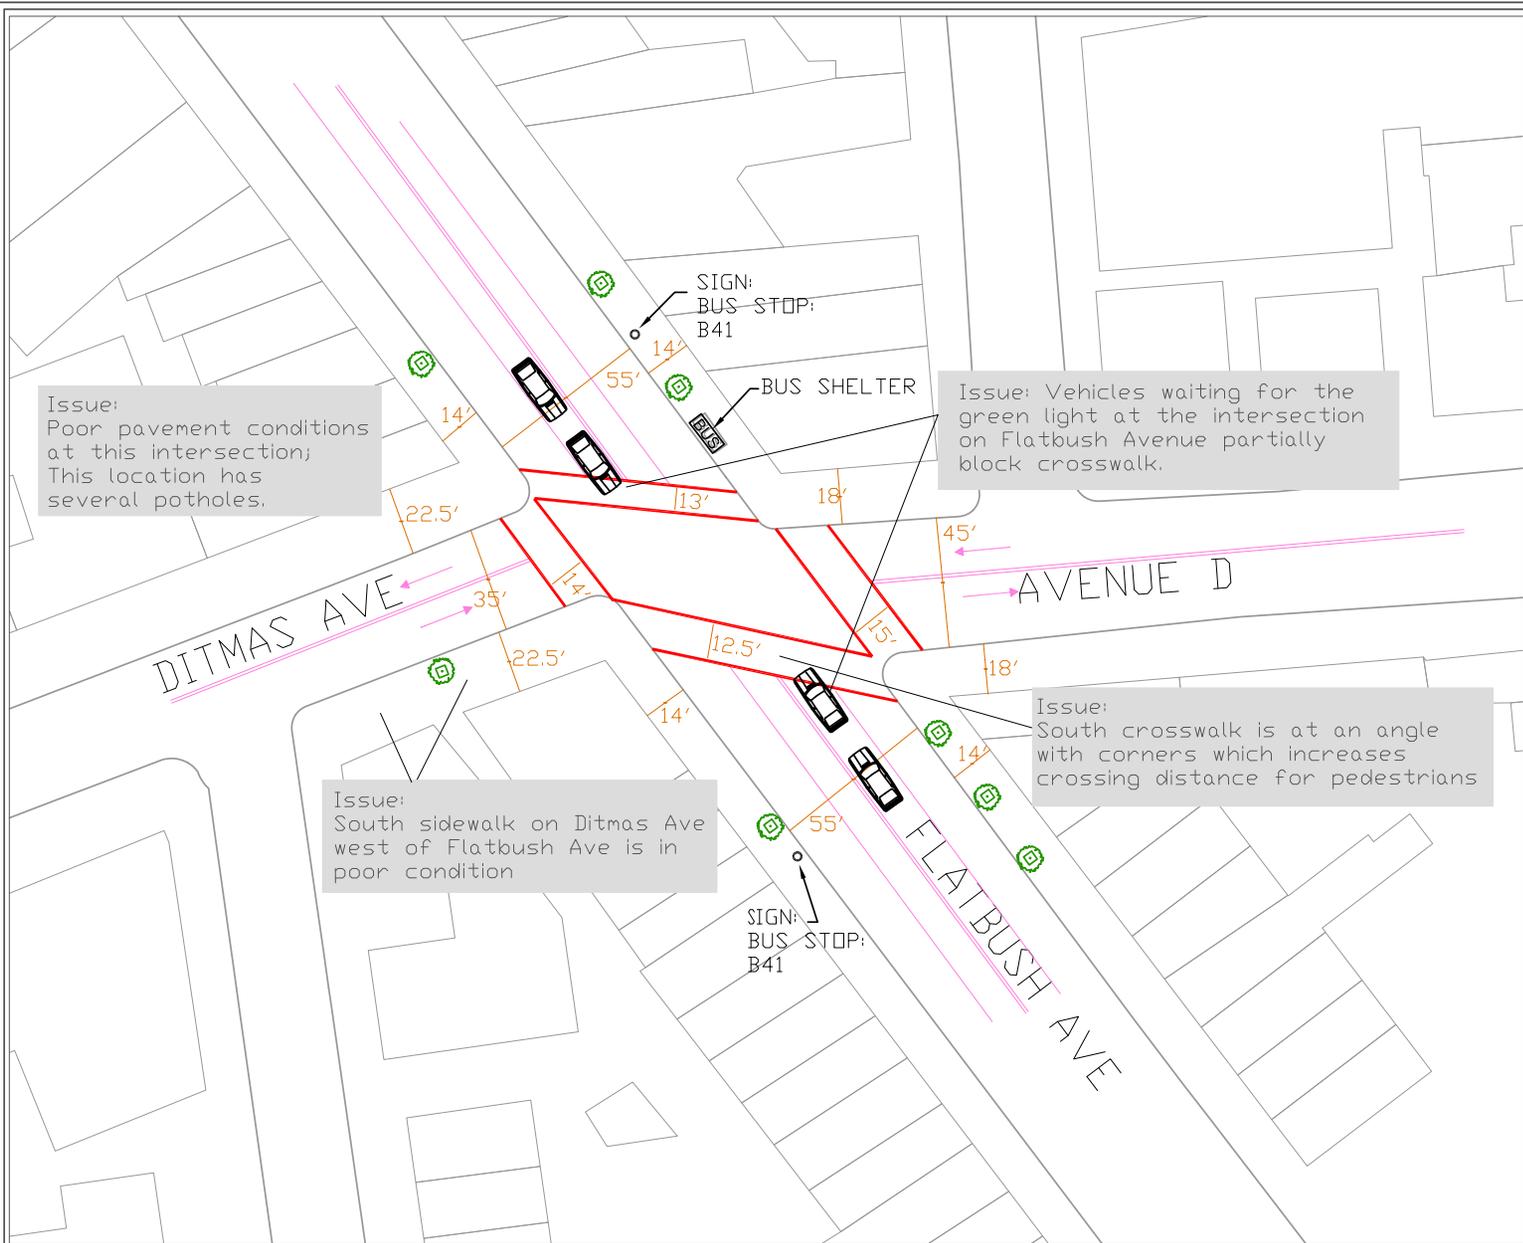
Flatbush Avenue and Ditmas Avenue/Avenue D
 Existing Conditions - Figure: C-11a

Flatbush Avenue is about 55 ft wide in this part of the study area. It also has two travel lanes and a parking lane in each direction of traffic. The sidewalks along this major street are 14 ft wide.

The intersecting street at this location has two different names: Ditmas Avenue/ Avenue D. Ditmas Avenue is located to the west of Flatbush Avenue with a width of 35 ft and has wide sidewalks, 22 - 23 ft wide. Avenue D is located to the east of Flatbush and is 45 ft wide. The sidewalks are 18 ft wide. These streets are both two-way streets with one travel lane in each direction of traffic.
