Location: Flatbush Avenue and Glenwood Road

**Intersection of Flatbush Avenue and Glenwood Road**

Description of Existing Conditions

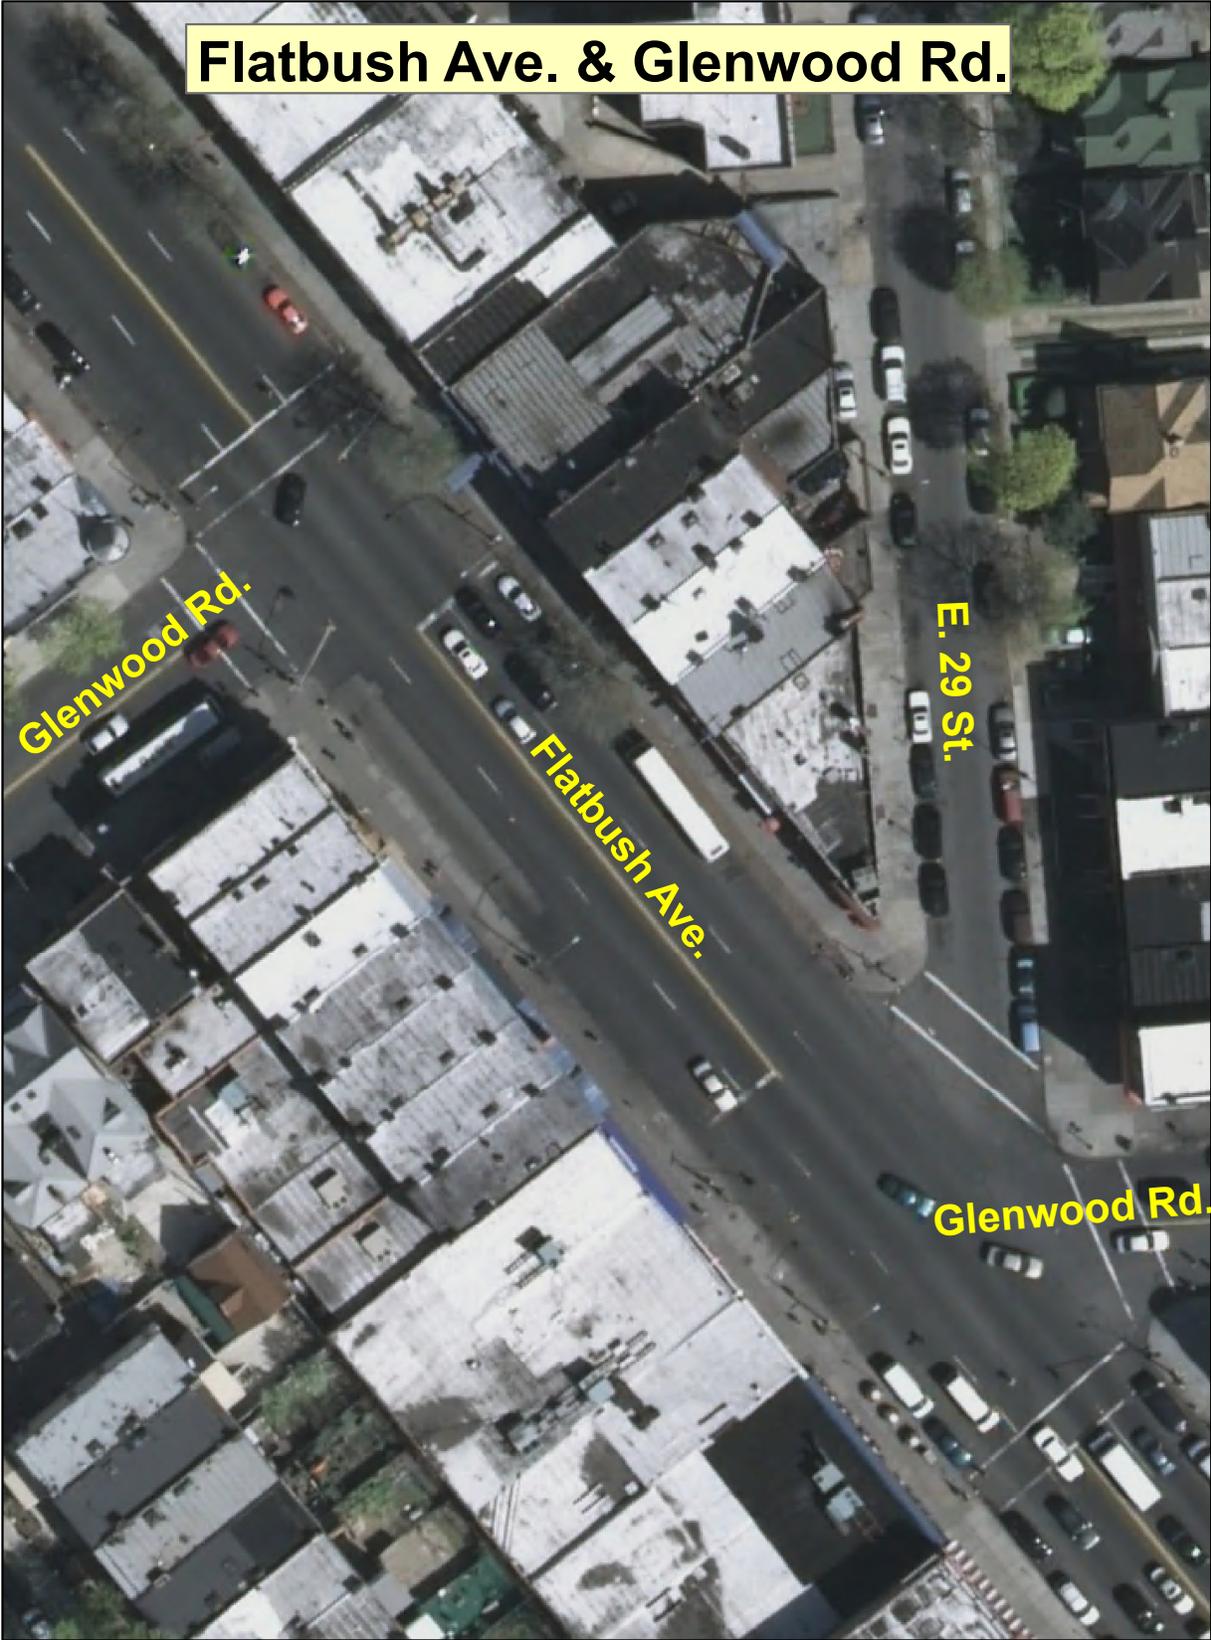
Flatbush Avenue is about 60 ft wide near Glenwood Road and has two travel lanes and a parking lane in each direction of traffic. The sidewalks along this major arterial are 17 –18 ft wide.

Glenwood Road is segmented and does not align as it intersects Flatbush Avenue. It is a two-way street with one travel lane in each direction of traffic and has a width of 40 ft. The sidewalks on Glenwood Road are 17 -18 ft wide.

Two signs near the “Stop bar” at the intersection (one at each stop bar location) inform pedestrians not to cross at that particular location: “No Ped Crossing Use Crosswalks”.

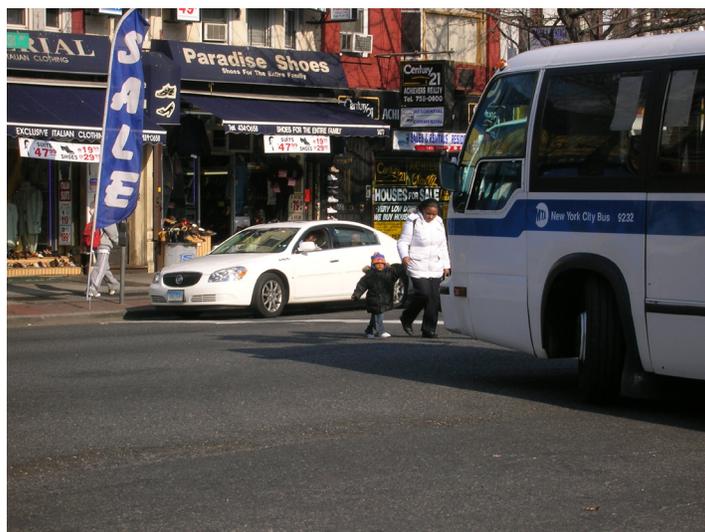
- Pedestrian Crossing at “Stop Bar” and Midblock locations  
Since Glenwood Road does not align when it intersects Flatbush Avenue, it creates two intersections. In between these intersections two stop bars have been placed on Flatbush Avenue to control vehicles as they approach the intersections. Several pedestrians were observed crossing Flatbush Avenue at the stop bars or midblock when the light turned green for Glenwood traffic. This is an unsafe situation for pedestrians since westbound and eastbound drivers making a turn onto Flatbush Avenue do not expect pedestrians to be crossing midblock or at the stop bars and do not slow down as they make the turn. There are signs to inform pedestrians not to cross at that particular location: “No Ped Crossing Use Crosswalks”. But these signs are smaller than the other regulatory signs posted and are not always noticed by pedestrians arriving at the intersection because of their size and location.

Pedestrians unsafely cross Flatbush Avenue near Glenwood Road at a stop bar while traffic from Glenwood Road have the green light and turn onto Flatbush Avenue.

- **Improve Pedestrian Crossing**  
The existing signs “No Ped Crossing Use Crosswalks” are not very useful based on their placement and orientation. As a recommendation, make each sign a double-sided sign that can be seen from both directions as you approach the midblock location. Have an additional sign put up adjacent to or above the “No Ped Crossing Use Crosswalks” sign. This sign should be an image of a pedestrian with a red interdiction symbol over it (MUTCD manual “R9-3a” sign; see Appendix D-2: Standards for Signs Recommended). It reinforces the first sign and displays graphically that it is prohibited for pedestrians to cross the roadway at an undesirable location where crossing is not designated.

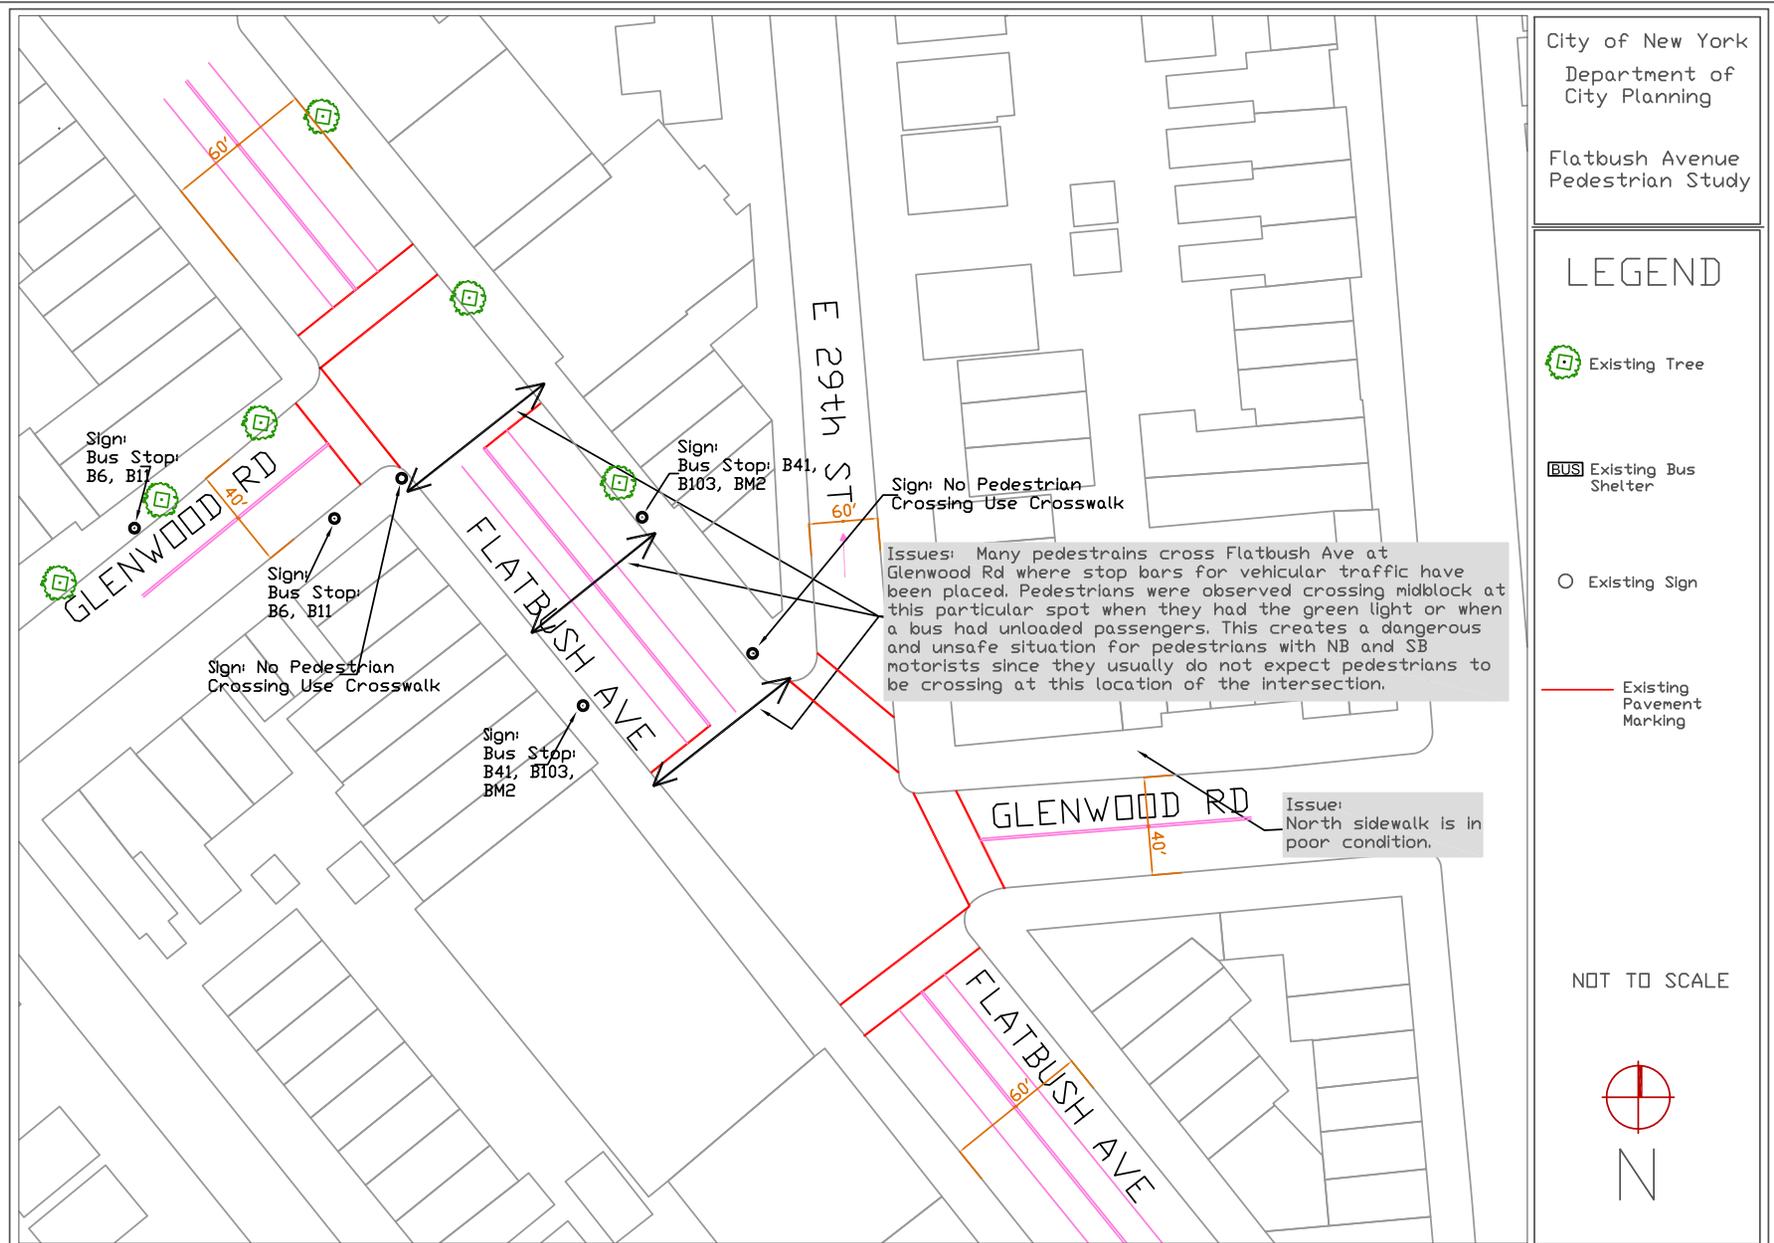
Flatbush Avenue and Glenwood Road  
Existing Conditions - Figure: C-13a

Furthermore this area of Flatbush Avenue is a common transfer point between the B41, B6 and B11. The bus stops are located on Flatbush Avenue and on Glenwood Road near the intersections (see following diagram map of existing conditions). Many pedestrians transferring from one bus to another often cross midblock without using the crosswalks.
