Location: Flatbush Avenue and Nostrand Avenue/ Hillel Place

Intersection of Flatbush Avenue and Nostrand Avenue/ Hillel Place

Description of Existing Conditions

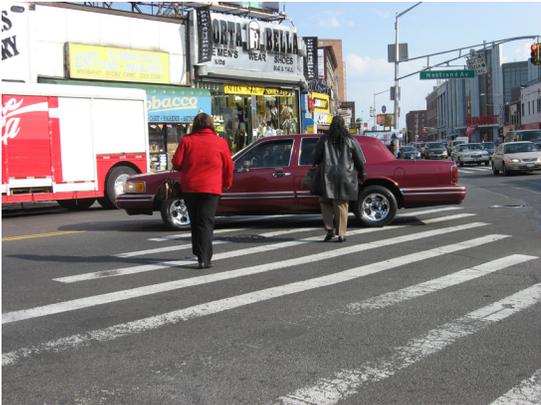
- Pedestrian/ Vehicular Conflicts
 Some pedestrians crossing at the intersection of Flatbush / Nostrand Avenue instead of waiting for the “Barnes Dance” phase, go ahead and cross with vehicular traffic when the vehicles have the green light. These pedestrians end up in the path of turning vehicles which is a dangerous situation. In general, vehicles go through the intersection without slowing down knowing that pedestrians have a red phase at the time at all approaches.

Pedestrians often cross when vehicles have the green light putting them in the path of turning vehicles

- **New Signage**
As a recommendation, have regulatory signs at all corners of the intersection that specifically request pedestrians to cross only when the pedestrian traffic signal allows for it: “Cross Only on Ped (image of ped) Signal” (MUTCD, R10-2a; see Appendix D-2: Standards for Signs Recommended). This will provide helpful information to pedestrians unfamiliar with the area and who do not know that there is an all pedestrian phase at this intersection.
- **New Pavement Markings**
The installation of a stop bar or stop line about 15 ft from each crosswalk at this intersection is recommended. This can reduce the potential for conflicts between pedestrians and drivers and improves sight distances for the driver

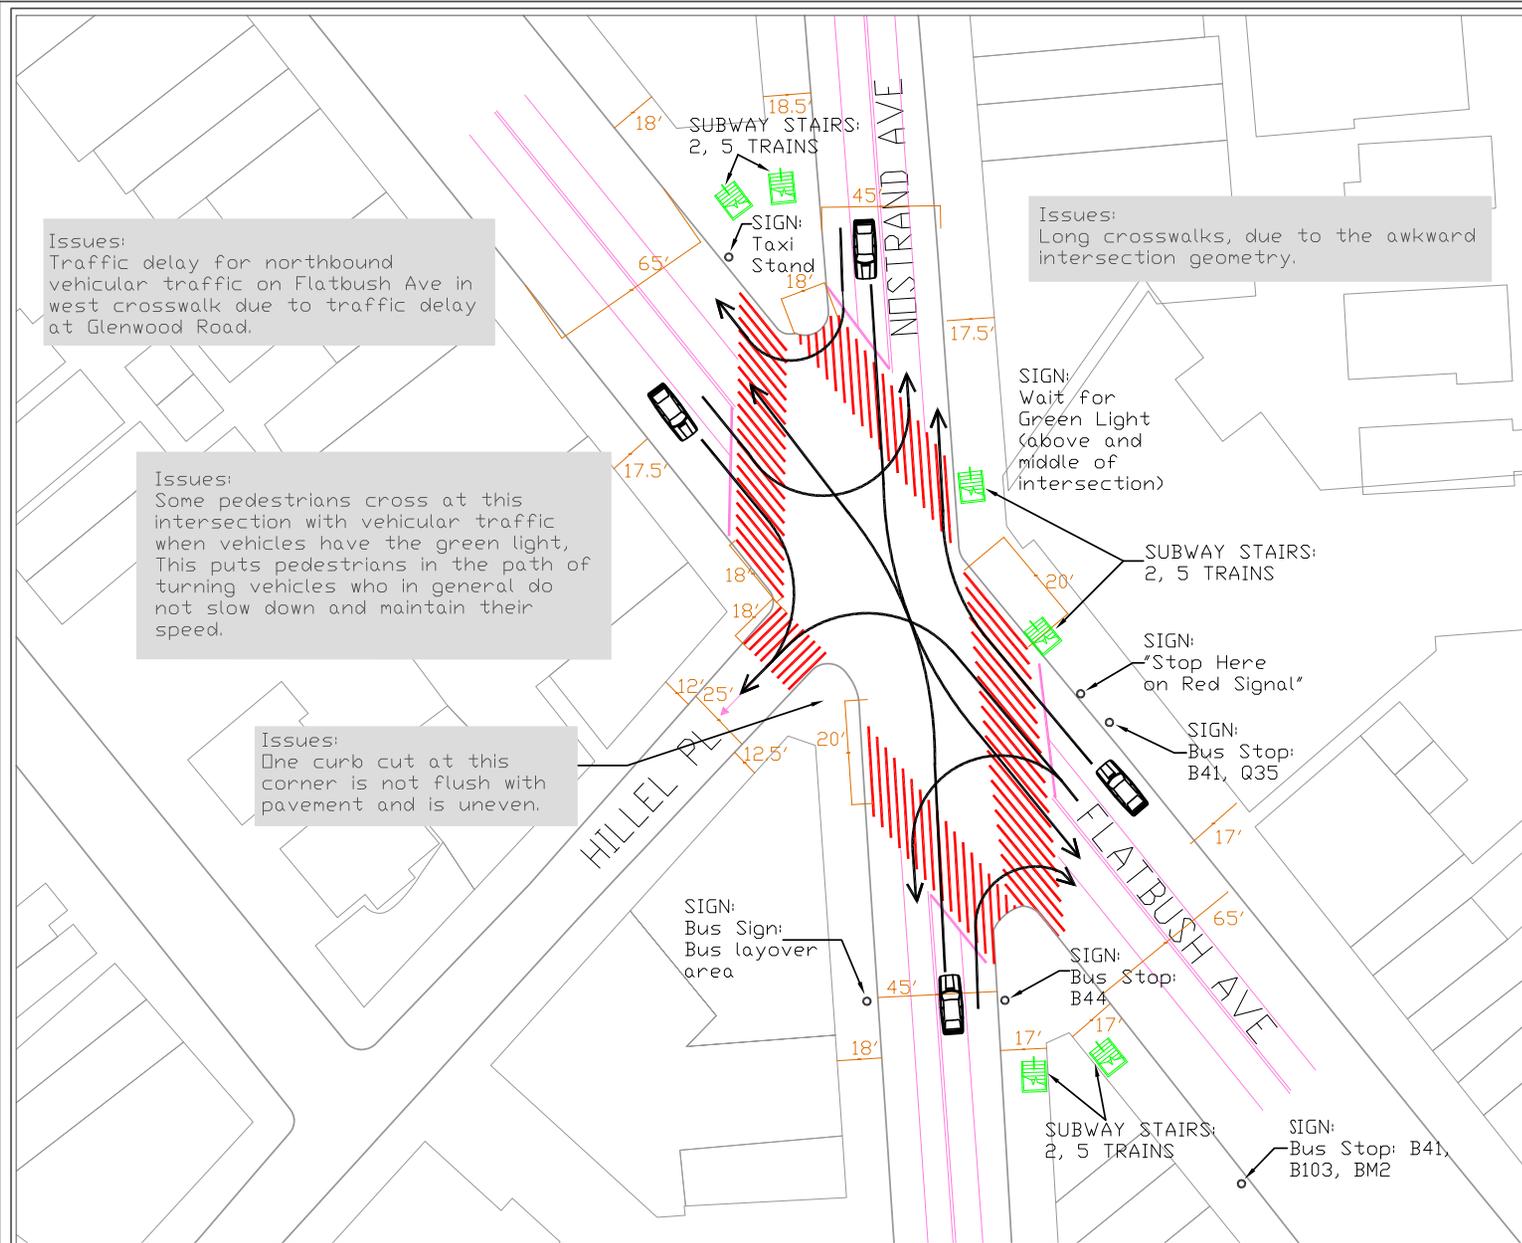
Flatbush Avenue and Nostrand Avenue/Hillel Place
Existing Conditions - Figure: C-14a

At this location two major arterials intersect at an awkward angle Flatbush Avenue and Nostrand Avenue. A smaller street, Hillel Place, ends at this intersection.

Flatbush Avenue is about 65 ft wide at this location with two travel lanes in each direction of traffic. The sidewalks along this major street are 17 to 18 ft wide.

Nostrand Avenue at this intersection is 45 ft wide and is a two-way street with one travel lane in each direction of traffic. Its sidewalks measure 17 to 18 ft wide.

Hillel Place is 25 ft wide. Its sidewalks are 12 - 13 ft wide.

- **Signs**
Several regulatory signs exist but are oriented towards vehicles approaching the intersection. These signs for drivers display the following the message: “Wait for green light”. However there are no signs regulating pedestrian traffic at this intersection.
- **Vehicles and Crosswalks**
Flatbush Avenue and Nostrand Avenue intersect at an angle which gives the intersection an awkward shape where vehicles often wait for the green light partially in the crosswalk. This creates conflicts between pedestrians and vehicles and reduces visibility due to a shorter sight distance at the intersection for the driver.

In addition traffic congestion occurs at times on Flatbush Avenue at Glenwood Road which backs up into Nostrand Avenue creating delays for northbound vehicular traffic. When this happens vehicles block the west crosswalk and make it difficult for pedestrians to cross especially during the peak hours of the day.

- **Pedestrian Amenities**
There are no trees or plantings near this intersection. In addition one of the curb cuts at the end of Hillel Place is not flush with the pavement surface which makes it inaccessible to those on wheels.

An additional recommendation is to stripe or have a “Don’t Block the Box” element for vehicular traffic at this intersection. This would deter northbound traffic from blocking the intersection of Flatbush/ Nostrand Avenue and particularly the west crosswalk where many pedestrians cross.

- **Pedestrian Amenities**
Plant new trees where possible and install bus shelters where functional. In addition improve the curb cuts at the corner of Hillel Place and Flatbush Avenue and make them ADA (American Disability Act) accessible.
