Location: Flatbush Avenue/Bedford Avenue and Foster Avenue

Intersection of Flatbush Avenue and Foster/Bedford Avenue

Description of Existing Conditions

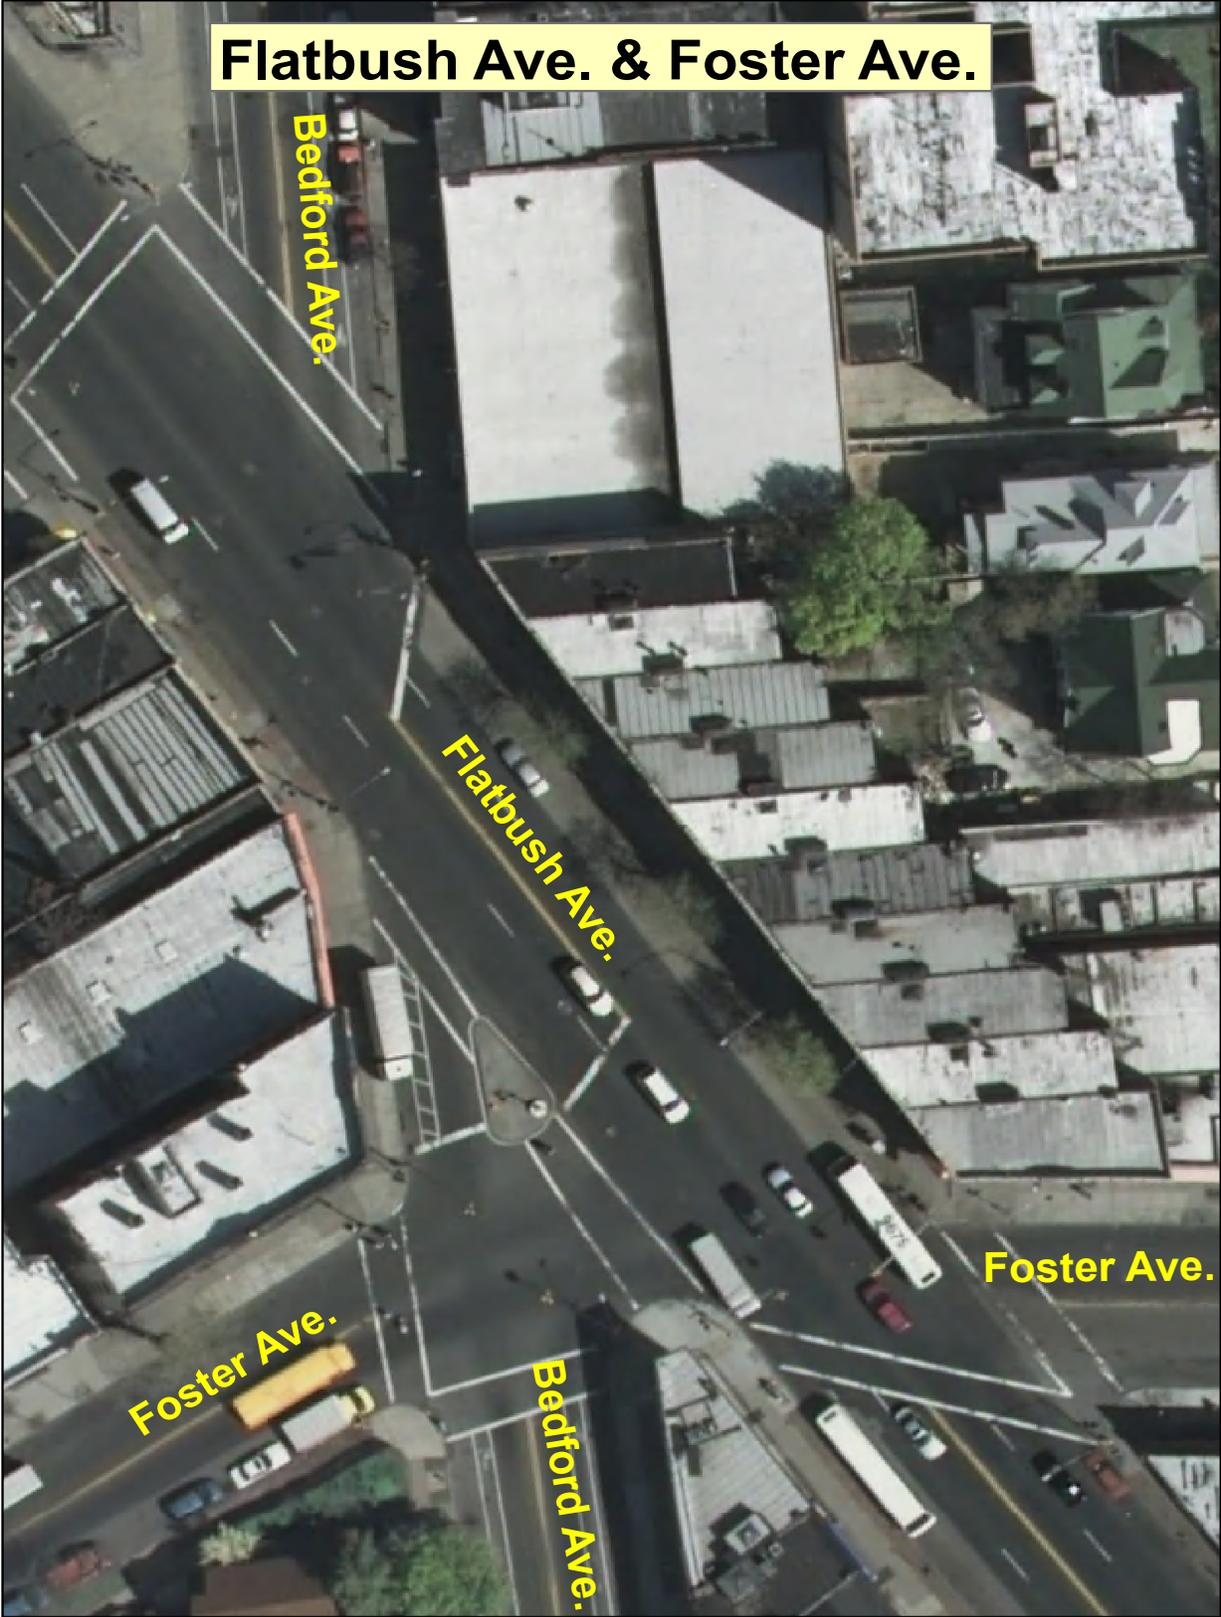
Flatbush Avenue intersects at an angle with two main avenues at this location, Foster Avenue and Bedford Avenue, which creates an awkwardly shaped intersection.

Flatbush Avenue has a width of 55 - 60 ft with two travel lanes in each direction of traffic. The sidewalks are approximately 11-14 ft wide in this area.

Foster Avenue is 40-45 ft wide and has one travel lane in each direction. The width of its sidewalks range from 10 to 17 ft.

Bedford Avenue travels north-south and is 45 feet wide. It has one travel lane and a bicycle lane in each direction of traffic.

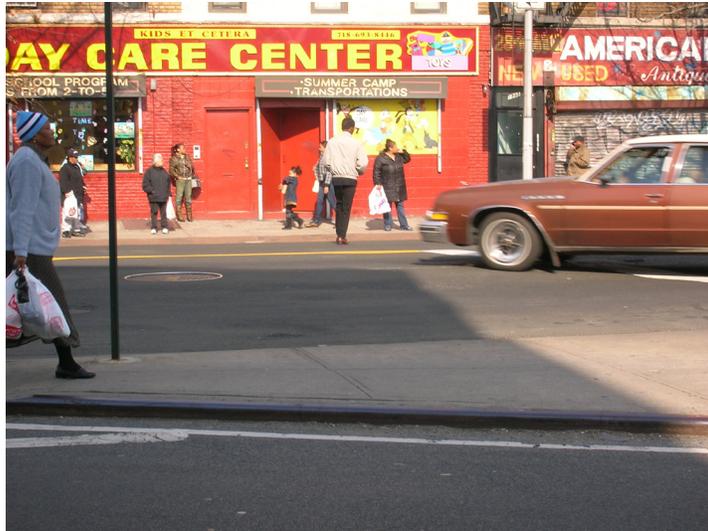
Pedestrian crossing Flatbush Avenue midblock just north of Foster Avenue

In addition, the passengers getting off at the bus stop on the east side of Flatbush Avenue (B41, BM2 and B103 buses) and heading westbound to Foster Avenue or southbound to Bedford Avenue often cross or jaywalk midblock to continue their route or to make a connection with the B49 going westbound which is a dangerous crossing location for pedestrians. The distance from the bus stop to the nearest crosswalk is at least 200 ft and often these pedestrians/bus passengers cross midblock and do not take the time to cross at the crosswalks (See following map of intersection).

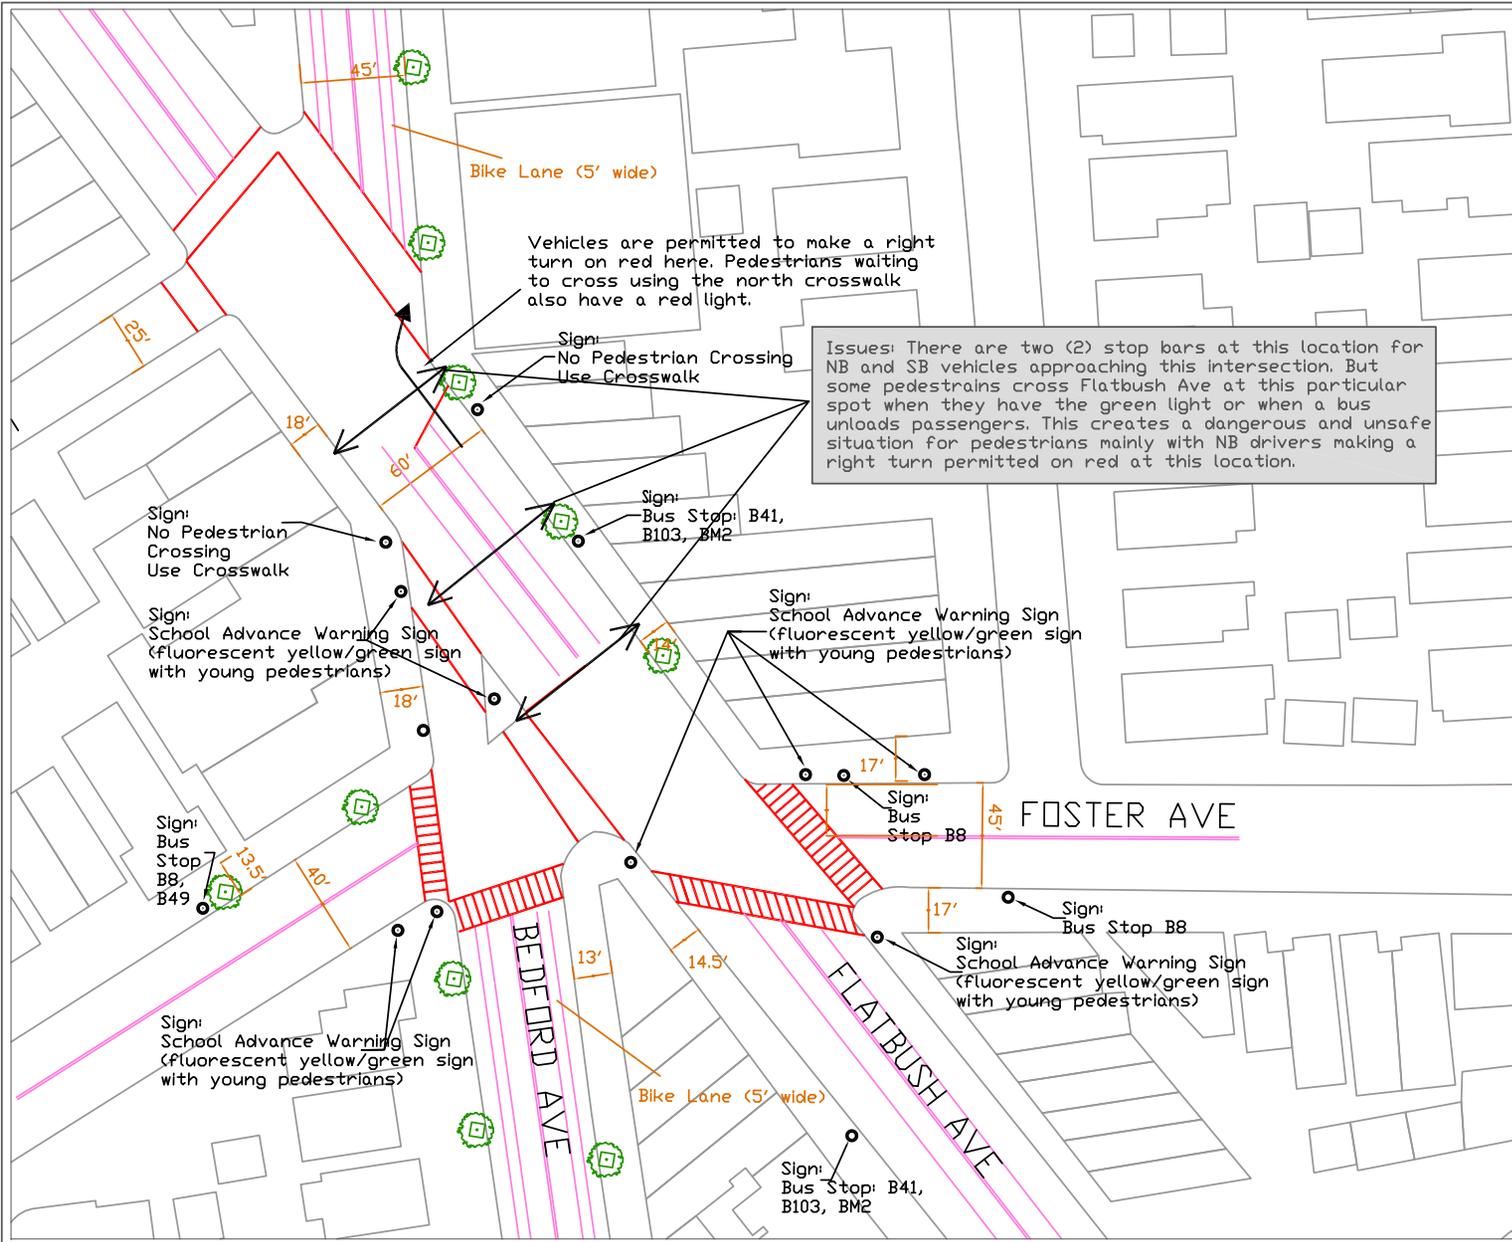
Flatbush Avenue/Bedford Avenue and Foster Avenue
Existing Conditions - Figure: C-2a

- Pedestrian Crossing Midblock and at “Stop Bar” locations
 Flatbush Avenue, Foster Avenue and Bedford Avenue all meet at this point. These streets do not align and are at an angle to each other. In addition “Stop bars” have been placed north of Foster Avenue to indicate where vehicles arriving at this location should stop in the middle of the block. Pedestrians were observed crossing at that particular spot. It was observed at that midblock location during the peak hours of a typical weekday that 41 pedestrians cross in the morning (7:00 - 9:00 am), 56 in the midday (12:00 – 2:00 pm) and 71 pedestrians cross in the evening (4:00 – 6:00 pm). During the weekend between 1:00 and 3:00pm 62 pedestrians typically cross Flatbush Avenue at that midblock location. In addition northbound traffic on Flatbush Avenue as it approaches Bedford Avenue often does not stop since it is permitted to make a right turn on red onto Bedford Avenue. There are signs to inform pedestrians not to cross at that particular location: “No Ped Crossing Use Crosswalks”. But these signs are ignored by pedestrians arriving at the intersection. See following map of intersection, Figure C2-a: Existing Conditions.

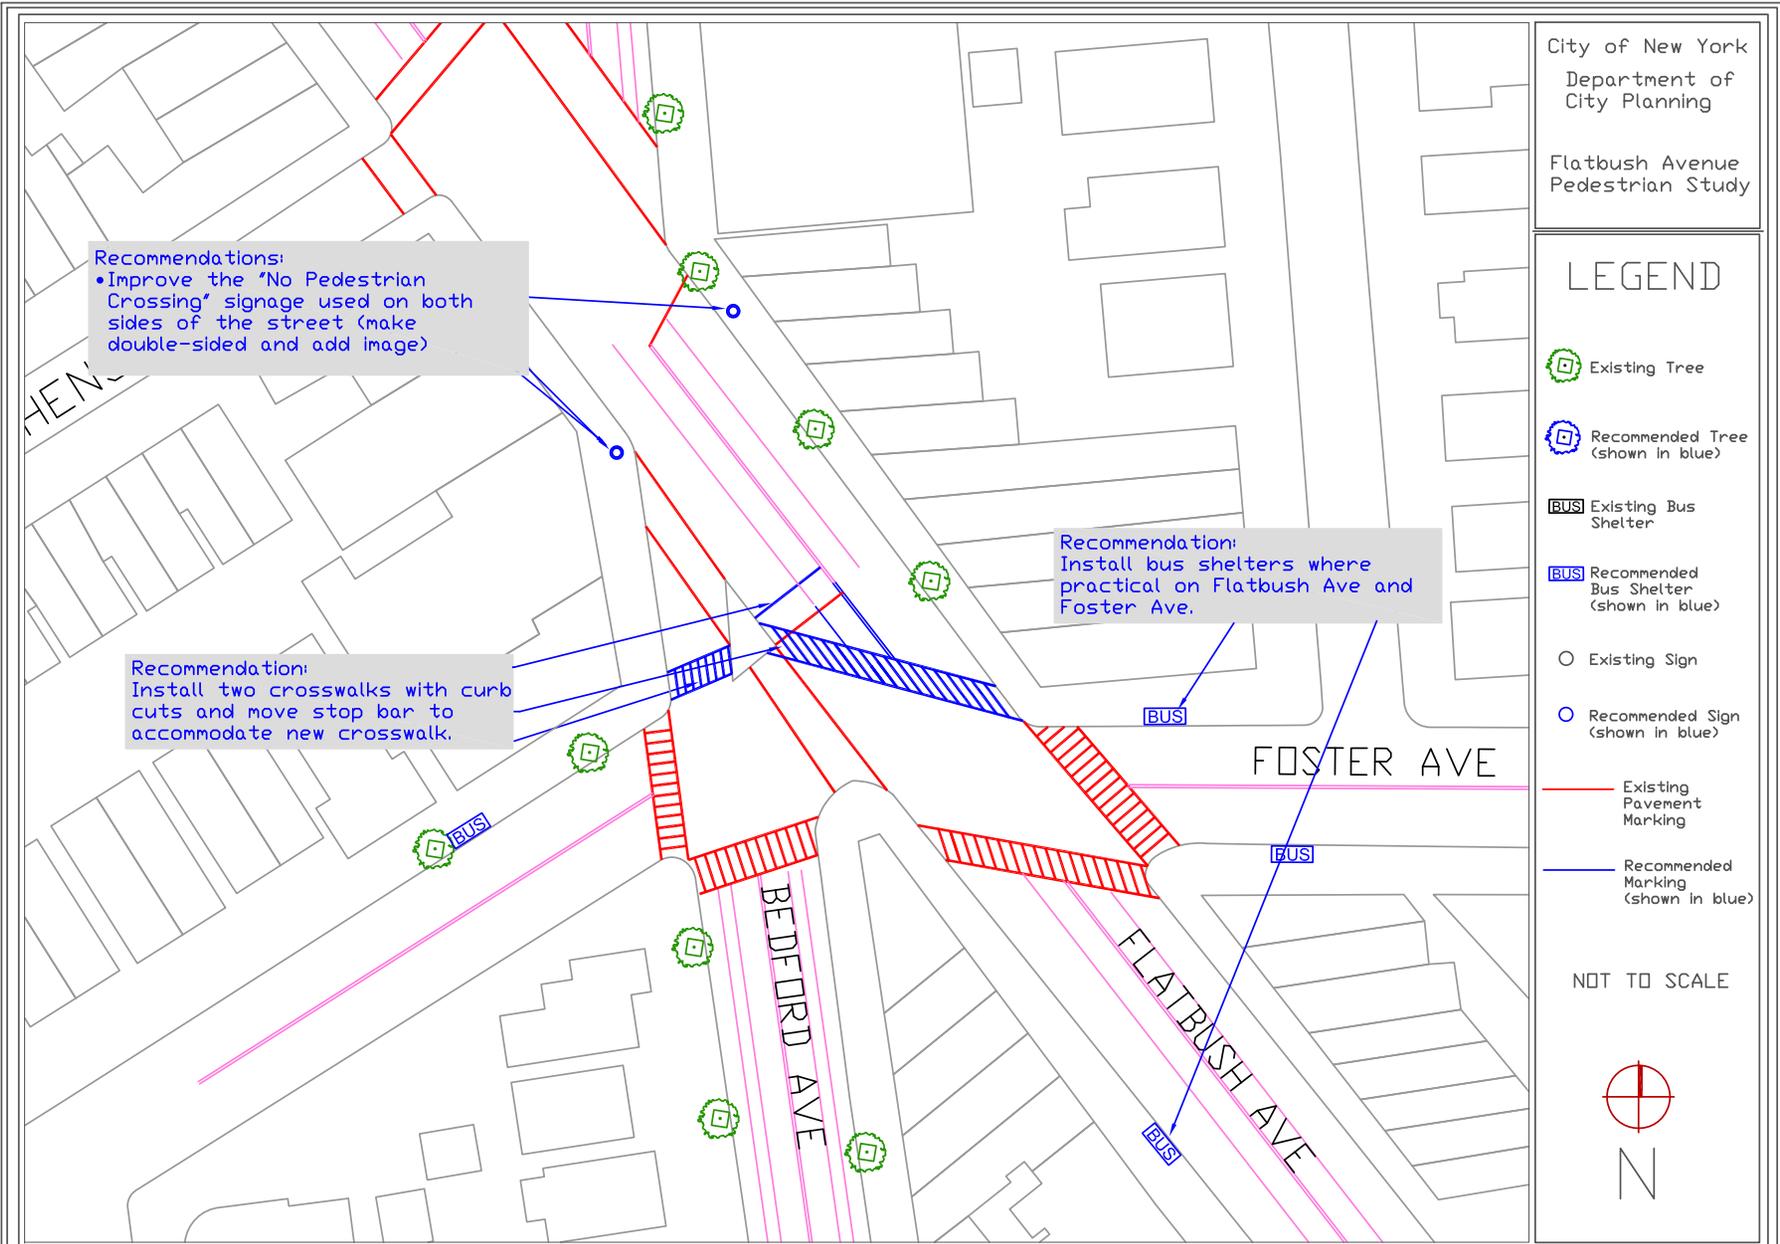
Flatbush Avenue/Bedford Avenue and Foster Avenue Recommendations - Figure: C-2b

- **Install a new crosswalk**
As a proposal, install a new crosswalk across Flatbush Avenue that would link the north sidewalks of Foster Avenue. This would provide a safe and designated crossing for pedestrians who often cross midblock just north of Foster Avenue. This new facility would also require an adjustment to the signal timing and the installation of a new pedestrian signal. The pedestrian signal should allow the right-of-way for crossing pedestrians during the Foster Avenue phase. During that phase traffic on Flatbush Avenue and on Bedford Avenue have the red light.
- **Improve Curb Cuts**
Improve existing curb cuts at the traffic island and add new curb cuts that would be necessary with the installation of the proposed crosswalk.

The existing signs “No Ped Crossing Use Crosswalks” are not very useful based on their placement and orientation. First of all, install double-sided signs that face all pedestrian approaches and can be seen from any direction as you approach the midblock location. Secondly, install an additional sign adjacent to or above the “No Ped Crossing Use Crosswalks” sign. This sign should be an image of a pedestrian with a red interdiction symbol over it (MUTCD manual “R9-3a” sign; see image in Appendix D-2: Standards for Signs Recommended). The graphic reinforces the first sign’s message that pedestrians are prohibited from crossing the roadway at this undesirable location.

It is recommended to plant trees and add landscaping at this location near the intersection: 3 - 4 trees on the west sidewalk of Flatbush Avenue between Foster Avenue and Stephens Ct. The number of trees has been determined based on the standards set by the New York City Department of Parks and Recreation in terms of tree spacing requirements from an intersection and from street lights. The traffic island could be improved with landscaping.

In addition install bus shelters at bus stops on Flatbush Avenue and Glenwood Road where passengers wait for the arrival of a bus. It may only be possible to install a narrow bus shelter at certain locations based on the width of the sidewalk and NYCDOT’s Street Furniture requirements (see Appendix D-4: Standards for Bus Shelters).
