Location: Flatbush Avenue between Avenue U and Avenue V

Midblock of Flatbush Avenue between Avenue U and Avenue V

Description of Existing Conditions

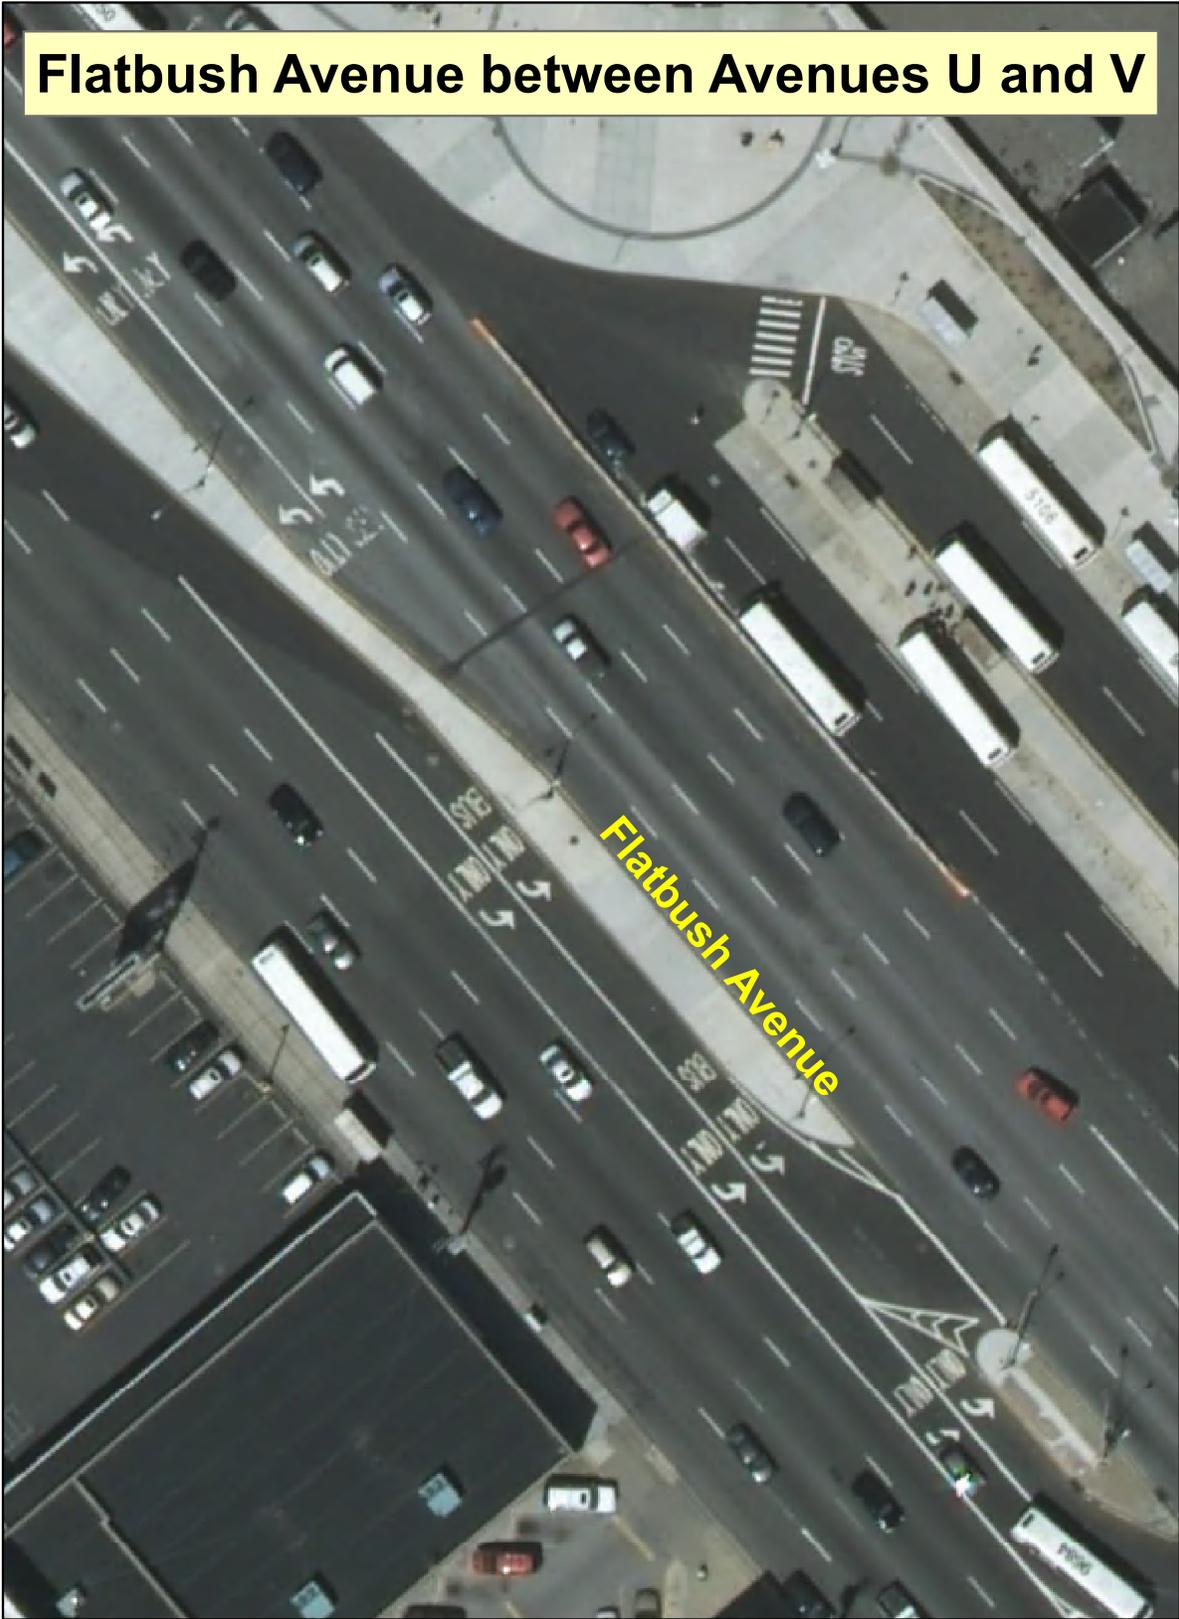
Flatbush Avenue as mentioned above is 145 ft wide with six travel lanes, in each direction of traffic which include dedicated turning lanes.

Flatbush Avenue has a median in the middle of the roadway which separates the two-way traffic of heavy vehicular volumes.

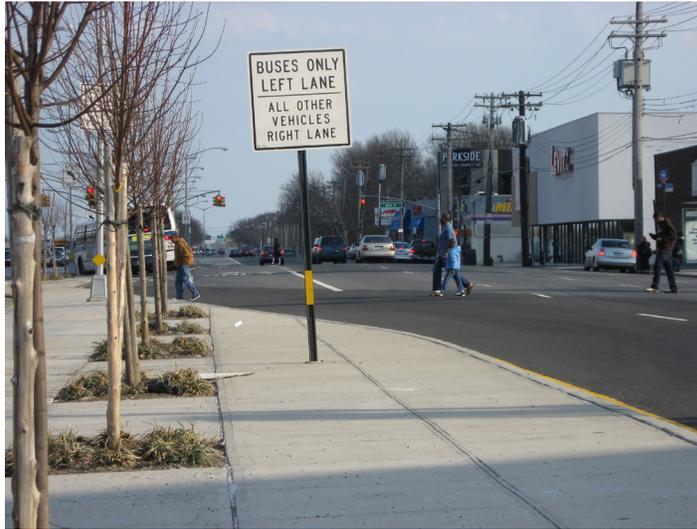
Flatbush Avenue at this location has the Kings Plaza Shopping Mall on the east side and a strip mall/big box retail stores on the west side. Some pedestrians jaywalk midblock from/to these buildings to cross Flatbush Avenue instead of using the crosswalks located at the intersection of Flatbush Avenue with Avenue U or Avenue V. There is also a bus stop for the Q35 midblock on the west side of the street which some shoppers get from/to by jaywalking.

This is an unsafe practice for pedestrians who jaywalk in the area. With the high volume of vehicles (NB = 285 and SB = 245 vehicles on average/ 15-minute peak volumes) traveling daily along Flatbush Avenue, accidents are bound to happen at this midblock location. A total of eight pedestrian accidents have already occurred at this location between 2004 and 2006 (see above accident table). A survey was done regarding the volume of pedestrians crossing midblock: AM Peak Period (7:00 – 9:00AM) = 7, MD Peak Period (12:00 – 2:00 PM) = 11 and PM Peak Period

Pedestrians crossing Flatbush Avenue midblock between Avenue U and Avenue V

- Install a barrier
Plant shrubs along the median in between Avenue U and Avenue V to block and discourage pedestrian from jaywalking. In addition, have some of the following signs installed midblock “Cross only at Crosswalks” and “Use Crosswalk (with a directional arrow)” directing pedestrians to the crosswalks at Avenue U or Avenue V (MUTCD Manual R9-2 and R9-3b signs; see Appendix D-2: Standards for Recommended Signs).
- Provide Additional Pedestrian Amenities
Place trees/planters on the sidewalks where possible. In terms of the medians on Flatbush Avenue, they recently as of December 2007, had small trees planted.

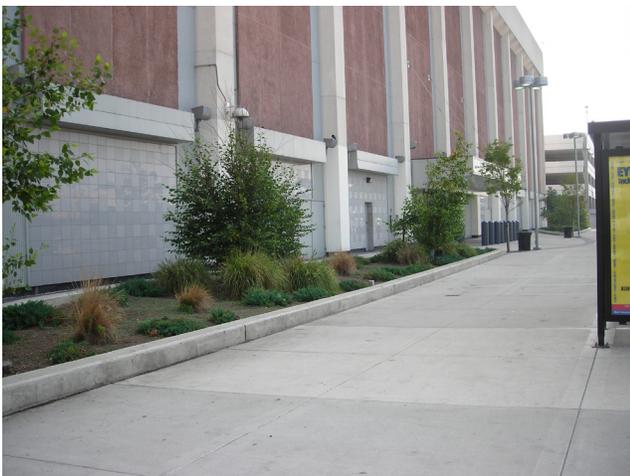
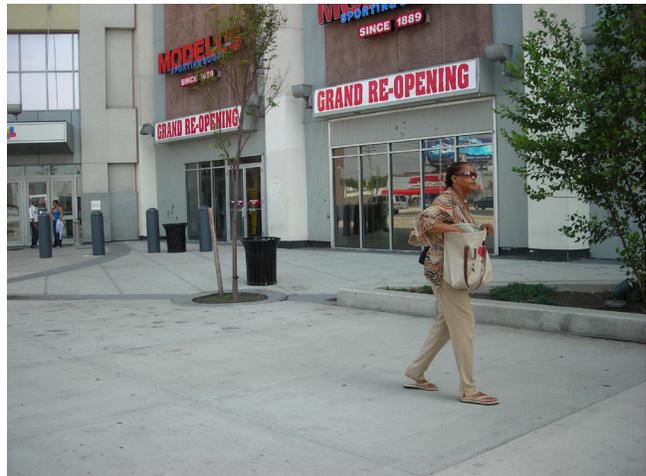
Also the plaza in front of the shopping mall lacks benches and sitting areas for the Kings Plaza patrons waiting for a bus.

Plaza in front of Kings Plaza Mall lack sitting area and benches

Additional sitting areas at the entrance of the Kings Plaza shopping mall would be convenient for patrons waiting for the arrival of the bus.

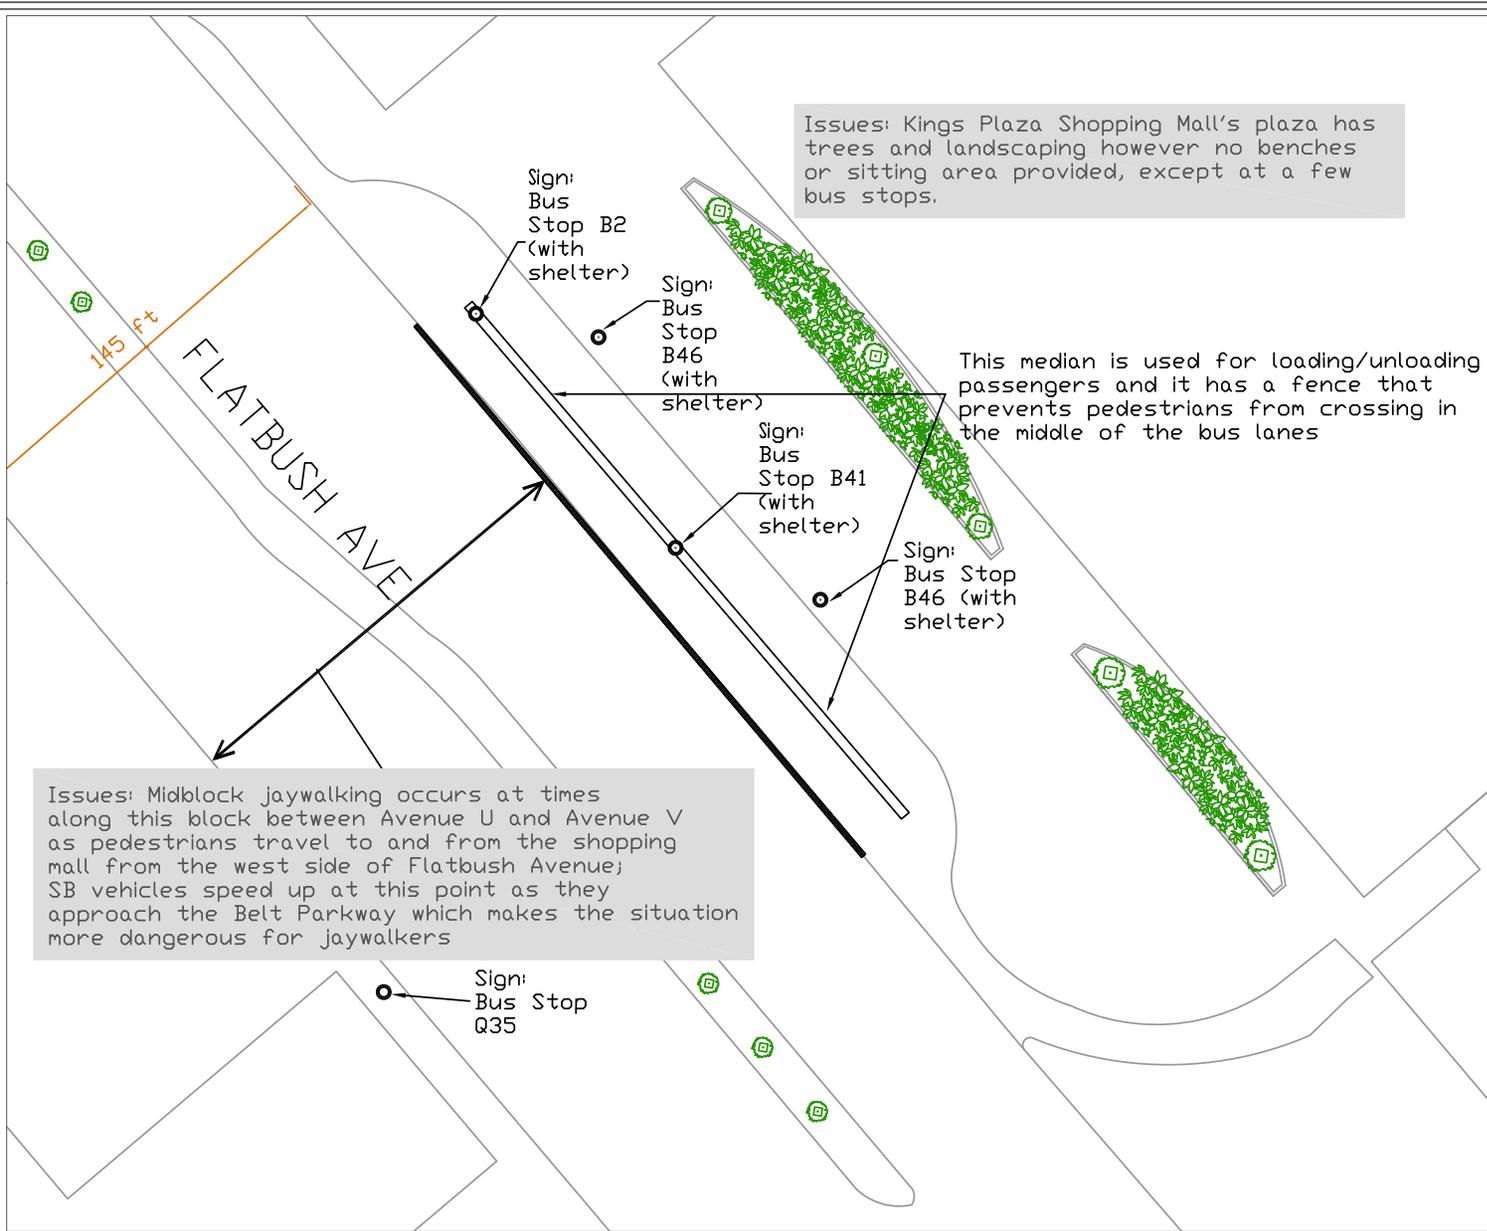
Flatbush Avenue between Avenue U and Avenue V
 Existing Conditions - Figure C-4a

Issues: Kings Plaza Shopping Mall's plaza has trees and landscaping however no benches or sitting area provided, except at a few bus stops.

This median is used for loading/unloading passengers and it has a fence that prevents pedestrians from crossing in the middle of the bus lanes

Issues: Midblock jaywalking occurs at times along this block between Avenue U and Avenue V as pedestrians travel to and from the shopping mall from the west side of Flatbush Avenue; SB vehicles speed up at this point as they approach the Belt Parkway which makes the situation more dangerous for jaywalkers
