Location: Flatbush Avenue and Parkside Avenue

Intersection of Flatbush Avenue and Parkside Avenue

City of New York
 Department of
 City Planning
 Flatbush Avenue
 Pedestrian Study

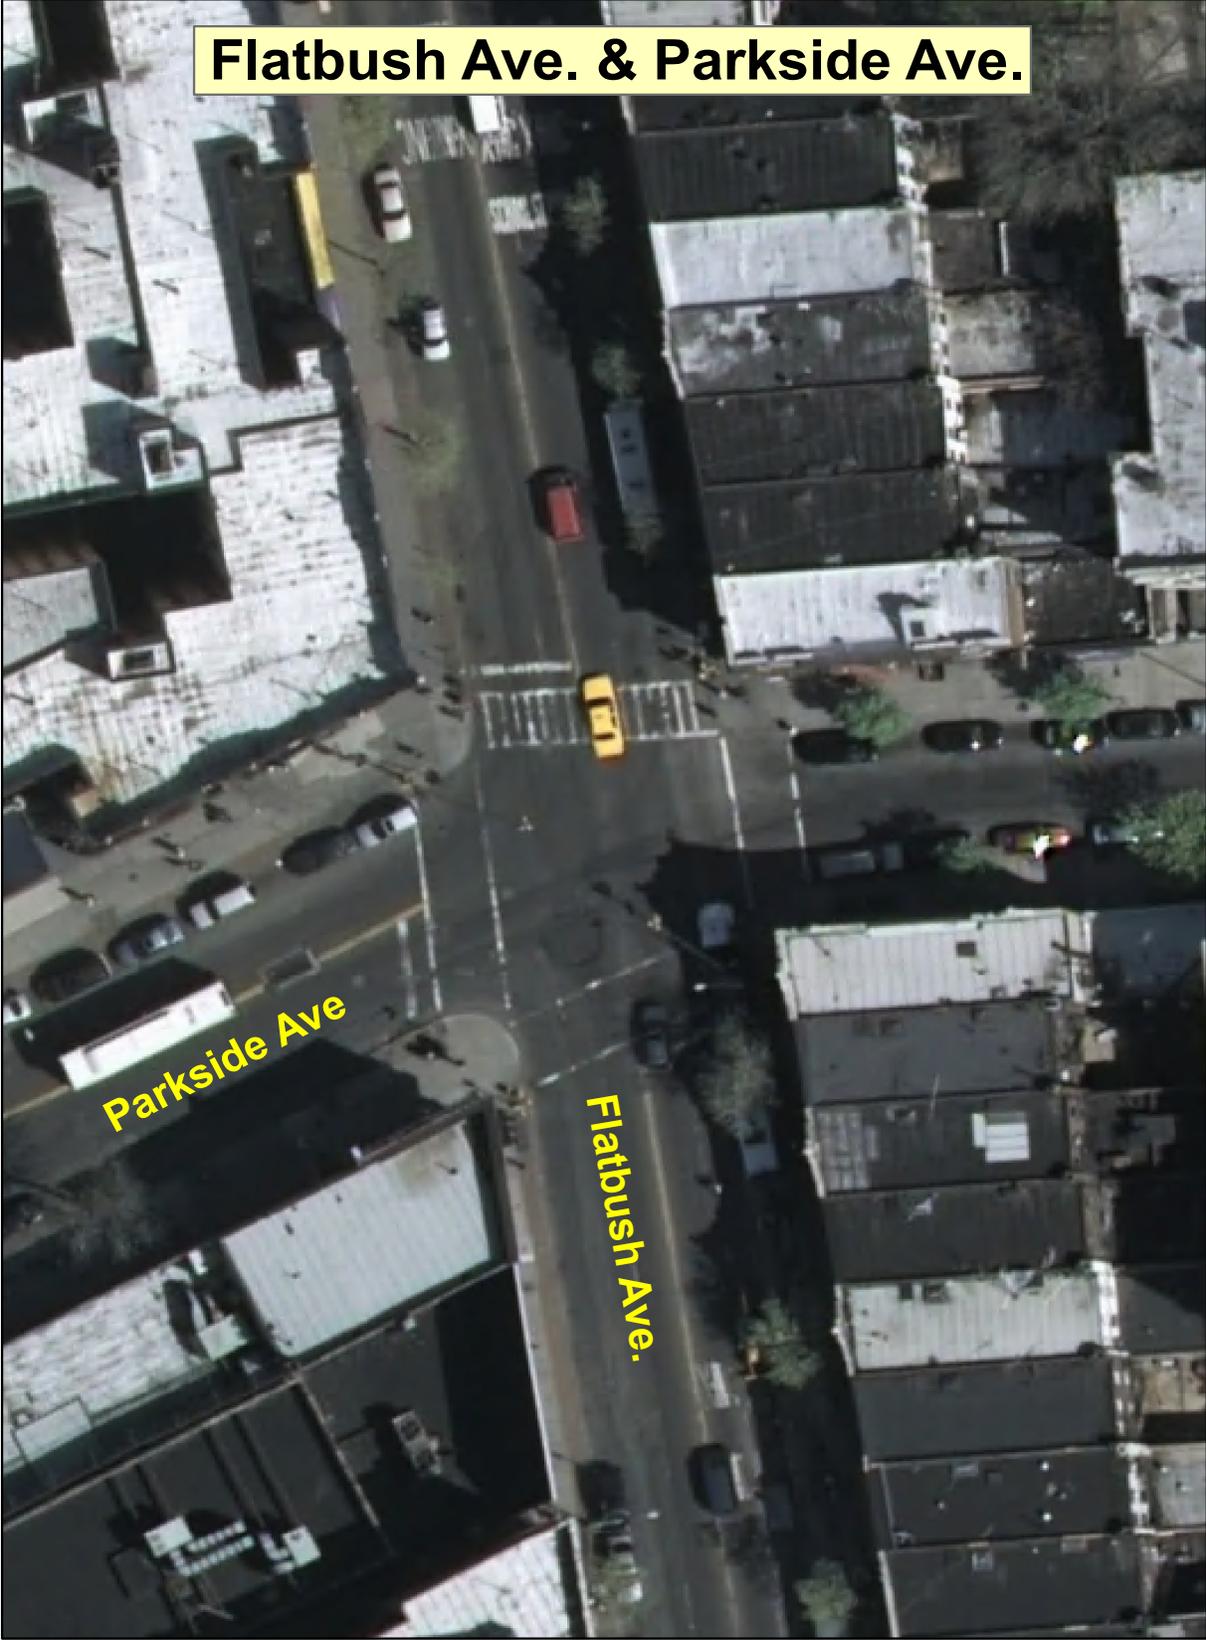
At this location Flatbush Avenue has a width of 55 ft with two travel lanes in each direction of traffic. The sidewalks along this major street are 13 – 14 ft wide.

Parkside Avenue to the west of Flatbush Avenue is 50 ft wide and has two-way vehicular traffic. The sidewalks are 18-19 ft wide. To the east of Flatbush Avenue this street is 30 ft wide with one-way traffic (eastbound). The width of the sidewalks range from 14 – 15 ft.

A significant volume of vehicles travel through the area and many of them make turning movements at this location. In addition there are “School Advance Warning” signs at the northwest and northeast corners (fluorescent yellow/green signs) warning motorists to yield to school children.

The southbound turning movements generate the most conflicts with pedestrians on the west side of the street (west crosswalk) where pedestrian volumes are the highest.

In general the pavement is in poor condition and covered with potholes which vehicles avoid by slowing down and swerving around them. This can be dangerous for pedestrians since drivers do this without warning and nearly swerve into the path of pedestrians crossing at the intersection.

The pavement markings have also faded and are in poor condition.

- **Increase Enforcement**
Increase police presence is recommended for this location for the enforcement of traffic regulations.

- **Improve Pavement Conditions**
Restripe crosswalks with high visibility markings on Flatbush Avenue. Reduce the swerving movement of vehicles by repairing and filling in potholes at this intersection. Additionally, installing concrete bus pads at the bus stops on Flatbush Avenue can help reduce pavement bumps generated by buses pulling in and out of the bus stops.

- **Additional Signage**
It is recommended to install at all corners of the intersection “Turning Vehicles Yield to Pedestrians” signs to get the attention of motorists making a turn at the intersection.

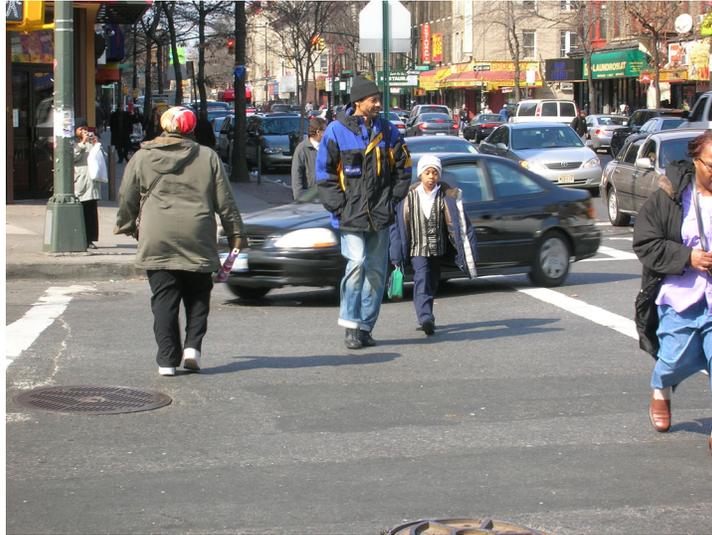
Turning vehicle movements occur at this intersection and are often in conflict with pedestrians crossing. Based on field observations, motorists do not always yield to pedestrians. The majority of the turns are made by southbound traffic making a turn to go west and eastbound traffic turning to go north.

Pedestrians are often in conflict with vehicles making a turn at the intersection of Flatbush Avenue and Parkside Avenue

- **Examine feasibility of a Leading Pedestrian Interval (LPI) Phase**
Install a Leading Pedestrian Interval Phase (LPI = 5 seconds) for pedestrians walking on Flatbush Avenue and crossing Parkside Avenue. It will give pedestrians a head start to vehicular traffic and also give them the advantage to be in the crosswalk when southbound and northbound vehicles position themselves to make their turn.

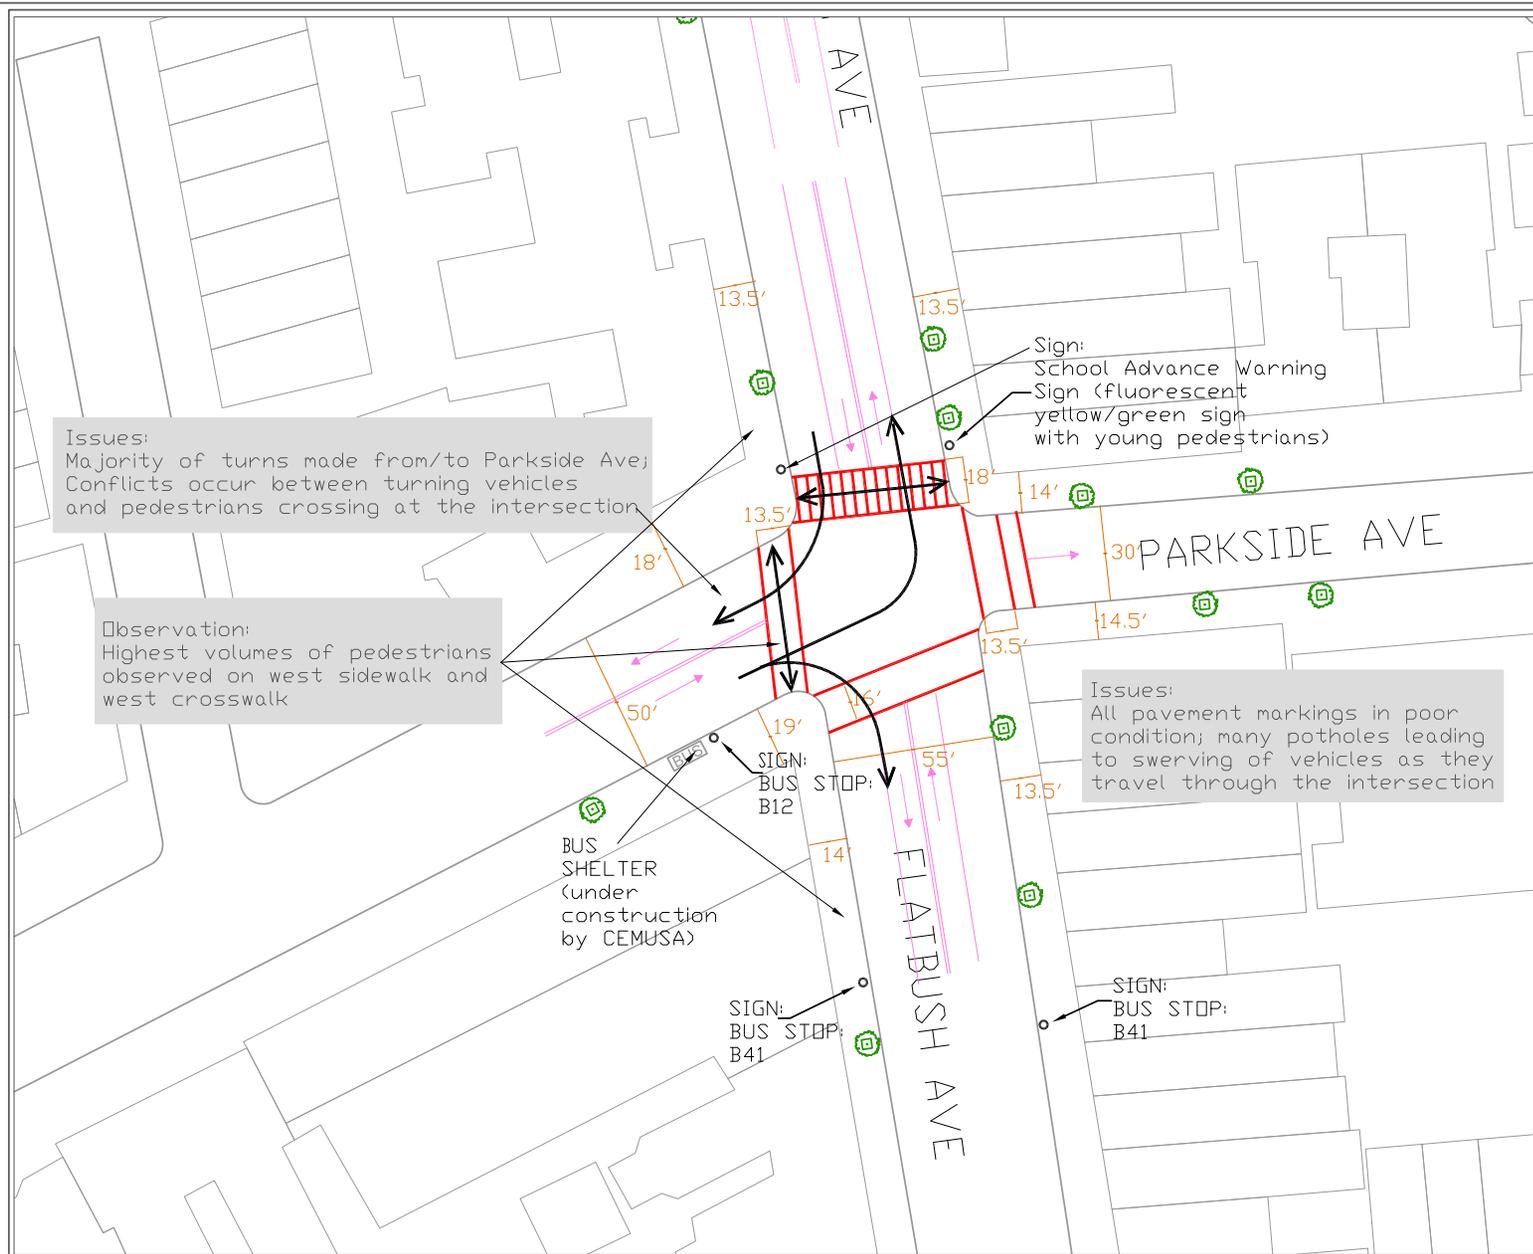
Flatbush Avenue and Parkside Avenue
Existing Conditions - Figure: C-7a

Issues:
Majority of turns made from/to Parkside Ave;
Conflicts occur between turning vehicles
and pedestrians crossing at the intersection

Observation:
Highest volumes of pedestrians
observed on west sidewalk and
west crosswalk

Issues:
All pavement markings in poor
condition; many potholes leading
to swerving of vehicles as they
travel through the intersection
