Part II: Data and Detailed Maps

This section of the report contains a list of bicycle facilities and a schematic map for each borough and for bridge crossings followed by detailed maps which are illustrations of the data collected along each bicycle facility.

Bronx Bicycle Lanes and Trails

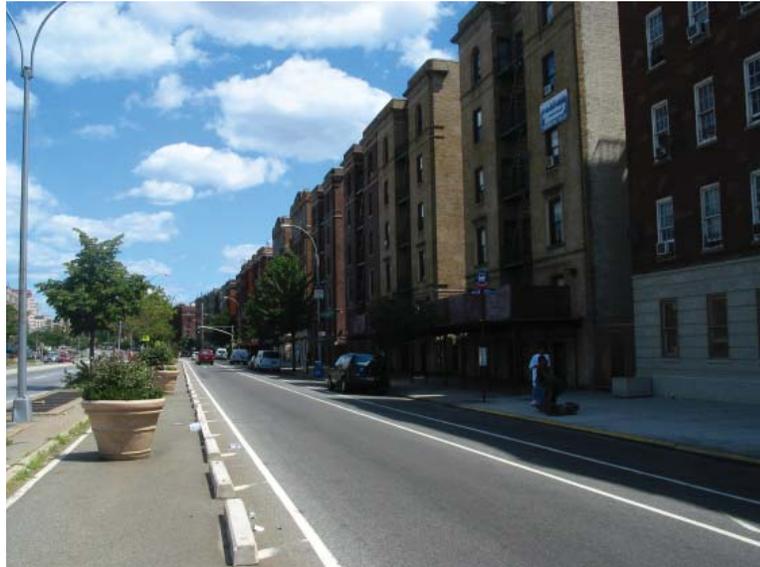
1. Grand Concourse Bicycle Lane

From Street:	E 170 th Street
To Street:	E 165 th Street
Length:	0.65 miles
Signs Condition:	100% Good
Observed: 8/20/06	0% Fair
	0% Poor
	All signs clearly visible to users.
	Bike signs = 17 regulatory
Lane Marking Condition:	87% Good
Observed: 8/11/06	7% Poor
	0% Patches
	6% No Marking
Symbols Condition:	52% Acceptable
Observed: 8/11/06	48% Poor
	Symbols: (23 Diamond)
Pavement Condition:	19% Good Condition
Observed: 11/30/06	56% Fair Condition
	18% Poor Condition
	Material: Asphalt*
2005 Bicycle Accidents:	No bicycle accidents reported along the Grand Concourse bicycle lane.
2005 Average Daily Bicycle Ridership:	N/A

* **Notes:** 7% of the route was under repair/construction when pavement condition data were collected.

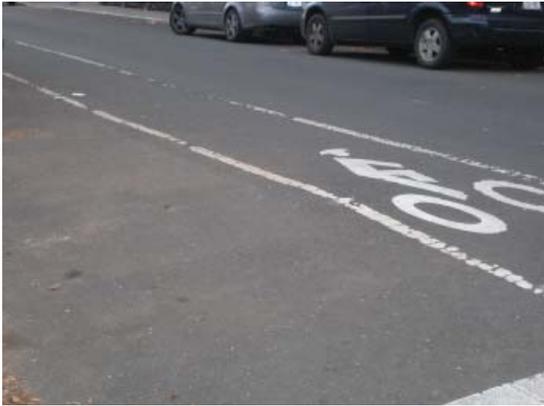
2. Hering Avenue Bicycle Lane

From Street:	Lydig Avenue
To Street:	Sackett Avenue
Length:	0.71 miles
Signs Condition: Observed:	No Signs
Lane Marking Condition: Observed: 12/11/06	0% Good 100% Poor 0% Patches 0% No Marking
Symbols Condition: Observed: 12/11/06	100% Acceptable 0% Poor Symbols: (18 Bicyclist)
Pavement Condition: Observed: 12/11/06	48% Good Condition 52% Fair Condition 0% Poor Condition Material: Asphalt
2005 Bicycle Accidents:	No bicycle accidents reported along the Hering Avenue bicycle lane.
2005 Average Daily Bicycle Ridership:	N/A

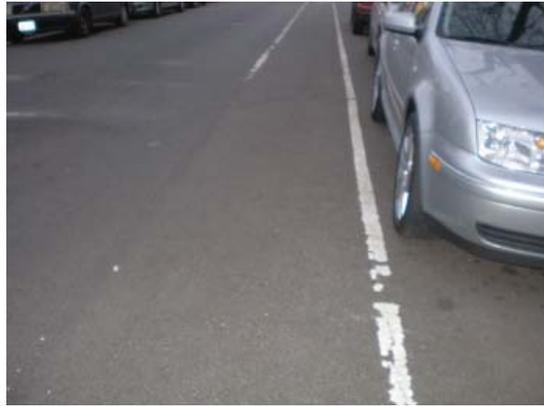
Yates Avenue Bicycle Lane

From Street:	Lydig Avenue
To Street:	Pierce Avenue
Length:	0.66 miles
Signs Condition: Observed:	No Signs
Lane Marking Condition: Observed: 12/11/06	0% Good 100% Poor 0% Patches 0% No Marking
Symbols Condition: Observed: 12/11/06	80% Acceptable 20% Poor Symbols: (15 Bicyclist)
Pavement Condition: Observed: 12/11/06	78% Good Condition 22% Fair Condition 0% Poor Condition Material: Asphalt
2005 Bicycle Accidents:	No bicycle accidents reported along the Yates Avenue bicycle lane.
2005 Average Daily Bicycle Ridership:	N/A

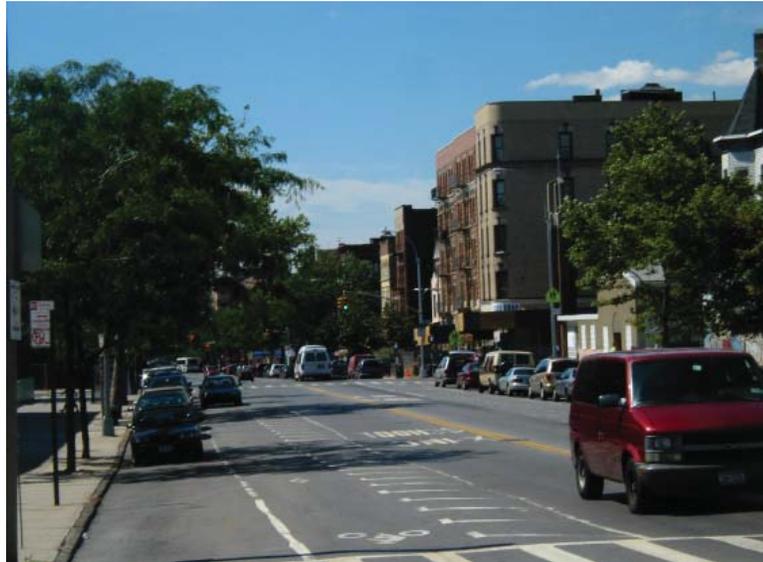
3. Prospect Avenue Bicycle Lane

From Street:	Crotona Park South
To Street:	E. 149 th Street
Length:	1.61 miles
Signs Condition:	100% Good
Observed: 8/14/06	0% Fair
	0% Poor
	Visibility of signs: 1 blocked
	Bike signs = 39 regulatory
Lane Marking Condition:	19% Good
Observed: 8/11/06	65% Poor
	0% Patches
	16% No Marking
Symbols Condition:	69% Acceptable
Observed: 8/11/06	31% Poor
	Symbols: (38 Diamond, 66 Bicyclist)
Pavement Condition:	29% Good Condition
Observed: 11/20/06	14% Fair Condition
	57% Poor Condition
	Material: Asphalt
2005 Bicycle Accidents:	One bicycle accident reported along the Prospect Avenue bike lane at the Westchester Avenue intersection.
2005 Average Daily Bicycle Ridership:	N/A

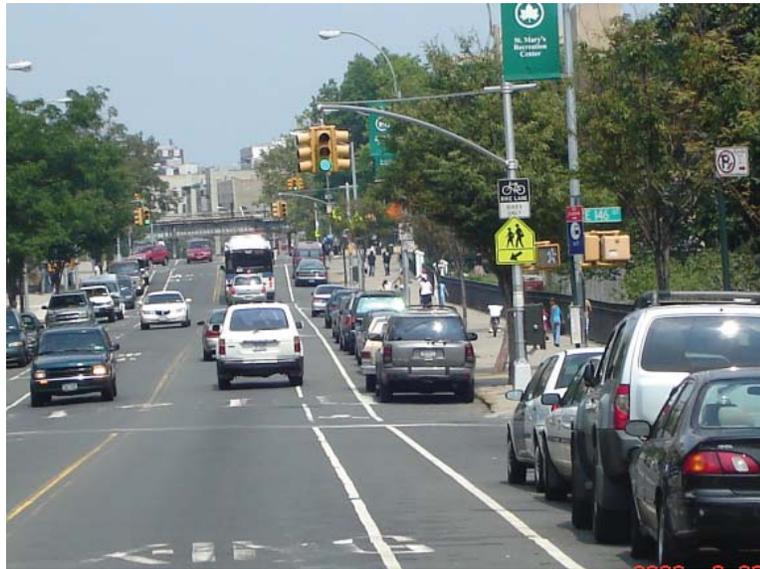
4. St. Ann's Avenue Bicycle Lane

From Street:	E. 161 st Street
To Street:	E. 135 th Street
Length:	1.33 miles
Signs Condition:	100% Good
Observed: 8/14/06	0% Fair
	0% Poor
	Visibility of signs: 3 blocked
	Bike signs = 43 regulatory, 1 informational
Lane Marking Condition:	53% Good
Observed: 8/11/06	44% Poor
	0% Patches
	2% No Marking
Symbols Condition:	68% Acceptable
Observed: 8/11/06	11% Poor
	Symbols: (76 Diamond)
Pavement Condition:	71% Good Condition
Observed: 11/20/06	25% Fair Condition
	4% Poor Condition
	Material: Asphalt
2005 Bicycle Accidents:	One bicycle accident reported along the St. Ann's Avenue bike lane at the 156 th Street intersection.
2005 Average Daily Bicycle Ridership:	N/A

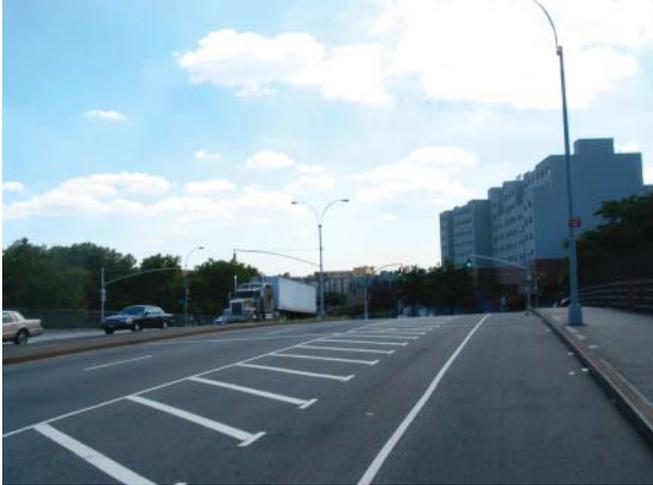
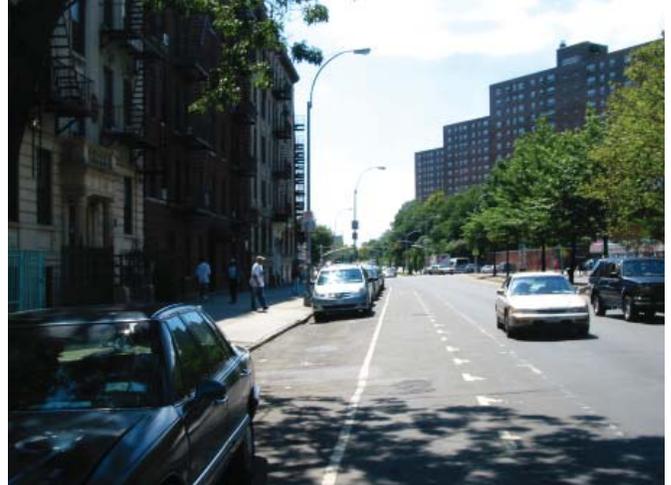
5. University Avenue / Edward L. Grant Highway Bicycle Lane

From Street:	W. Tremont Avenue
To Street:	E. 167 th Street
Length:	1.15 miles
Signs Condition:	100% Good
Observed: 8/16/06	0% Fair
	0% Poor
	All signs clearly visible to users.
	Bike signs = 23 regulatory, 2 informational
Lane Marking Condition:	19% Good
Observed: 8/16/06	66% Poor
	6% Patches
	9% No Marking
Symbols Condition:	80% Acceptable
Observed: 8/16/06	20% Poor
	Symbols: (66 Bicyclist)
Pavement Condition:	35% Good Condition
Observed: 11/30/06	31% Fair Condition
	34% Poor Condition
	Material: Asphalt
2005 Bicycle Accidents:	No bicycle accidents reported along the University Avenue/ Edward L. Grant Highway bicycle lane.
2005 Average Daily Bicycle Ridership:	N/A

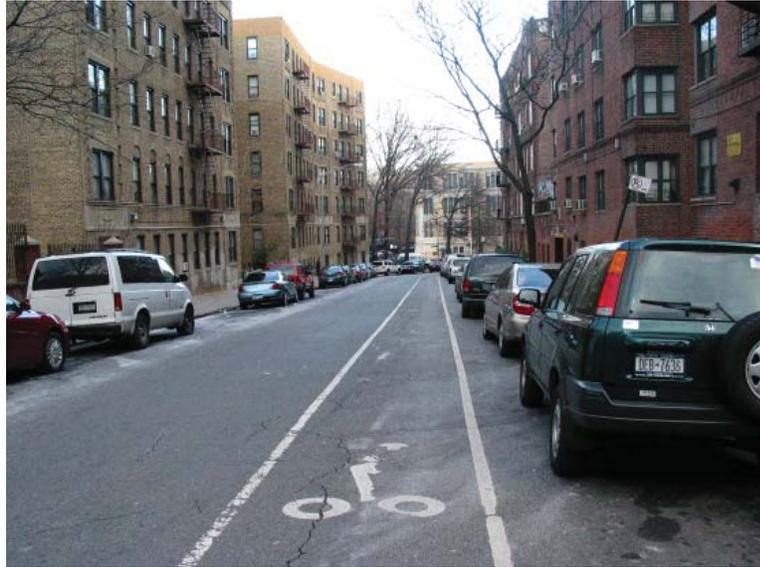
6. University Avenue/ Reservoir Avenue/ Strong Street Bicycle Lane

From Street:	W. 195 th Street
To Street:	Strong Street
Length:	0.27 .miles
Signs Condition:	100% Good
Observed: 1/19/07	0% Fair
	0% Poor
	All signs clearly visible to users
	Bike signs = 4 regulatory
Lane Marking Condition:	63% Good
Observed: 1/19/07	37% Poor
	0% Patches
	0% No Marking
Symbols Condition:	60% Acceptable
Observed: 1/19/07	40% Poor
	Symbols: (10 Bicyclist)
Pavement Condition:	0% Good Condition
Observed: 1/19/07	89% Fair Condition
	11% Poor Condition
	Material: Asphalt
2005 Bicycle Accidents:	No bicycle accidents reported along the University Ave/Strong St/ Reservoir Ave bicycle lane.
2005 Average Daily Bicycle Ridership:	N/A
