### 15. Christopher Street/ Greenwich Street Bicycle Lane

**16. Dyckman Street/ Staff Street Bicycle Lane**

### 17. Fort Washington Avenue/ Margaret Corbin Drive Bicycle Lane

## 18. Haven Avenue Bicycle Lane

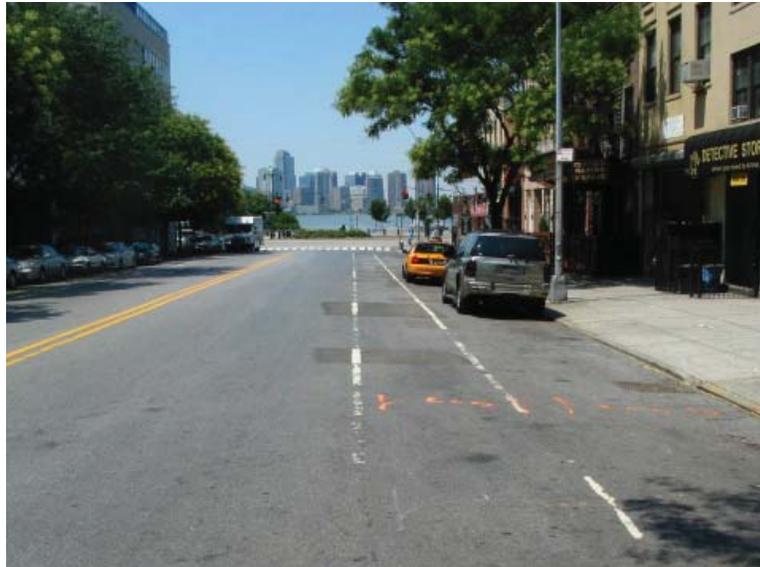
From Street:	W. 10 <sup>th</sup> Street
To Street:	West Street
Length:	0.17 miles
Signs Condition: Observed: 8/16/06	No signs on Christopher Street between 10 <sup>th</sup> St and West St.  No signs on Greenwich Street.
Lane Marking Condition: Observed: 7/17/06	25% Good 42% Poor 0% Patches 33% No Marking
Symbols Condition: Observed: 7/17/06	33% Acceptable 67% Poor Symbols: ( 6 Bicyclist )
Pavement Condition: Observed: 8/16/06	42% Good Condition 58% Fair Condition 0% Poor Condition Material: Asphalt
2005 Bicycle Accidents:	No bicycle accidents reported along the Christopher Street/Greenwich Street bike lane.
2005 Average Daily Bicycle Ridership:	N/A

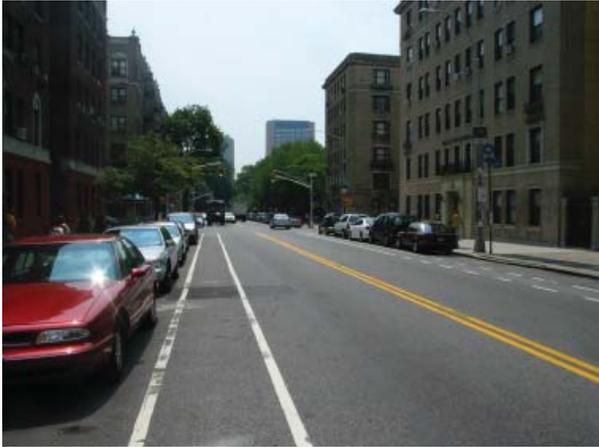
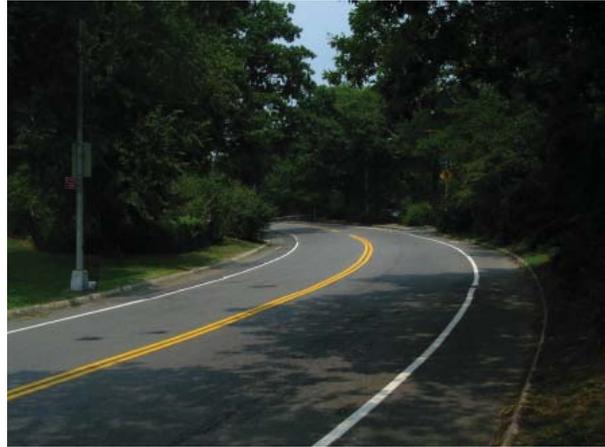
From Street:	W. 160 <sup>th</sup> Street
To Street:	The Cloisters
Length:	2.11 miles
Signs Condition:	94% Good
Observed: 11/6/06	6% Fair
	0% Poor
	All signs clearly visible to users.
	Bike signs = 35 regulatory, 12 informational, 2 greenway
Lane Marking Condition:	89% Good
Observed: 7/11/06	3% Poor
	0% Patches
	8% No Marking
Symbols Condition:	86% Acceptable
Observed: 7/11/06	14% Poor
	Symbols: ( 24 Diamond, 74 Bicyclist, 13 Other )
Pavement Condition:	91% Good Condition
Observed: 8/16/06	3% Fair Condition
	0% Poor Condition
	Material: Asphalt *
2005 Bicycle Accidents:	One accident reported along the Fort Washington Avenue/Margaret Corbin Drive at the West 177 <sup>th</sup> Street intersection.
2005 Average Daily Bicycle Ridership:	548 bicyclists

\* **Note:** 6% of the roadway (between 171<sup>st</sup> St and 177<sup>th</sup> St) on the northbound side of the road was under repair/construction when pavement condition data were collected.
