**New York City Department of Transportation
Office of School Safety Engineering**

School Safety Engineering Project

FINAL REPORT: Our Lady of Mercy, Bronx

**Prepared by
The RBA Group and URBITRAN Associates Inc.**

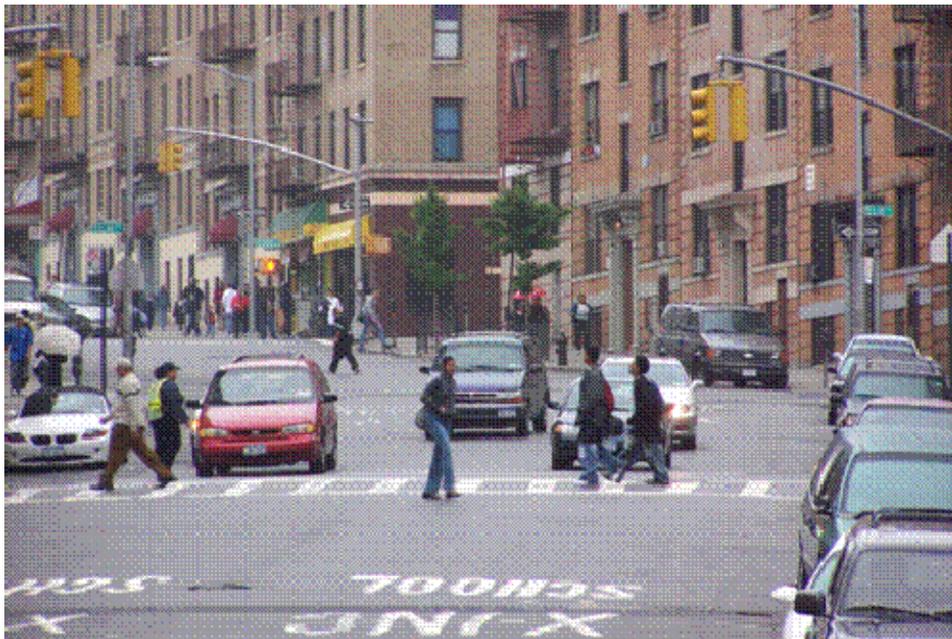
According to the school principal, one school crossing guard is assigned to the intersection of Marion Avenue and East 188th Street.

Figure 2: Crossing guard at the intersection of Marion Avenue and East 188th Street at arrival time

➤ *Request that NYPD assign a crossing guard at the intersection of East Fordham Road and Marion Avenue*

- Consider assigning a school crossing guard to the intersection of East Fordham Road and Marion Avenue.

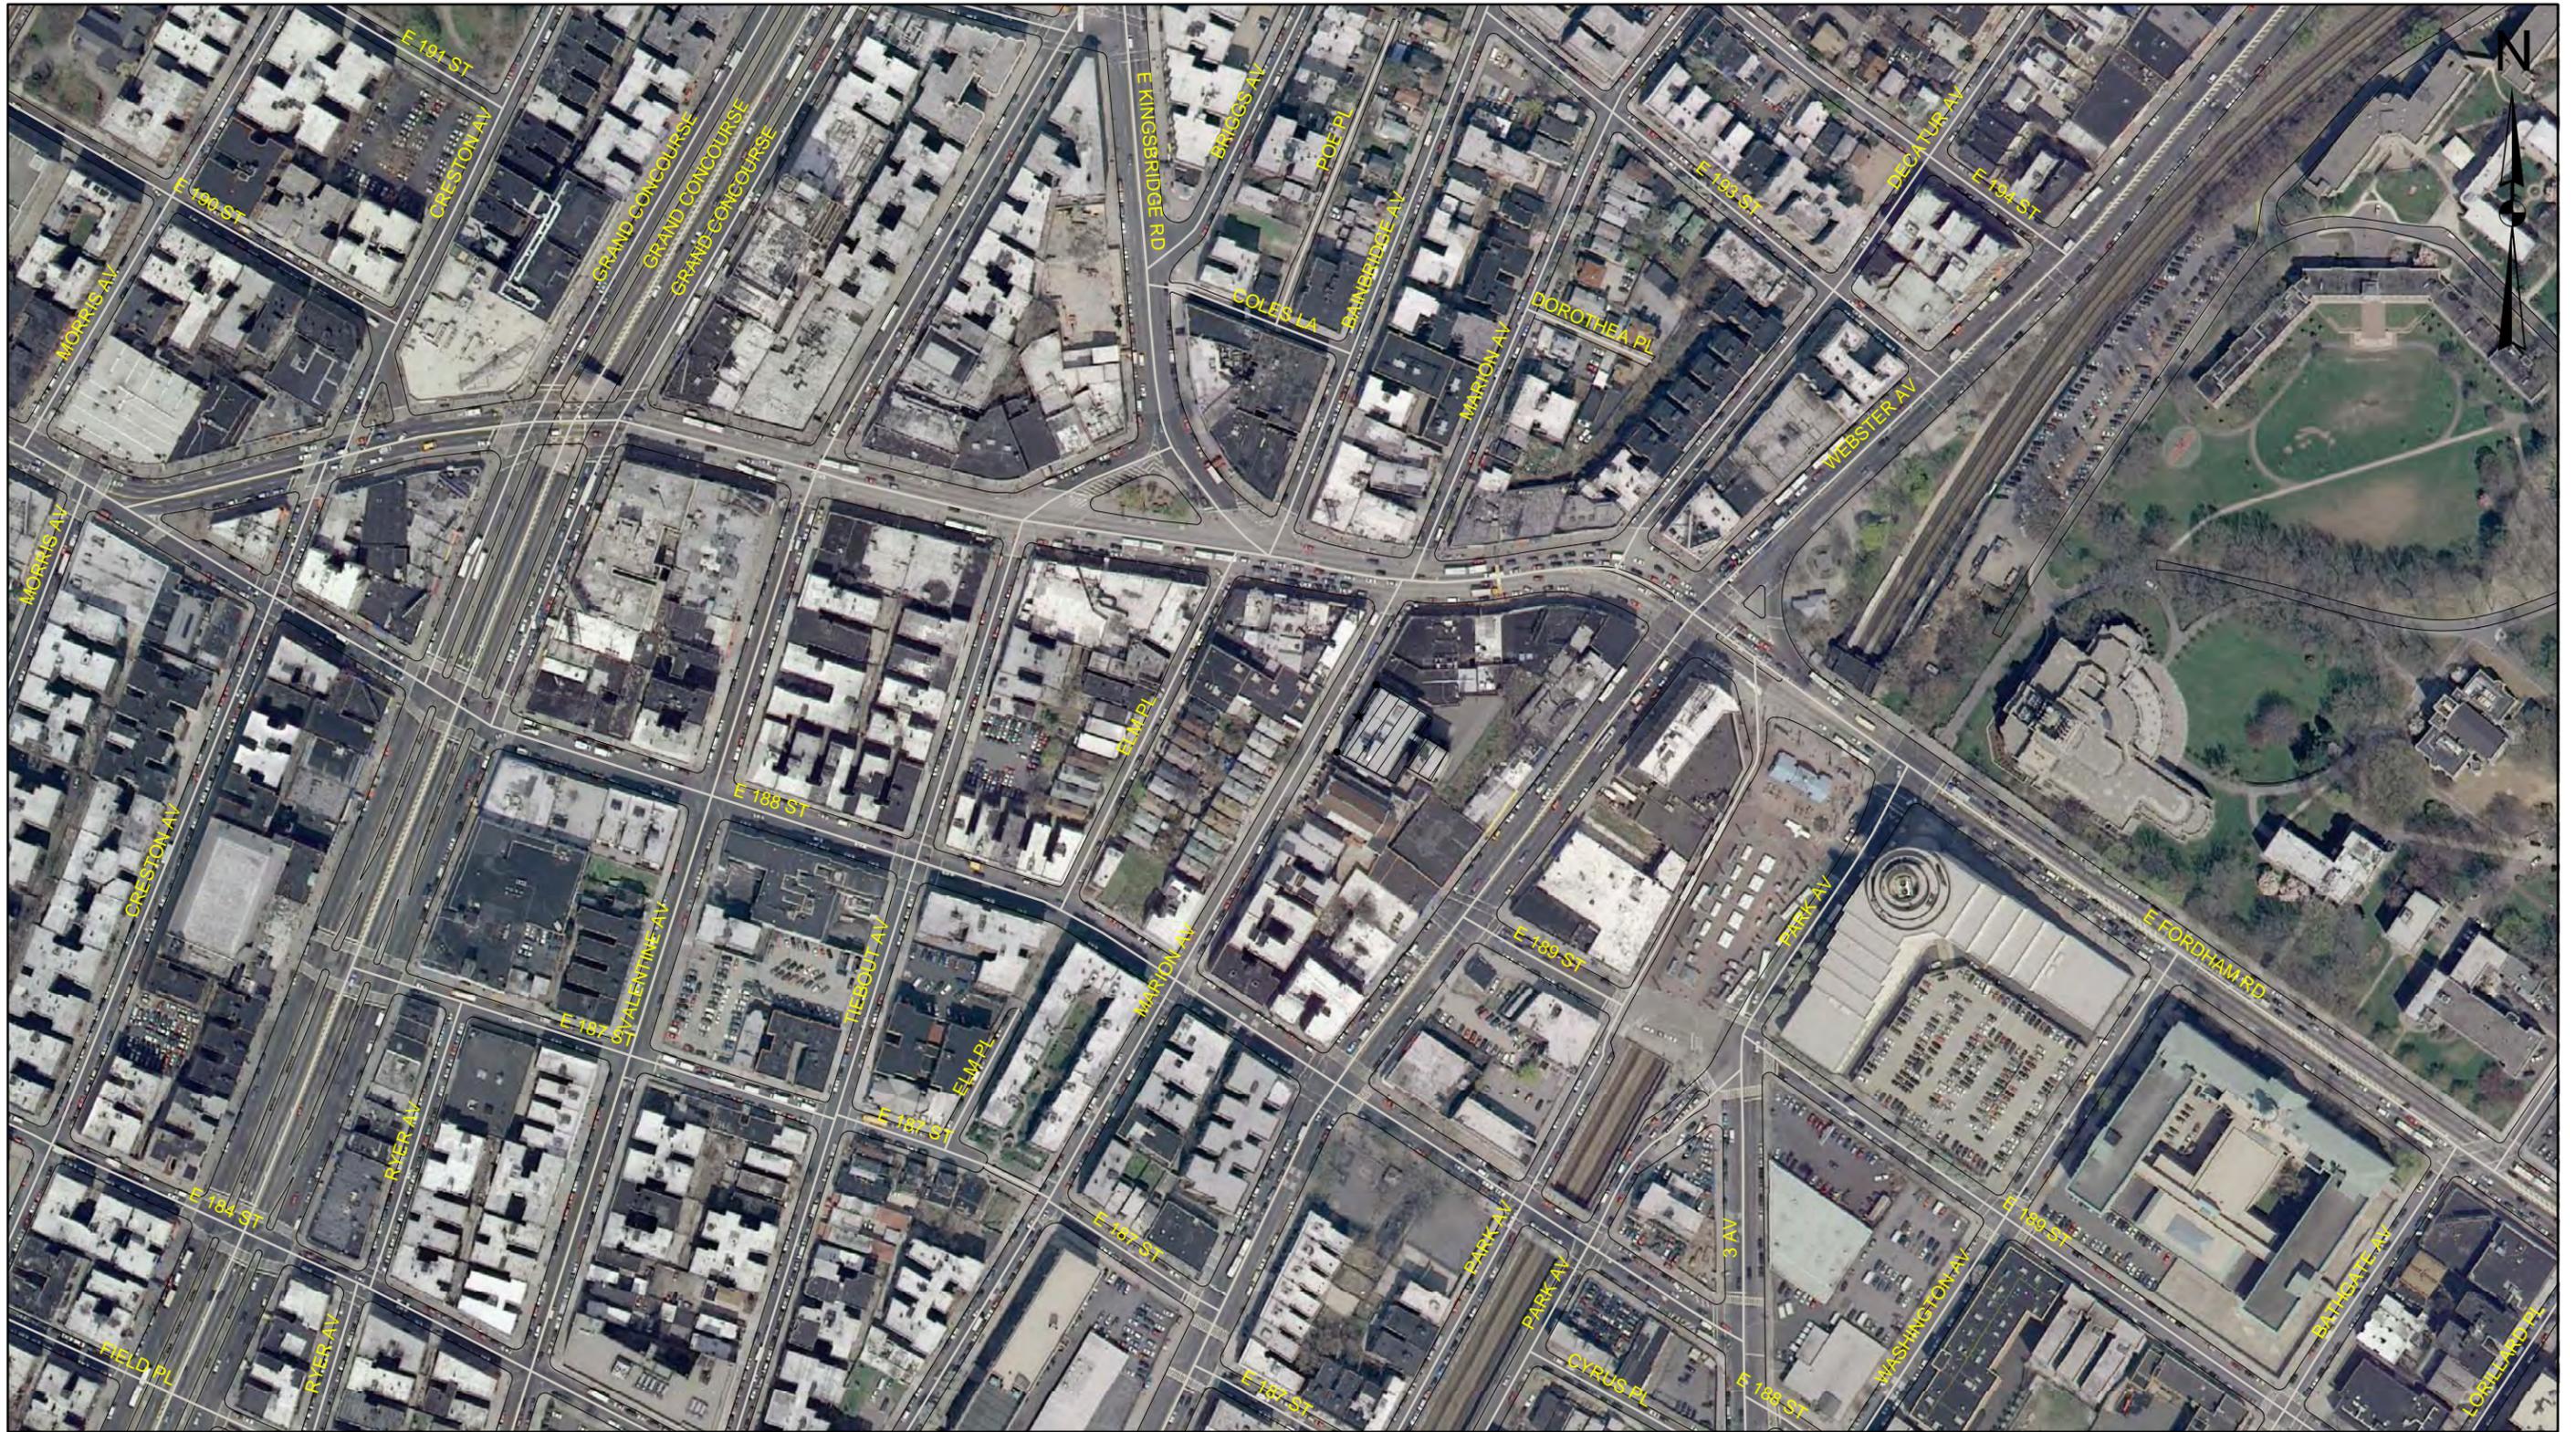
EXHIBIT 1

Exhibit 1 shows an aerial view of the neighborhood surrounding the school. Our Lady of Mercy School is bounded by East Fordham Road to the north, East 188th Street to the south, Webster Avenue to the east, and Marion Avenue to the west. The area surrounding the school is generally residential in character with primarily high-density, multi-level apartment buildings. However, Webster Avenue and East Fordham Road are major commercial corridors with significant vehicle and pedestrian traffic. Commercial activities are also found on East Kingsbridge Road, one block to the north of Our Lady of Mercy School. In addition, the Grand Concourse is a major commercial corridor located four blocks to the west of Our Lady of Mercy School. Fordham University and Rose Hill Park are situated north of East Fordham Road and east of Webster Avenue.

OUR LADY OF MERCY SCHOOL BRONX

AERIAL PHOTOGRAPH

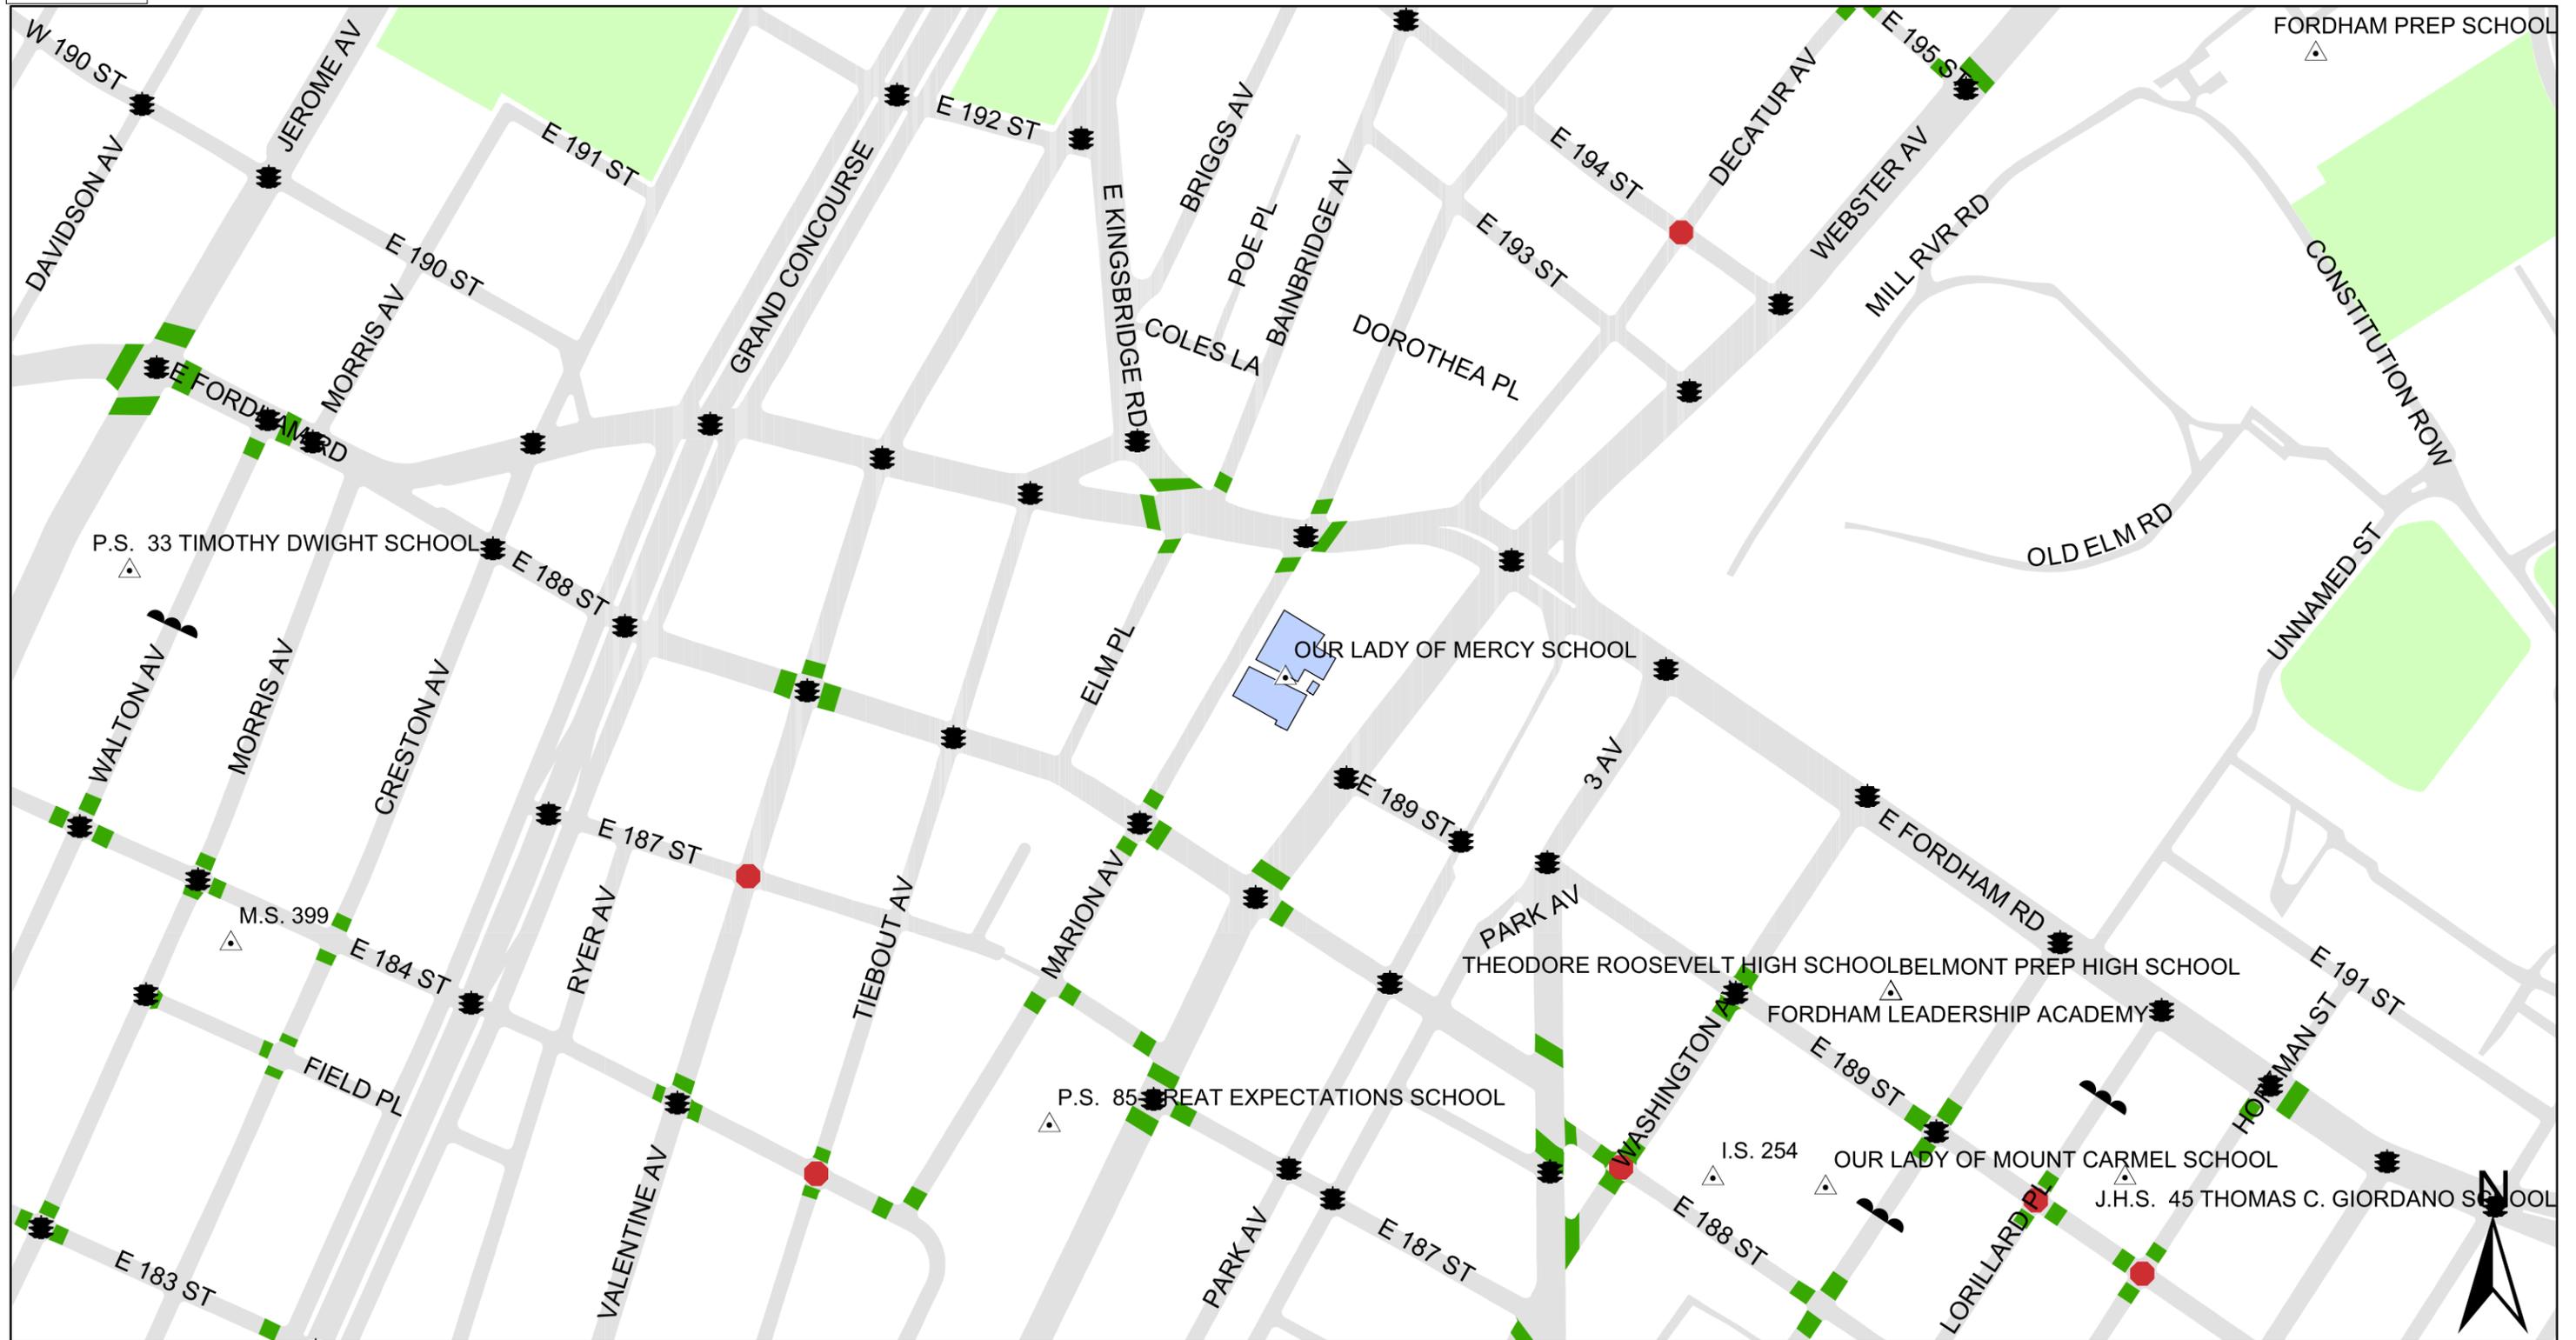
EXHIBIT 2

The School Traffic Safety Map was established to help provide the maximum degree of safety for children going to and from school - by indicating the location of speed reducers, school crosswalks and some traffic control devices. (While virtually all intersections in NYC benefit from traffic control devices - such as stop signs, traffic signals, yield signs, and all way stop signs - this map shows only traffic signals and all way stop signs.) The school crosswalks that are shown are ladder striped and make the crosswalk more visible to drivers and help make the intersection safer. These crosswalks are where school children are recommended to cross.

Exhibit 2 shows the existing school signals and pavement markings around Our Lady of Mercy School. It should be noted that a citywide signage program is currently underway to upgrade school signage to current Federal Manual on Uniform Traffic Control Devices (MUTCD) standards of fluorescent yellow-green signs accompanied by downward pointing arrows. Signs scheduled to be installed under this program are shown as “existing” in Exhibit 6.

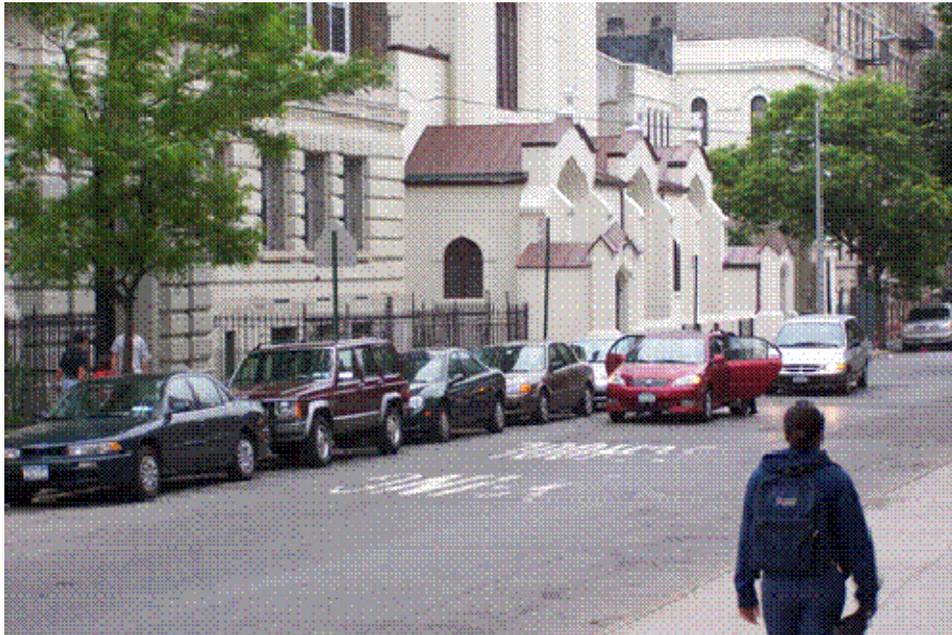
According to school's principal, approximately ten percent of the students are being dropped off in the morning.

Figure 3: Looking south at student drop-off on Marion Avenue

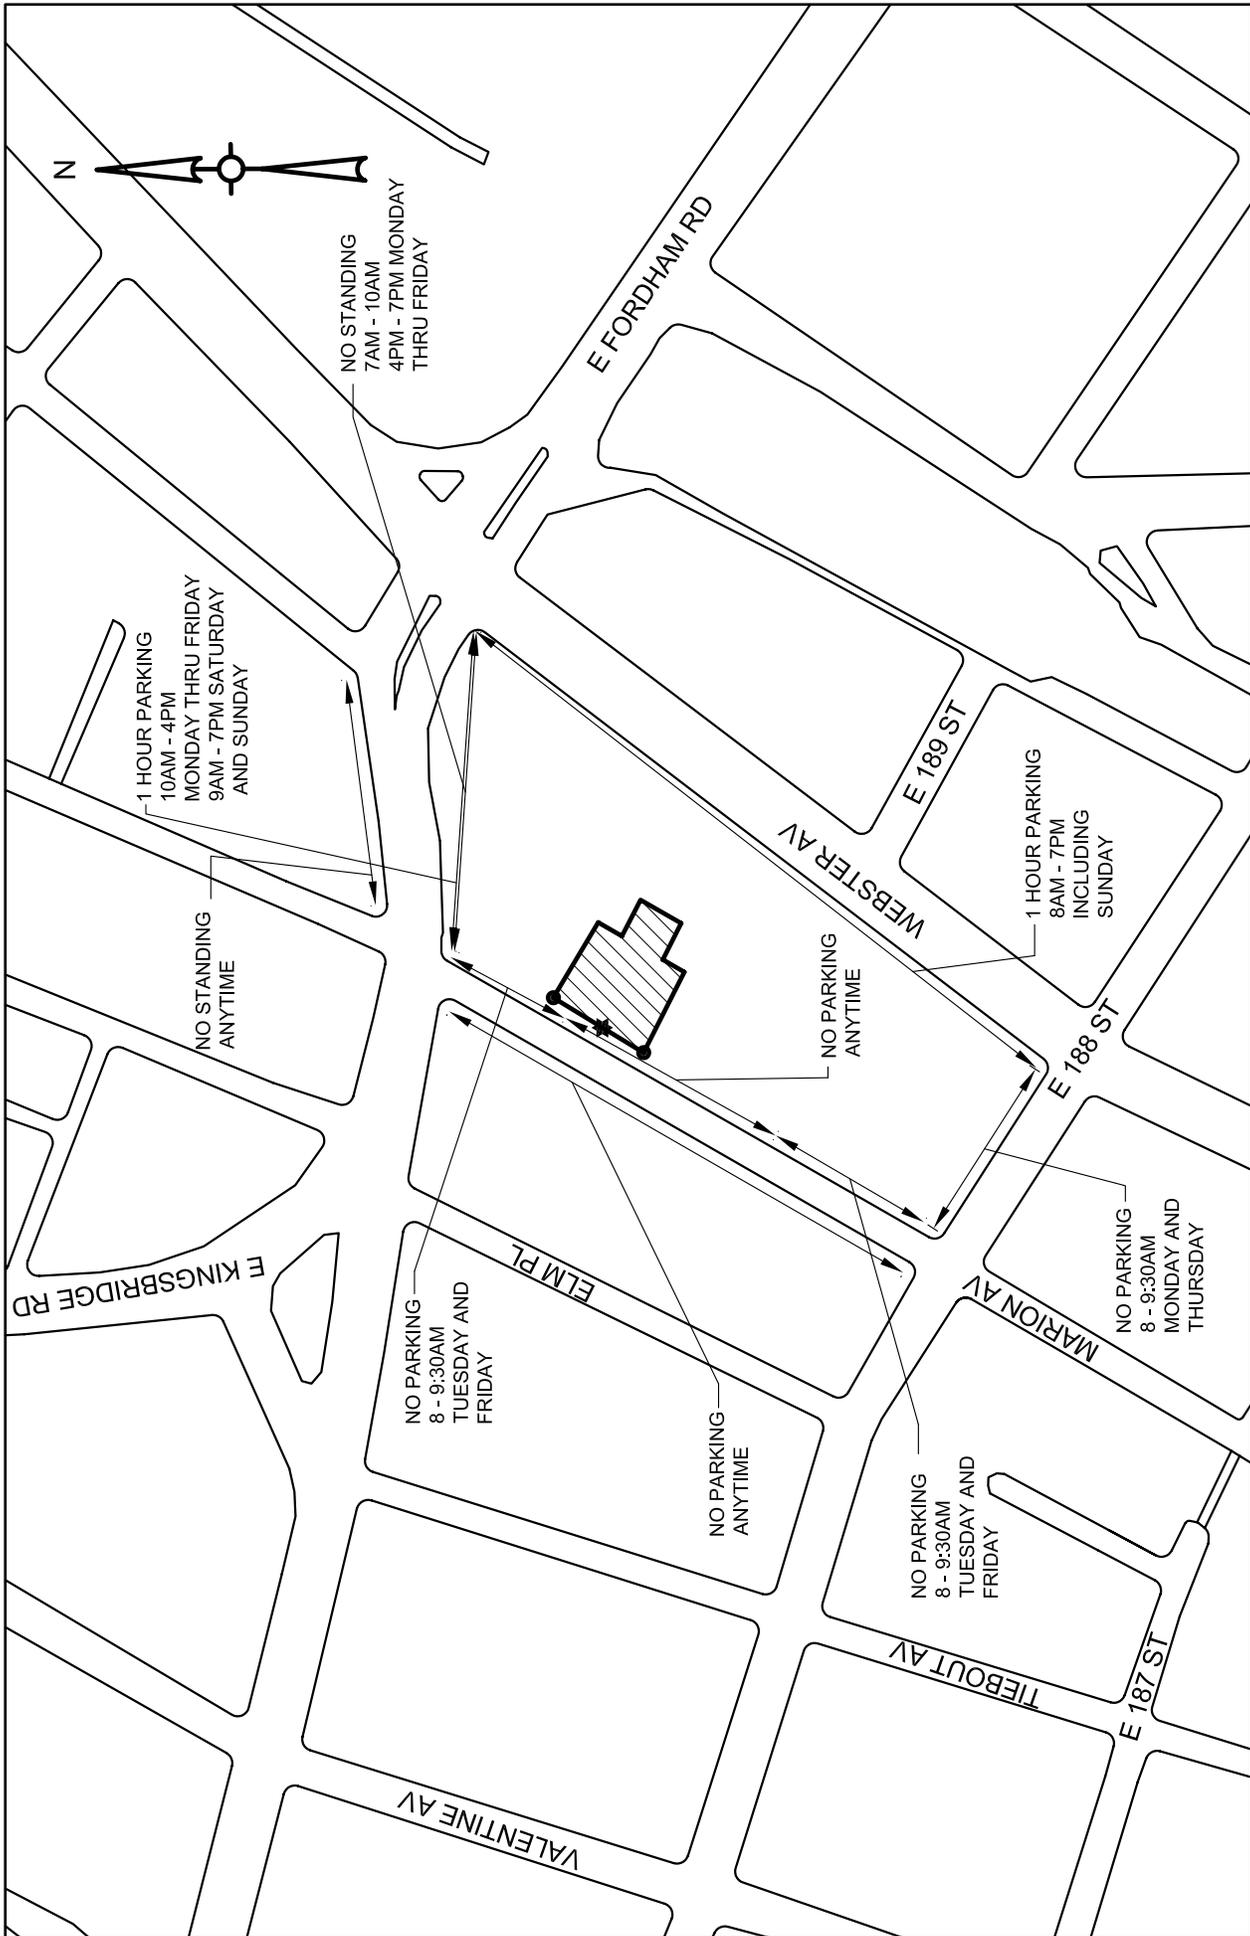
EXHIBIT 4

Parking regulations around the school block-faces are shown in Exhibit 4 at this section.

OUR LADY OF MERCY SCHOOL BRONX
EXISTING PARKING REGULATIONS

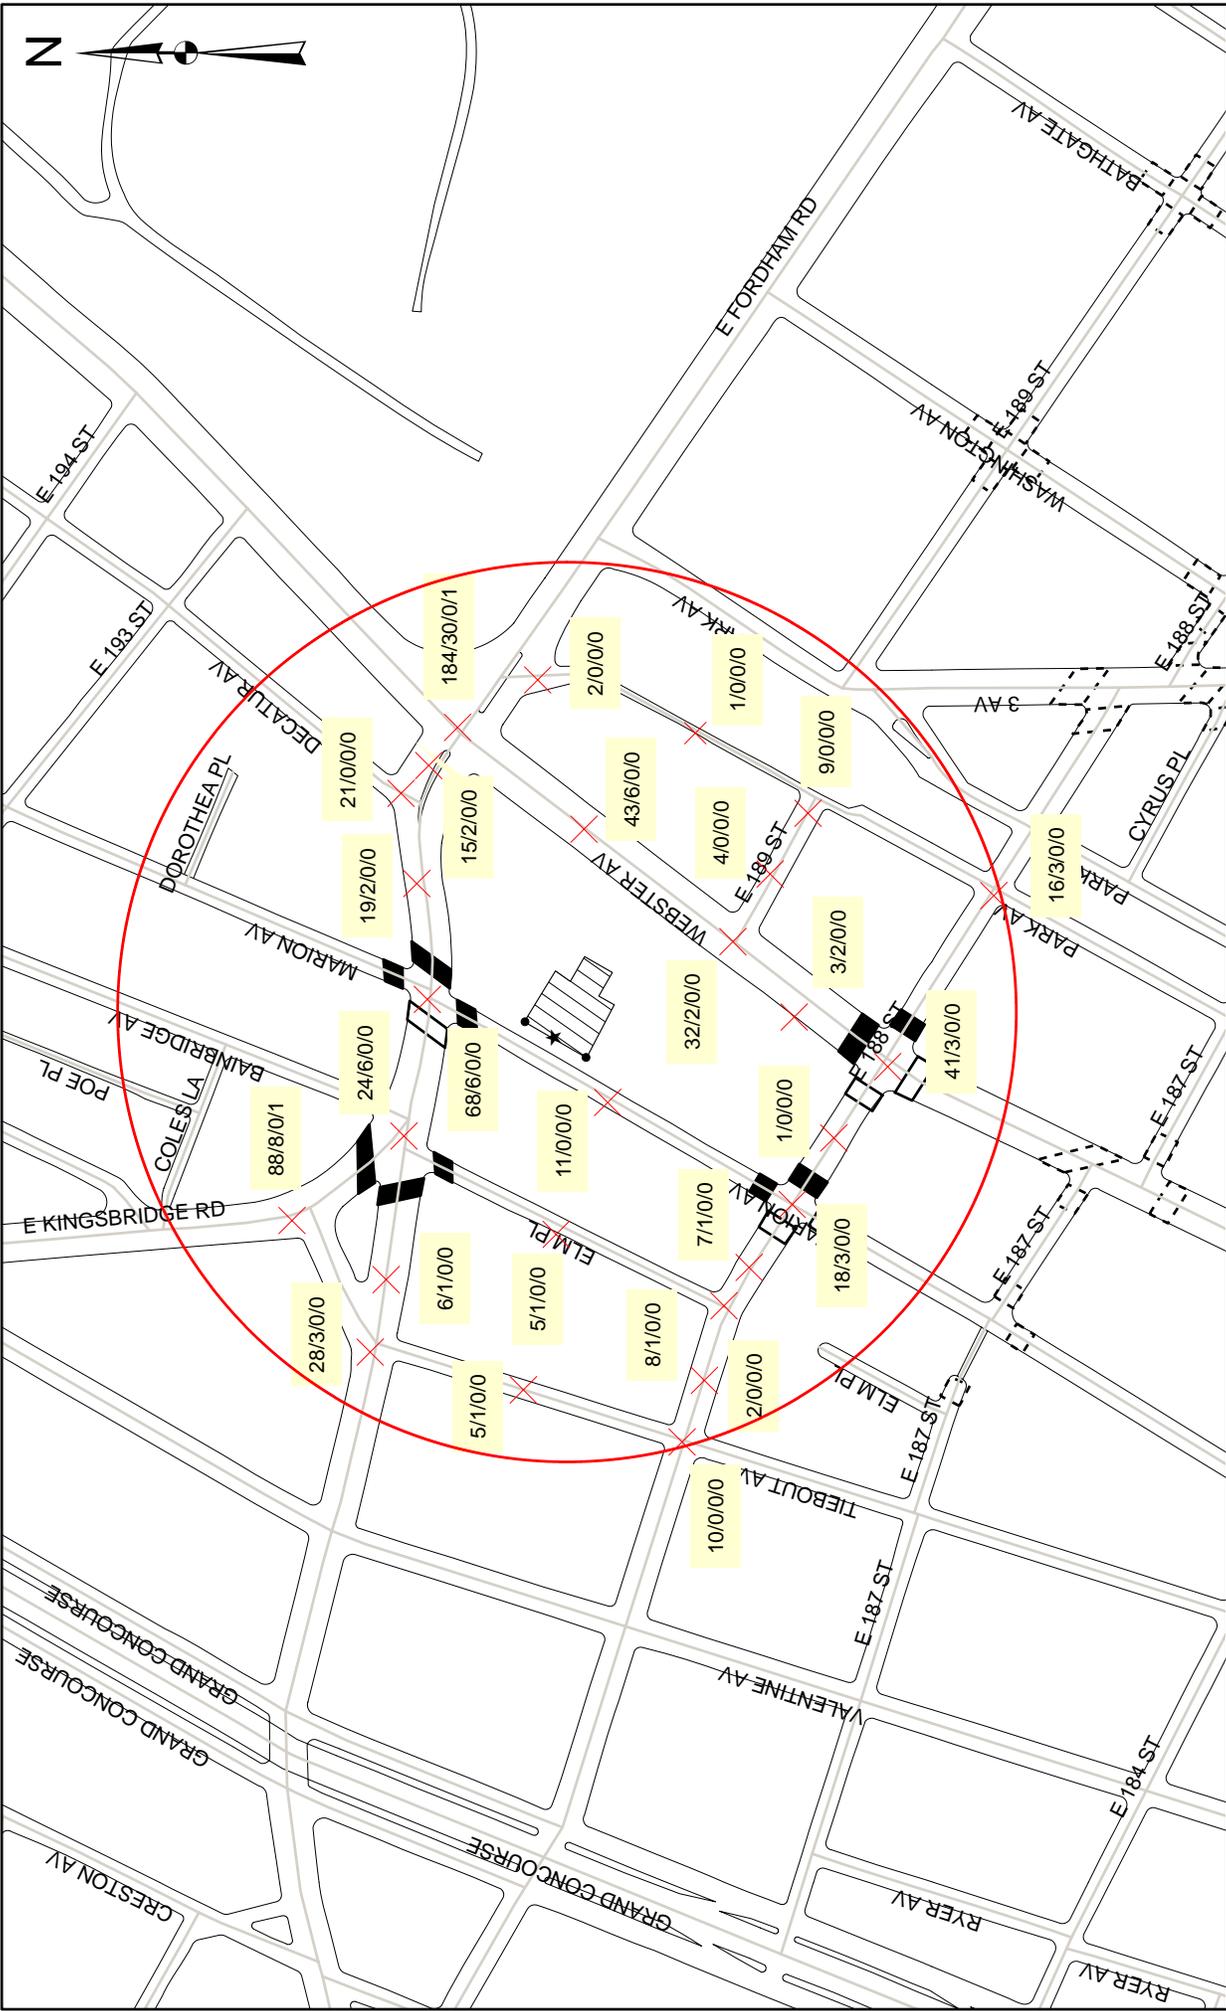
EXHIBIT 5

Exhibit 5 and Table 2 show a summary of accidents, as obtained from the New York State Department of Motor Vehicles (DMV), in the vicinity of Our Lady of Mercy School for the three-year period from January 1, 1998 through December 31, 2000. The DMV data provides some detail relating to the circumstances and cause of the accident. Table 3 is a summary of more recent accident data obtained from the NYC Police Department (NYPD). Though current through 2004, the NYPD data does not provide the same level of detail as the DMV data.

ACCIDENT SUMMARY (1998-2000)

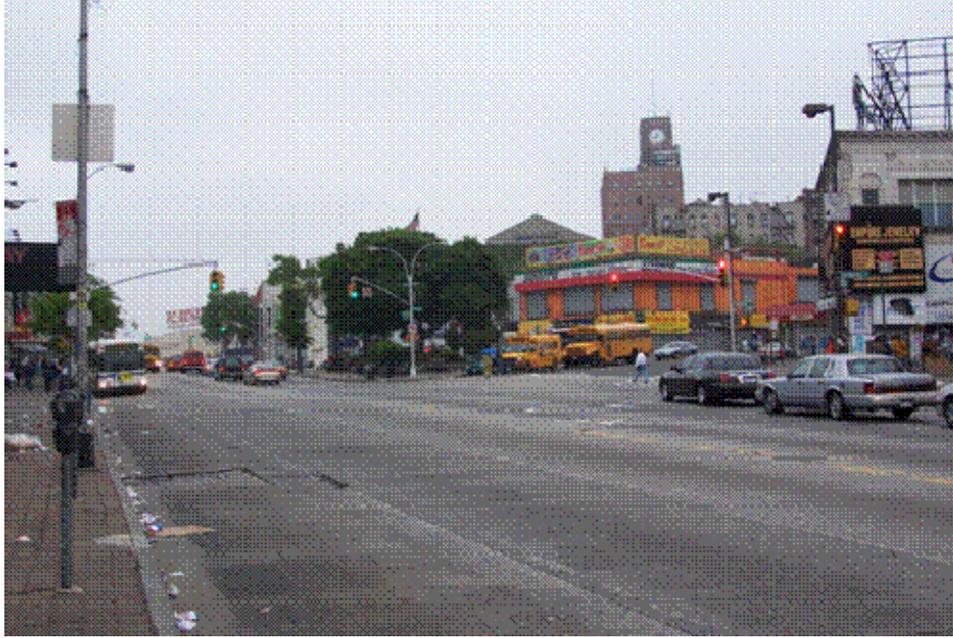
This is a five-leg signalized intersection. All the crosswalks at this intersection are constructed with brick-pavers. However, the School Traffic Safety Map shows the north, south, and west legs of the intersection as school crosswalks (see Figure 4). East Fordham Road is a major, east-west corridor in the Bronx. In the vicinity of Our Lady of Mercy School, East Fordham Road has three travel lanes during the morning (7:00 am to 10:00 am) and afternoon (4:00 pm to 7:00 pm) peak periods with a curb lane designated as a bus lane on both sides of the street. One hour muni-meter parking is permitted on East Fordham Road between 10:00 am and 4:00 pm. However parking is not permitted along the north curb of East Fordham Road between Marion Avenue and Bainbridge Avenue. East Kingsbridge is a two-way street with one travel lane in each direction and parking permitted on both sides of the street. Bainbridge Avenue, north of East Fordham Road, is a one-way northbound street with one travel lane and on-street parking permitted on both sides of the roadway. Elm Place, south of East Fordham Road, is a one-way southbound street with one travel and parking permitted on both sides of the street

There were 112 accidents reported at this intersection between 1998 and 2000 (Table 2), 14 of which were pedestrian accidents including one school-related accident. The school-related accident occurred on Wednesday, October 14, 1998 at approximately 3:00 pm, and involved a 12-year-old pedestrian who was crossing the street against the signal. The pedestrian suffered an incapacitating injury. The accident occurred at the curved roadway section under daylight conditions. At the time of accident, the roadway surface was dry and the weather was clear. There were no pedestrian fatalities reported at this intersection during the same three-year period.

Figure 4: Looking northwest across East Fordham Road at its intersection with East Kingsbridge Road

- Westbound approach of East Fordham Road at East Kingsbridge Road.

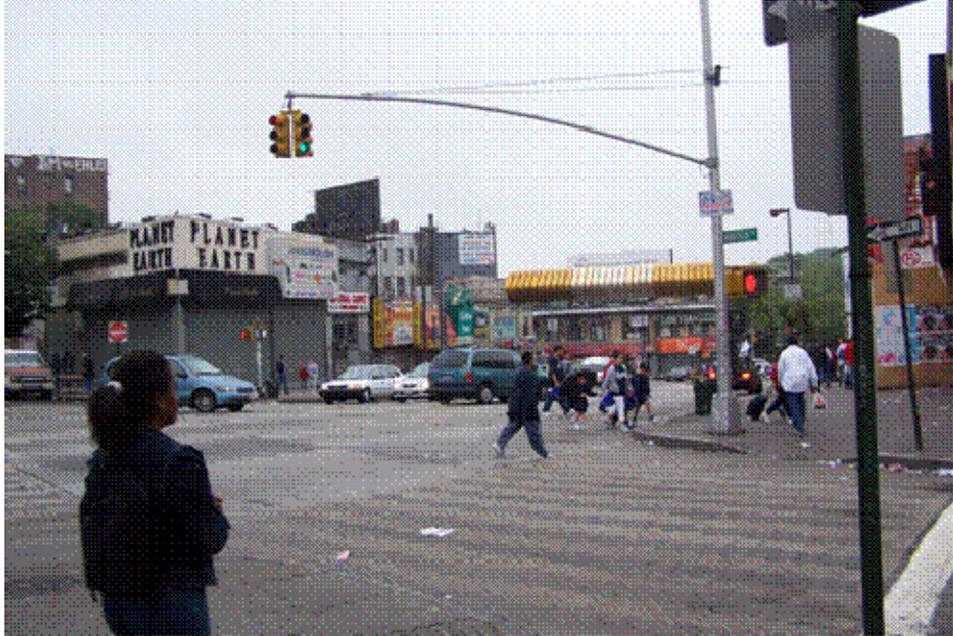
This is a four-leg signalized intersection. All the crosswalks at this intersection are constructed with brick-pavers. However, the School Traffic Safety Map shows the north, south, and east legs of the intersection as school crosswalks (see Figures 5 and 6). In the vicinity of Our Lady of Mercy School, East Fordham Road provides three travel lanes in each direction during the morning (7:00 am to 10:00 am) and afternoon (4:00 pm to 7:00 pm) peak periods. The curb lane on both sides of East Fordham Road is designated as a bus lane during the morning and afternoon peak periods. On-street muni-meter parking is permitted on both sides of East Fordham Road between 10:00 am and 4:00 pm. Marion Avenue, south of East Fordham Road, is a one-way northbound street and wide enough to provide two travel lanes and on-street parking on the east side of the roadway. Marion

There were 68 accidents reported at this intersection between 1998 and 2000 (Table 2), including six pedestrian accidents, none of which were school-related. There were no pedestrian fatalities reported at this intersection.

Figure 5: Looking northeast across Marion Avenue and the East Fordham Road intersection

- Provide a channelized blockbuster type of treatment at the East Fordham Road and Marion Avenue intersection, as shown in Exhibit 6.

- Reconstruct the pedestrian ramps on the southwest and the southeast corners of the East Fordham Road and Marion Avenue intersection.

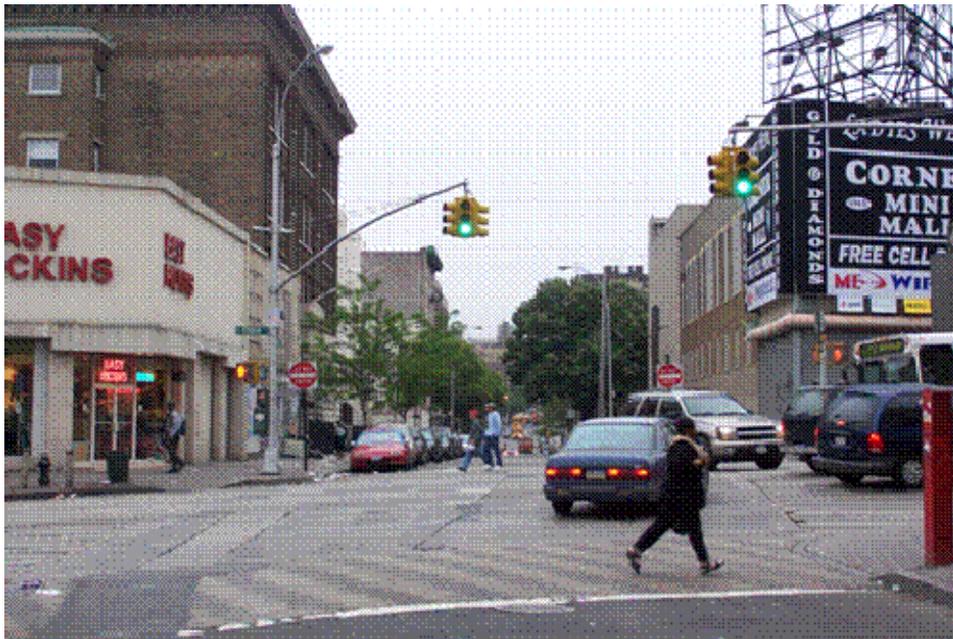
Figure 6: Looking north across East Fordham Road at the Marion Avenue intersection

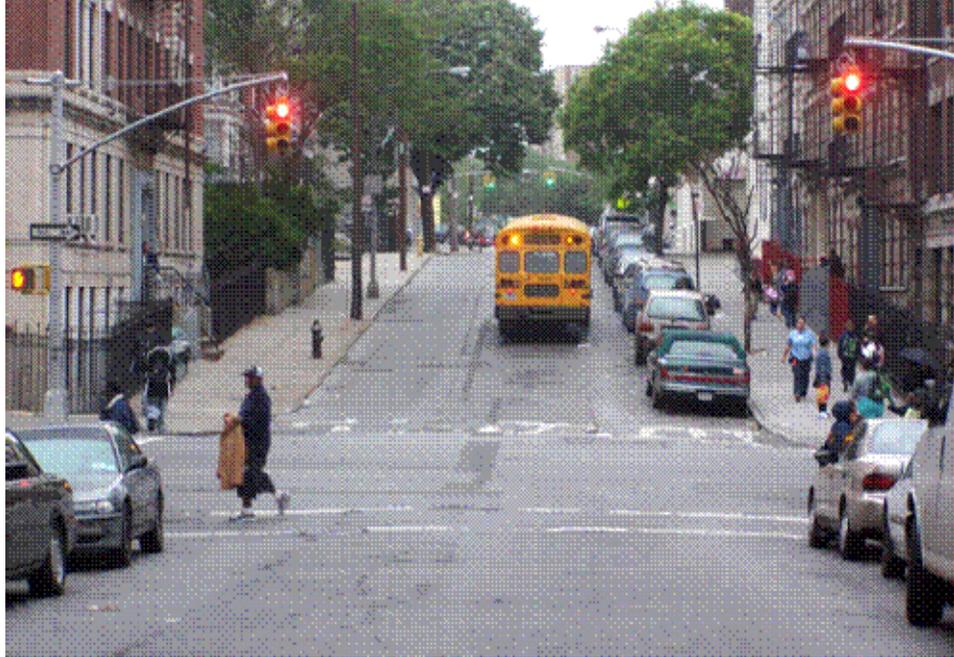
This is a four-leg signalized intersection with school crosswalks located across the north and east legs. East 188th Street is a one-way eastbound street with no lane markings, and on-street parking permitted on both sides of the roadway. During the field visit, three lanes were observed to be formed on East 188th Street approaching Marion Avenue. Marion Avenue, south of East 188th Street is a two-way roadway with one travel lane and an on-street parking lane on each side of the roadway. North of East 188th Street, Marion Avenue is a one-way northbound street and on-street parking permitted only on the east side of the roadway. Marion Avenue has no lane markings, but is wide enough to provide two travel lanes (see Figures 7 and 8).

Figure 7: Looking north on Marion Avenue toward the intersection with East 188th Street

- Provide pavement markings on East 188th Street between the eastbound approach to Valentine Avenue and the eastbound approach of Park Avenue as shown in Exhibit 6.

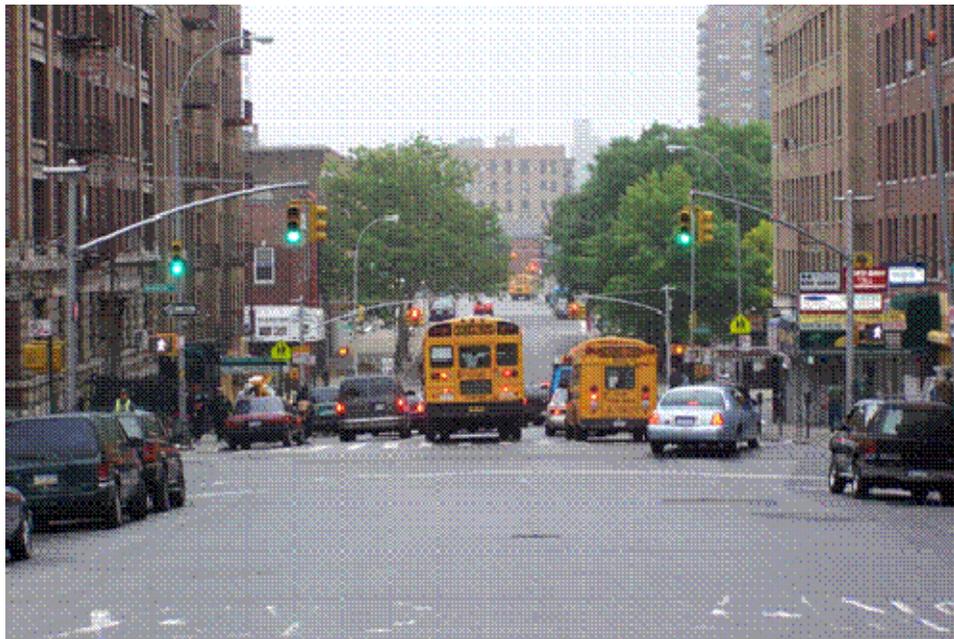
Figure 8: Looking east along East 188th Street toward the intersection with Marion Avenue

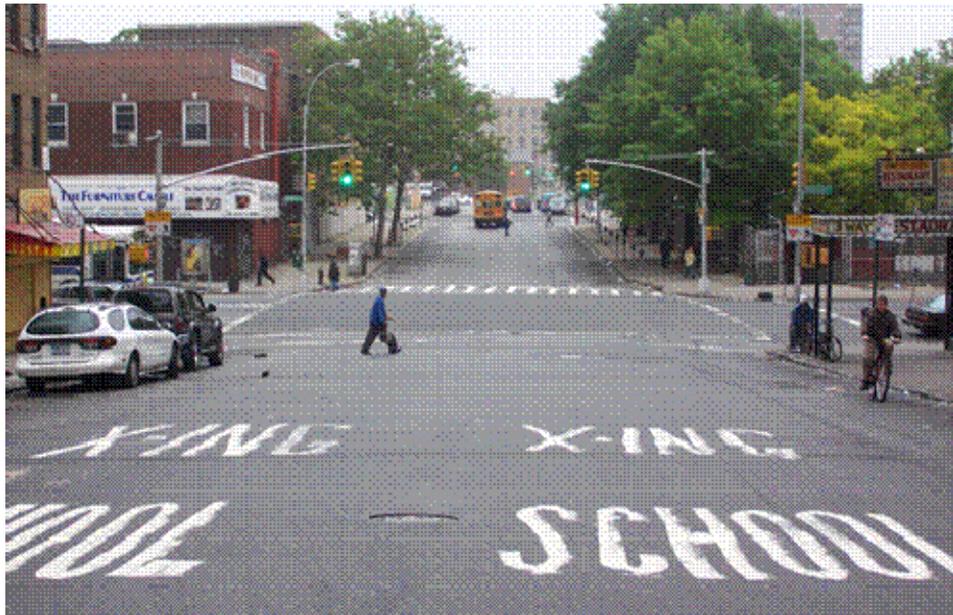
This is a four-leg signalized intersection with school crosswalks located across the north and east legs. East 188th Street is a one-way eastbound street with no lane markings. However, during the field visit, three lanes were observed to be formed on East 188th Street approaching Webster Avenue. On-street parking is permitted on both sides of East 188th Street. Webster Avenue is a two-way north-south street with two travel lanes and

on-street metered parking on both sides of the roadway. The southbound approach of Webster Avenue also provides an exclusive left-turn lane (bay). Webster Avenue is a designated local truck route (see Figures 9 and 10).

Figure 9: Looking east along East 188th Street toward the Webster Avenue intersection

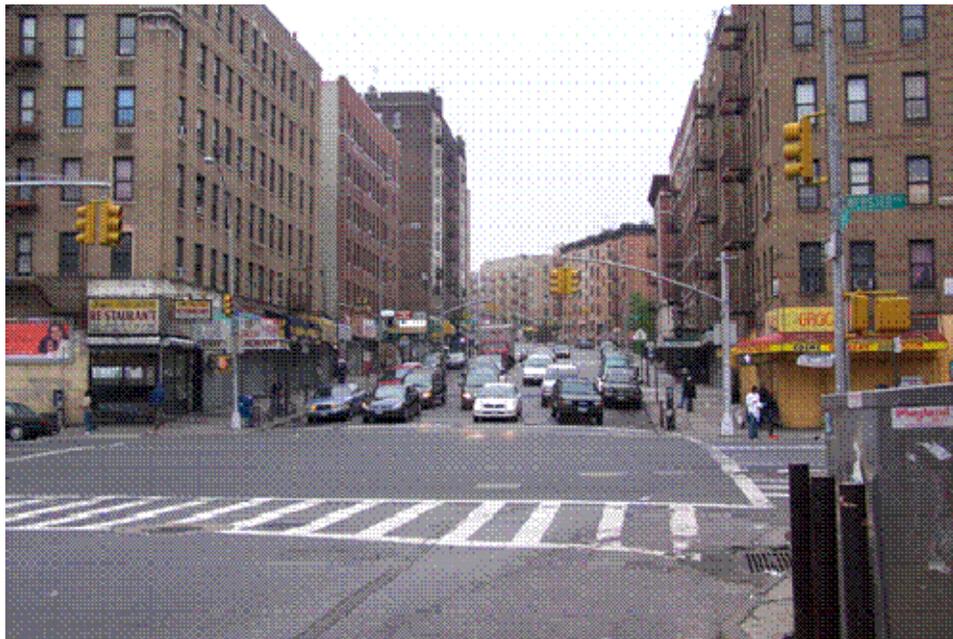
Figure 10: Looking west along East 188th Street toward the Webster Avenue intersection
