**New York City Department of Transportation
Office of School Safety Engineering**

School Safety Engineering Project

FINAL REPORT: Our Lady of Mercy, Bronx

**Prepared by
The RBA Group and URBITRAN Associates Inc.**

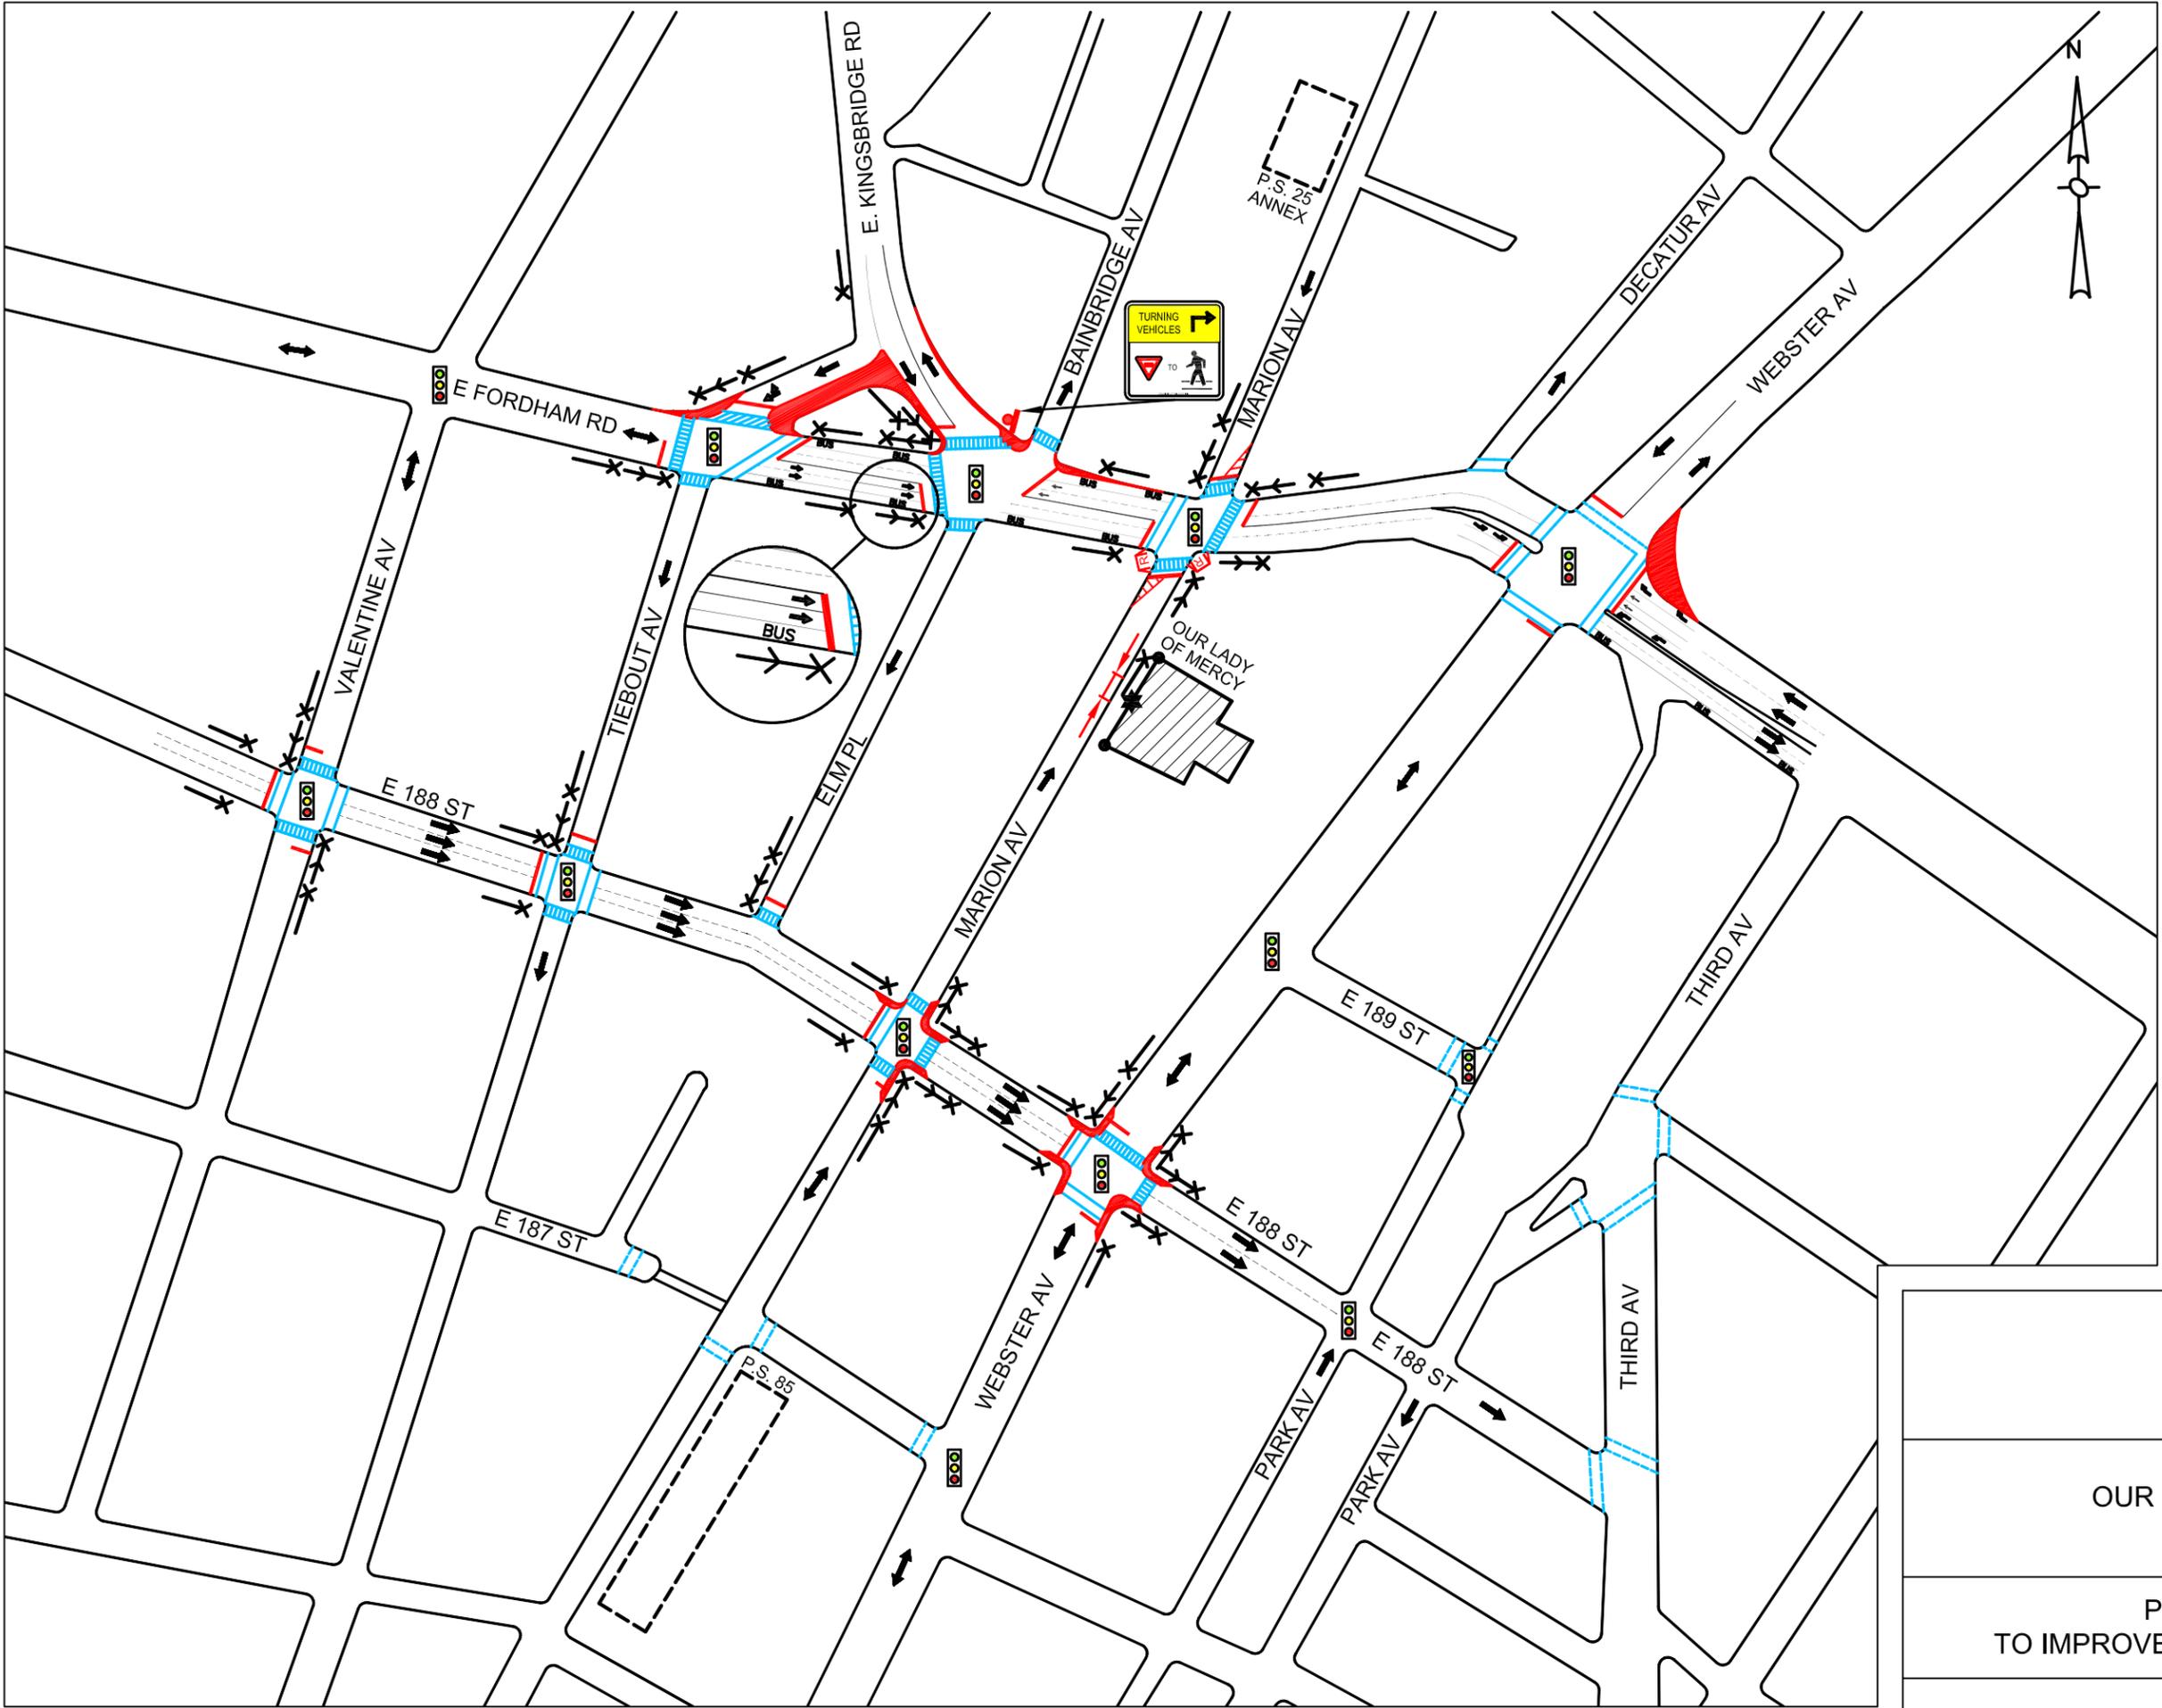
EXHIBIT 6

POTENTIAL MEASURES
TO IMPROVE STUDENT PEDESTRIAN SAFETY

This section describes the proposed measures to improve school pedestrian safety around Our Lady of Mercy School. The proposed recommendations are divided into short-term and long-term measures. Short-term measures are those that potentially can be performed in-house. Long-term measures involve capital improvements. Each of the short- and long-term measures recommended for Our Lady of Mercy School is discussed as follows, and is shown in more detail in Exhibit 6 at the end of this section.

The MUTCD and New York City DOT standard for placement of a stop bar is four feet in advance of a marked crosswalk. At signalized (or stop controlled) crosswalks, the vehicle stop line can be placed farther back from the crosswalk in order to maximize visibility of pedestrians and to minimize the potential for pedestrian/vehicle conflicts. Therefore, it is recommended that stop bars be placed ten feet in advance of all school crosswalks, as shown in Exhibit 6.

- Provide pavement markings on East 188th Street between the eastbound approach to Valentine Avenue and the eastbound approach of Park Avenue as shown in Exhibit 6.

- Provide a channelized blockbuster type of treatment at the East Fordham Road and Marion Avenue intersection, as shown in Exhibit 6.

- Provide curb extensions on the northeast, southeast, and northwest corners of the Marion Avenue and East 188th Street intersection, as shown in Exhibit 6.
- Provide curb extensions on all four corners of the Webster Avenue and East 188th Street intersection, as shown in Exhibit 6.

- Change the painted areas to raised concrete areas by extending the sidewalks on the triangular island, as shown in Exhibit 6.
- Provide a curb extension on the northwest corner of the East Fordham Road and East Kingsbridge Road/Tiebout Avenue intersection.
