School Safety Engineering Project

FINAL REPORT: P.S. 7, M. Samuel Stern School, Manhattan

**Prepared by
The RBA Group/Urbitrans Associates**

JUNE 8, 2006

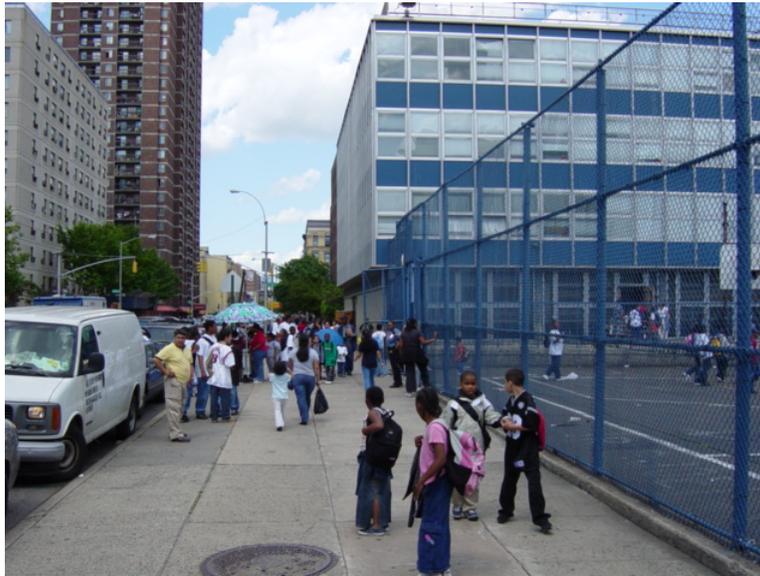
Figure 1: Lexington Avenue south of P.S. 7 (looking north)

The surrounding land uses are primarily residential high-rise buildings on Lexington Avenue, commercial properties on East 119th Street and East 120th Street and three to four story residential buildings, with first floor commercial properties along Third Avenue.

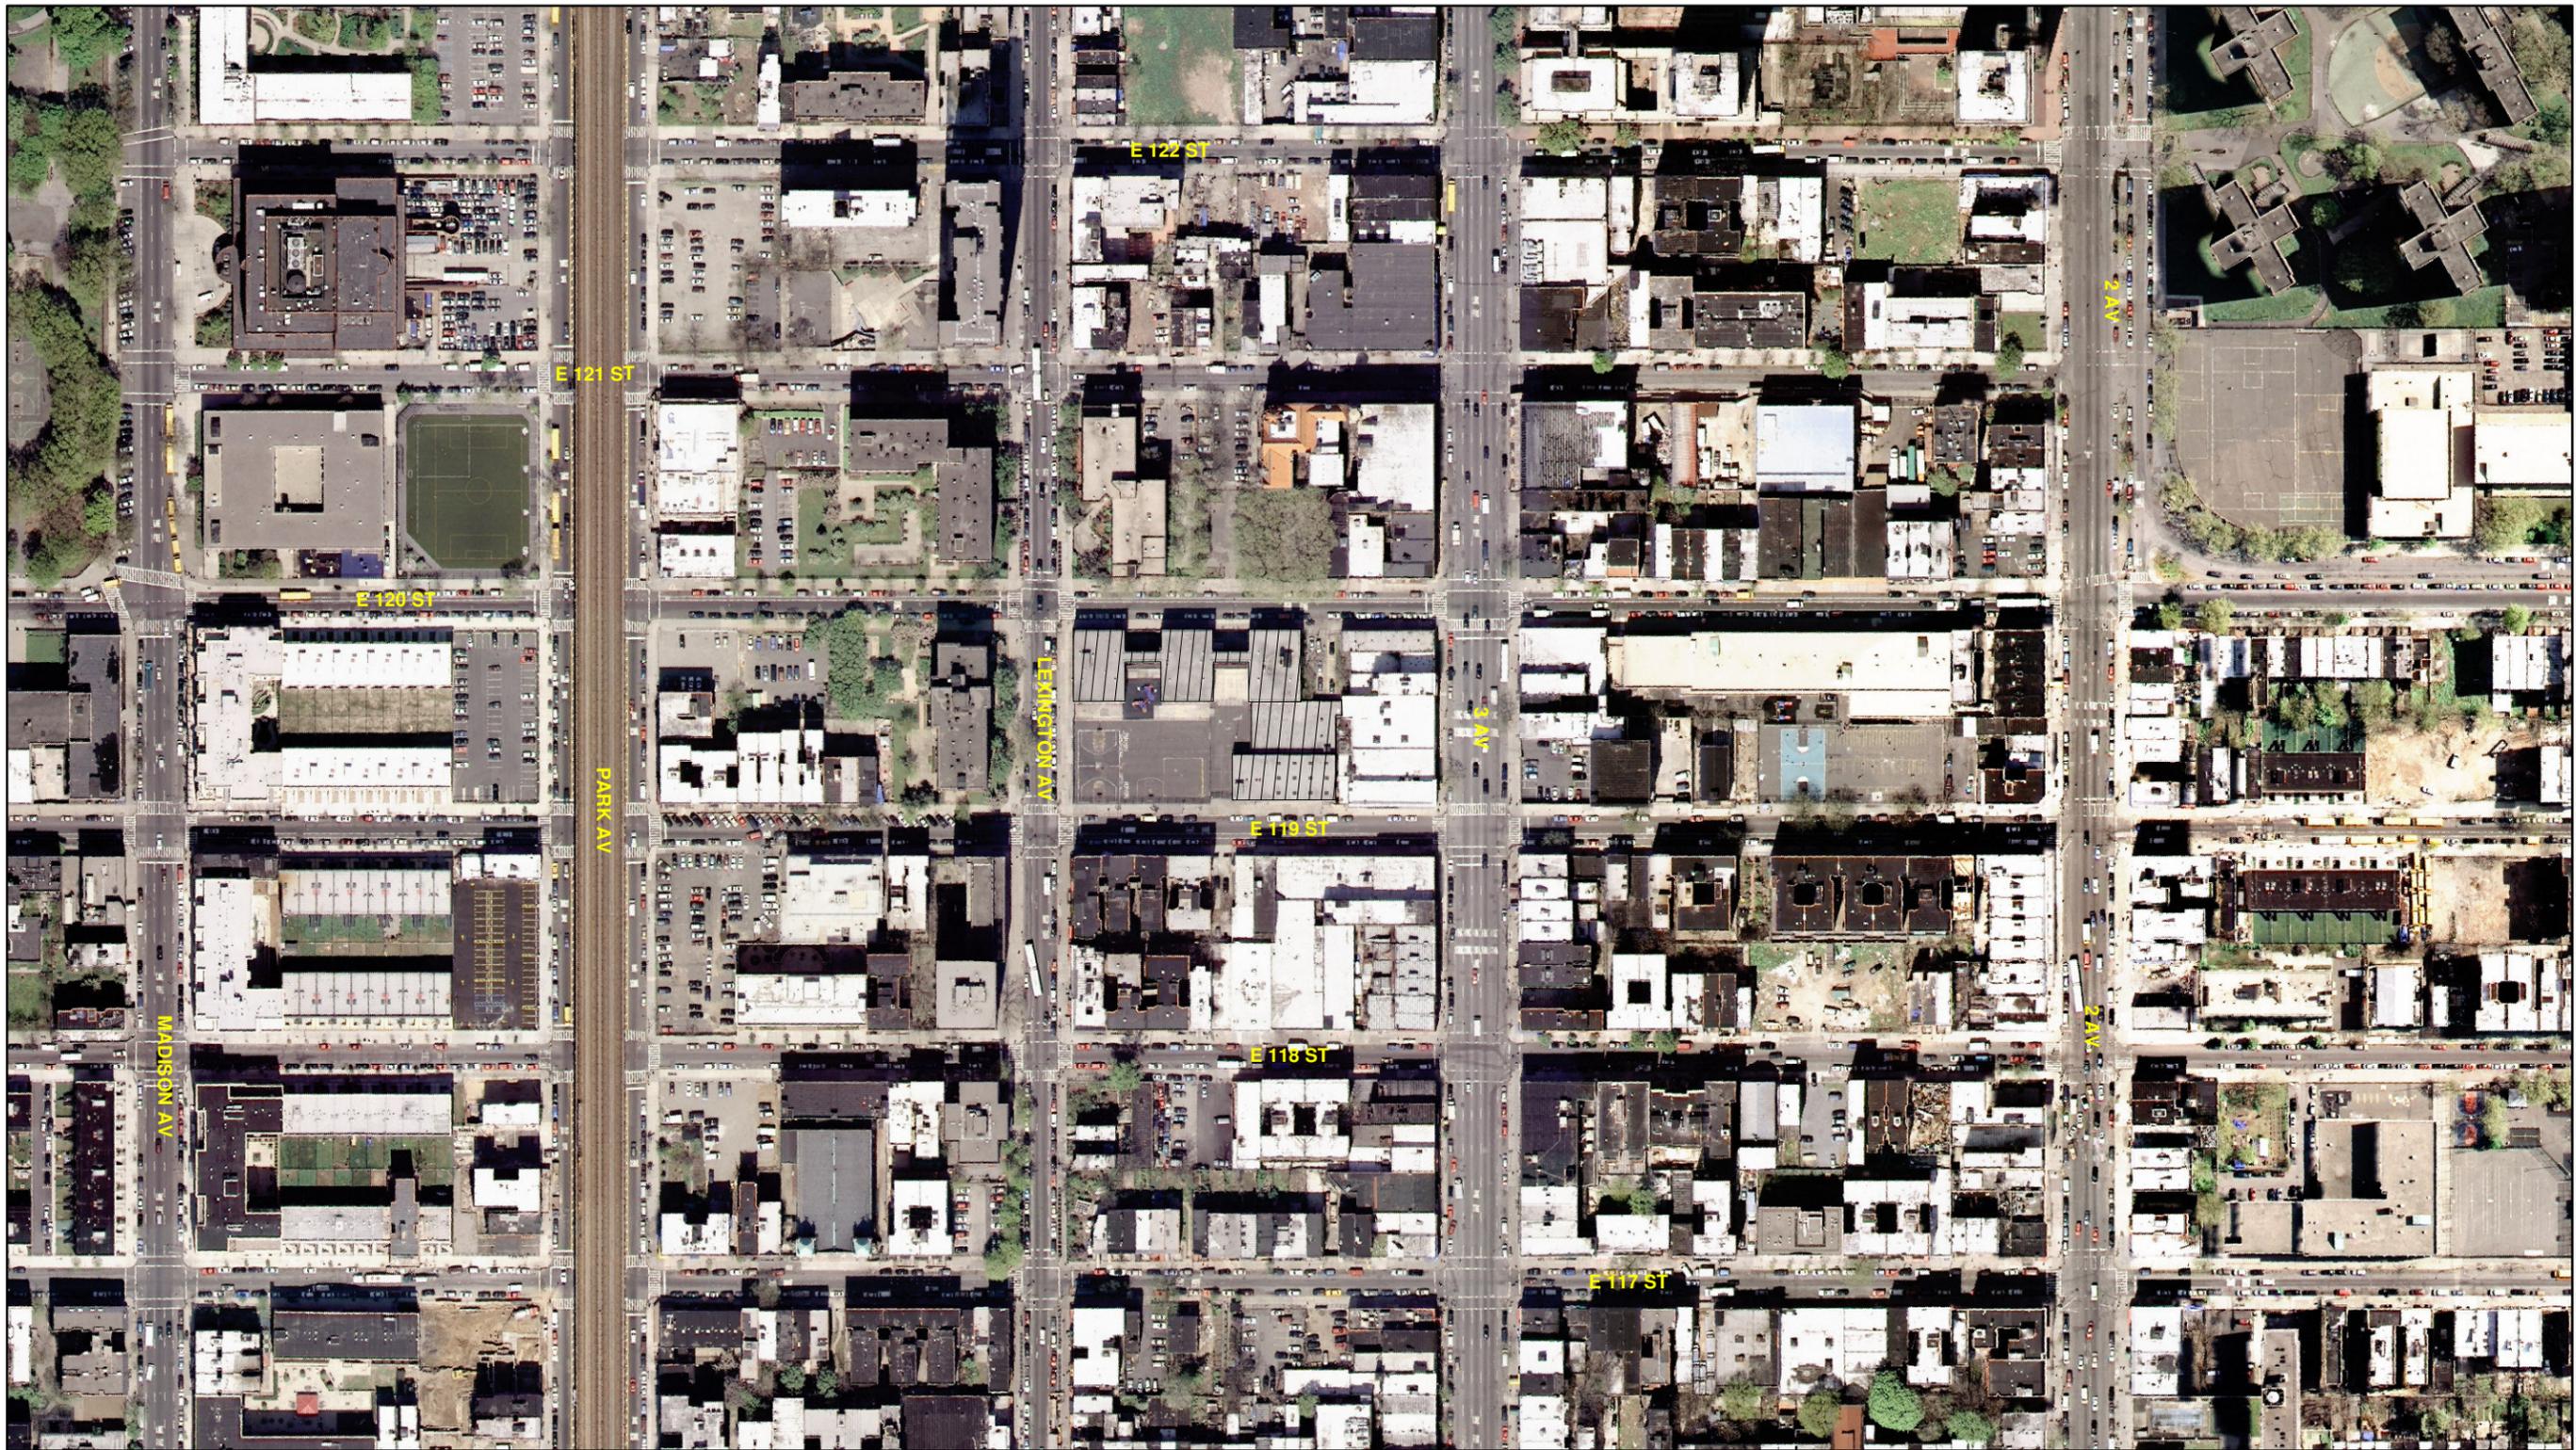
EXHIBIT 1
M. SAMUEL STERN SCHOOL
P.S. 7, MANHATTAN
AERIAL PHOTOGRAPH

Located at 160 East 120th Street in Manhattan, P.S. 7 is situated between Lexington Avenue and Third Avenue and spans from East 119th Street to East 120th Street. All four surrounding intersections are signalized (see Exhibit 1 for Aerial Photograph).

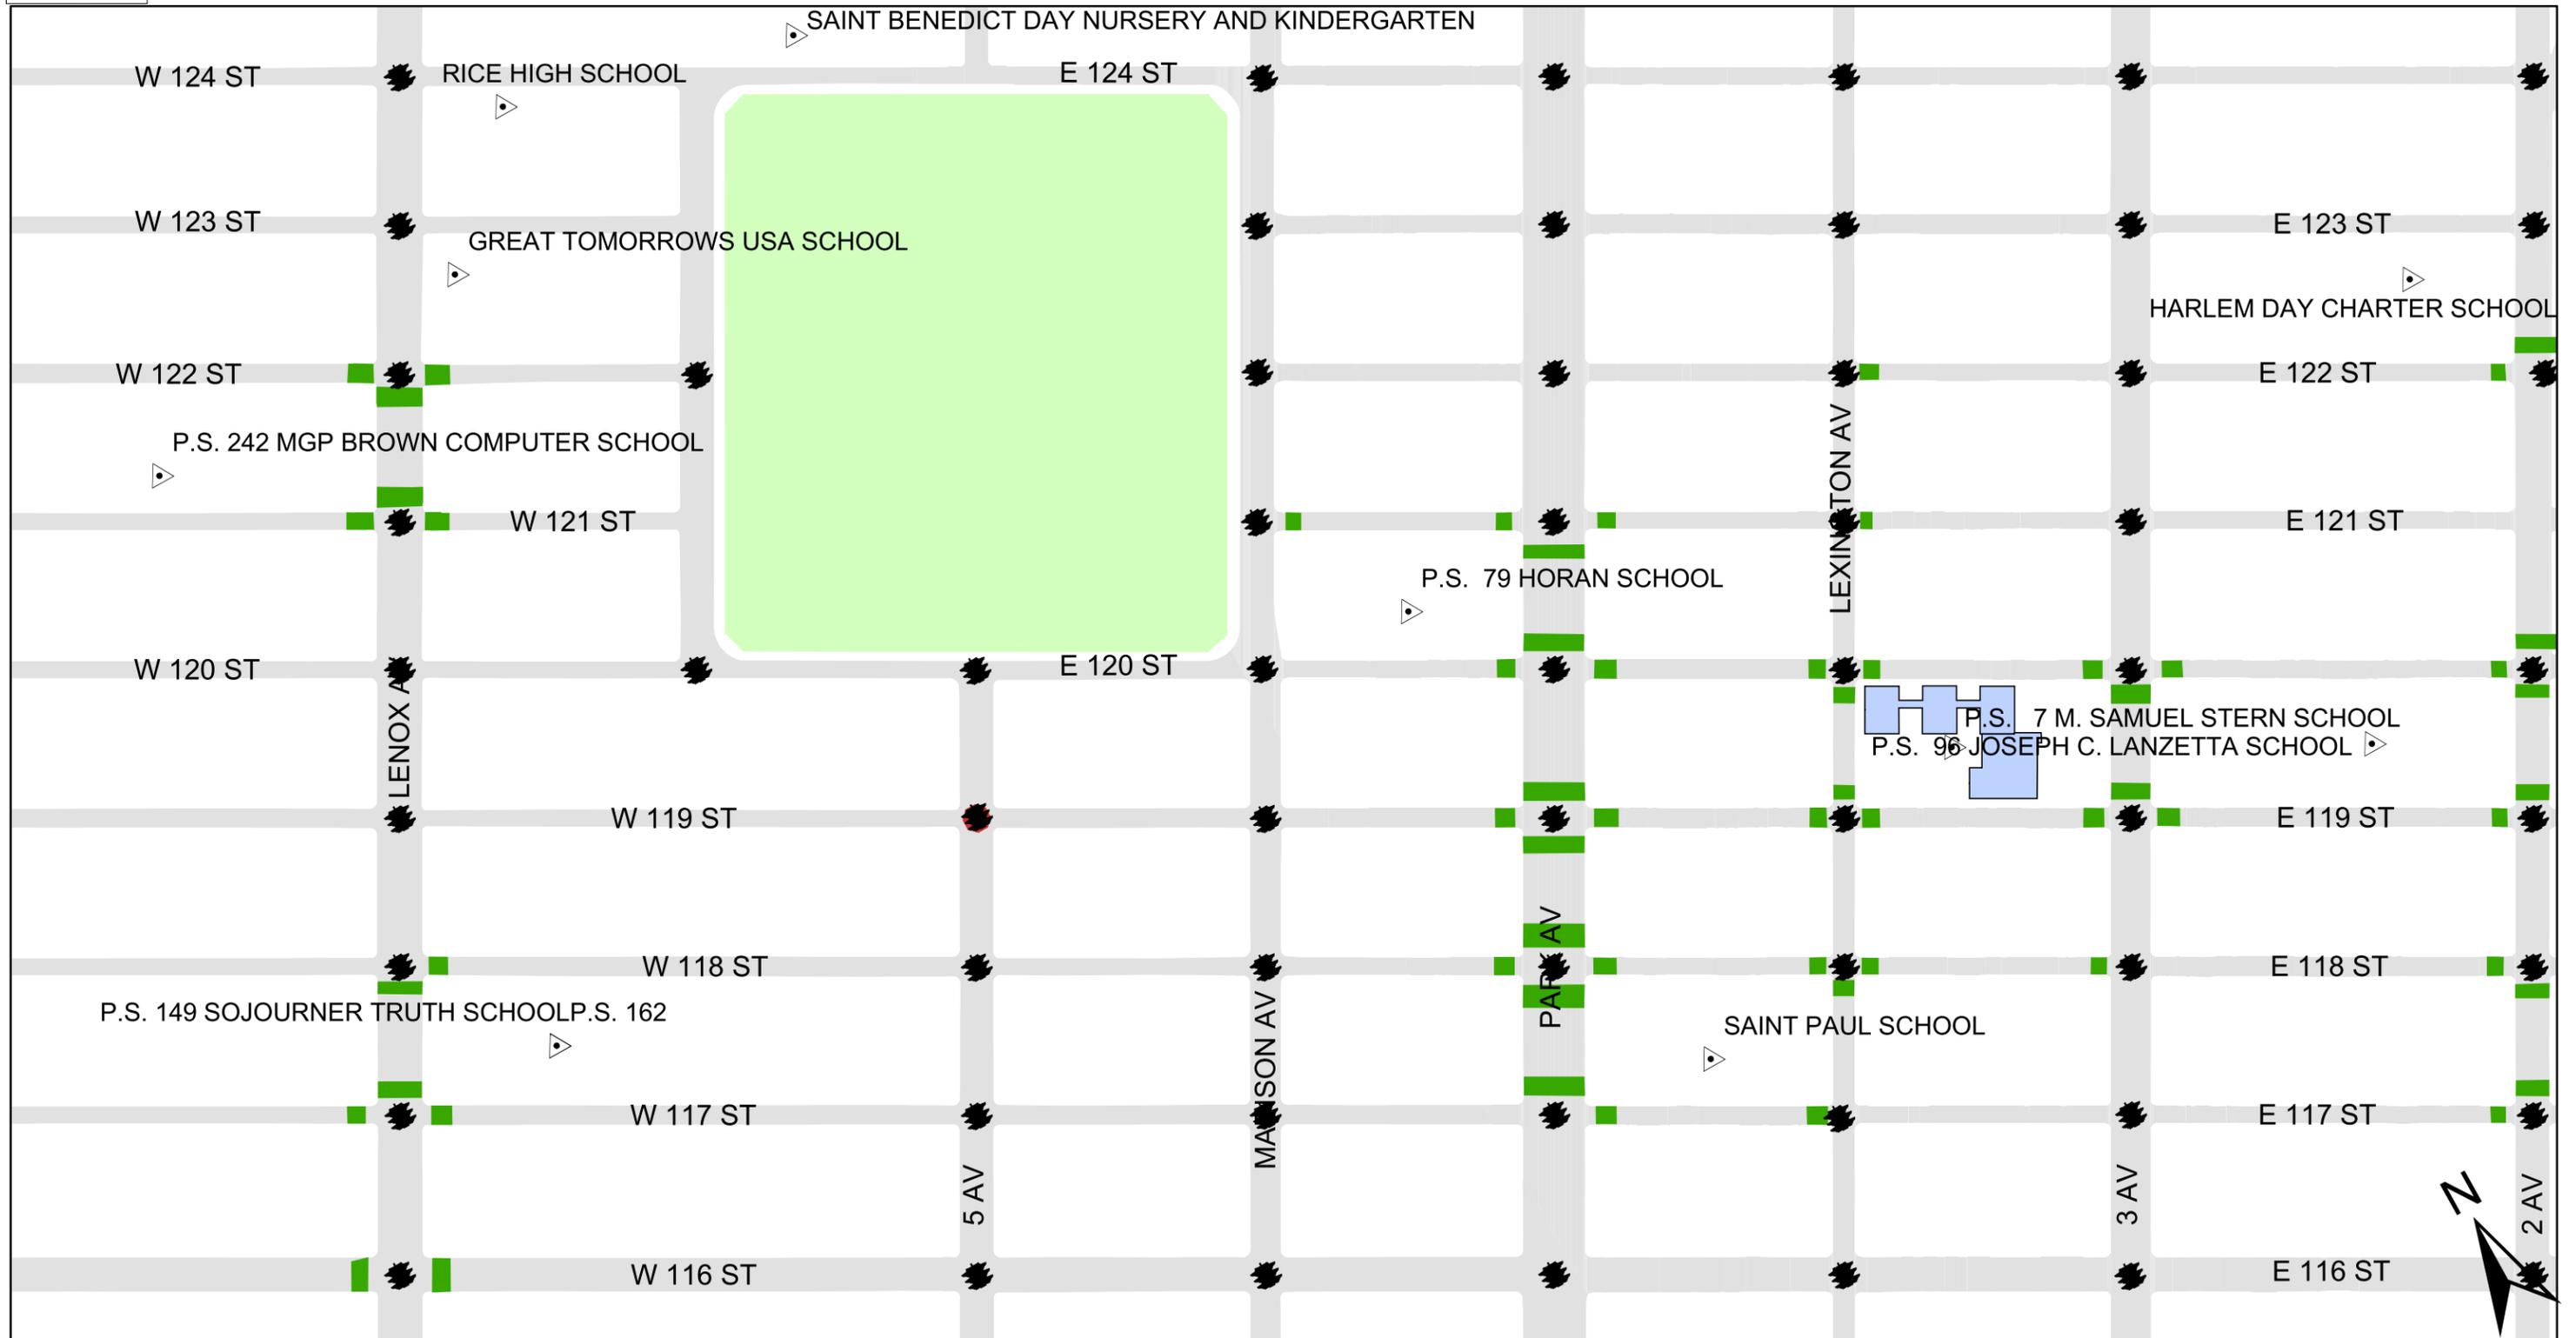
EXHIBIT 2

The School Traffic Safety Map was established to help provide the maximum degree of safety for children going to and from school - by indicating the location of speed reducers, school crosswalks and some traffic control devices. (While virtually all intersections in NYC benefit from traffic control devices - such as stop signs, traffic signals, yield signs, and all way stop signs - this map shows only traffic signals and all way stop signs.) The school crosswalks that are shown are ladder striped and make the crosswalk more visible to drivers and help make the intersection safer. These crosswalks are where school children are recommended to cross.

The Traffic Safety Map, Exhibit 2, shows existing signals and pavement markings in the vicinity of the school. It is noted that a citywide signage program is currently underway to upgrade school signage to current MUTCD standards of fluorescent yellow-green accompanied by downward pointing arrows. Signs scheduled to be installed under this program are shown as “existing” on Exhibit 8.

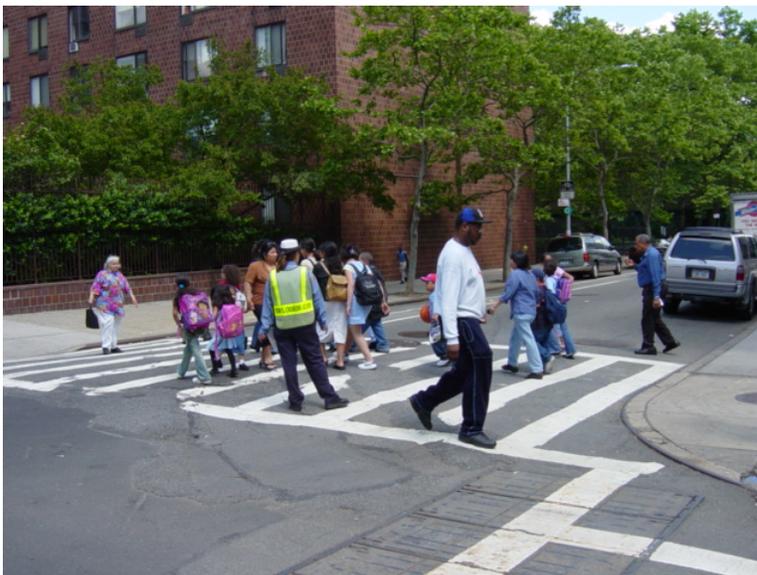
Fig. 2 – A Crossing guard at the intersection of Lexington Avenue and East 120th Street

According to field observations and as confirmed by the school principal, there are currently two crossing guards assigned to this school. The guards are stationed at the following intersections:

- Lexington Avenue and East 119th Streets
- Lexington Avenue and East 120th Streets

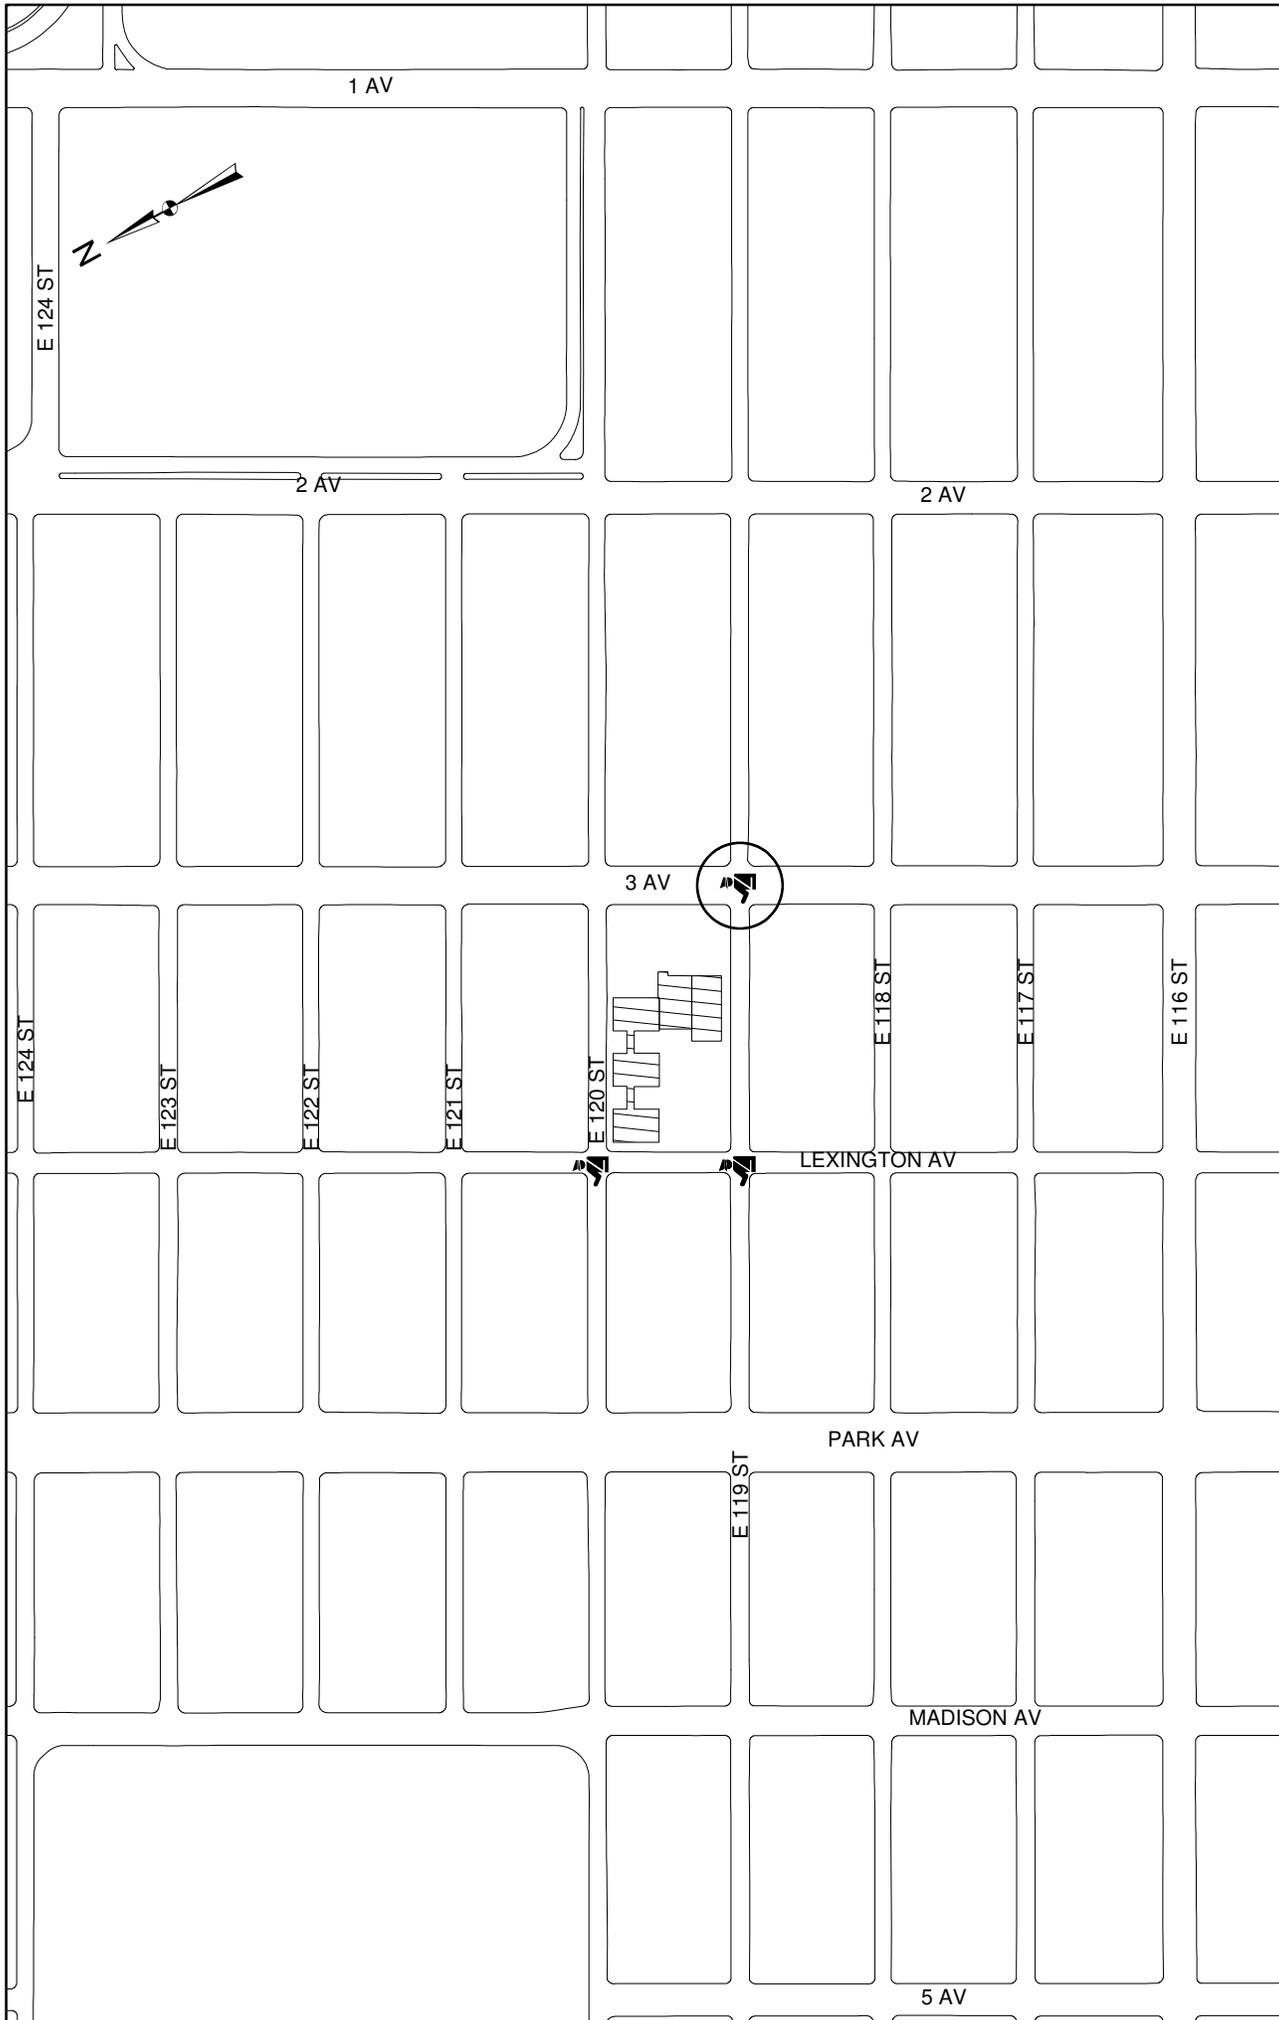
EXHIBIT 4

CROSSING GUARD

CROSSING GUARD ASSIGNED TO ANOTHER SCHOOL

CROSSING GUARD ASSIGNED TO P.S.7

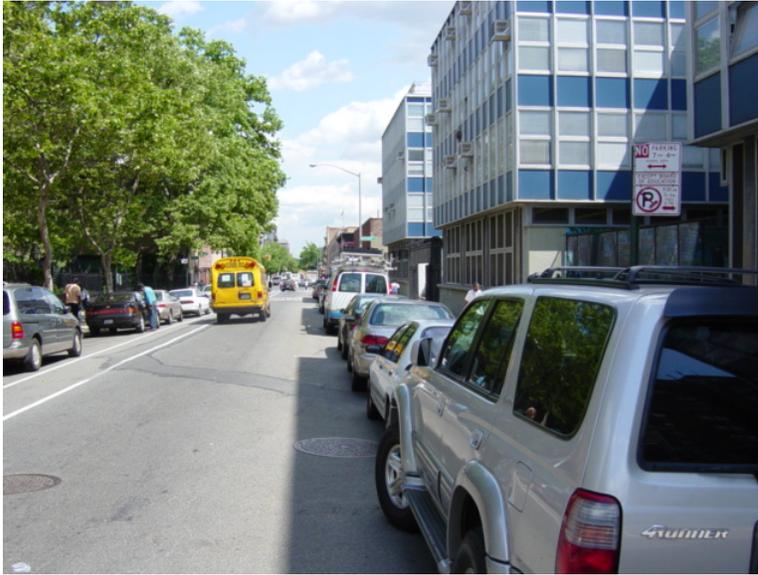
Figure 3: School buses double-park on East 120th Street during dismissal time

According to school representatives, the school buses are primarily used by special education students. All buses park, or double-park, in front of the school on East 120th Street (Figure 3).

- Upgrade No Parking to No-Standing Zone on East 120th Street in front of P.S. 7

“NO STANDING 7AM – 4 PM, SCHOOL DAYS” parking regulations should be considered in front of school entrance on East 120th Street for a length of 30 feet to provide sufficient clear frontage for school buses to drop off and pick up students. The lost teachers parking would be compensated east of the school building (as shown in Exhibit 8). Also, “NO PARKING 7AM – 4 PM, SCHOOL DAYS” parking regulation on East 119th Street should be upgraded to “NO STANDING 7AM – 4 PM, SCHOOL DAYS””
- Administer student pedestrian safety education program

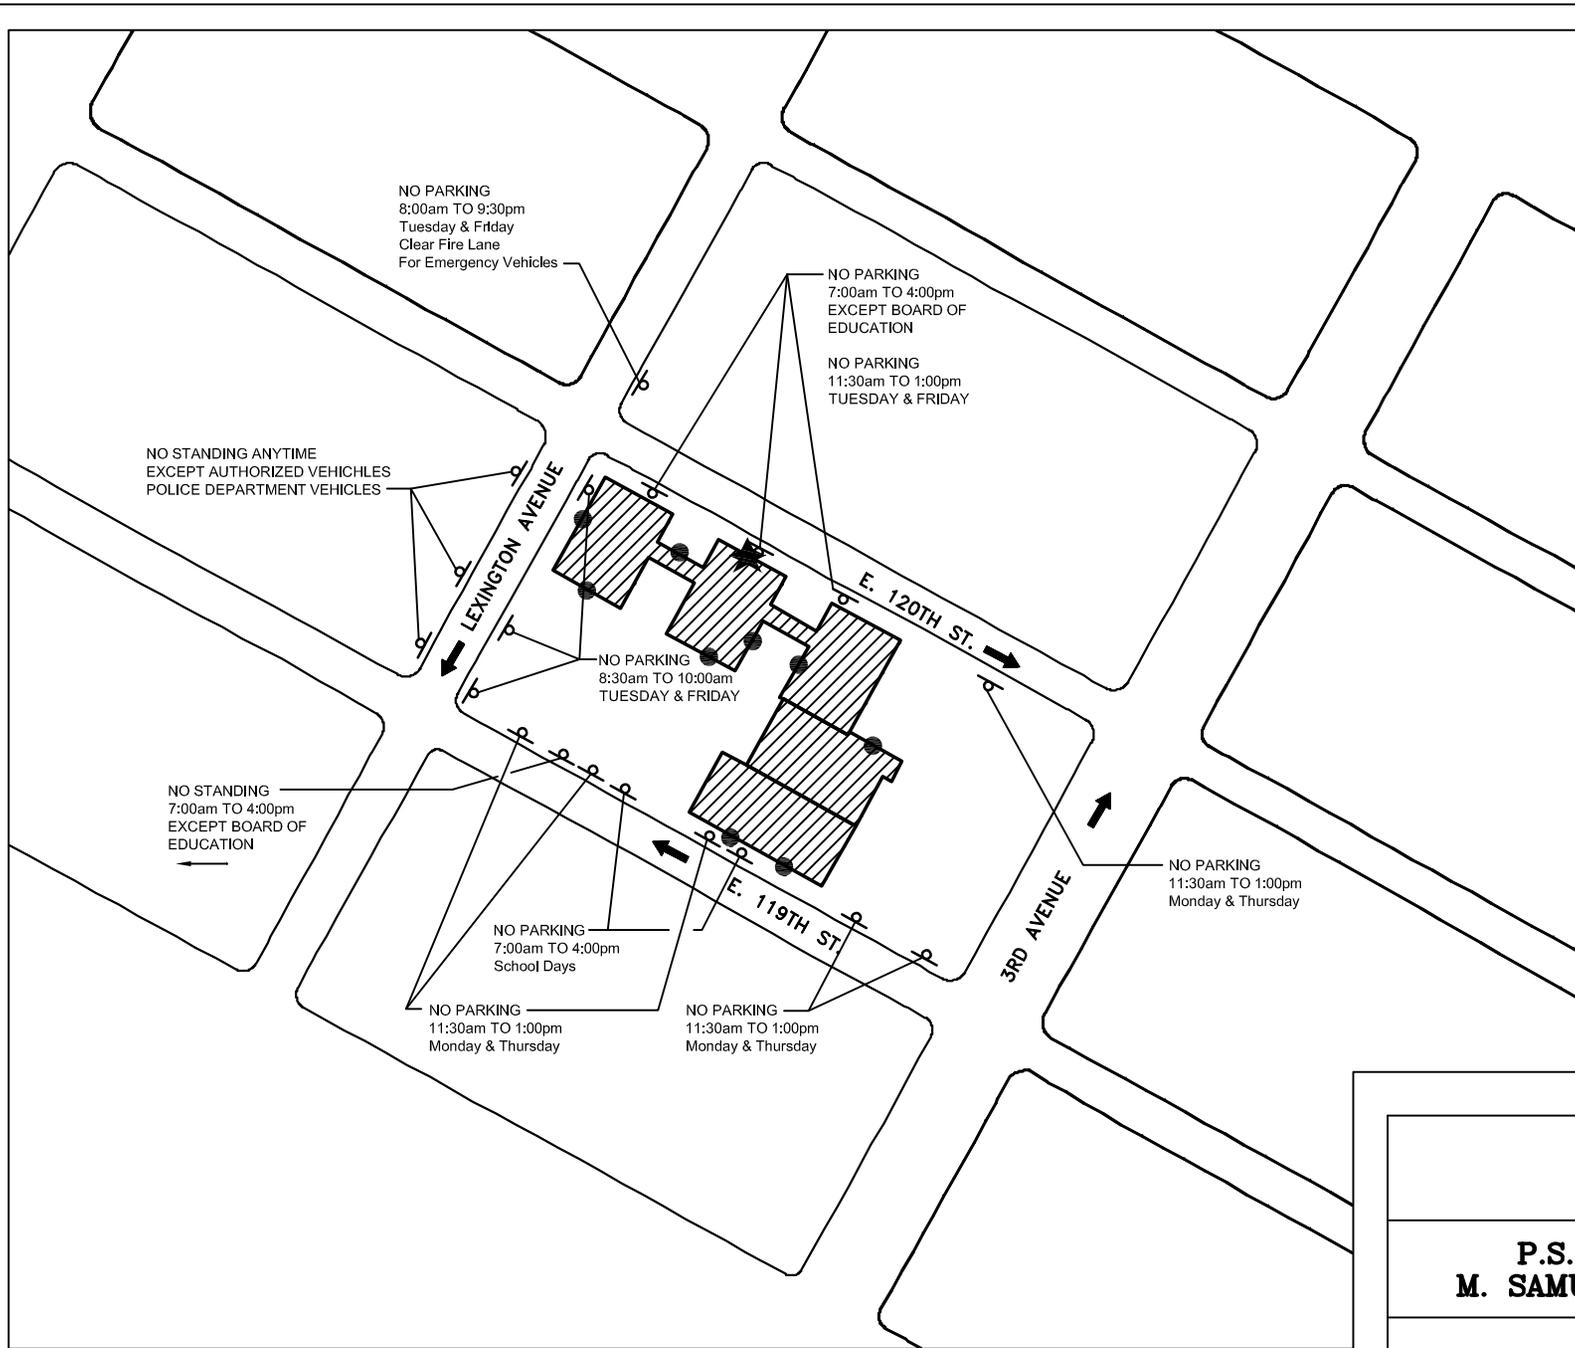
EXHIBIT 5

Exhibit 5 displays parking regulations around P.S. 7. On East 120th Street, "NO PARKING 7AM – 4PM SCHOOL DAYS EXCEPT BOARD OF EDUCATION" parking regulation signs are posted in front of the school. "NO PARKING 7AM – 4PM SCHOOL DAYS EXCEPT BOARD OF EDUCATION" parking regulations exist on East 119th Street near the intersection with Lexington Avenue. "NO PARKING 7AM – 4PM SCHOOL DAYS" regulations are posted on East 119th Street in front of the school.

EXISTING PARKING REGULATIONS

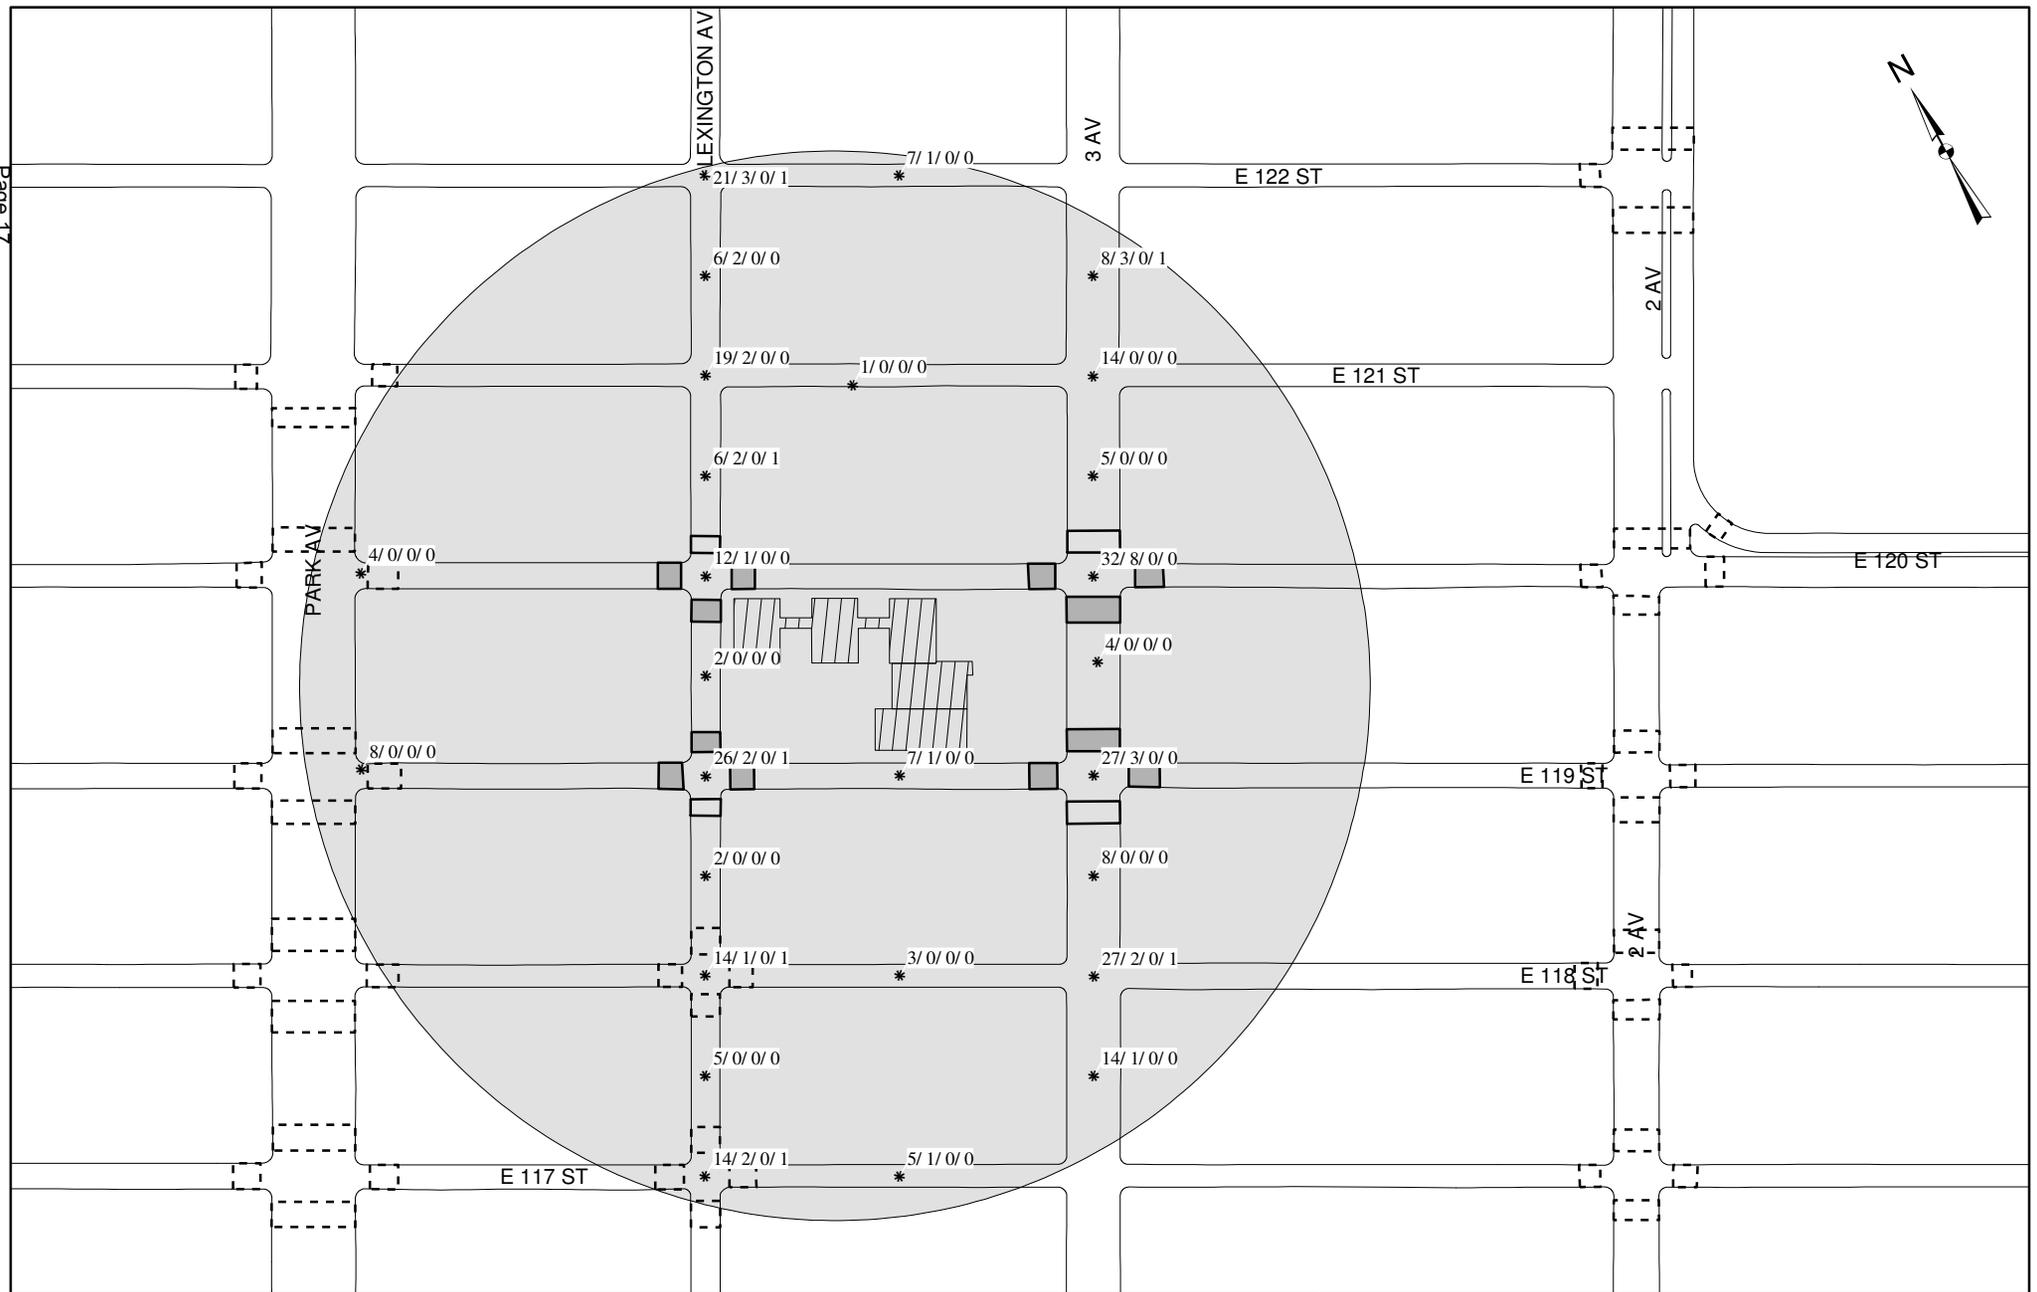
EXHIBIT 6

Exhibit 6 and Table 2 show a summary of accidents, as obtained from the New York State Department of Motor Vehicles (DMV), in the vicinity of P.S. 7 for the three-year period from January 1, 1998 through December 31, 2000. The DMV data provides some detail relating to the circumstances and cause of the accident. Table 3 is a summary of more recent accident data obtained from the NYC Police Department (NYPD). Though current through 2004, the NYPD data does not provide the same level of detail as the DMV data.

**ACCIDENT SUMMARY
THREE YEAR PERIOD
(1998-2000)**

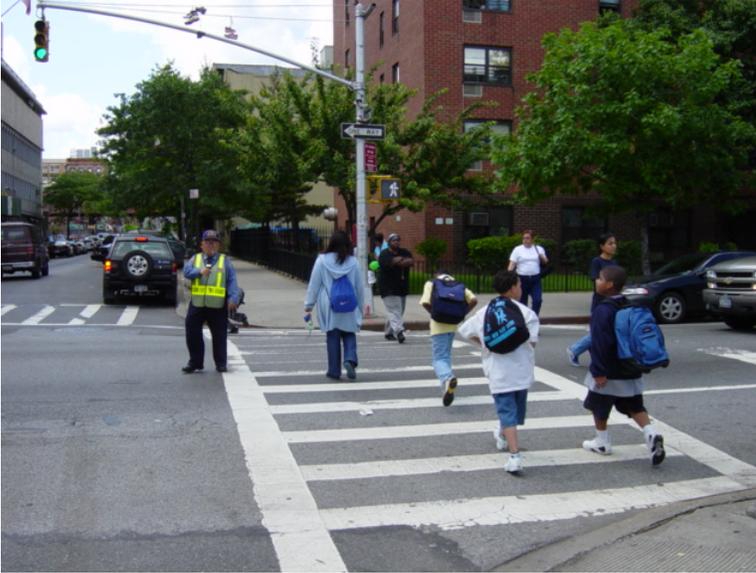
Figure 4: Looking west on East 119th Street at the intersection with Lexington Avenue

East 119th Street is a 32-foot wide one-way westbound street with one travel lane, a bicycle lane, and parallel parking on both sides of the roadway (Figure 4). School crosswalks are delineated across the east, west and north legs of the intersection. In the morning there is a large concentration of traffic entering Manhattan from the Tri-borough Bridge that travels along these two roadways. Many school children walk to school along Lexington Avenue.

This signalized intersection had 26 accidents in the three-year period from 1998 to 2000 (Exhibit 6 and Table 2). Two accidents involved pedestrians, including one that was school-related. The school age pedestrian accident was a result of pedestrian error. No other information was available about this accident. The other pedestrian accident was reported to have been caused by a “defective accelerator” while the driver was traveling west.

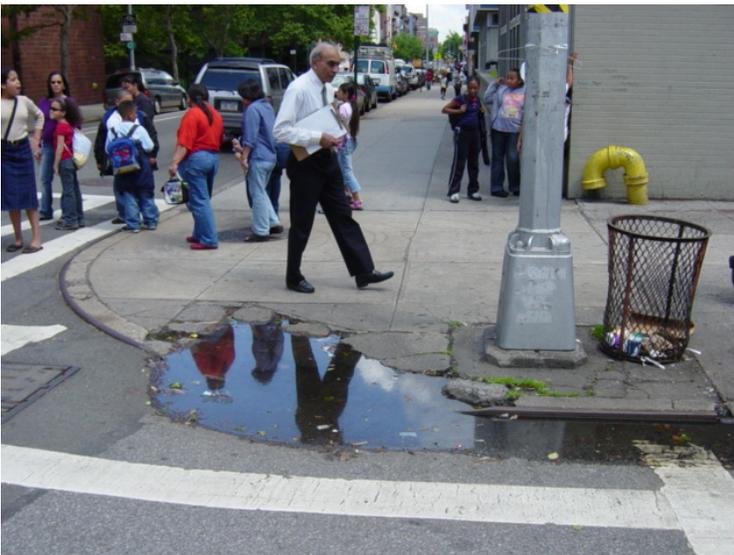
Figure 6: East 120th Street and Lexington Avenue (looking east)

East 120th Street is a 30-foot one-way eastbound street with one moving lane, a bicycle lane and parking on both sides of the street. There are two pedestrian ramps at each corner of the intersection except for the southeast quadrant, closest to the school. There was also some standing water at this location (Figure 6).

The roadways curbs and sidewalk in the vicinity of the project are generally in fairly good condition. There is a localized are of standing water at the southeast quadrant of the 120th Street and Lexington Avenue intersection (see Figure 6).

- Reconstruct pedestrian ramps at the East 120th Street and Lexington Avenue intersection

As shown in Figure 6, this street corner has outstanding drainage and pedestrian access needs. New curbing and pedestrian ramps should be constructed to mitigate the existing condition at the southeast corner of the intersection. Curb extension recommendations for this location are described below.

The existing drainage problem at this corner should also be addressed at the time the pedestrian ramps are installed. Further investigation is required to determine the extent of the issue causing ponding at this corner.

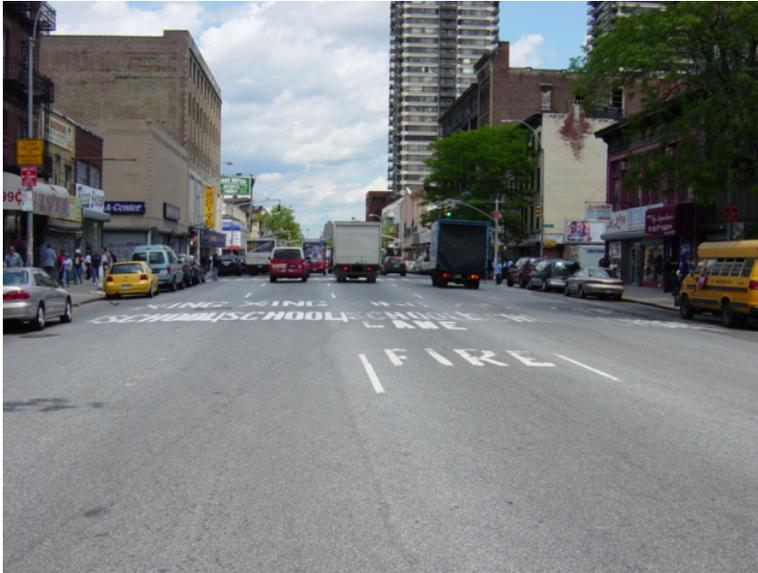
Figure 8: The 3rd Avenue and East 119th Street intersection (looking north)

Third Avenue is a 70-foot one-way northbound street with five moving lanes and parking along each side of the roadway (Figure 5). The intersection of East 119th Street and Third Avenue is controlled by a two-phase signal.

There were 27 accidents reported at this intersection in the 1998-2000 time period, including 3 pedestrian accidents, none of which were fatal or school related. One of the pedestrian accidents occurred while the pedestrian was crossing with the signal and the motorist failed to yield while making a left turn. Another of the accidents occurred while the pedestrian was crossing with the signal and the motorist was traveling west. The third accident at this intersection involved a pedestrian crossing outside of the crosswalk while the motorist was traveling north.

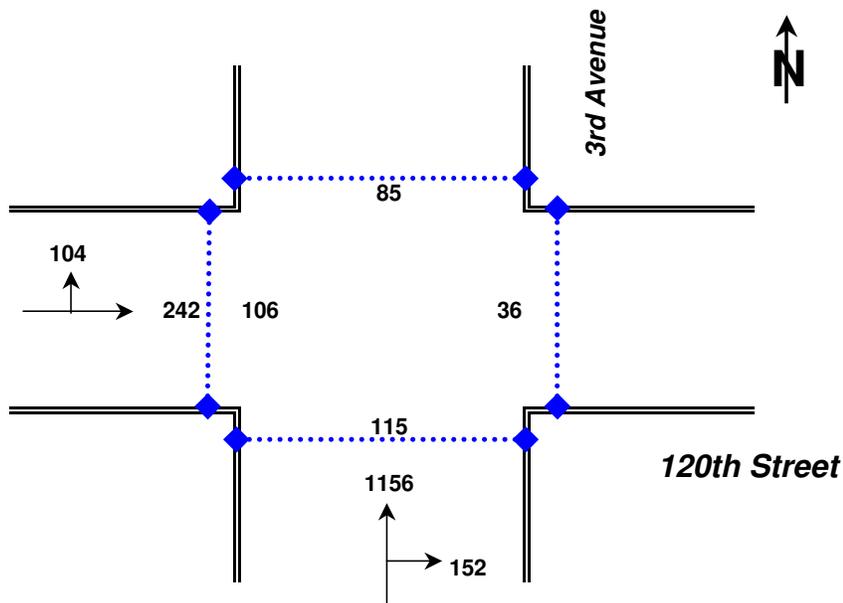
Intersection of 3rd Avenue and 120th Street - (7:30 AM - 8:30 AM September 28, 2005)

A one-hour traffic count was performed on Wednesday September 28, 2005. Results are shown in Exhibit 7. A lead pedestrian interval was considered for the intersection of Third Avenue and East 120th Street. This intersection has moderate volumes and adequate crossing time. 152 vehicles/hour turn right onto East 120th Street, with 36 pedestrians crossing a distance of 34 feet (walk phase is 55 seconds), an LPI is therefore not proposed.

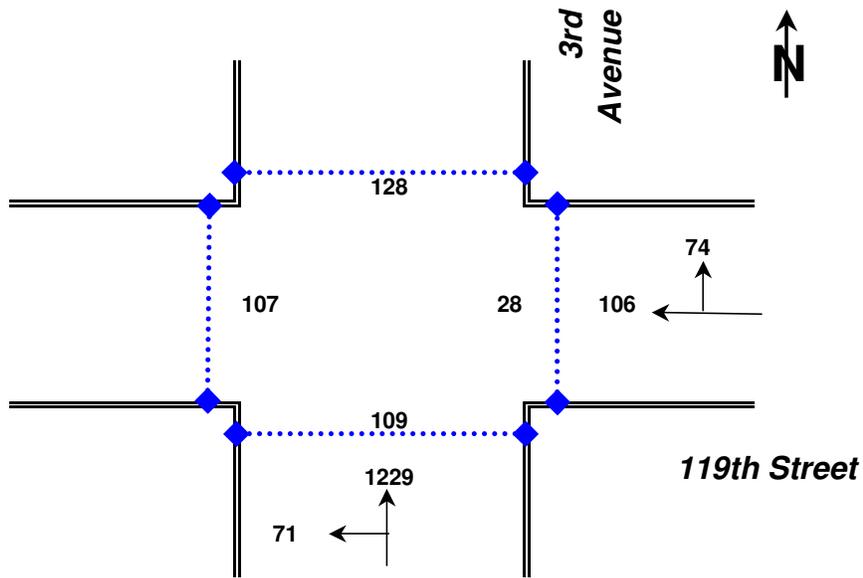
Intersection of 3rd Avenue and 119th Street - (7:30 AM - 8:30 AM September 28, 2005)

A one-hour traffic count was performed at this intersection between the hours of 7:30 am - 8:30 am on Wednesday September 28, 2005 with the results shown in Exhibit 7. The data collected indicates that vehicular volumes are predominant in the northbound direction, and crossing pedestrian volumes are moderate in all directions, excluding the eastern leg, which had a minimal volume.
