School Safety Engineering Project

FINAL REPORT: P.S. 7, M. Samuel Stern School, Manhattan

**Prepared by
The RBA Group/Urbitrans Associates**

JUNE 8, 2006

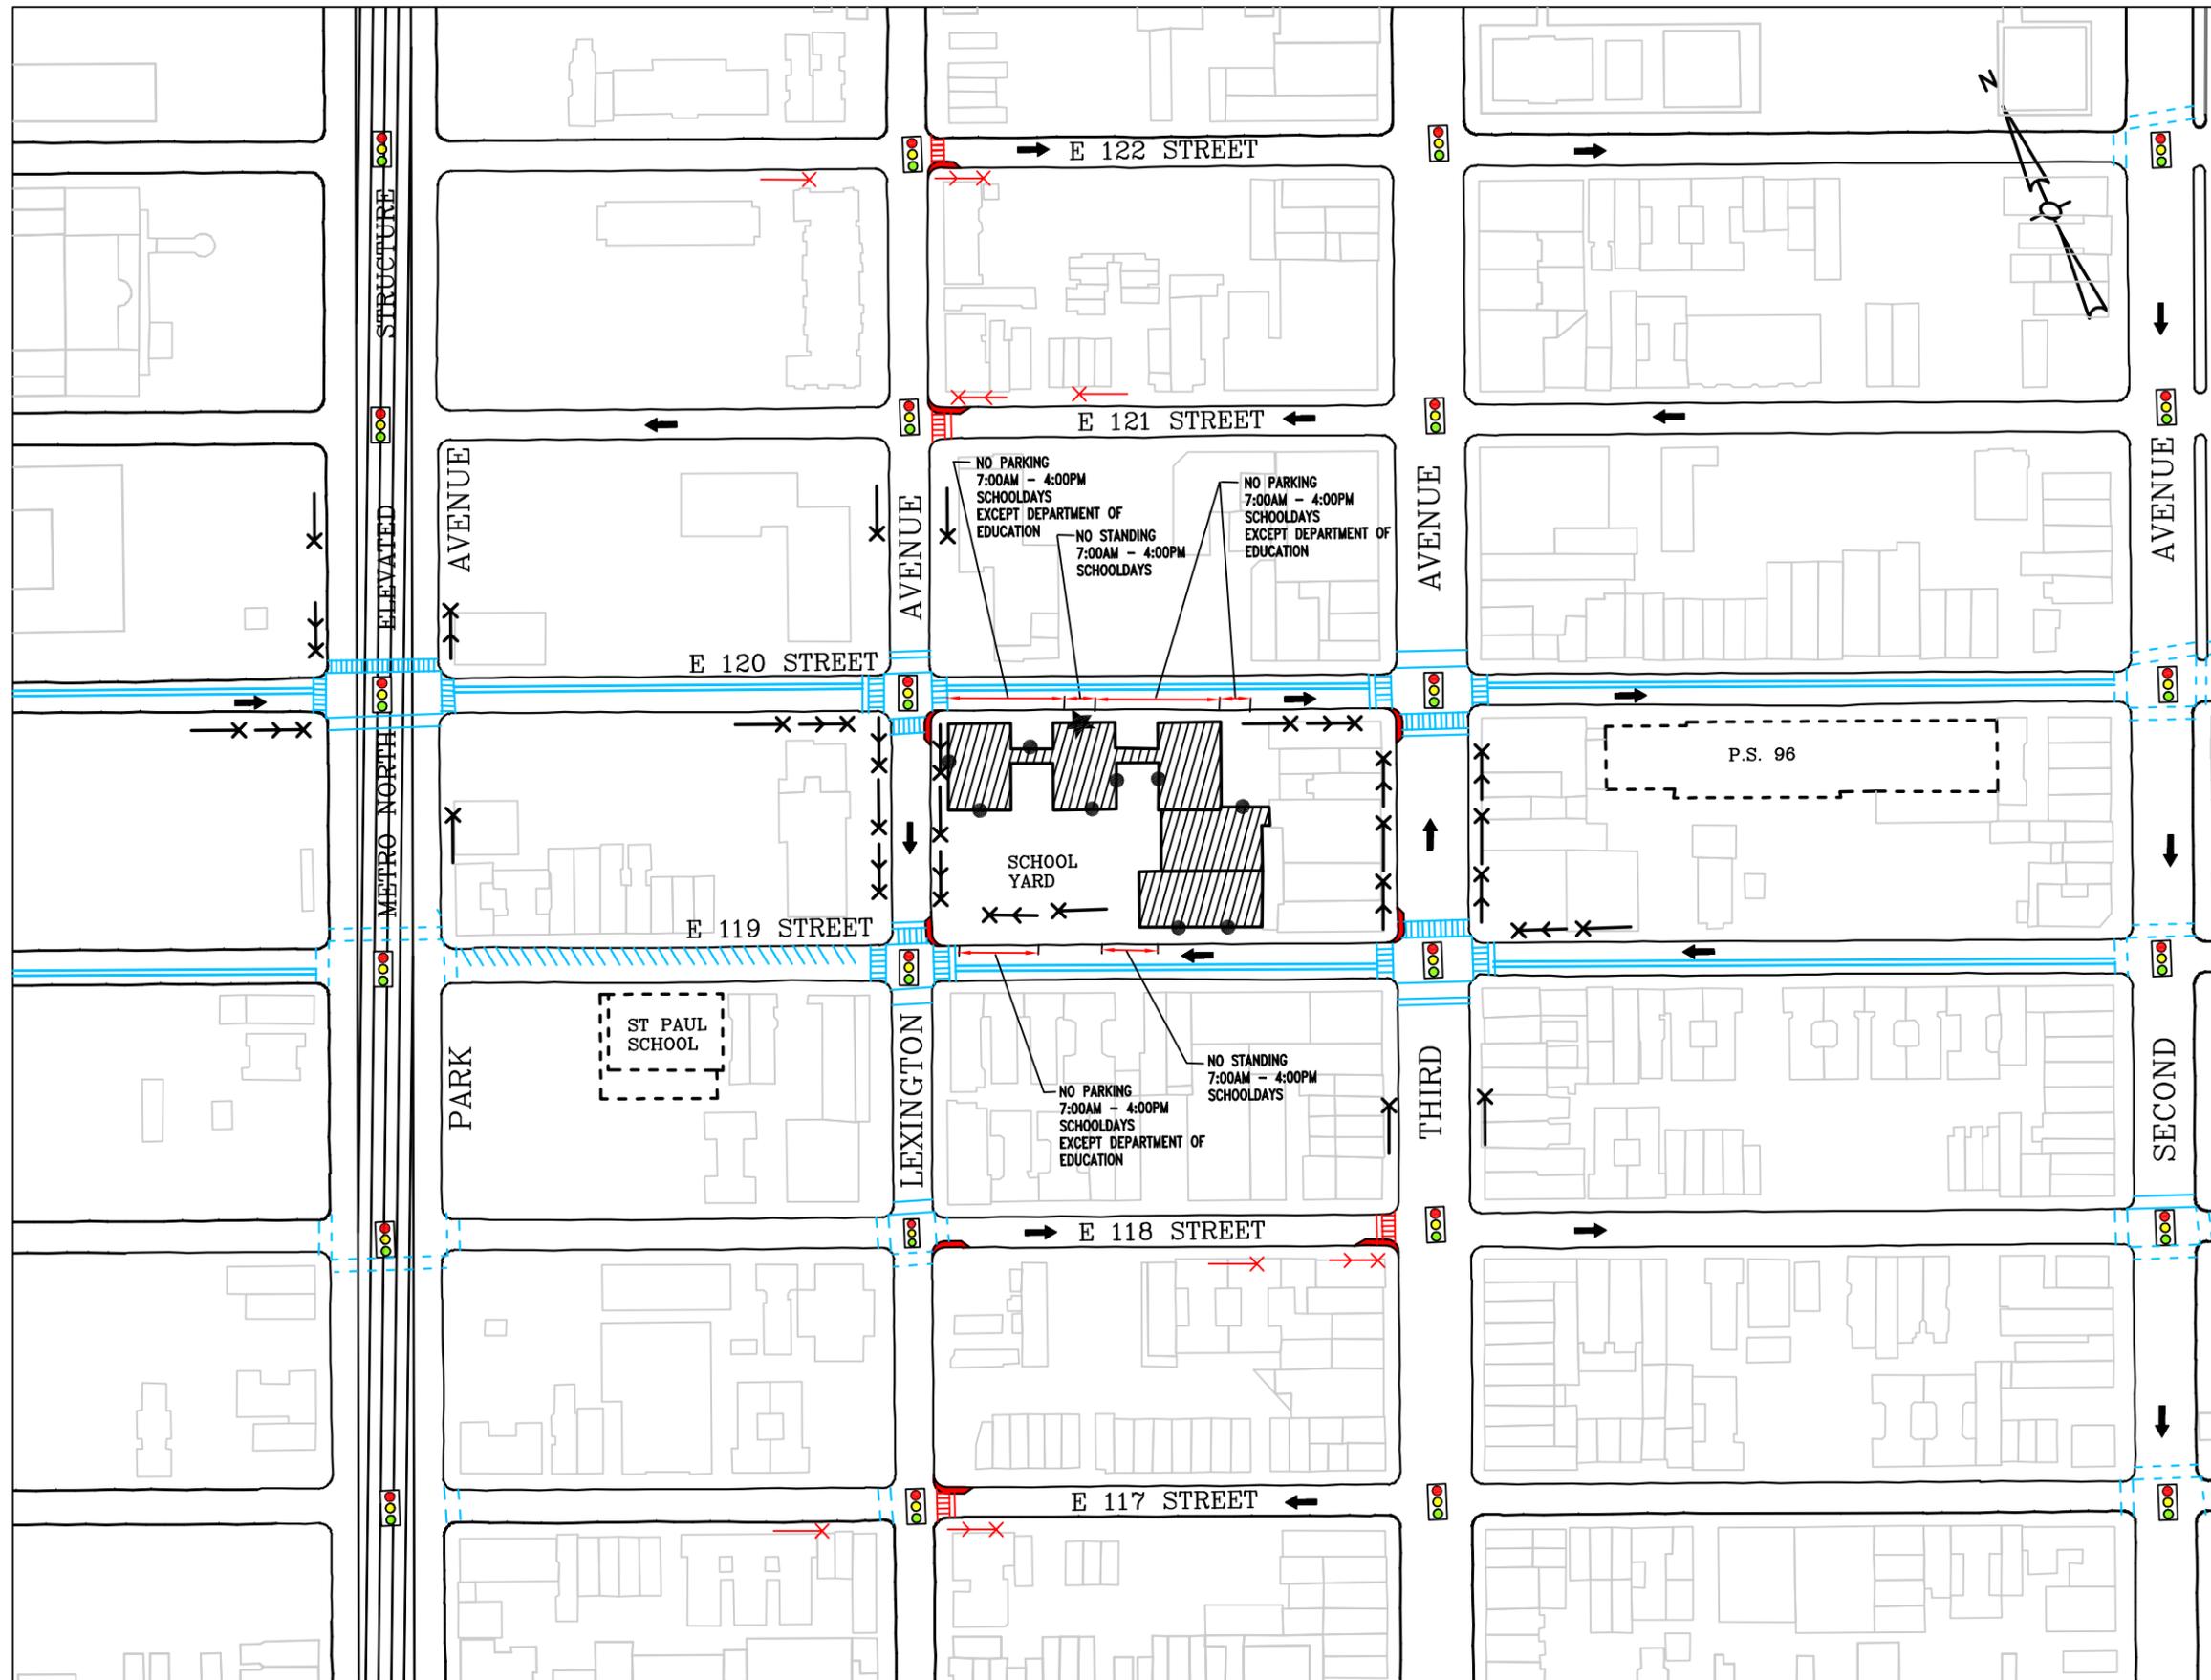
EXHIBIT 8

Curb extensions should be installed at the corners as shown in Exhibit 8.

The purpose of the curb extensions is to reduce speeds of vehicles approaching and turning at these heavily utilized school crosswalks.

**PROPOSED MEASURES
TO IMPROVE SAFETY**

- Lexington Avenue and East 117th Street – east leg
 - Lexington Avenue and East 121st Street – east leg
 - Lexington Avenue and East 122nd Street – east leg
 - Third Avenue and East 117th Street – west leg
 - Third Avenue and East 118th Street – west leg

- Consider curb extensions at the following intersections:
 - Lexington Avenue and East 117th Street – northeast corner
 - Lexington Avenue and East 118th Street – southeast corner
 - Lexington Avenue and East 119th Street - northeast corner
 - Lexington Avenue and East 120th Street - southeast corner
 - Lexington Avenue and East 121st Street – northeast corner
 - Lexington Avenue and East 122nd Street – southeast corner
 - East 117th Street and Third Avenue - northwest corner
 - East 118th Street and Third Avenue - southwest corner
 - East 119th Street and Third Avenue - northwest corner
 - East 120th Street and Third Avenue - southwest corner

These curb extensions will not eliminate or reduce the width any moving lanes. Curb extensions are not proposed where they would hinder the ability of vehicles to turn. Final details pertaining to curb extensions will be developed during the Final Design/Contract Document preparation.
