**New York City Department of Transportation
Office of School Safety Engineering**

School Safety Engineering Project

FINAL REPORT: I.S. 93 (Ridgewood Intermediate School), Queens

**Prepared by
The RBA Group and URBITRAN Associates Inc.**

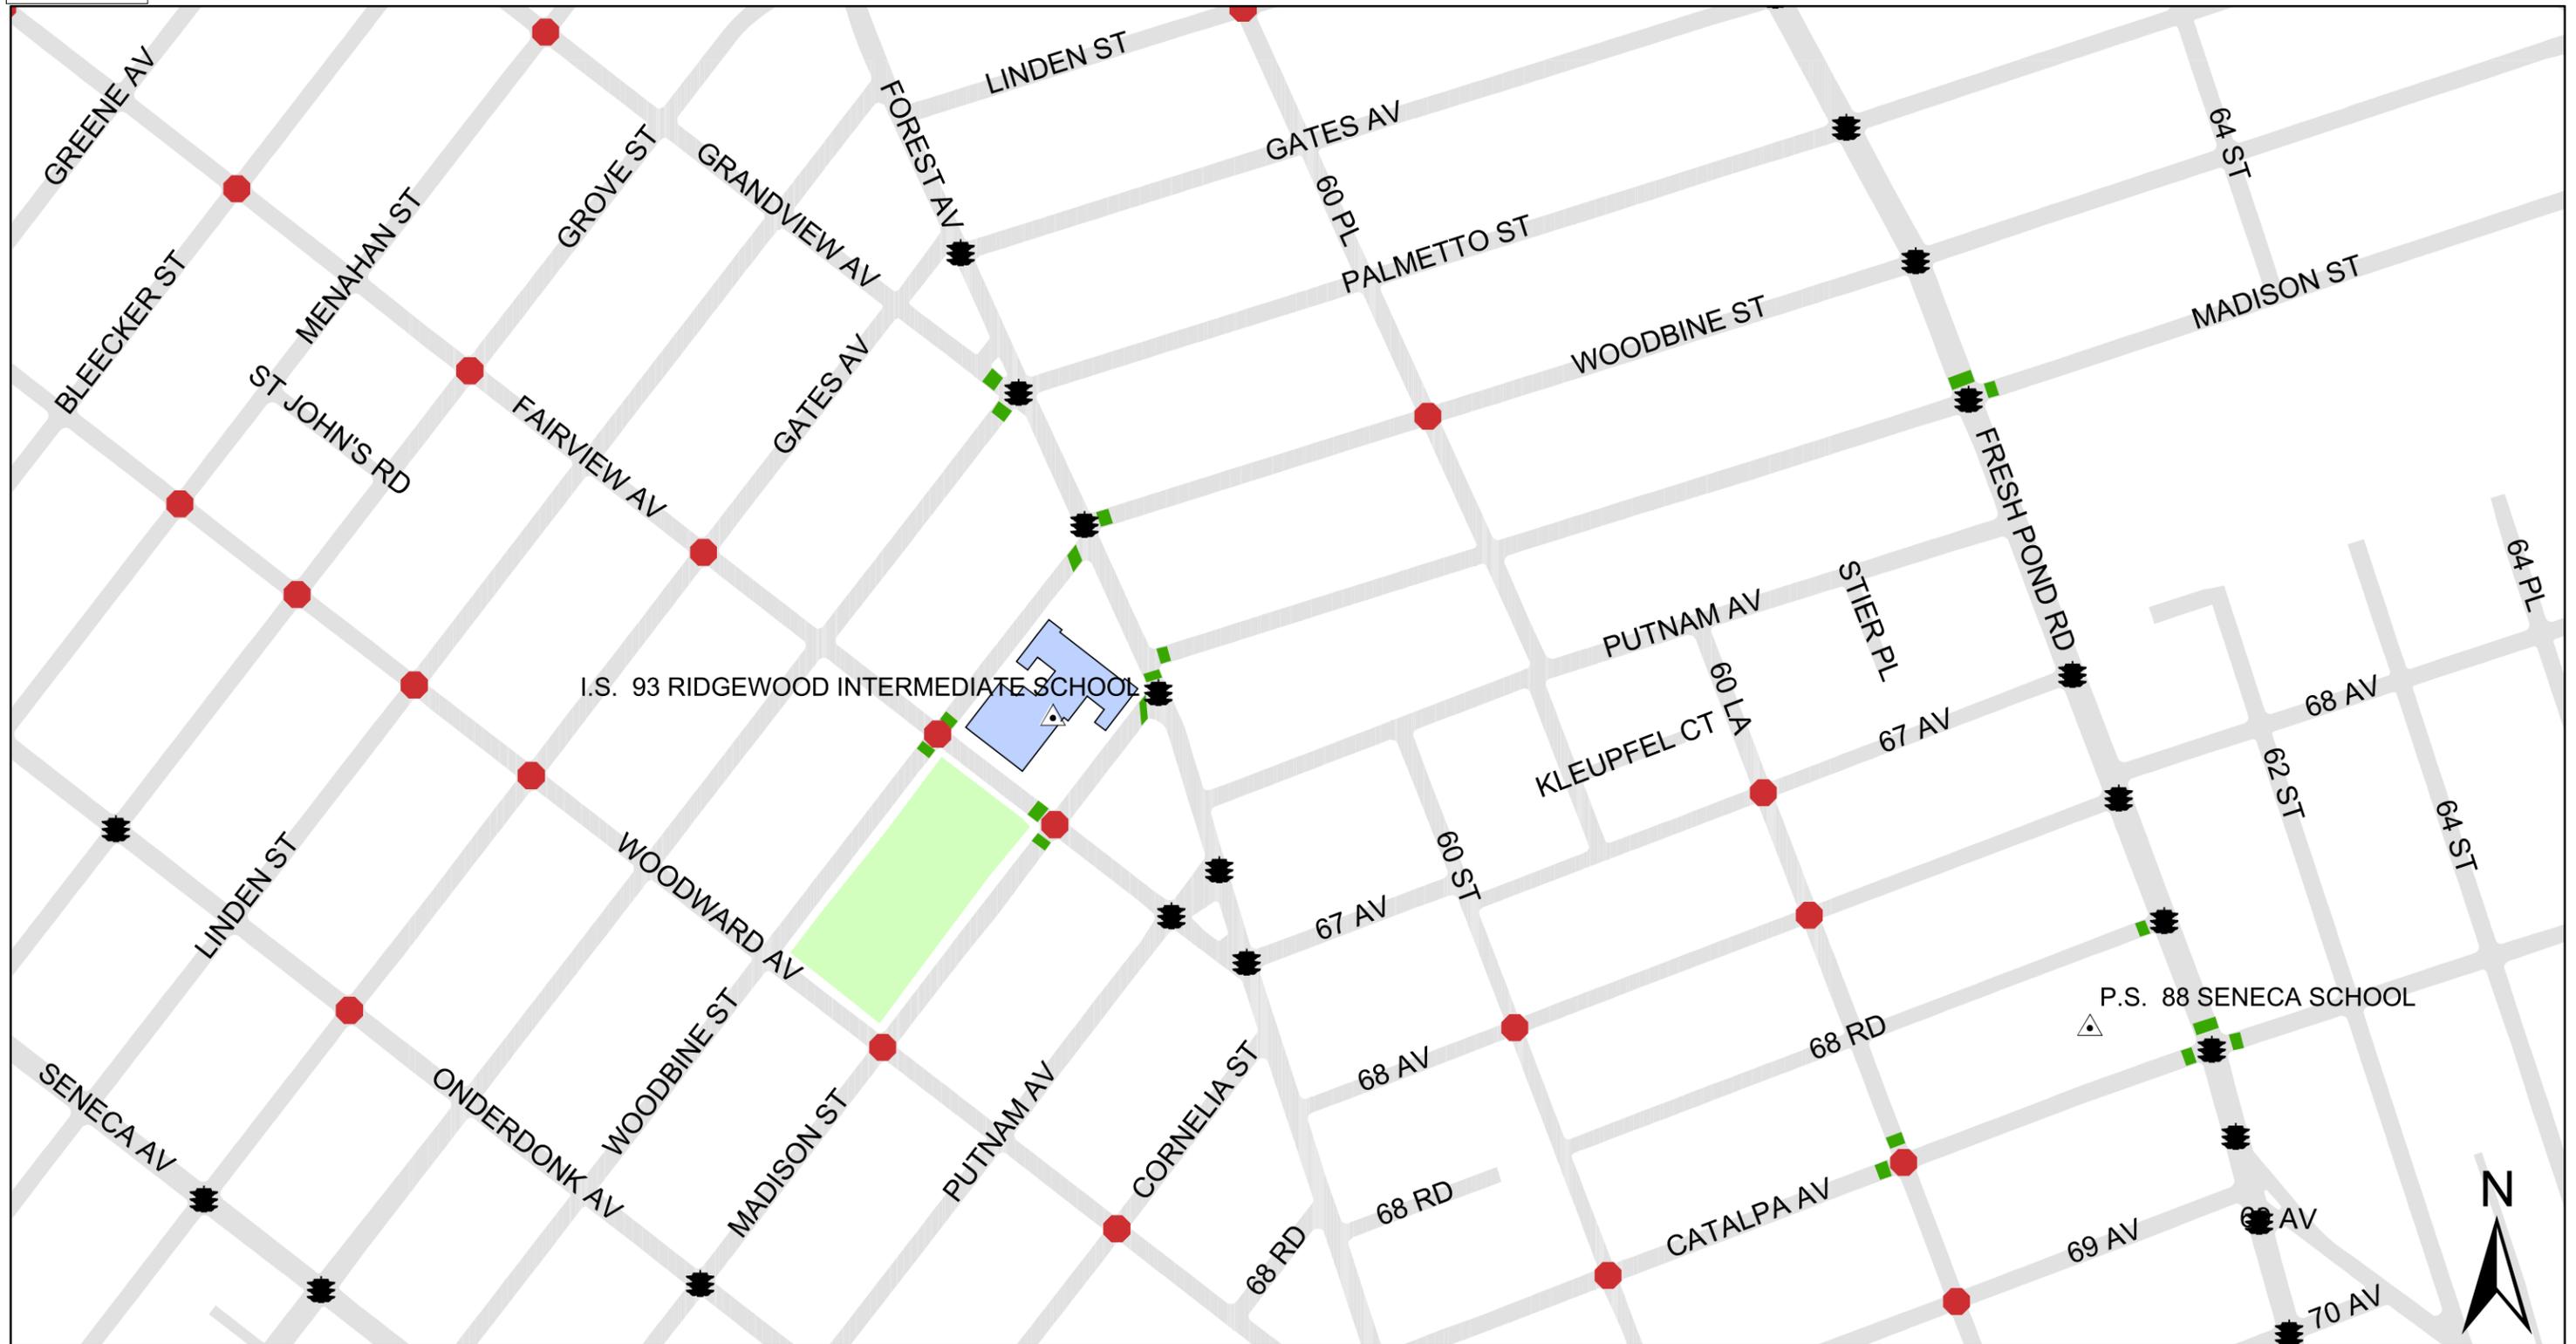
EXHIBIT 3

The School Traffic Safety Map was established to help provide the maximum degree of safety for children going to and from school - by indicating the location of speed reducers, school crosswalks and some traffic control devices. (While virtually all intersections in NYC benefit from traffic control devices - such as stop signs, traffic signals, yield signs, and all way stop signs - this map shows only traffic signals and all way stop signs.) The school crosswalks that are shown are ladder striped and make the crosswalk more visible to drivers and help make the intersection safer. These crosswalks are where school children are recommended to cross.

Exhibit 3, at the end of Section 2, shows the existing school signs, signals, and pavement markings around I.S. 93 as of June 2004. It should be noted that a citywide signage program is currently underway to upgrade school signage to current Federal Manual on Uniform Traffic Control Devices (MUTCD) standards of fluorescent yellow-green accompanied by downward pointing arrows. The MUTCD further directs that the School Crosswalk Warning assembly shall not be installed on approaches controlled by a STOP sign. Signs scheduled to be installed under this program are shown as “existing” in Exhibit 6.

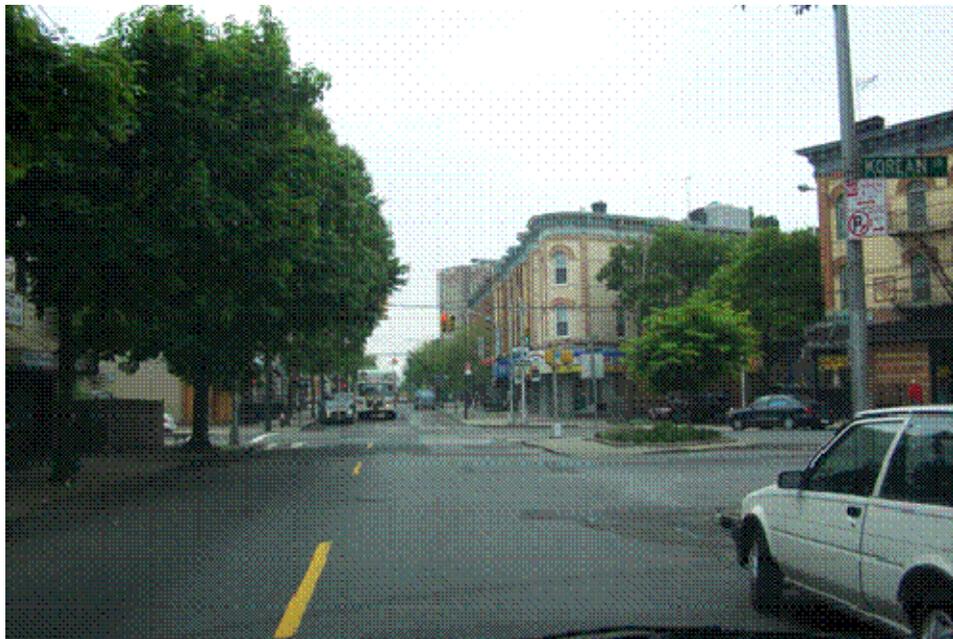
This is a signalized intersection with school crosswalks located across the west legs of Palmetto Street and across the north leg of Grandview Avenue. There are pedestrian crosswalks located across the north and south legs of Forest Avenue and the east leg of Palmetto Street. Forest Avenue is a two-way street with one travel lane and a parking lane on each side of the roadway. Palmetto Street is a one-way eastbound street with one

There were eight (8) accidents reported at this intersection between 1998 and 2000; none of these accidents were pedestrian accidents (Table 2). The NYPD accident data (Table 3) shows nineteen (19) accidents including one (1) pedestrian accident between 2001 and 2004. The pedestrian accident was not a fatal or school-related accident.

Figure 1: Looking east on Forest Avenue toward intersection with Palmetto Street (Grandview Avenue is to right)

There is a triangular island at the intersection of Grandview Avenue/Forest Avenue/Palmetto Street formed by the intersecting roadways, with Forest Avenue on the north, Grandview Avenue on the south and a short connecting roadway between Forest Avenue and Grandview Avenue on the west. The eastern apex of the triangle lies at the intersection of Forest Avenue and Palmetto Street. It is recommended to:

- Extend the eastern apex of the triangle to further east, as shown in Exhibit 6, and align both crosswalks across Grandview Avenue and Forest Avenues. Provide at least 5-foot at grade cut through section at the extended eastern apex of the triangle.

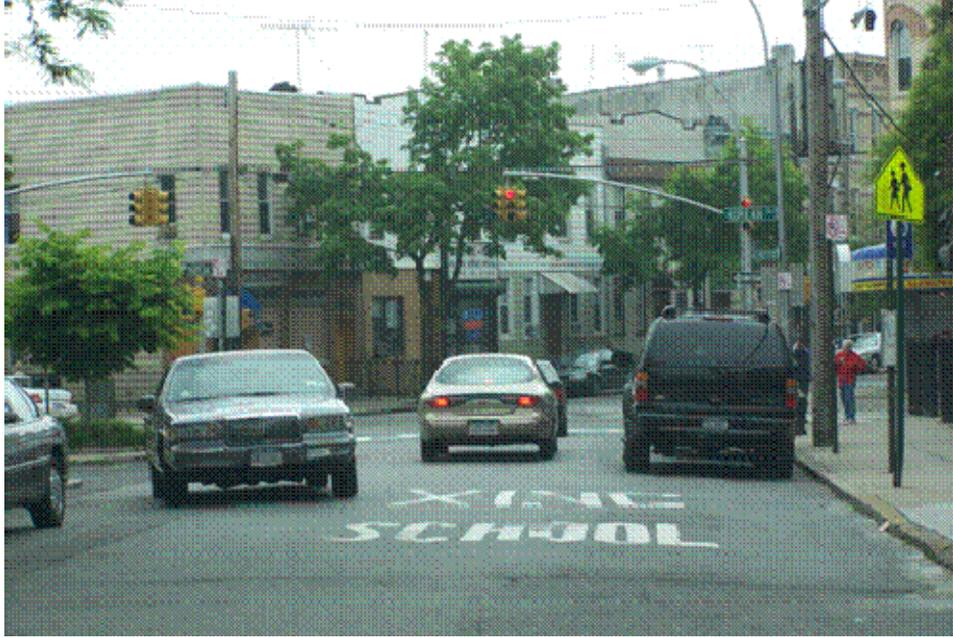
Figure 2: Looking east on Grandview Avenue toward Palmetto Street and Forest Avenue

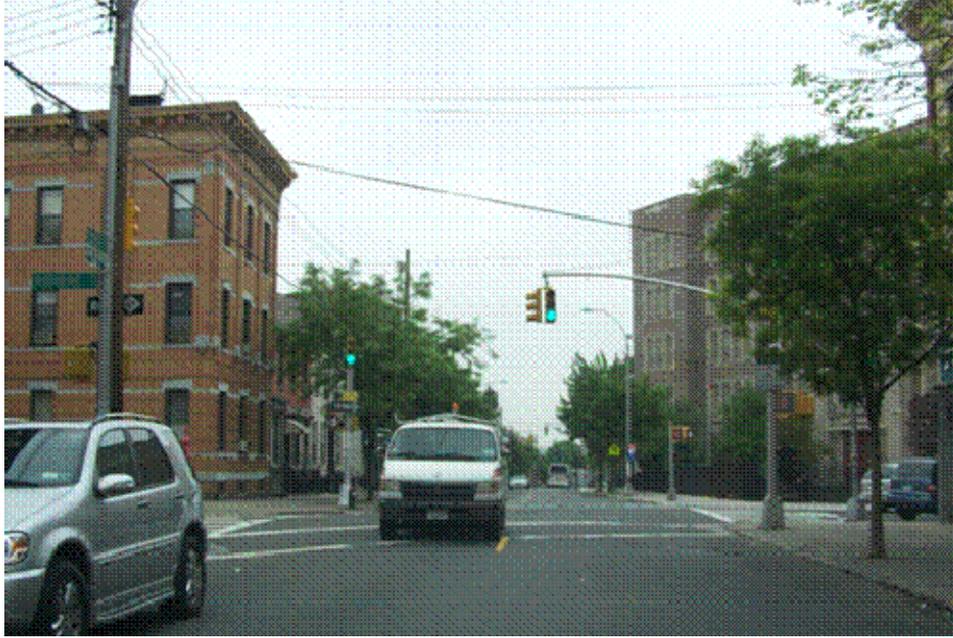
This is a signalized intersection with school crosswalks located across the east and west legs of Woodbine Street and pedestrian crosswalks located across the north and south legs of Forest Avenue. Forest Avenue is a two-way street with one travel lane and a parking lane on each side of the roadway. Woodbine Street is a one-way westbound street with one travel lane and parking on both sides of the roadway. This is a slightly offset intersection with the east leg of Woodbine Street slightly north of the west leg. The east leg also intersects with Forest Avenue at an approximately right angle, whereas the west leg intersects with Forest Avenue at an approximately 45-degree angle (see Figures 3, 4, and 5).

Figure 3: Looking South on Forest Avenue toward Woodbine Street intersection (I.S. 93 can be seen on far right)

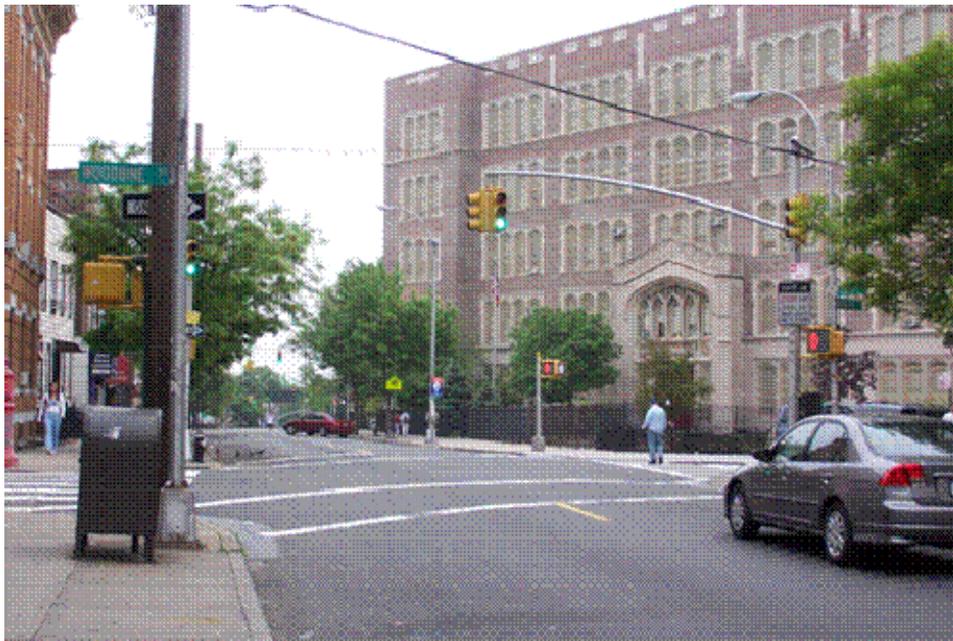
Figure 4: Looking south along Forest Avenue at Woodbine Street intersection (I.S. 93 can be seen on far side of intersection)

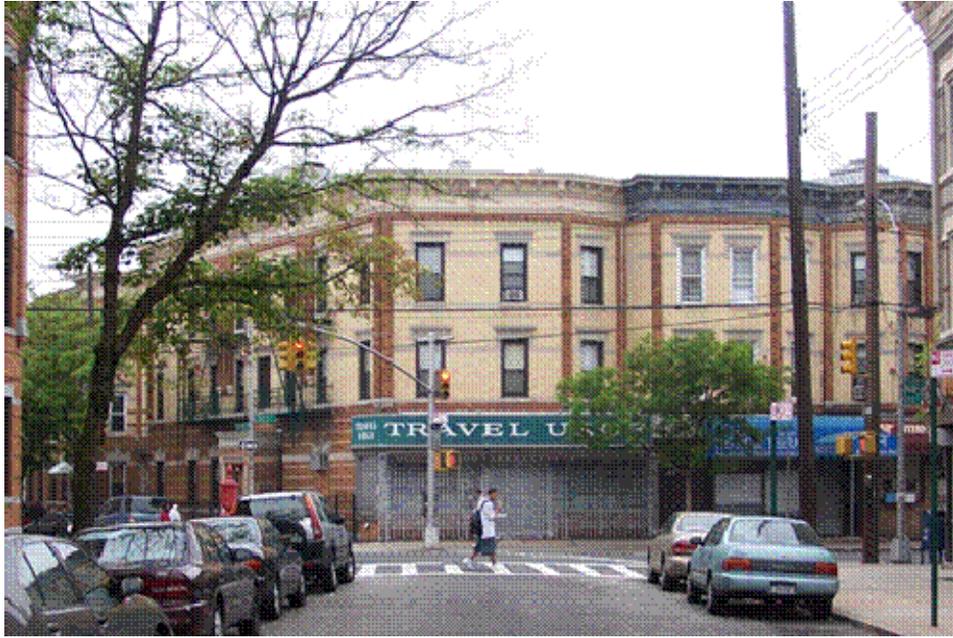
Figure 5: Looking west on Woodbine Street toward Forest Avenue

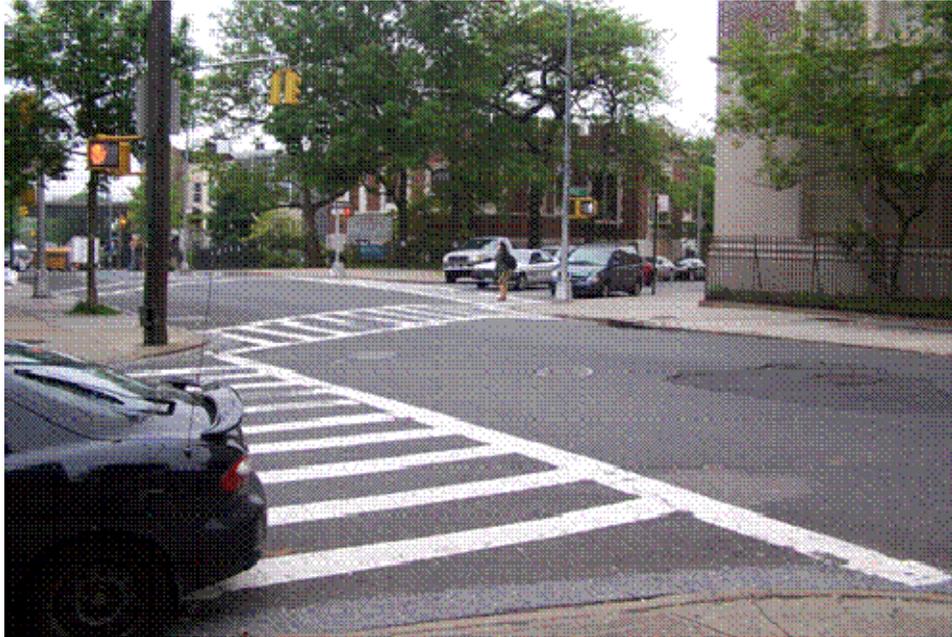
This is a signalized intersection with school crosswalks located across the east and west legs of Madison Street and also across the portion of Forest Avenue midway between the east and west legs of Madison Avenue. Pedestrian crosswalks are located across the north and south legs of Forest Avenue. Forest Avenue is a two-way street with one travel lane and a parking lane on each side of the roadway. Madison Street is a one-way eastbound street with one travel lane and parking on both sides of the roadway. This is an offset intersection with the east leg of Madison Street situated north of the west leg. The east leg also intersects with Forest Avenue at an approximately right angle, whereas the west leg intersects with Forest Avenue at an approximately 45-degree angle (see Figure 6).

Figure 6: Looking southwest from east leg of Woodbine Street across Forest Avenue toward west leg of Woodbine Street (corner of school building is on far right)

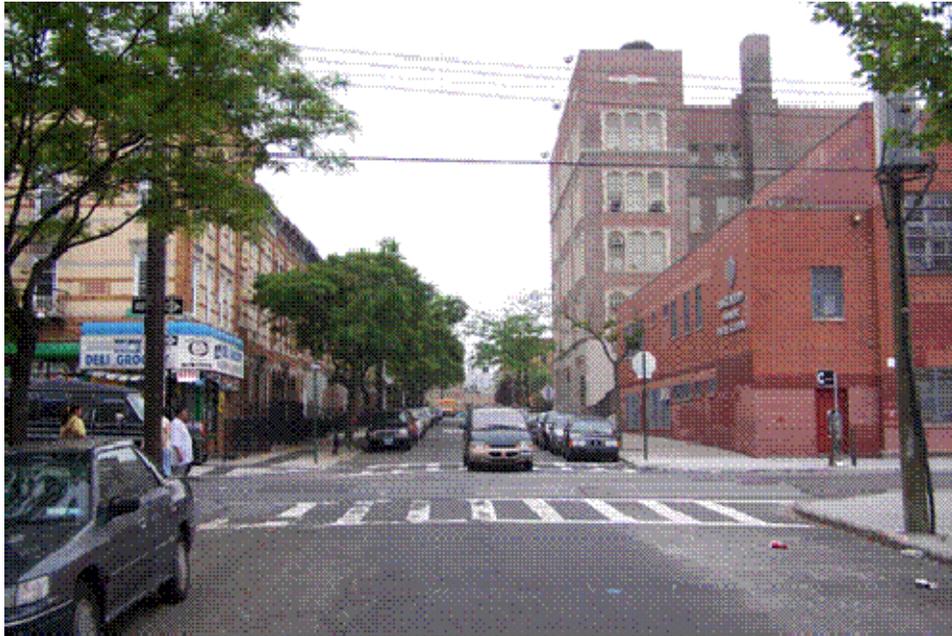
This is an unsignalized all-way stop-controlled intersection with school crosswalks located across both legs of Woodbine Street. Fairview Avenue is a one-way southbound street with one travel lane and parking on both sides of the roadway. Woodbine Street is a one-way westbound street with one travel lane and parking on both sides of the roadway. There are stop signs for both roadway approaches to the intersection (see Figure 7).

This intersection has been the site of fifteen (15) accidents between 1998 and 2000; two (2) of these were pedestrian accidents, one of which was school-related. In the school-related accident, a thirteen-year old pedestrian sustained a “possible injury” on Tuesday, September 28, 1999 at 8:00 am and was reported as crossing, with no signal or crosswalk at the intersection. The road was dry and the weather was clear. The traffic control was a stop sign. There were no pedestrian fatalities during the same three-year period. The NYPD accident data (Table 3) also shows fifteen (15) accidents between 2001 and 2004. There were no pedestrian fatalities or school-related accidents during the same four-year period.

Figure 7: Looking east on Woodbine Street across Fairview Avenue intersection (school is on far right side of intersection)

The pedestrian ramps on the southeast corner of Fairview Avenue & Woodbine Street, for the school crosswalk located across the east leg of Woodbine Street, and the unmarked crosswalk located across the south leg of Fairview Avenue do not provide smooth transitions from pavement to sidewalk. The curbs have small lips. The roadway pavement at the curb for the crosswalk located across the east leg of Woodbine Street is also in need of repair.

- Modify the pedestrian ramps on the southeast corner of Fairview Avenue & Woodbine Street, for the school crosswalk located across the east leg of Woodbine Street, and the unmarked crosswalk located across the south leg of Fairview Avenue, to provide a smooth transition from pavement to curb for the pedestrian ramp.
- Repair the roadway pavement at the southeast corner of Fairview Avenue & Woodbine Street along the curb for the crosswalk located across the east leg of Woodbine Street. .

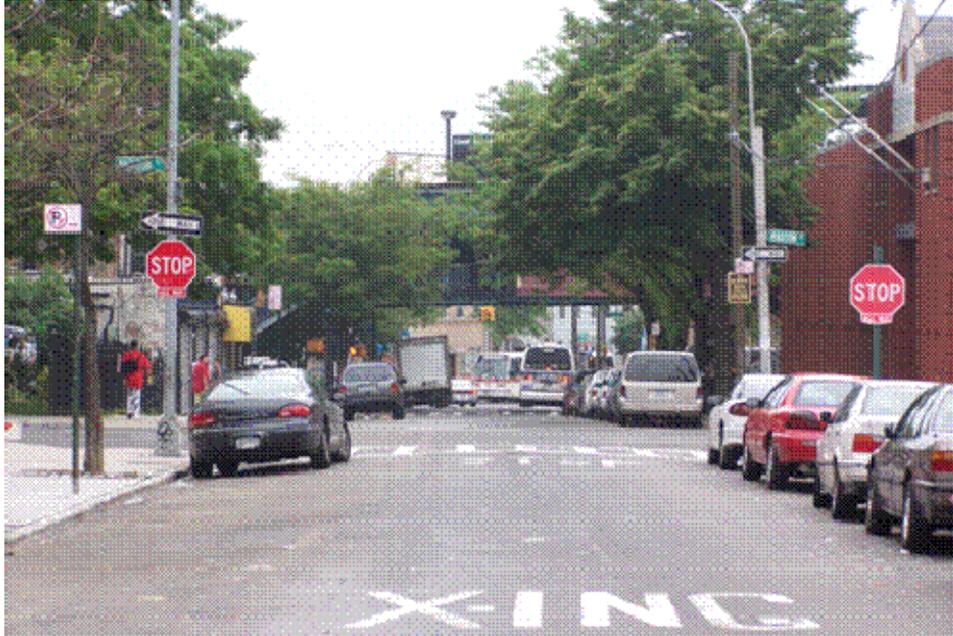
This is an unsignalized all-way stop-controlled intersection with school crosswalks located across the north leg of Fairview Avenue and the west leg of Madison Street. Fairview Avenue is a one-way southbound street with one travel lane and parking on both sides of the roadway. Madison Street is a one-way eastbound street with one travel lane and parking on both sides of the roadway. There are stop signs for both approaches to the intersection (see Figures 8 and 9).

Figure 8: Looking south on Fairview Avenue toward Madison Street intersection

- Install the standard pedestrian crosswalk markings at the following locations:
 - ❖ Across the north-west leg of Fairview Avenue at Woodbine Street
 - ❖ Across the south-east leg of Fairview Avenue at Madison Street
 - ❖ Across the north-west leg of Madison Street at Fairview Avenue

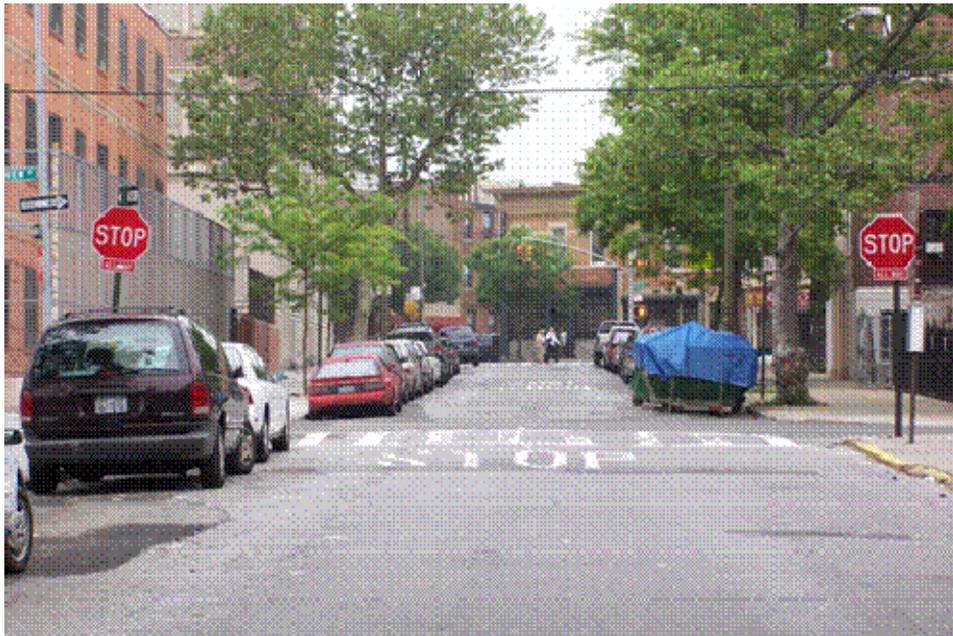
Figure 9: Looking east on Madison Street toward Fairview Avenue intersection (school is on far left)

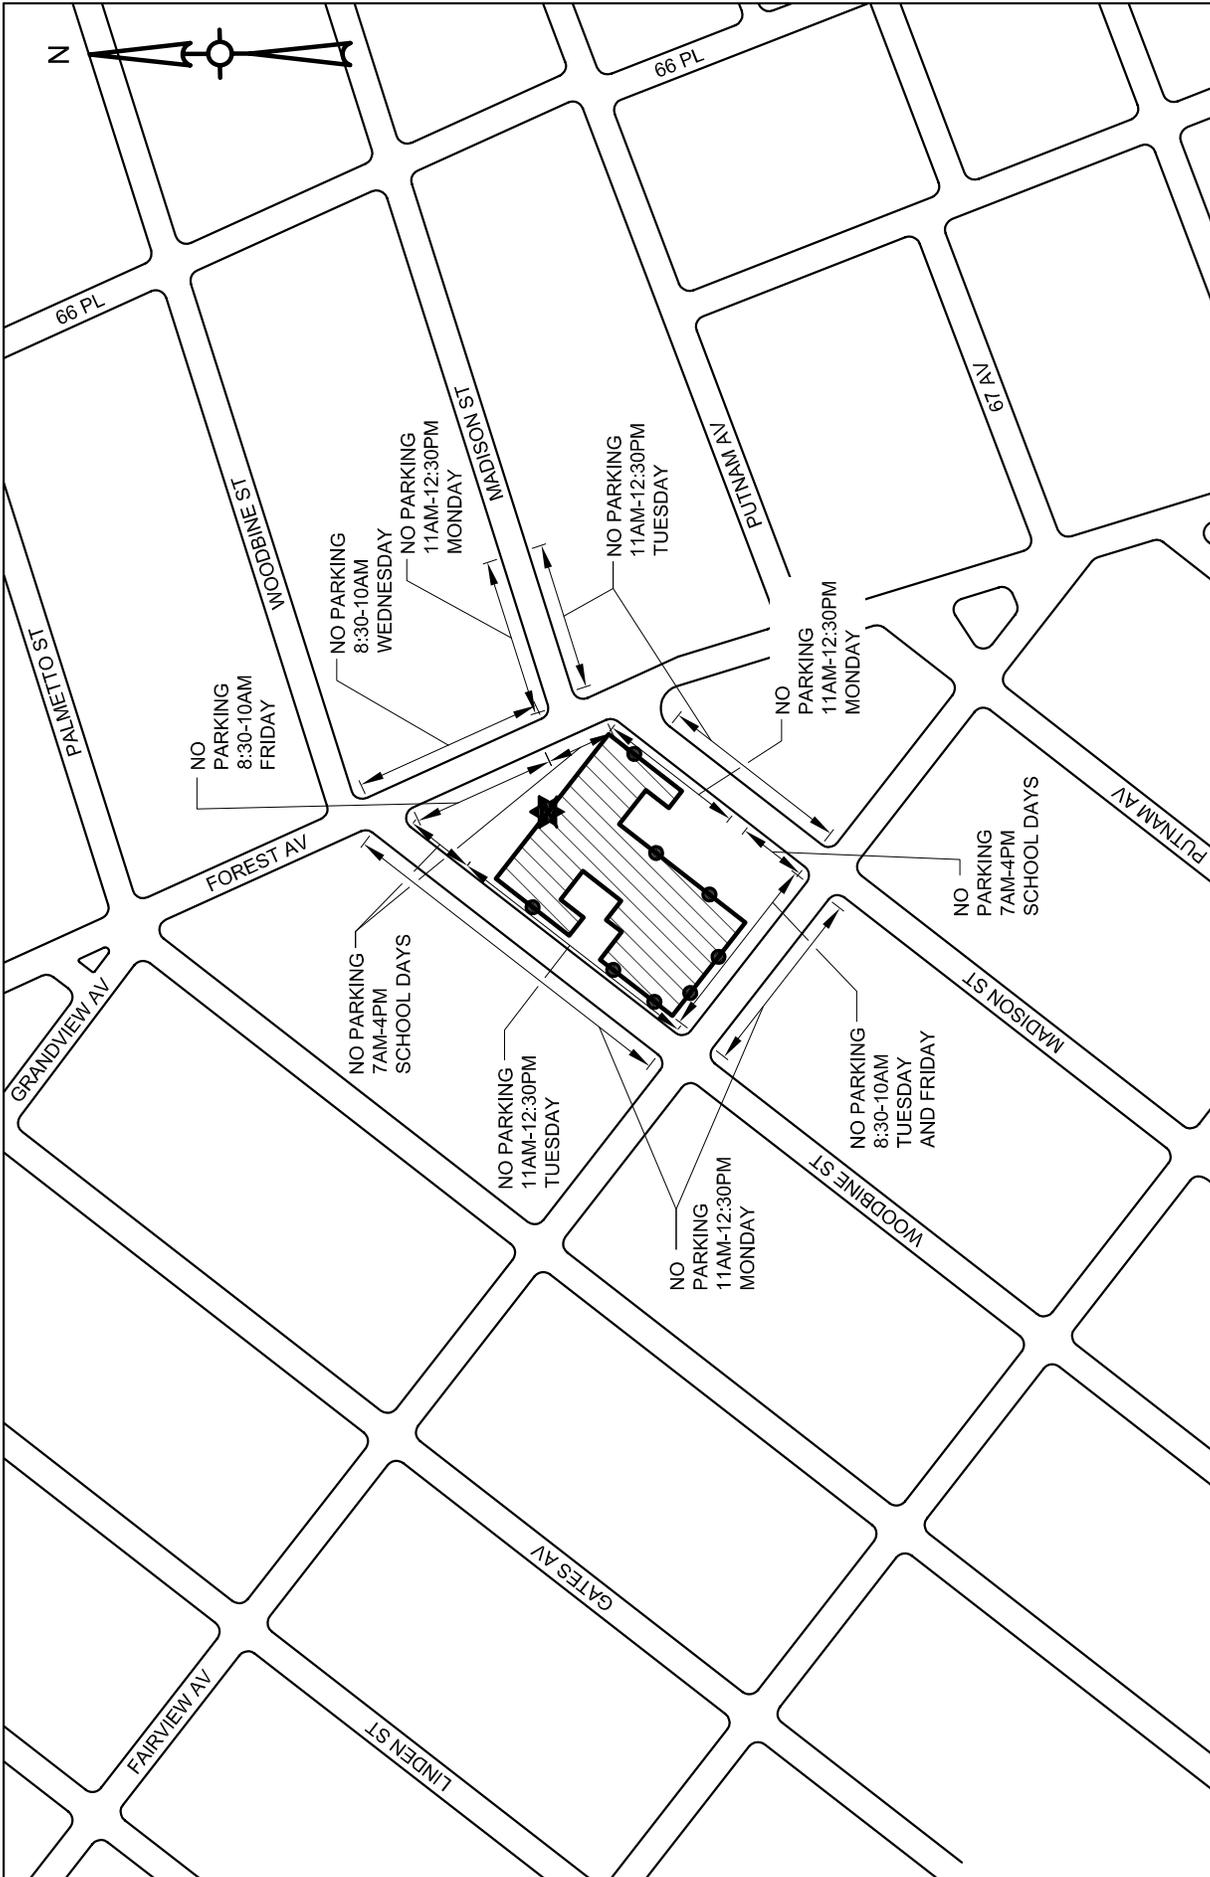
EXHIBIT 4
I.S. 93 QUEENS
RIDGEWOOD INTERMEDIATE SCHOOL
EXISTING PARKING REGULATIONS

Parking regulations around the school block are shown in Exhibit 4 at the end of this section.

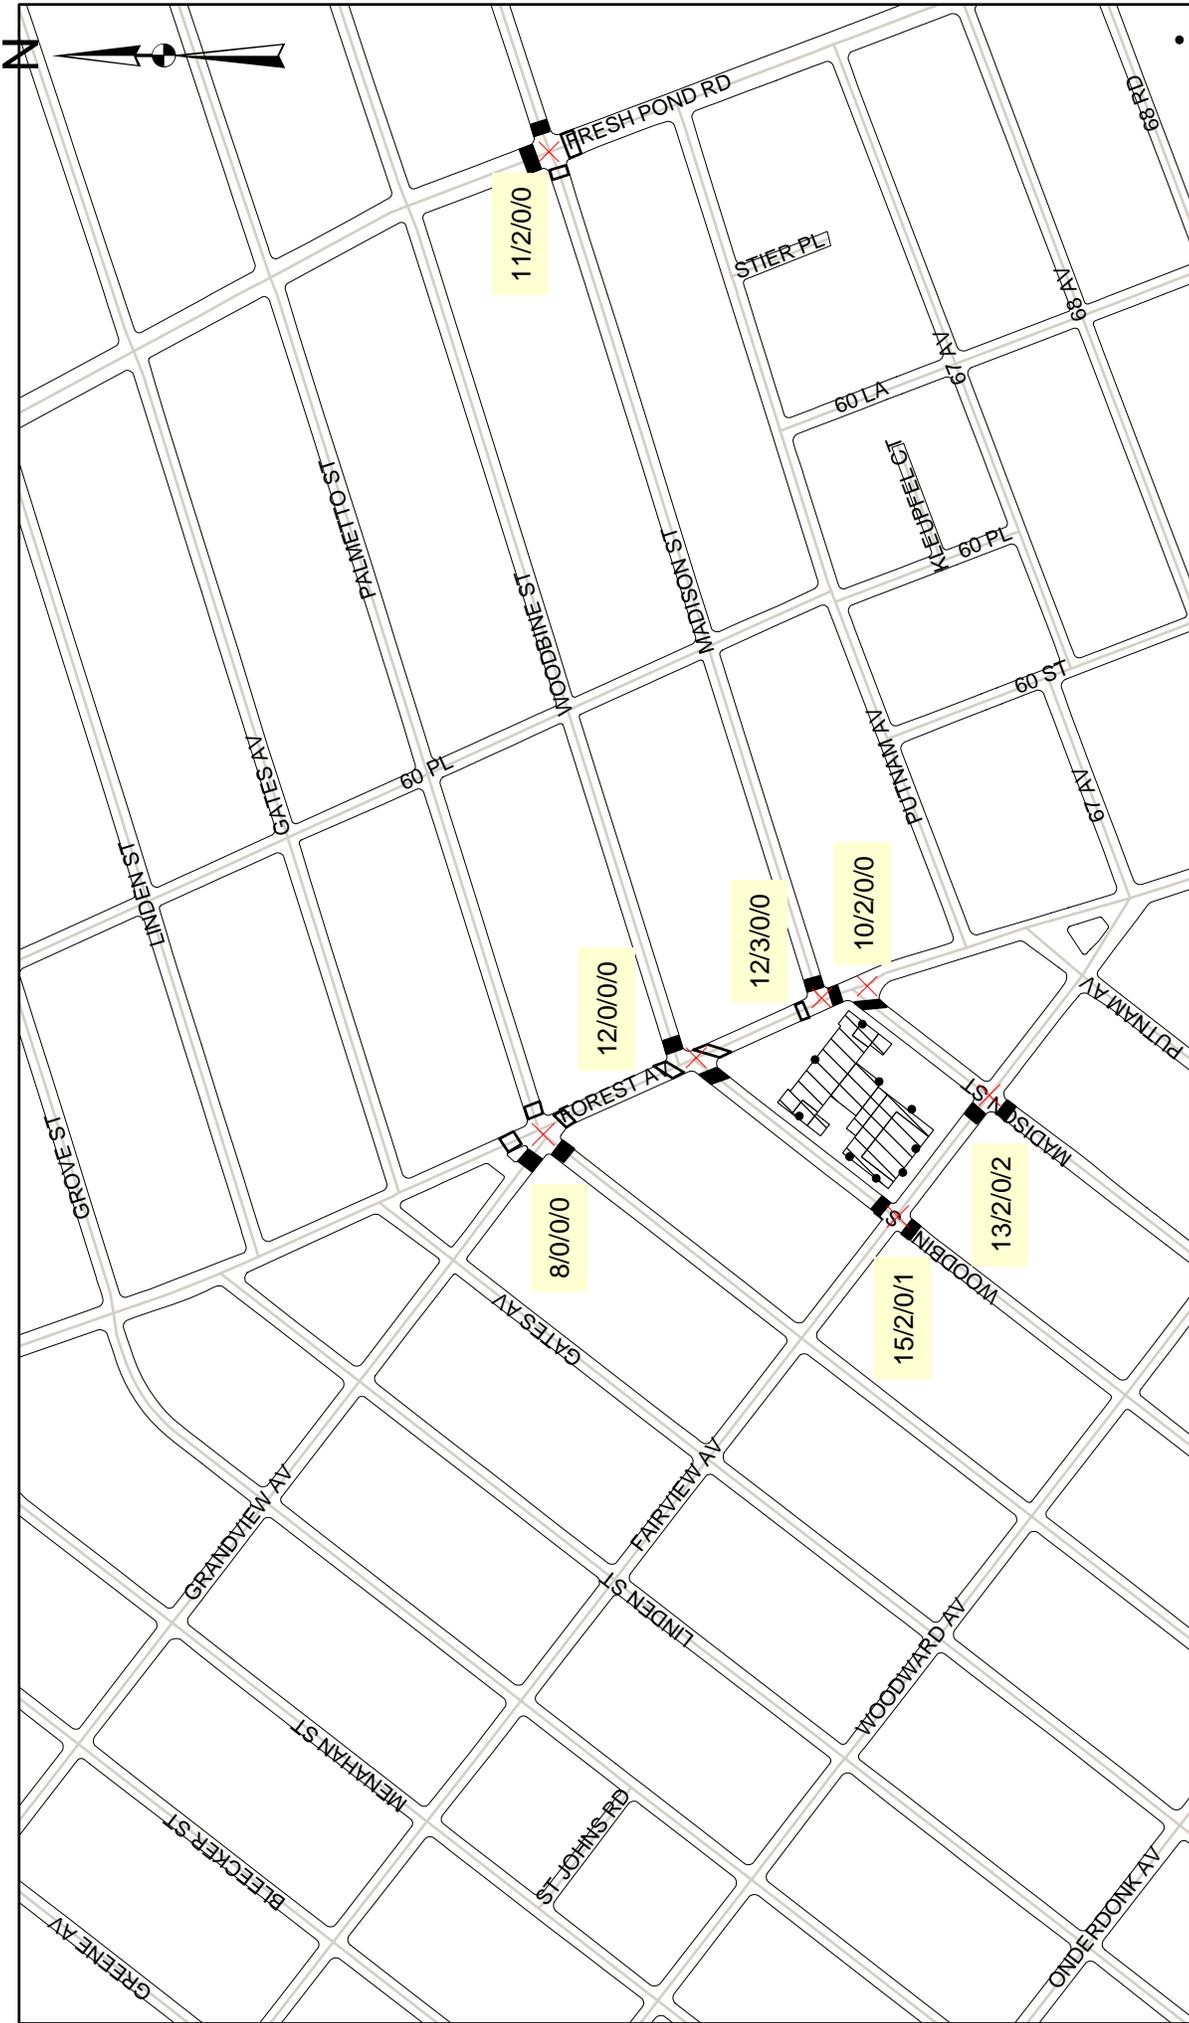
EXHIBIT 5
I.S. 93 QUEENS
RIDGEWOOD INTERMEDIATE SCHOOL
ACCIDENT SUMMARY (1998-2000)

Exhibit 5, at end of this section, and Table 2 show a summary of accidents, as obtained from the New York State Department of Motor Vehicles (NYS DMV) in the vicinity of I.S. 93 for a three-year period from January 1, 1998 to December 1, 2000. The NYS DMV data provides some detail relating to the cause of an accident. Table 3 is a summary of more recent accident data obtained from the New York City Police Department (NYPD). Though current through 2004, the NYPD data does not provide the same level of detail as the NYS DMV data.

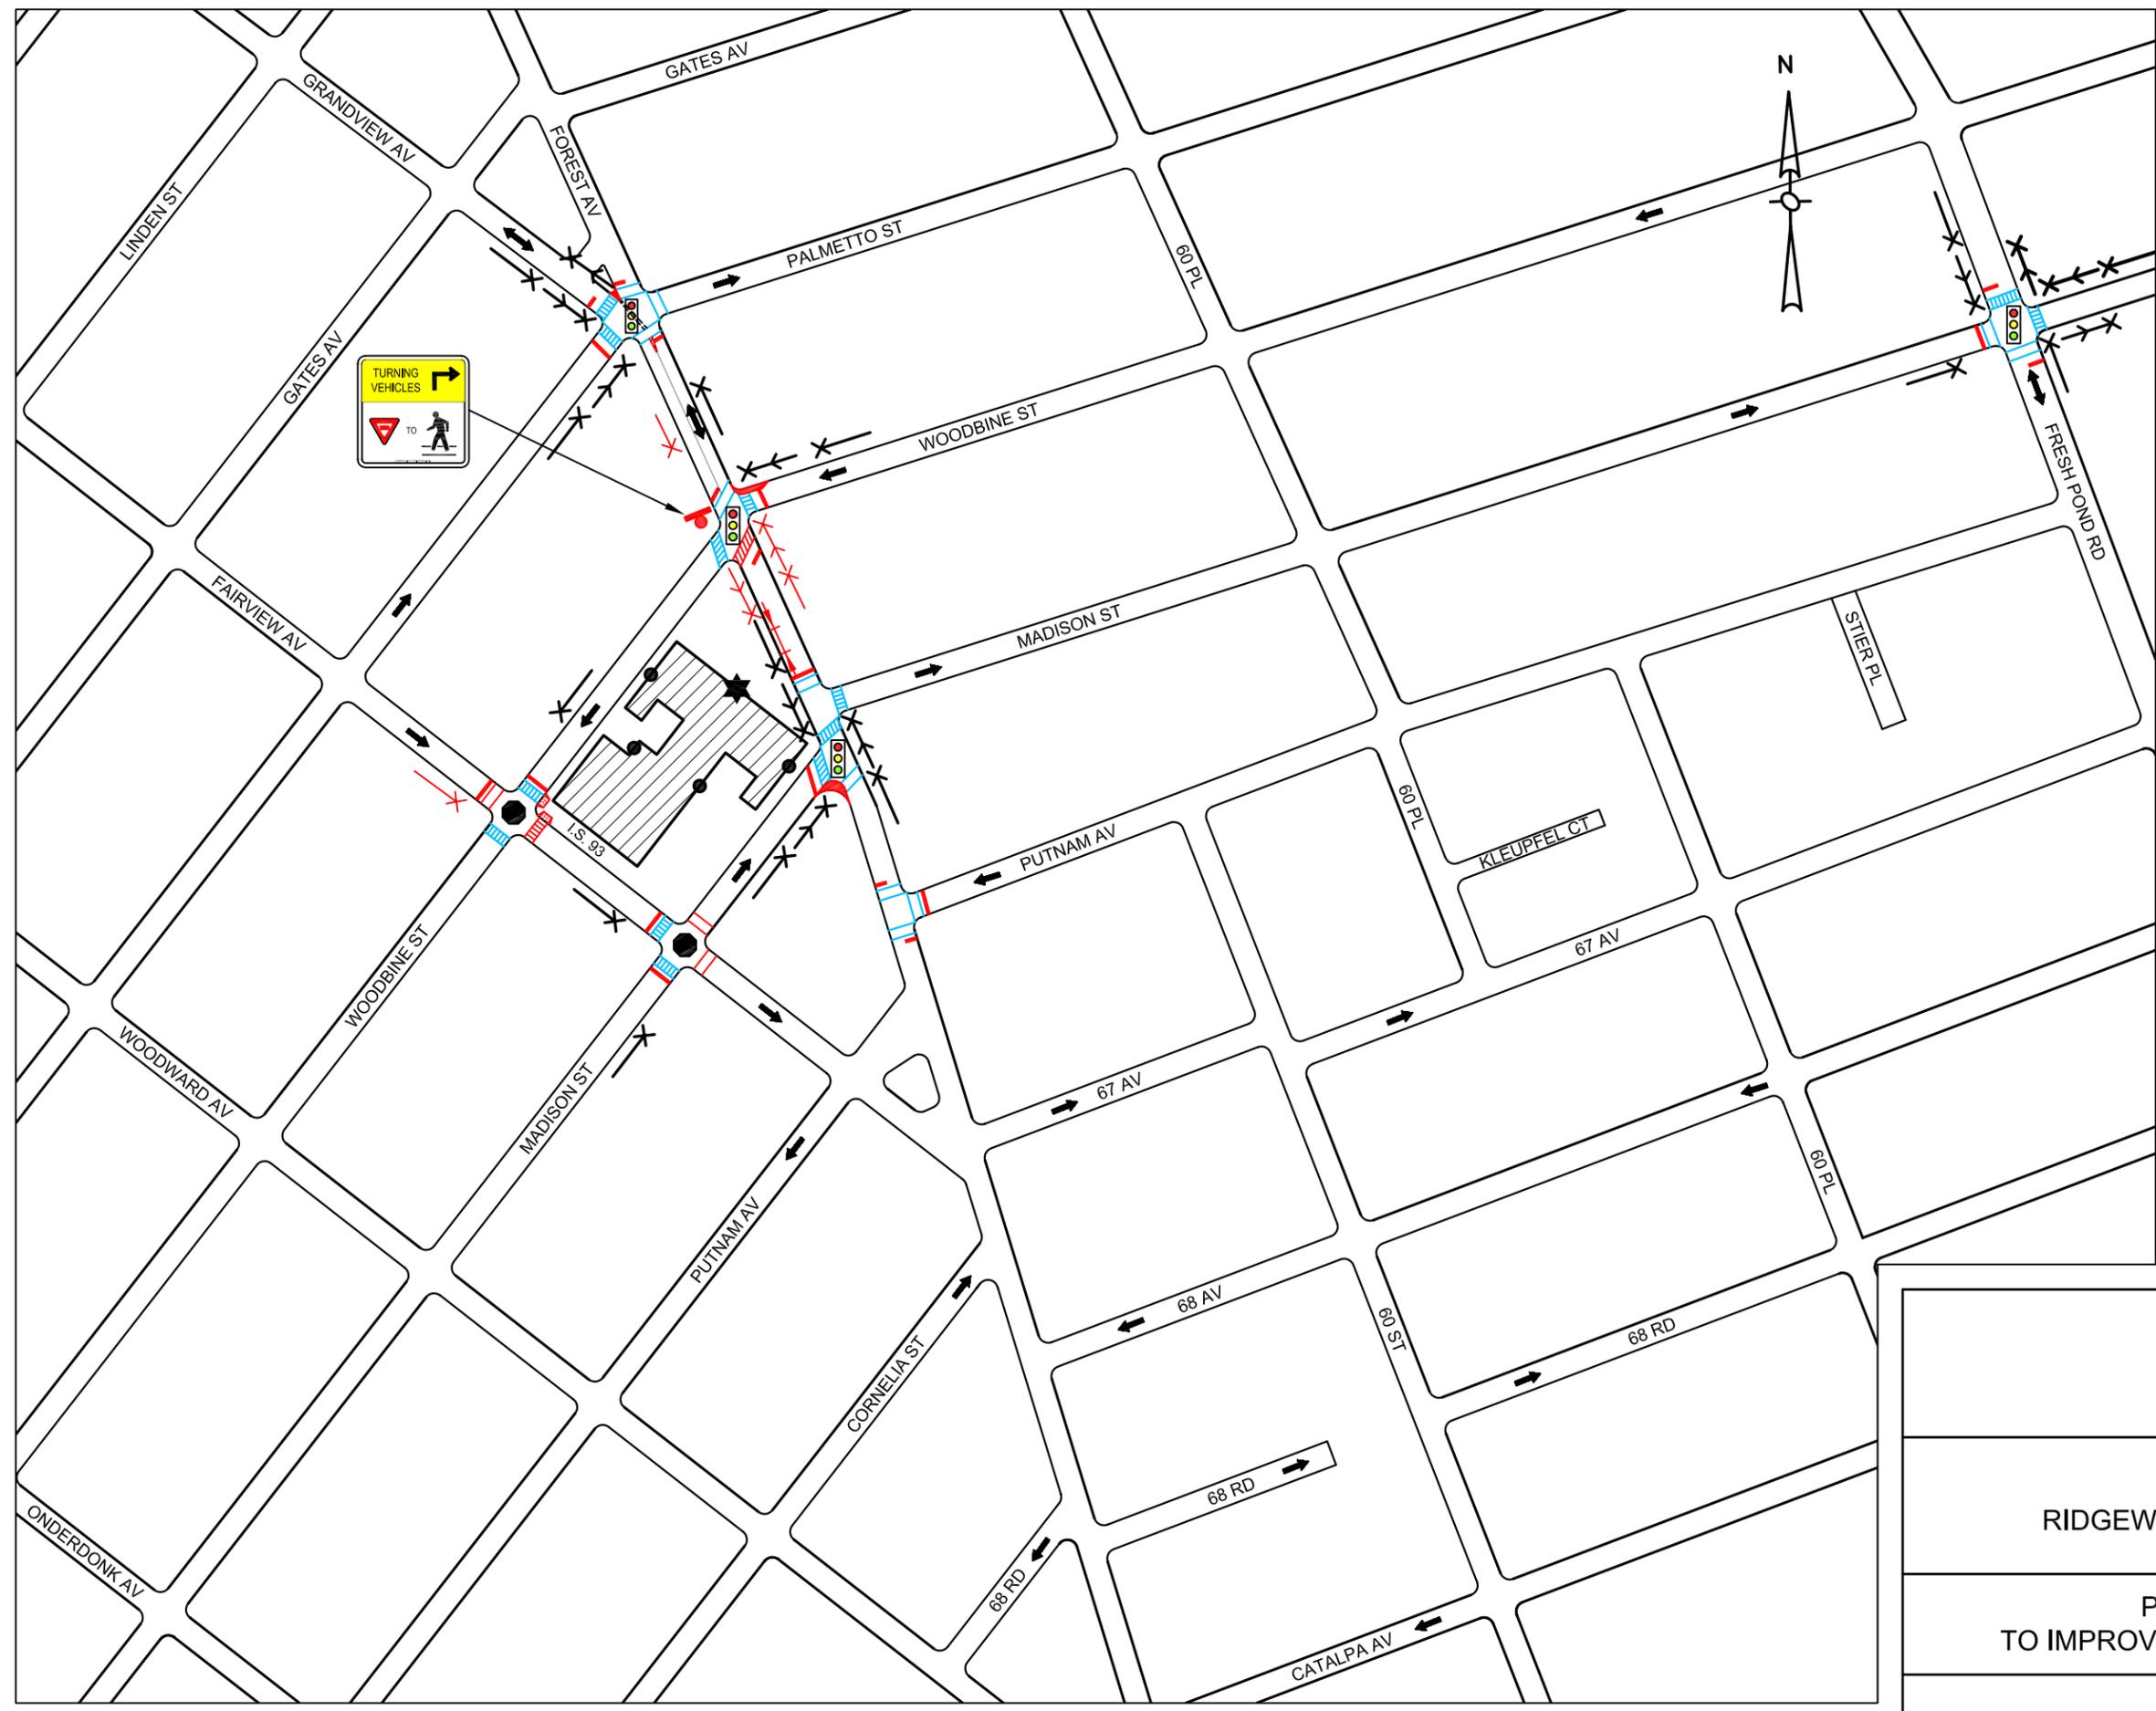
EXHIBIT 6

**PROPOSED MEASURES
TO IMPROVE SCHOOL PEDESTRIAN SAFETY**

Curb extensions should be installed at the corners as shown in Exhibit 6. The purpose of the curb extension is to provide additional reservoir space for pedestrians, to shorten the crossing distance for pedestrians, and to reduce the speed of vehicles approaching and turning on school crosswalks. The curb extension will not eliminate or reduce the width of any travel lanes. Curb extensions are not proposed where they would hinder the ability of a vehicle to turn.

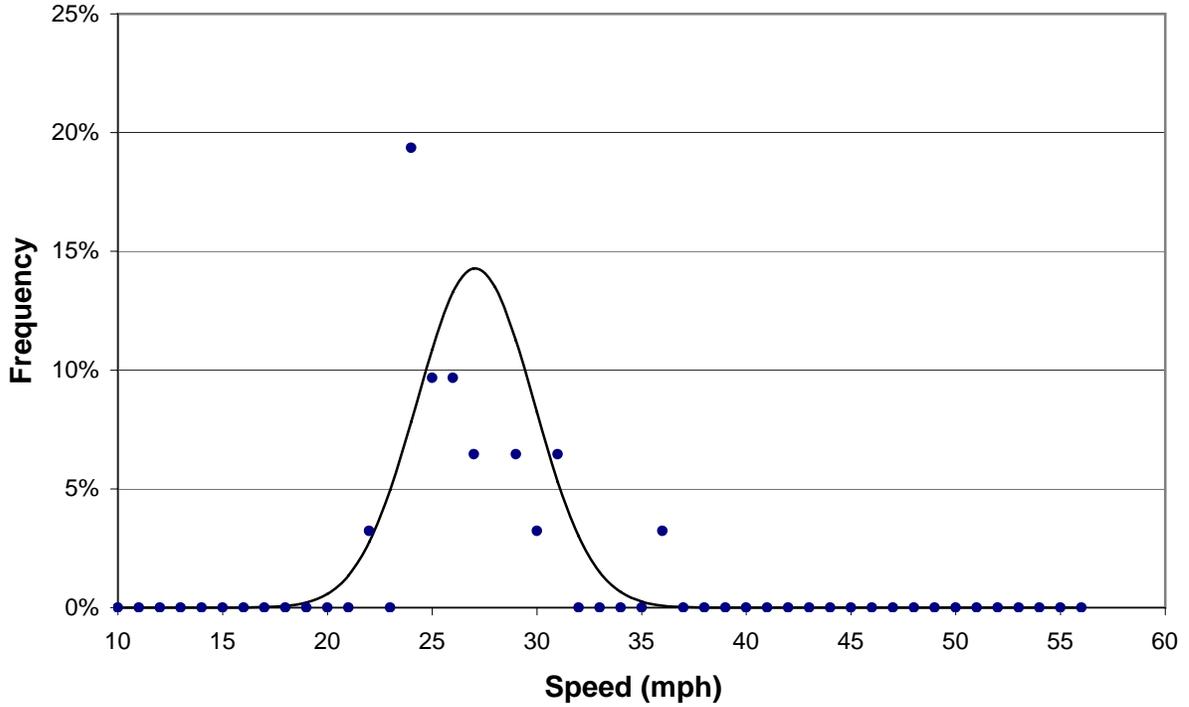
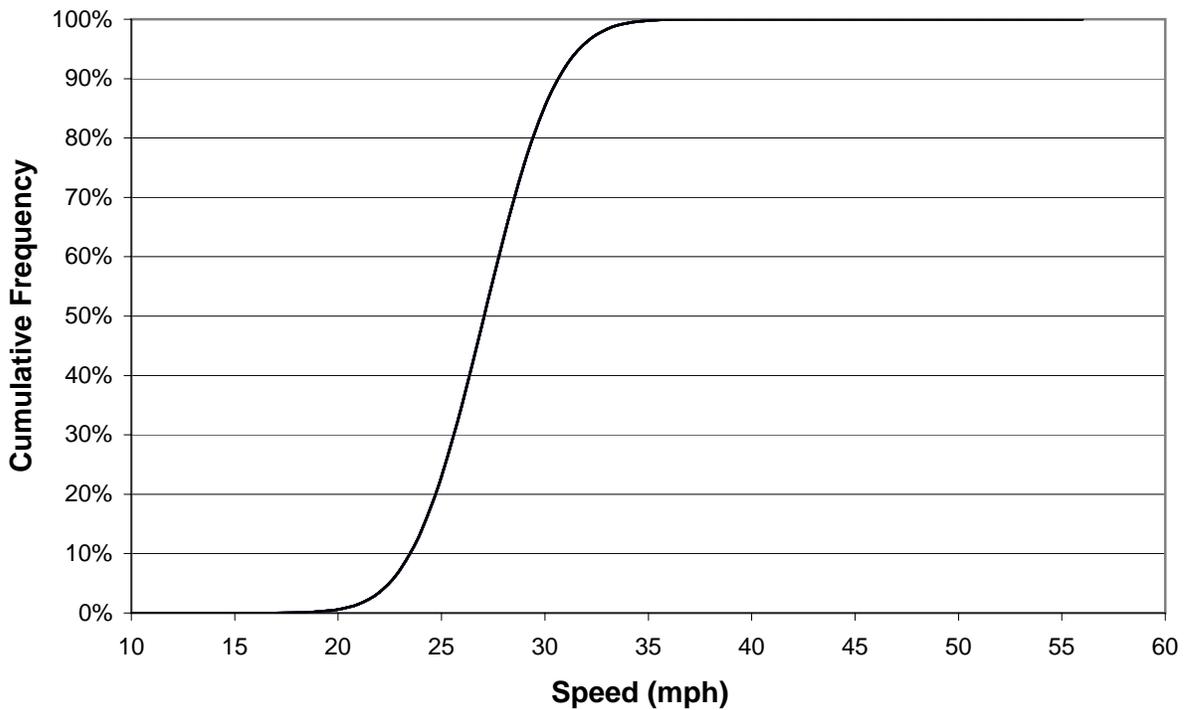
The 85th percentile speed for northbound vehicles on Forest Avenue between Woodbine Street and Madison Street was found to be 30 mph. The 85th percentile speed for southbound vehicles on Forest Avenue between Woodbine Street and Madison Street was found to be 31 mph.

Mean Speed = 27.1 mph Median Speed = 27.1 mph
 Standard Deviation = 2.8 mph 15th Percentile Speed = 24.2 mph
 Margin of Error (95% Confidence) = ± 1.0 mph 85th Percentile Speed = 30.0 mph
