**New York City Department of Transportation
Office of School Safety Engineering**

School Safety Engineering Project

FINAL REPORT: I.S. 93 (Ridgewood Intermediate School), Queens

**Prepared by
The RBA Group and URBITRAN Associates Inc.**

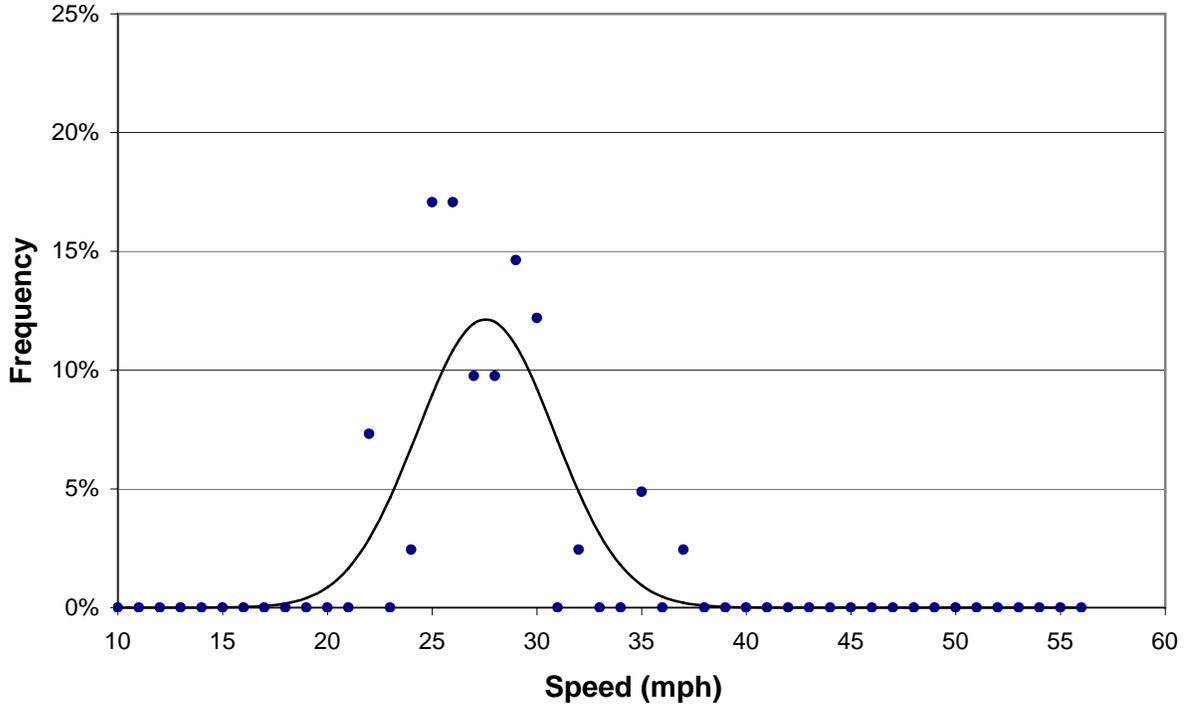
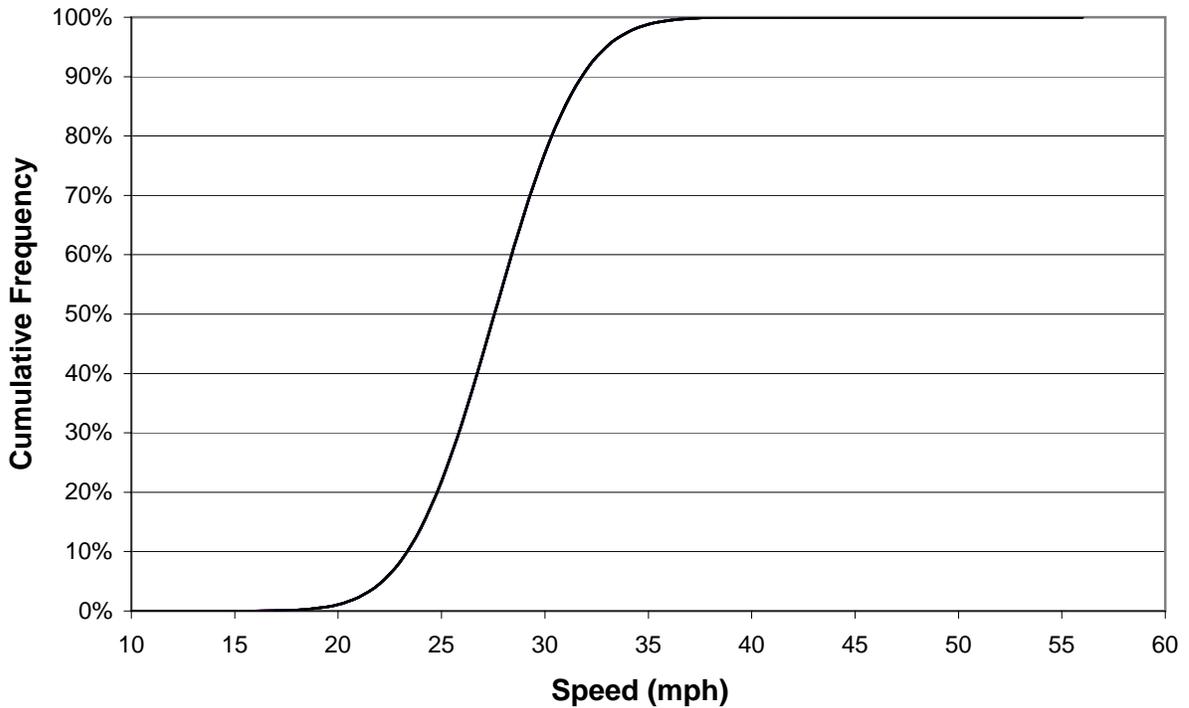
Standard Deviation = 3.3 mph
15th Percentile Speed = 24.2 mph

Margin of Error (95% Confidence) = ± 1.0 mph
85th Percentile Speed = 31.0 mph
