CONSTRUCTION SAFETY REPORT CARD 2021

ANNUAL CONSTRUCTION-RELATED INJURIES & FATALITIES

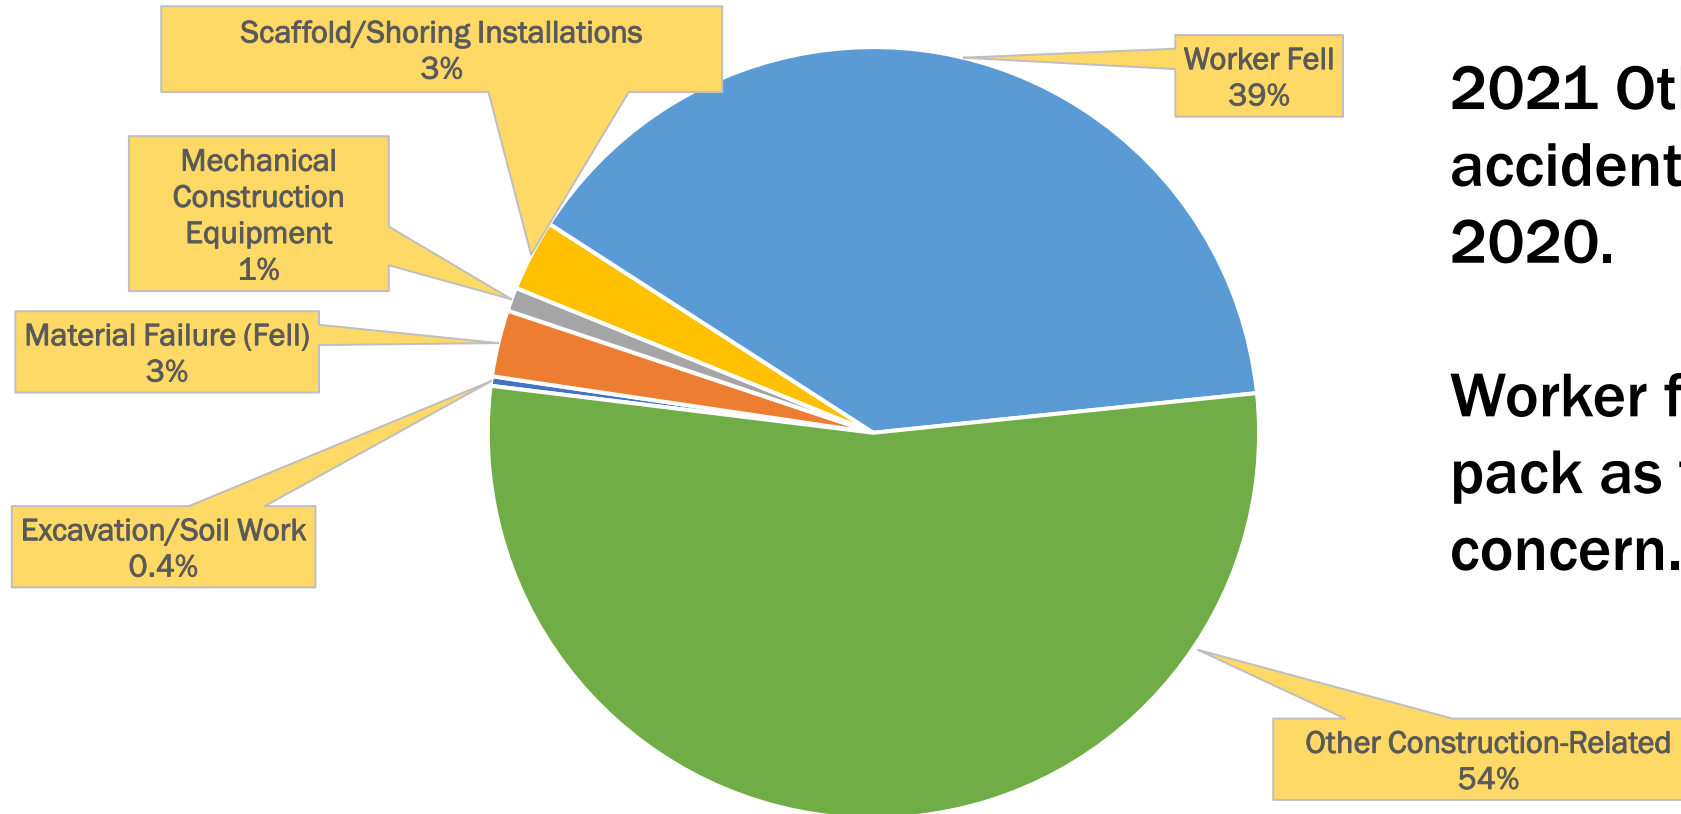
2021 CONSTRUCTION-RELATED ACCIDENTS BY CAUSE OF ACCIDENT

2021 Other Construction-Related accidents increased by **11%** over 2020.

Worker falls continue to lead the pack as the primary area of concern.

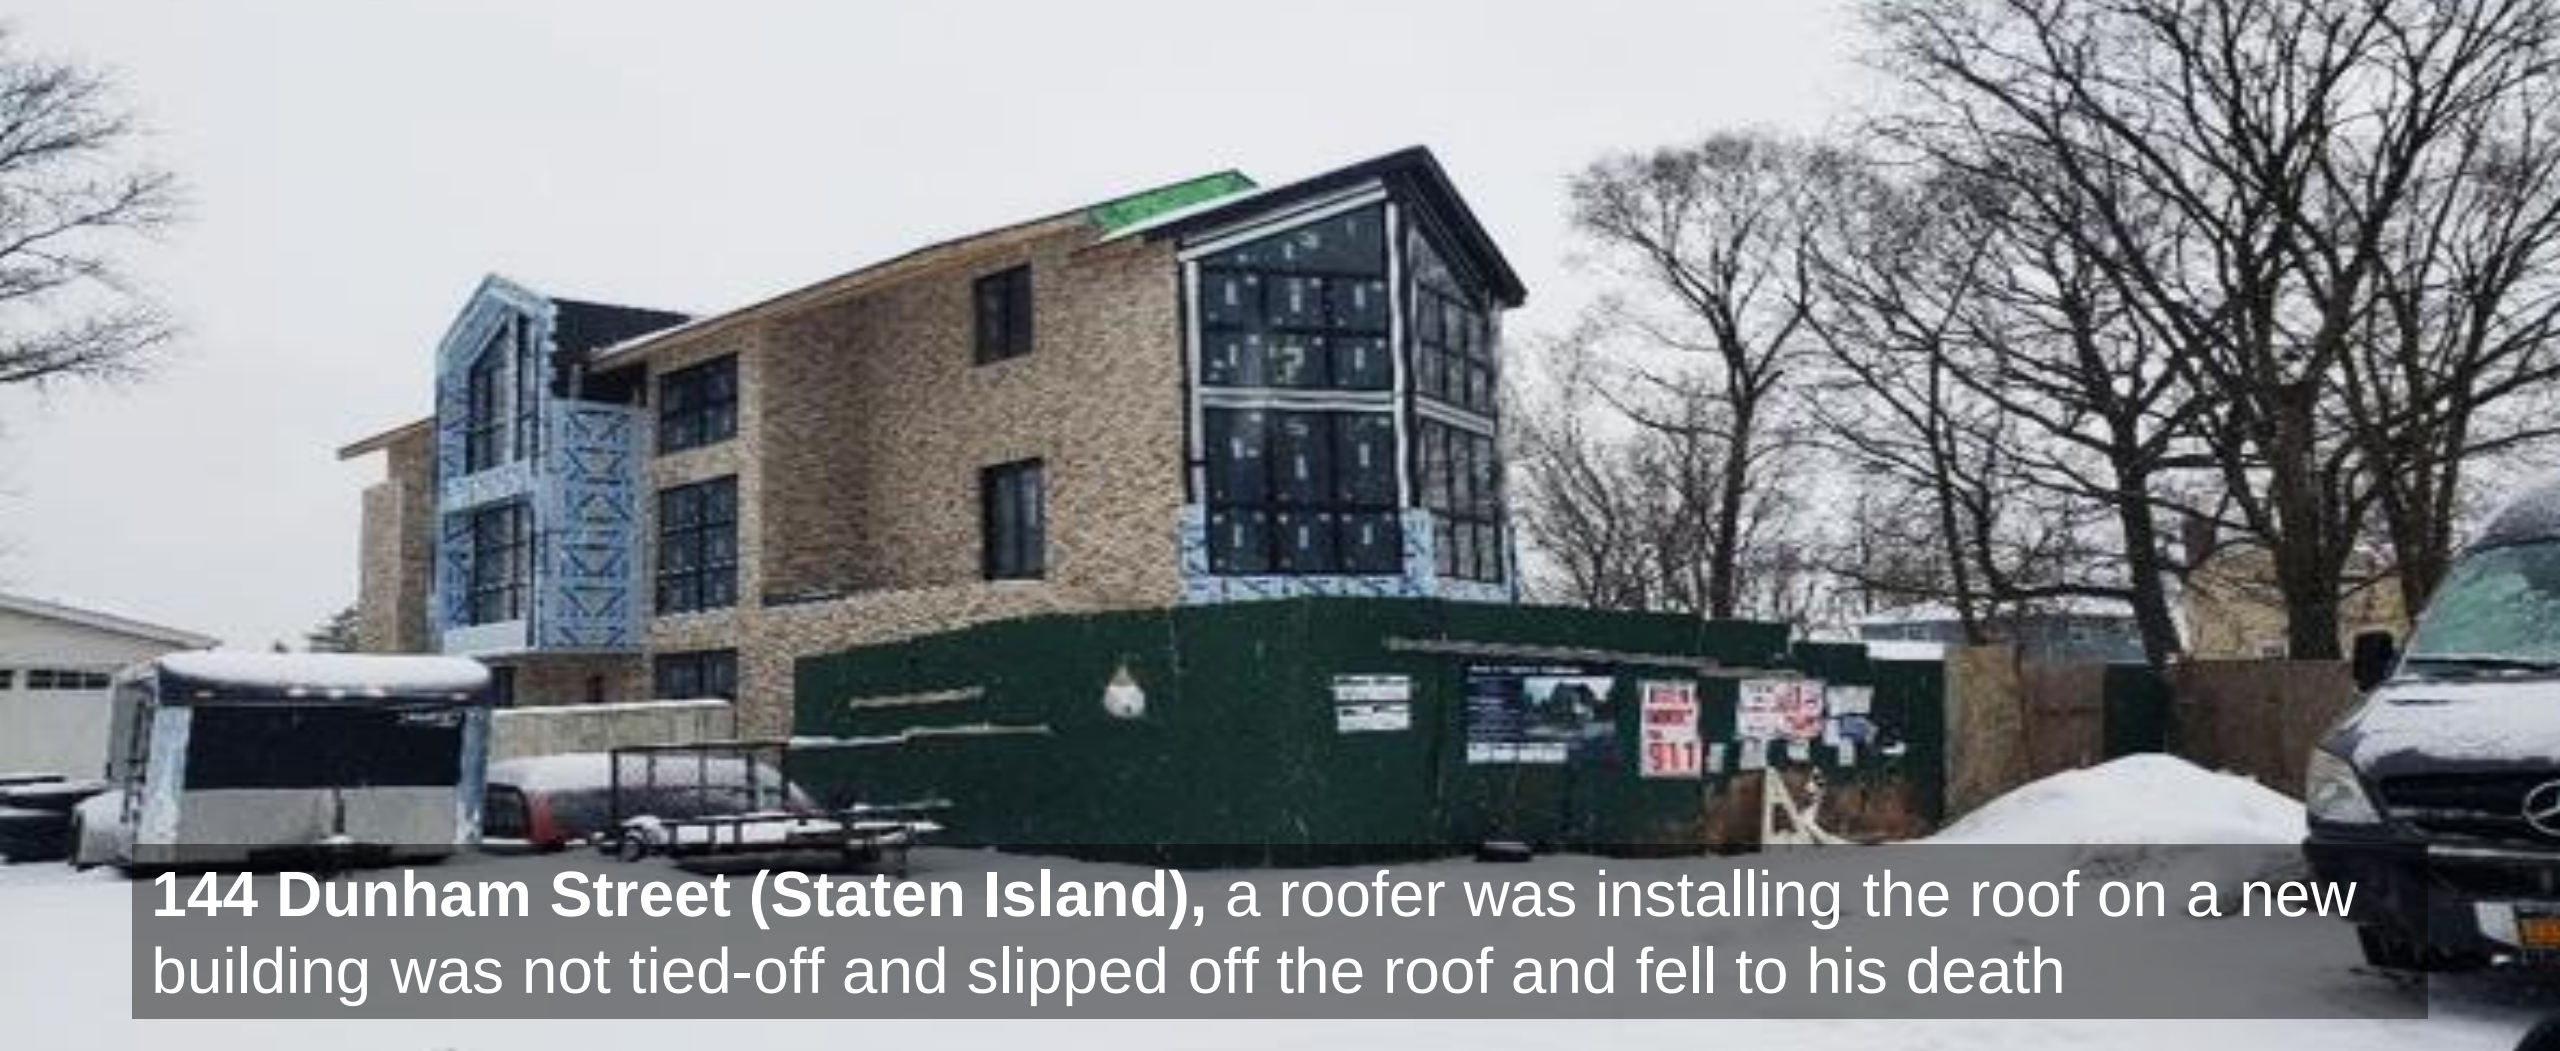
2/17/21: ROOF WORKER FALL

144 Dunham Street (Staten Island), a roofer was installing the roof on a new building was not tied-off and slipped off the roof and fell to his death

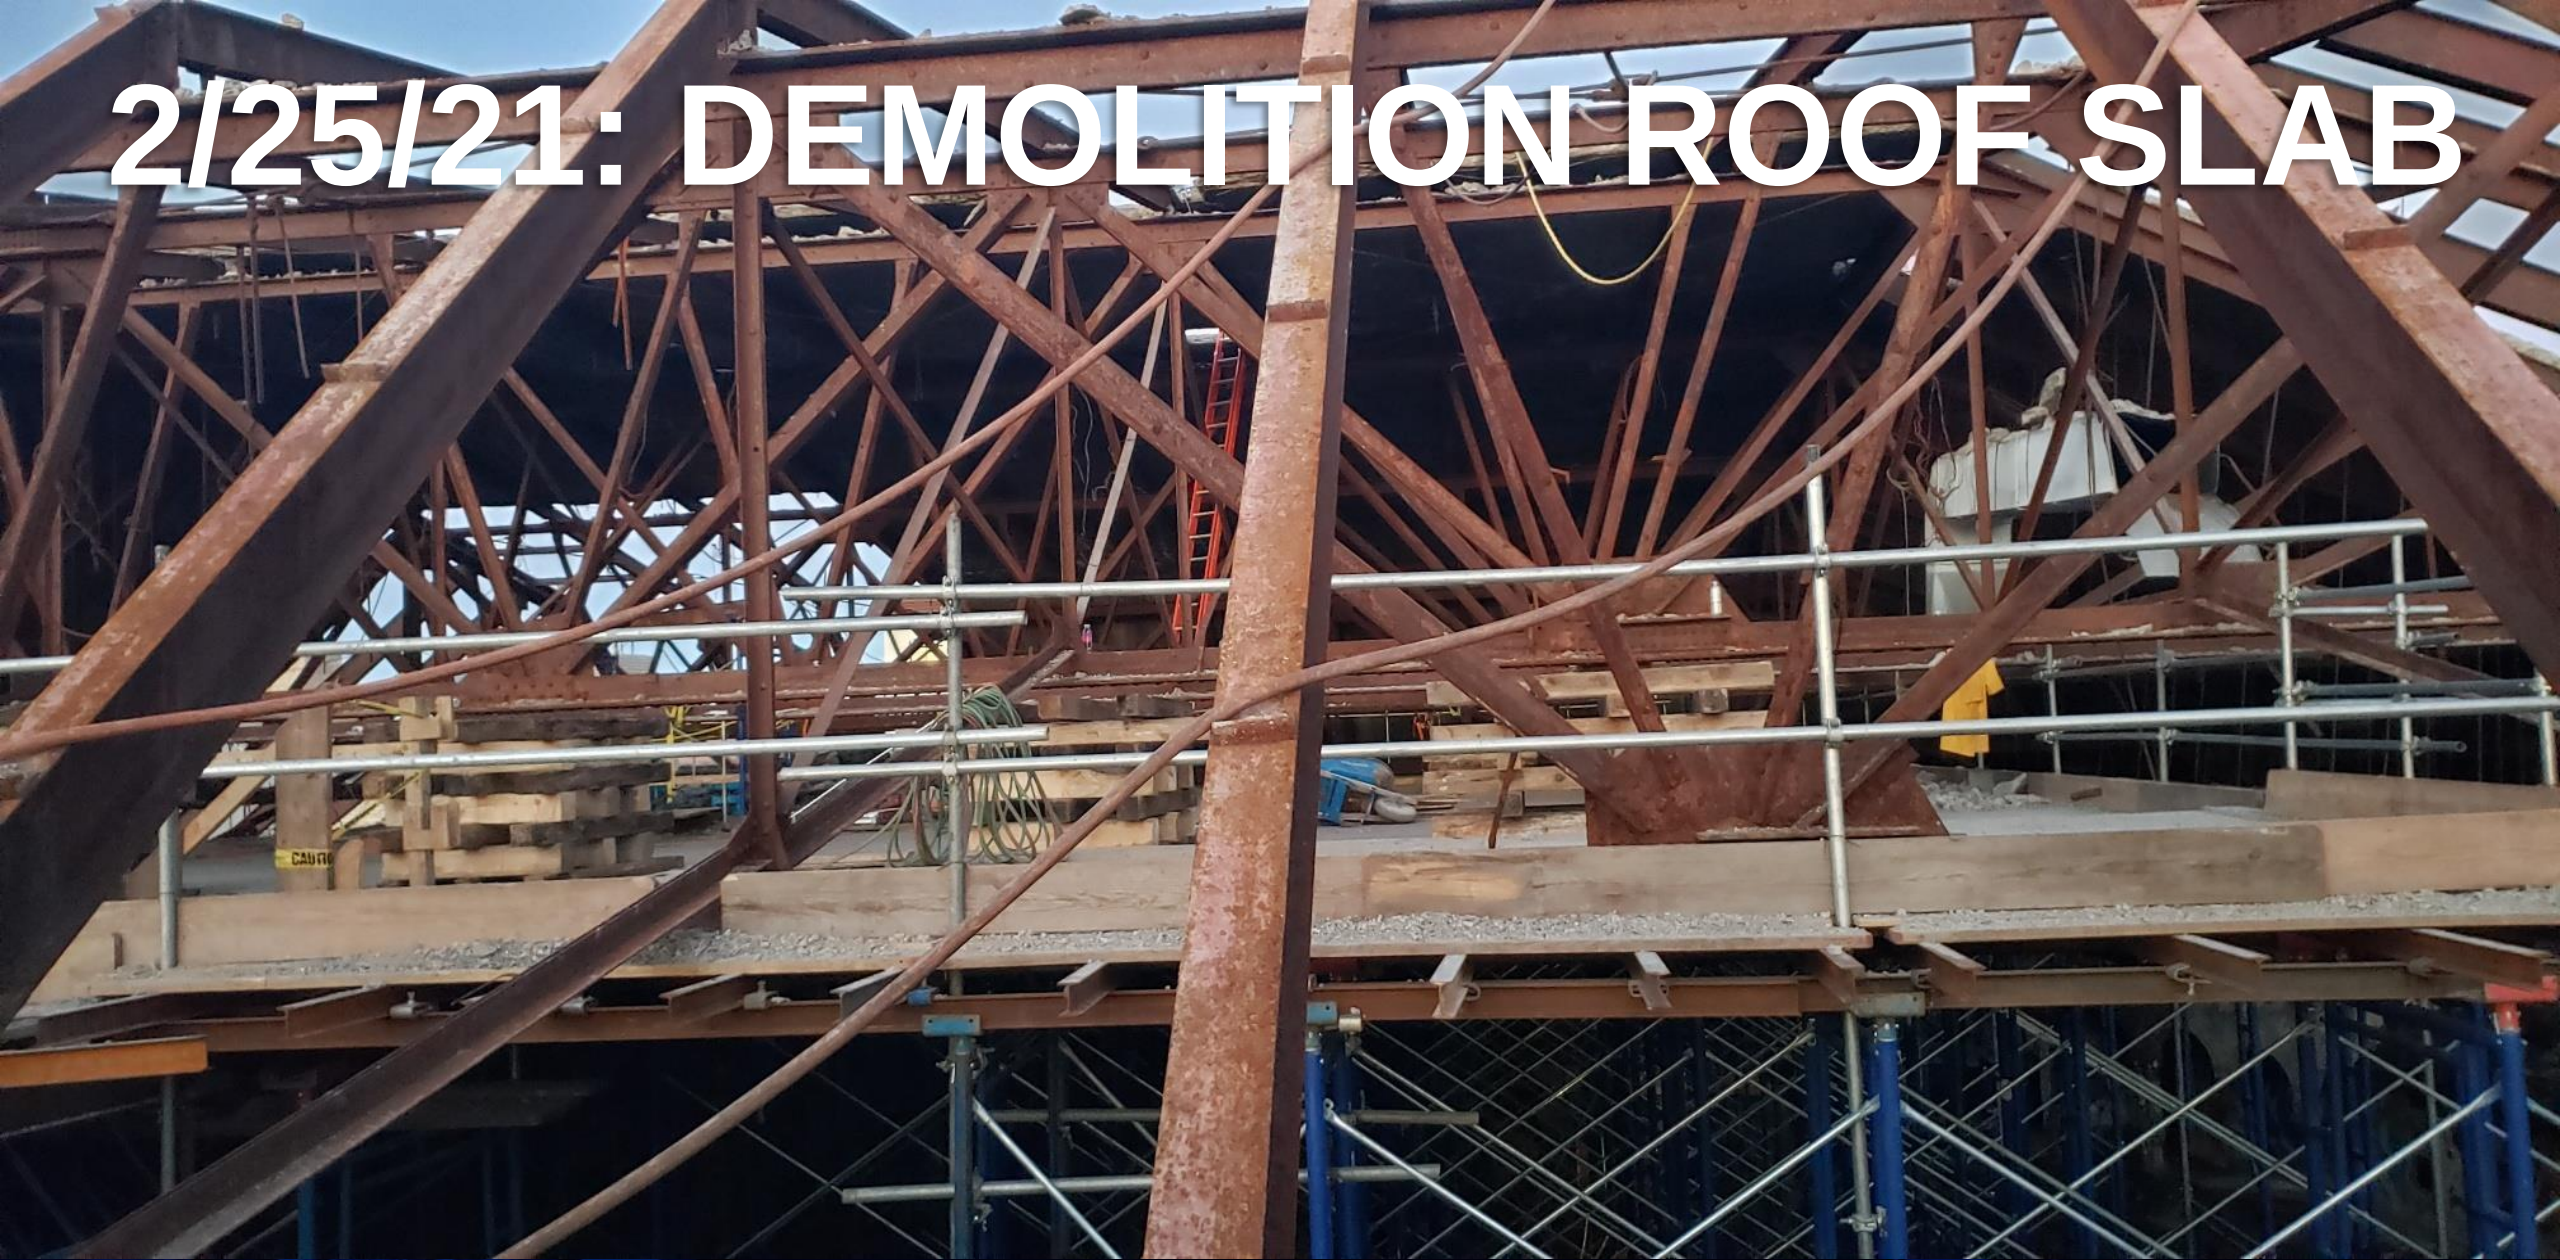
2/25/21: DEMOLITION ROOF SLAB

135-35 Northern Boulevard (Queens)

- A team of workers attempted to conduct maintenance on a tower crane. The workers were not properly trained and tried to remove the drive motor which serves as the brake for the crane boom.
- While removing the drive motor, the boom collapsed and slammed into the mast of the crane. No major injuries occurred but it took a week to resolve the securing of the crane.

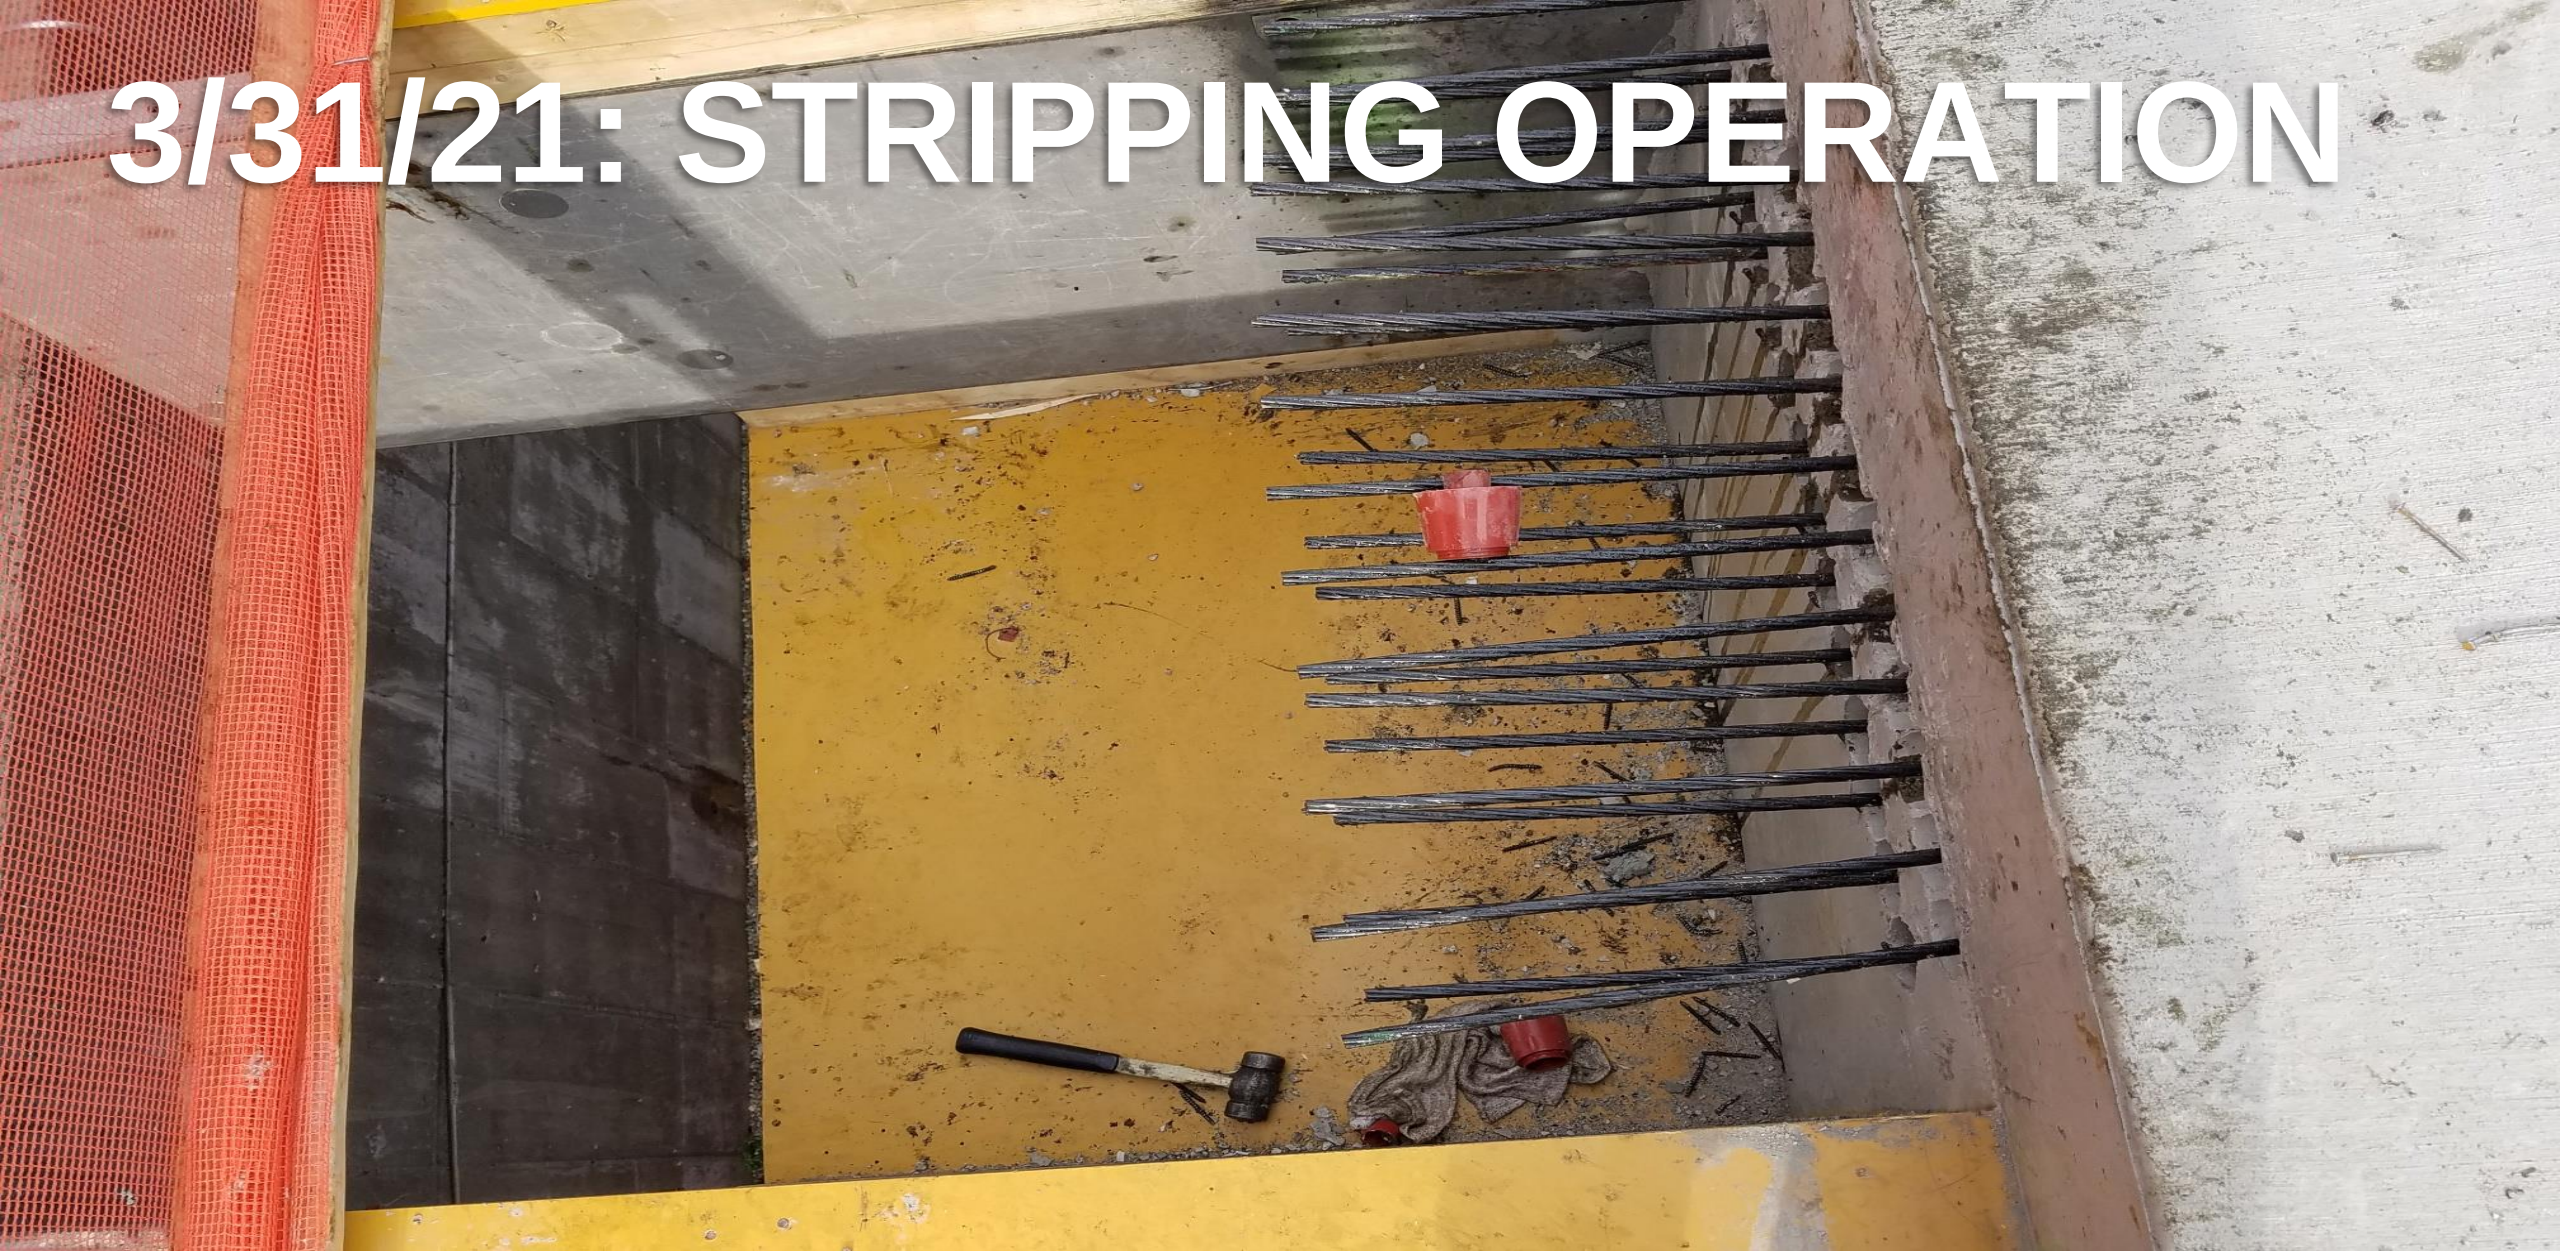
3/31/21: STRIPPING OPERATION

640 Columbia Street (Brooklyn)

- A laborer attempted to strip formwork from a section of a building. The worker was in a controlled access zone which required tie-off.
- The worker did not tie-off and while stripping the forms, stepped back and fell 20 feet. He survived his injuries.

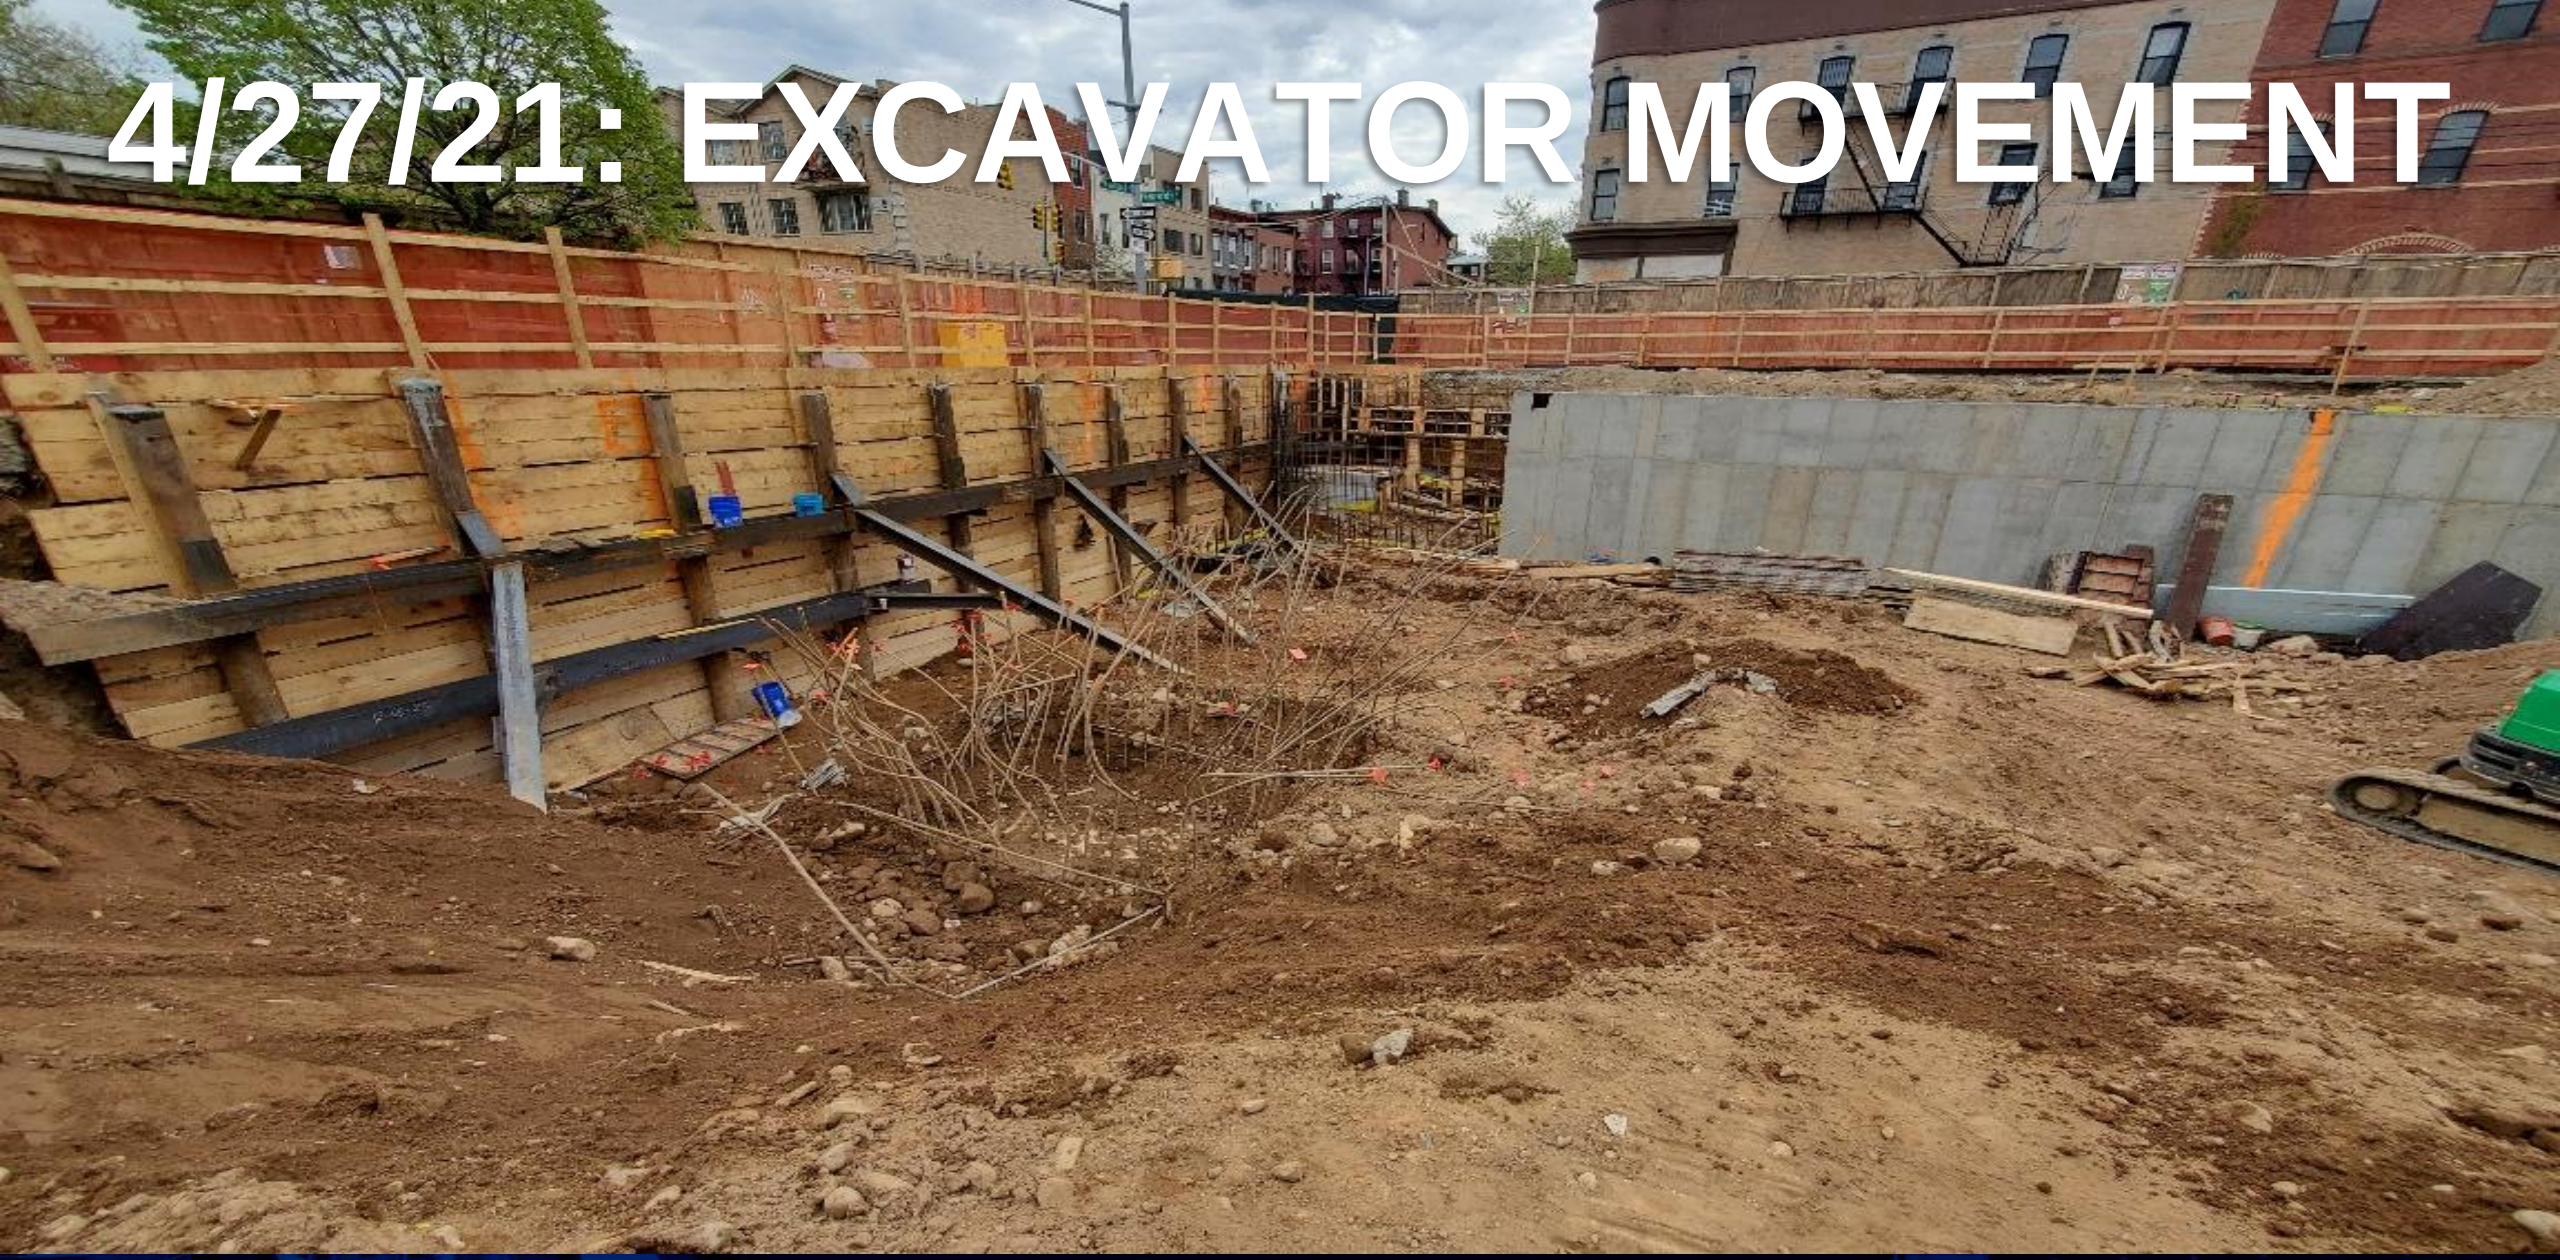
4/27/21: EXCAVATOR MOVEMENT

184 Nostrand Avenue (Brooklyn)

- An excavator operator moved soil on a site. As he positioned the excavator, his treads ran over a piece of re-bar which snapped off and flew across the site striking a worker on the chest.
- The worker struck in the chest required major medical assistance but survived his injuries.

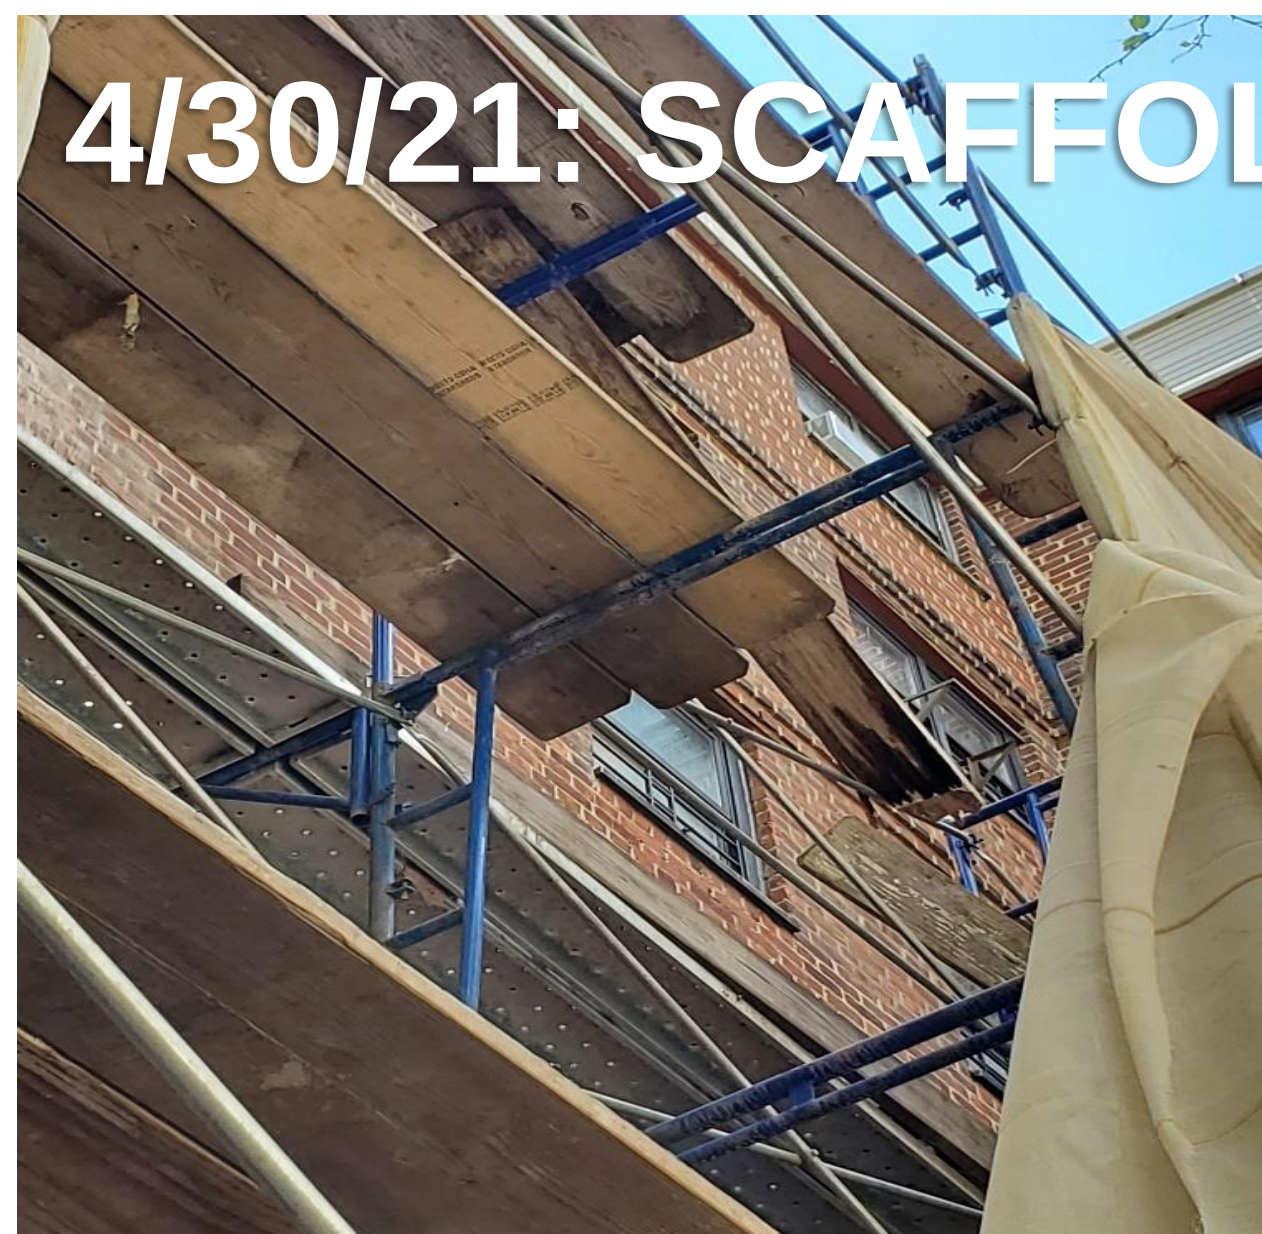
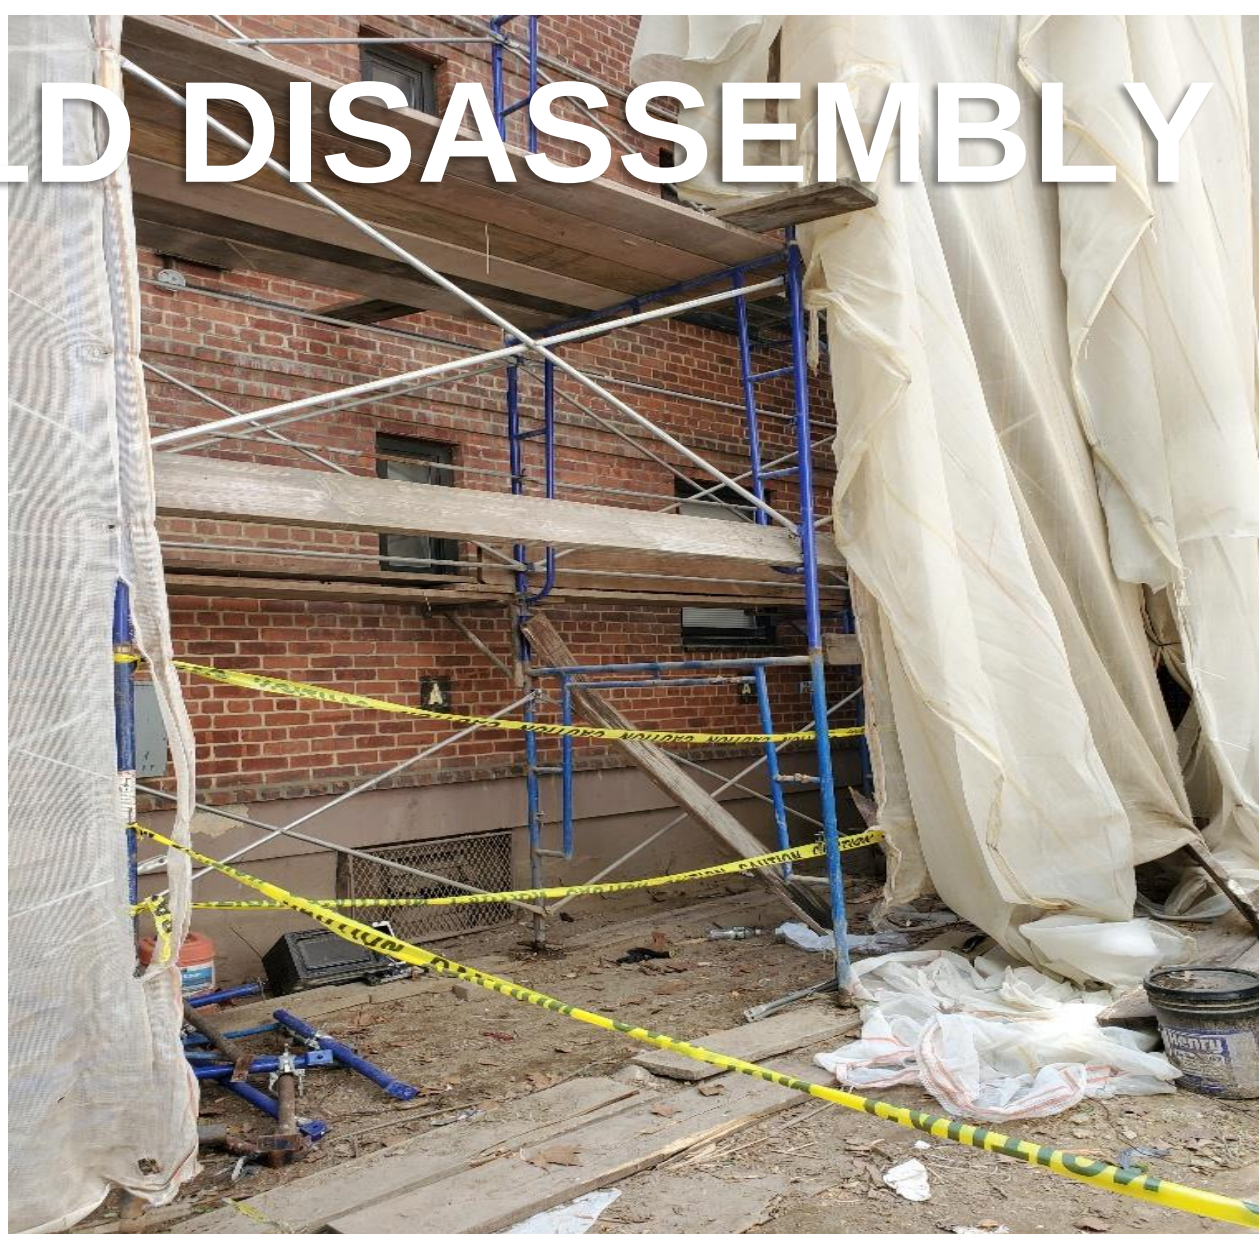
4/30/21: SCAFFOLD DISASSEMBLY

10 West 64th Street (Manhattan)

- A scaffold disassembly worker attempted to disassemble a supported scaffold. He stepped on a rotted plank, which snapped in half.
- The worker fell 30 feet and survived his injuries.

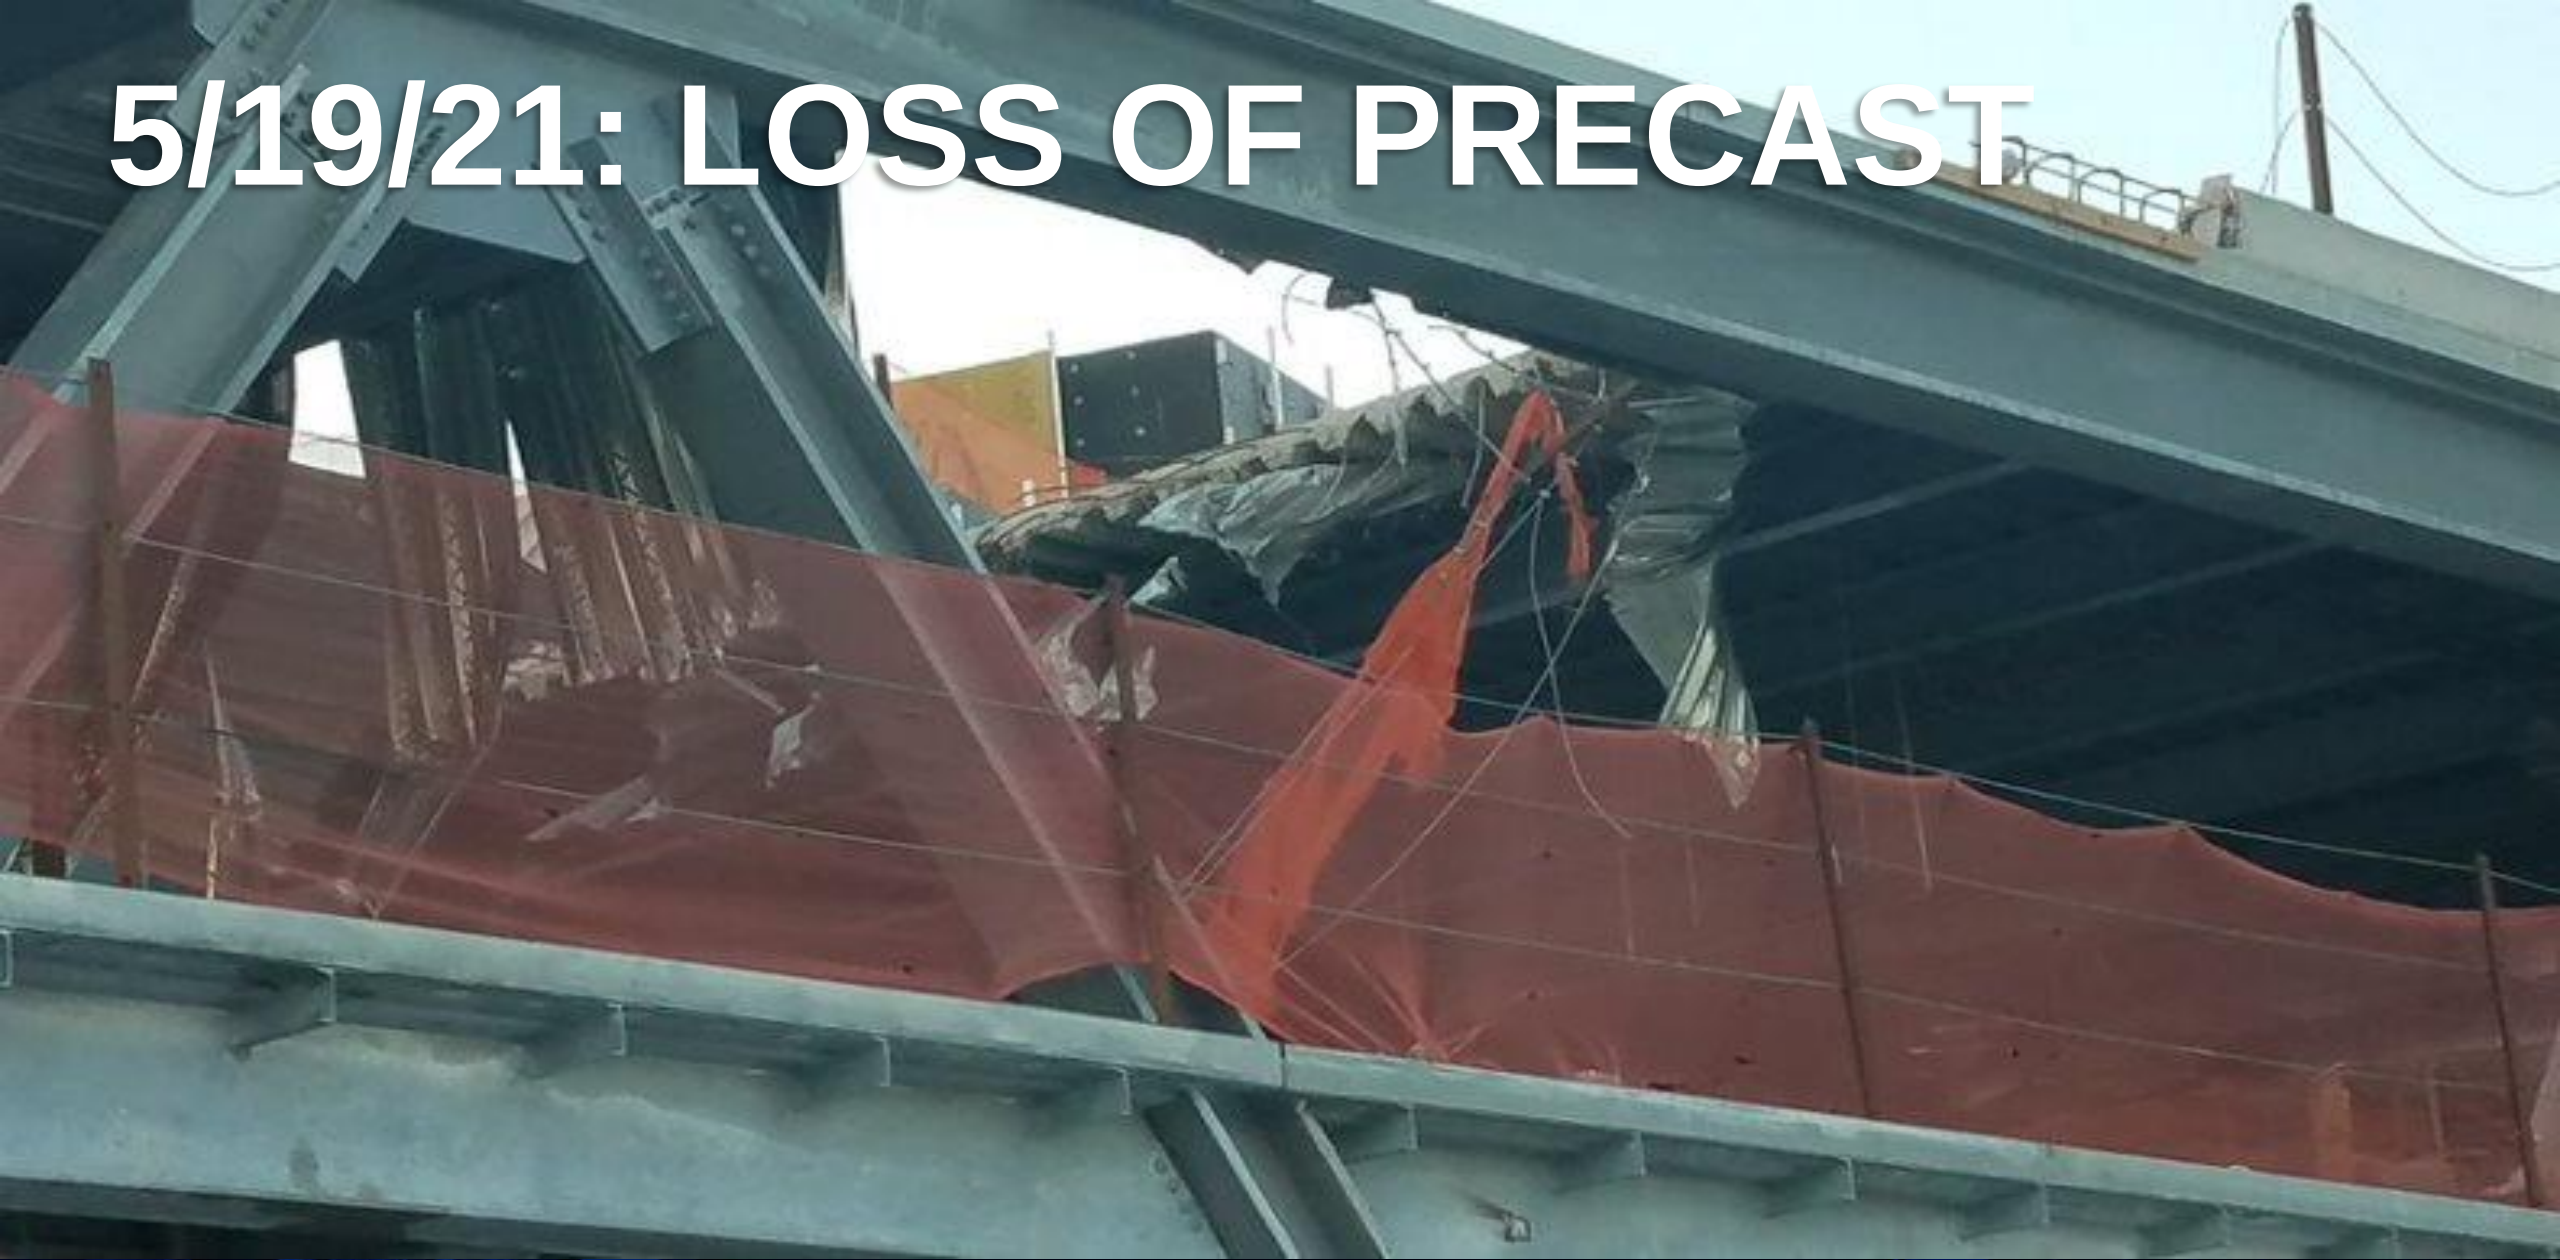
5/19/21: LOSS OF PRECAST

1 Eagle Street (Brooklyn)

- A team of laborers attempted to place a precast façade section on the tenth floor of the building. The workers removed the rope holding the precast section in place before it was properly secured.
- The precast fell to the 7th floor setback where it crashed through the slab to the sixth floor. No major injuries were reported.
