CONSTRUCTION SAFETY REPORT CARD 2021

ANNUAL CONSTRUCTION-RELATED INJURIES & FATALITIES

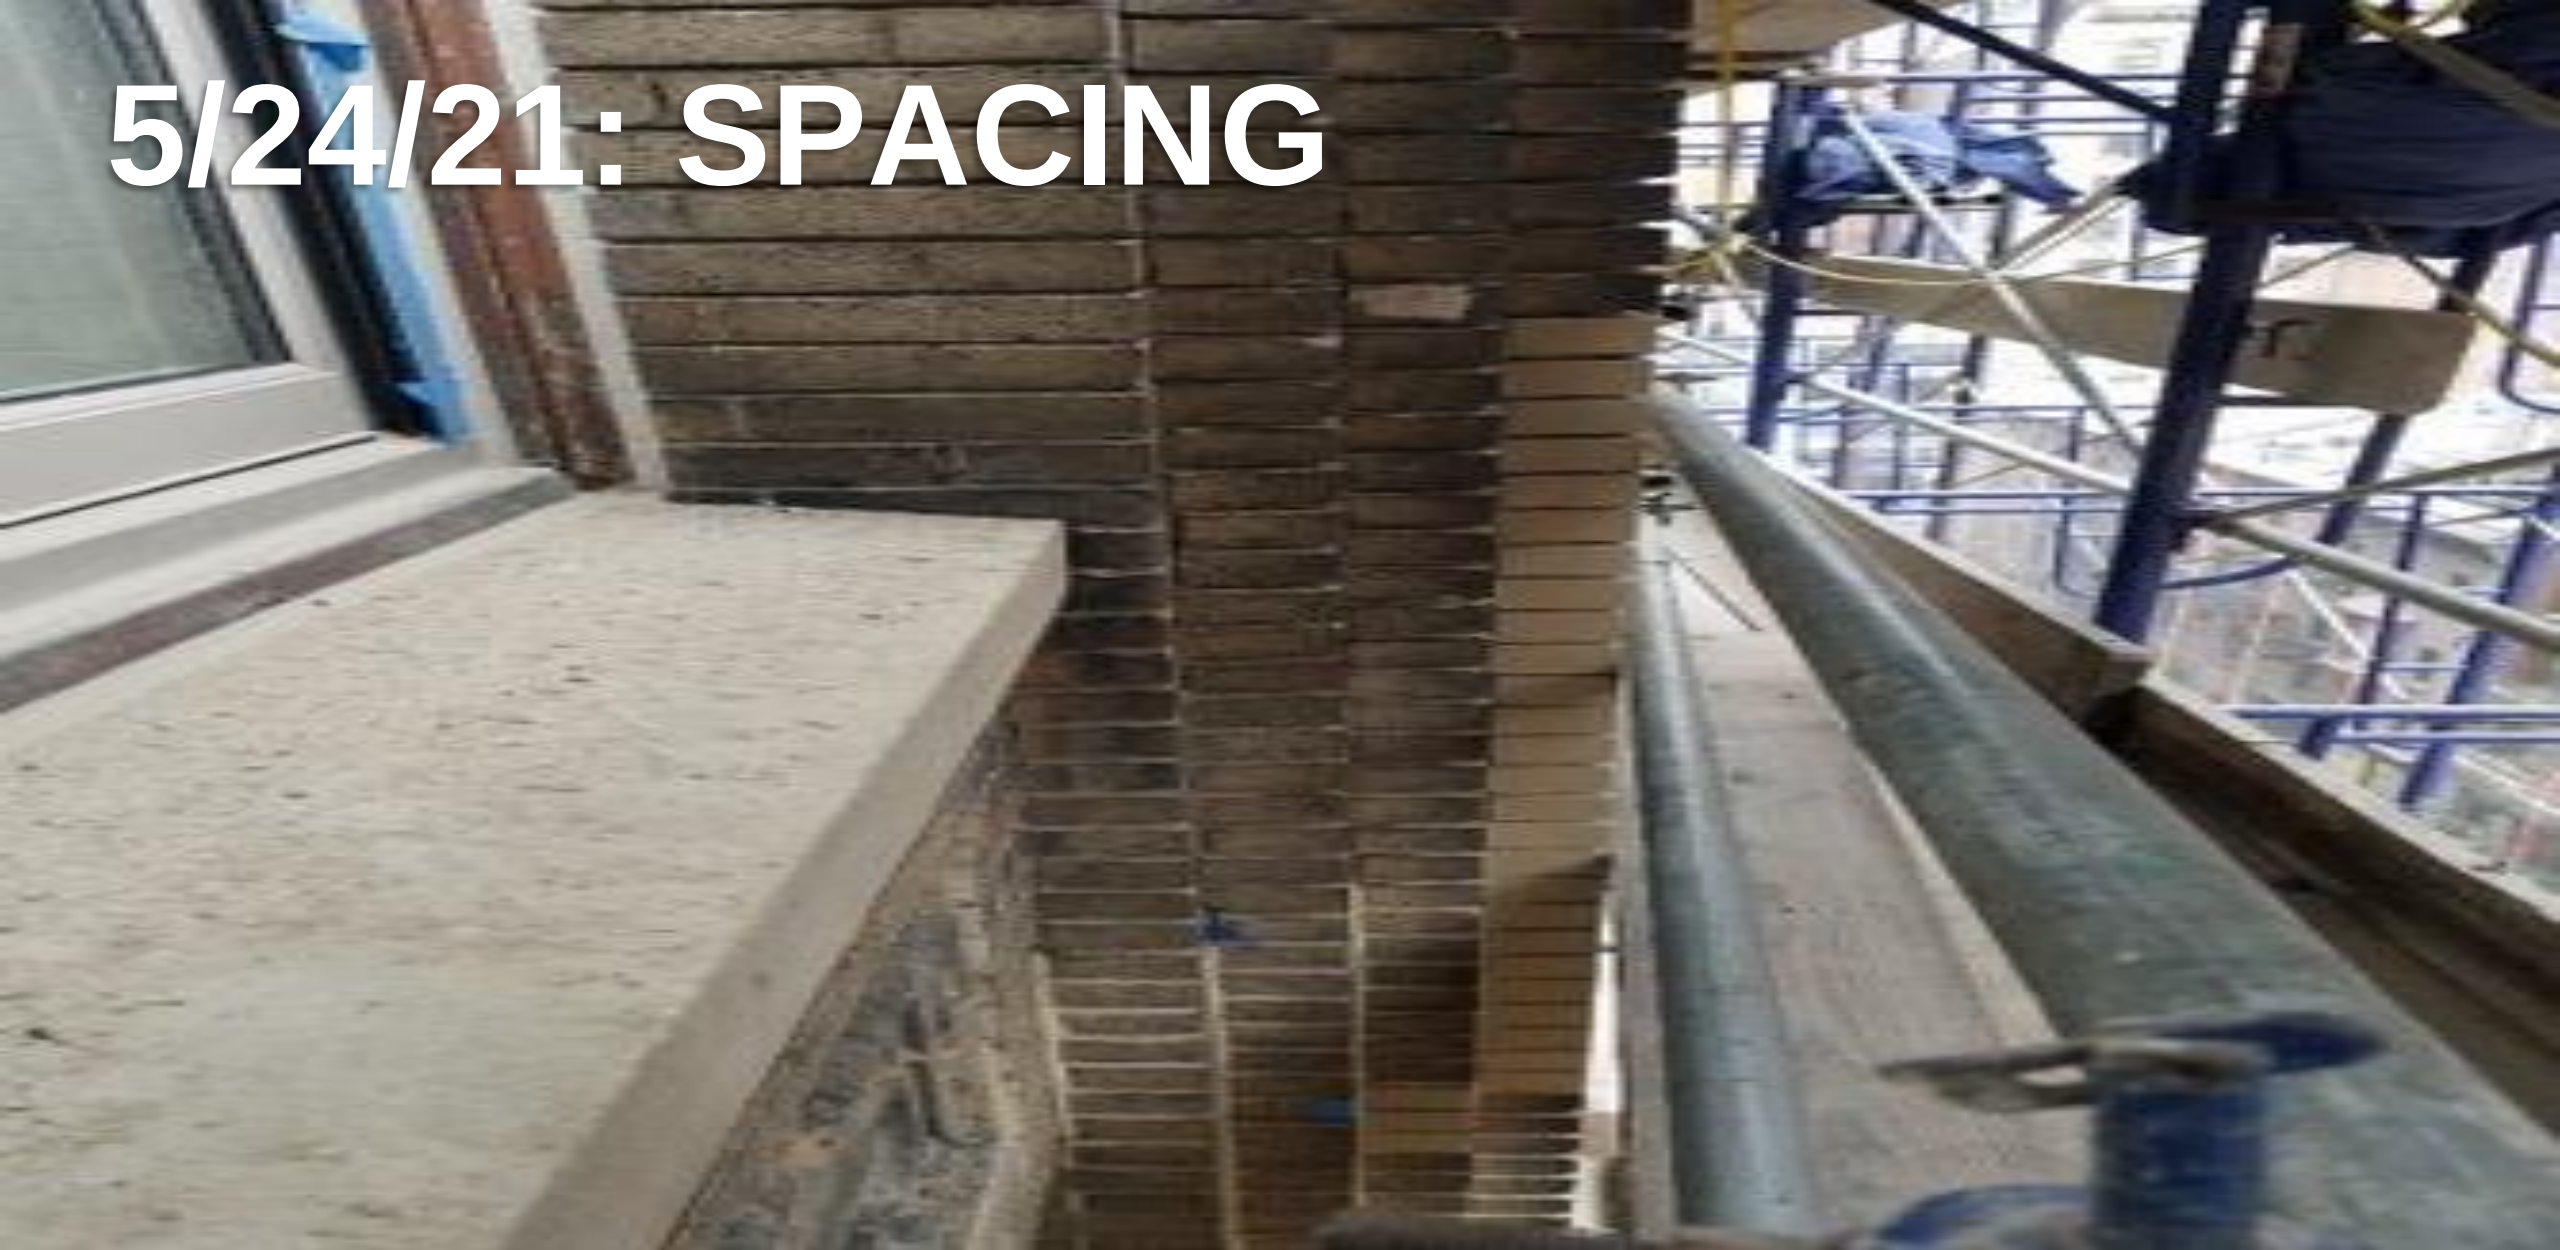
5/24/21: SPACING

15 East 26th Street (Manhattan)

- A façade laborer attempted to sit and rest on a bicycle bracket on a supported scaffold.
- The laborer lost his balance and fell 30 feet. He survived his injuries.

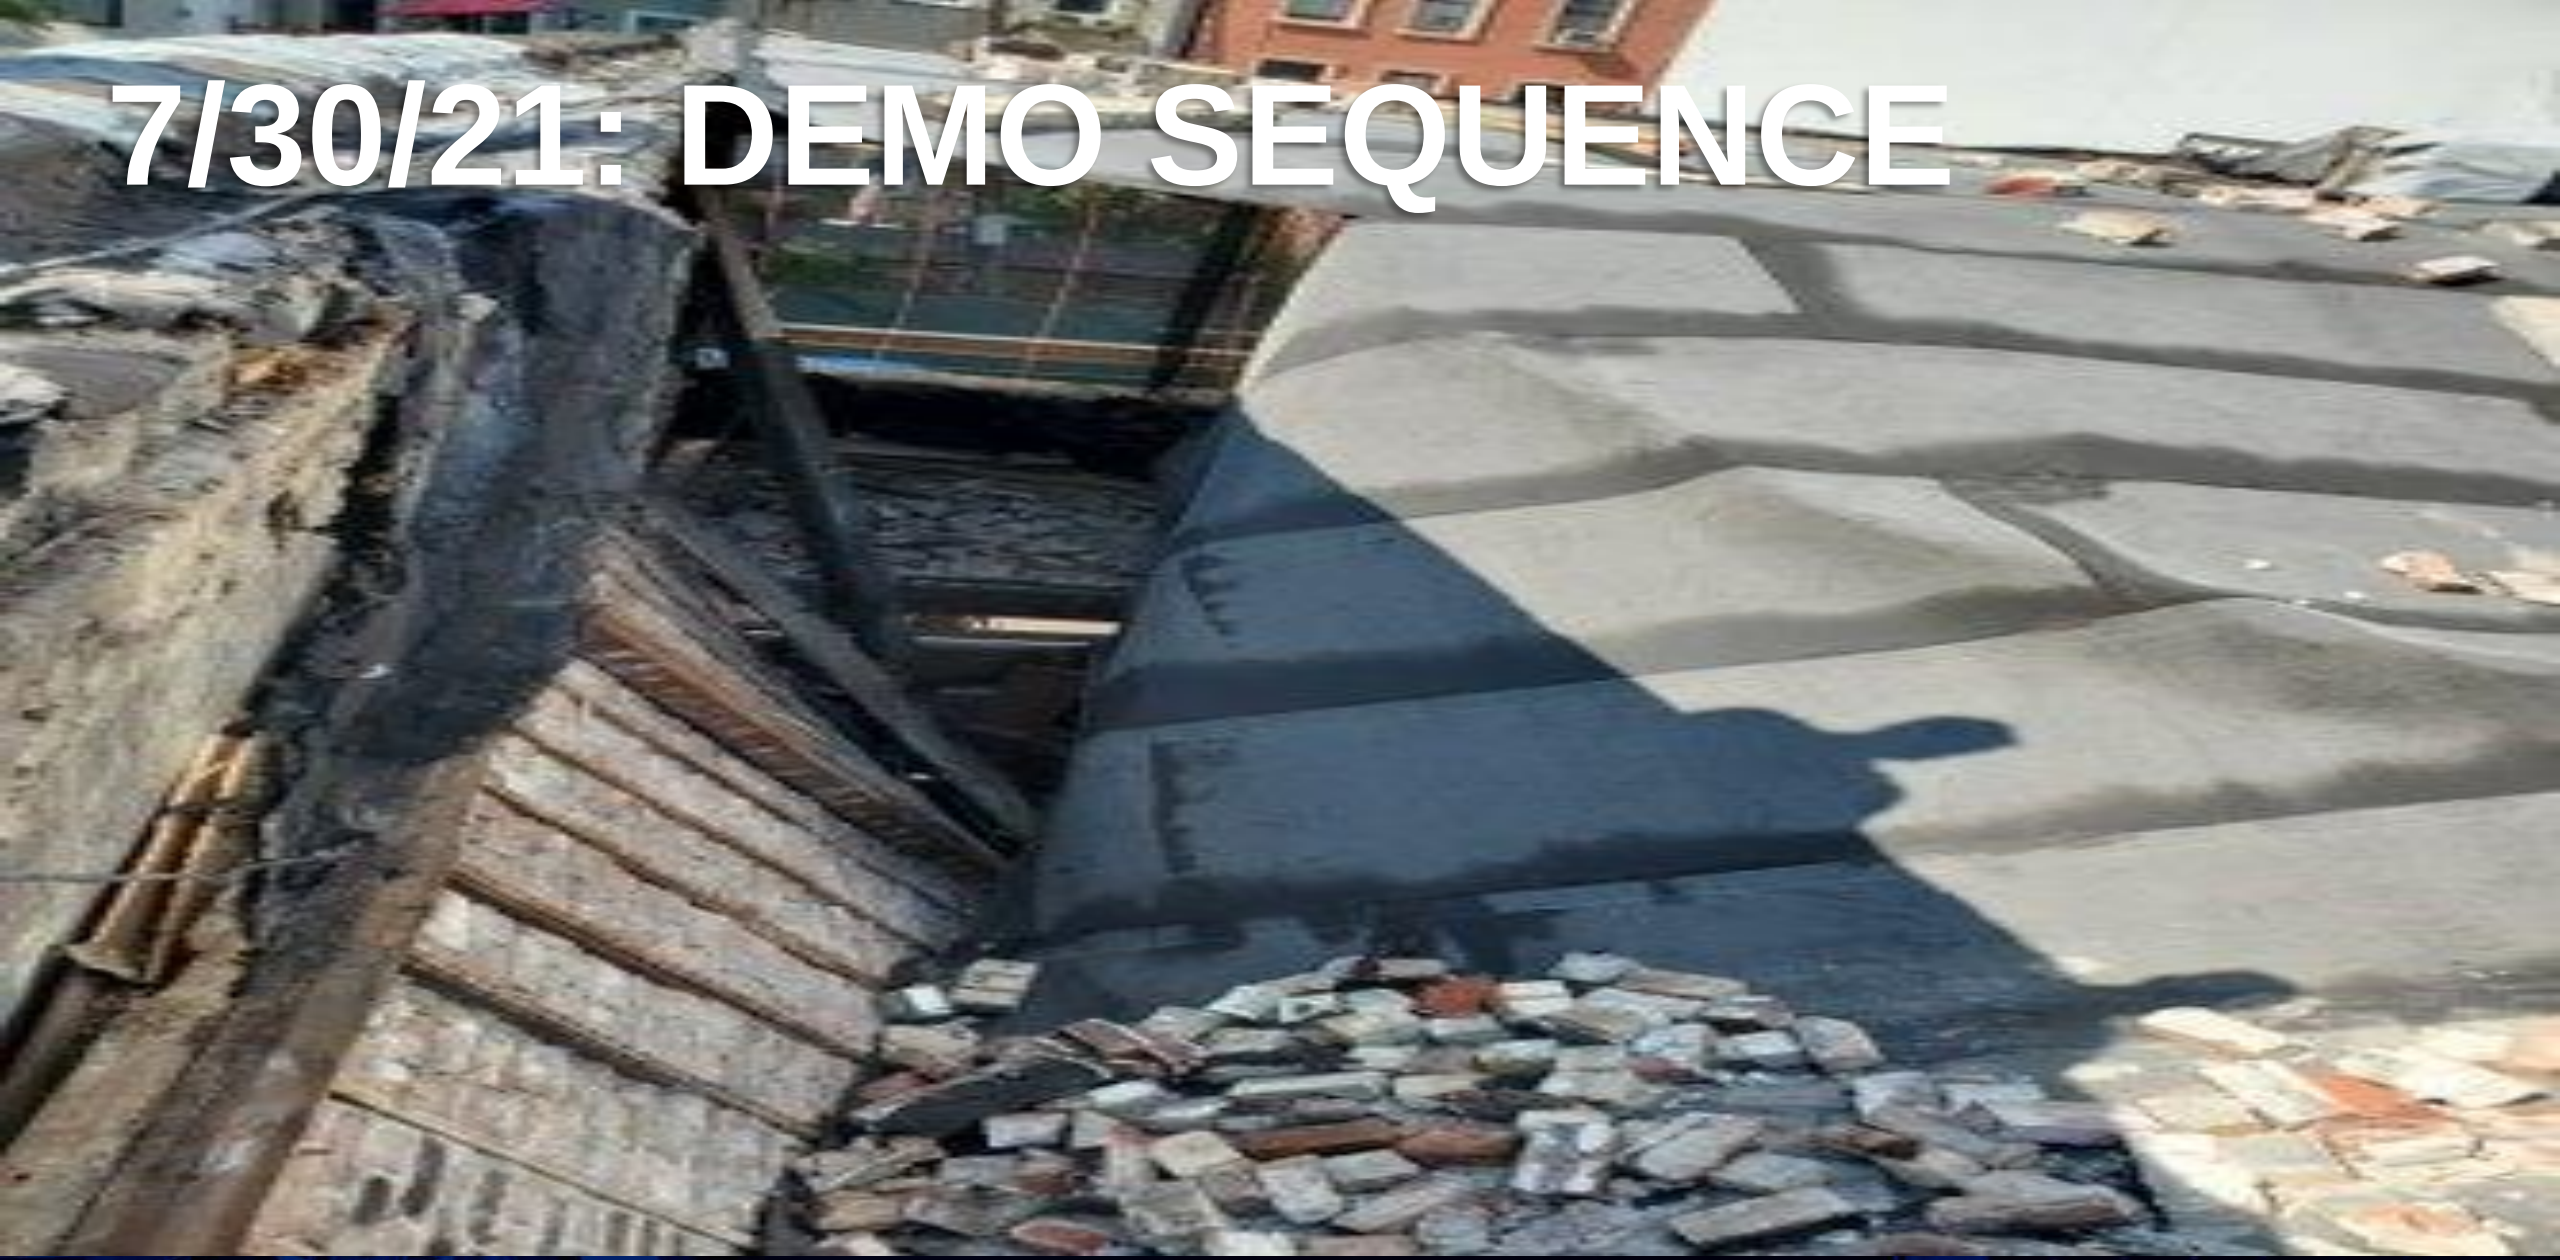
7/30/21: DEMO SEQUENCE

439 Lincoln Road (Brooklyn)

- A team of demolition laborers attempted the demo of a second-floor wall of a building. The workers stood on a newly placed deck consisting of cold form steel that was not properly installed and shored. Additionally, the workers had not shored and braced the upper wall and roof of the building before attempting to demo the wall.
- The roof collapsed through the second-floor deck trapping two workers. FDNY had to rescue the workers and all the workers survived their injuries.

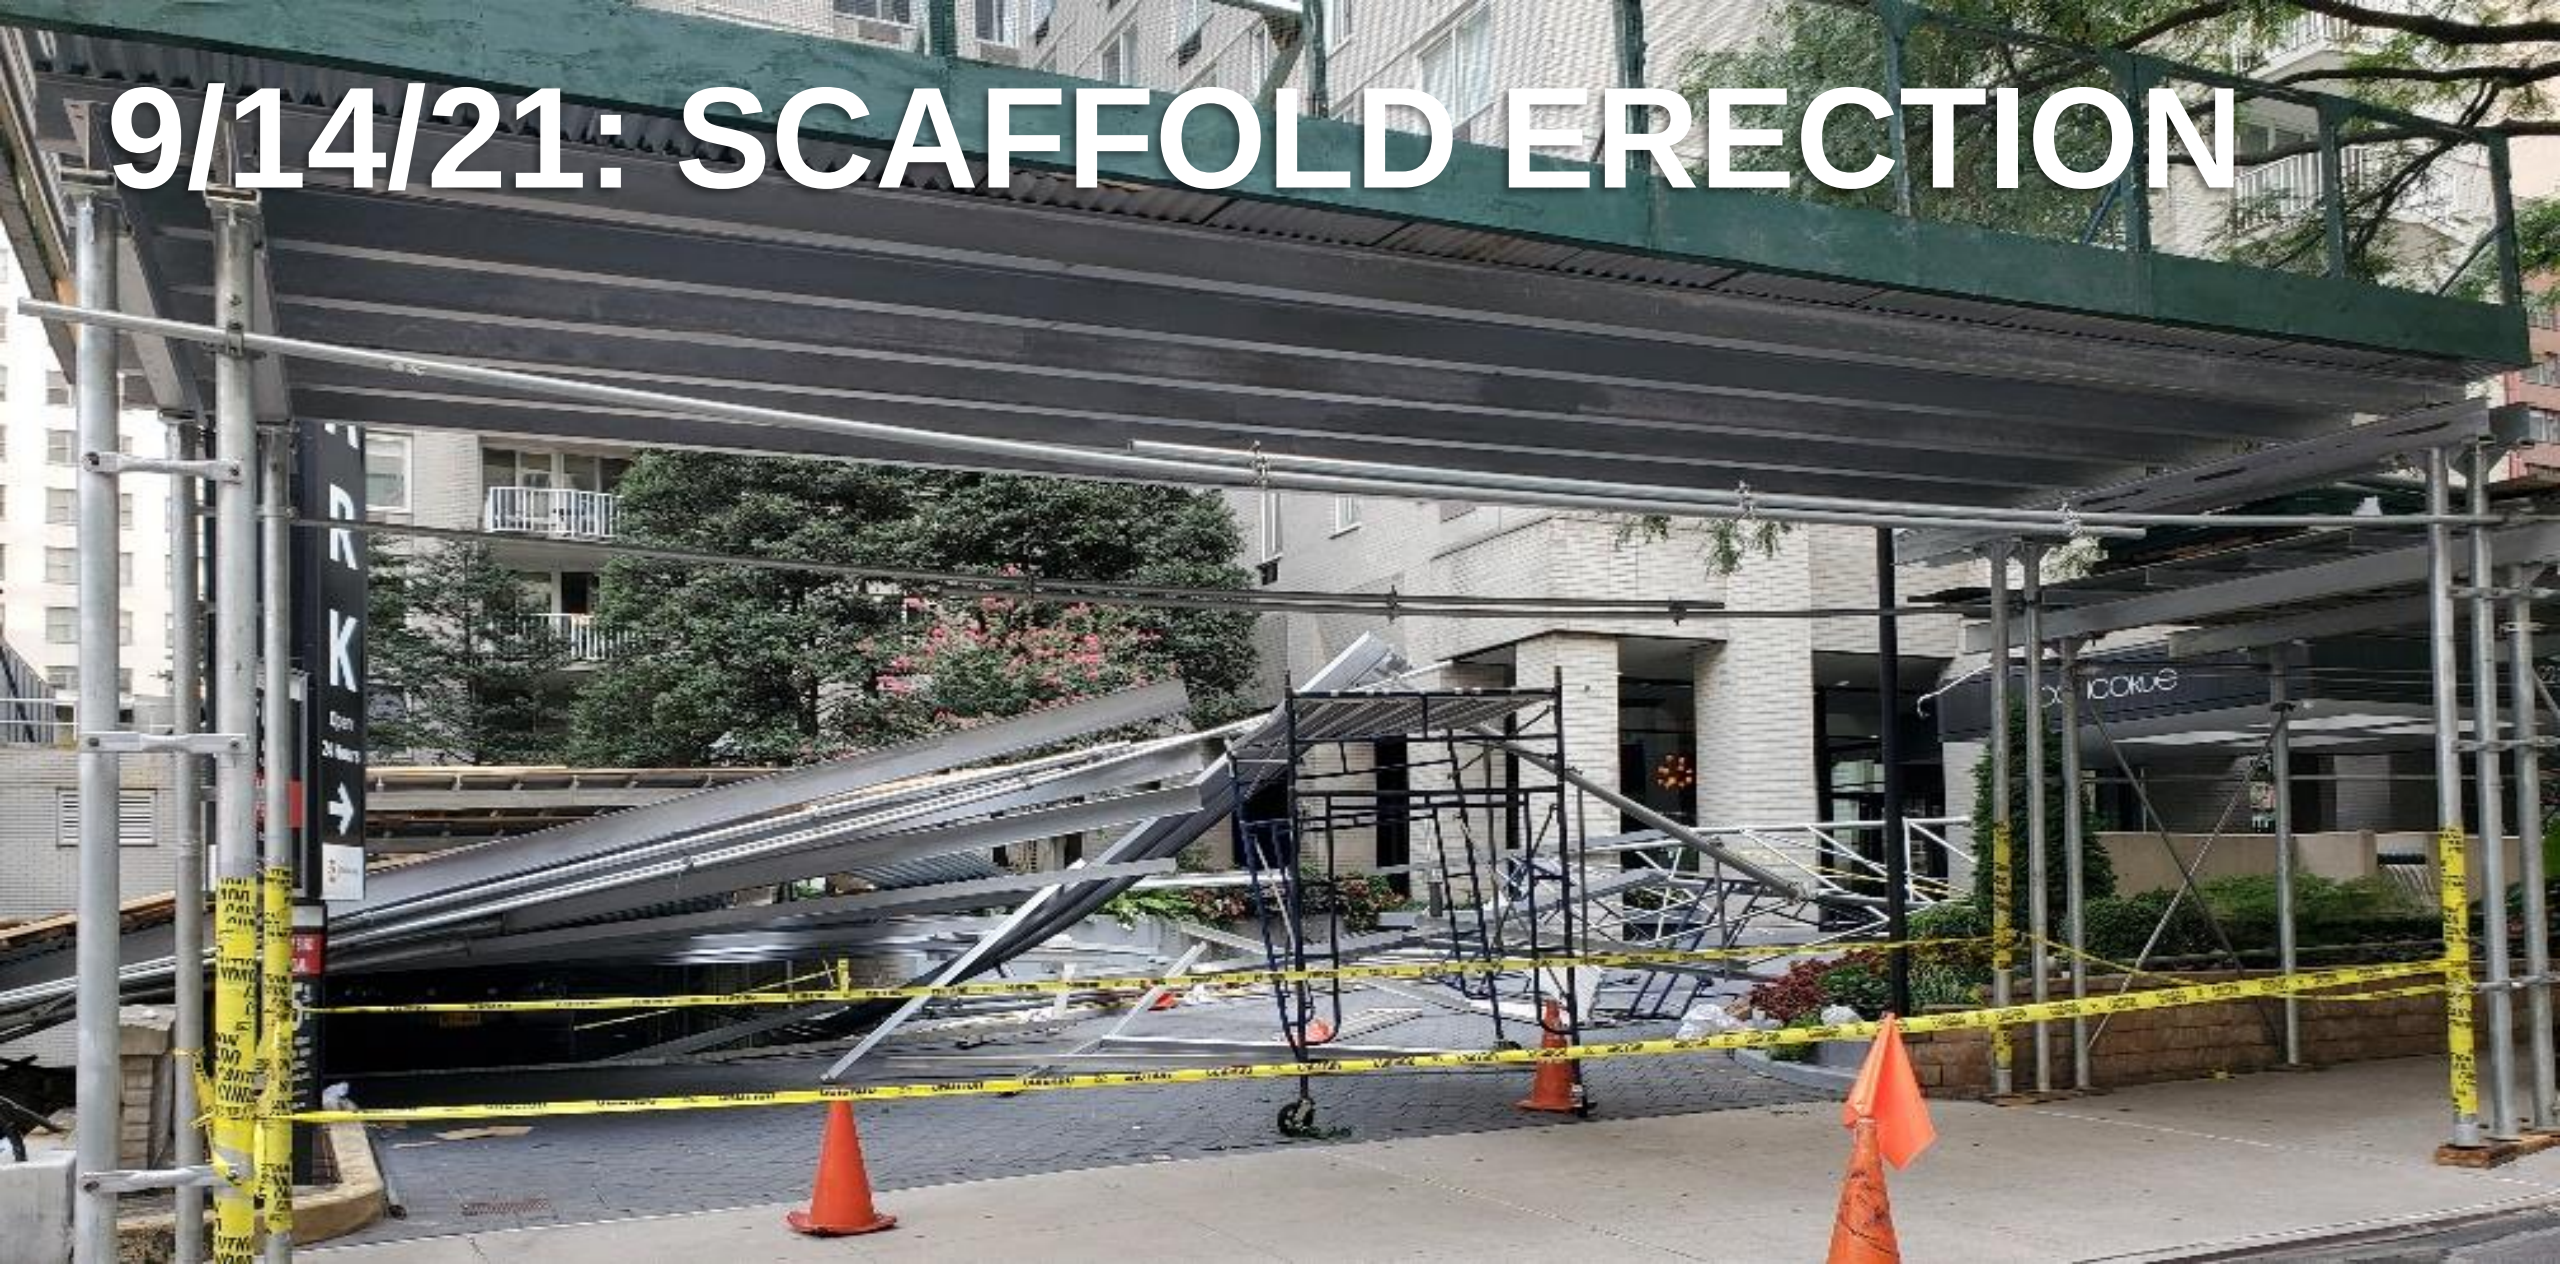
9/14/21: SCAFFOLD ERECTION

220 East 65th Street (Manhattan)

- A scaffold assembly team attempted to assemble a sizeable sidewalk shed over an active garage entrance. The team failed to properly install the support beams, which failed, and the entire assembly collapsed down to the ground.
- No major injuries were reported.
