NYC Green Infrastructure Plan:

2012 Green Infrastructure Pilot Monitoring Report

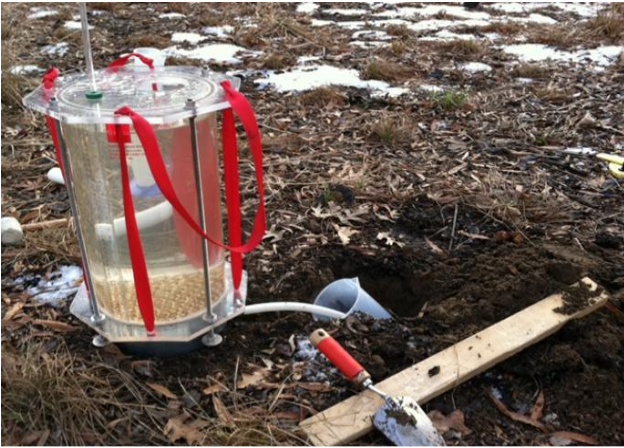
Soil infiltration testing underway at a bioretention pilot.

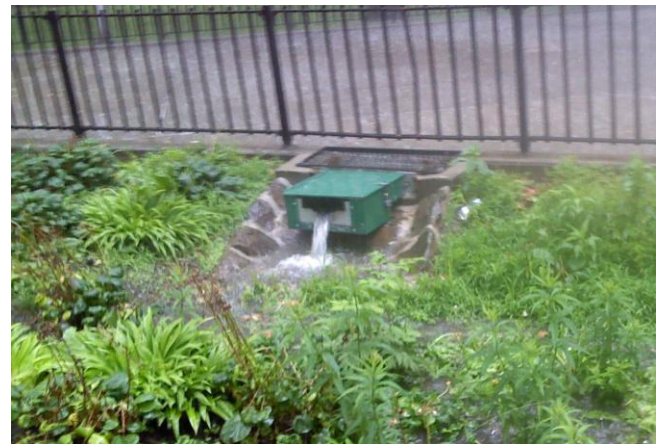
Runoff flows from a curb cut through a weir box where flow is measured as it enters a bioretention pilot.

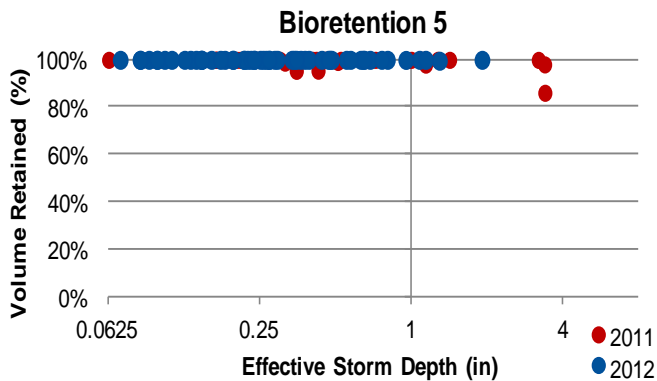
Chart A. Volume retained by a bioretention area at Bronx River Houses, showing little runoff leaving the control via the underdrain of surface overflow to reach the combined sewer.

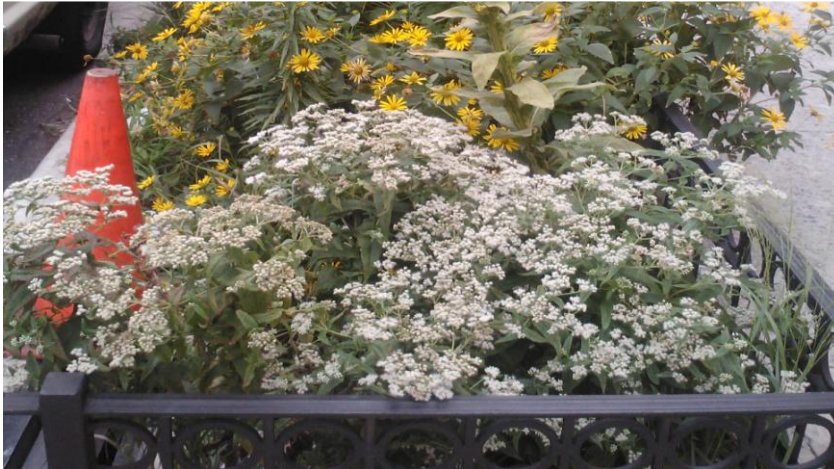
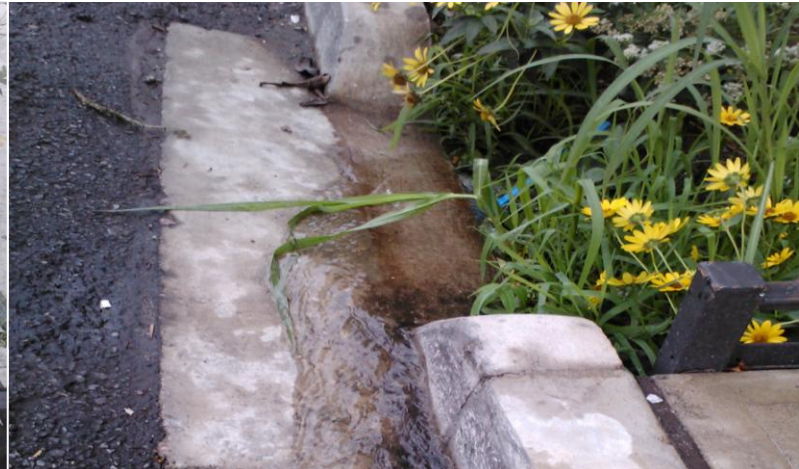
Vegetation at an enhanced tree pit at Blake Avenue (left), which has modified open curb cuts (right) to capture stormwater runoff.

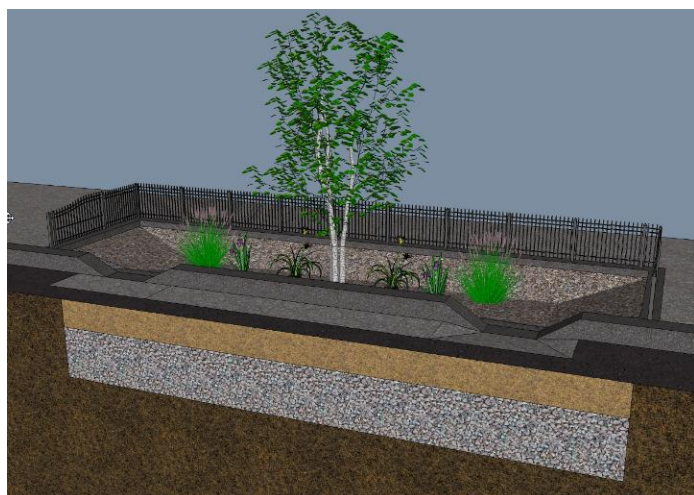
Example design of an enhanced tree pit with open curb cuts.

infrastructure: enhanced tree pits and street-side infiltration swales. Both types of controls are constructed within the sidewalk areas adjacent to the roadway with similar designs. Enhanced tree pits are typically 20 feet long, with an engineered soil layer underlain by gravel, recycled glass, or storage chambers. Enhanced tree pits were precursors to right-of-way bioswales now being implemented throughout the city. Street-side infiltration swales are typically 40 feet long, and do not contain a storage layer with gravel, recycled glass, or storage chambers. Both of these controls use curb cuts or constructed inlets to divert water from the roadway gutter into the source control. The controls at Blake and Ridgewood Avenues, as well as at Union and Howard Streets, were retrofitted in May 2012 to increase the ponding depth by removing some soil and decrease inlet clogging through the installation of open curb cuts.

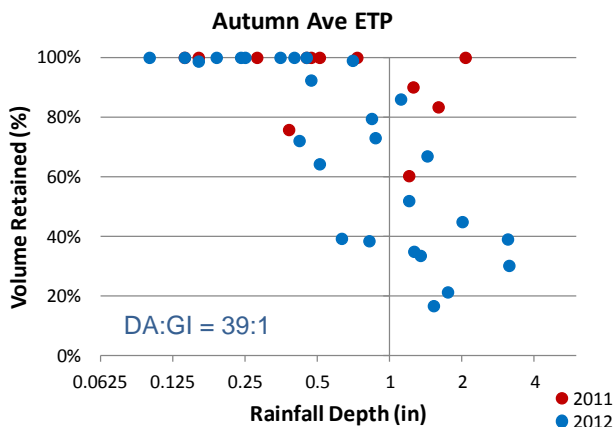
The Autumn Ave enhanced tree pit captured and fully retained the majority of storms smaller than one-inch, with reduced performance for larger storms in 2012 possibly due to individual storm characteristics.

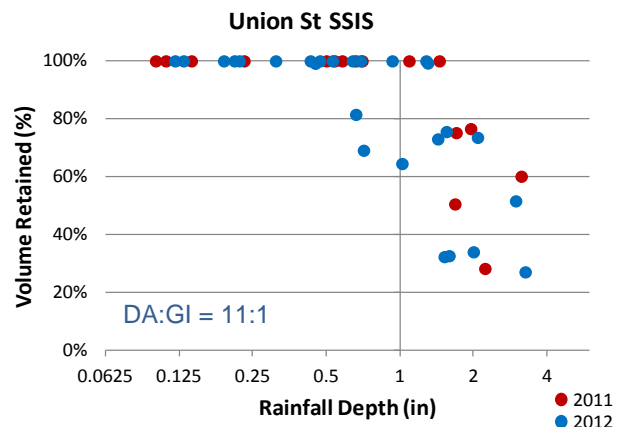
The Union St pilot was the largest street-side Infiltration swale in relation to its drainage area, which likely explains why it provided the best volume retention performance.

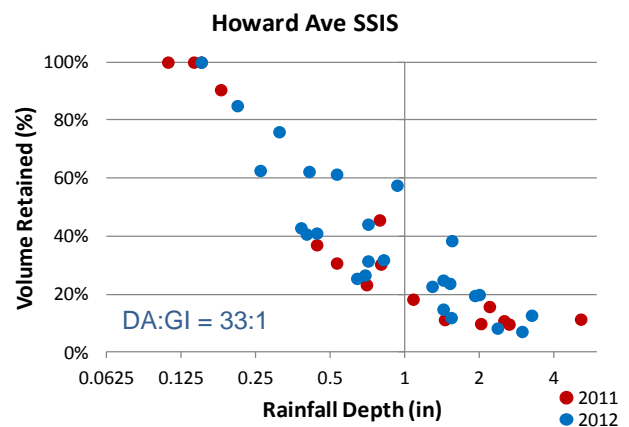
The high slope at the Howard Ave street-side infiltration swale limits surface storage capacity, causing substantial reductions in volume retention as storm depths increase.

- Low runoff capture performance at the Eastern Pkwy enhanced tree pit was likely due to the high 99:1 ratio of watershed area to green infrastructure area.
- The relatively lower capture percentage at the Howard Ave site was likely due to a combination of larger watershed area and steeper slopes, limiting surface storage and opportunities for infiltration before runoff reached the outlet.
- The performance of the Ridgewood street-side infiltration swale did not significantly improve with retrofits, indicating other factors, such as the removal of plants in September 2012, could be affecting infiltration rates.
- Open curb cuts at the Union St. enhanced tree pit have appeared to increase volume retention, particularly for larger storms.

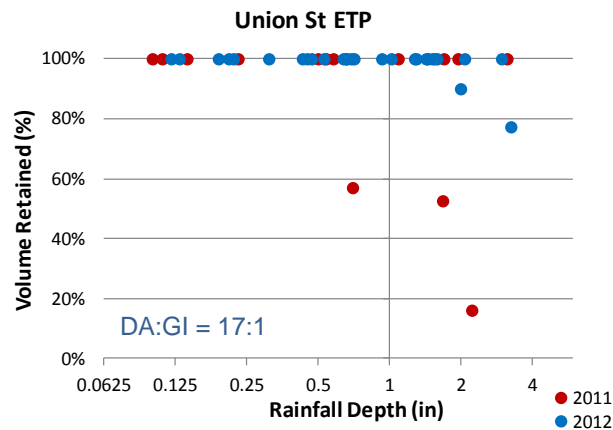
The Union St pilot had the smallest drainage area of all the enhanced tree pits, which explains why it provided the best volume retention performance.

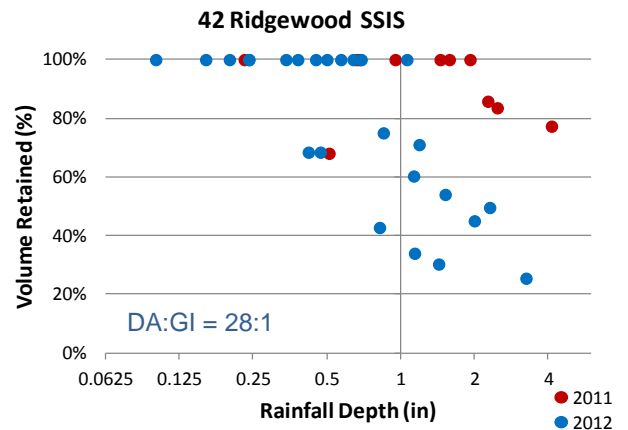
Volume retention performance at the Ridgewood street-side infiltration swale appeared to diminish for larger storms in 2012, which differed from performance evaluations at the other street-side infiltration swale pilots.

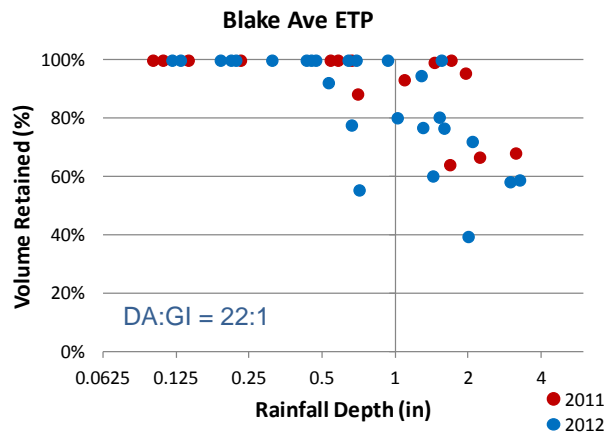
The Blake Ave enhanced tree pit consistently retained storms with depths less than 0.5-inches, while also retaining a substantial portion of storms larger than one-inch.

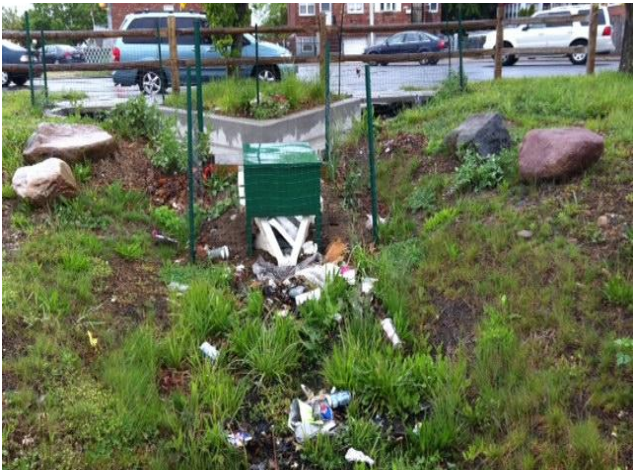
An example of litter and debris flowing from the curb cut inlets.

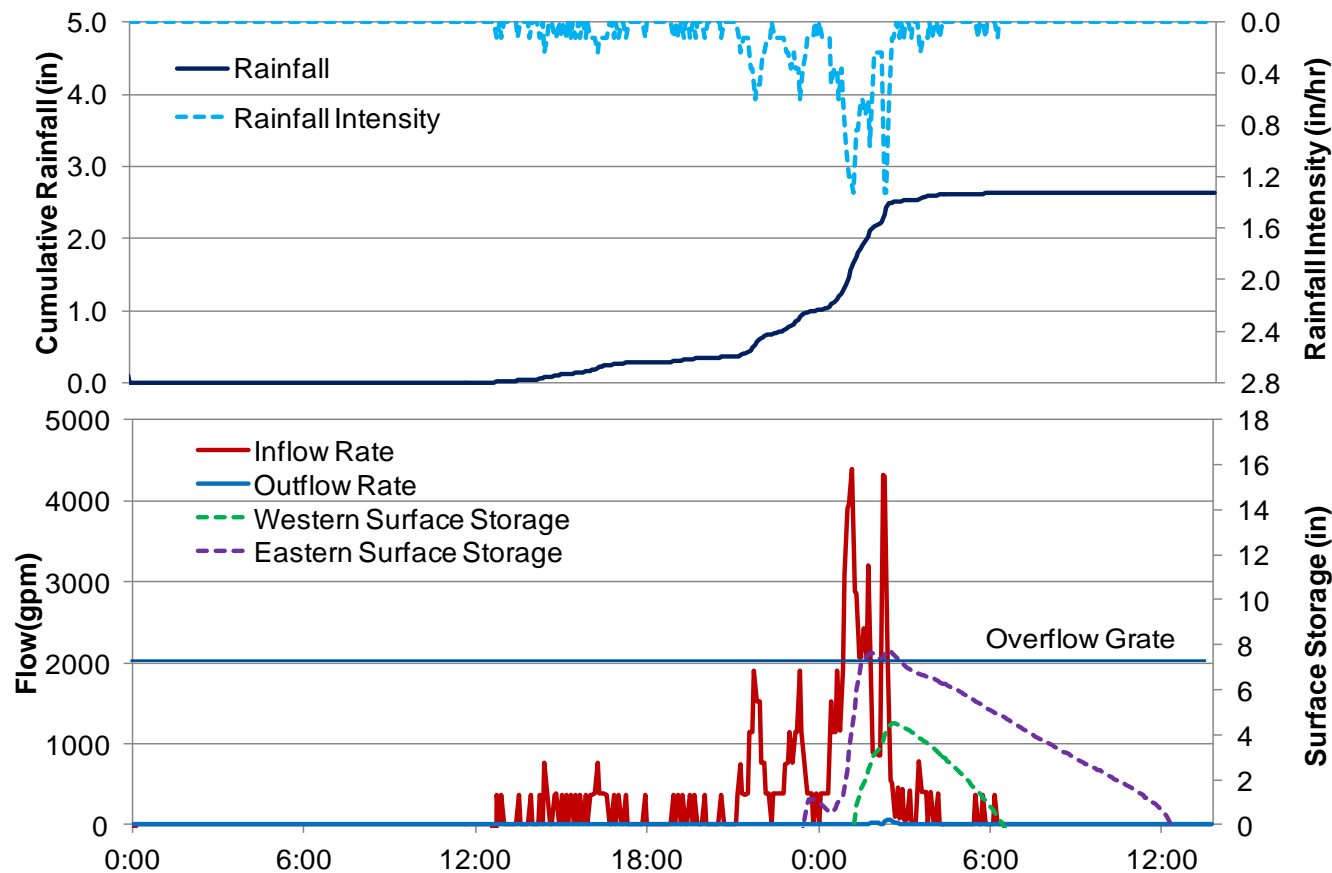
North and South Conduit Avenues Bioretention Representative Hydrograph

Chart 8. Representative hydrograph showing North & South Conduit Avenues bioretention performance during a 2.6-inch storm on June 12, 2012. Nearly all inflow is retained in the bioretention facilities for this large storm event with only a small amount of outflow released via the overflow gate.

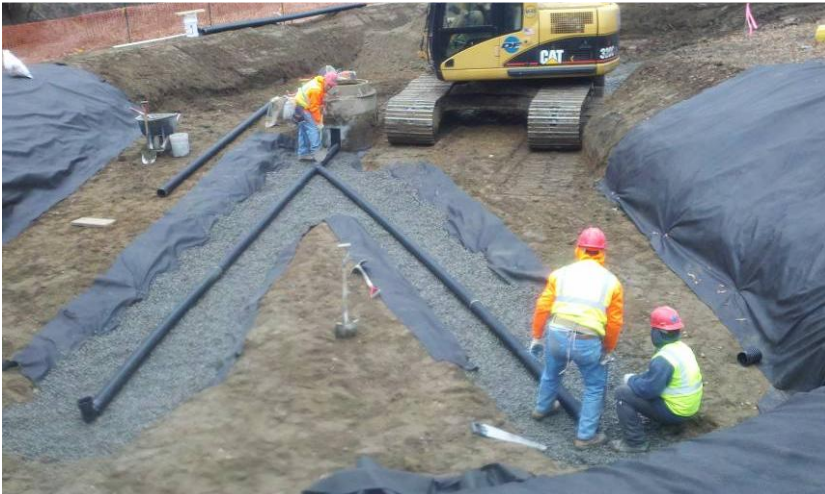
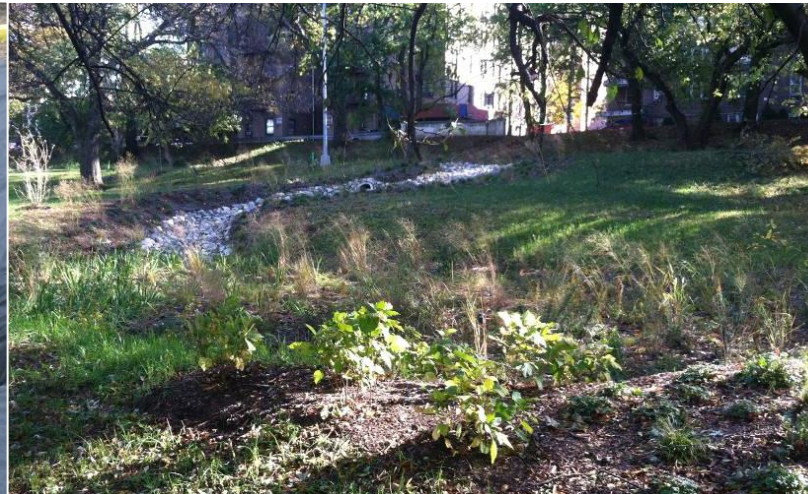
Construction of the tiered bioretention facility at Shoelace Park, completed in 2012. Monitoring activities during 2013 will evaluate pilot performance.

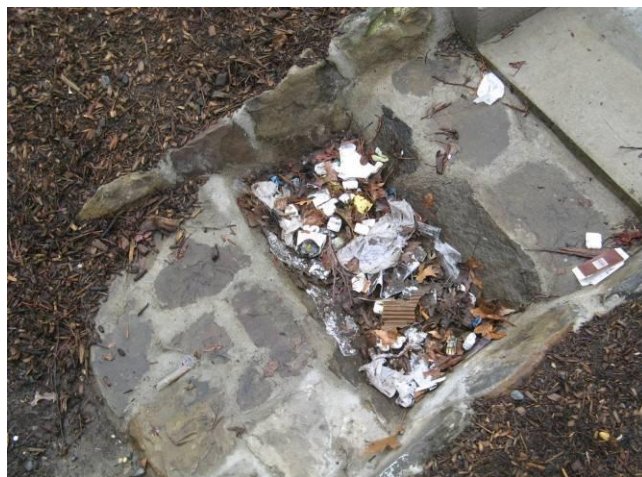
Litter and debris captured by a bioretention curb cut inlet sump, which consolidated maintenance activities.

Maintenance at the bioretention facilities included regular removal of litter and debris, much of which was captured near the curb cuts, along with seasonal mulching and weeding. Some areas required minor erosion repairs during initial stabilization following construction.

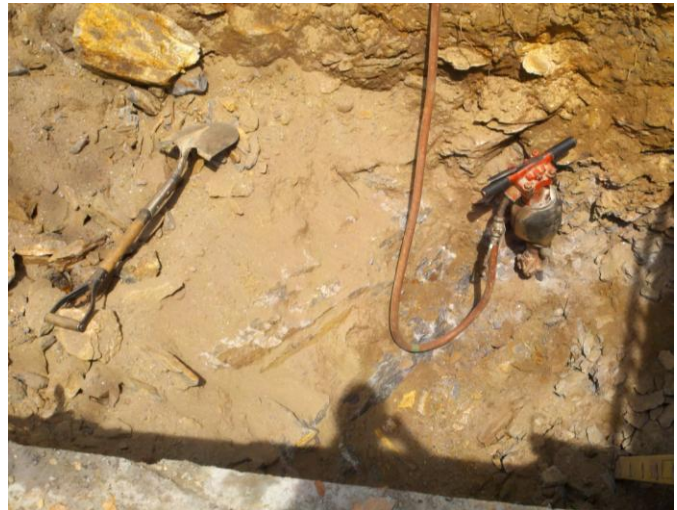
Subsurface conditions below the south parking lot system consist mostly of clay and large rocks.

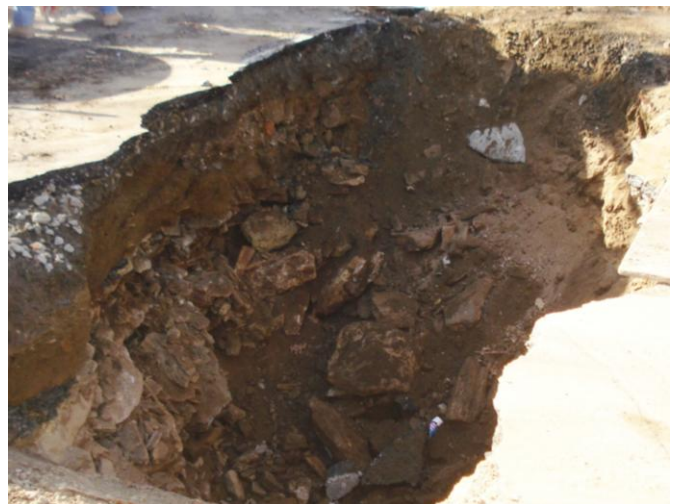
Smaller and fractured rock was more common under the north parking lot system, along with less clay and more loamy soil.

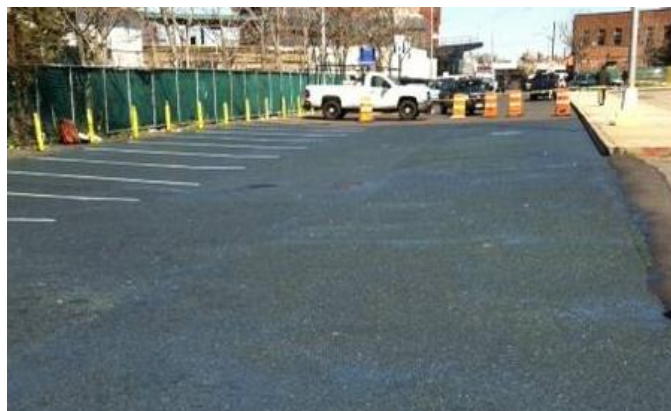
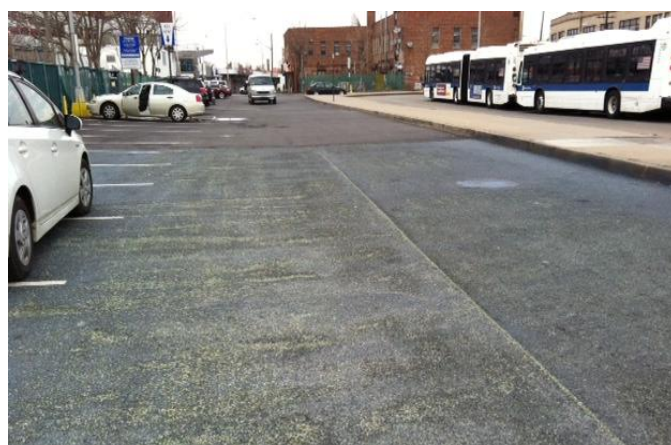
FilterPave™ resurfacing in April 2012 (top) and observed condition in January 2013 (bottom).

FilterPave™ pilot which retained 100% of the rainfall it received but presented issues of surface deterioration.

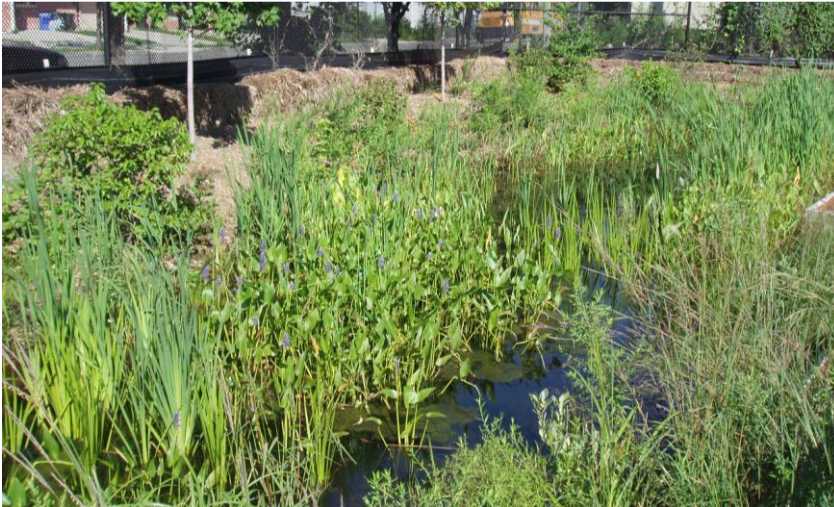
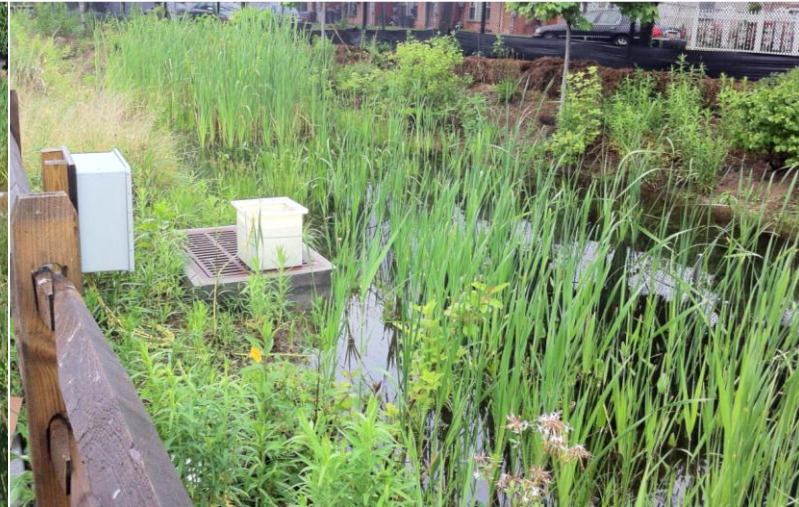
Established vegetation in the wet meadow pilot at the Spring Creek MTA Bus Terminal under saturated conditions. Monitoring equipment was installed at the outlet (shown on right) to measure outflow.

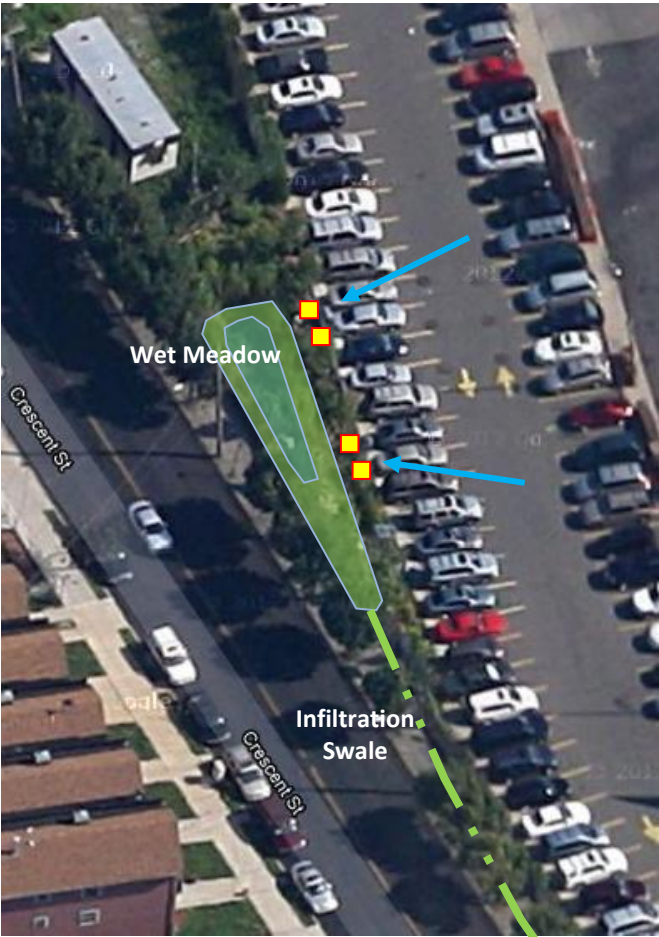
Stormwater runoff from the MTA parking lot is diverted to the wet meadow via perimeter catch basins. Excess water overflows into an infiltrating bioswale.

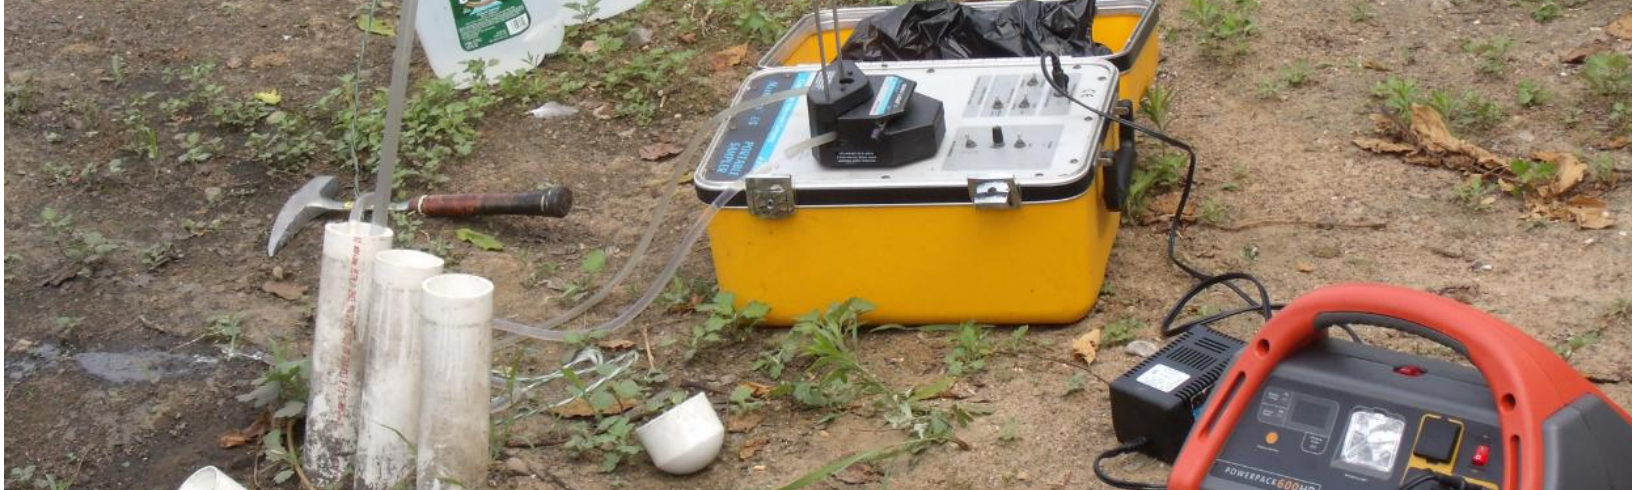
Water quality sampling equipment at a bioretention facility, drawing water from wells that capture runoff after it has infiltrated through the soil.

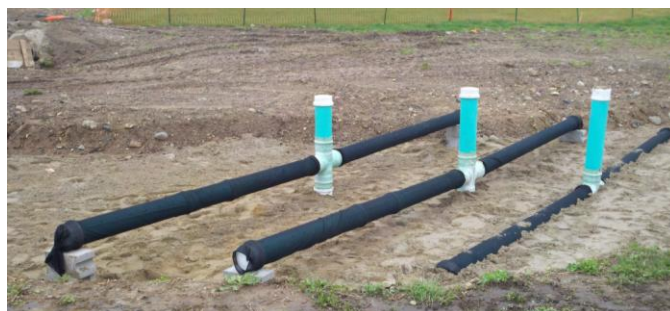
Infiltration wells at North and South Conduit Avenues bioretention prior to bioretention soil installation. These wells capture water that has infiltrated through a depth of soil.

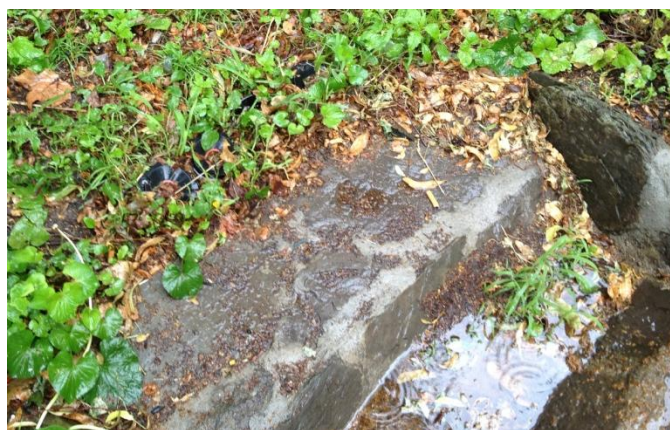
Subsurface sampling canisters, partially shrouded by vegetation, capture water flowing into a bioretention area, then seal once they are full.
