Randolph Houses RFP Addendum 2

Addendum 2 issue date: October 5, 2011

Contents of the Addendum

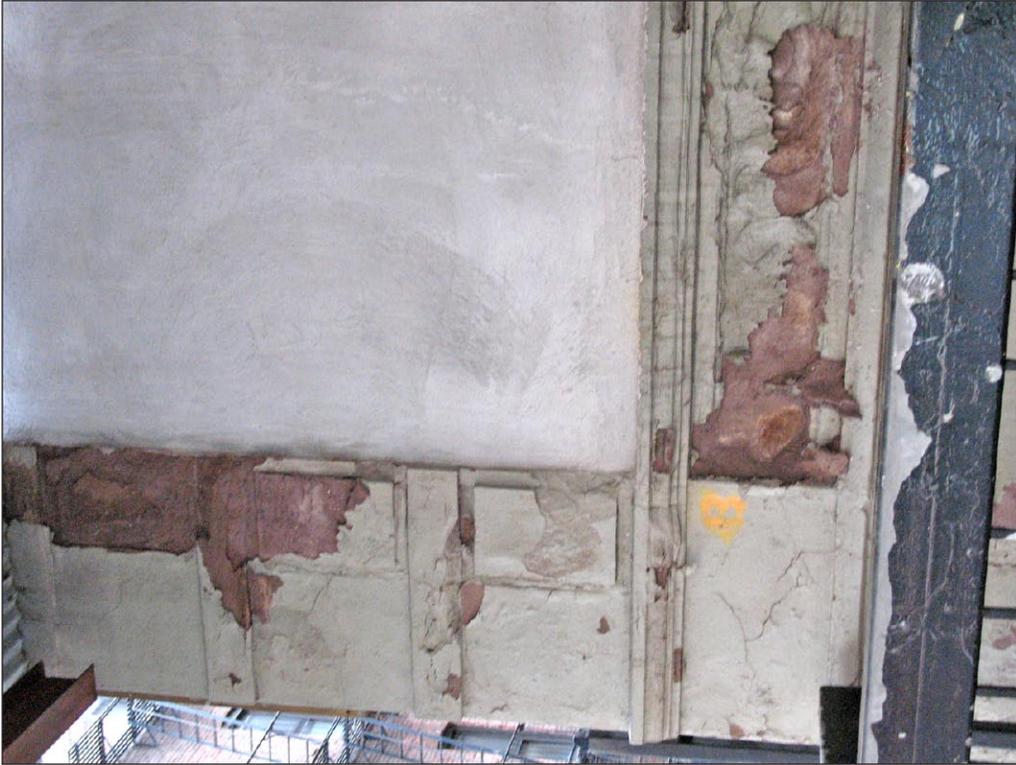
Ground floor facade of 204 West 114th Street 7

The buildings are 5-stories and are constructed of wood and brick – brick load bearing walls and wood floor joists. The primary facades are clad in brick with brownstone used to clad the ground floors and used as ornament at the upper floors (see Figures 11-13). Typically, the stone has been painted and is deteriorated in a number of locations (see Figure 14). The stoops are replacements, and are of concrete (see Figure 12). As described above, some of the buildings have missing and sealed up window openings, missing cornices, and insertion of openings with roll-down metal security gates at ground level to create storage spaces (see Figures 11 and 12).

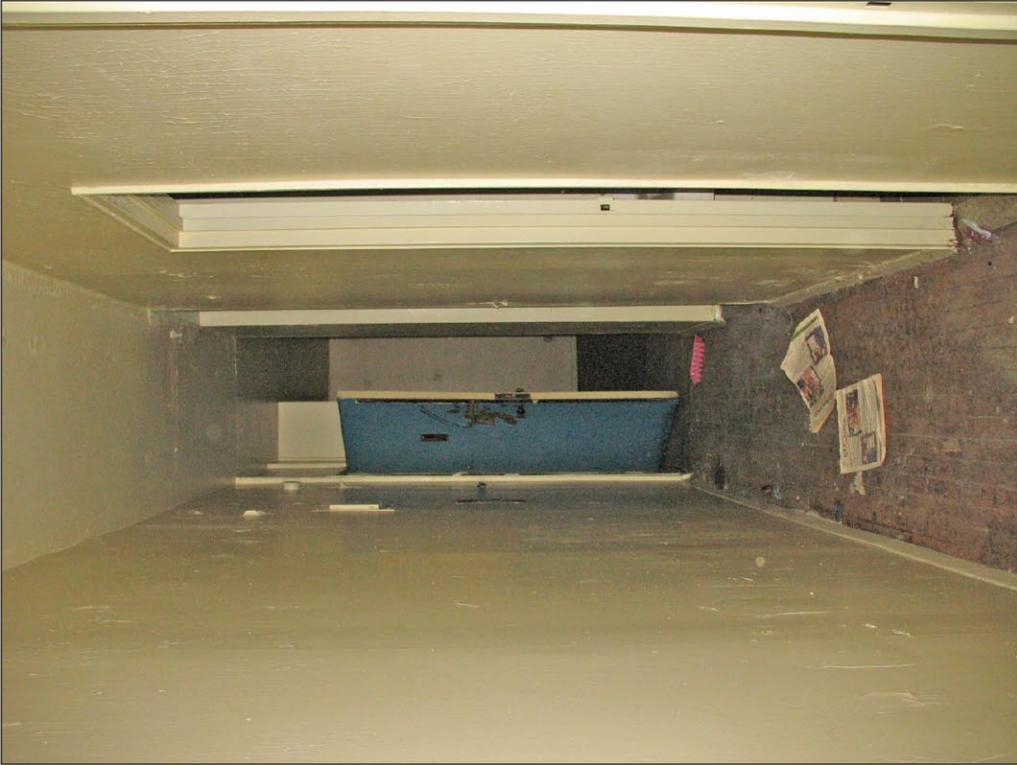
Typical apartment hallway 11

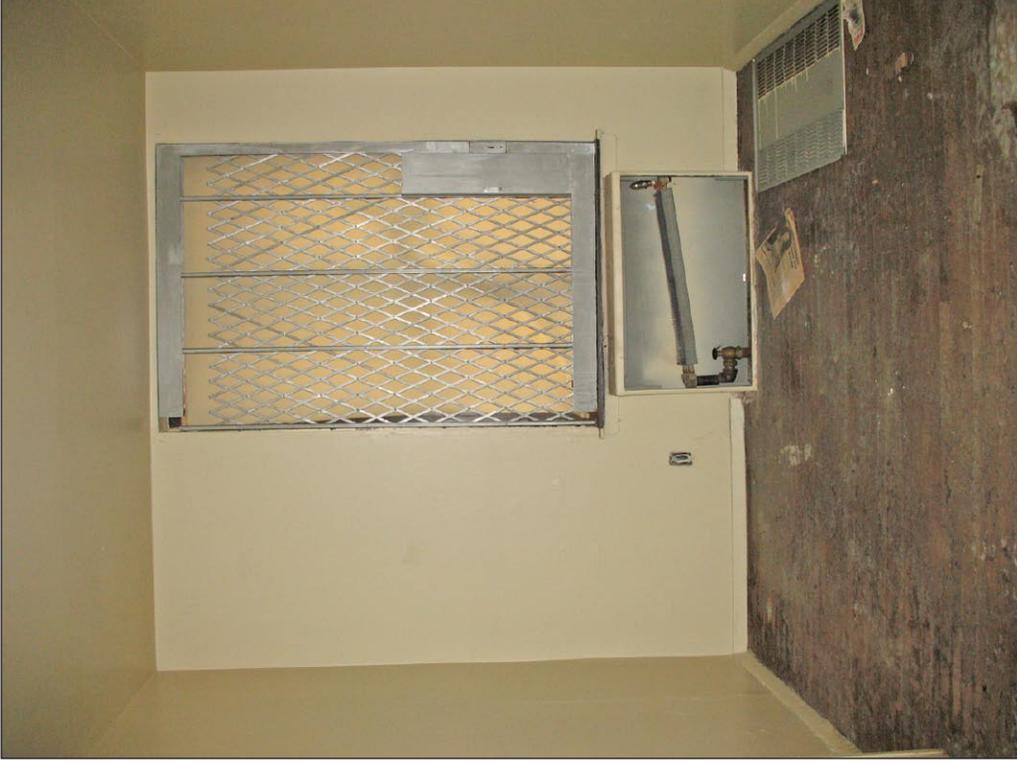
Typical room with security gate 12
