## **BUSH TOWER**

# 135 WEST 41<sup>ST</sup> STREET (130 WEST 42<sup>ND</sup> STREET)

PROPOSAL FOR THE REMOVAL OF EXTERIOR STAIRS AND REPLACEMENT OF EXISTING GROUND FLOOR STOREFRONTS AND AWNINGS AT 135 W 41ST STREET, NEW YORK, NY 10036

LANDMARKS PRESENTATION

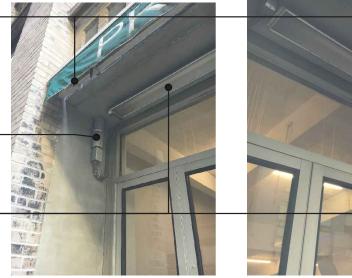
EXISTING AWNING — CONNECTION DETAIL ON FACE OF BRICK HEADER

EXISTING JUNCTION BOX MOUNTED TO SIDE OF WALL

(2) EXISTING LIGHT FIXTURES MOUNTED TO UNDERSIDE OF HEADER

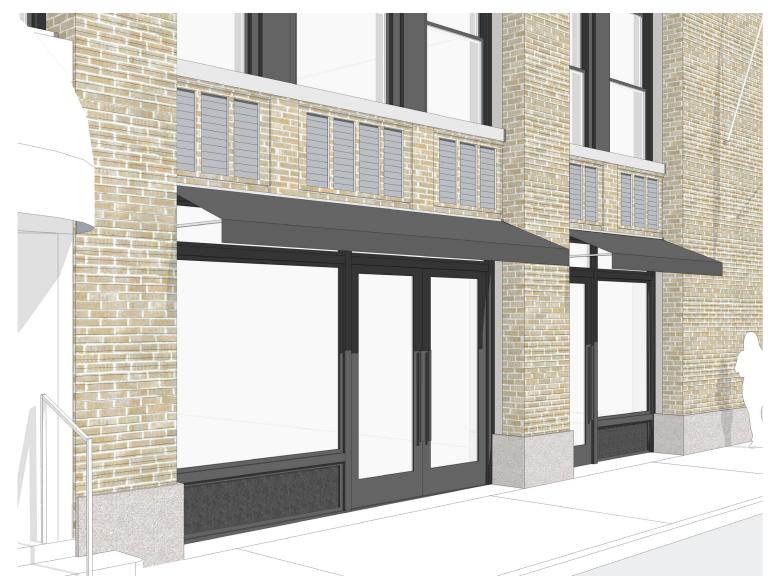
RENDERED STOREFRONT SIDEWALK PERSPECTIVE (WEST VIEW)

SEE AWNING DETAIL AT PAGE 13. SKIRT IS LOOSE AND WEIGHTED AT THE BOTTOM, NOT FRAMED.

AWNING SIGNAGE TO BE ON LOOSE SKIRT ONLY.
