Preservation Department – Item 7, LPC-20-08722

44-54 9th Avenue/351-355 West 14th Street,

44-54 NINTH AVENUE & 351-355 WEST 14TH STREET

LPC PUBLIC HEARING 06/02/2020

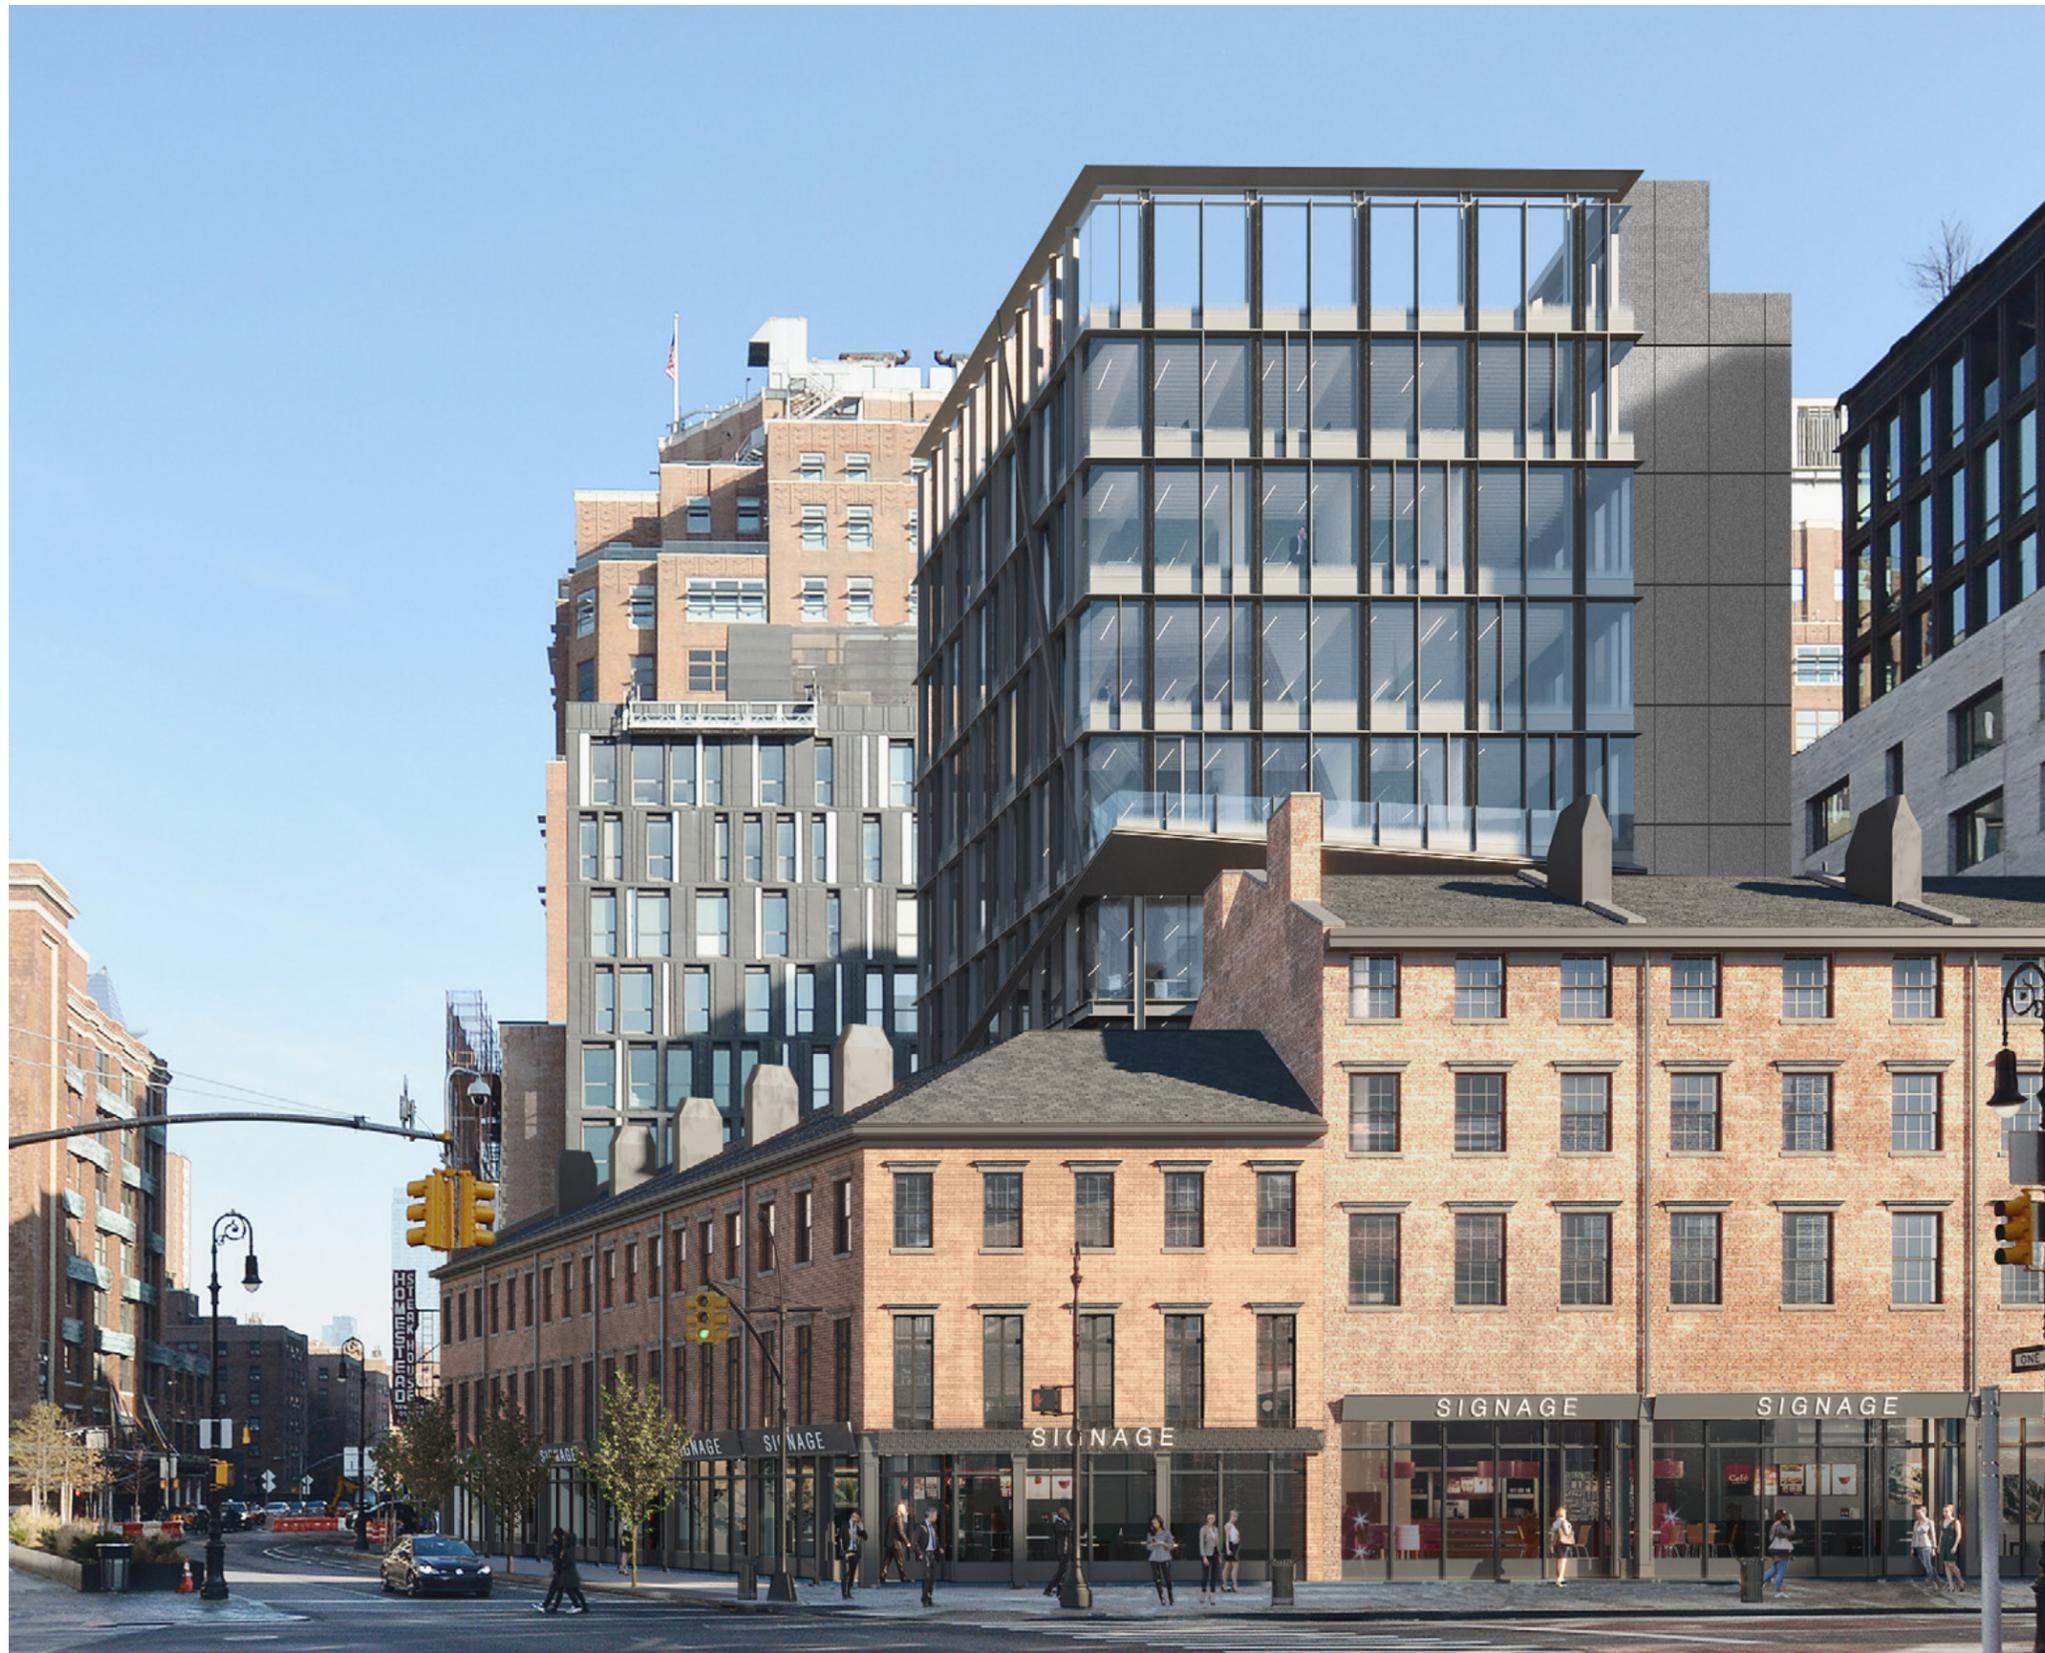
① CURTAIN WALL DETAIL SECTION @ 6-8TH FL
3/8" = 1'-0"

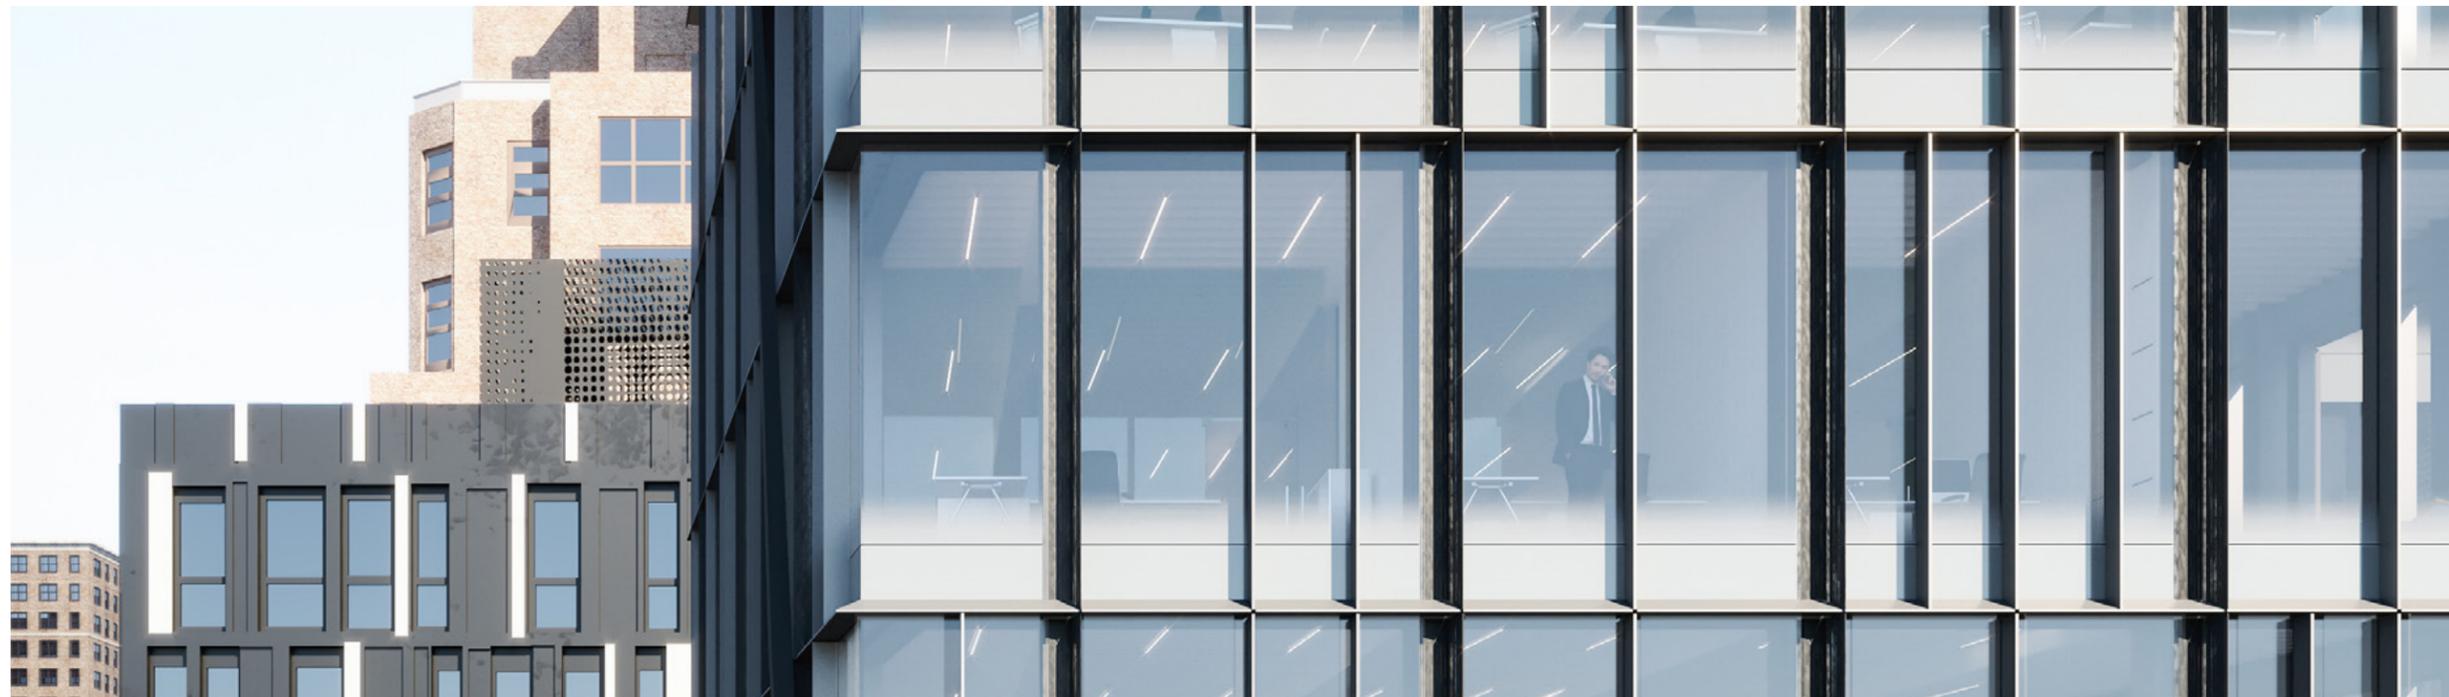
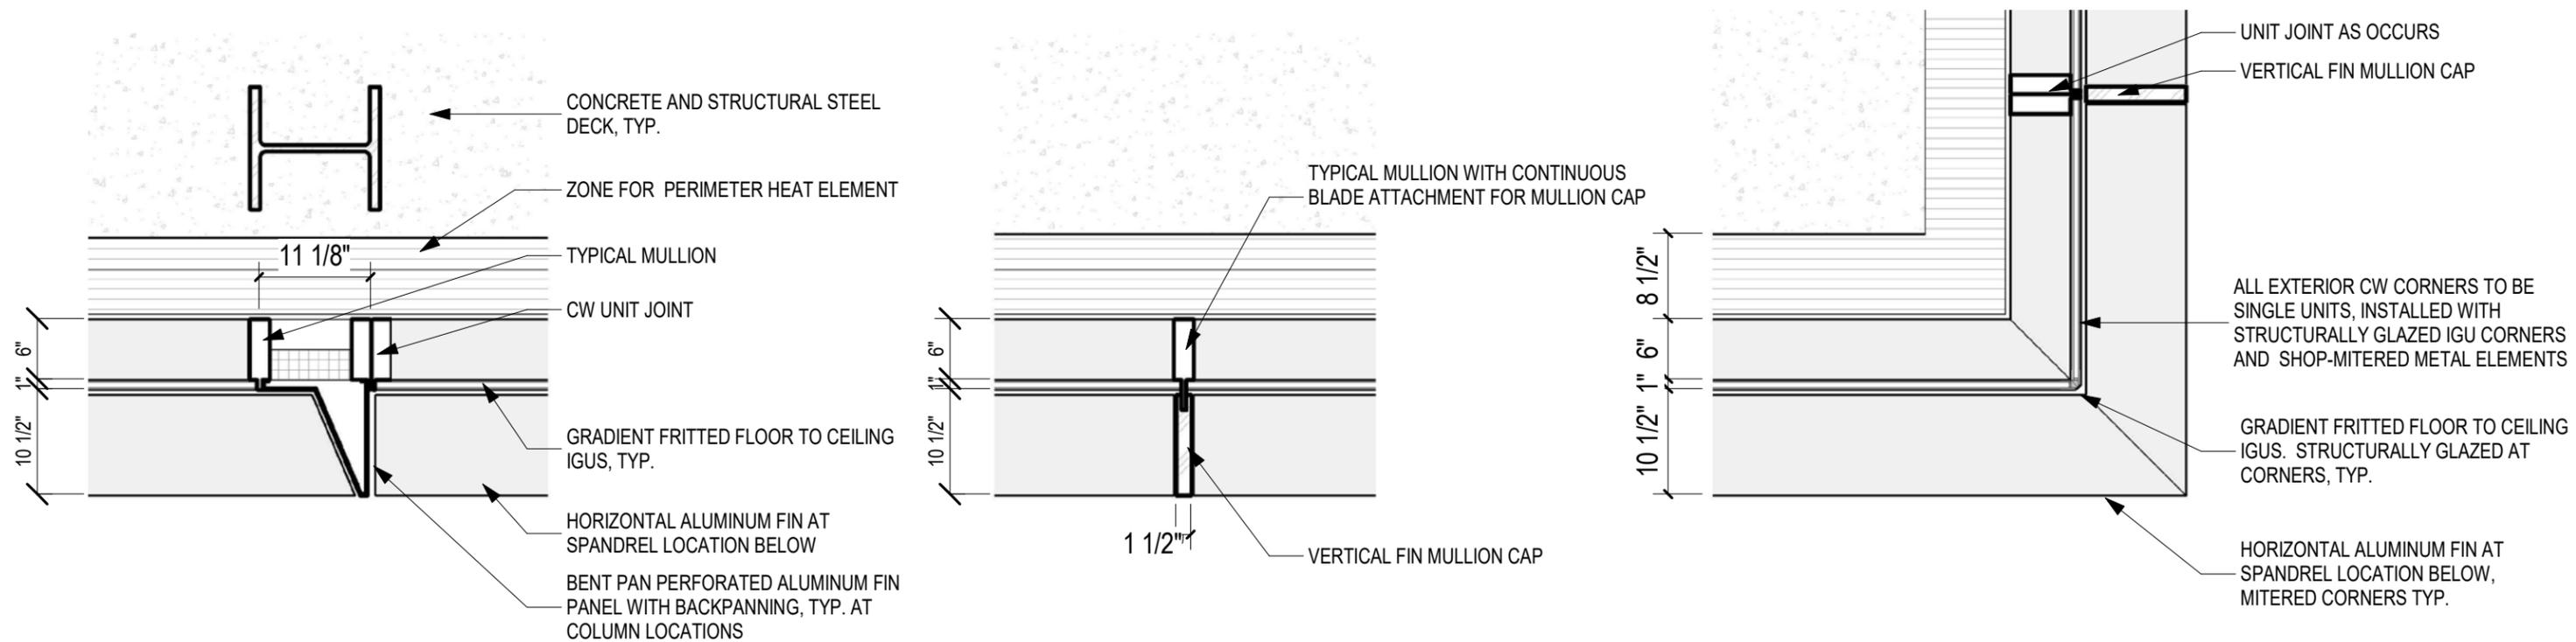
3 PLAN DETAIL - TYPICAL UPPER FLOOR CW AT COLUMN
 3/4" = 1'-0"

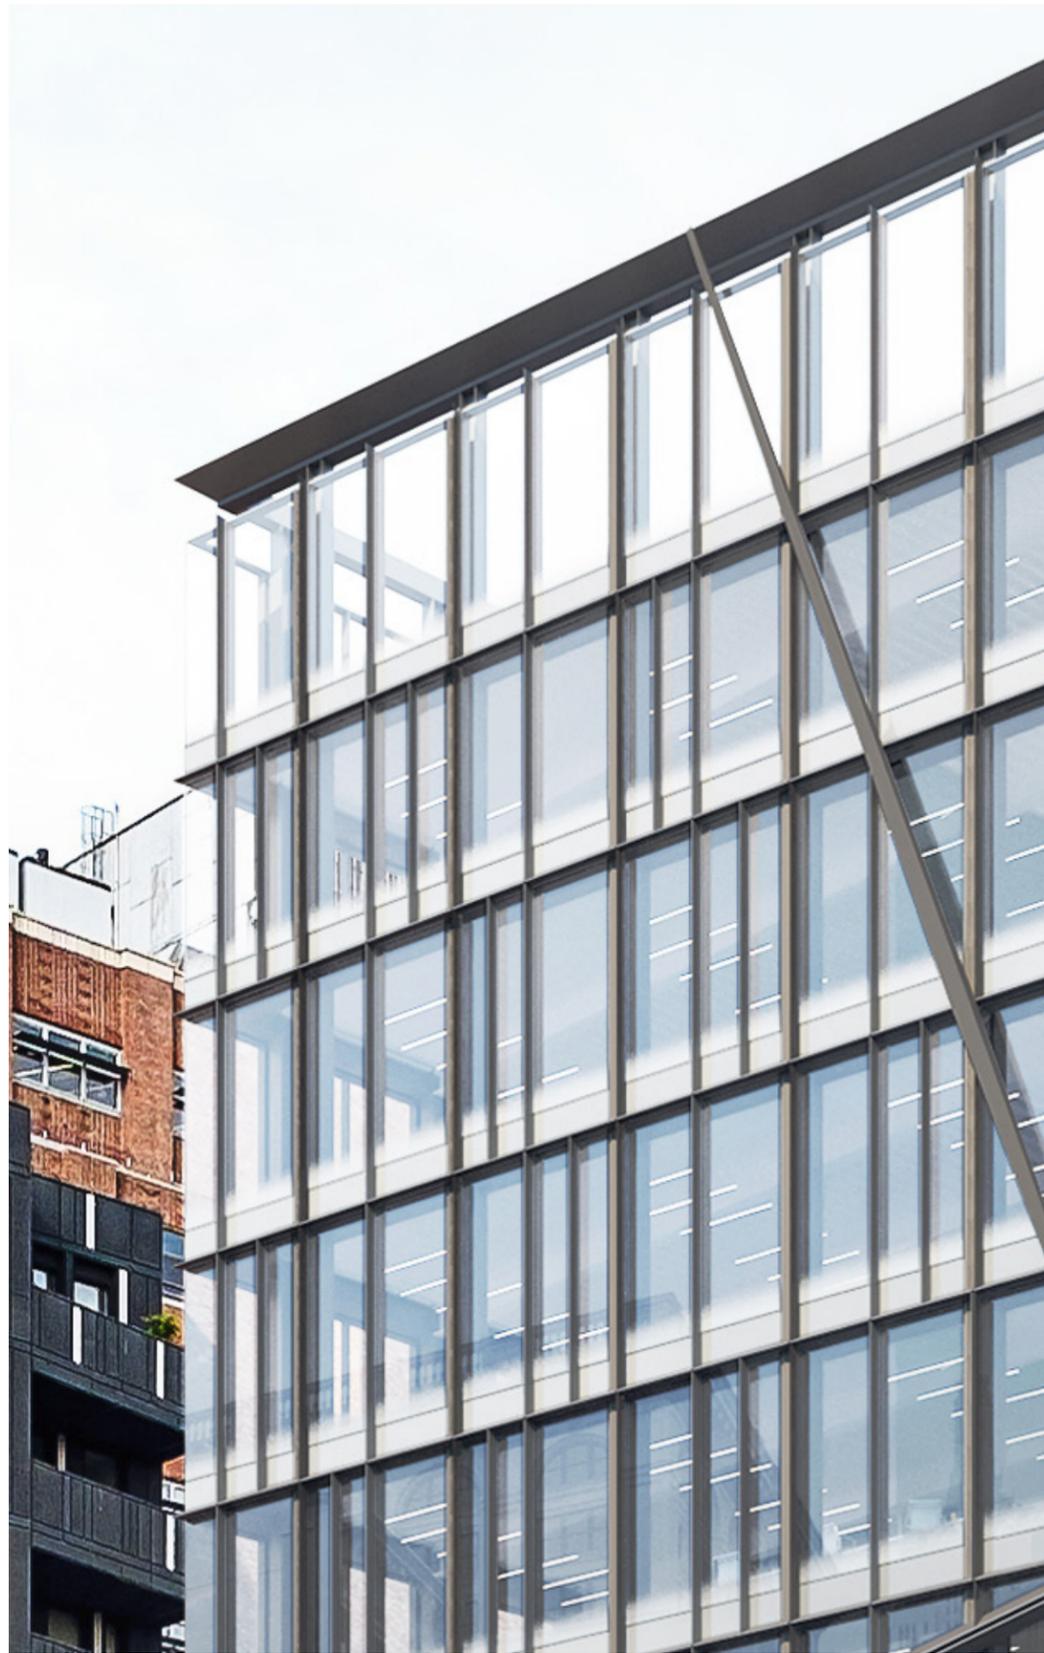
② CURTAIN WALL DETAIL SECTION @ ROOFTOP
3/8" = 1'-0"

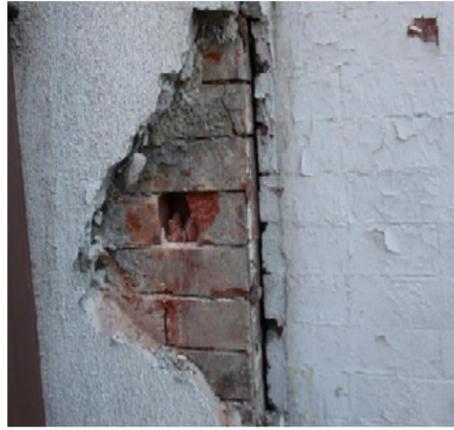
1. KEEP THE DOUBLE-WYTHE BACKUP BRICK WALL THAT IS IN SOUND CONDITION
2. REMOVE THE 2~3" STUCCO AND FURRING STRIPS
3. CAREFULLY REMOVE AND SALVAGE THE FACE BRICKS
4. REATTACH FACE BRICKS TO STABILIZED BACK WALL
5. IF FACE BRICK IS DAMAGED, REINSTALL USING THE UNDAMAGED BACK SIDE

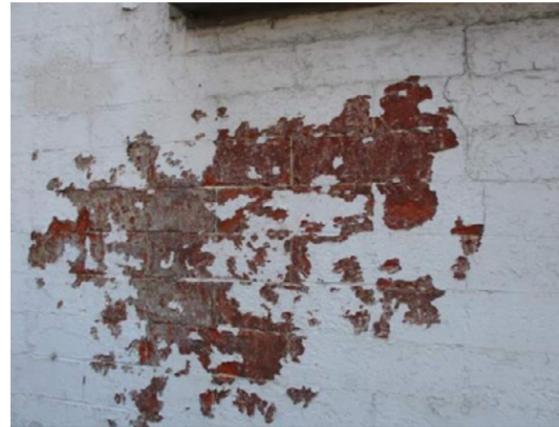
1. KEEP THE DOUBLE-WYTHE BACKUP BRICK WALL THAT IS IN SOUND CONDITION, ADD BACK UP BRICKS UNDER WINDOWS WHERE IS ONLY SINGLE WYTHE
 2. CAREFULLY REMOVE AND SALVAGE THE FACE BRICKS, REMOVE WHITE PAINT BY CHEMICAL PROCESS
 3. REATTACH FACE BRICKS TO STABILIZED BACK WALL
 4. REINSTALL THE FACE BRICKS USING THE BACK SIDE OF BRICK IF IT'S ORIGINAL FACE IS DAMAGED SEVERELY
- * REMINISCENT WHITE PAINT WILL BE VISIBLE

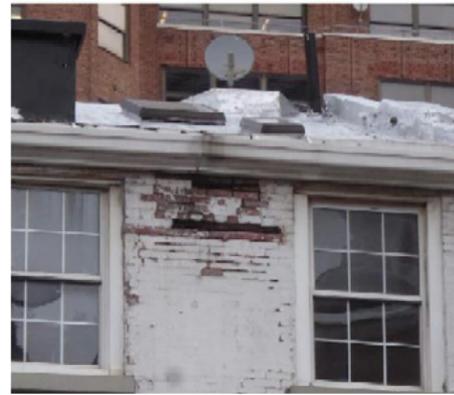
14TH ST BLDG
 EXPOSED DETERIORATED NAILER WOOD OF THE FASCIA BOARD IMPACTING THE STABILITY OF THE ADJACENT MASONRY.

RESTORATION PLAN: REINSTALL THE CORNICE AND FASCIA BOARD ACCORDING TO THE HISTORIC PHOTO

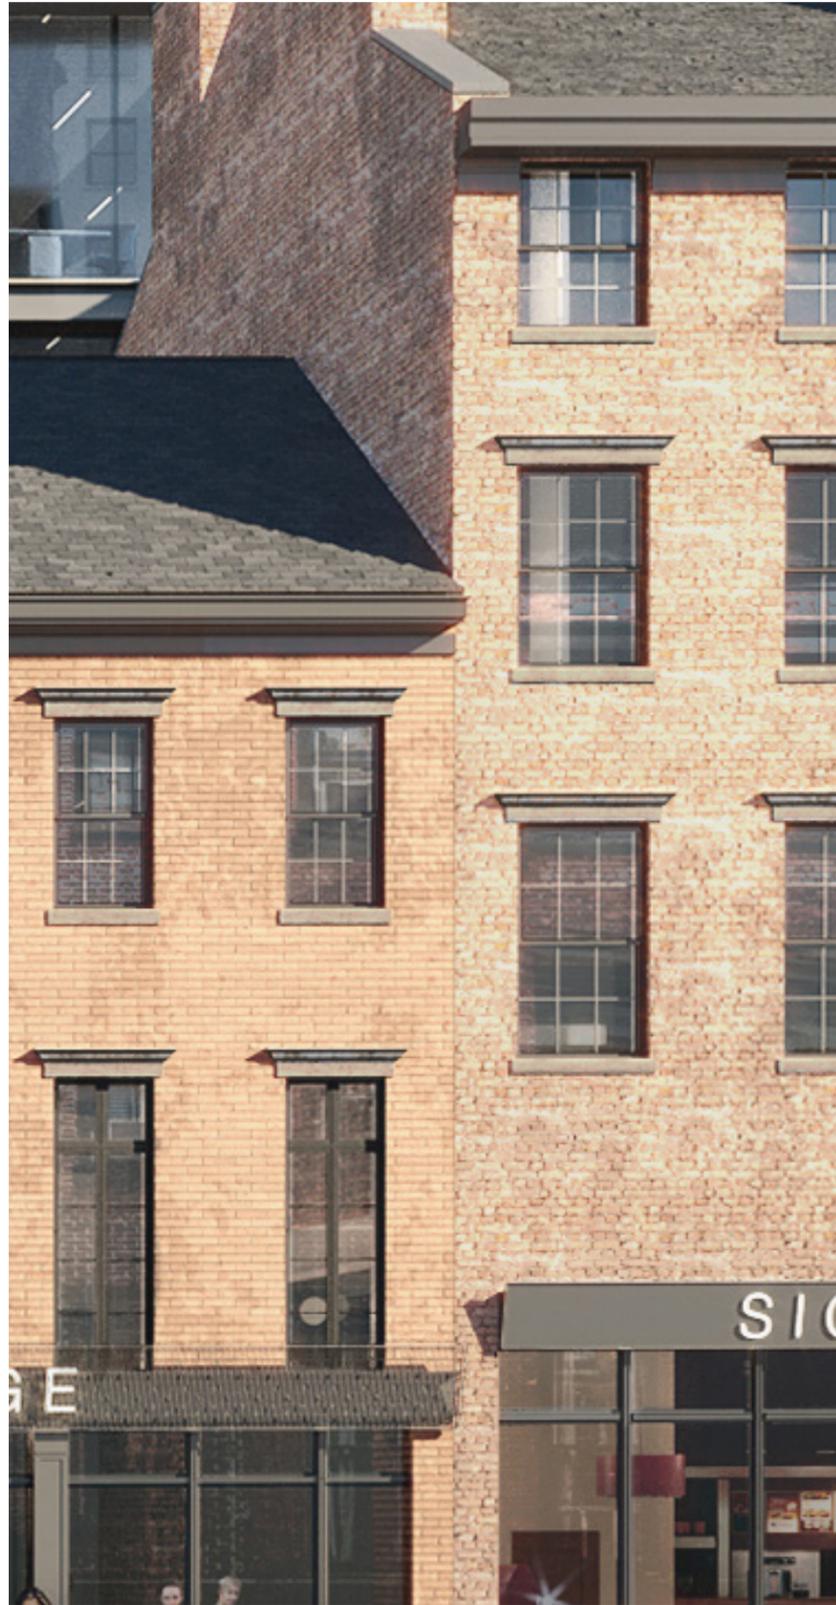
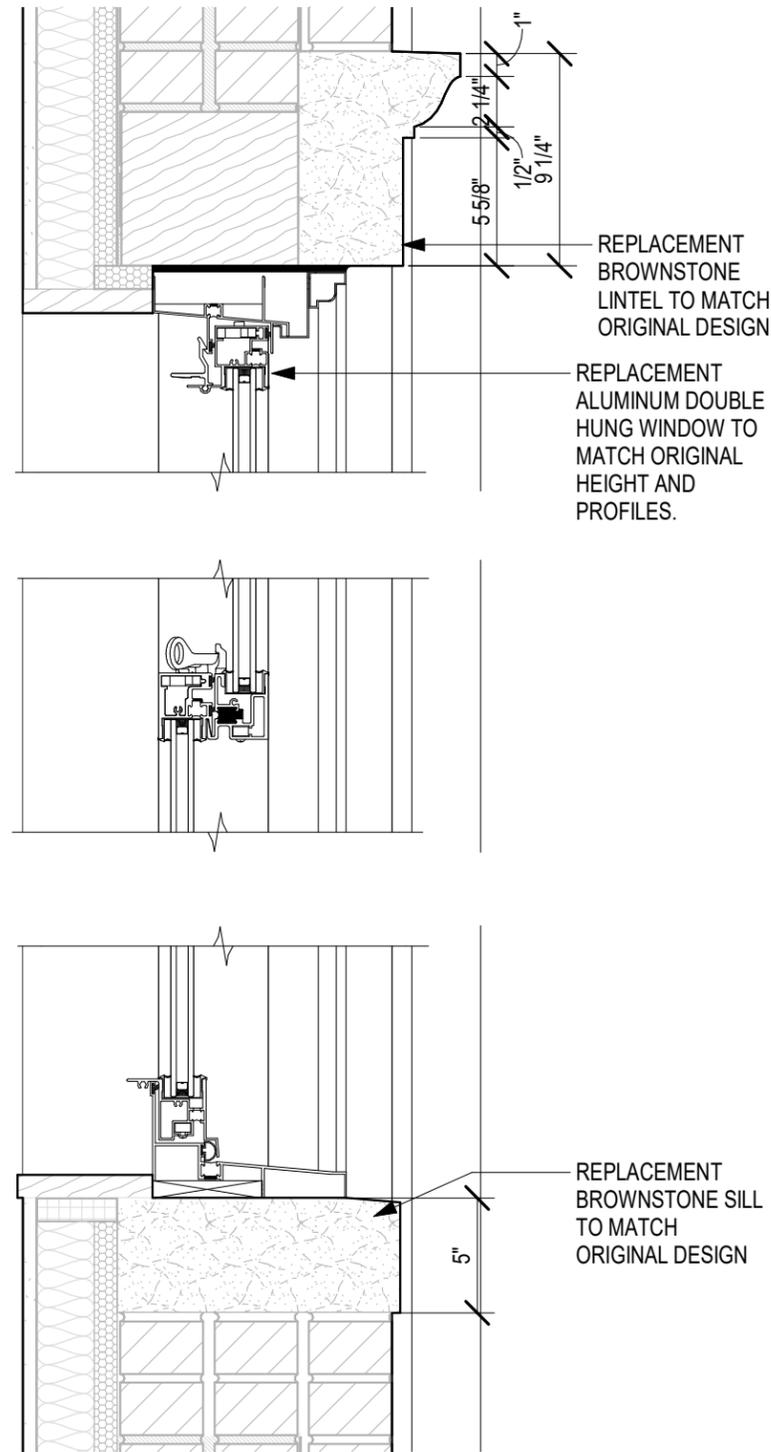
① TYPICAL DOUBLE HUNG WINDOW SECTION DETAIL
1 1/2" = 1'-0"

② TYPICAL 9TH AVE BLDG TALL CASEMENT WINDOW SECTION DETAIL
1 1/2" = 1'-0"

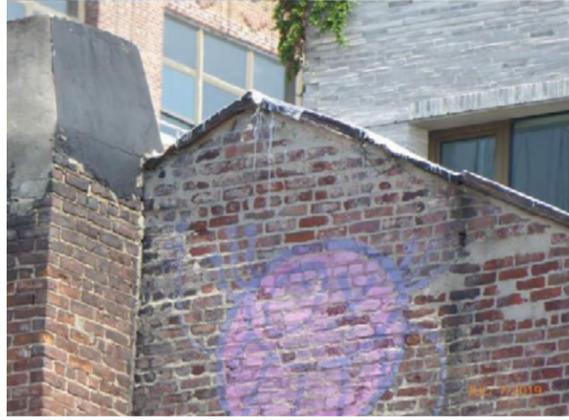
WEST FAÇADE. DELAMINATING AND SPALLED BLUESTONE COPING STONES.

RESTORATION PLAN: REINSTALL THE BRICK PARTY WALL ON ROOF AND BLUESTONE COPING

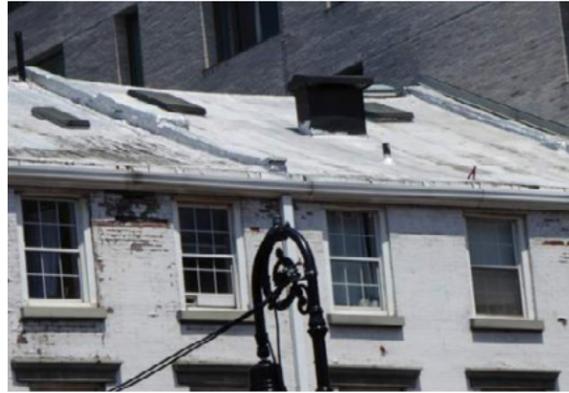
BASE FLASHING EXTENDED UP THE RISING WALL OF 14TH ST BLDG, TERMINATED WITH SURFACE-MOUNTED ALUMINUM FLASHING.

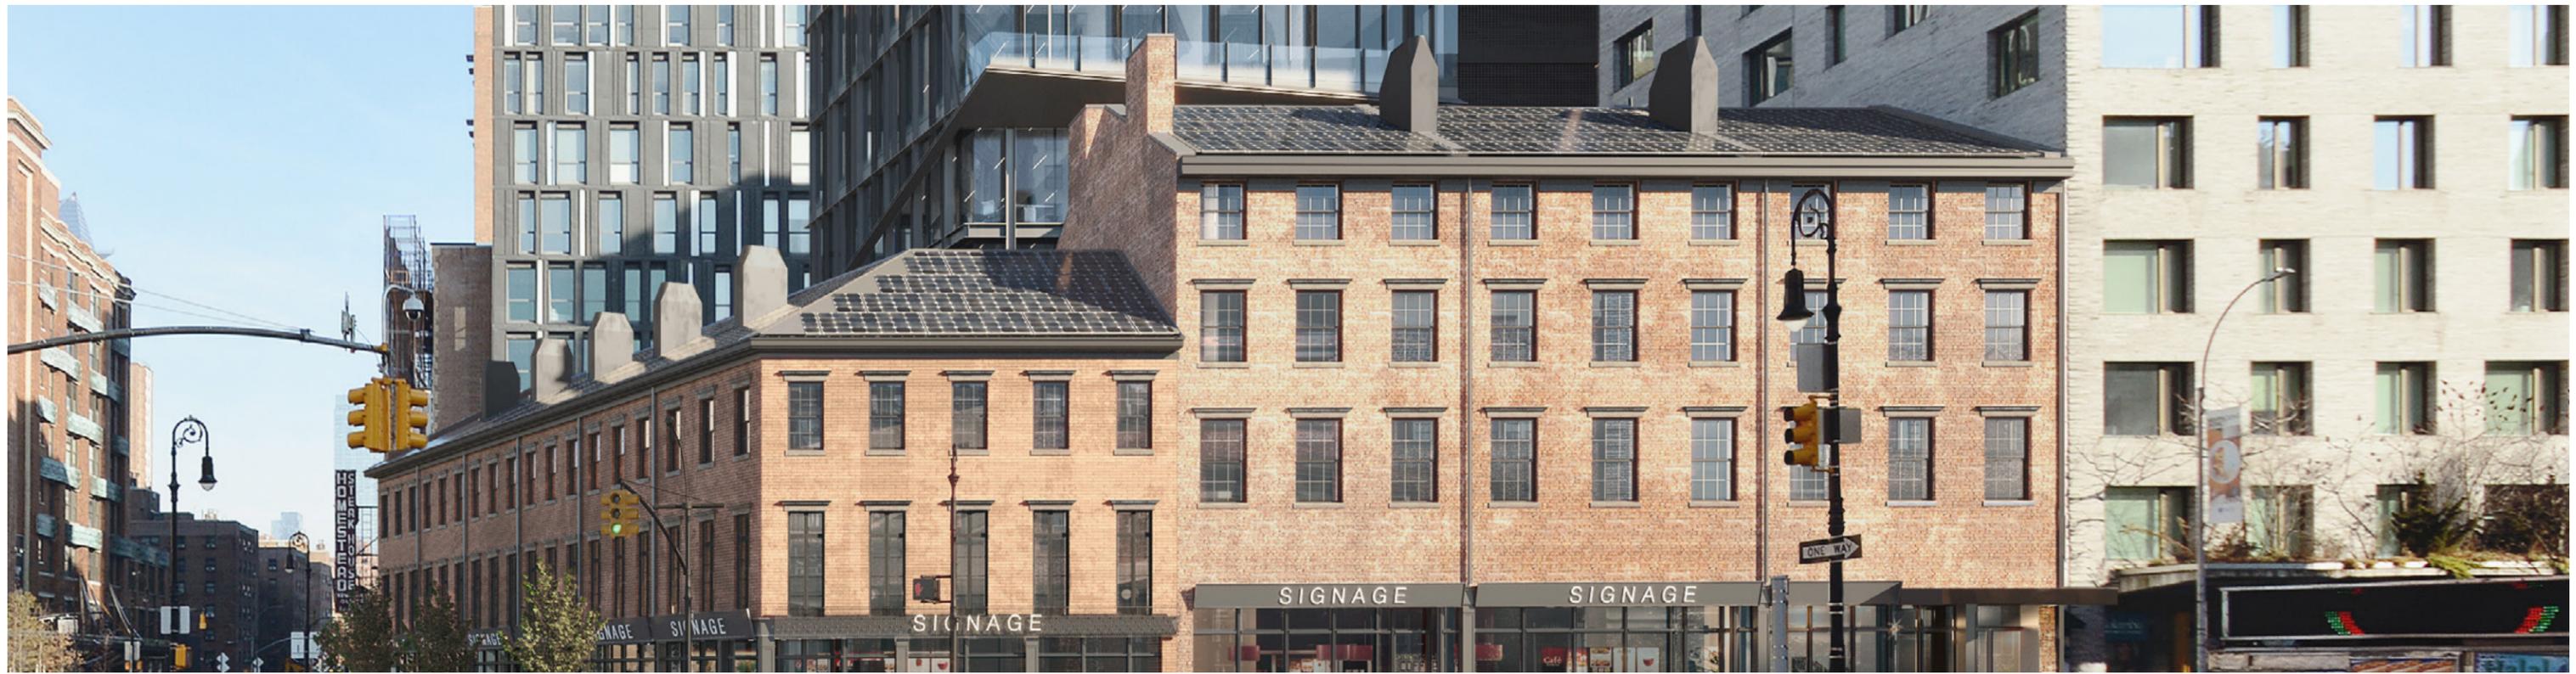
SOLAR PANEL ON STANDING SEAM ROOF

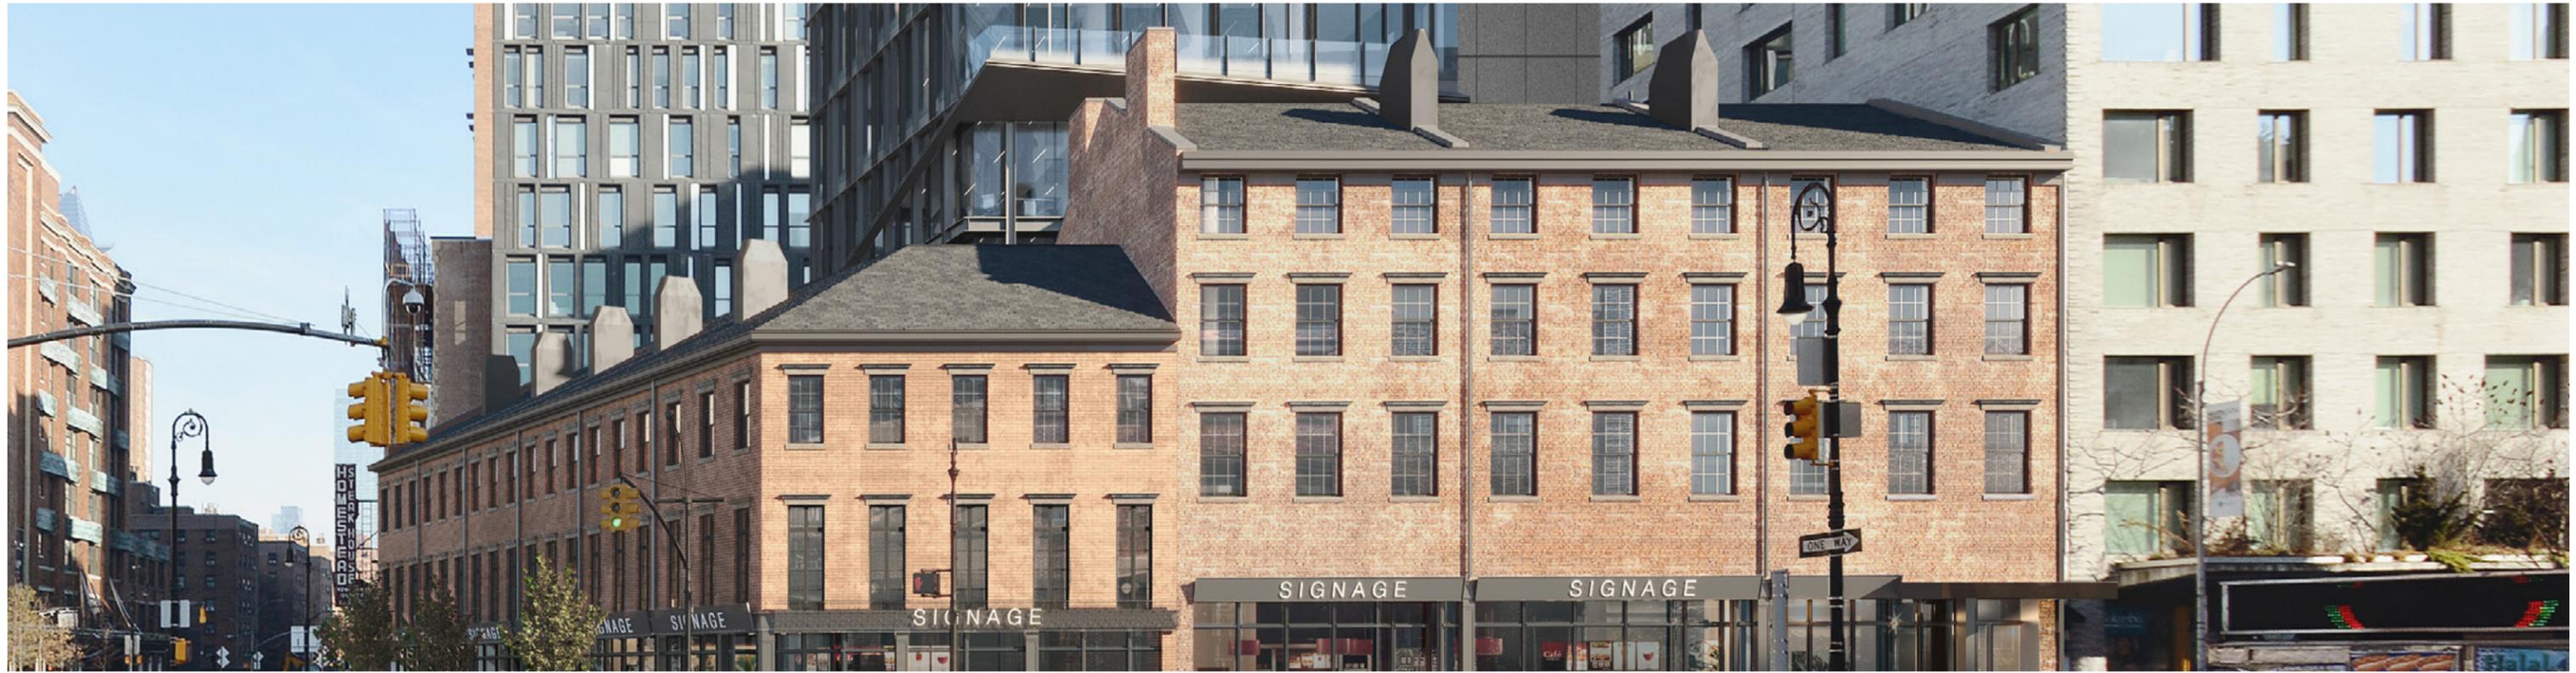
RESTORED SLATE ROOF

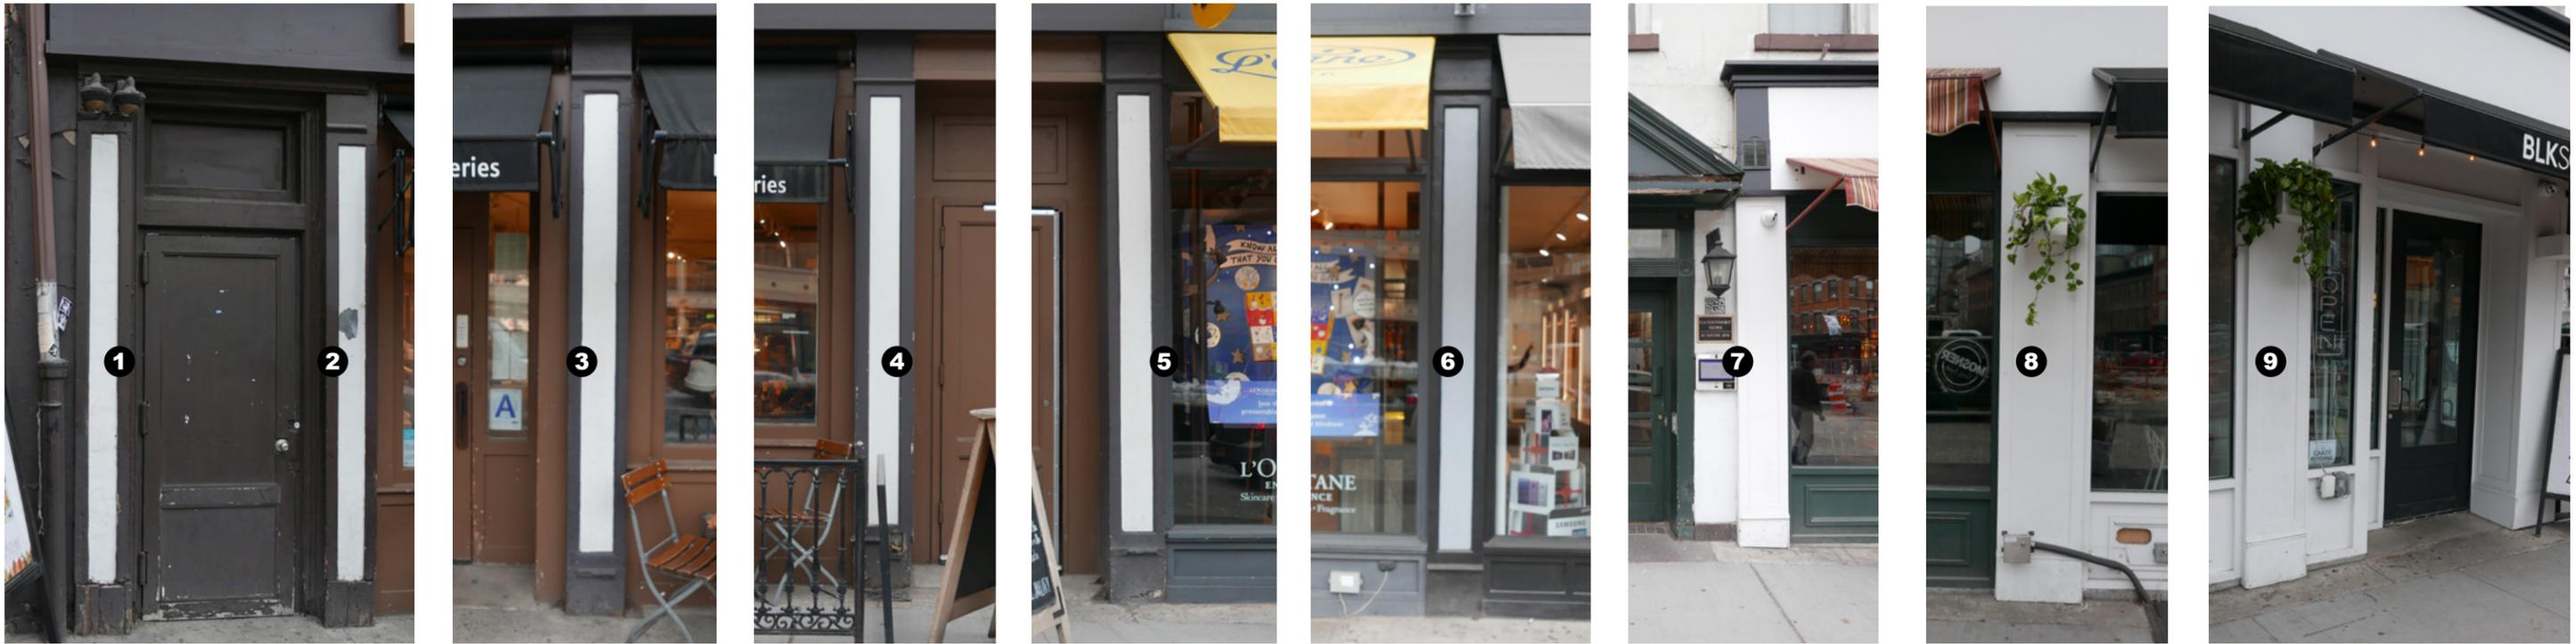
- EXPOSED CAST IRON COLUMNS TO REMAIN
- COVERED CAST IRON COLUMNS TO BE EXPOSED
- FAUX CAST-IRON COLUMN TO BE REMOVED
- BRICK PIERS TO BE EXPOSED

9TH AVENUE STOREFRONT SCALE: 1/8"=1'-0"

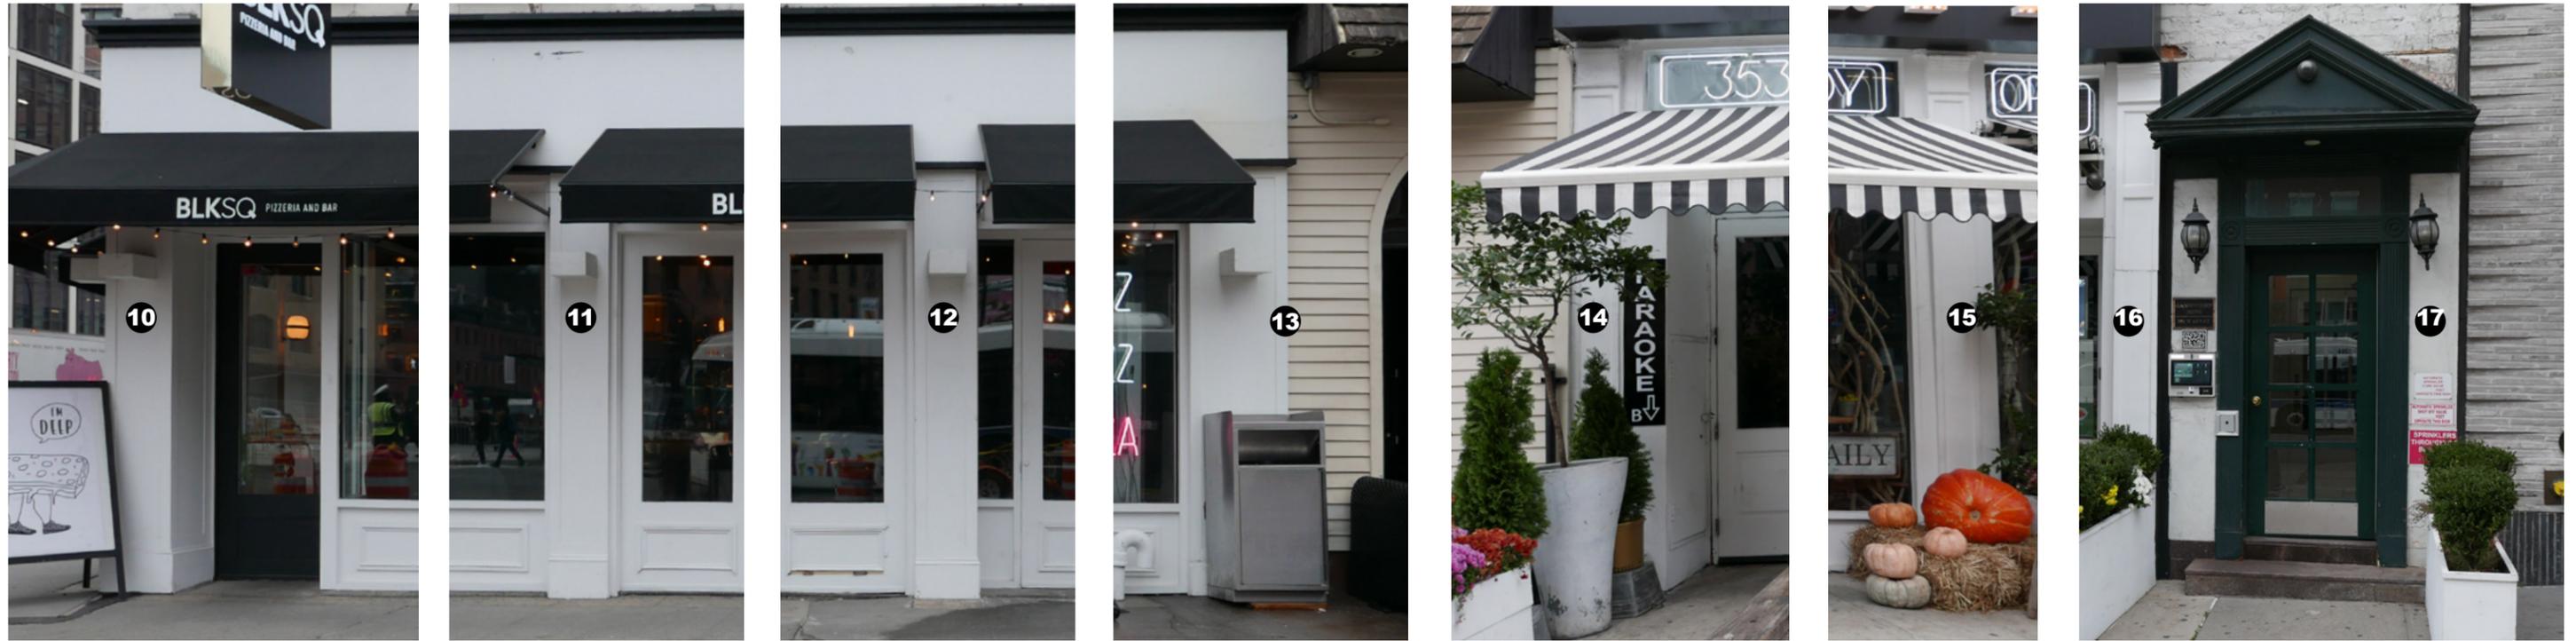
- EXPOSED CAST IRON COLUMNS TO REMAIN
- COVERED CAST IRON COLUMNS TO BE EXPOSED
- FAUX CAST-IRON COLUMN TO BE REMOVED
- BRICK PIERS TO BE EXPOSED

14 TH STREET STOREFRONT SCALE: 1/8"=1'-0"

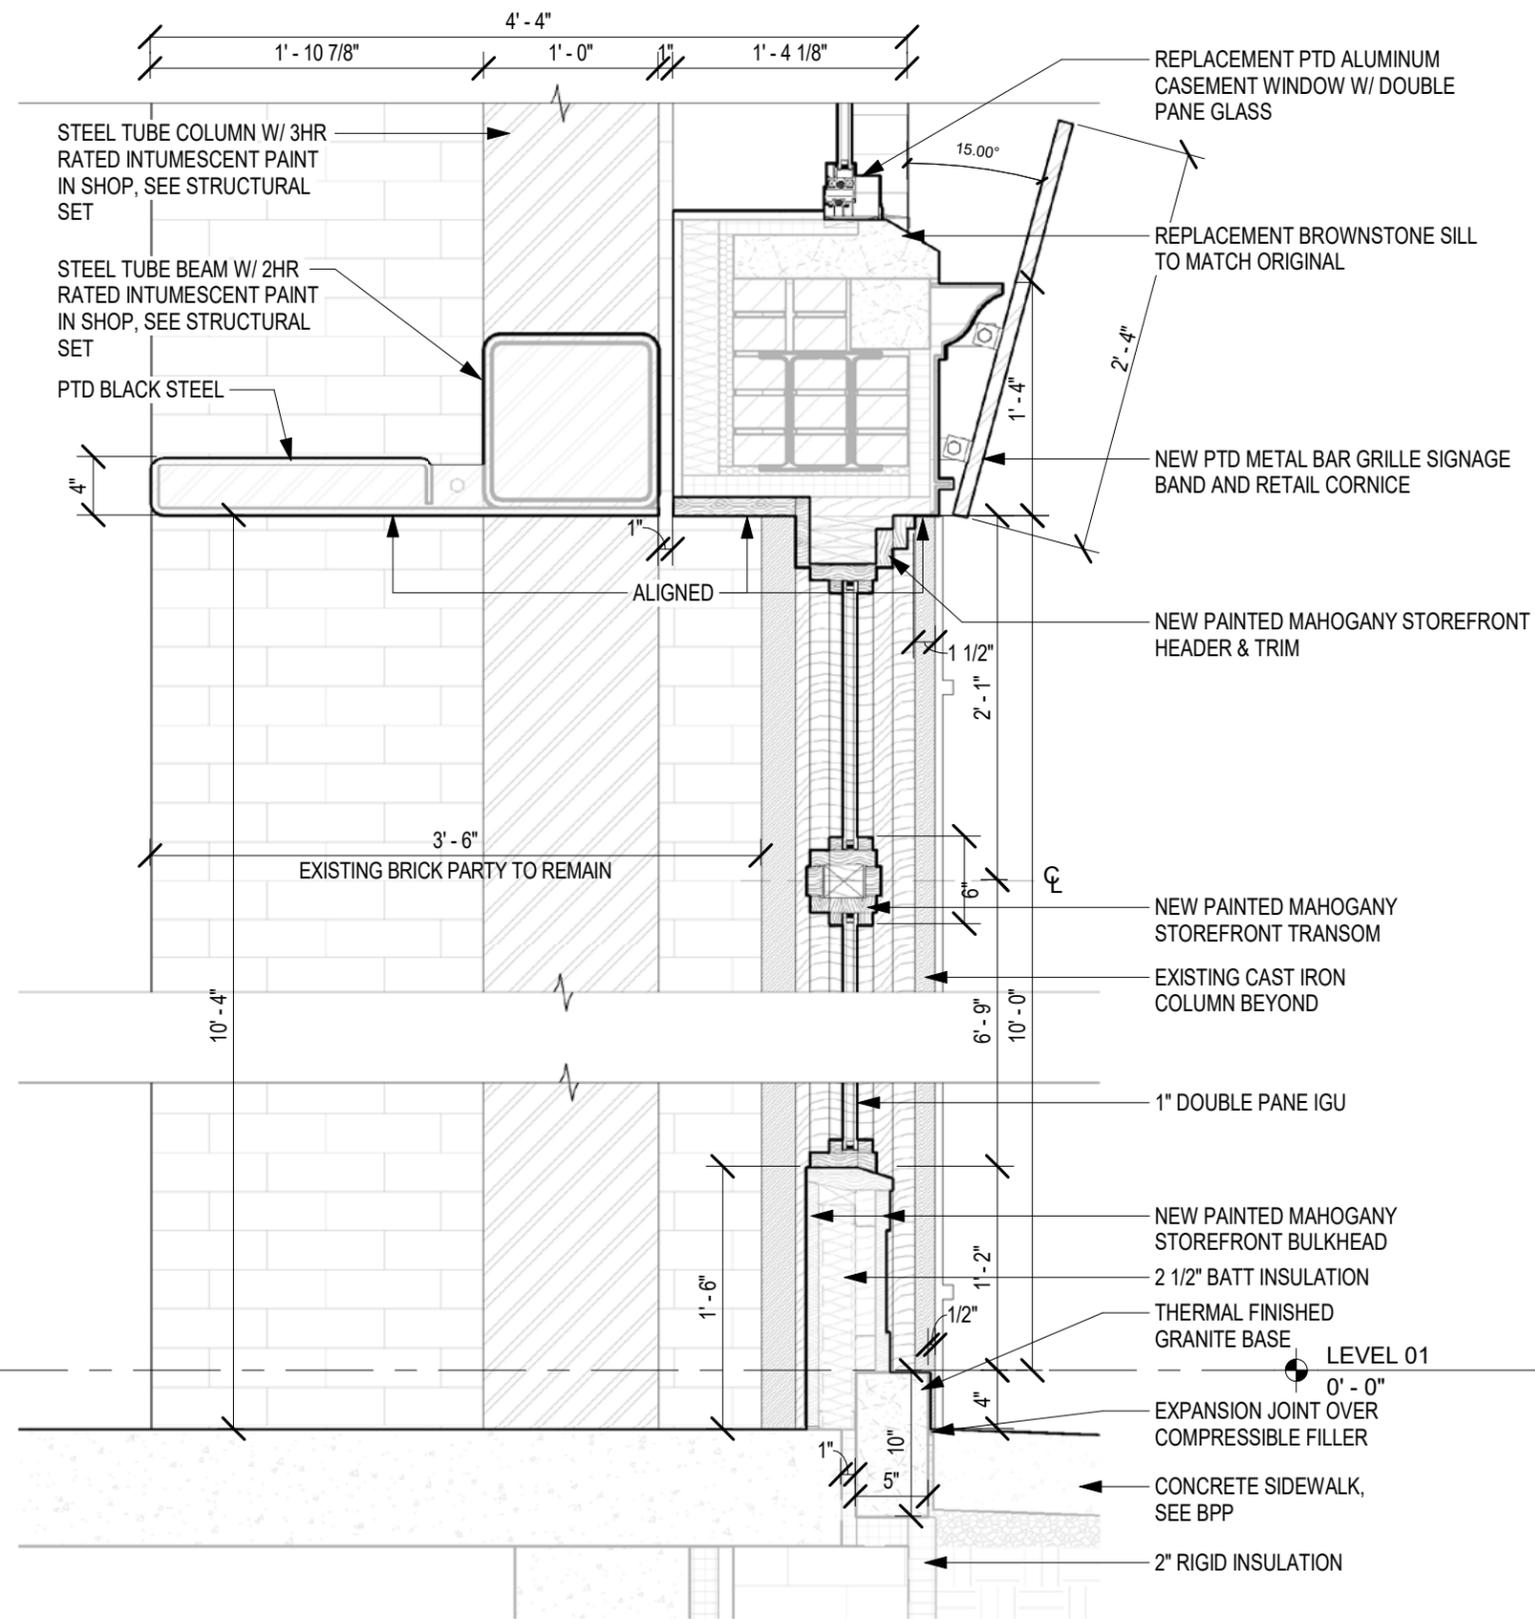
① 9TH AVE STOREFRONT DETAIL SECTION
1" = 1'-0"
